**Historic building recording
at Shalford Hall Farm barns,
The Street, Shalford, Essex
February 2015**

**report prepared by
Chris Lister**

**commissioned by
Alun Design Consultancy Ltd
on behalf of
Mr Allan Stevenson**

CAT Report 841
July 2015

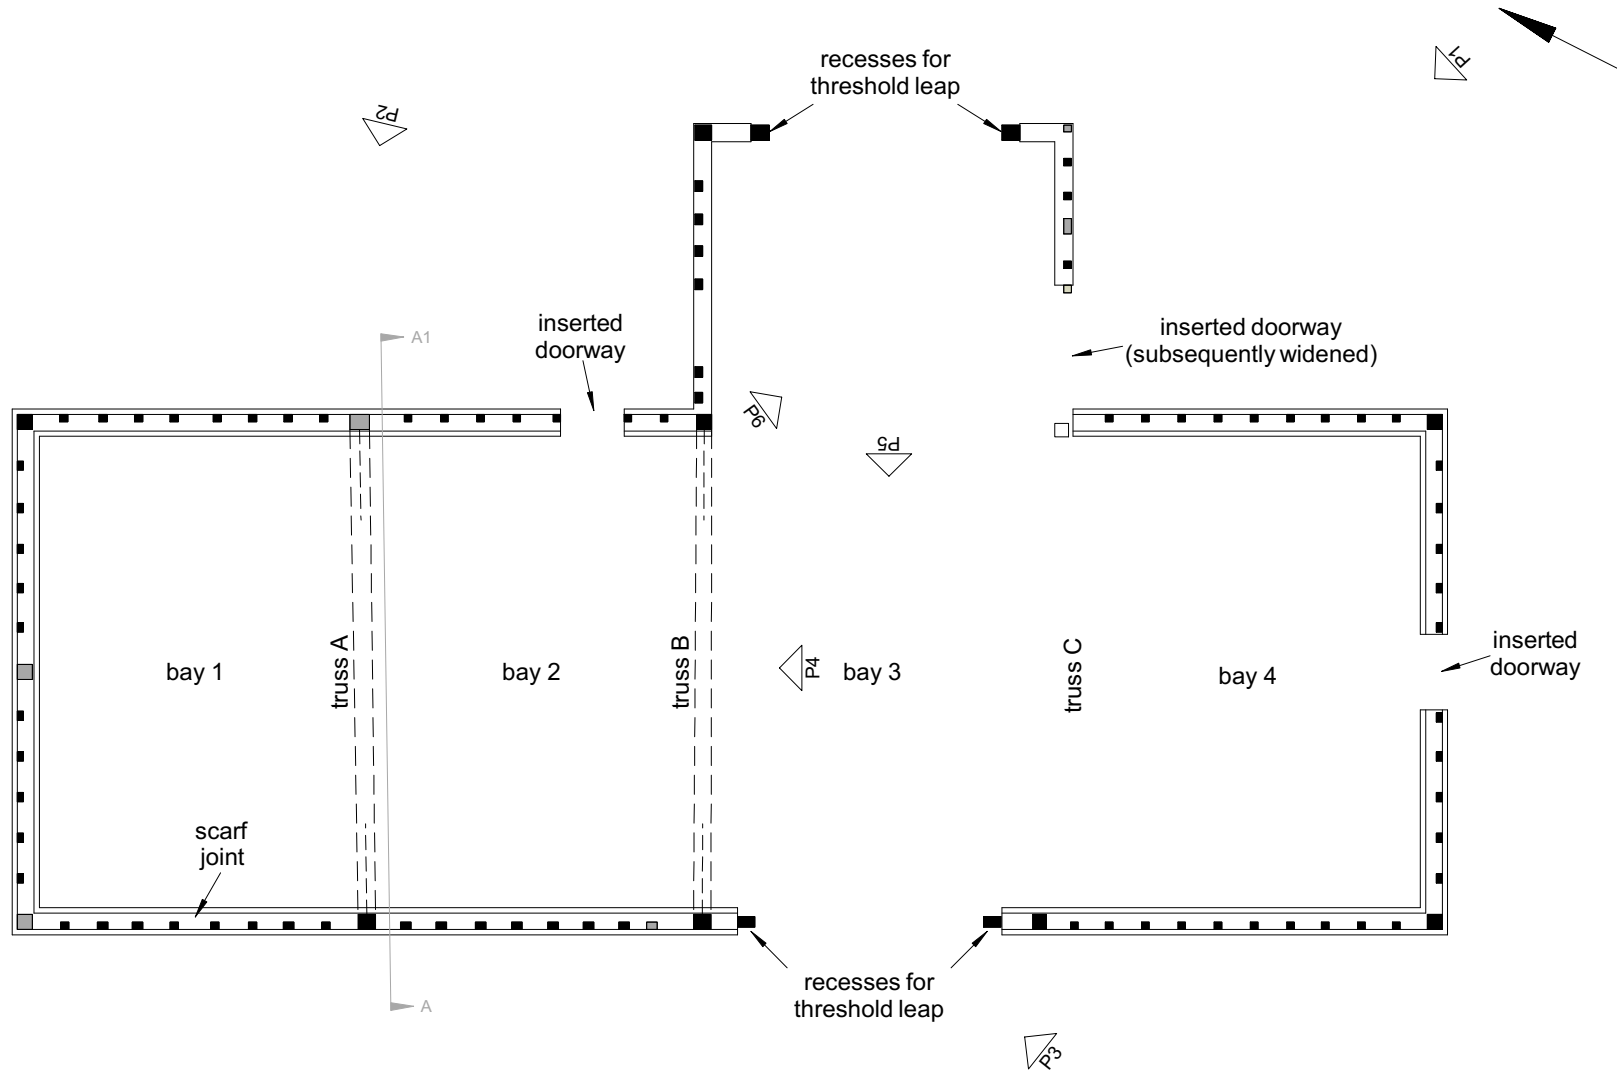
Fig 2 Plan of the Grain Barn at Shalford Hall Farm, showing phases and alterations. The location and orientation of photographs included in this report are indicated the numbered arrows.

A single face-halved scarf joint with bladed abutments was noted in the sill beam of bay 1 (Fig 2) and others were present in the wall plate above the barn door opening in bay 3 (Fig 8) and near the head of the post in the wall plate on the north-east side of truss C (Fig 7). Additionally the bases of the north-east posts to trusses B and C have crude scarf joints, which may have something to do with the rebuilding of the midstreys (Fig 7).

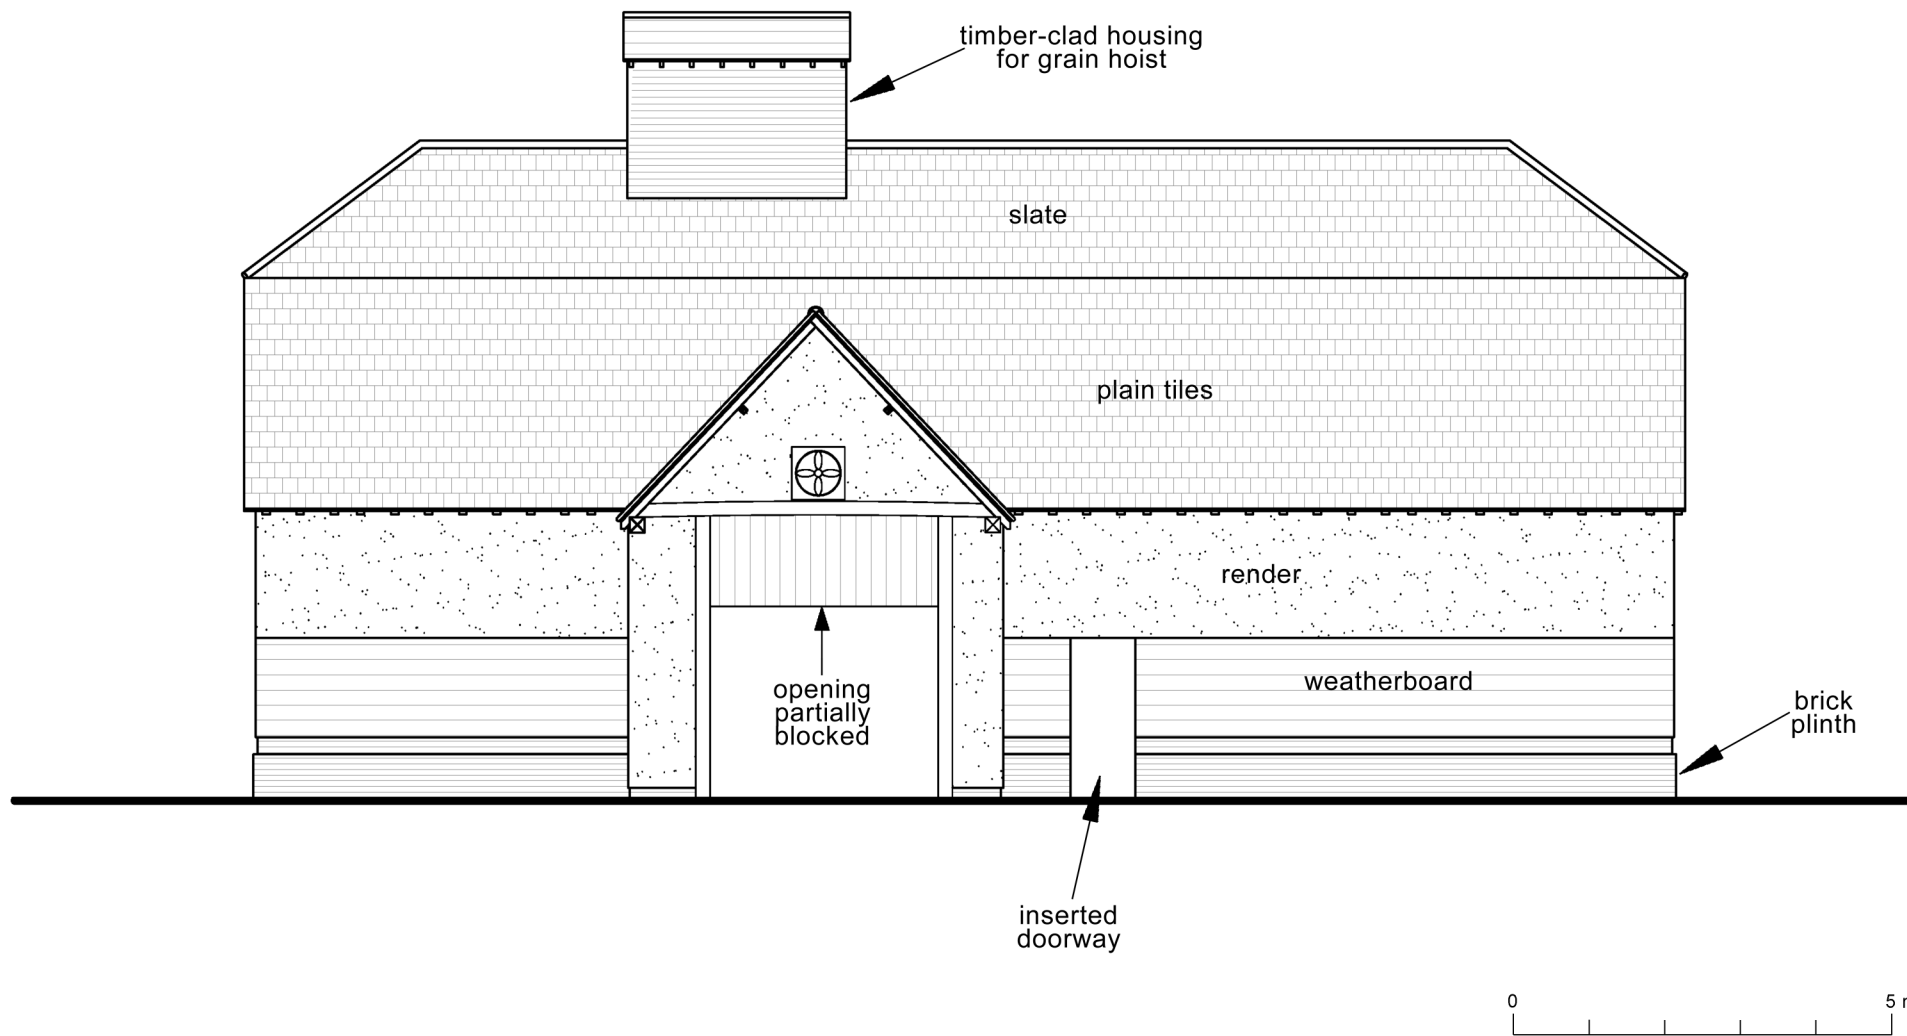
Fig 3 North-east elevation of the Grain Barn.

The north-east elevation (Fig 3) has an off-centre midstrey projecting from it, in line with a pair of full height barn doors in the south-west elevation (Fig 4). The midstrey doorposts have recesses for a threshold leap and there is a modern equivalent of a threshold leap in the south-west doorway, although the recesses have been replaced by iron stanchions. Although the barn doors have been replaced they appear to retain the original strap and pintel hinges (Plate 3).

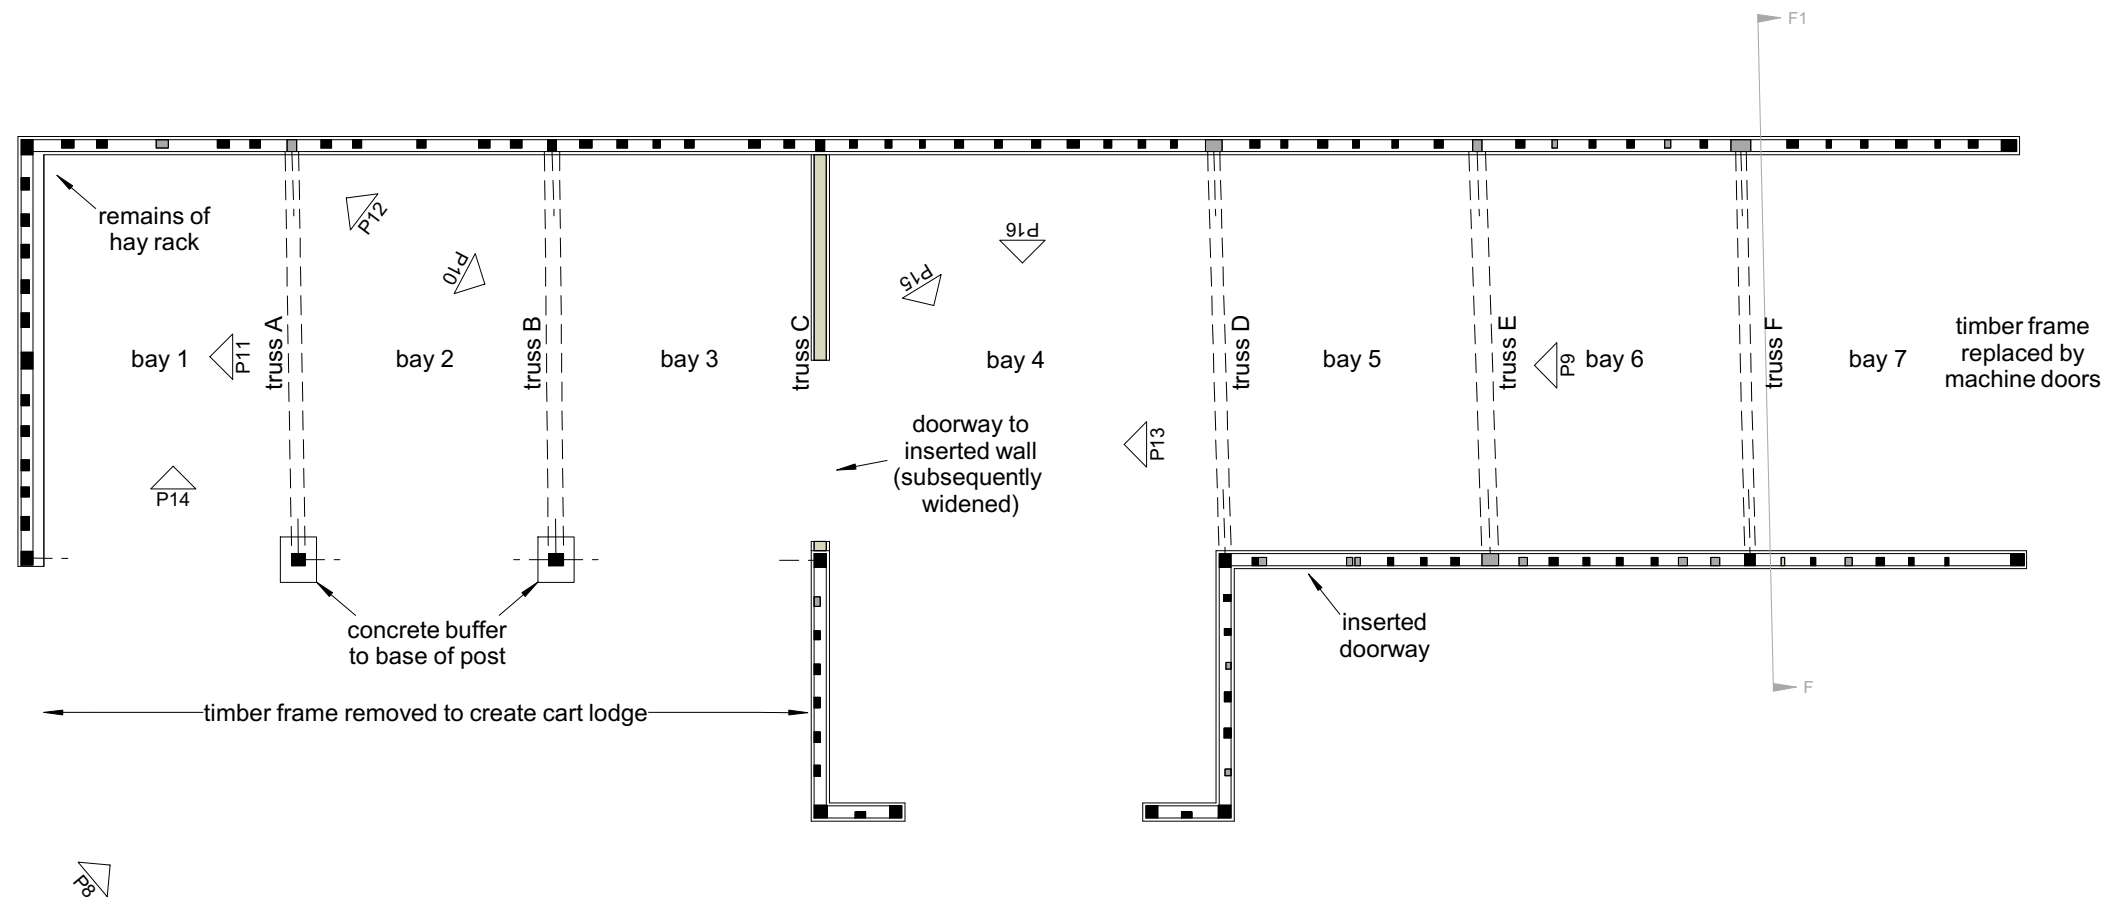
Fig 12 Plan of the Church Barn at Shalford Hall Farm, showing phases and alterations. The location and orientation of photographs included in this report are indicated the numbered arrows.

The interior of the Church Barn is divided into seven bays, three roughly equal-sized bays to either side of the midstrey bay which is much wider (Plate 9, Fig 12). The frame consists of hand-sawn hardwood timbers with posts of varying dimensions, girding beams and wall plates, all of which include many re-used timbers (Figs 17-21). The studs are not of uniform scantling and consist of both re-used timbers and timbers original to the building, although the deteriorated state of the posts and studs makes differentiating this very difficult.
