Historic building recording at 11 Trinity Street, Colchester, Essex, CO1 1JN

May-June 2016

CAT Report 990
August 2016

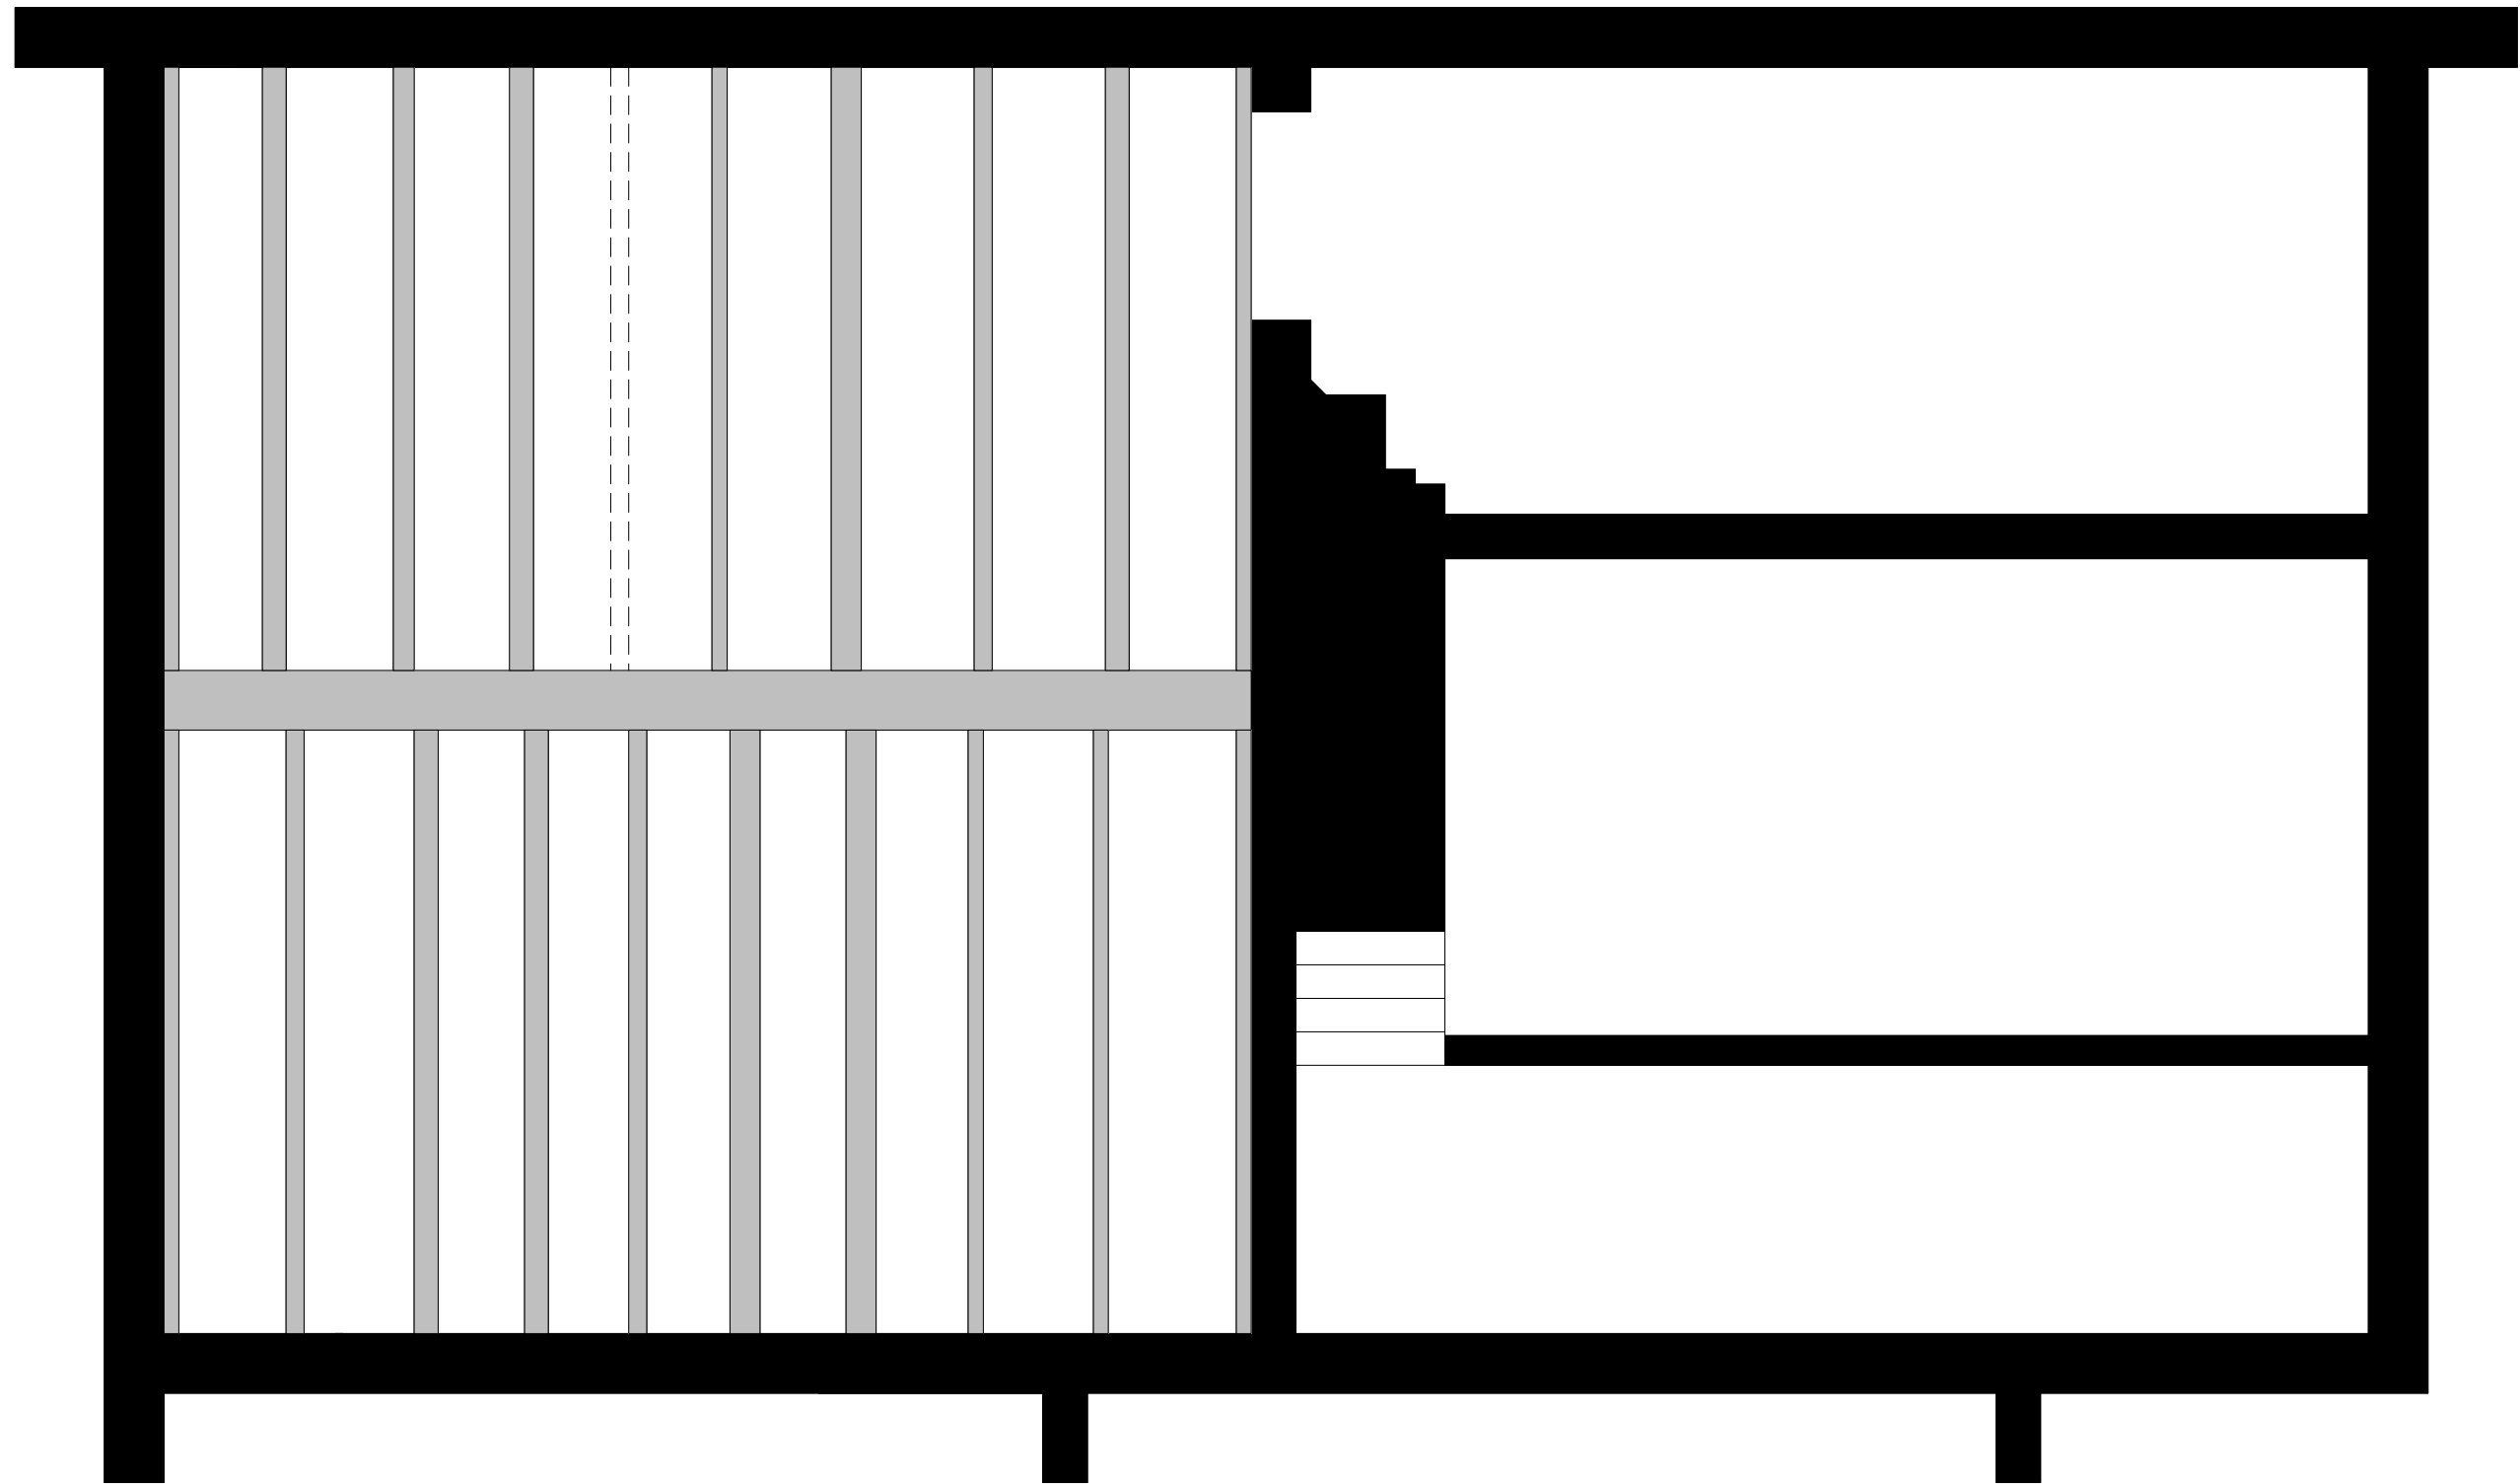
Fig 2 19th-century ceiling joist layout.

After contractors had stripped away the modern plasterboard ceiling, exposing the joists, an inspection of the roof space was undertaken. The joists were a mixture of machine-cut and hand-sawn timbers, aligned east-west across the original building and jointed at the centrally-located bridging beam (Photograph 6, Fig 2). The joists were jointed to the bridging beam with staggered mortises (Photograph 7). Although modern plasterboard was removed from the ceiling this had been covering lath and plaster, the ghost of which can be seen on the underside of the joists. Despite this lath and plaster covering it is clear that the sagging ceiling was a 19th or early 20th-century insertion to the building as the machine-cut timbers of the joists were contemporary to the ceiling and not later repairs.

Visible above the inserted ceiling were the remains of an earlier lath and plaster ceiling, the deterioration of which had caused the later ceiling to sag and bulge. This was constructed from horsehair plaster applied to laths nailed to the rafters and the undersides of collars. These collars were scarfed to the purlins with birdsmouth joints but were formed from machine cut-timbers (Photograph 8), which suggests that this earlier lath and plaster ceiling dates to the late 18th or early 19th century (machine cut-timbers appear with the advent of the circular saw blade during the Industrial Revolution towards the end of the 18th century).

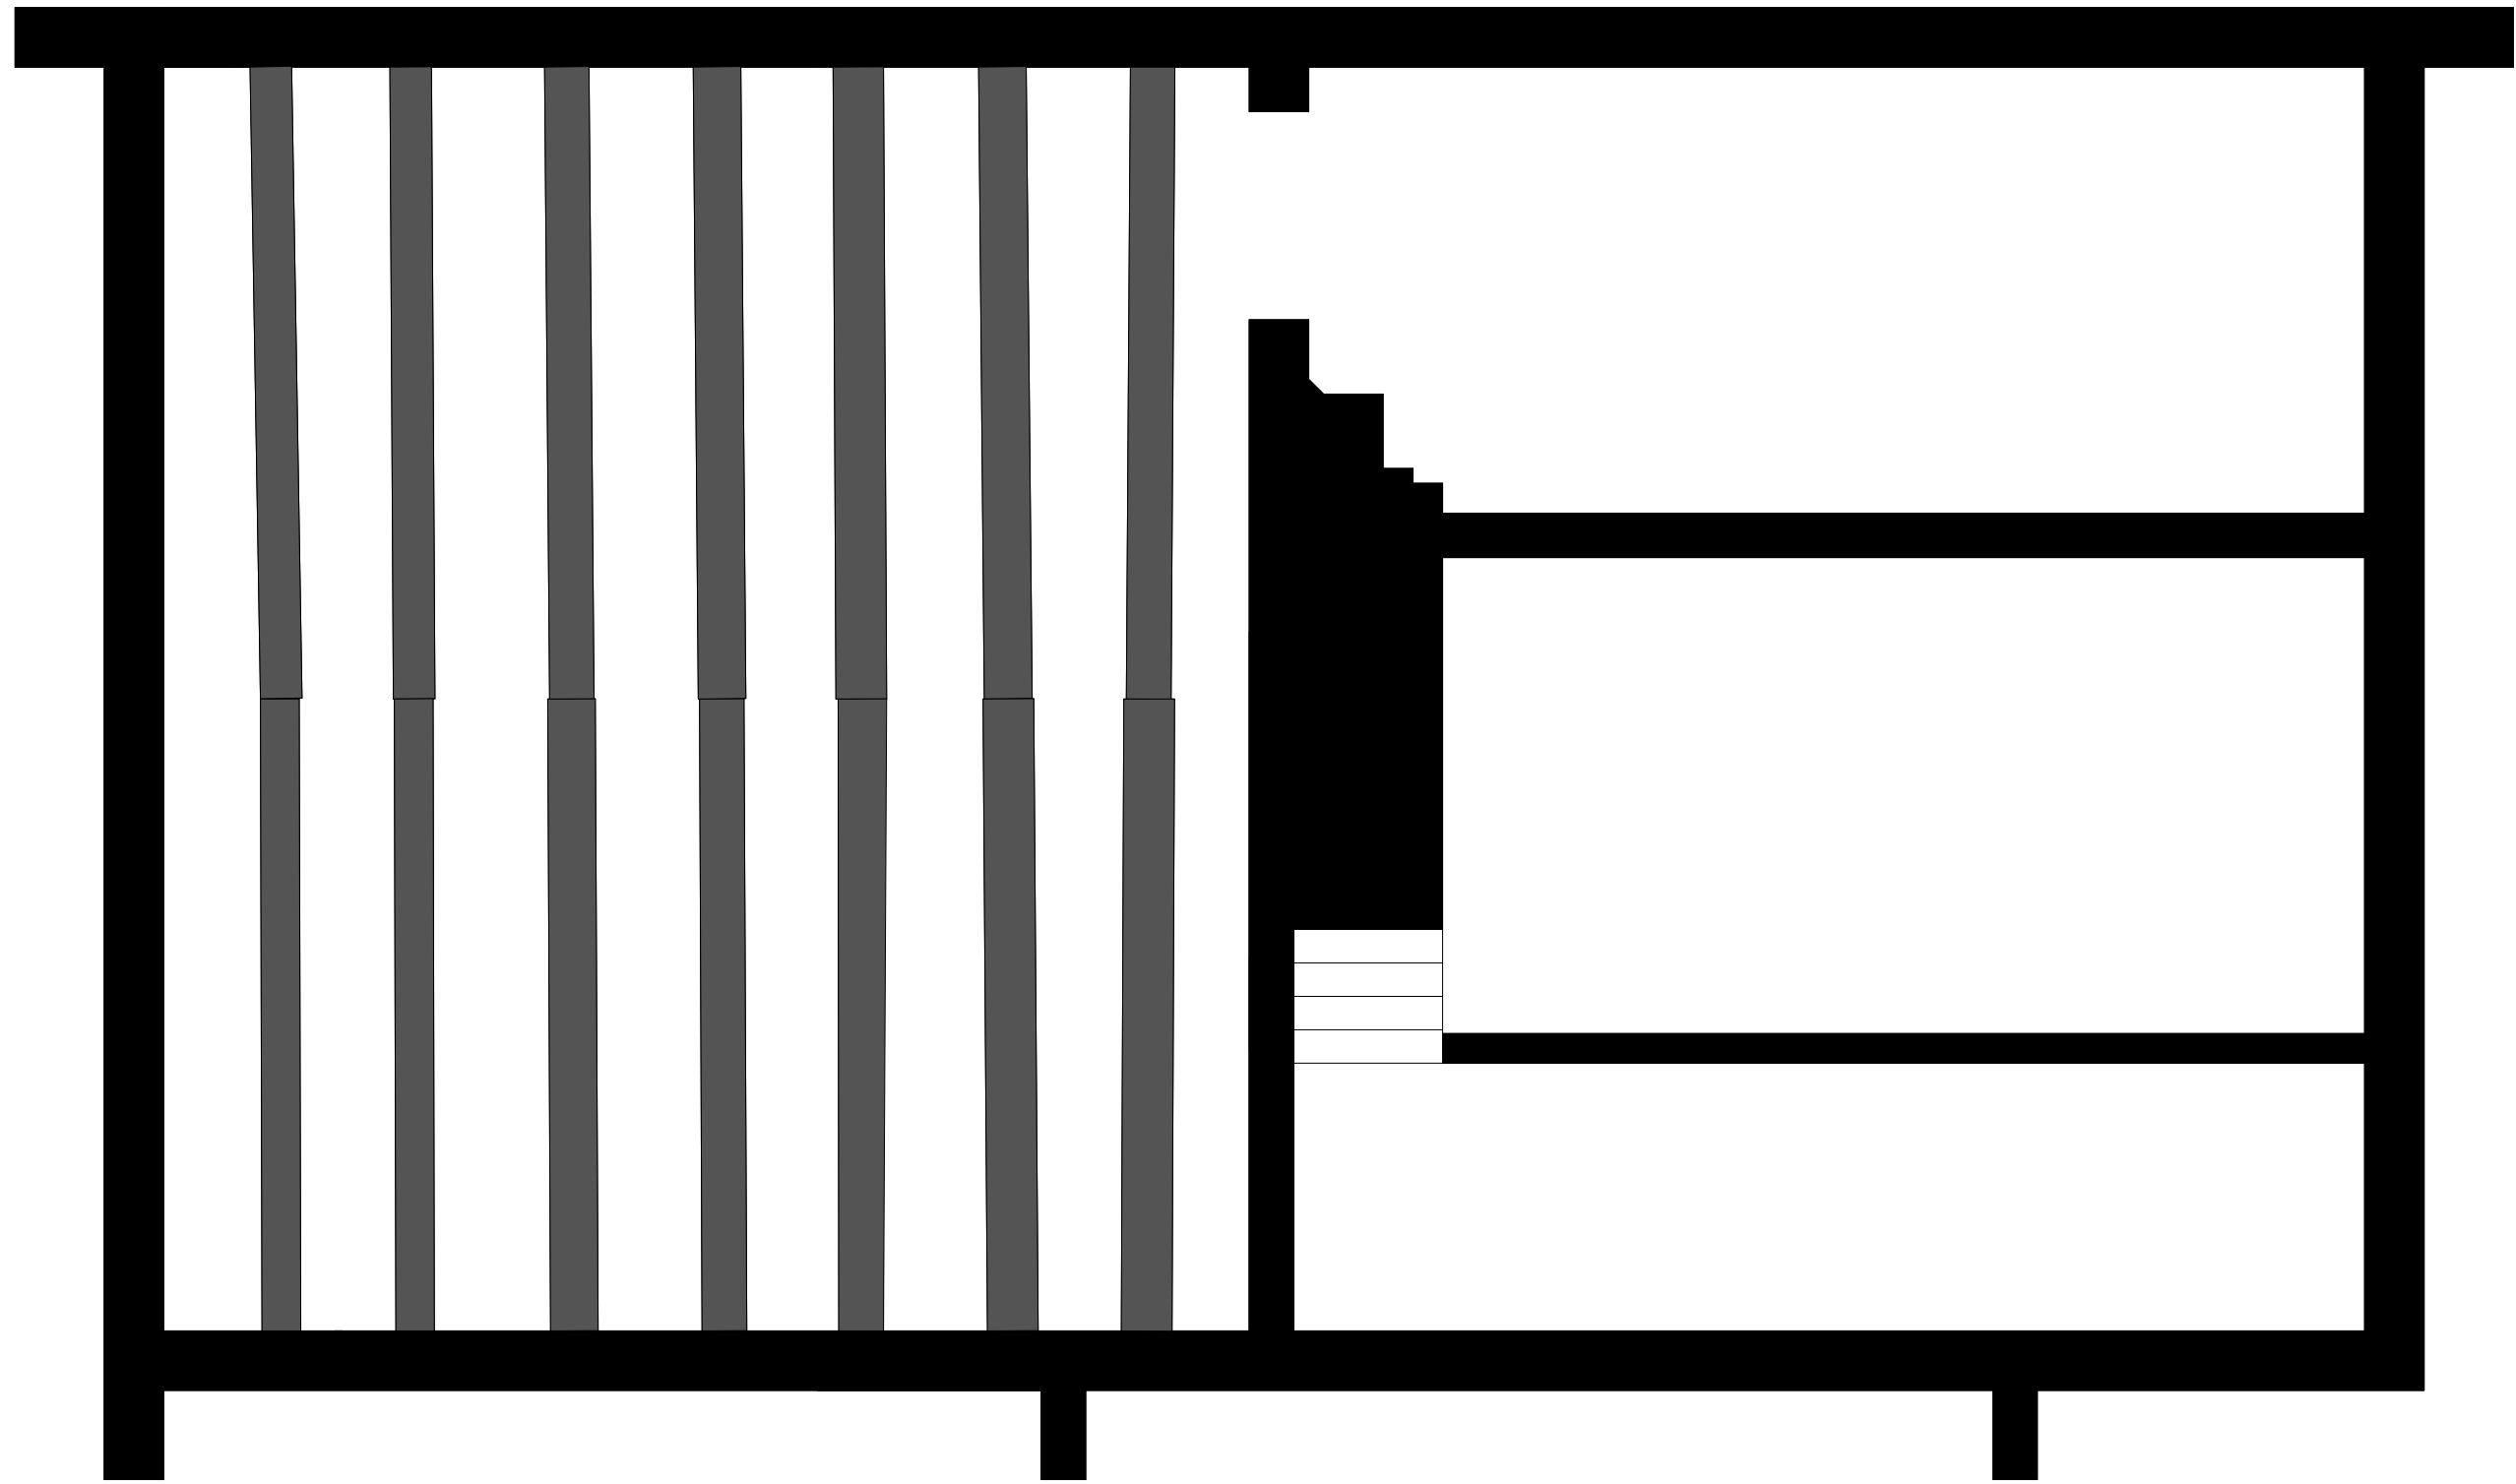
Fig 3 Original rafter configuration.

A third inspection was undertaken after the remains of the earlier lath and horsehair plaster ceiling was removed and the roof space fully exposed. This showed that the roof timbers are predominantly re-used oak timbers with common rafters of varying dimensions carried on a single purlin to each pitch (Photographs 9, 10 & 11, Figures 3 & 4). The purlins are lightly trenched into the collars at the north gable frame and at the central cross frame and are single-pegged to the principal rafters. The studs of the gable frame and the cross frame are single-pegged to original collar beams.

Where the roof covering flares out on the street side to cover the increased width caused by the brick facing this has been achieved by the insertion of sprockets to the feet of the rafters (Photographs 15 & 16). Why this has been undertaken at the rear of the original building is unclear unless there is a brick skin to the rear of the building, subsequently covered by the 19th-century extension. The sprockets to the rear of the building extend further than those to the front, so it is more likely that the rear had a small extension built at the same time as the brick facing and prior to the construction of the 19th-century extension.
