**Historic building recording at
50 Silver Street, Buckden, St Neots,
Huntingdonshire, Cambridgeshire, PE19 5TS**

June 2016

**commissioned by
S. Pell Builders Ltd**

CAT Report 976
August 2016

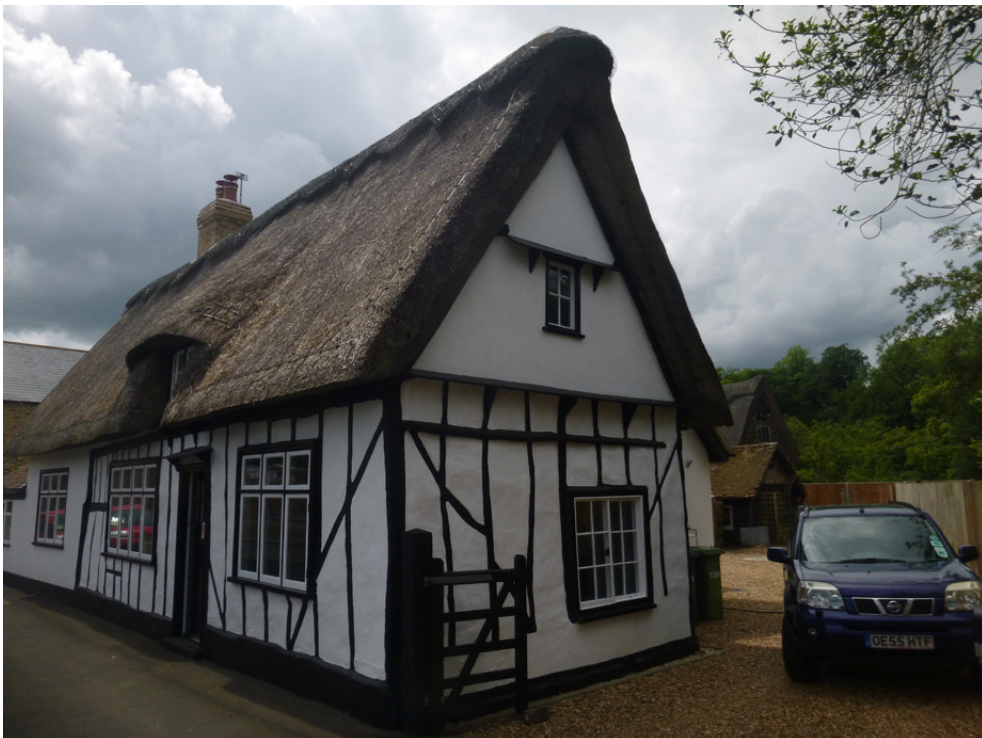
Photograph 16 Shot of 17th-century cottage (50 Silver Street), with garage visible in background – shot taken facing south-west.

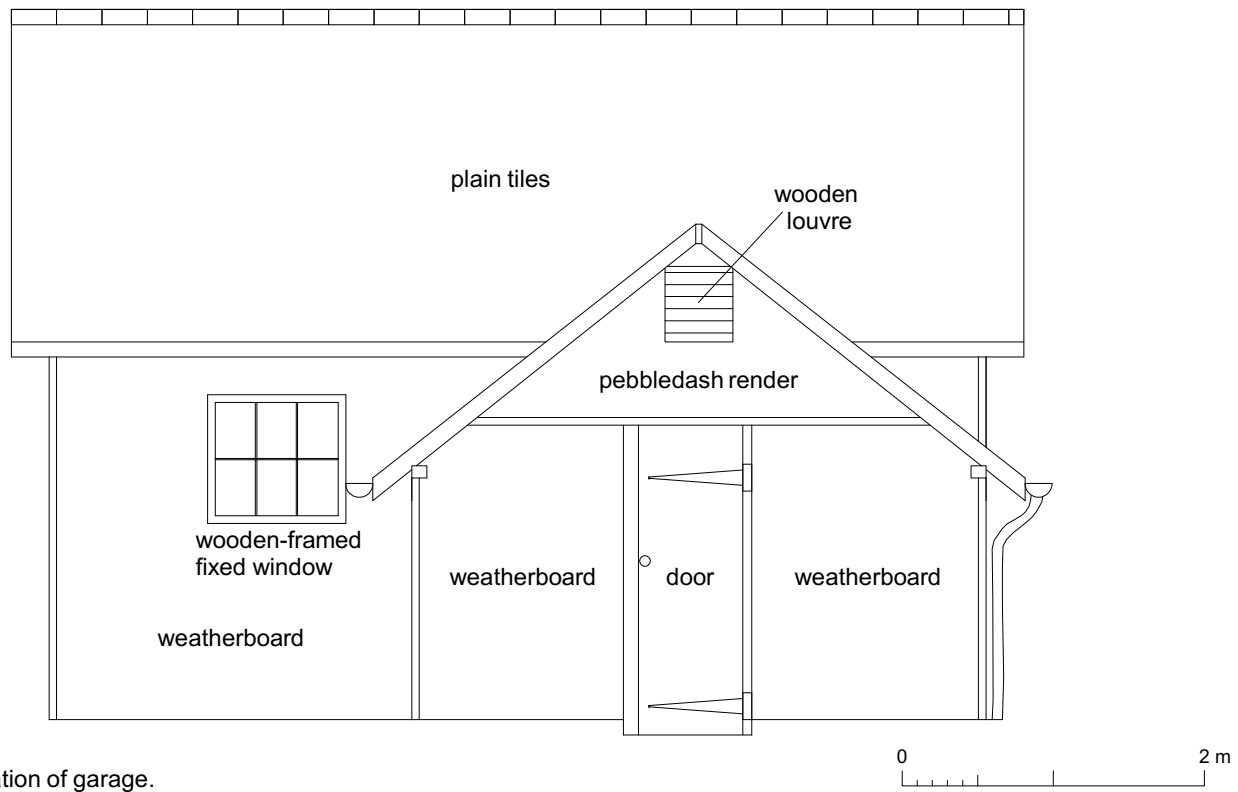
Fig 2 Northern elevation of garage.

The northern elevation (Fig 2) has a vertical-planked door with three battens and attached with metal hinges below the north wing gable (Photograph 1). The gable itself is covered by pebble-dash render and contains a small wooden louvre. There is six-light fixed window in the wall of the main garage on this elevation.

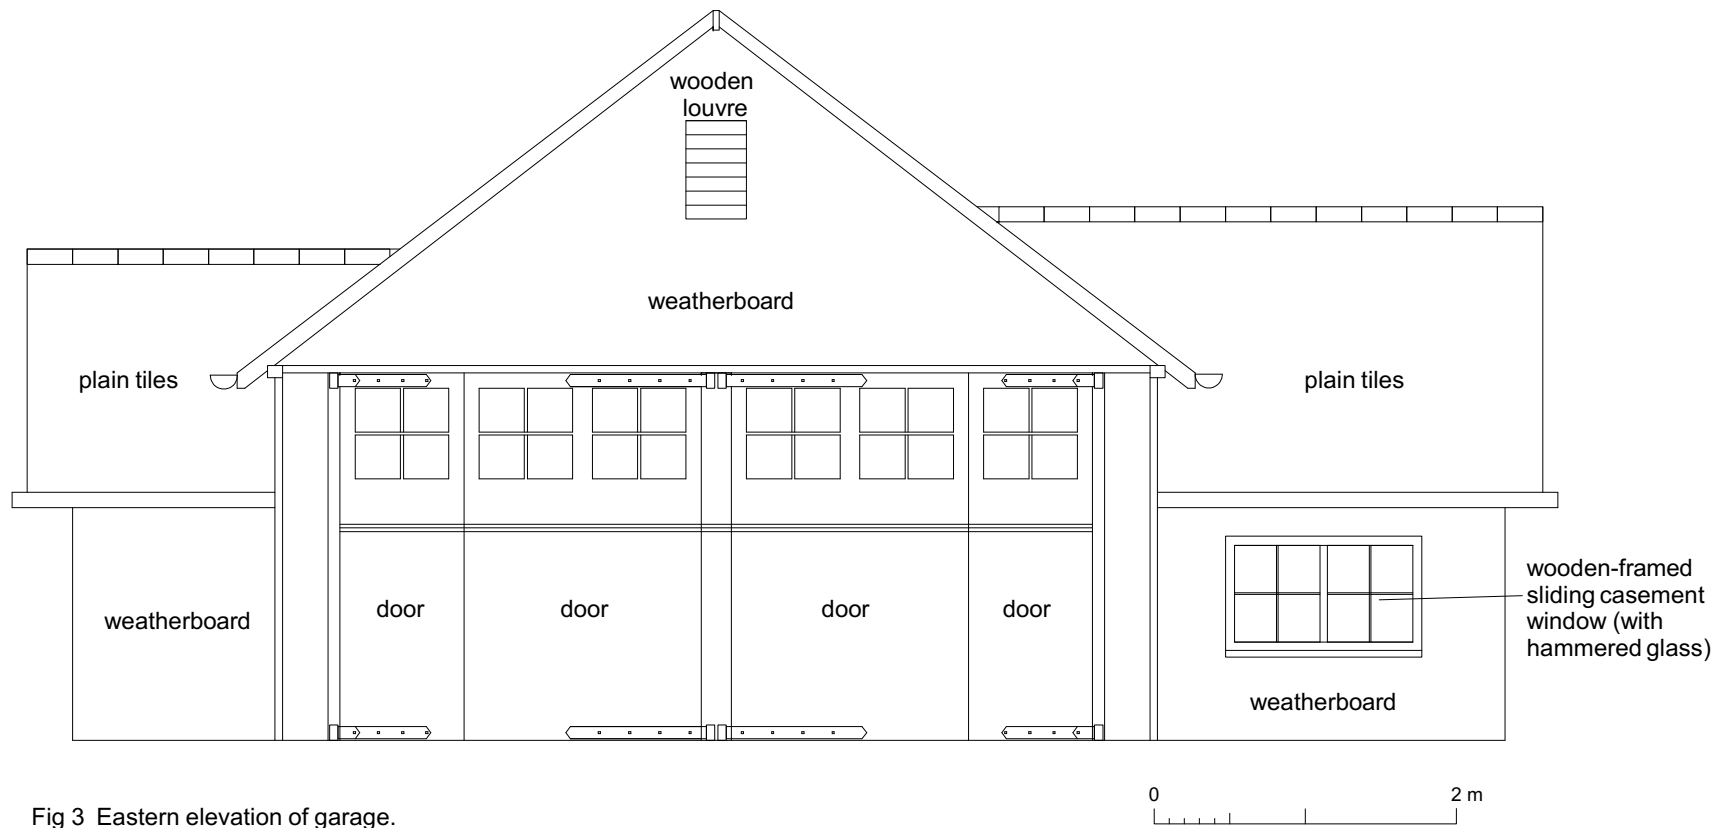
Fig 3 Eastern elevation of garage.

The eastern elevation (Fig 3) has four large half-glazed doors providing access, held in place by large metal hinges (Photograph 2). Two of these doors are double width. These four doors are positioned to create two sets of double doors. These are original to the building and suggest that it was a garage from the outset. The doors have four-lights or eight-lights in the upper panels, depending on width. Also on this elevation on the north wing is an eight-light sliding casement window, with hammered glass.

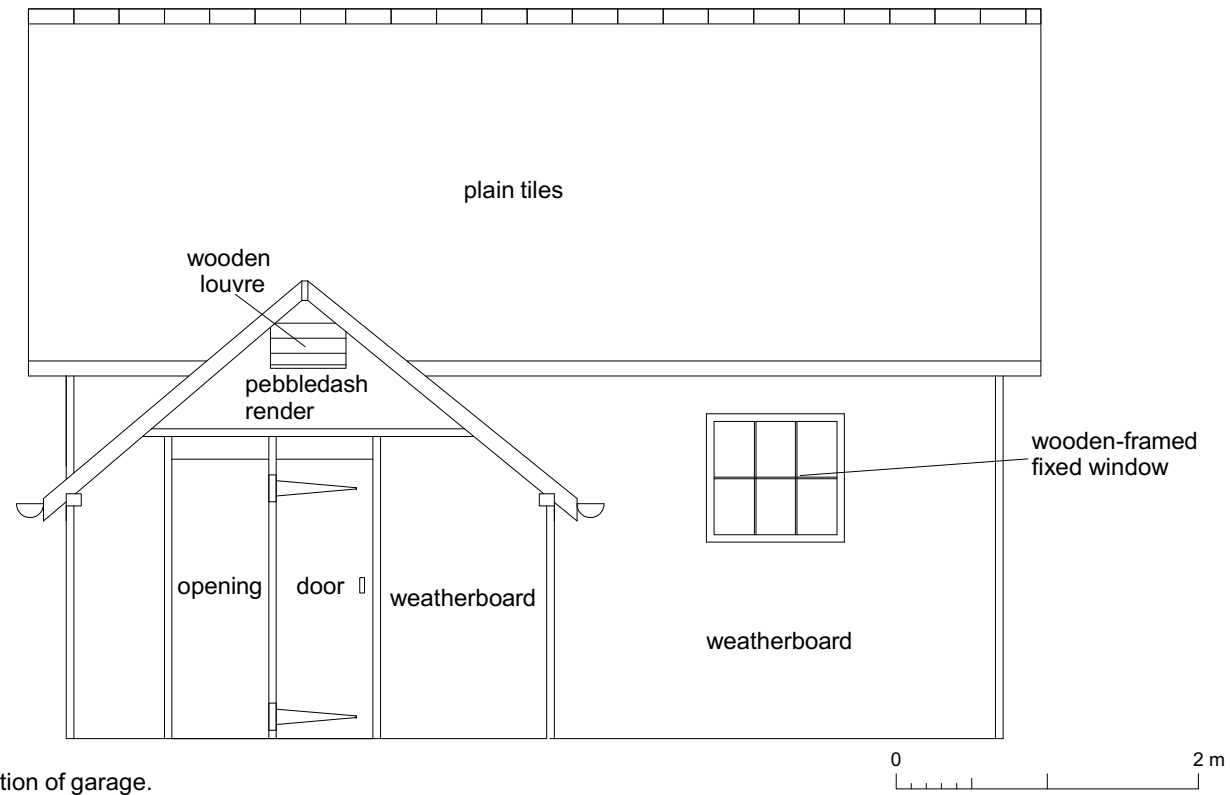
Fig 4 Southern elevation of garage.

The southern elevation (Fig 4) has two entrances, both on the south wing (Photograph 3). One is into the building proper and has a vertical planked door, and the other has no door and leads into a separate room not accessible from the main structure. This separate room is totally devoid of features and, like the rest of the building, the interior is clad in asbestos panels (Photograph 6). The owner suggested that at some point it was in use as an outside privy (*pers comm*) – although, given the use of the building, it seems more likely to have been a petrol store. Also on the south elevation on the main building is a six-light fixed window, identical to the one on the north elevation (see above). As in the north wing, the south wing gable is covered by pebble-dash render and contains a wooden louvre.

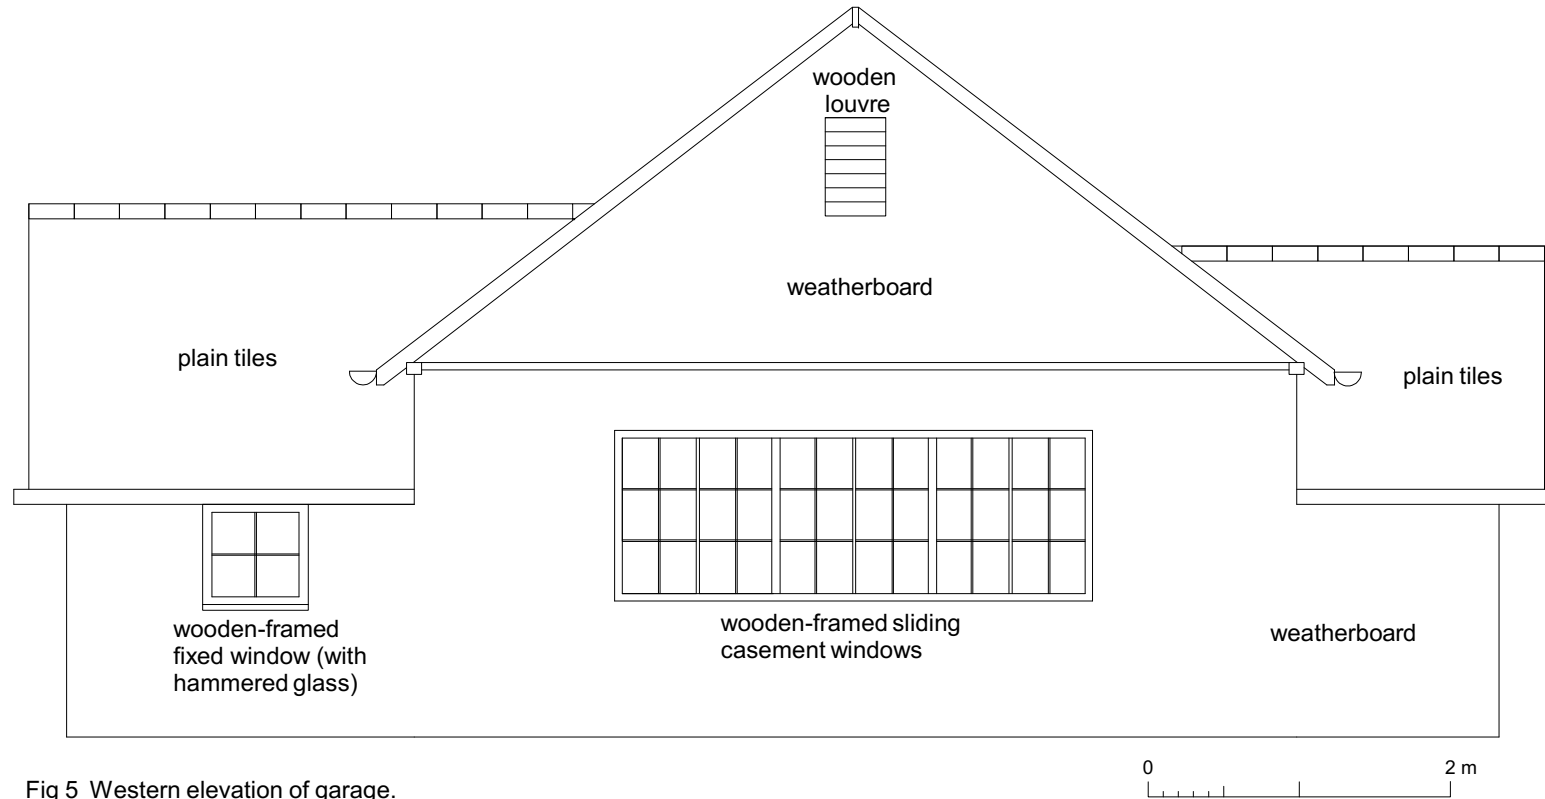
Fig 5 Western elevation of garage.

The western elevation (Fig 5) has three twelve-light sliding casement windows centrally positioned on main building (Photograph 4). Like every other elevation, there is a wooden

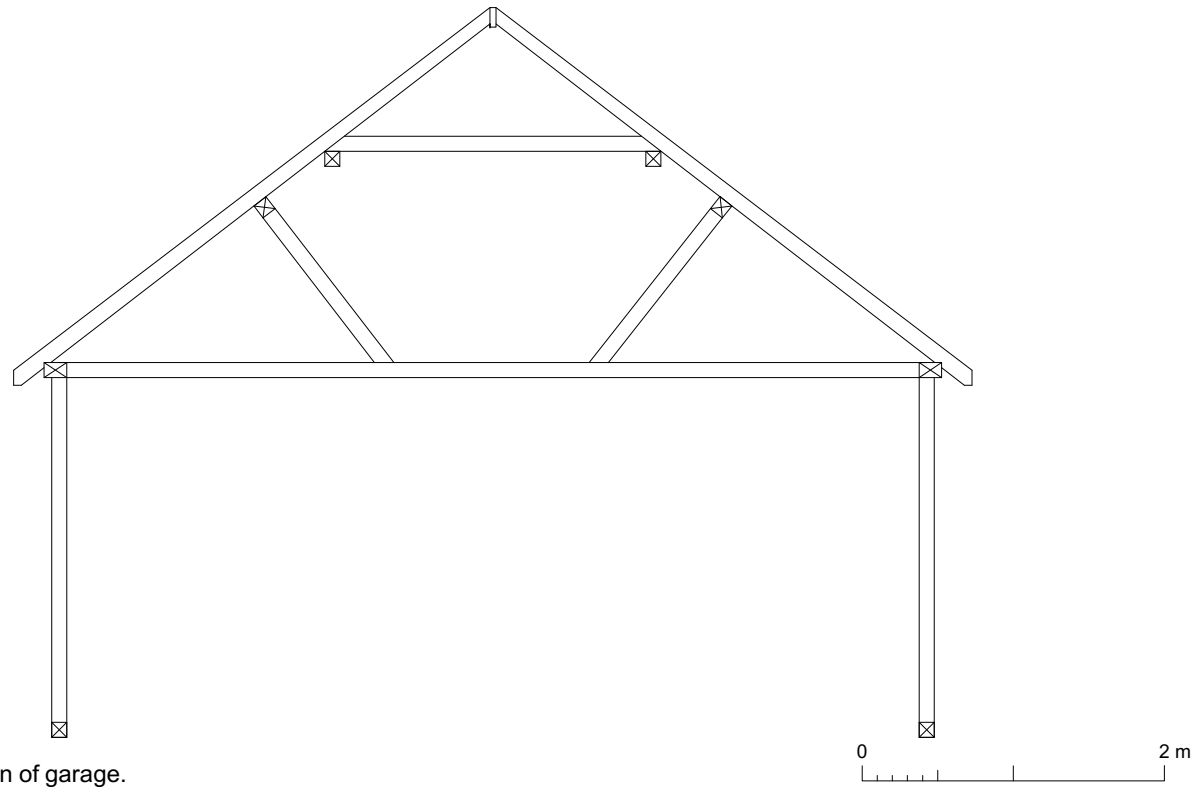
Fig 6 Truss cross-section of garage.

When the roof was observed through an inserted hatch, it was found to be made of nailed machine-cut timbers (Photograph 15). Several timbers had been nailed in place at various angles in order to further support the roof, running from one truss to another and varying in length and size. The truss cross-section (Fig 6) shows only what appears to be the original elements of the roof's structure.

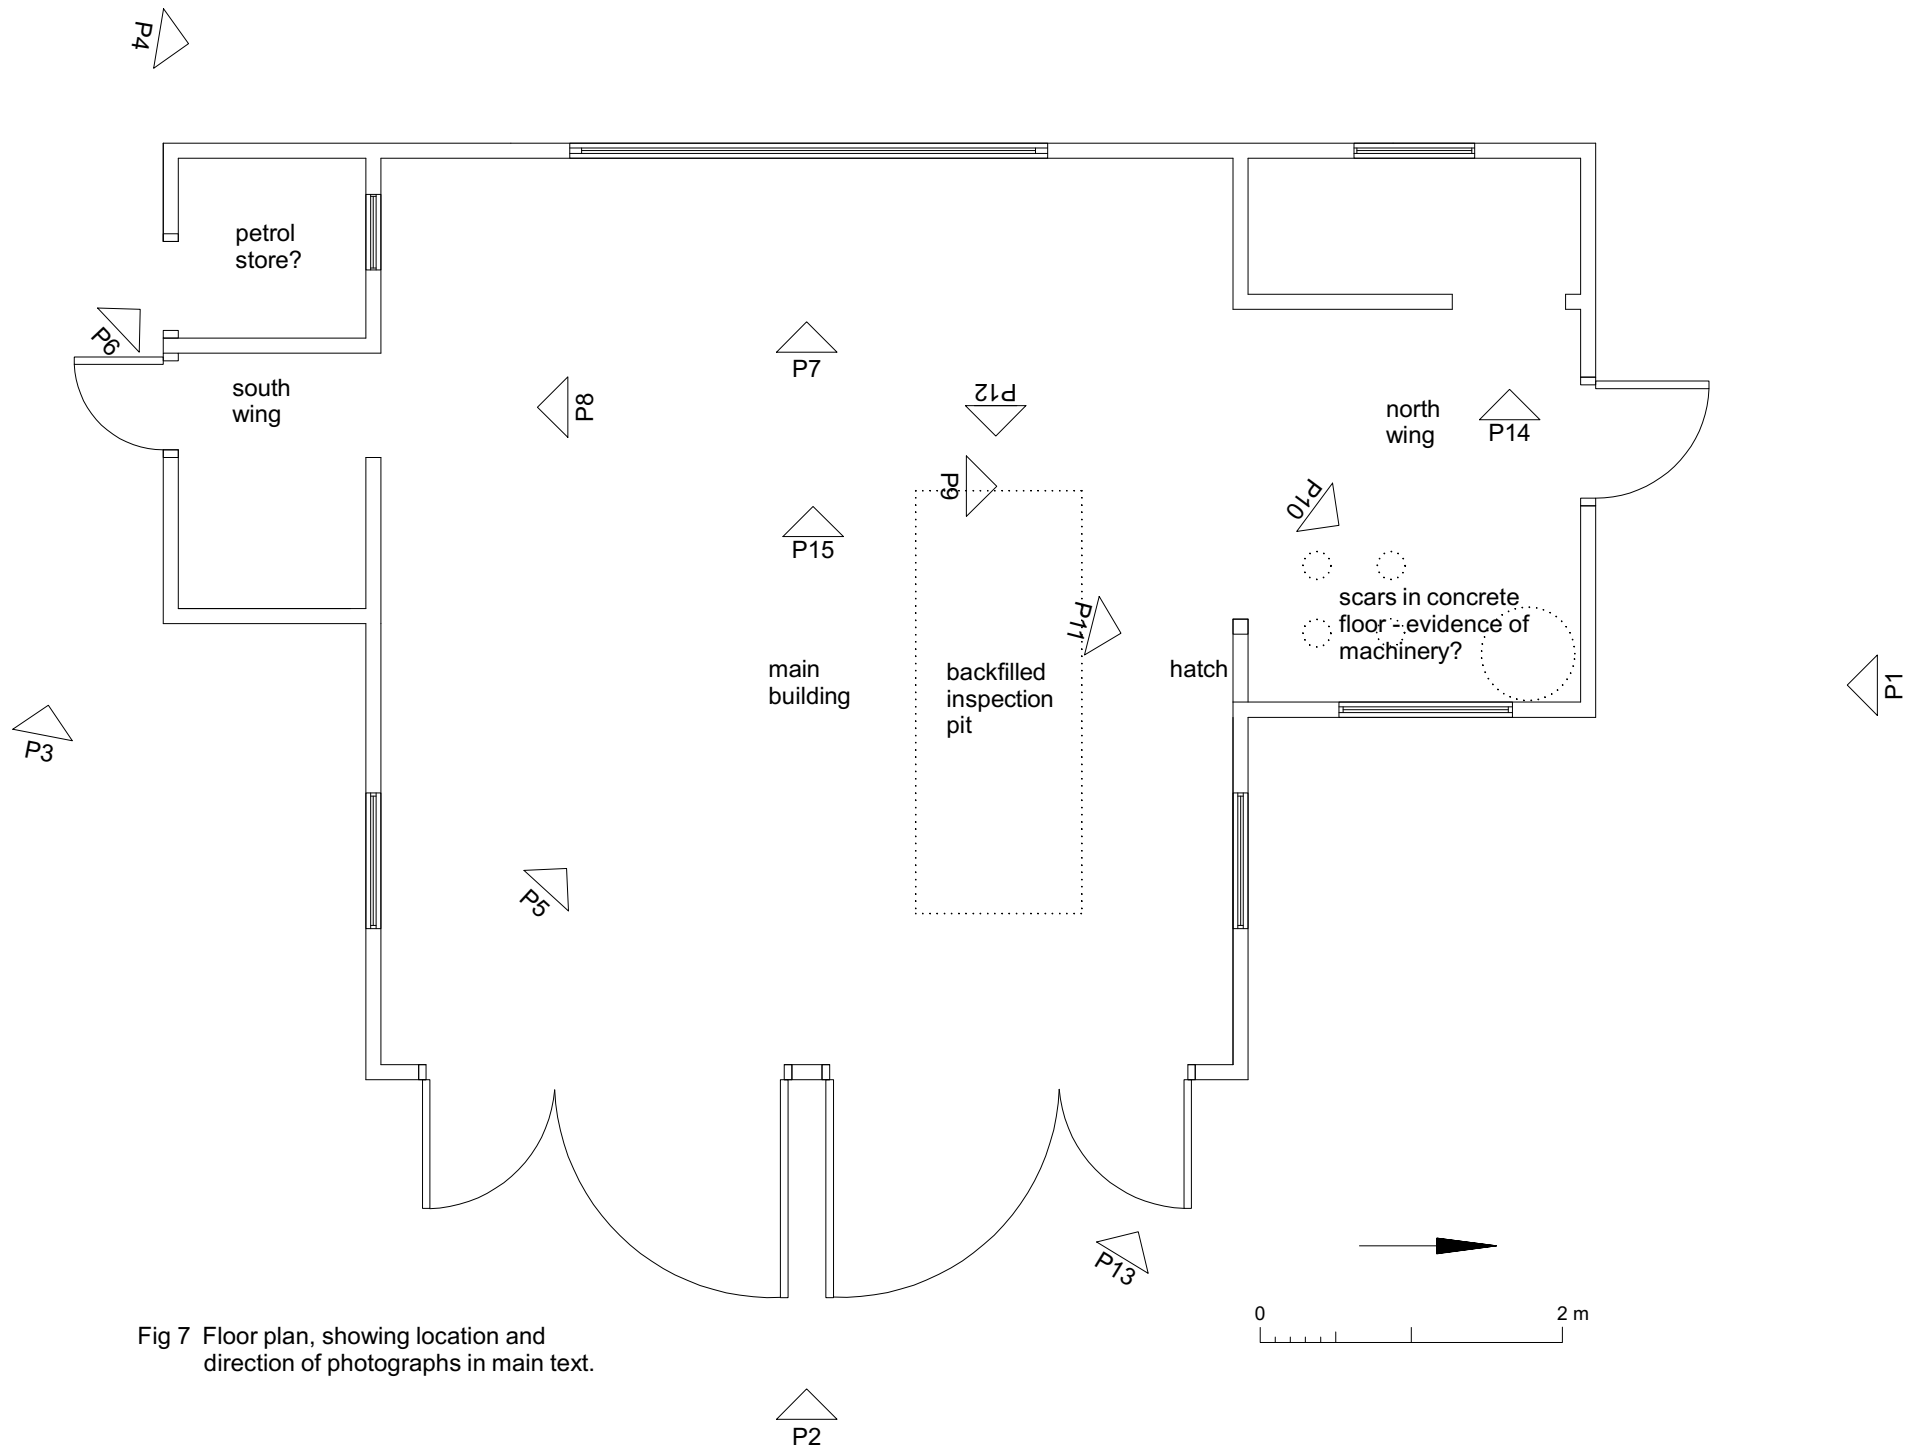
Fig 7 Floor plan, showing location and direction of photographs in main text.

The garage is aligned north-south. It is one-storey and is T-shaped in plan (Fig 7), with a central main building and wings to the north and south. The term 'wing' is grandiose given the building under discussion, but is used as it serves to differentiate between the parts of the building. It is a softwood machine-cut timber-framed building, 6.1m long x 9.5m wide with a concrete floor. The building is clad in traditional weatherboarding, with a modern nib tile-covered gable-ended roof.
