Historic building recording at Sturgeon's Farm, Middle Green, Wakes Colne, Colchester CO6 2BN

May 2017

CAT Report 1131
July 2017

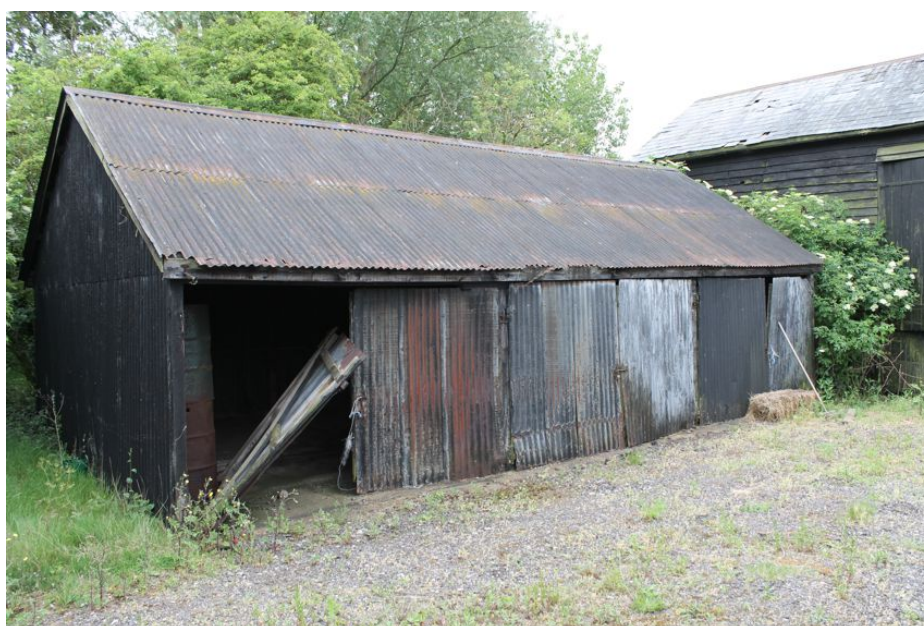
The western elevation of the building has three double doors covered in corrugated galvanised iron, and attached with metal hinges (Photograph 14). There are no features on any other elevations of the building.

Photograph 14 Exterior shot of Building A. Photograph taken facing south-east.

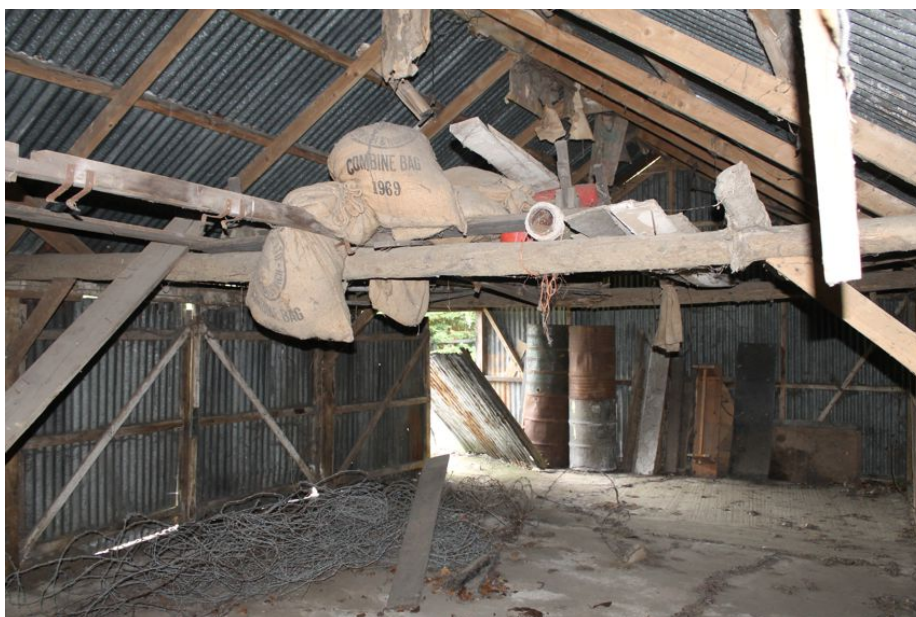
The timber-frame has a central girding-beam all around the structure, and braces supporting each corner-post (Photograph 15). There are four edge-halved scarf joints in the structure; one on the wall-plate on each elevation. The two tie-beams are the only hand-sawn timbers in the structure, and are extremely rudimentary: they appear to be tree trunks with extraneous branches removed. Above the tie-beams are upper-collars supporting the ridgeboard.

Photograph 15 Interior shot of Building A. Photograph taken facing north-west.

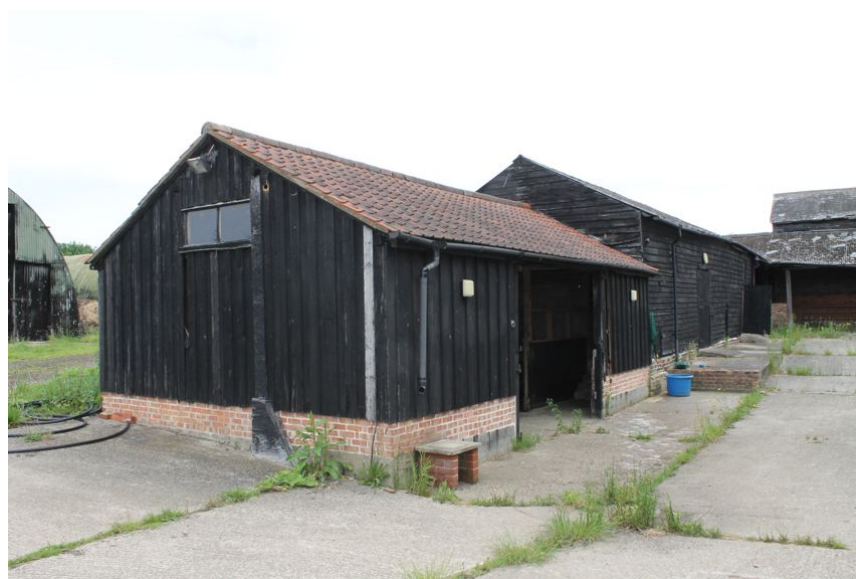
Building B is aligned north-east to south-west, and is currently in use as a stable. It is the southernmost building of the west-wing of the farm complex (Fig 8). Its north-eastern end is built against Building C. It is a single-storey three-bay timber-framed building, constructed of softwood machine-cut timber. The building measures 8.5m x 5m, and is built on a concrete-and-brick plinth. It is clad in vertical-weatherboarding, with a modern pantile-covered gabled-ended roof. Its timber-frame is nailed together.

Photograph 16 South-west and south-east elevations of Building B. Photograph taken facing north-west.

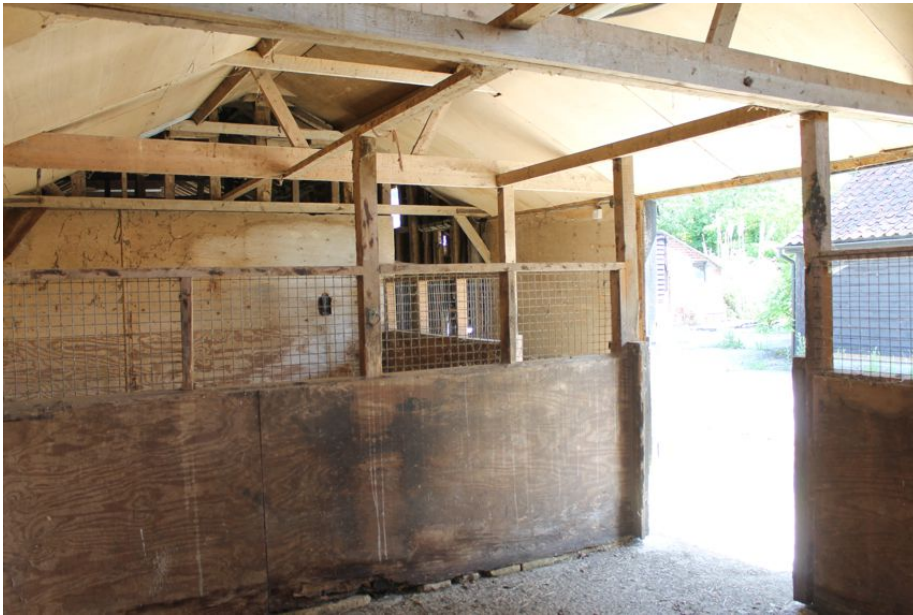
The building has a concrete floor and modern machine-cut timber divisions between two stalls (Photograph 17). The timber-frame is covered with plywood panelling, with only the (machine-cut) tie-beams and braces visible.

Photograph 17 Interior shot of Building B. Photograph taken facing east.

The trusses in the building consist of tie-beams, at bay intervals. Two inclined braces rise from these tie-beams to the single machine-cut purlin on each roof pitch. There is a collar above the tie-beam that these braces are nailed to (Photograph 17).

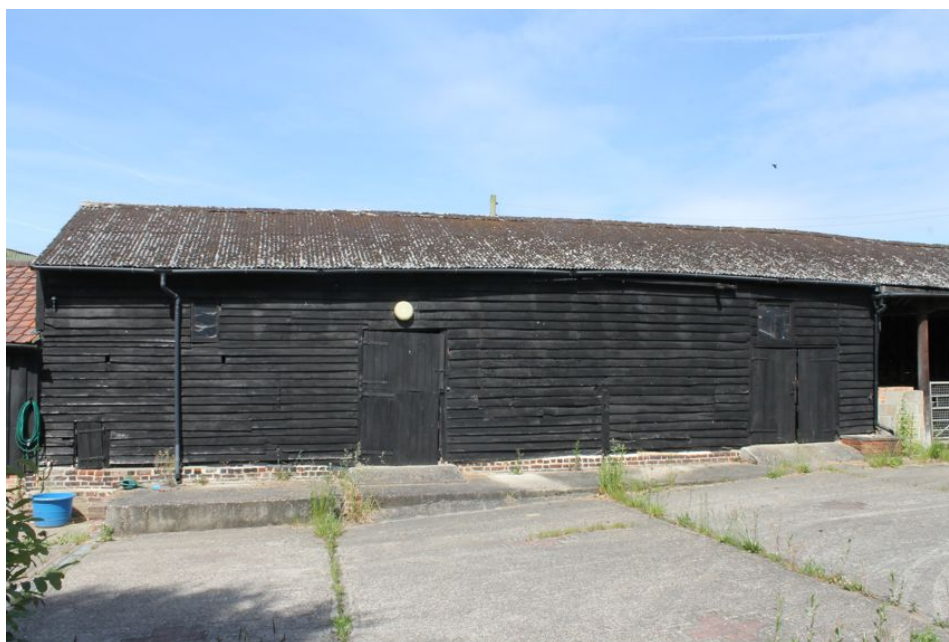
The eastern elevation of the building has two inserted entrances. One is a vertical-planked stable door, the other is two double-doors. Also on the eastern elevation is a small inserted hatch at floor level, and two inserted one-light windows (Photograph 19). The western elevation of Building C has two vertical-planked doors, but no other features.

Photograph 19 South-east elevation of Building C. Photograph taken facing north-west.

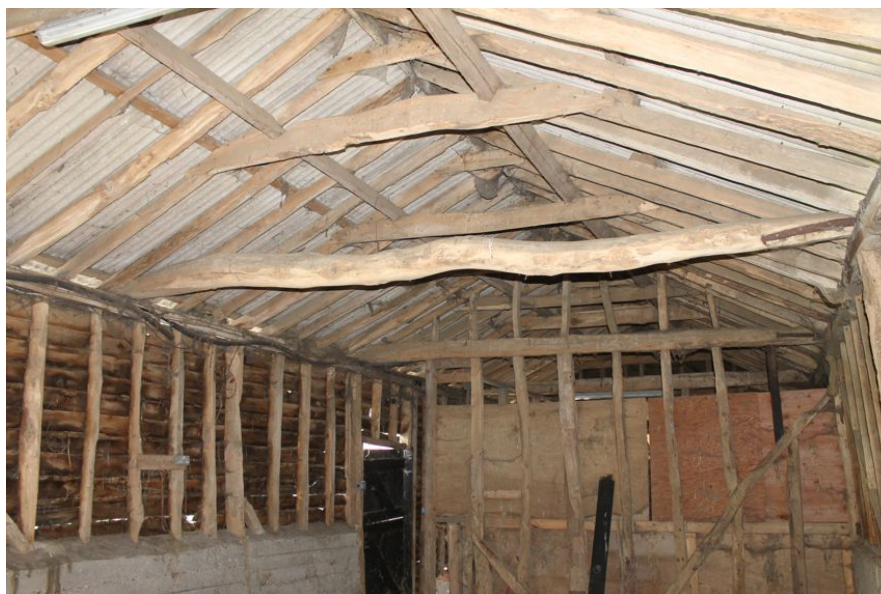
The building's trusses consist of tie-beams supported on the wall-plates, with a collar above them supporting a single clasped-purlin on each roof pitch (Photograph 20). The tie-beams are hand-sawn timbers, and they are very rudimentary in design, resembling the tie-beams in the barn (see above). Again, like the barn, the tie-beams are all attached to the wall-plates using iron straps (Photograph 22). None of the tie-beams are supported by braces, or have mortices on their underside, with the exception of the western end of the southernmost tie-beam, which is supported by a, probably reused, knee brace (Photograph 23).

Photograph 22 Roof truss in Building C. Photograph taken facing south.

Although the tie-beams have undoubtedly been re-sited, given that both their supporting wall-plates have been replaced, they all appear to be original to the building – there is no evidence of bracing or unused mortices in the remainder of the frame to suggest different tie-beams were ever used.

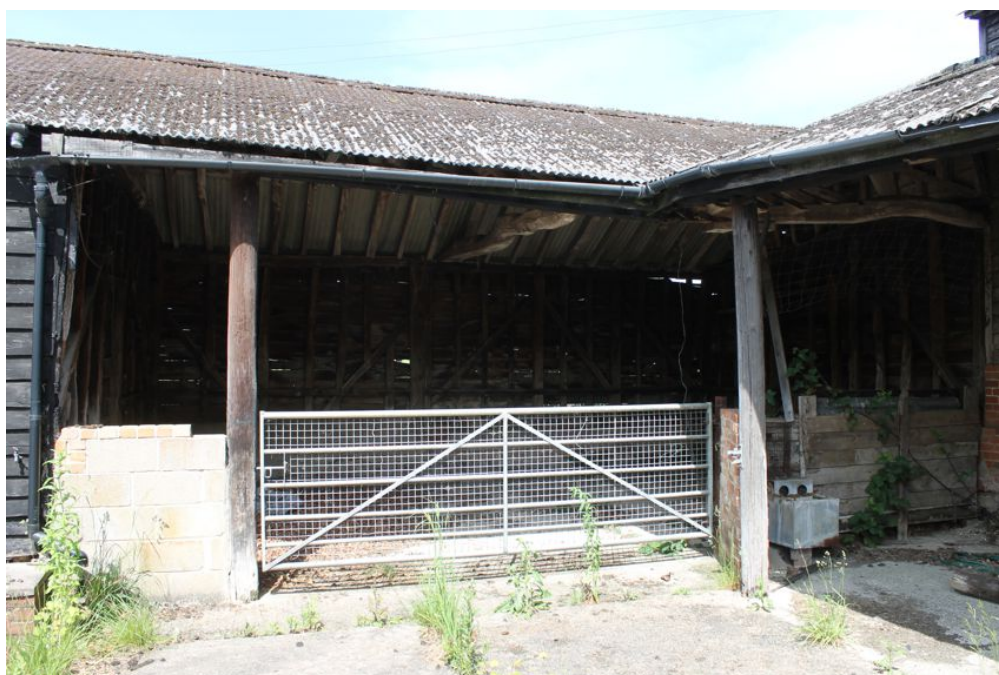
Building D is a rectangular structure, and is the northernmost of the three buildings making up the west-wing of the farm complex (Fig 8). Building C is built against its south-western end. Building D is currently empty, but the modern gate and low concrete wall on its eastern elevation suggest it was recently used as an animal shelter (Photograph 24).

Photograph 24 South-east elevation of Building D. Photograph taken facing north-west.

The frame on the south-east elevation of the building has been entirely removed, with modern concrete blocks and bricks forming a low wall in its place. Two inserted cut-down telegraph poles and an upright steel beam support this elevation, in the absence of any its original timbers. On the southern elevation of the building is a small inserted vertical planked timber door, which leads into Building C (Photograph 25). The remainder of the exterior has no features.

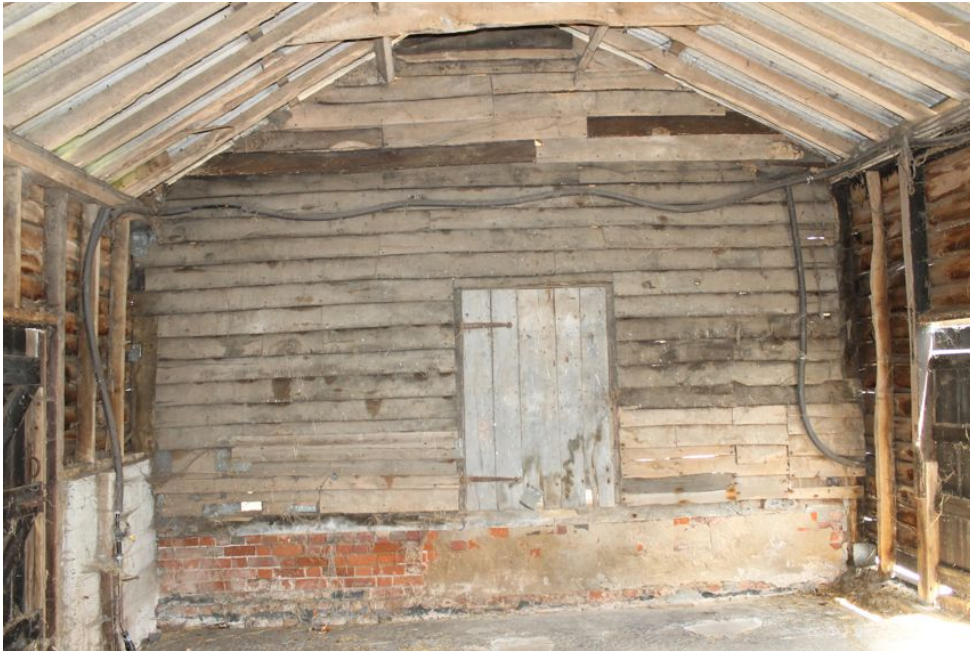
Photograph 25 South-west elevation of Building D, from inside Building C. Photograph taken facing north-east.

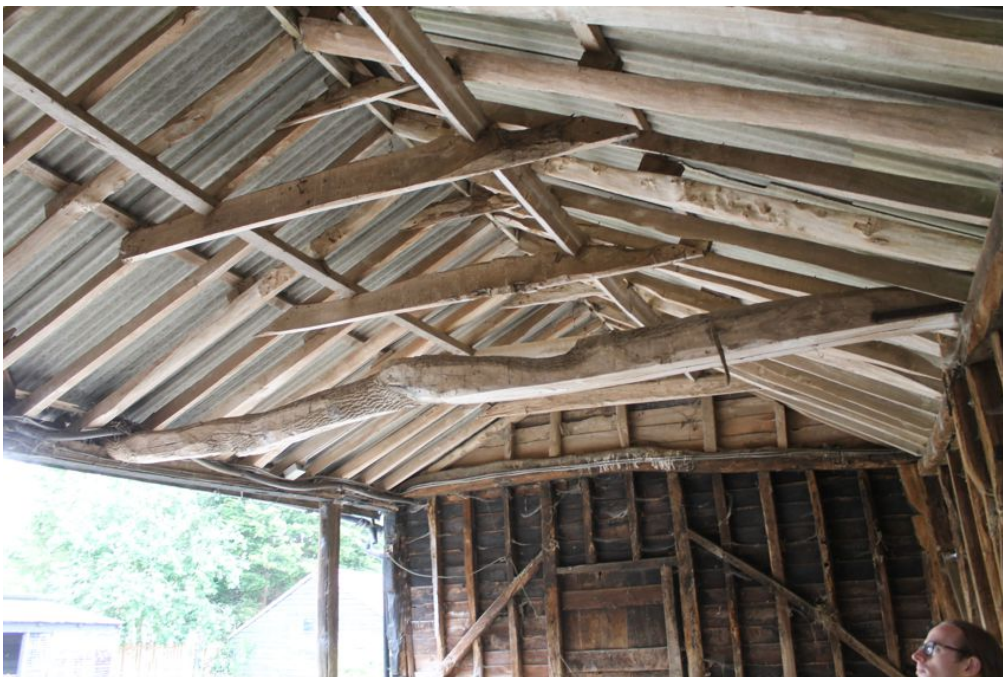
The tie-beam in Building D is similar to ones in Building C and the barn: a very rudimentary hand-sawn timber supported by iron straps rather than bracing (Photograph 26), with a collar above. Unlike in Building C and the barn, however, the tie-beam in Building D does is not original to the structure, and was probably added when the roof was redone.

Photograph 26 Truss in Building D. Photograph taken facing south.

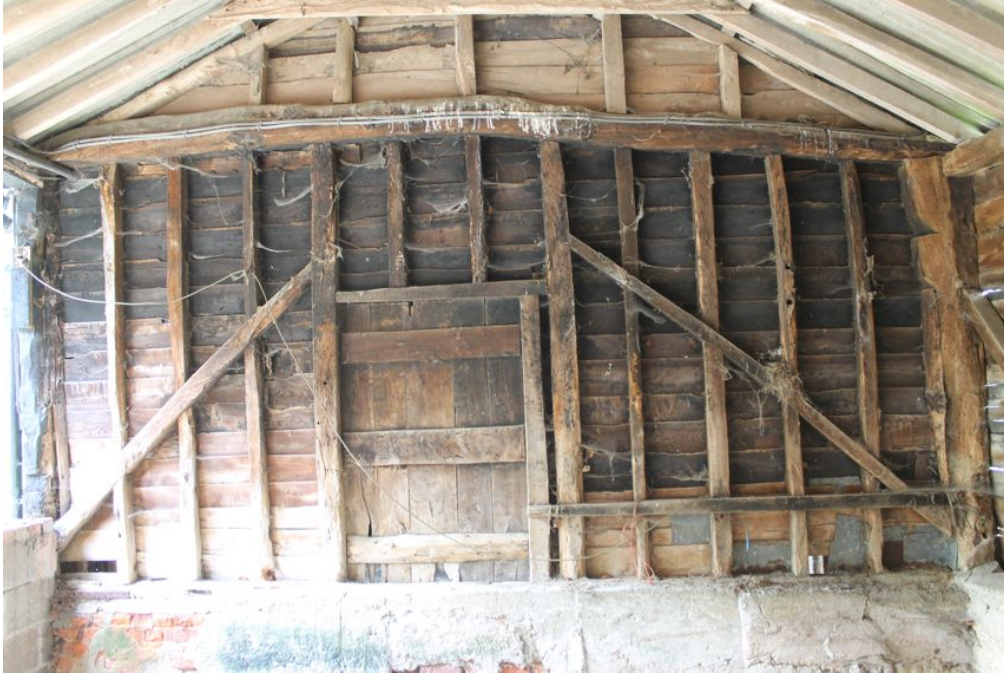
The remaining frame in Building D, including the wall-plates, is made of hand-sawn timber, supported by primary diagonal-bracing (Photograph 28). The only machine-cut timbers are two on the northern elevation, blocking up a possible old entrance into the building (Photograph 29) There are also multiple timbers that show evidence of being reused from earlier buildings. The wall-plate immediately to the south of the principal post on the western elevation is clearly reused from an earlier structure, as it has a large unused recess on its underside, which might have originally received a knee brace.

Photograph 28 South-west elevation of Building D, with double jowled corner post visible to right of photo. Photograph taken facing south-west.

The south-west corner-post in the building is substantially larger than the others (measuring 190mm x 240mm compared to 105mm x 150mm). It has an ornate double-jowled head supporting the wall-plate (Photograph 28), and probably originated in an earlier structure. It is supported by a small stud underneath the jowl. The surviving sill-beams in the structure are largely covered in render or concrete, but on the south-west elevation some un-used mortices are visible on the front face of the timber (Photograph 28), showing that it, too, is reused. Some studs on the north-east elevation also have unused mortices.

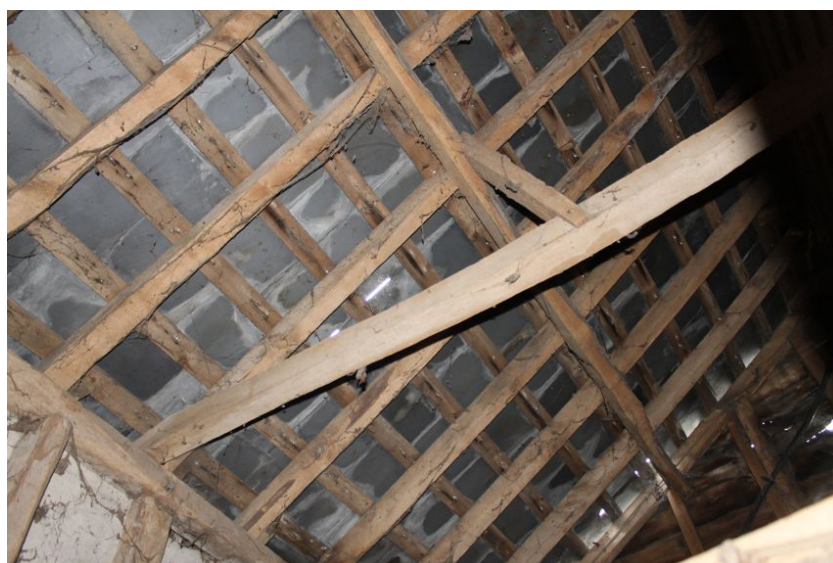
There are partially surviving chipboard walls and a lowered ceiling on the interior, all supported by modern machine-cut batons. Close inspection of the timber-frame was impossible, but it appeared to be largely constructed from machine-cut timber, nailed together, although there was also some hand-sawn timber in its make-up (Photograph 31). The catslide roof is largely constructed on machine-cut timber.

Photograph 31 Interior shot of the roof of Building F. Photograph taken facing south-east.

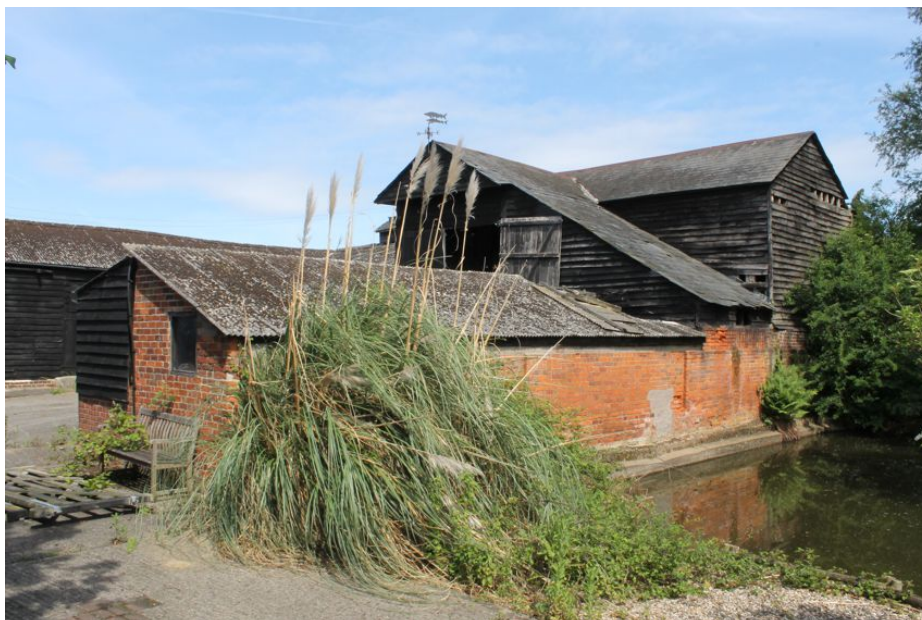
Building G is a small outshot from the barn, measuring 3.5m x 2.8m. It is built up against another outshot, Building F, and the southern wall of the main range of the barn (Fig 8). It is covered, along with Building F, by a slate-covered catslide roof extended from the eastern pitch of the midstrey (Photograph 32).

Photograph 32 Exterior shot of farm complex, with Building H in the foreground. Catslide roof covering Buildings F and G visible, as well as wall bordering pond. Photograph taken facing north.

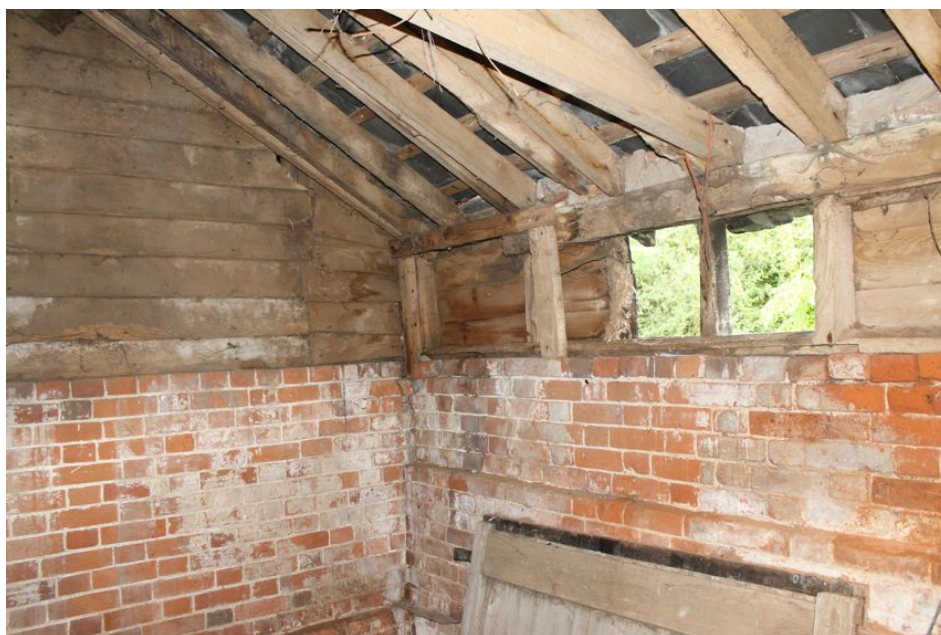
Building G has a concrete floor. The timber-framing on the southern and eastern elevation, as well as the roof of the structure, is nailed together and made of machine-cut timber.

Photograph 33 Interior shot of Building G, showing timber-framing above wall. Photograph taken facing east.

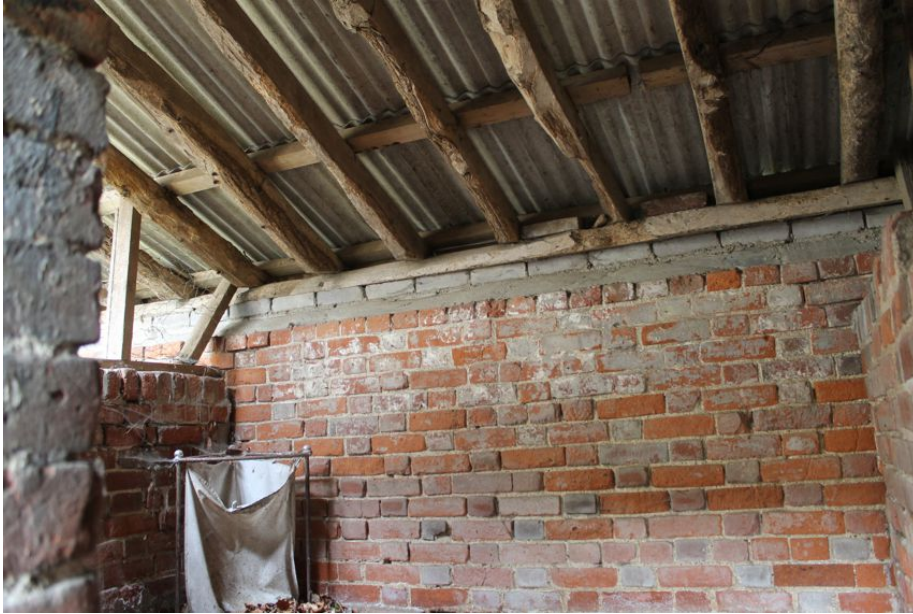
The original eastern half of the structure is built against the low wall bordering the pond, in Flemish bond, with brick dimensions of 230 x 110 x 65mm. The modern extension to the building is built in spacer bond, and has brick dimensions of 210 x 70 x 120mm. Both the original structure and the extension are divided into three small chambers by low walls (Fig 8). Modern timber, nailed together, and wire fencing, is also used to divide these chambers, and to support the hand-sawn rafters above the original half of the building (Photograph 35).

Photograph 35 Interior of original half of Building H, showing brickwork and rafters. Photograph taken facing east.

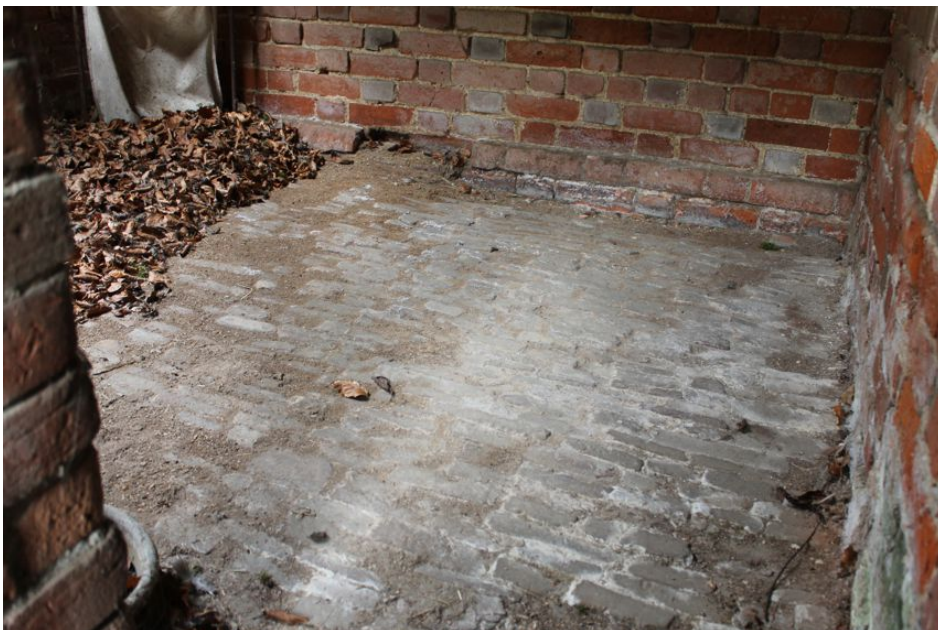
The original structure has some surviving pavior bricks in its floor to the north (Photograph 36). The rest of the structure has a concrete floor.

Photograph 36 Interior of original half of Building H, showing pavior brick floor. Photograph taken facing east.
