**Historic building recording at
5 and 6 St Nicholas Street (formerly 'Jacks'),
Colchester
CO1 1LB**

September 2017

**report prepared by
Mark Baister**

CAT Report 1222
March 2018

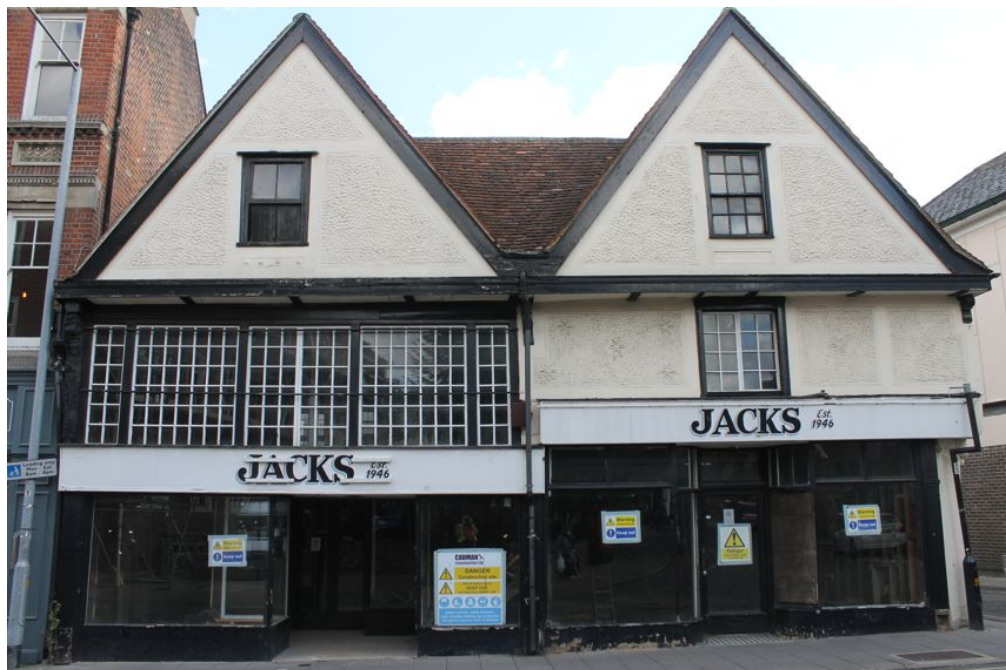
Photograph 2 Current western elevation of Buildings A (left) and B (right).

Comparing the 1908 photograph (Photograph 1) with the current frontage of Buildings A and B (Photograph 2), shows that the facade of the building has changed significantly in the last century, with the entire lower floor shop front and signs having been completely replaced, and a large range of windows inserted in the first-floor of Building A. These

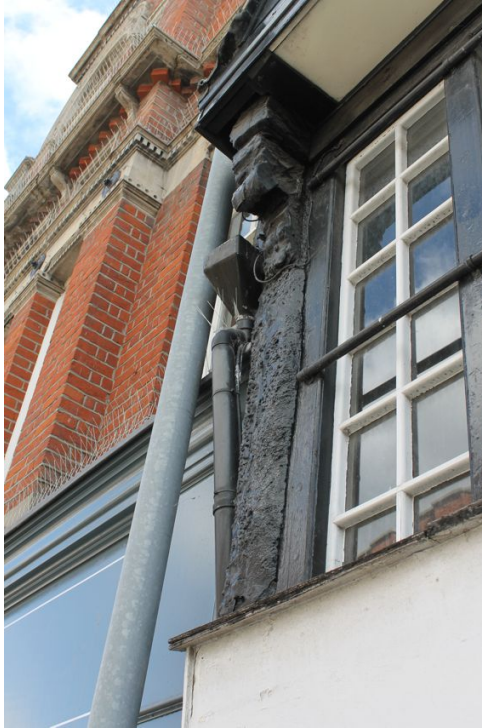
Photograph 5 North-west corner-post supporting second-floor jetty. Note carved top. Photograph taken facing north-east.

The western elevation of Building A is jettied on the first- and second-floor, with both overhanging the floor below (Photograph 2). The corner-post supporting the second-floor's jetty has a carved decoration at its apex (Photograph 5). There is simple pargetting on this rendered gable-end, which contains an off-centre inserted four-light sash window. Below this the entire first-floor wall has been removed and five large windows have been inserted (two fixed twelve-lights, two fixed 42-lights and one 36-lights casement). The ground-floor on this elevation is a windowed shop front, wooden-framed with large panes of glass and a double door. The pargetting, windows and shop front on this elevation have all been added to the building since 1908 (see historical background pg 11).

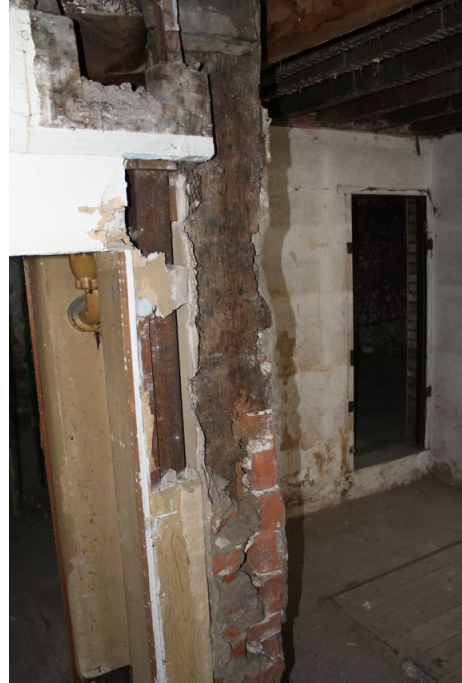
Three of the four corner-posts are still present, but none survive to ground level, either being supported by brickwork, or, in some cases, not being supported at all (Photograph 7 and 8). The corner-post in the south-west corner is not visible, and has probably been replaced by a metal girder (see Building B below). No studs survive. Only one small section of the northern sill-beam survives. Beneath this is a section of brick plinth that may be original to the building: it is in very poor condition, with three courses of indeterminate bonding and bricks measuring 170 x 100 x 60mm (Photograph 9).

Photograph 8 Remains of south-east corner-post of Building A at the ground floor. Photograph taken facing north-east.

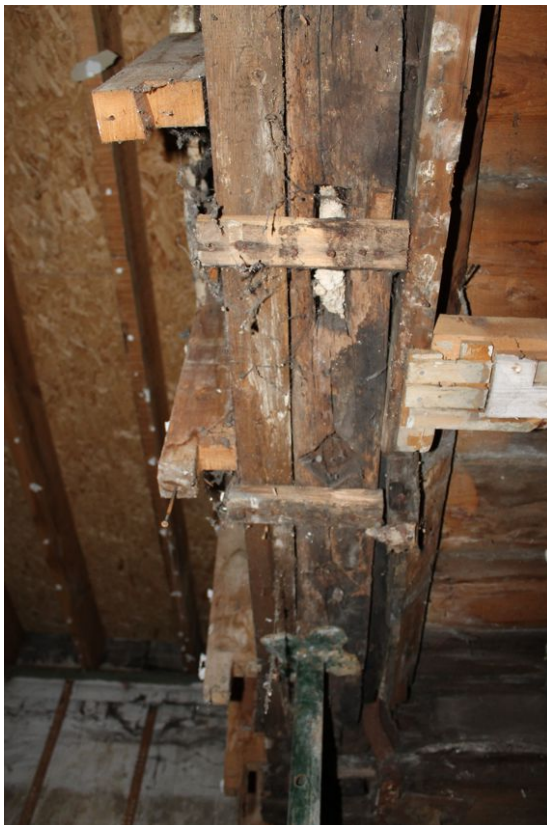
The southern elevation of the ground-floor is, like the eastern, devoid of features. A brick pillar encases and reinforces the surviving principal-post in this elevation but no studwork remains. The underside of the girding-beam, where visible, has mortices spaced 250-300mm apart. No gaps in the mortices were observed that could indicate an opening into the building. To the west of the southern elevation (below where the

Photograph 13 Underside of girding-beam on eastern side of Building A. Diamond window mullions visible.

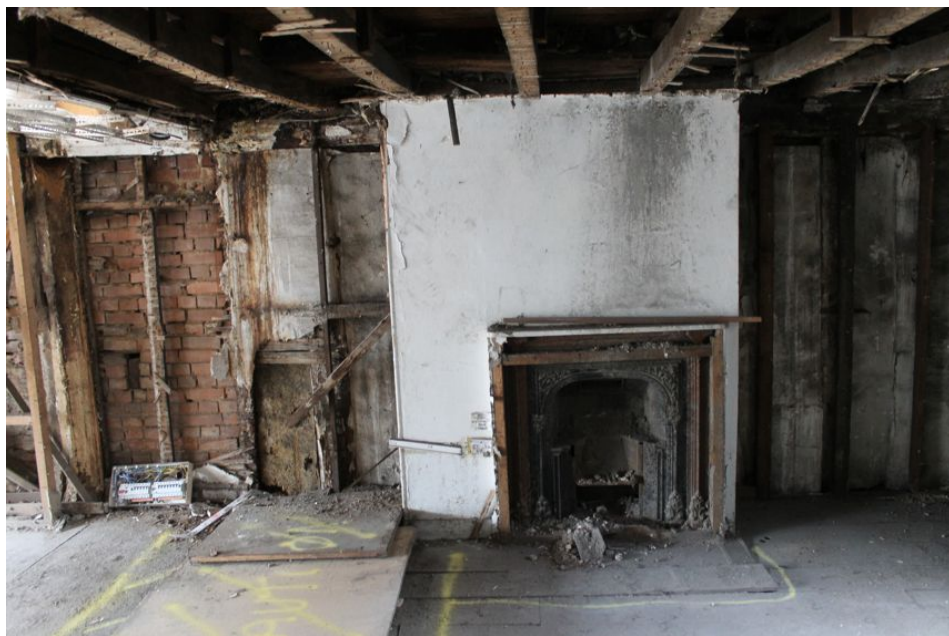
The northern elevation, like on the ground-floor, is dominated by the red brick wall of the neighbouring building; 4 St Nicholas Street. As with the floor below, several sections of brick wall are providing additional support to the timber-frame on this elevation. The chimney stack continues up through the first-floor, and has a modern metal cast fireplace inserted into it (Photograph 16). Also on this elevation a section of the wall-plate has been cut between the location of two studs (one of which is now missing), and lath and plaster added behind it, bonded to the brick wall (Photograph 17). Few studs are surviving, but those that are have dimensions of 150 x 110mm. The surviving mortices are spaced 330-350mm apart.

Photograph 16 Chimney-stack and later fireplace in first-floor of Building A. Photograph taken facing north.

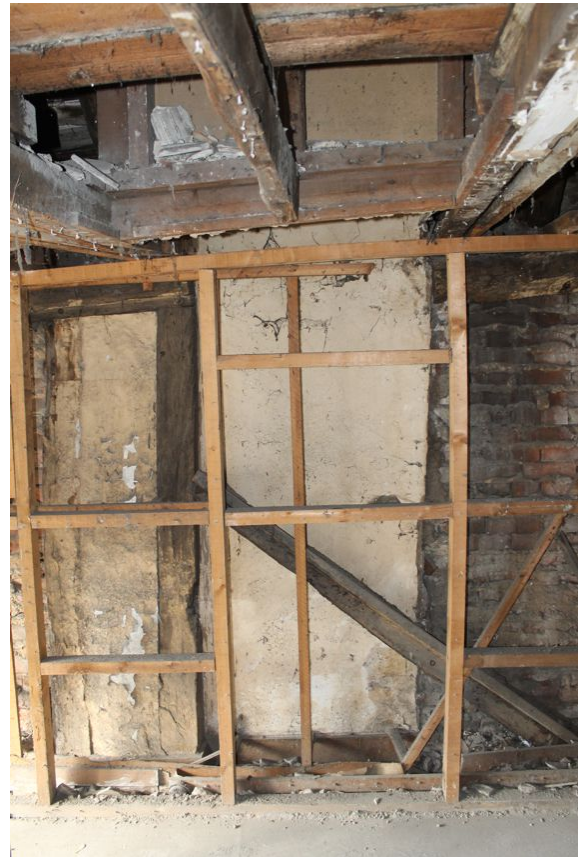
Photograph 17 Wall-plate cut and lath and plaster added behind on first-floor of Building A. Photograph taken facing north.

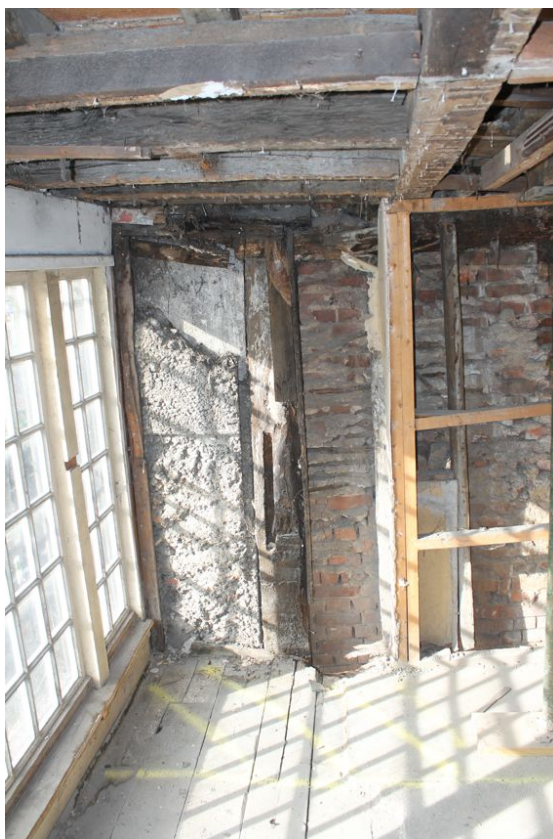
The north-west corner-post on the northern elevation has a large unused mortice in its face, probably for an arched brace (Photograph 18). Above this corner-post on the wall-plate is a large and rudimentary scarf joint; an edge-halved scarf with square abutments (Photograph 19). This joint connects the main wall-plate of the building with that of the jetty overhanging onto St Nicholas Street. Having a scarf joint in such a location would provide little structural stability to the jetty and would put a lot of pressure on the wall-plate and corner-post. This feature is one of the few instructive and diagnostic elements left in the building's frame, and is examined in detail in the discussion.

Photograph 18 North-west corner-post of Building A, showing unused mortice for arch brace and scarf joint above. Photograph taken facing north.

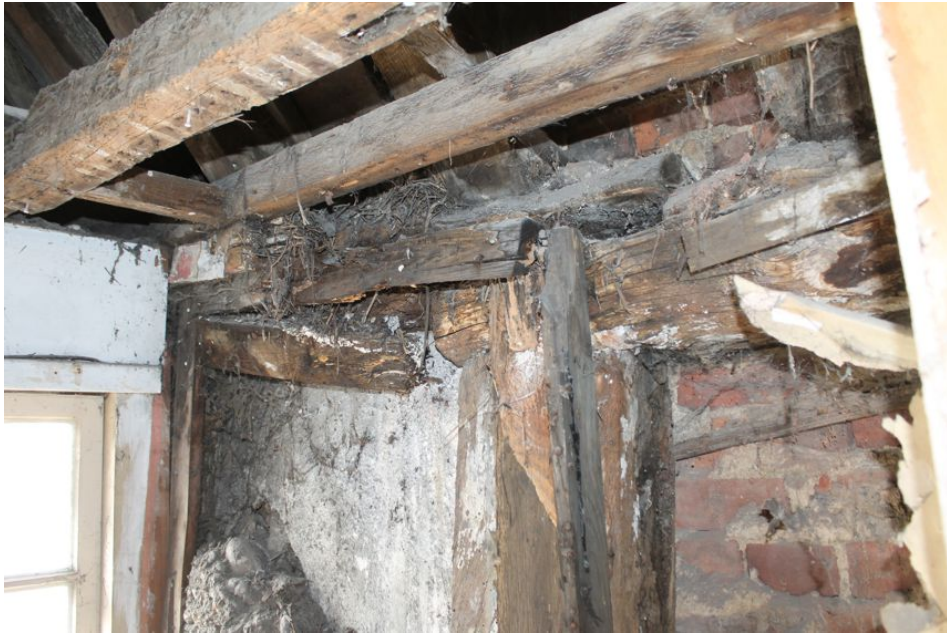
Photograph 19 Detailed photograph showing scarf joint in wall-plate above north-west corner-post in Building A. Photograph taken facing north-west.

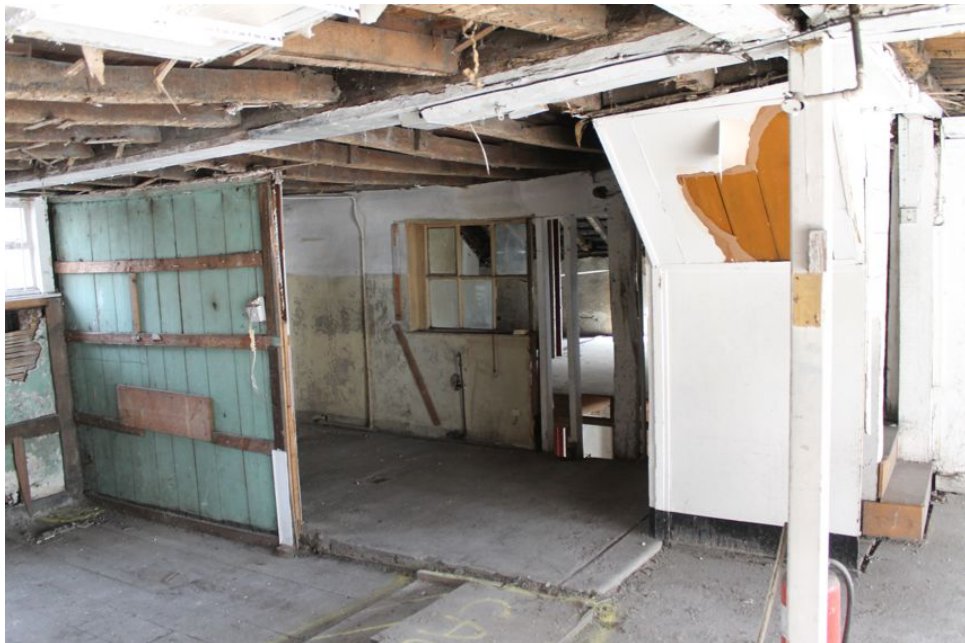
Above this level, the second-floor is supported in much the same way as the first: by three chamfered binding-beams, that are jointed onto the principal-posts of each elevation. The larger one is jointed on the east and west elevations, and two jointing out from it to the north and south (Photograph 21). Like on the ground-floor, there is a modern post supporting these beams in the centre of the building. Unlike on the ground-floor, however, the two smaller binding-beams between the north and south elevations have mortices on their underside, suggesting that this floor was originally divided in two (Photograph 22). There is no gap between any of the mortices that would suggest an entranceway, but the binding-beam jointed to the southern elevation is partially covered by modern boards, obscuring several mortices. The west binding-beam is supported by an additional modern post.

Photograph 21 First-floor of Building A, with binding-beams visible supporting floor above and modern post in centre of building. Photograph taken facing south-east.

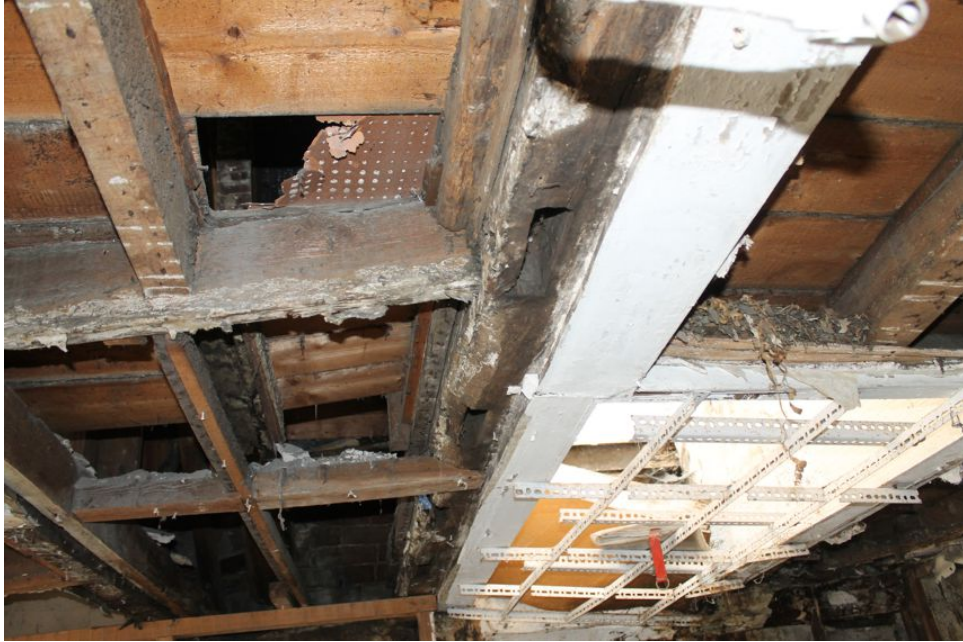
Photograph 22 Underside of north-south binding-beam supporting the second-floor, showing unused mortices. Photograph taken facing north.

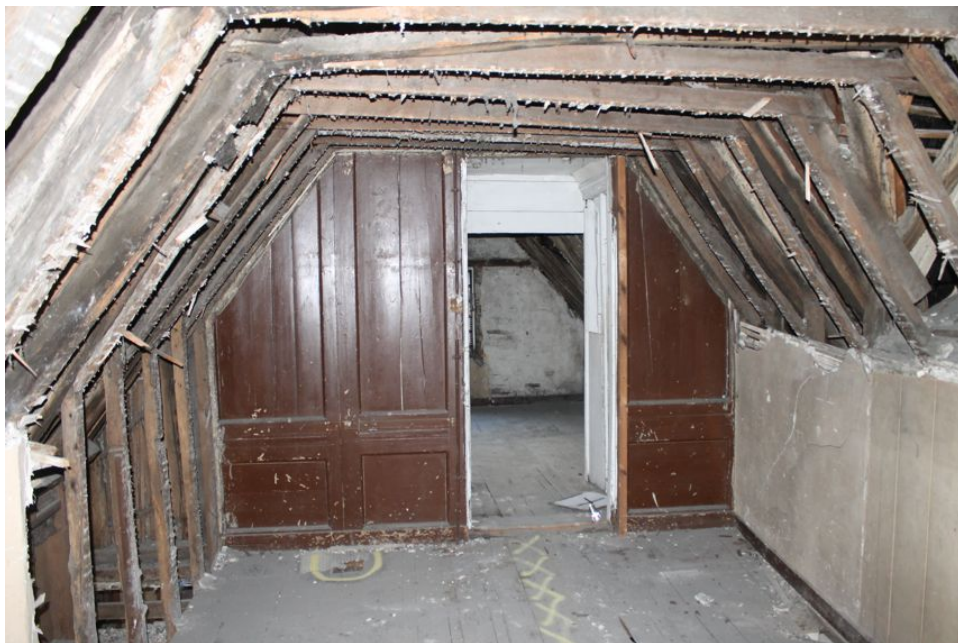
Photograph 23 West room on second-floor of Building A. Photograph taken facing east.

The western room on the second-floor (Photograph 23) measures 5.3 x 5.7m. The western gable end has several hand-sawn studs and a beam, all of which have thinner planks nailed to them which until recently were rendered in lath and plaster. These studs and beam are all pegged into place. In this room all the collars between each pair of rafters have a later collar nailed in place just below them, which was rendered in lath and plaster until quite recently, just like the gable end. The westernmost two collars (the ones above the jetty) both have nailed in place queen-posts and king-posts (Photograph 31).

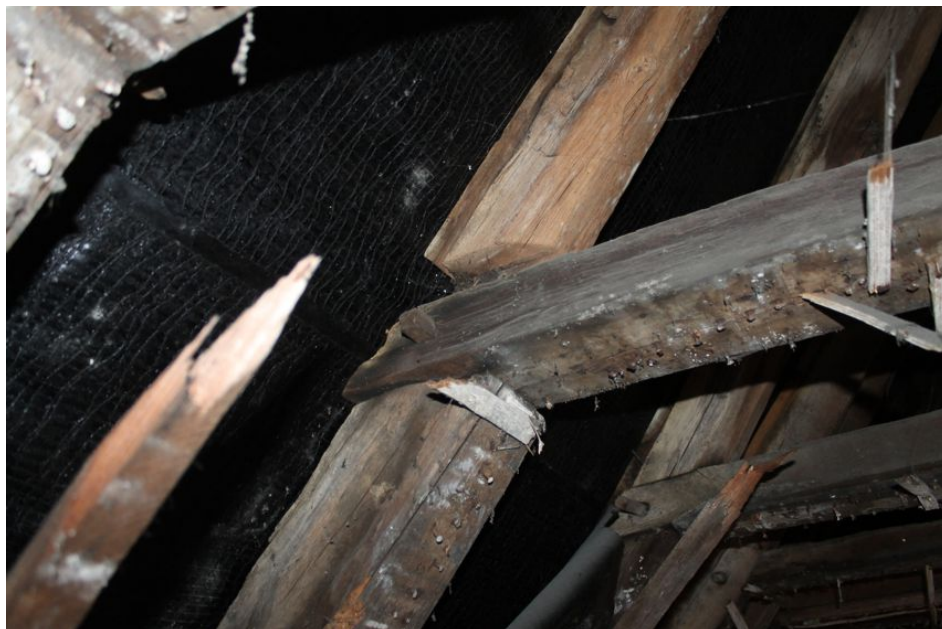
Building A has a collar rafter roof, constructed with no ridgeboard or purlins. Each pair of rafters meets at the apex of the roof and are jointed together by a peg (Photograph 24). A collar connects each pair of rafters, and again is pegged into place (Photograph 25).

Photograph 25 Detail of peg joining collar and rafter in east room of Building A. Photograph taken facing north-east.

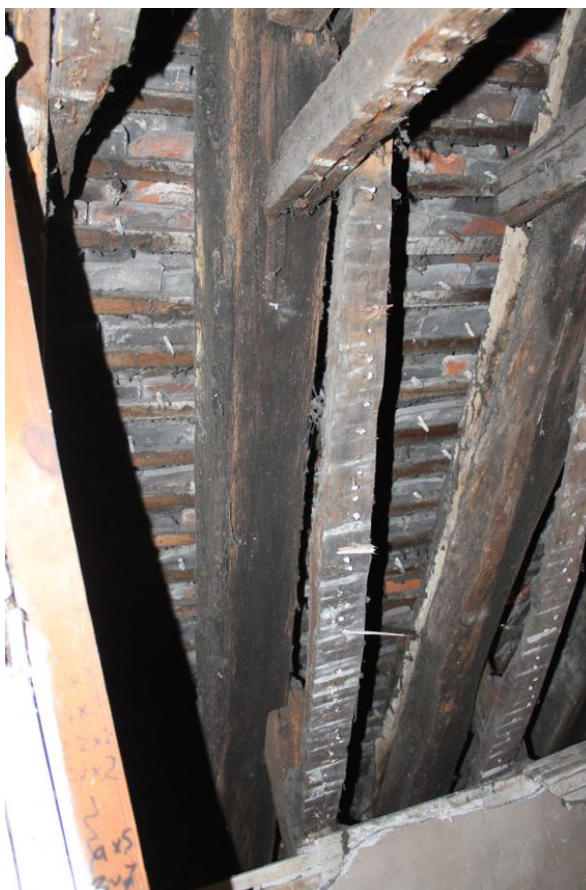
Most of the rafters have evidence of smoke blackening, particularly at their apex (Photographs 26 and 27). The smoke blackening seems most concentrated in the centre of the roof, becoming less prominent towards the eastern and western ends of the building (Photograph 27). The pair of rafters on the extreme western end of the building (above the jetty) are made of a noticeably different wood to the rest, and have no evidence of smoke-blackening at all.

Photograph 26 Detail of smoke-blackening on rafters in centre of Building A. Photograph taken facing south-west.

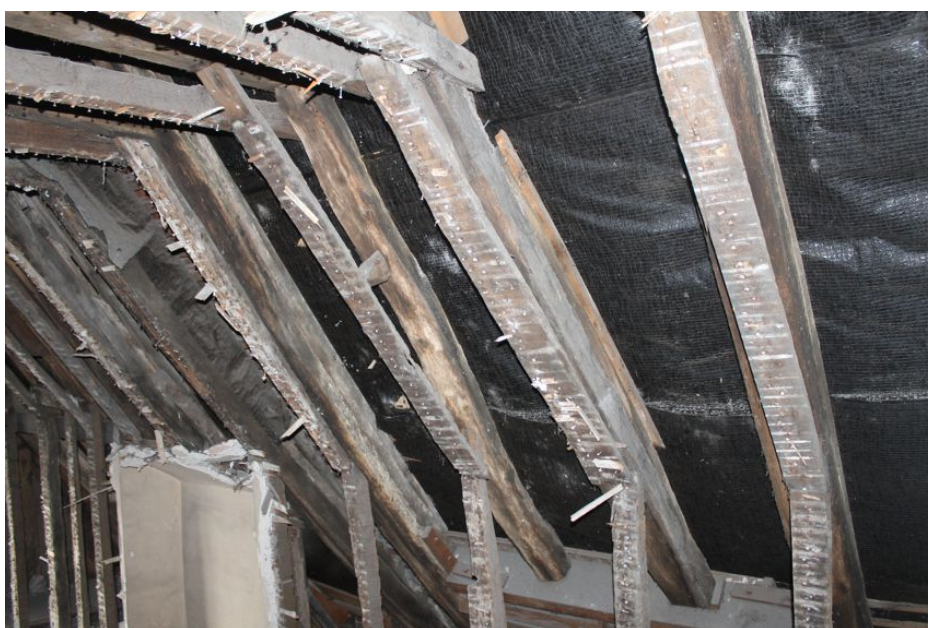
Photograph 27 Smoke-blackening on rafters in Building A. Shows variation in smoke-blackening from centre of building (right) outwards. Photograph taken facing north-west.

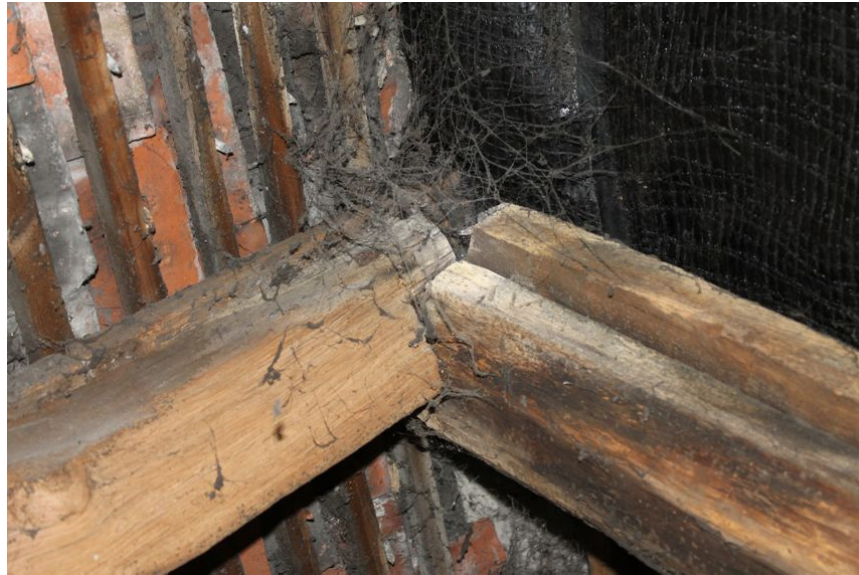
Photograph 28 Carpenter's mark "IV" at apex of rafters in Building A.

The carpenter's marks (Fig 6) were observed either at the apex of the rafters (Photograph 28), or more centrally-placed on their inner face (Photographs 29 and 30). Of the two, the centrally-placed marks were the more common, with 10 observed, compared to only 3 at the apex. The 3 apex marks did not appear to have a matching

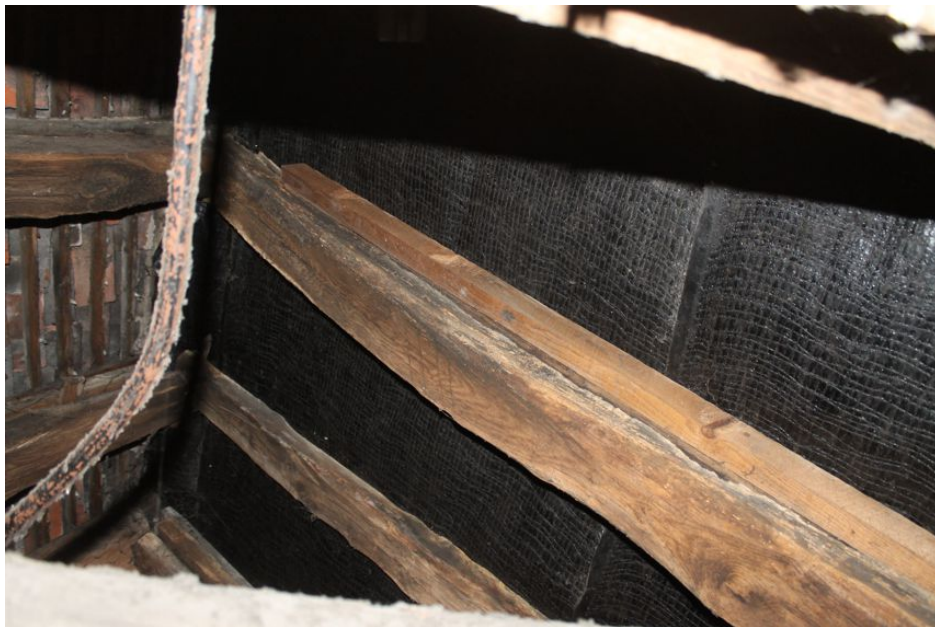
Photograph 29 Carpenter's mark "IIII" on side of rafters in Building A.

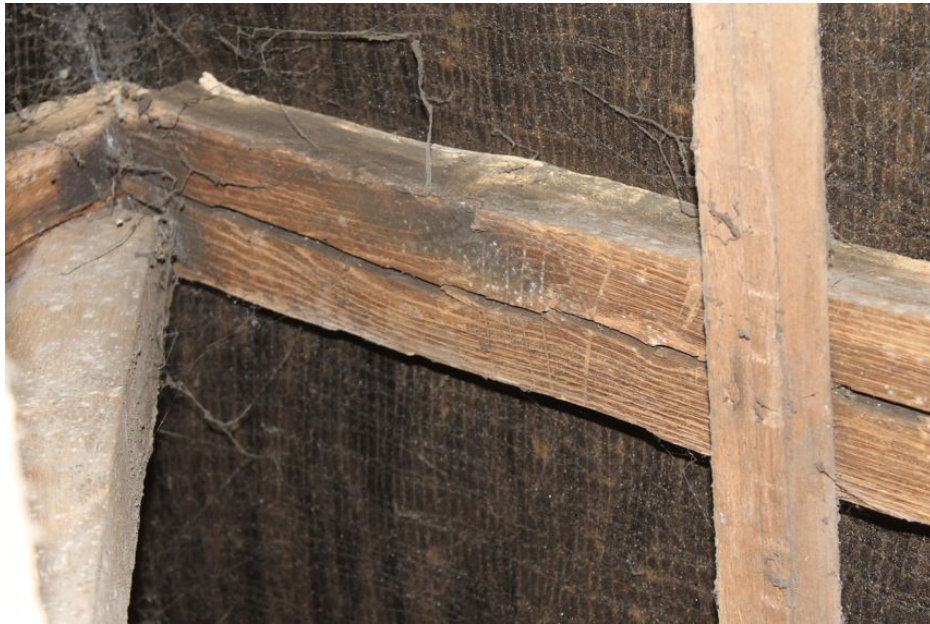
Photograph 30 Carpenter's mark "XIII" on side of rafters in Building A.

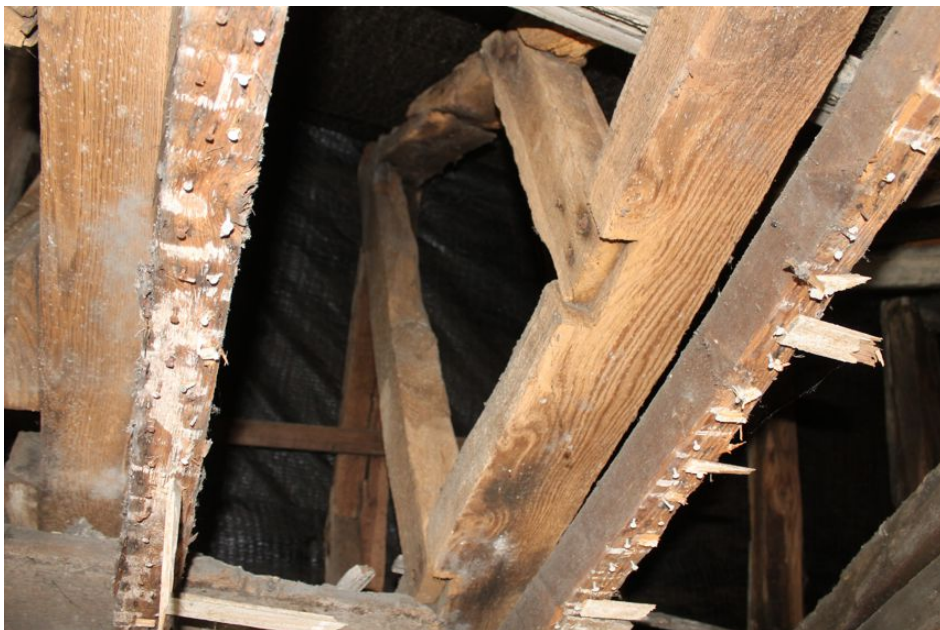
Photograph 31 Queen and king-posts nailed in place on the two westernmost collars in Building A.

As well as these king and queen-posts, there is also a very thin and wide collar purlin projecting out from the western gable, that ends some short distance before the second collar. This collar-purlin is resting on the lower collars, and was probably inserted at the same time. These additions to the western gable (the queen- and king-posts and the

collar purlin) were all presumably added in order to provide more stability to the jetty.

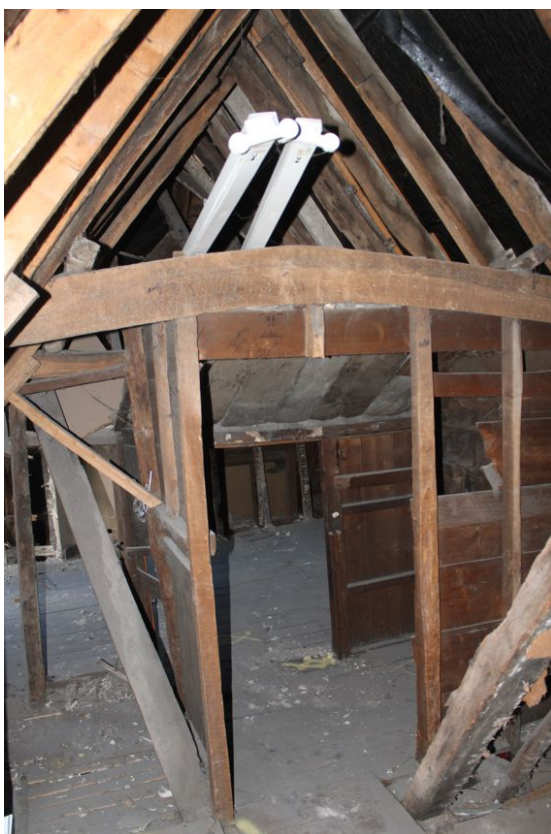
Photograph 32 Small timber room in the joining section of roof between the second-floor of Buildings A and B. Arched collar used as part of the structure. Photograph taken facing north.

The southern elevation of the western room has four rafters that have been cut off to allow access into the second-floor of Building B. The joining section of roof between Buildings A and B has a small timber room within it, which uses the hand-sawn arched collar of the joining section of roof as one of its structural timbers (Photograph 32). The purpose of this room is unclear, but presumably it was used for storage.

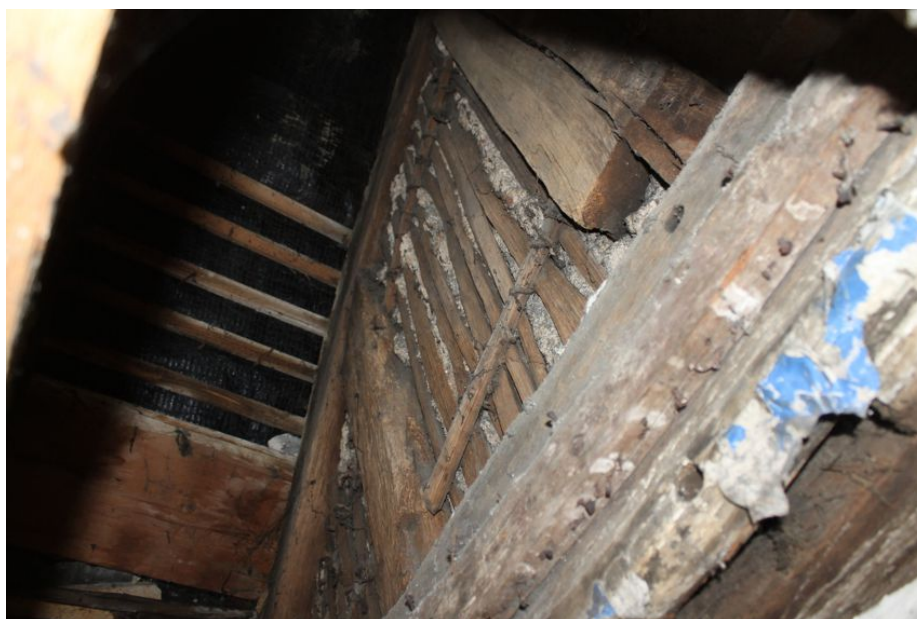
Photograph 33 Possible original rudimentary lath and plaster on west side of the modern skylight in Building A. Photograph taken from first-floor looking up.

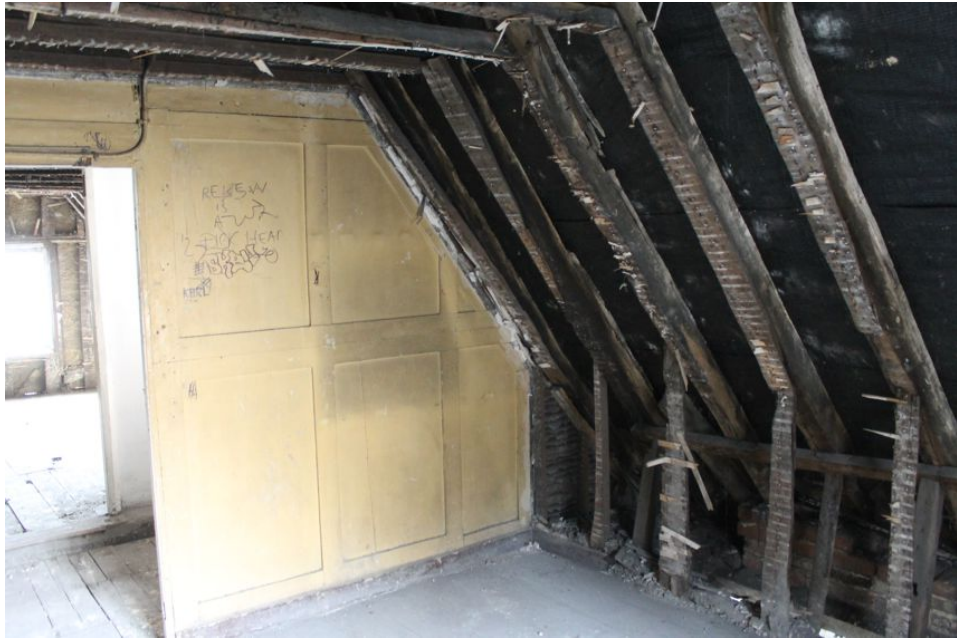
The eastern room on the second-floor of Building A measures 3.6 x 6.1m (Photograph 34). A low lath and plaster wall obscures the lower part of the rafters on the southern elevation. The eastern gable end is likewise covered with render, with only a modern machine-cut girding beam, nailed to the end-rafters, visible. Like the western room,

Photograph 34 East room on second-floor of Building A. smoke-blackened rafters visible. Photograph taken facing north-west.

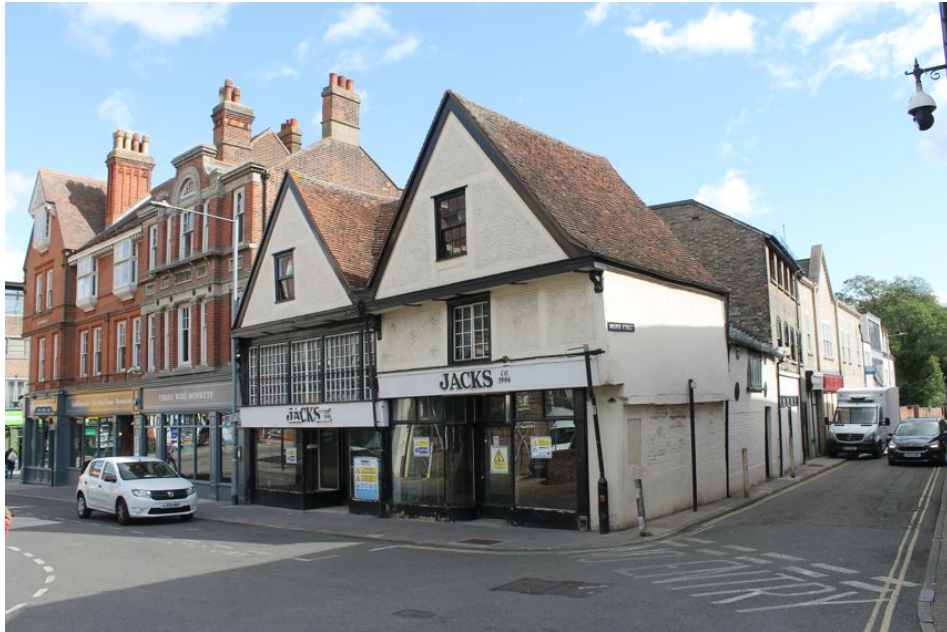
Building B is a timber-framed three-storey building with a single bay, 6m long x 5.6m wide x 8.5m tall, fronting onto St Nicholas Street to the west and Culver Street East to the south (Photograph 36). It is essentially a square, with the exception of the southern wall, which follows the alignment of Culver Street East and makes the building marginally wider at its western end compared to its eastern (Fig 4). Beneath the building is a brick-built cellar on the same alignment, which would have supported the structures principal timbers when they were extant (Photograph 37).

Photograph 36 Entire site, showing Buildings A, B, C and D. Underbuilding in brick below Building B's southern jetty visible. Photograph taken facing north-east.

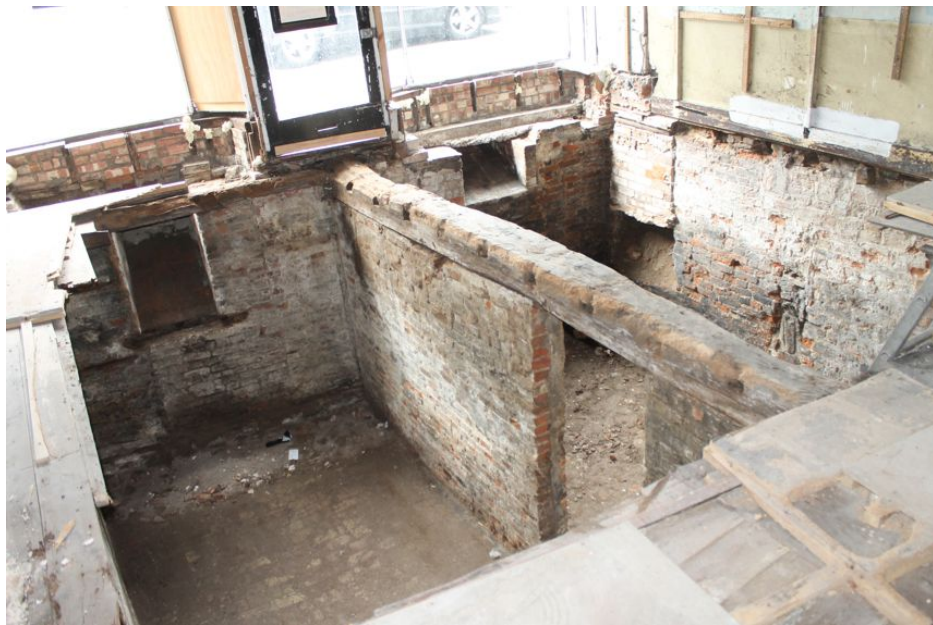
Photograph 37 Brick-built cellar below Building B. Photograph taken facing north-west.

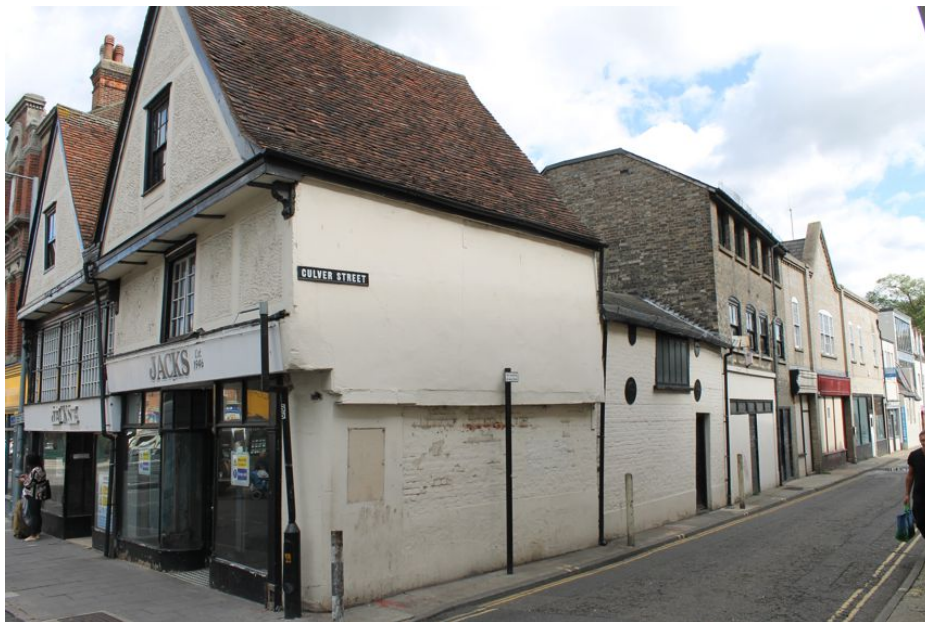
The southern elevation of Building B is jettied on the first-floor, but not on the second. This jetty has been under-built in brick (with dimensions of 215 x 100 x 60mm) laid in English-bond and bonded to the wall of Building C (Photograph 40). The first-floor has no features, and is rendered-over.

Photograph 40 Southern elevation of Building B, showing brick underbuilding. Photograph taken facing north-east.

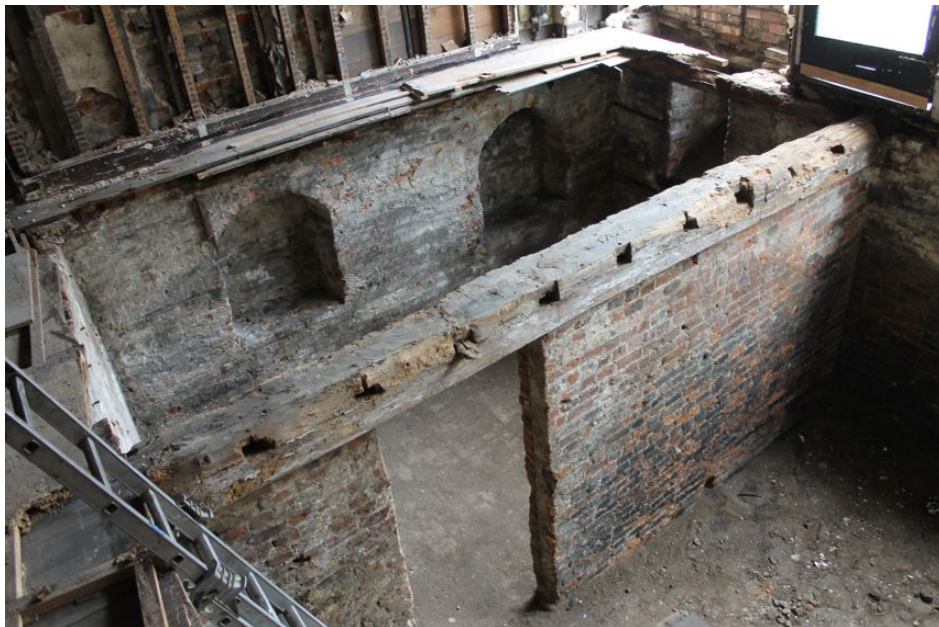
Photograph 41 Cellar beneath Building B, showing recesses for shelving. Photograph taken facing south-east.

Above the dividing wall is a binding-beam that would have supported the joists above the cellar (Photograph 41). This beam is itself supported on two timber posts embedded in the brickwork on the east and west sides of the cellar. The eastern post of these is embedded in a bricked up arched opening, similar to the ones still open on the southern elevation (Photograph 50). This means that this post was a later insertion into the cellar, and might suggest the binding-beam is not original. Alternatively the binding-beam above the cellar could have initially been supported on the brickwork alone.

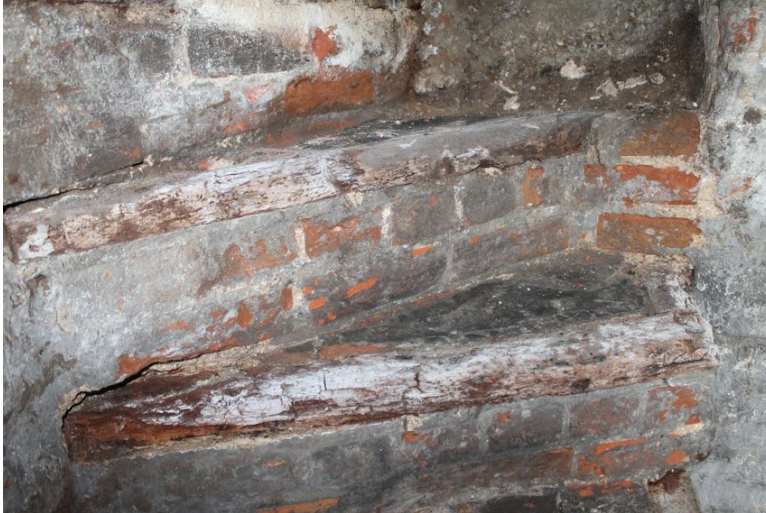
Photograph 44 Detail of steps on stairway. Photograph taken facing north-east.

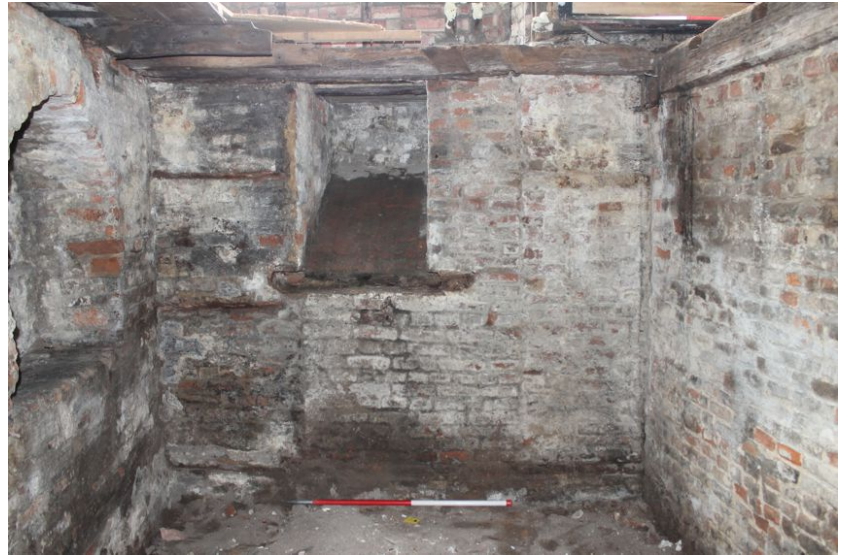
Photograph 45 Western elevation of southern room, showing coal chute inserted into an earlier, bricked up, opening. Photograph taken facing west.

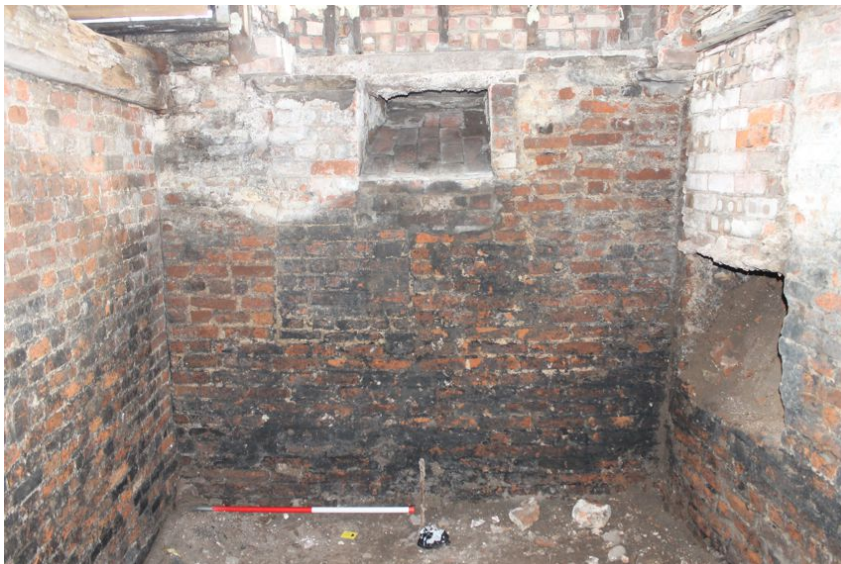
Photograph 46 Western elevation of northern room, showing coal chute replacing an earlier, bricked up, opening. Photograph taken facing west.

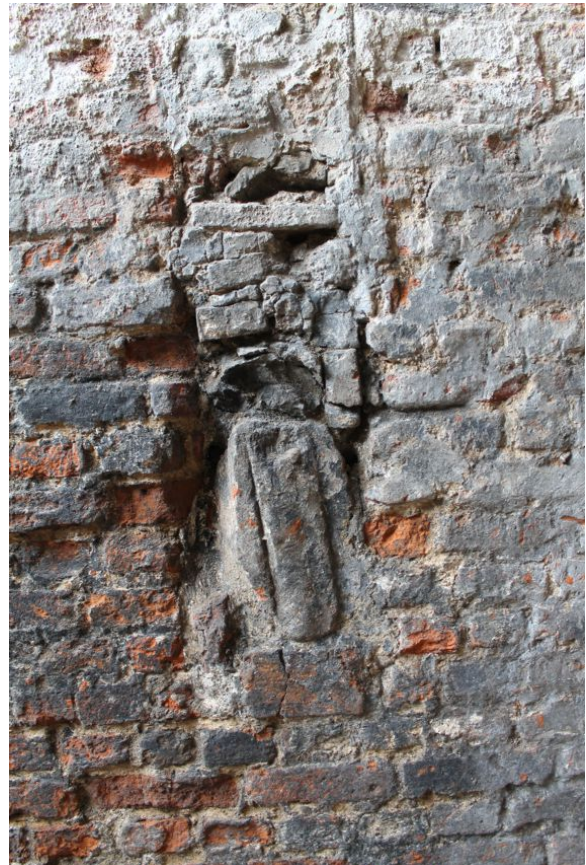
There is also a significant area of infilling within the brick wall on the northern elevation (Photograph 47). As well as more substantial brickwork (230 x 140 x 110mm) and irregular bonding, there is a large piece of worked stone that has been inserted into the wall (Photograph 48). This infilling appears to be where a post was embedded into the brickwork and has since been removed, with associated damage to the top of the wall.

Photograph 48 Detail of worked stone in northern wall of cellar.

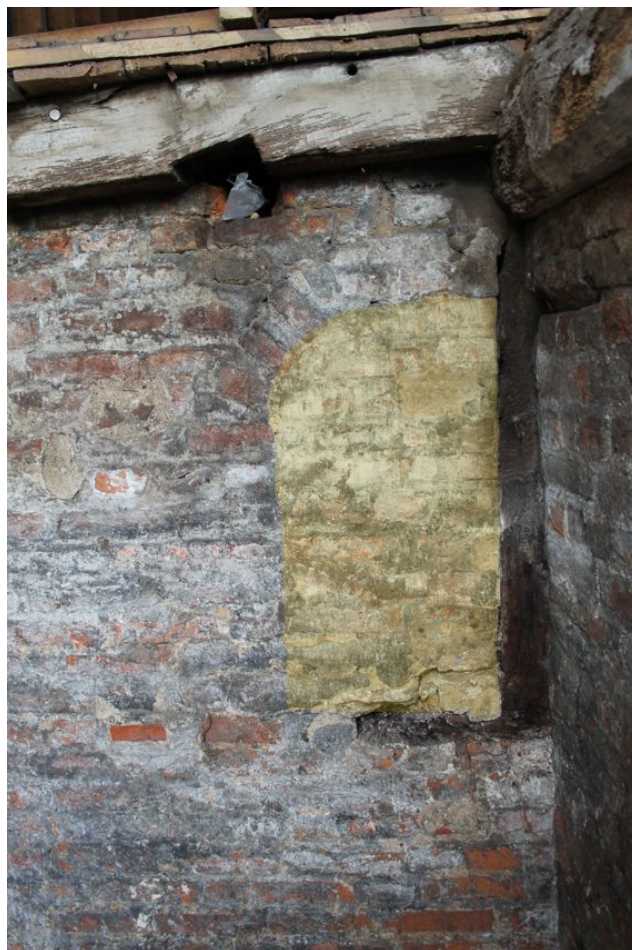
Photograph 50 Highlighted blocked archway in eastern wall of cellar, including post supporting binding-beam. Photograph taken facing east.

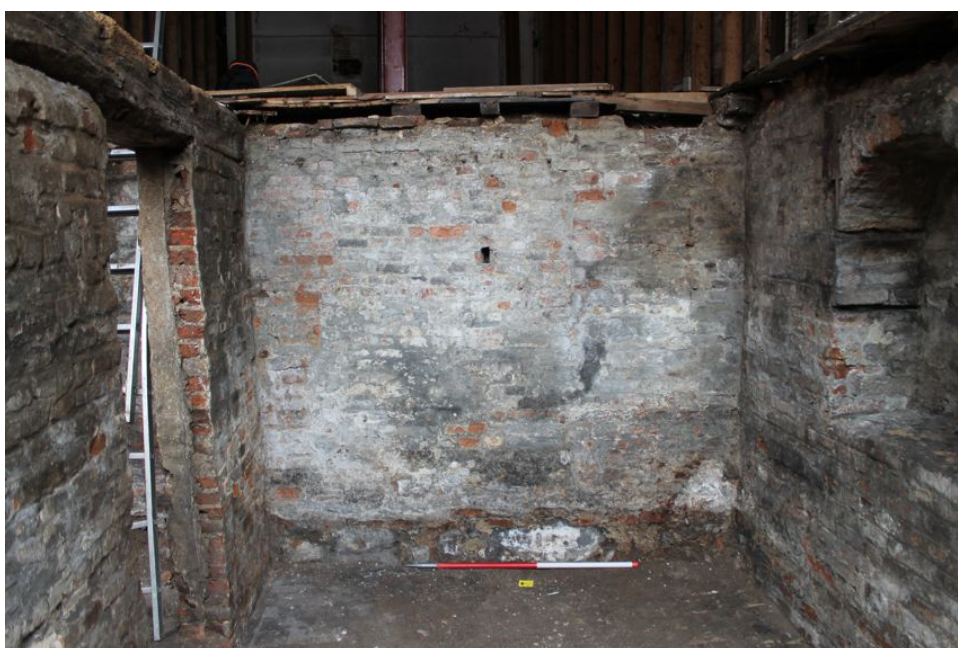
One final note of interest concerning the cellar is that the eastern wall appears to be partially built upon a Roman foundation, constructed of lime mortar and septaria (Photograph 51).

Photograph 51 Eastern wall in southern room of cellar, with Roman foundation at base. Photograph taken facing east.

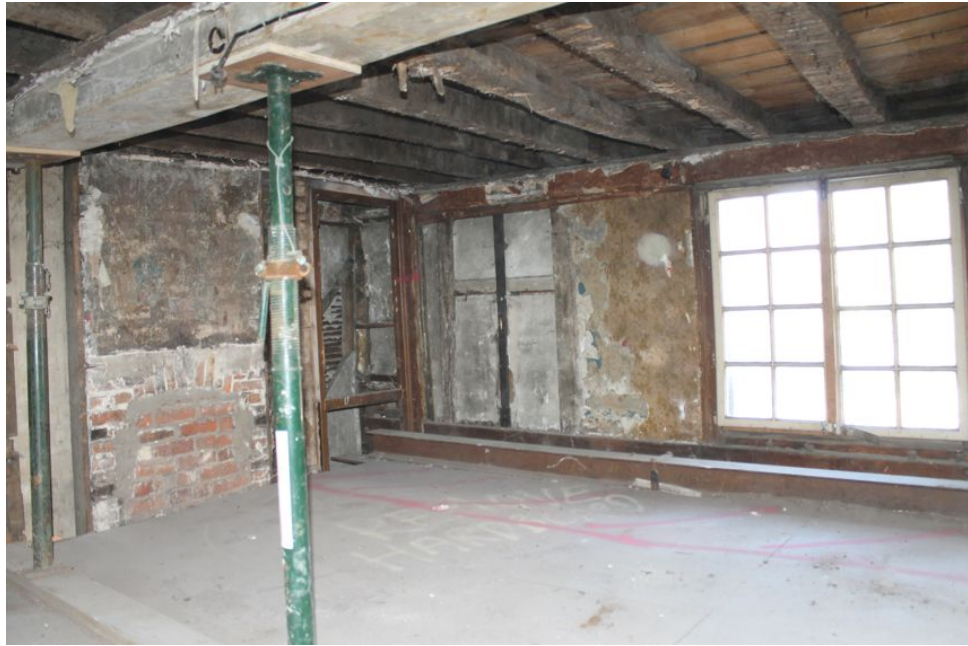
The first-floor of Building B is divided by three thin inserted walls covered in lath and plaster (Fig 5). The entire floor level has been raised to create more space on the ground-floor, and is supported on several metal girders (Photograph 39). The result is that this floor is very compact in size, with only 1.5m between the floor and ceiling (Photograph 54).

Photograph 54 First-floor of Building B, showing blocked fireplace and raised floor level. Photograph taken facing south-west.

The wall-plate survives around the entire building, although it is partially obscured on the southern elevation by an inserted chimney-stack (Photograph 54). All four corner-posts are intact at this level.

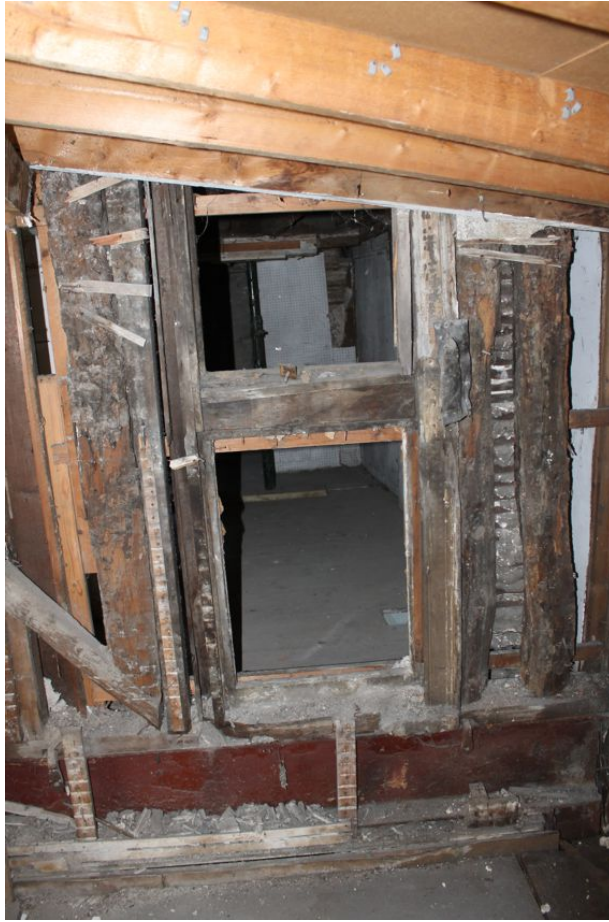
The eastern elevation of the first-floor has an inserted wooden-framed two-light fixed window, with no surviving glass (Photograph 55). Also on this elevation is an inserted entrance into Building C, forming by removing a stud to the north of the principal-post (Photograph 39). There is a section of diagonal primary-bracing on this elevation which stylistically dates from the end of the 16th century onwards (Stenning 2013, 130).

Photograph 55 Detail of inserted window-frame in east wall of Building B's first-floor. Photograph taken facing west.

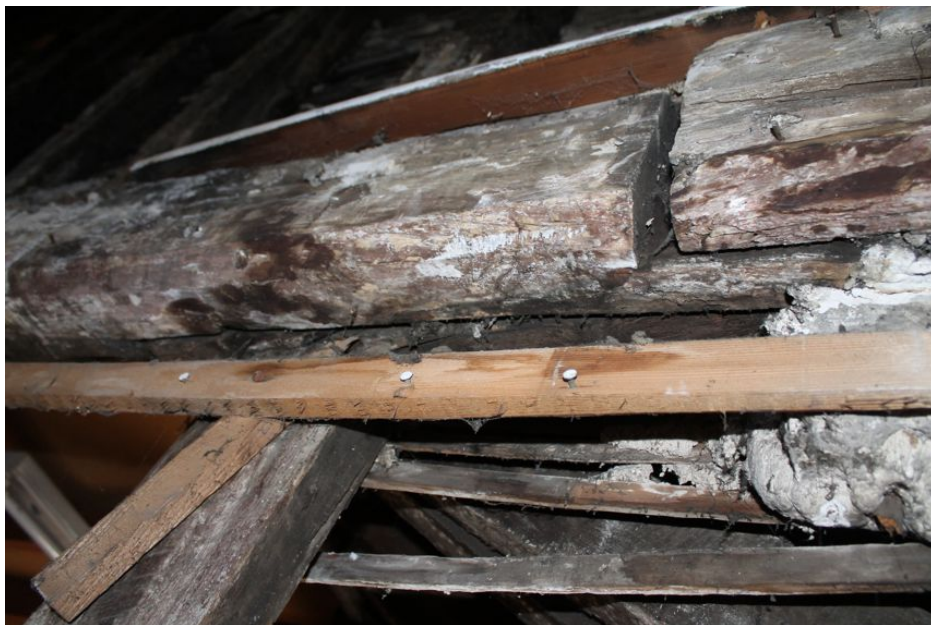
On the wall-plate on the eastern elevation is a face-halved and bladed scarf joint (Photograph 56) with one visible edge peg (although in actuality it probably has two or more that are not visible beneath remaining render and the roof timbers of Building C). This style of scarf joint is first seen in the late 16th century and continues in use right through to the present day (Hewett 1980, 269).

Photograph 56 Detail of scarf joint on eastern wall-plate of Building B.
