**Historic building recording at
5 and 6 St Nicholas Street (formerly 'Jacks'),
Colchester
CO1 1LB**

September 2017

**report prepared by
Mark Baister**

CAT Report 1222
March 2018

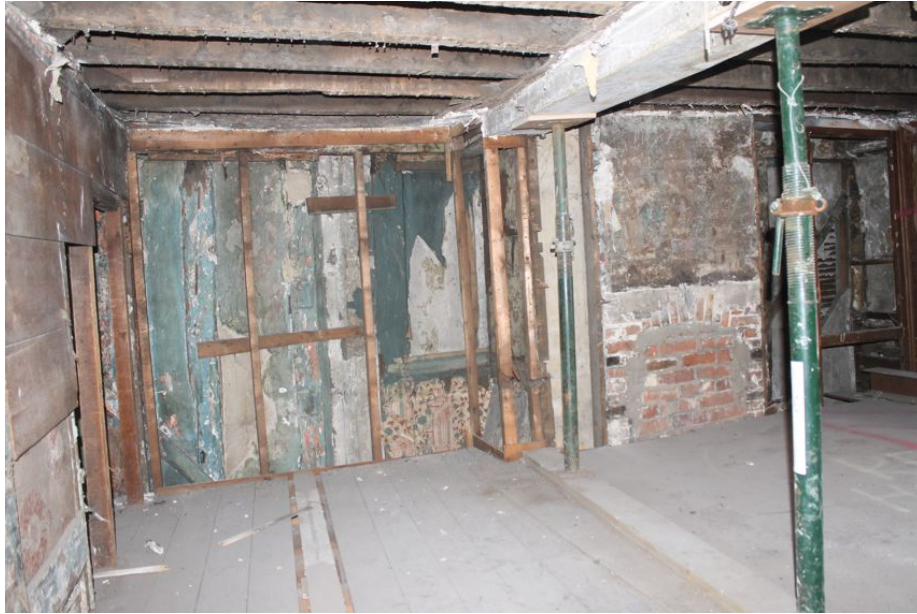
Photograph 57 Internal southern elevation of first-floor in Building B. Photograph taken facing south.

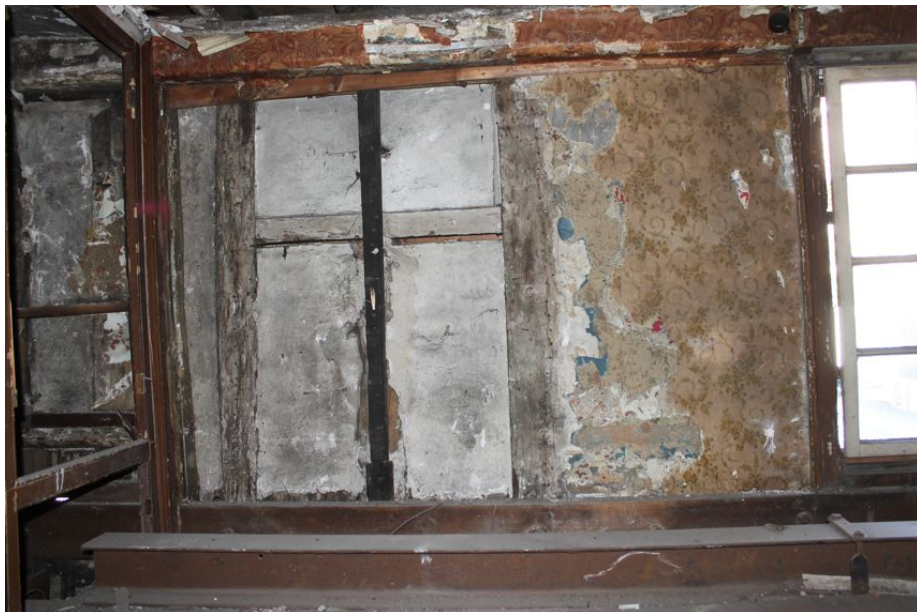
division between them, with one infilled with a modern machine-cut stud (Photograph 58). Whether these large division are indicators of earlier windows or not is uncertain. Unfortunately closer examination was impossible due to the unstable nature of the floorboards.

Photograph 58 Western wall of first-floor in Building B, showing possible infilled window opening. Photograph taken facing west.

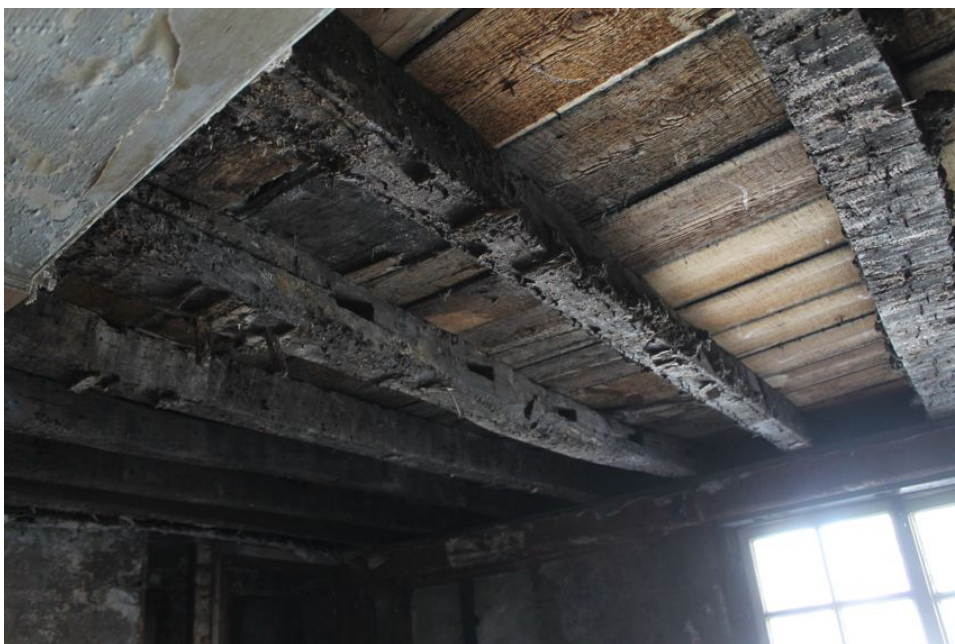
of the fireplace or the floor level being raised may have removed it (and a principal-post would not be expected on the northern elevation, as it is part of the frame of Building A). One of the joists supporting the second-floor is re-used, and has several empty mortices on its northern side (Photograph 59).

Photograph 59 Unused mortices on joist of second-floor of Building B. Photograph taken facing south-west.

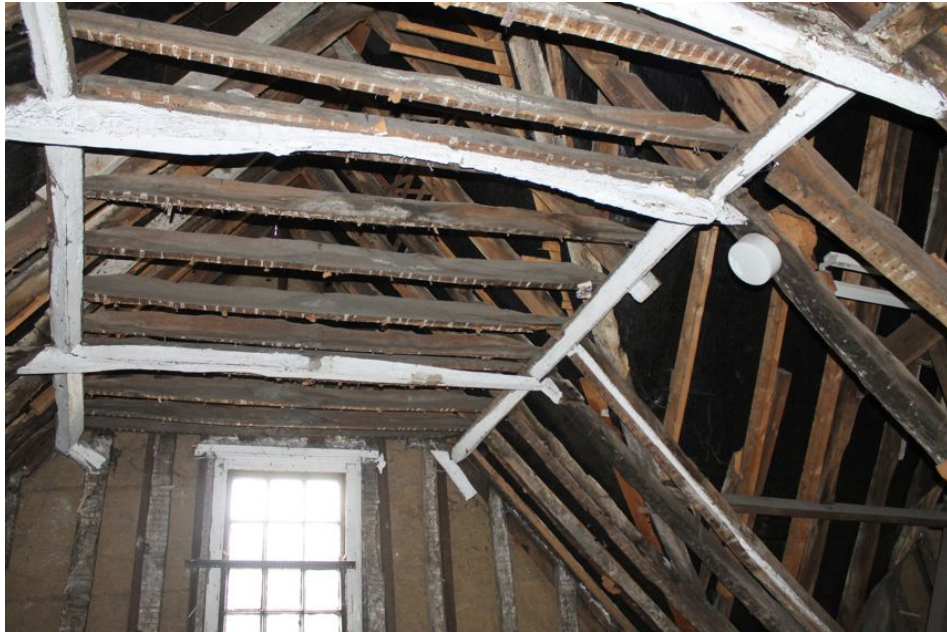
Building B has a roof supported with five large arched collars irregularly spaced across the rafter pairs (Fig 6). Further supporting the rafters are two large clasped-purlins (Photograph 60). Nailed to the purlins are 19 hand-sawn braces; they not attached to the rafters and as a result are not collars in the strictest sense. They appear to be later additions to the building and were probably added to the purlins in an attempt to prevent the roof racking. The building has no ridgeboard, and each pair of rafters are pegged at their apex (Photograph 61). Several rafters have simple splayed scarf joints, or possibly repairs, often with large numbers of face pegs and nails keeping them together (Photograph 61).

Photograph 60 Roof of Building B, showing original collars and purlins, as well as later braces. Photograph taken facing west.

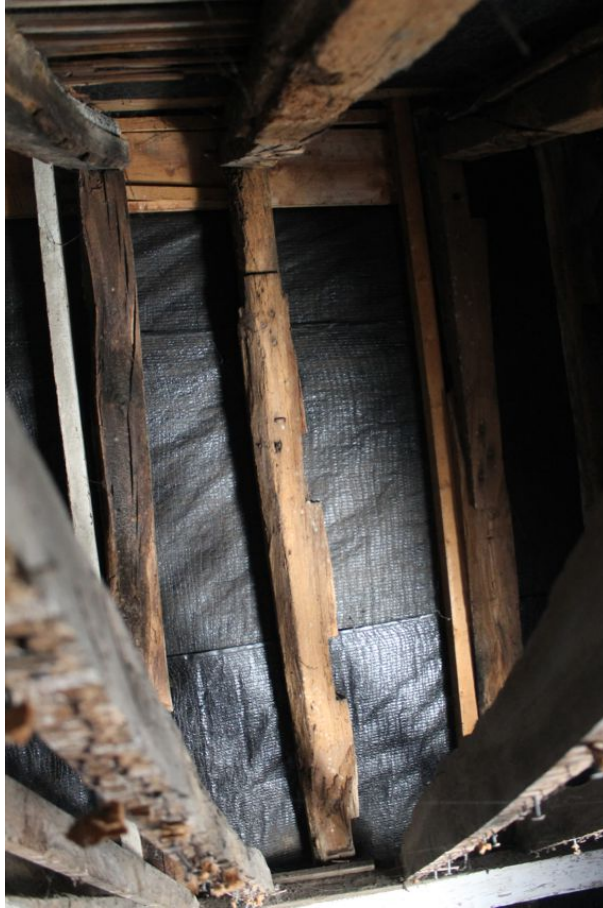
Like Building A, several of the rafters have evidence of smoke blackening. Several rafter pairs are heavily blackened, but, unlike in Building A, are adjacent to rafter pairs that are not blackened at all (Photographs 61 and 62). This suggests that the smoke-blackened rafters are re-used and that the roof has been built using rafters from an earlier building that had an open fire. Additionally, several of the non-blackened rafters

have evidence they were originally from another building in the form of empty mortices (Photograph 62).

Photograph 62 Reused timber in roof of Building B, and evidence of smoke-blackening. Photograph taken facing south.

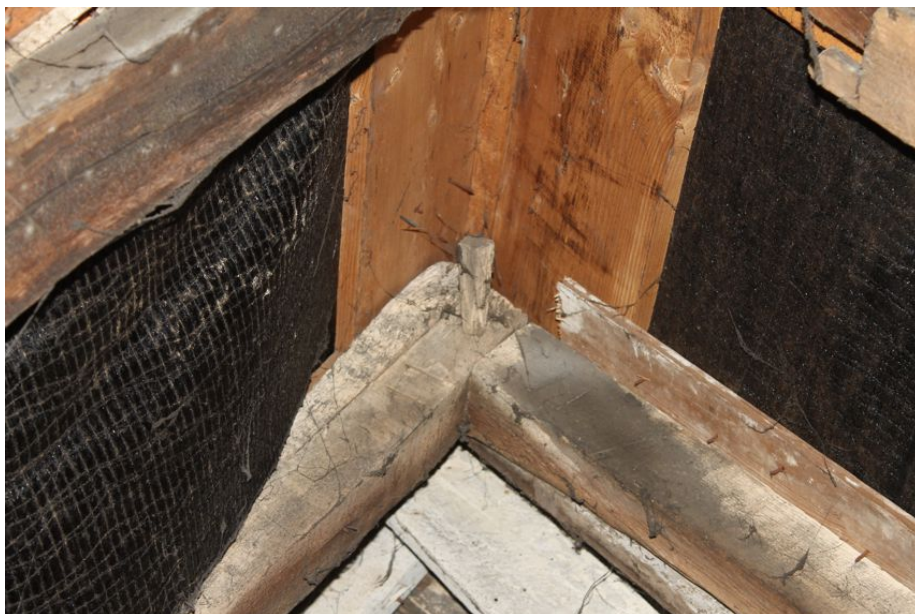
Two carpenter's marks (Photograph 63) were observed on the rafters. Both had a match on their opposing rafter, but they do not make sense sequentially (since they are 'II' and 'III' and are two rafter pairs away from each other). As with the smoke blackening and the unused mortices, these carpenter's marks are probably a result of the rafters being re-used from an earlier building.

Photograph 63 Carpenter's mark "III" at apex of roof in Building B.
Photograph 63 Carpenter's mark 'III' at apex of roof in Building B.

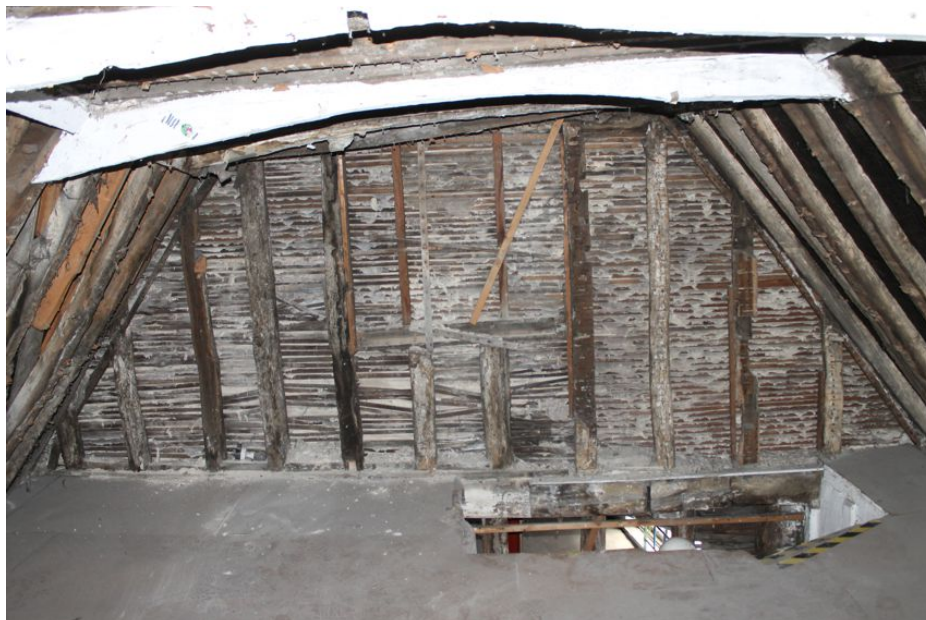
The eastern elevation of the second-floor has an inserted window opening, that has been covered the lath and plaster rendering (Photograph 64). This means that the lath and plaster currently on the building is not original, and has been redone.

Photograph 64 East gable end in Building B, showing inserted window opening that has been covered in lath and plaster. Photograph taken facing east.

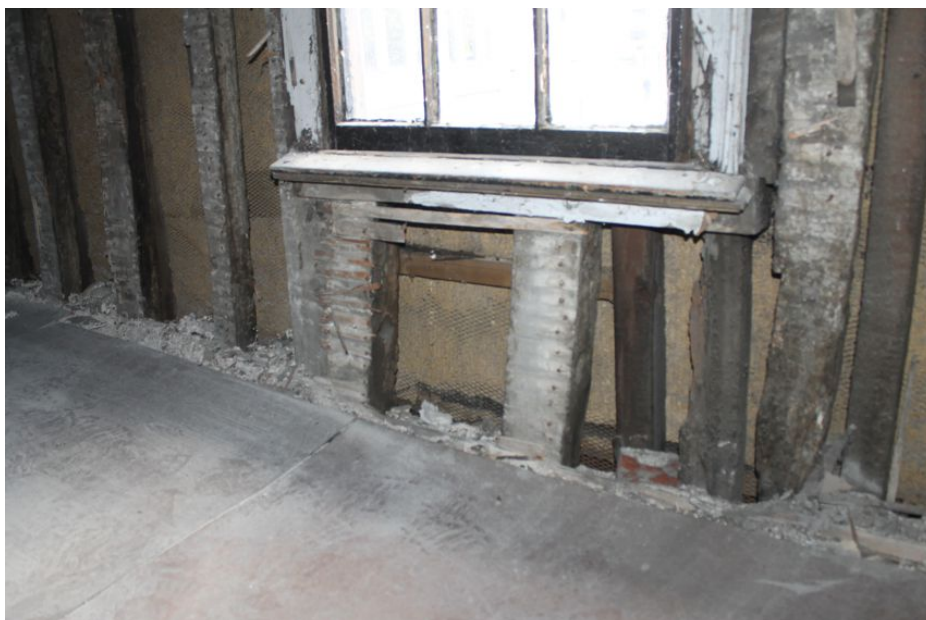
The western elevation has an inserted window supported by a modern timber to the south, and by two cut off original studs

below. One of these cut studs has evidence of re-use in the form of diamond mullions on its northern face (Photograph 65).

Photograph 65 Cut studs beneath inserted window in west gable end of Building B. Diamond mullions visible on left stud. Photograph taken facing south-west.

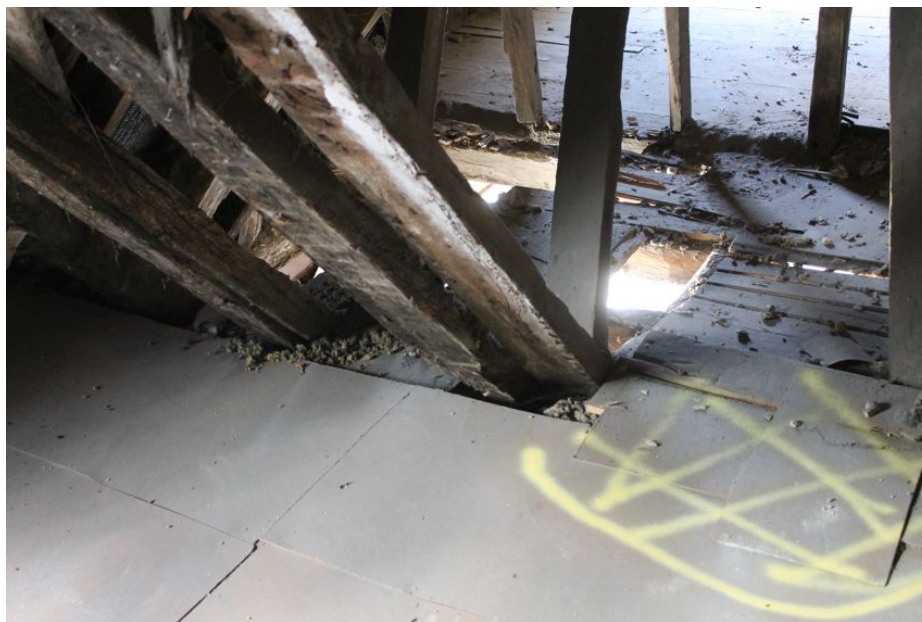
The northern elevation has a cut rafter, allowing access into the second-floor of Building A. In addition, two of the rafters on this elevation rise from one point on the wall-plate (Photograph 66). This may have been a later alteration to allow better access into Building A.

Photograph 66 Two rafters rising from one point on wall-plate to north of Building B. Photograph taken facing north-west.

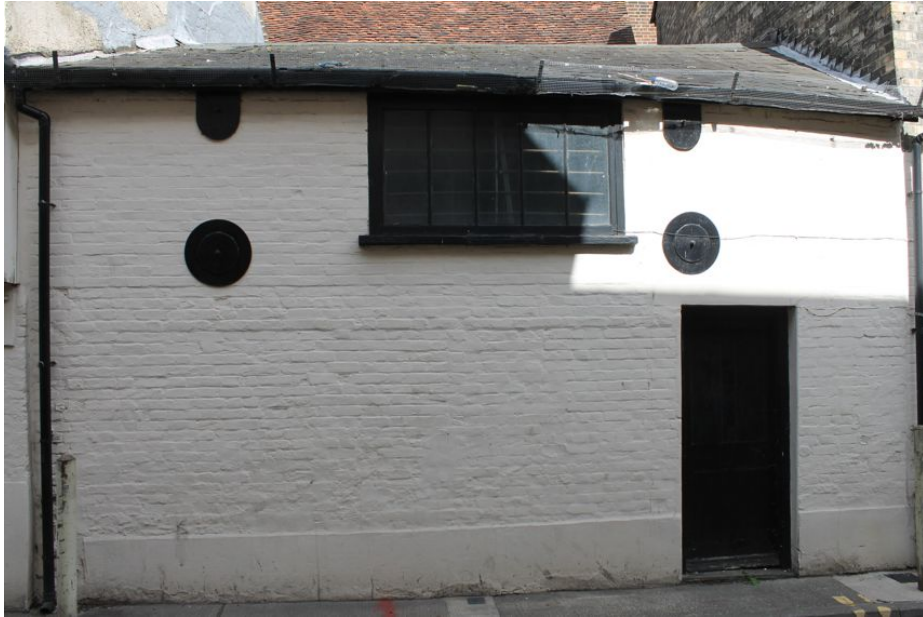
The southern elevation has an inserted wooden-framed four-panel door, and an inserted five-light fixed window (Photograph 67). These were both added to the structure in 1936, when several other alterations were carried out to Building D (see historical background pg 13).

The southern elevation has two distinct phases of brickwork (Photograph 67). The lower 2.25m of bricks are smaller, measuring at 200 x 95 x 70 mm. The top 1.3m of brickwork is made of larger bricks, measuring at 230 x 110 x 75 mm. The upper bricks are laid in Flemish bond, whereas the lower bricks are laid irregularly (although in some areas

resemble a form of Sussex bond). The larger bricks represent a second-storey that was added to the building between 1848 and 1876 (see historical background pg 9).

Photograph 67 Southern elevation of Building C. Photograph taken facing north.

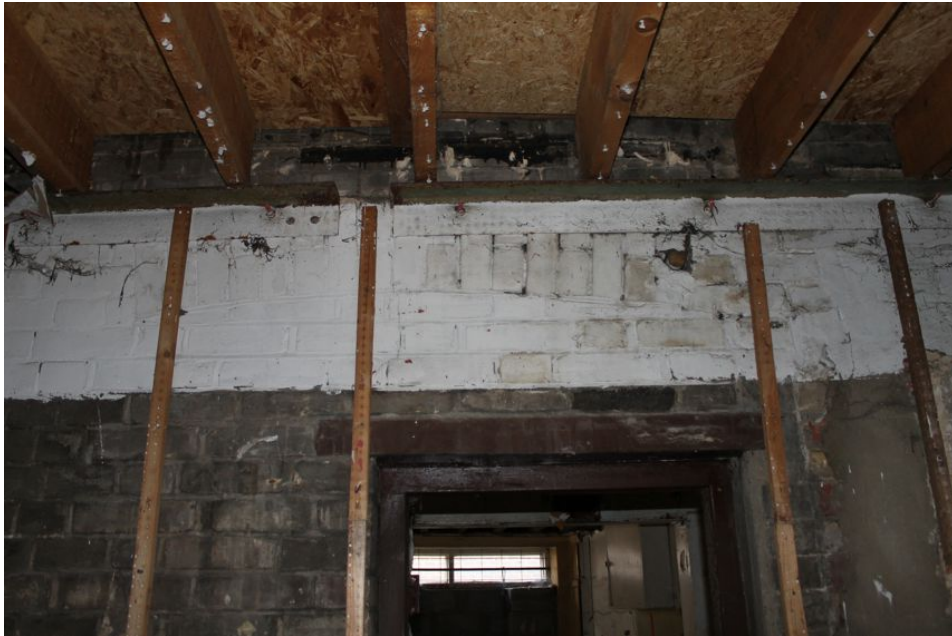
The ground-floor of the northern elevation of Building D is within Building E. On the ground-floor level are three doorways leading into the structure, all of which have been inserted. Above the westernmost doorway is a large arch, showing it was originally a window opening (Photograph 71). Outside Building E, the northern (and every other) elevation of Building D has two distinct levels of brickwork, corresponding with the addition of the second-floor in 1920 (see historical background pg 13). The brickwork in both levels has dimensions of 230 x 110 x 70mm and is laid in Flemish bond.

Photograph 71 Archway above inserted doorway in northern elevation of Building D, showing location of original window. Photograph taken facing south.

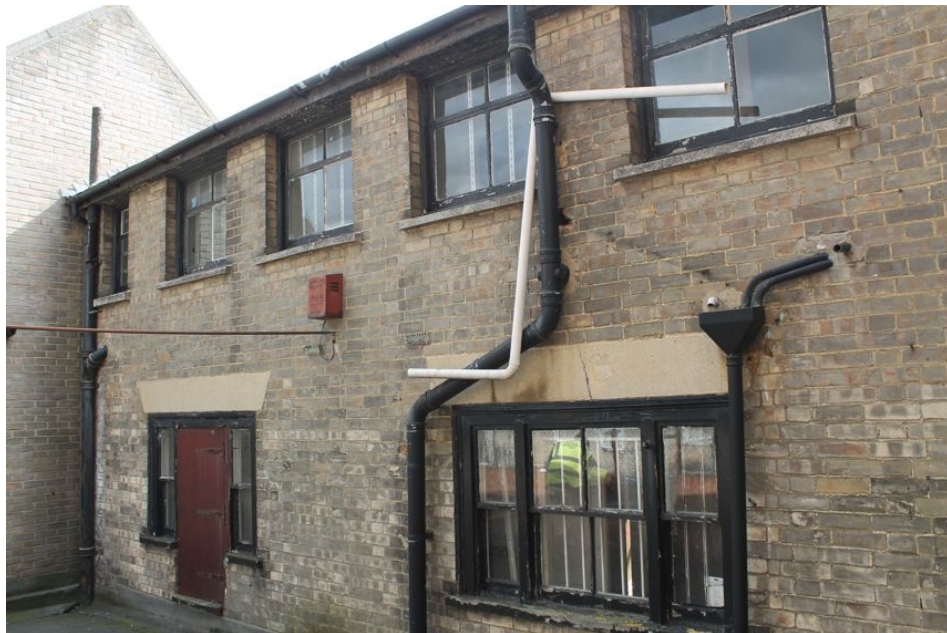
On the first-floor of the northern elevation are two wide wooden-framed sash windows, both of which are original to the first phase of the building. The northernmost one of these windows has had a door inserted into it, leading onto the roof of Building E (Photograph 72). Clearly this would have been inserted at the same time Building E was constructed. On the second-floor level of the northern elevation are five wooden-framed awning windows (4 four-light and 1 two-light), all original to the second-floor addition.

Photograph 72 Northern elevation of Building D. Photograph taken from roof of Building E, facing south-east.

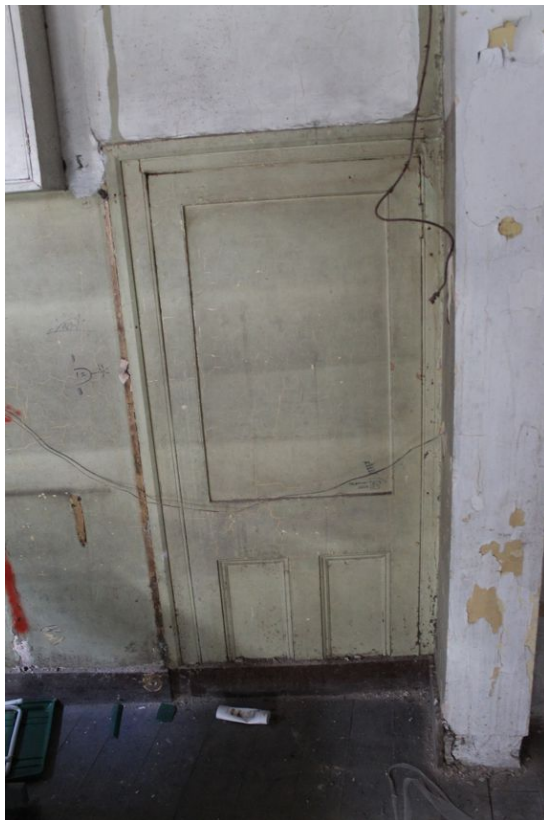
Photograph 73 Blocked door in western wall of ground-floor of Building D. Photograph taken facing west.

modern concrete floor, but in the shop the concrete is covered with floorboards. Most of the structures original internal divisions at this level have gone, having been removed in 1936. The shop room has two doors, one on the western elevation that is original to the structure and was blocked in 1936 (the door survives: Photograph 73), and one on the eastern elevation that was added in 1936. The joists of the floor above are supported by a large metal beam positioned east/west across the shop room and itself supported on brick pillars.

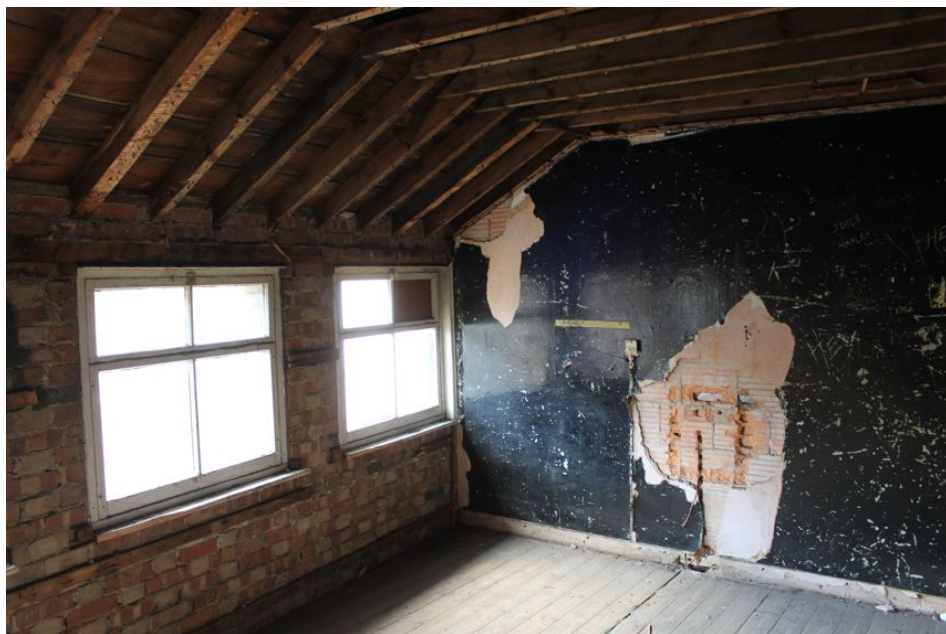
Like the floor below, all the interior walls on this level are rendered over and painted, with little surviving in the way of features. The southern exterior wall is exposed brickwork (Photograph 76), although until the soft-strip it would have been covered in plasterboard. As with the floor below, the four-panel doors are wooden. Exposed behind the plaster on some internal walls are hollow-tile blocks, used to facilitate the plaster adhering to the walls (Photograph 76).

Photograph 76 Second-floor of Building D. Hollow-tile bricks visible beneath plaster to right. Photograph taken facing south-west.
