Historic building recording at The Lordships Stud, Back Road, Writtle, Essex, CM1 3PD

August 2017

CAT project ref.: 17/07h
NGR: TL 6712 0637 (centre)
Planning reference: CHL 15/01855/FUL
ECC project code: WRLS17
Chelmsford Museum accession number: CHMRE: 2017.095
OASIS reference: colchest3-290699

CAT Report 1237
March 2018

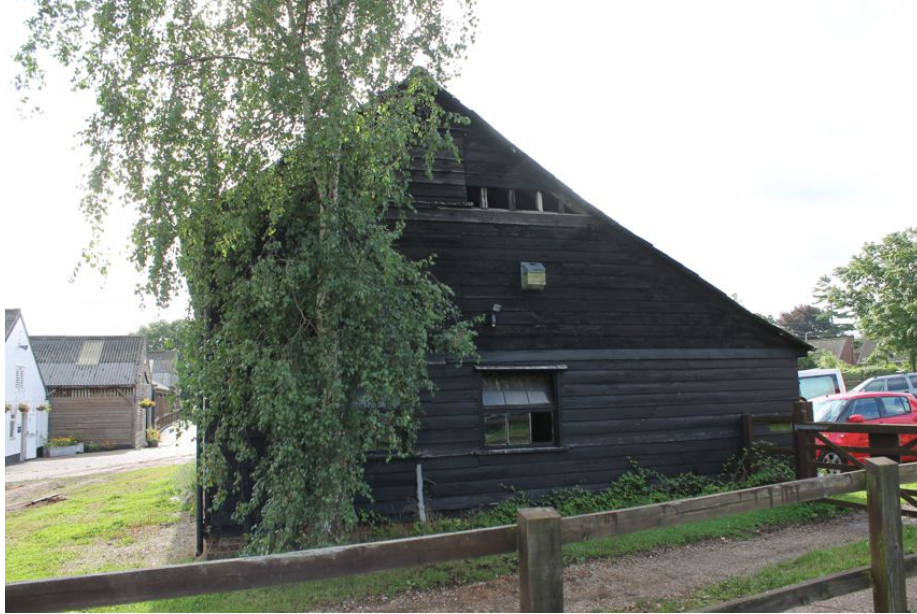
The west elevation of the barn (Photograph 4 and Fig 6) has two inserted six-light wooden-framed windows, with three lower fixed-lights and three upper awning lights. Also on this elevation, in the gable of the barn, is a pitching door covered by weatherboarding.

Photograph 4 Western elevation of barn and outshot A. Photograph taken facing east.

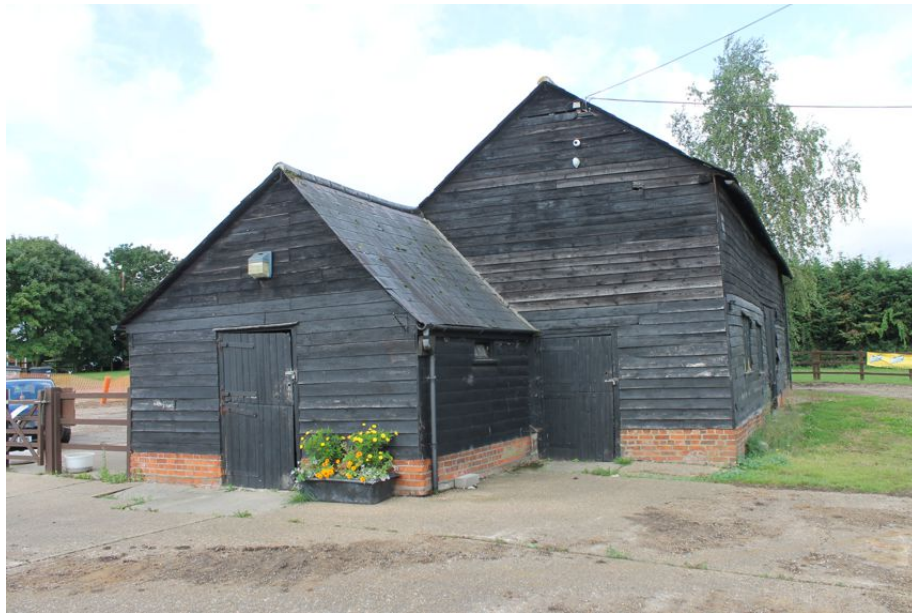
The eastern elevation of the barn (Photograph 5 and Fig 6) has an inserted vertically-planked stable door directly adjacent to outshot B. The eastern elevation of outshot B also has a vertically-planked stable door.

Photograph 5 Eastern elevation of barn and outshot B. Photograph taken facing west.

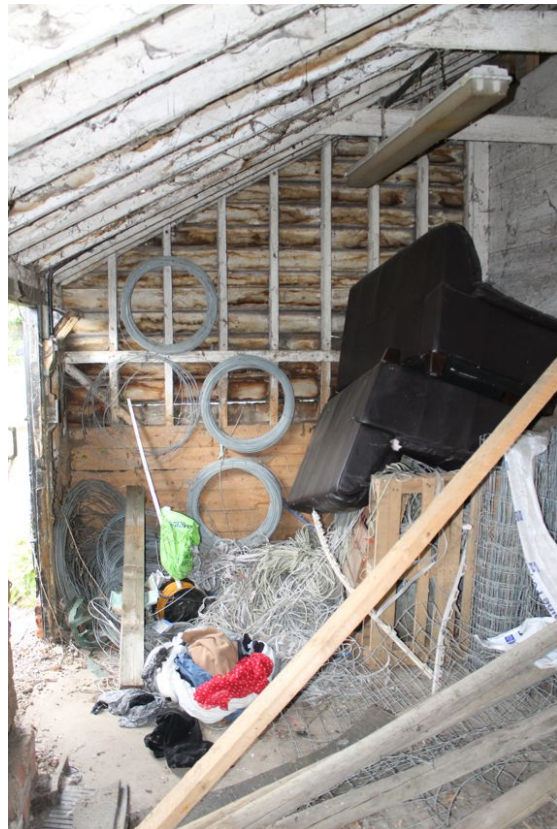
The timber-frame of outshot A is entirely comprised of machine-cut timber, occasionally reinforced by diagonal through-bracing (Photograph 6). There is a girding-beam around the timber-frame. The whole structure is supported by the southern elevation of the barn.

Photograph 6 Interior of outshot A. Photograph taken facing west.

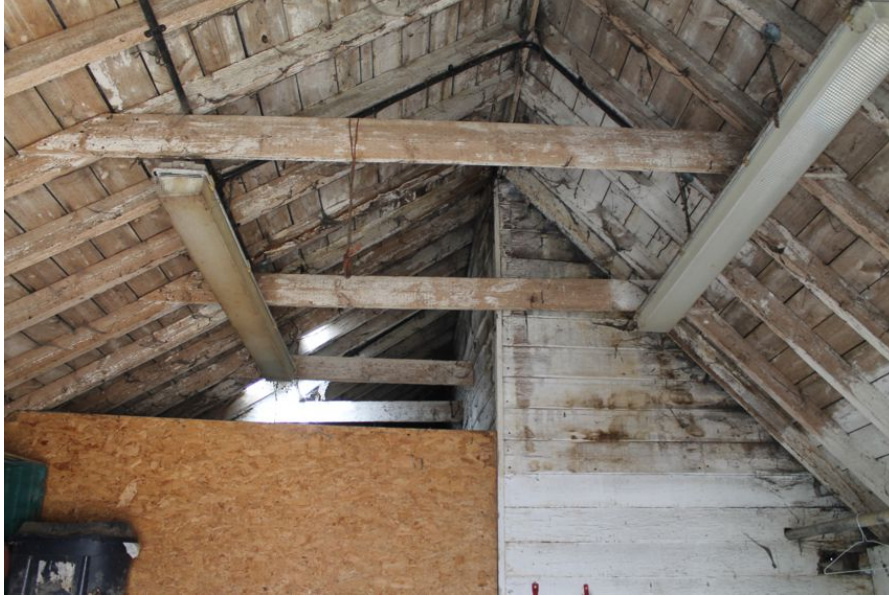
Like outshot A, the visible frame of outshot B is entirely constructed of machine-cut timber (Photograph 7). It is subdivided by a large section of chipboard into two rooms, one of which is accessible from the outside, and one of which is accessible from the barn (Fig 3).

Photograph 7 Interior of outshot B, showing corner and weatherboarding of barn. Photograph taken facing west.

Most of the frame of outshot B is covered by large painted pieces of chipboard, so a close inspection was not possible. However, given the modern timbers visible in the roof and the cartographic evidence (showing this extension as having been built between 1919 and 1939 – see Maps 6 and 7) this outshot is of little interest.

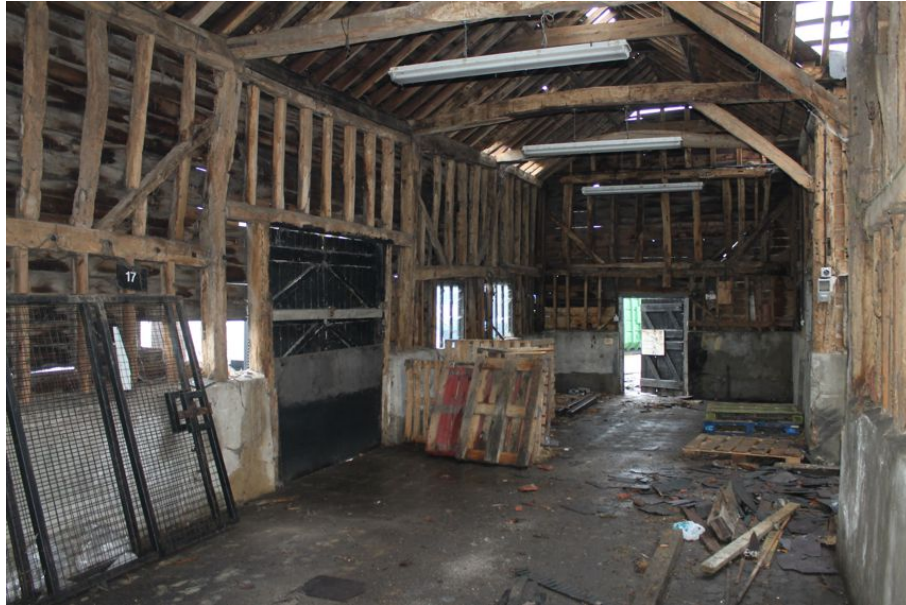
The timber-frame of the barn contains a mixture of machine-cut and hand-sawn timbers and is supported by diagonal through-bracing on the upper register (Photograph 8).

Photograph 8 Interior of barn. Photograph taken facing north-east.

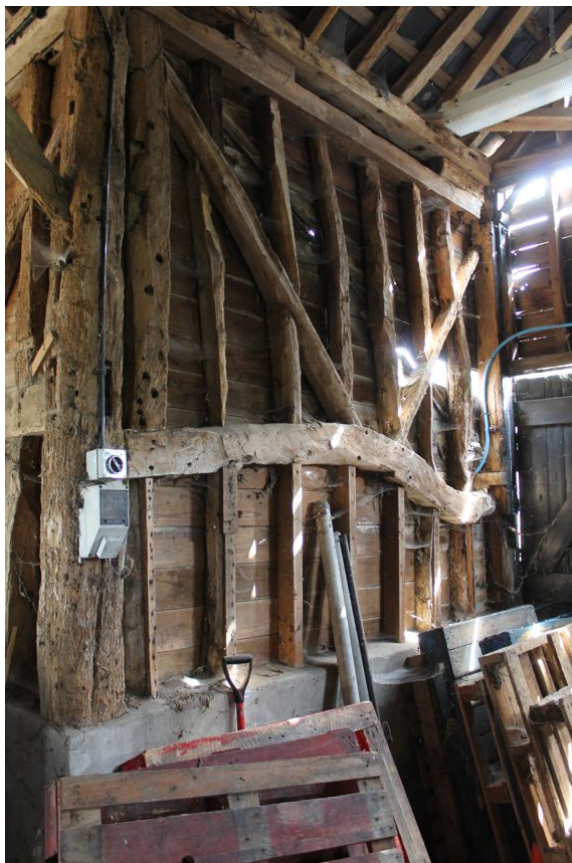
Photograph 20 Eastern elevation of midstrey. Photograph taken facing south-east.

on the eastern elevation of the midstrey are entirely machine-cut, whereas on the western elevation they are largely hand sawn timbers with evidence of re-use. Also on the eastern elevation is an extremely sinuous girding-beam (Photograph 20).

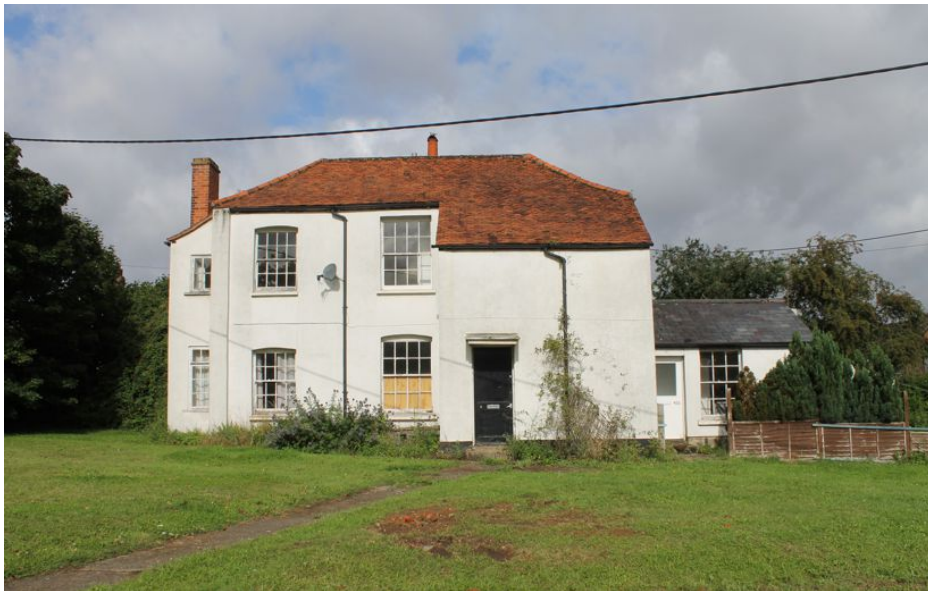
Photograph 24 Eastern elevation of farmhouse, showing extensions B, C and D. Photograph taken facing west.

The eastern elevation of the farmhouse (Fig 11) has four sixteen-light sash windows with horns, with the two to the north being larger than the two to the south (Photograph 24). Extension C projects from this elevation with a catslide roof, and has a modern two-panel door on the ground floor (Photograph 24).

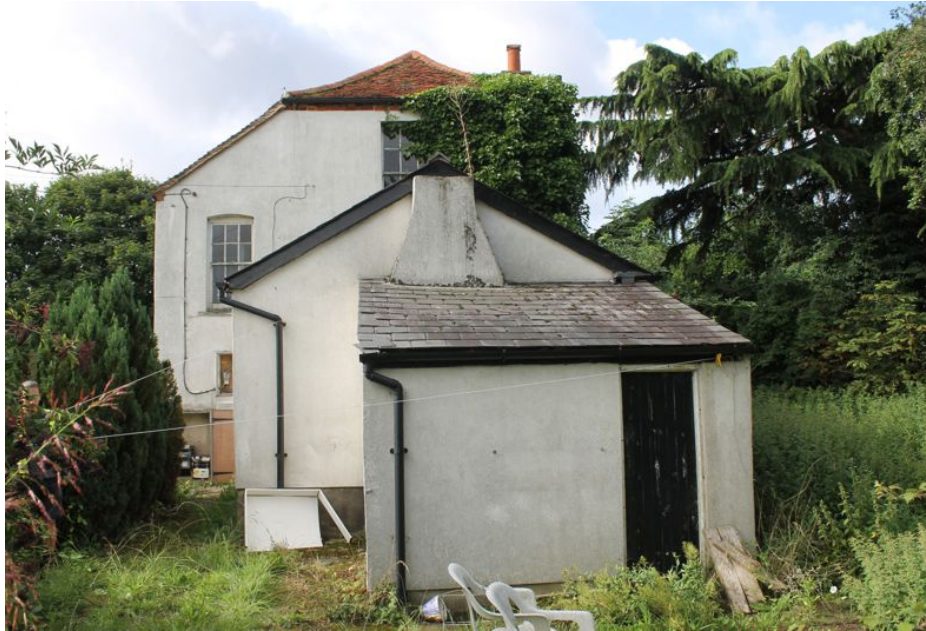
The northern elevation of the farmhouse (Fig 13) has a centrally located six-light sash window with horns on the first-floor. Extension C has a similar, but smaller, six-light casement window at the first-floor level (Photograph 25). Extension B has a vertical-planked door on this elevation, leading into one of its northern rooms.

Photograph 25 Northern elevation of farmhouse, showing extensions B and C. Photograph taken facing south.

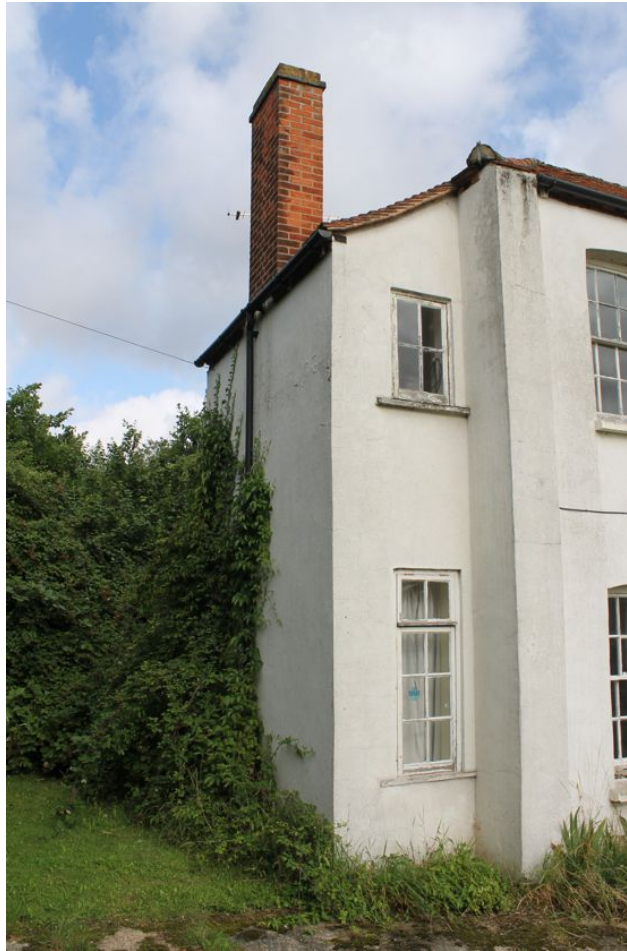
Photograph 26 Southern and eastern elevation of farmhouse, showing extension D. Photograph taken facing north-west.

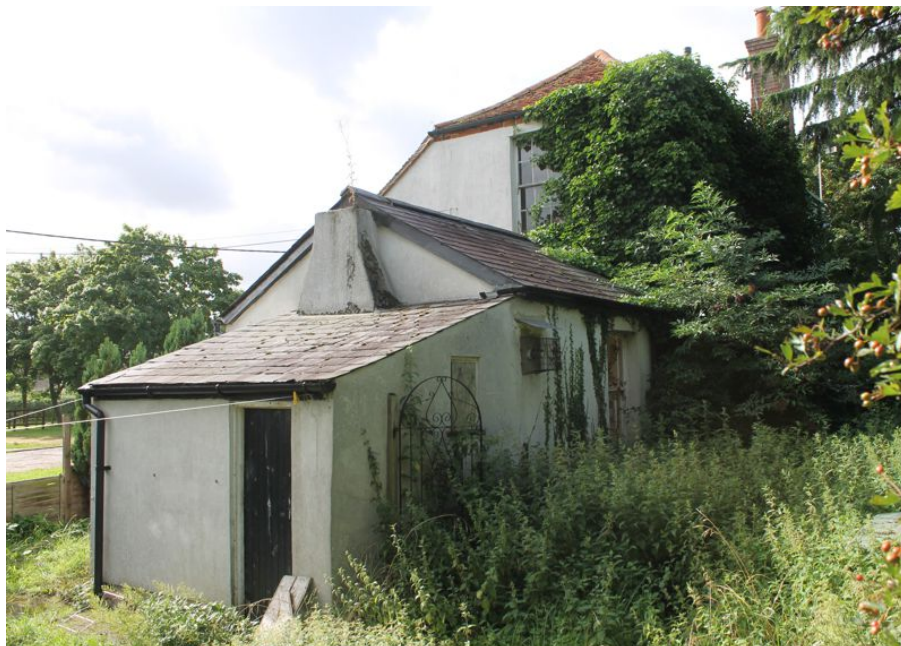
The western elevation of the farmhouse (Fig 12) has two small four-light casement windows on the ground-floor, along with one on Extension B (Photograph 27). Also on Extension B on this elevation is a six-light sash window, identical to the one on the eastern elevation (see above). There is also a small blocked window on Extension B.

Photograph 27 Western and northern elevation of farmhouse, showing extensions A and B. Photograph taken facing south-east.

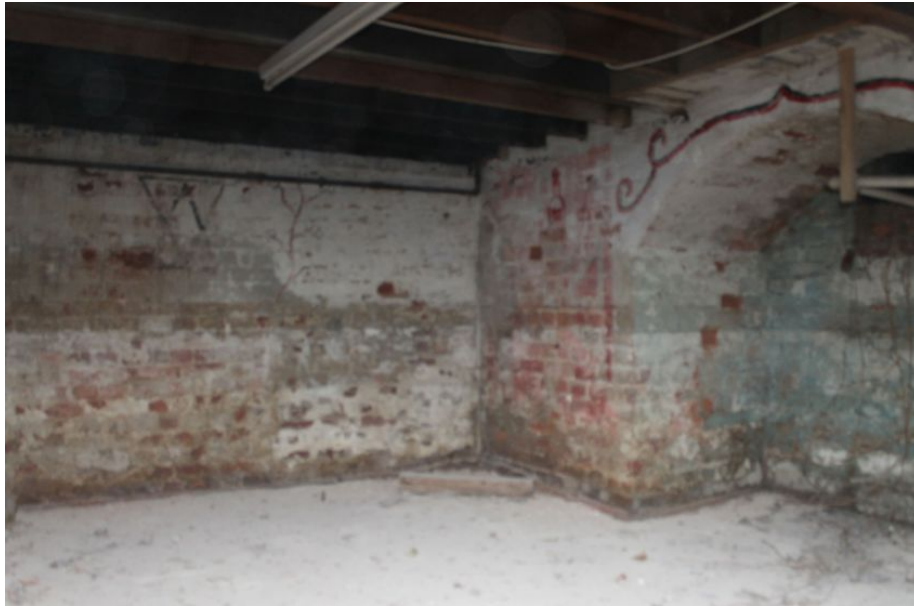
The cellar of the farmhouse has no surviving fixtures or fittings, but does have some faint marks on its brickwork where shelving may have been attached. No evidence remains of the original internal entrance into the cellar, which was blocked up in 1976 (Fig 8). There is an internal division within the cellar, which is original.

Photograph 28 Interior of farmhouse cellar. Photograph taken facing southwest.

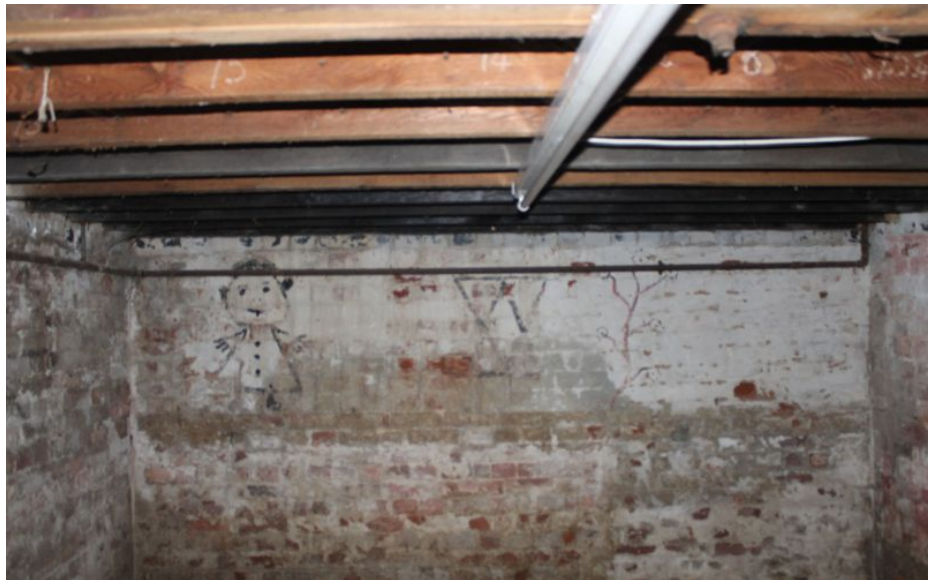
Also on the basement walls are several instances of painted graffiti, likely 20th century in origin (Photograph 31).

Photograph 31 Graffiti on southern wall of cellar. Photograph taken facing south.

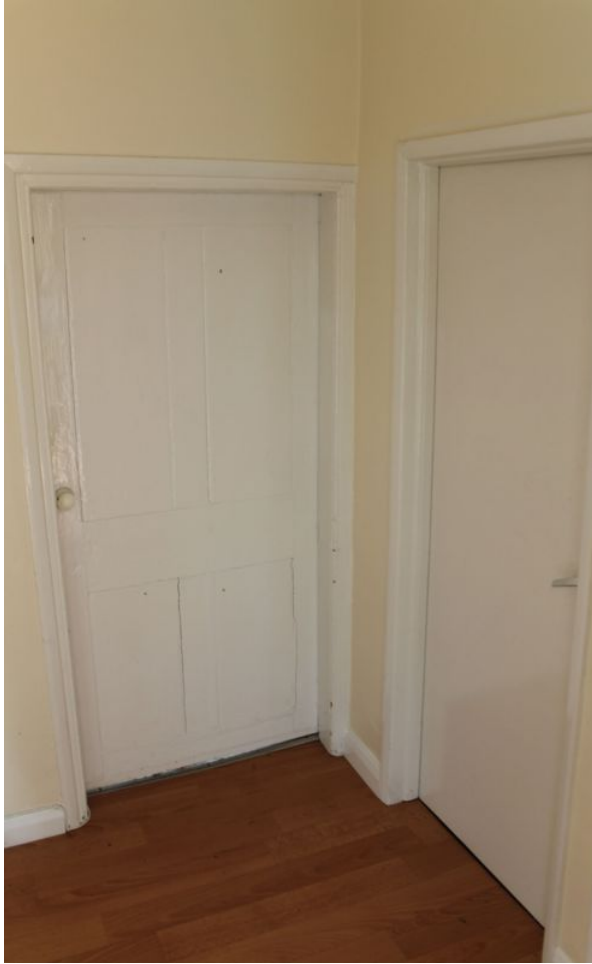
Photograph 32 Original door on the ground-floor of the farmhouse (left) next to a later insertion (right). Photograph taken facing south-west.

The central room on the ground-floor is accessed by two four-panel doors that are original to the building, although they both have replacement handles (Photograph 32

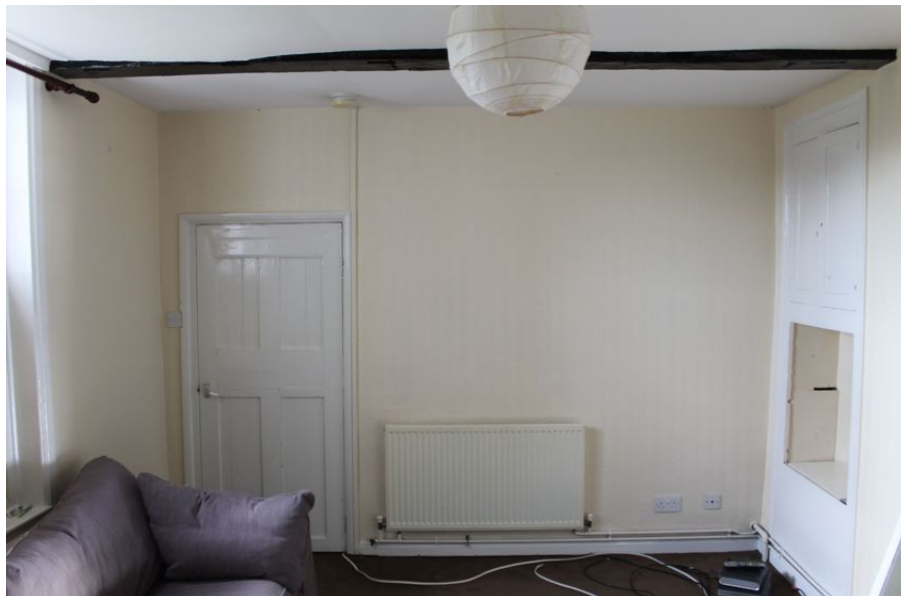
Photograph 33 Original southern wall of central room on ground-floor of farmhouse. Original door to left. Photograph taken facing south.

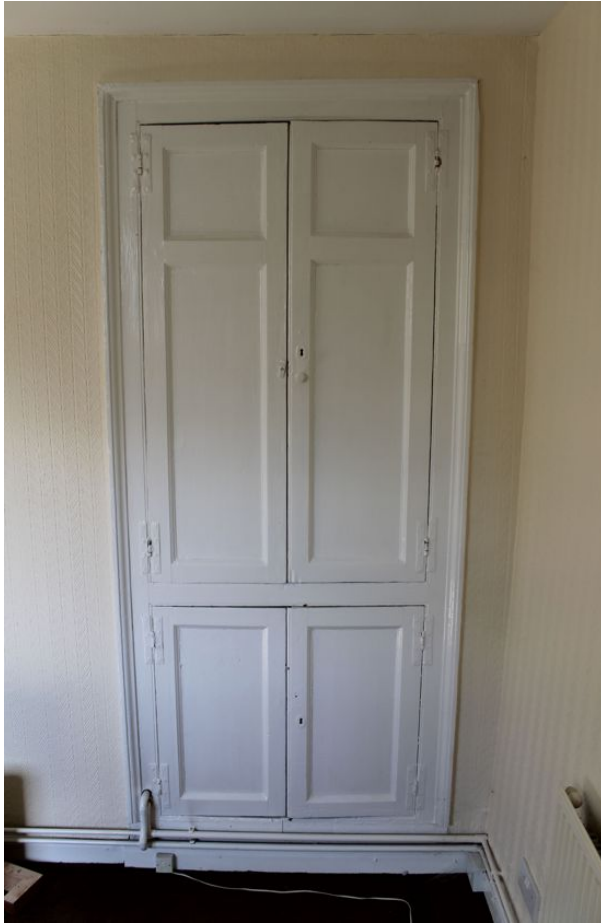
and 33). The central room also contains two cupboards on its western wall (Fig 9). The lower half and doors of both cupboards have been altered but the relatively

Photograph 34 Northernmost cupboard in central ground-floor room of farmhouse. Photograph taken facing west.

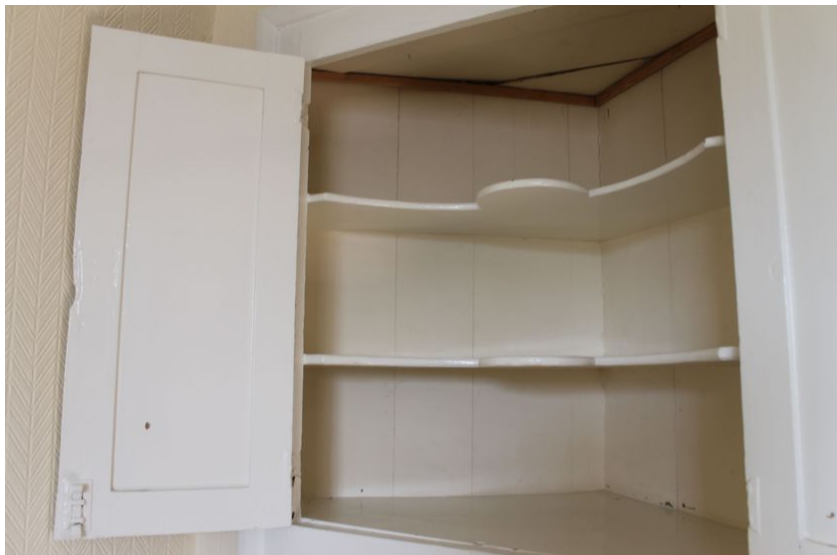
Photograph 35 Southernmost cupboard in central ground-floor room of farmhouse, showing shelving and latch. Photograph taken facing south-west.

ornate shelving inside suggests they may be early 19th century in origin and contemporary with Extension A, rather than a product of the 1976 refurbishment (Photograph 34 and 35).

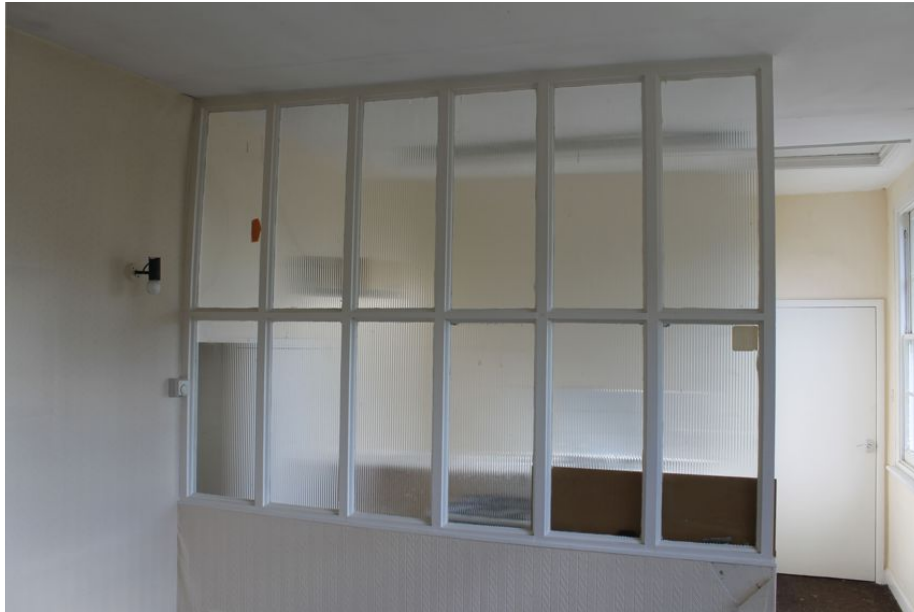
The first-floor would have likewise been divided into three rooms (Fig 10), before its internal divisions were altered in 1976 (Photographs 36 and 37). No original fixtures or fittings survive on the first-floor; the doors are all later replacements or insertions.

Photograph 36 Glass division in first-floor of farmhouse, added in 1976. Photograph taken facing north-west.

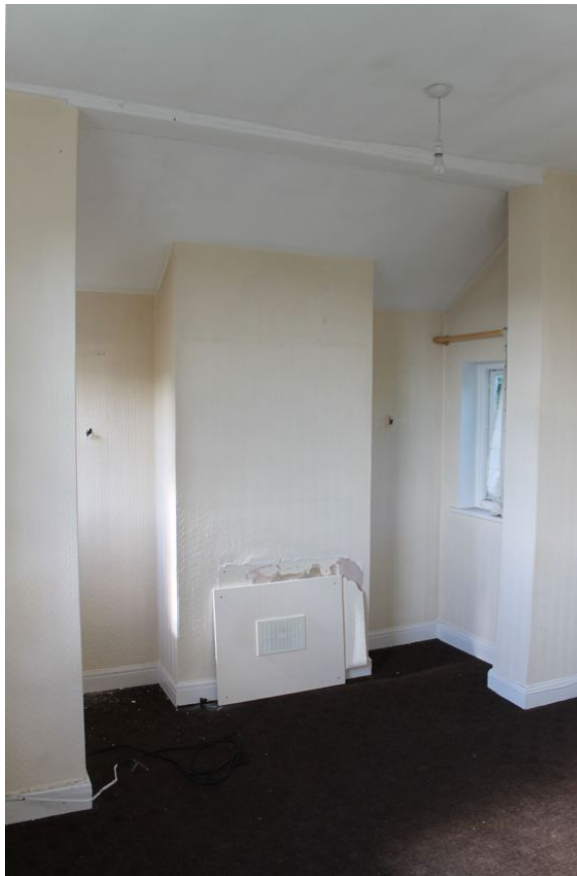
Photograph 37 View of extension D from first-floor of farmhouse. Blocked fireplace visible. Photograph taken facing south-west.

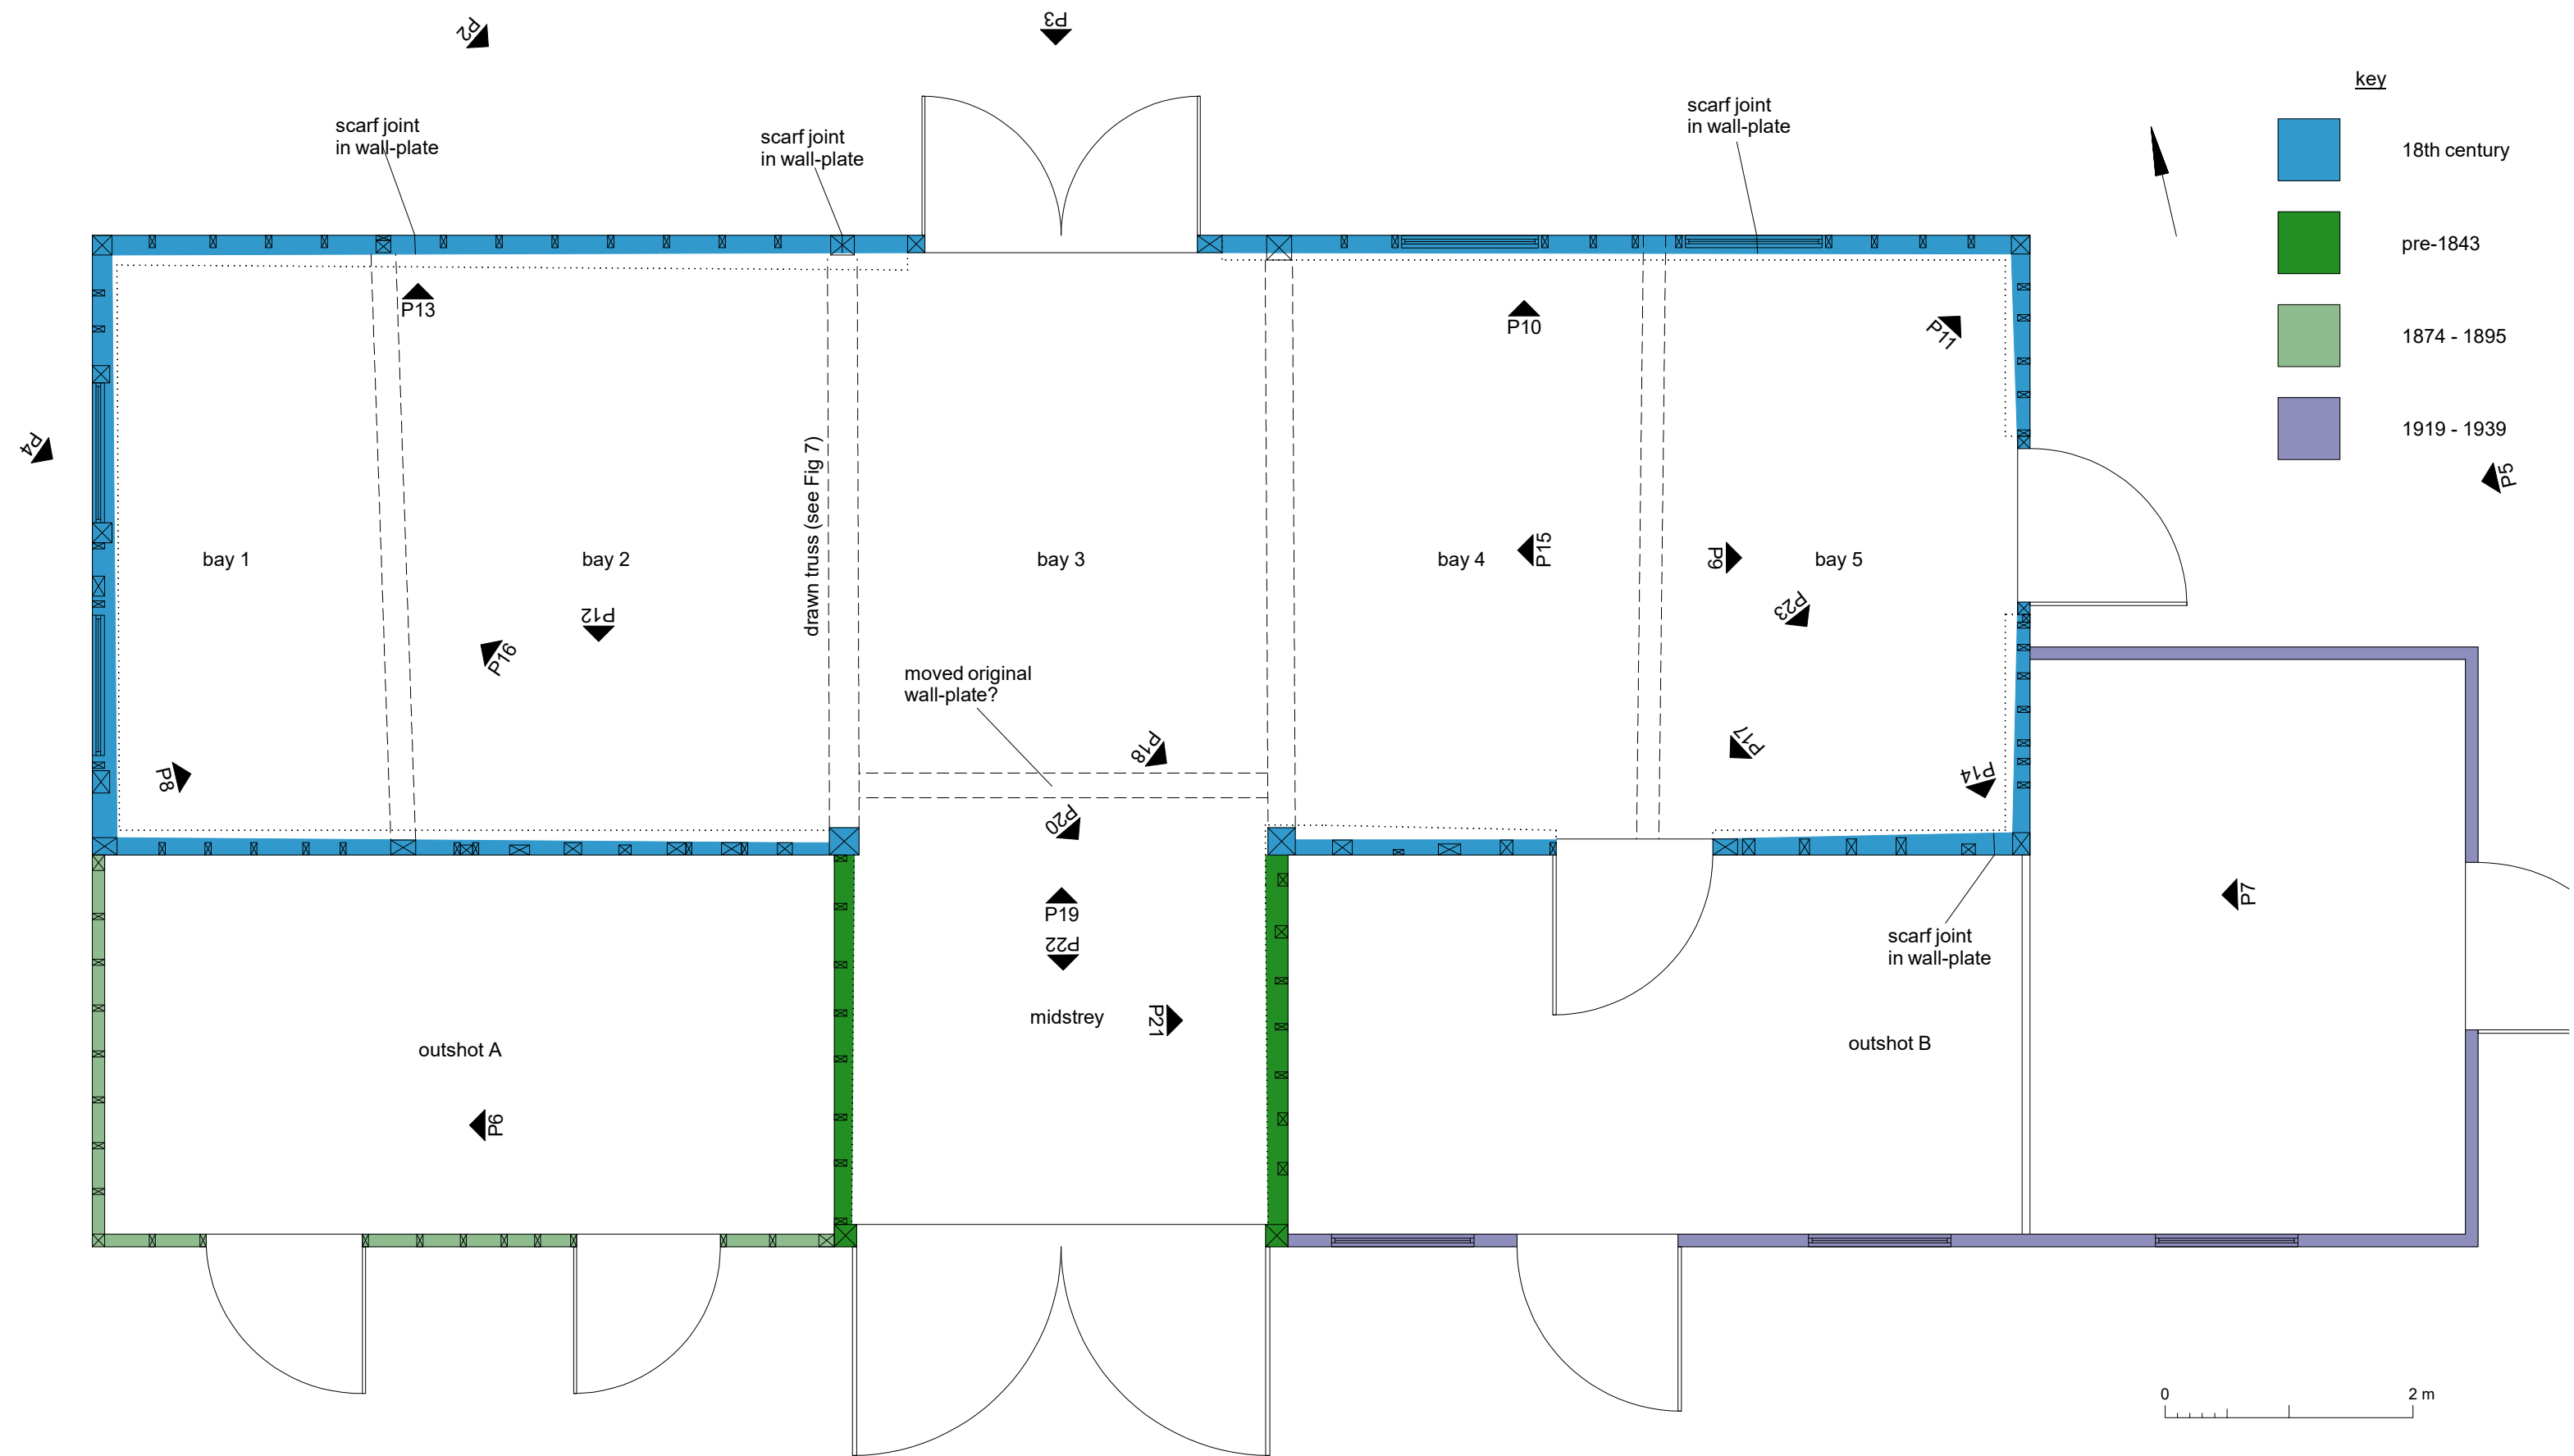
Fig 3 Plan of threshing barn and outshots with phasing. Location and direction of photographs included in text marked.

The wall-plates of the barn have four scarf joints (Fig 3). Three of them are rudimentary: an edge-halved scarf with square abutments and one or two face pegs (Photograph 13) and sometimes supported with a metal strap. One scarf joint differed: adjacent to the south-east corner-post was an edge-halved scarf with bridled abutments and a single metal bolt (Photograph 14). This scarf joint is probably the result of re-use of the timber, as having a joint so close to the corner of the barn makes little sense structurally.

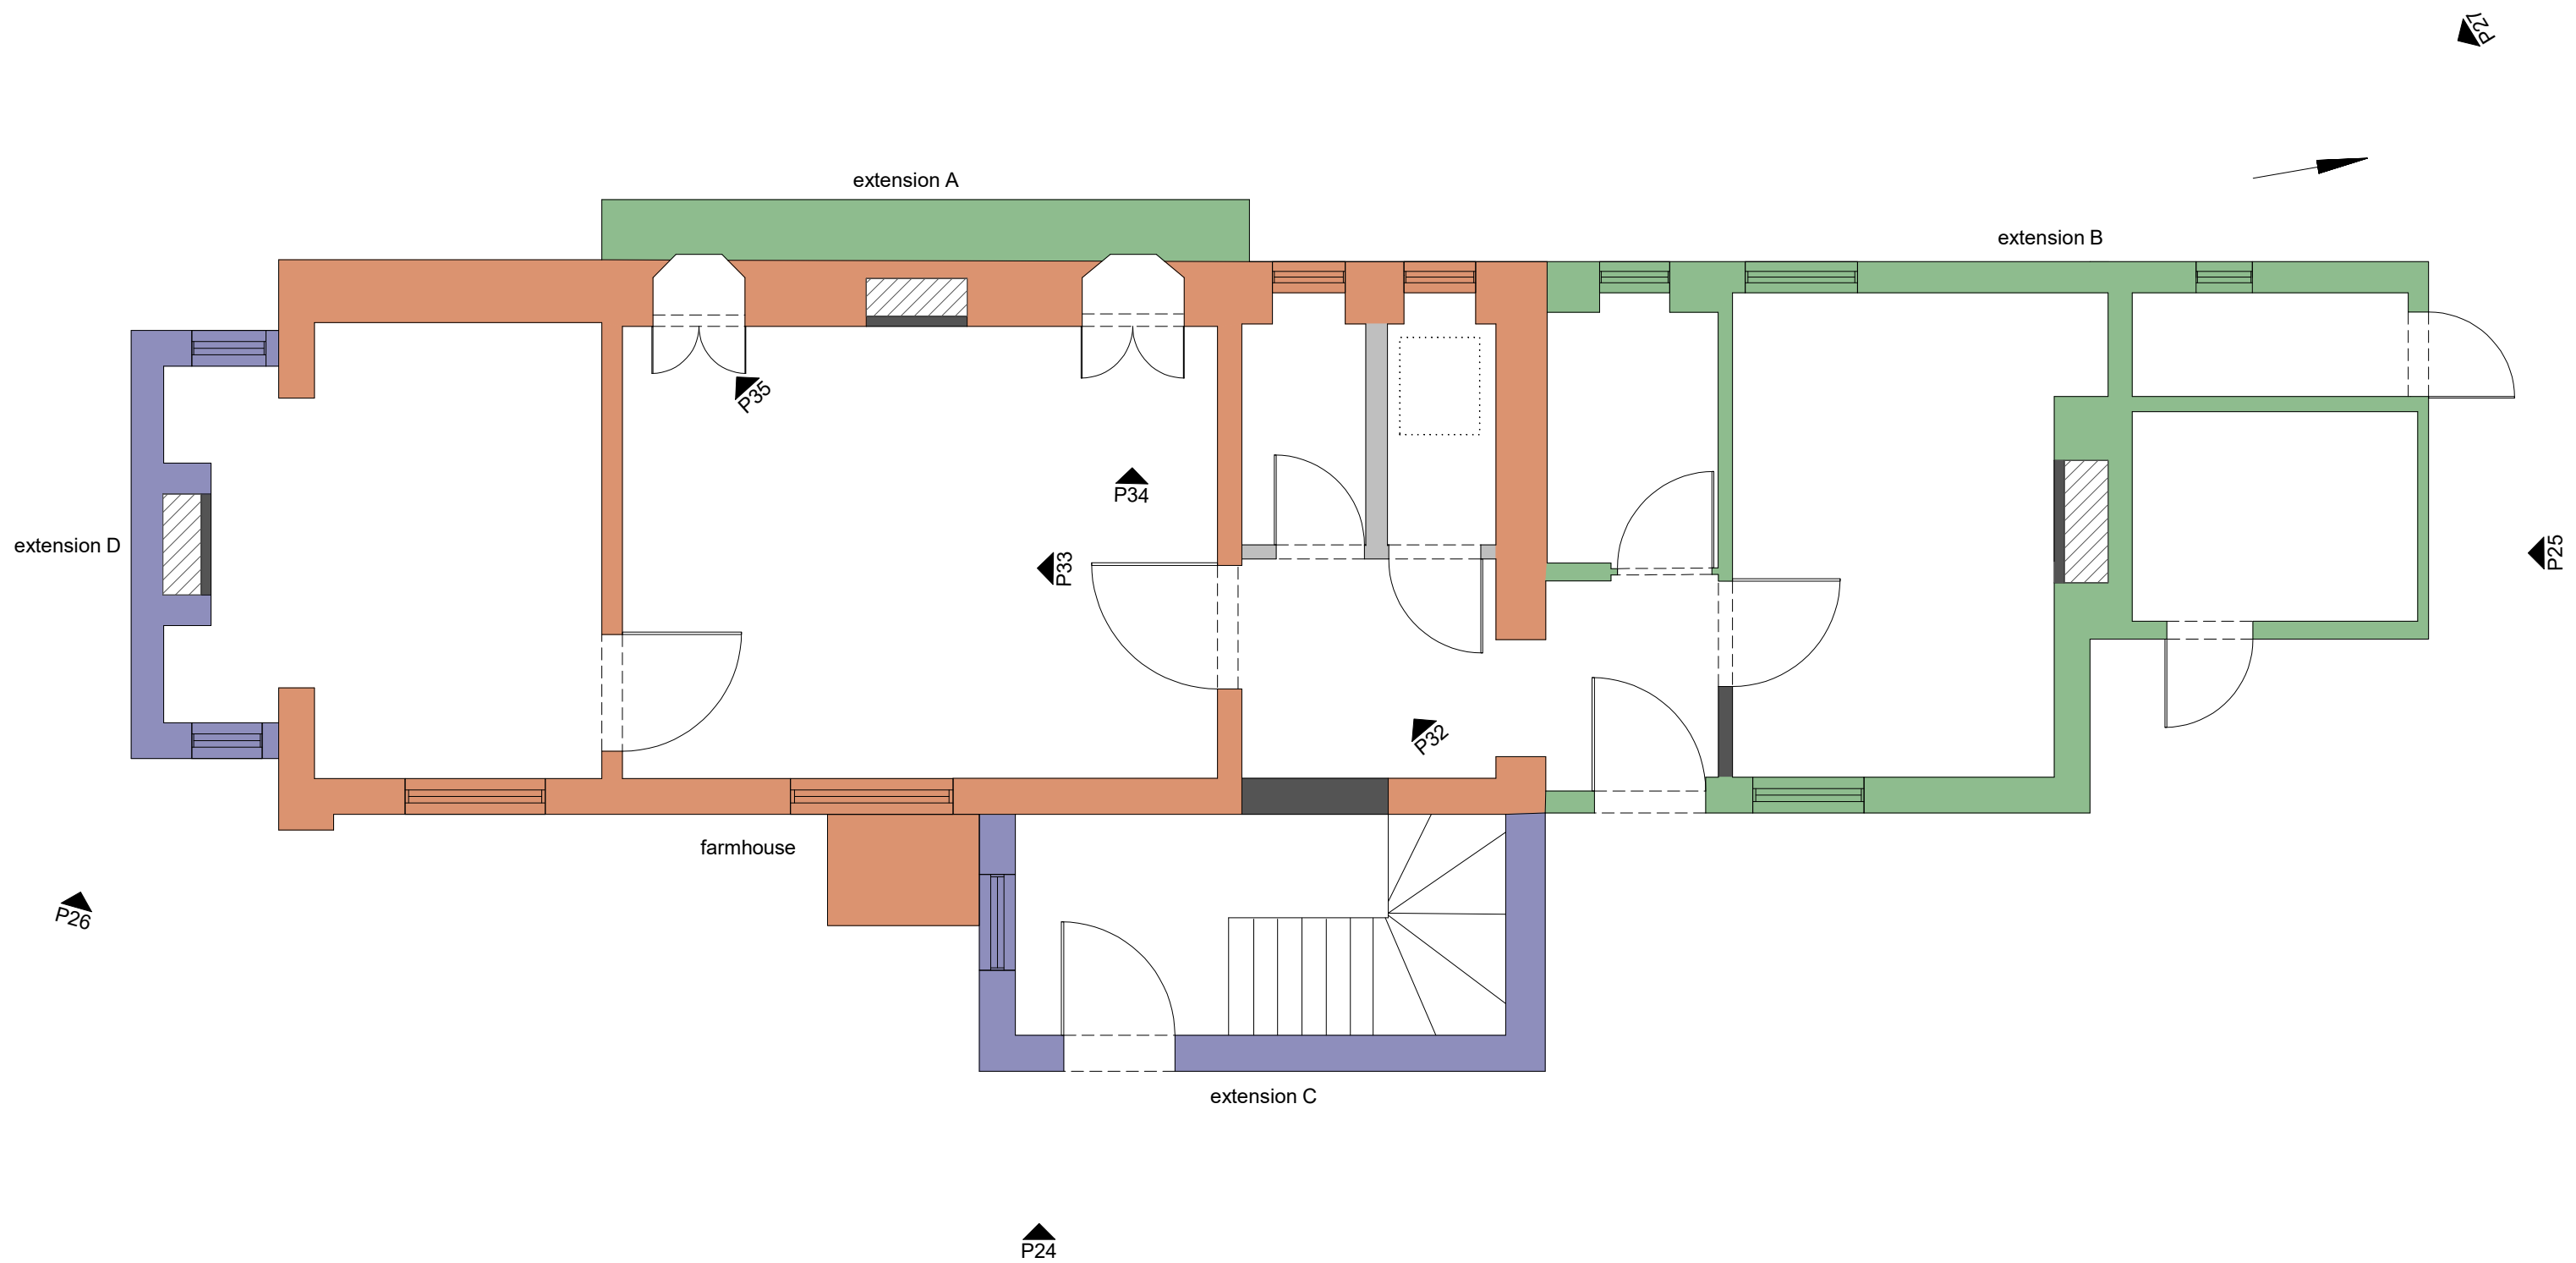
Fig 9 Farmhouse ground-floor plan with phasing. Location and direction of photographs reproduced in text marked.

Extension A is partially constructed on the walls of western alcove of the basement (Figs 8 and 9).

The ground-floor of the farmhouse is divided into three rooms, the northern one of which has been further subdivided into three in the modern period (pre 1976) (Fig 9). It is likely that the original staircase up to the first-floor was also in this northern room, above the entrance into the cellar, but since the ground- and first-floor floorboards and joists were completely relaid in 1976, it is impossible to be certain.
