**Historic building recording at
the White Hart Hotel, 1 High Street,
West Mersea, Essex CO5 8QD**

August 2018, April and November 2019

**report prepared by
Mark Baister
with contributions from
Chris Lister**

CAT Report 1324
May 2020

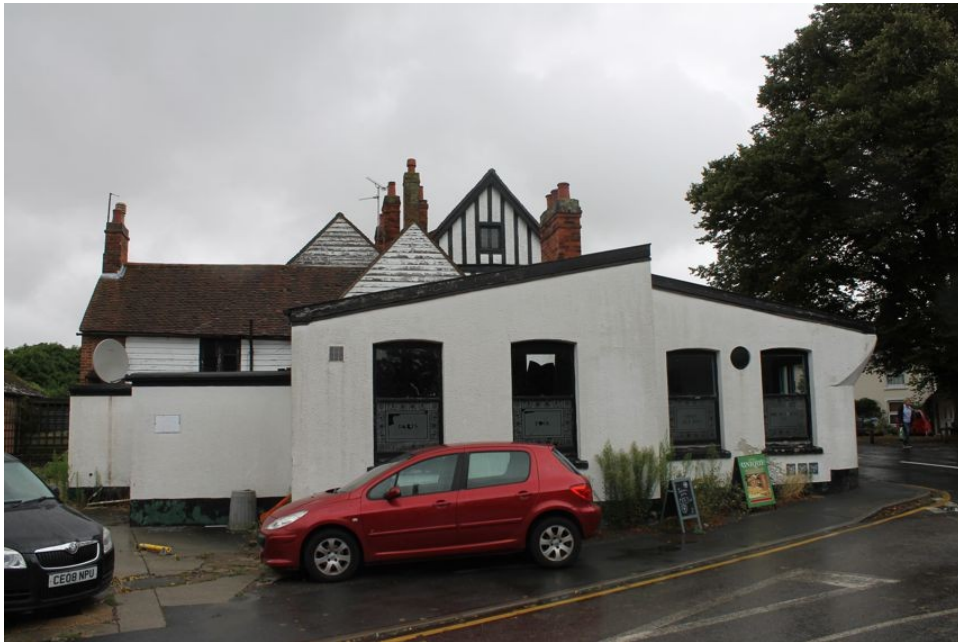
Structures E, F and G on this elevation are all brick-built and rendered in white-painted pebble-dash. Structures E and F are single-storey buildings and each have two two-light sash windows on this elevation, each with a frosted lower pane (Photograph 10).

Photograph 10 South-west elevation of White Hart. Photograph taken facing north-east.

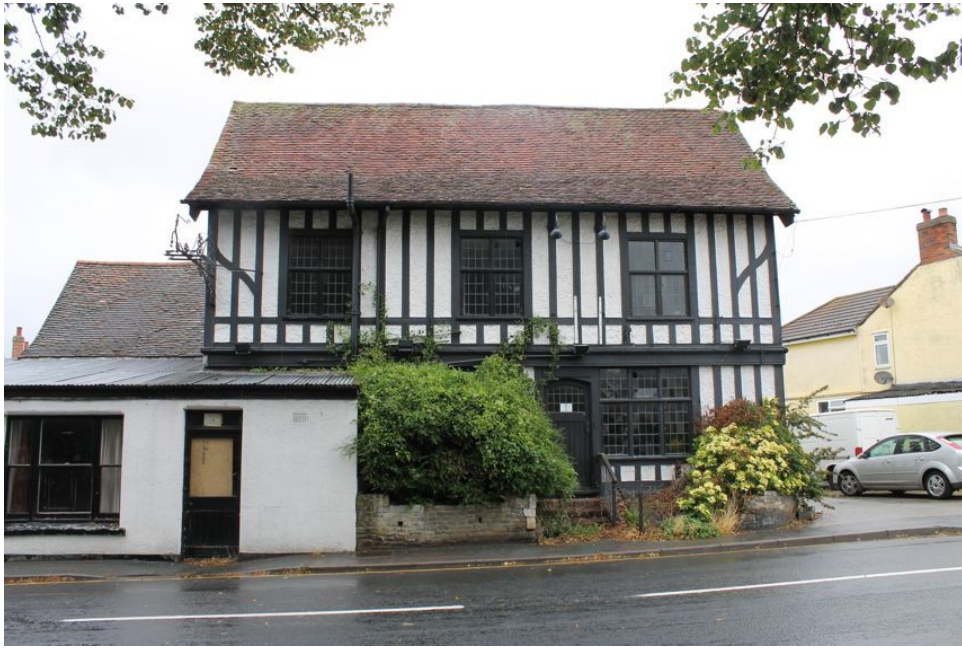
Photograph 11 South-east elevation of Structure C. Photograph taken facing south-west.

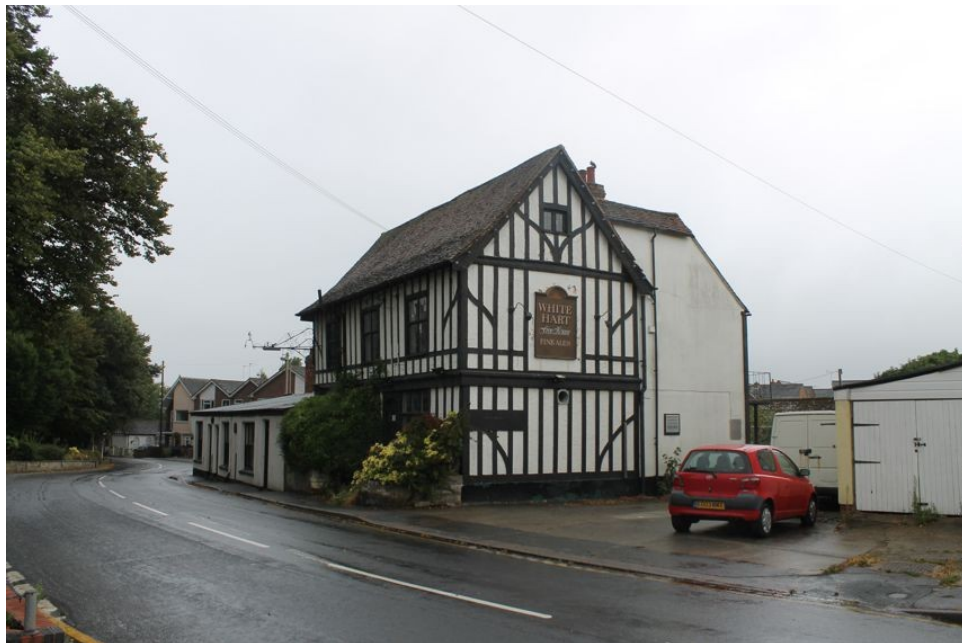
As on the other elevations, the faux timber-framing on Structure C continues here. The second-floor has a small two-light leaded casement window in the gable (Photograph 12).

Photograph 12 North-east elevation of the White Hart. Photograph taken facing south-east.

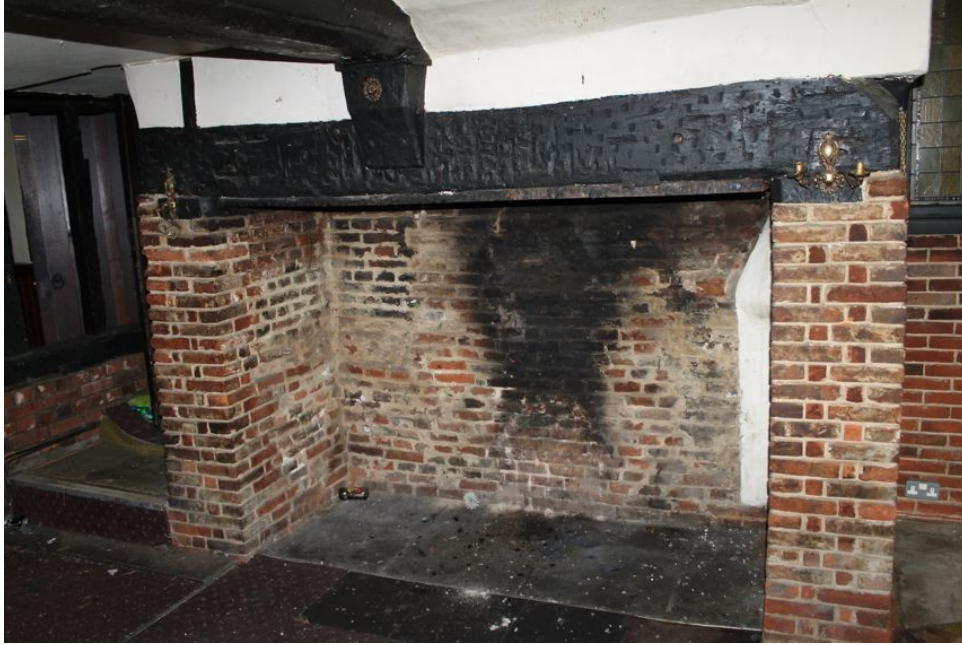
The flooring comprises timber floorboards (which do not appear particularly old) and the floor level is lower than adjacent Structures B and D. The floorboards had been removed at the time of the second visit and no earlier floor was visible beneath. The north-east ground-floor wall of Structure A is dominated by a large red brick fireplace, complete with an inglenook (Photograph 14). The original brickwork of the fireplace is laid in an irregular English bond and bonded in lime mortar. The brick dimensions are 235mm x 110mm x 45mm. The front of the two pillars on either side of the fireplace have been rebuilt (Photograph 15), presumably to support the large timber forming the current mantel-beam. This timber in turn supports the binding-beam of the floor above (Photograph 14). Clearly the rebuilding of the brickwork below this timber suggests it is a later addition to the fireplace, and the original mantel-beam may not have been as substantial.

Photograph 14 Large fireplace in north-east ground-floor wall of Structure A. Photograph taken facing north.

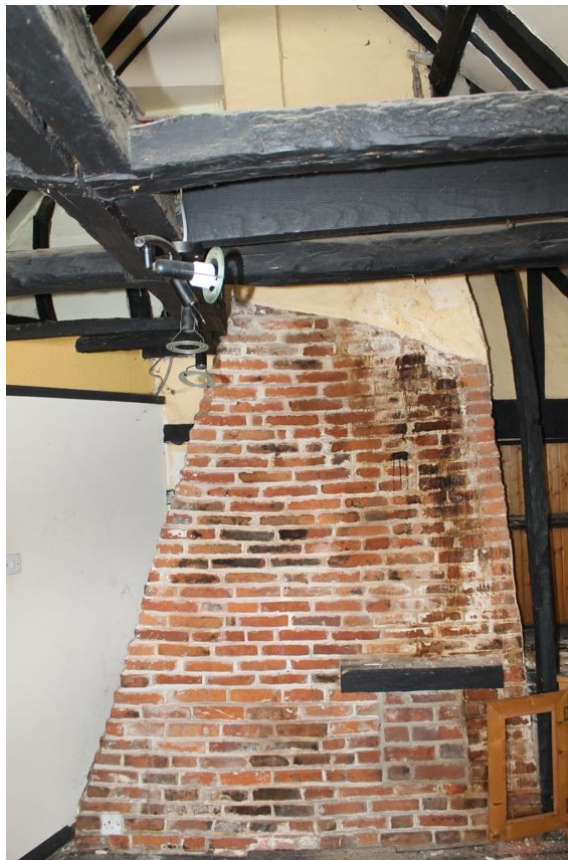
Photograph 19 Chimney stack in north-east first-floor wall of Structure A. Photograph taken facing north-east.

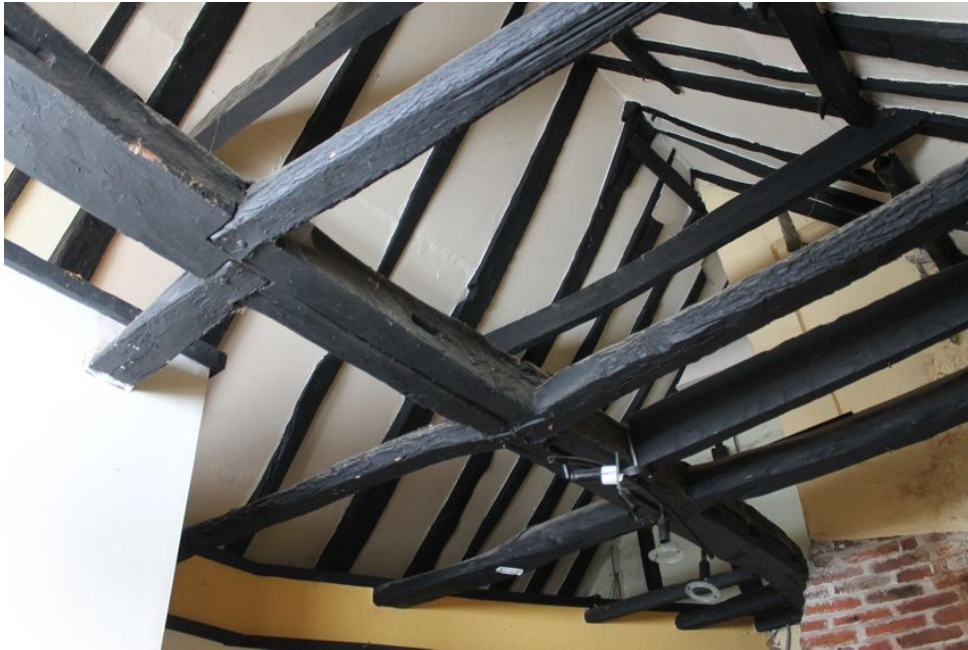
Photograph 20 Roof structure of Structure A, showing collar-purlin and braces. Photograph taken facing north.

Rather than supporting collars immediately above, the collar-purlin is jointed into multiple braces coming from the rafters on both roof pitches. Although not all of these braces survive, most of the ones that do are secured to the collar-purlin by simple mortice and tenon joints (Photograph 20). Six of the braces (in alternating sets of two) are instead connected onto the underside of the collar purlin with joggled lap-joints (Photograph 21) secured by two bolts (one original peg remains). All the surviving braces, regardless of how they are attached to the collar-purlin, have chiselled carpenter's marks on their underside (Photographs 22 and 23). These marks are sequential, going from the south-west of the building to the north-east, and appear original, as they account for gaps caused by missing braces.

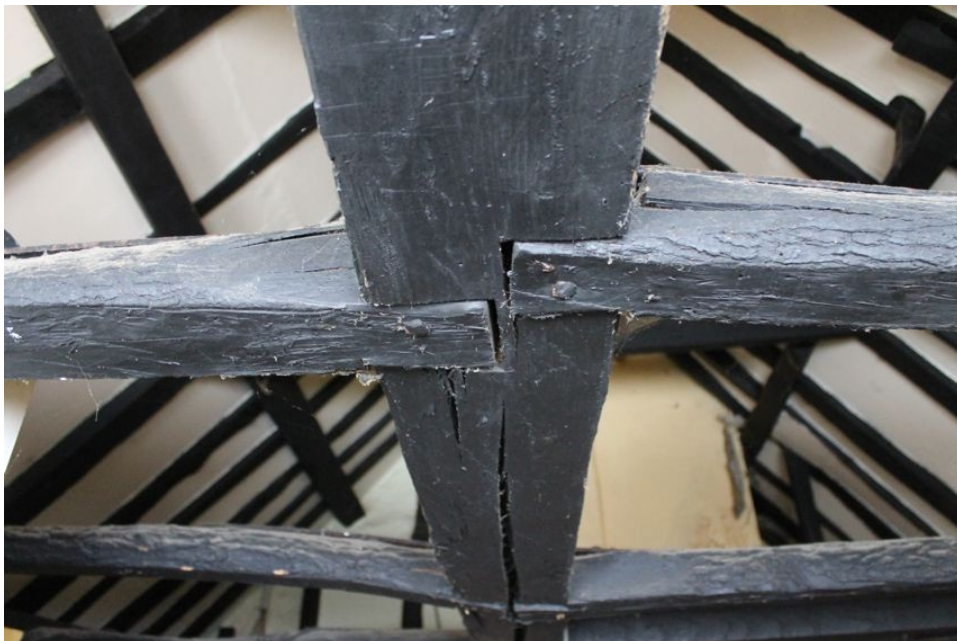
Photograph 21 Detail of underside of collar-purlin, showing joggled lap-joints. Photograph taken facing north-east.

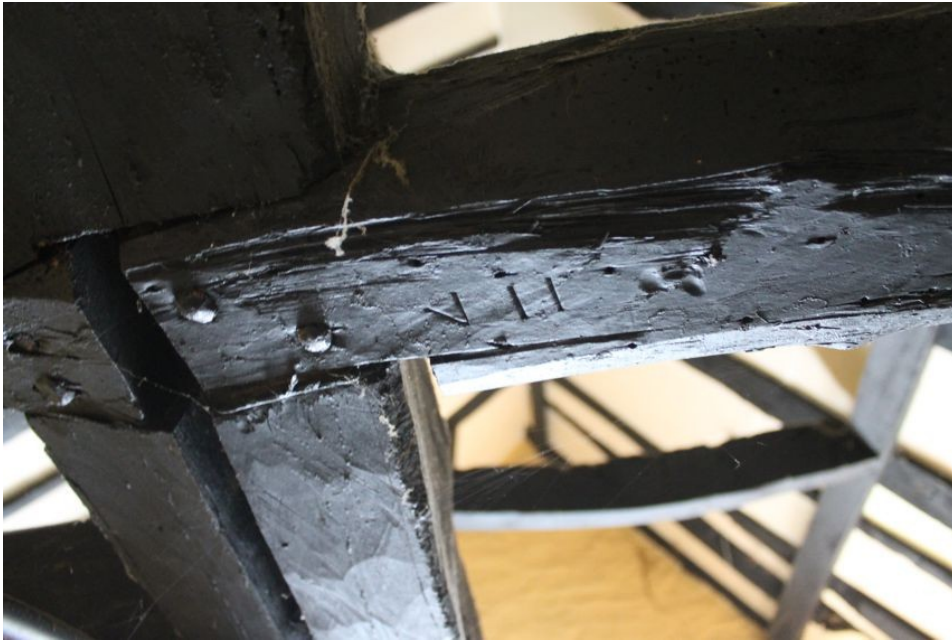
Photograph 22 Detail showing carpenter's mark "VII" on underside of brace to collar-purlin. Photograph taken facing north-east.

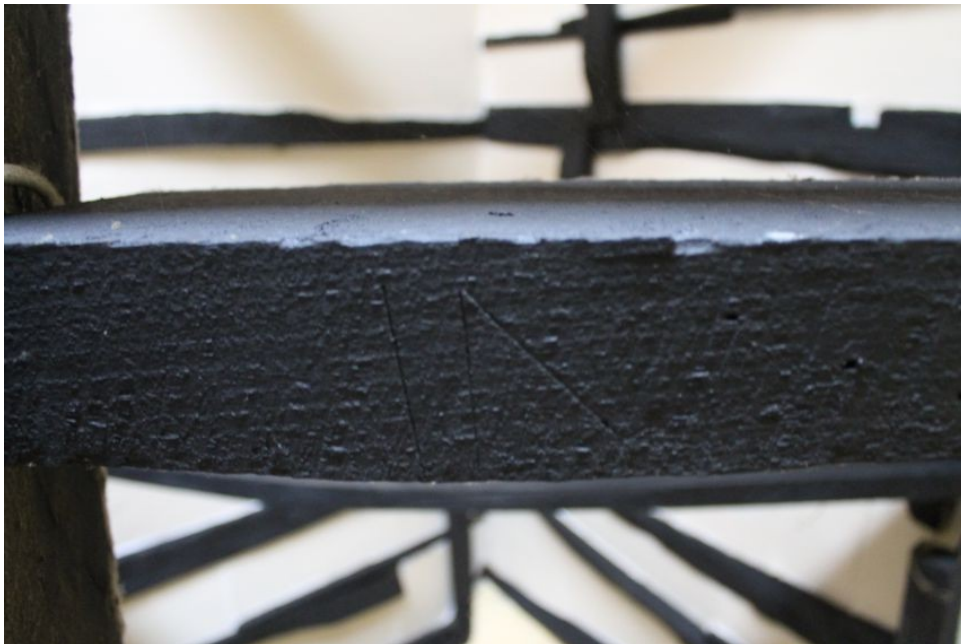
Photograph 23 Detail showing carpenter's mark "VI" on underside of brace to collar-purlin.

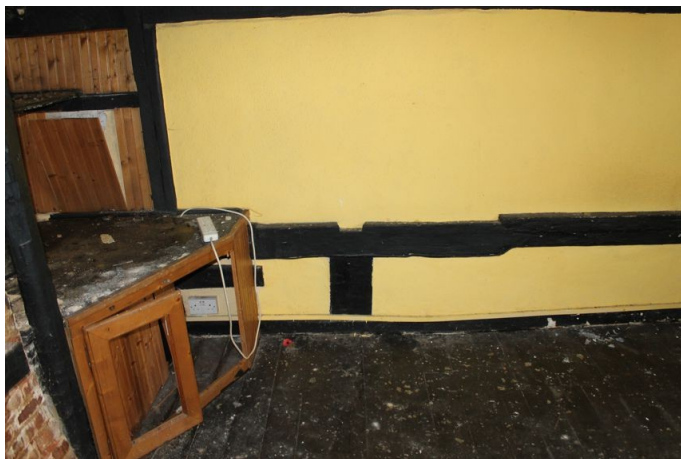
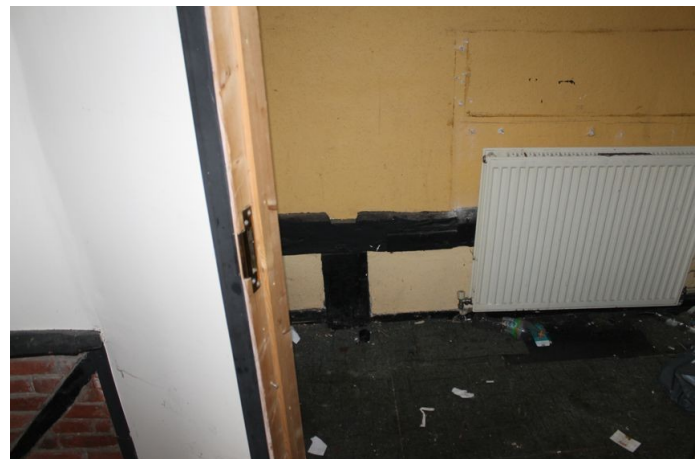
Projecting up from the floor-level on the south-east and north-west walls are two posts with empty lap-joints on their upper face. These would have supported a binding-beam and an earlier floor (Photograph 25 and 26). The floor-level would have been around 420mm higher than the current one, and would have been added to the building when the chimney was inserted (see discussion pg 34). The mortice for a brace supporting this binding-beam is visible on the ground-floor (see above).

Photographs 25 and 26 Empty lap-joints on south-east (left) and north-west (right) walls of Structure A that would have supported the original binding-beam and floor.

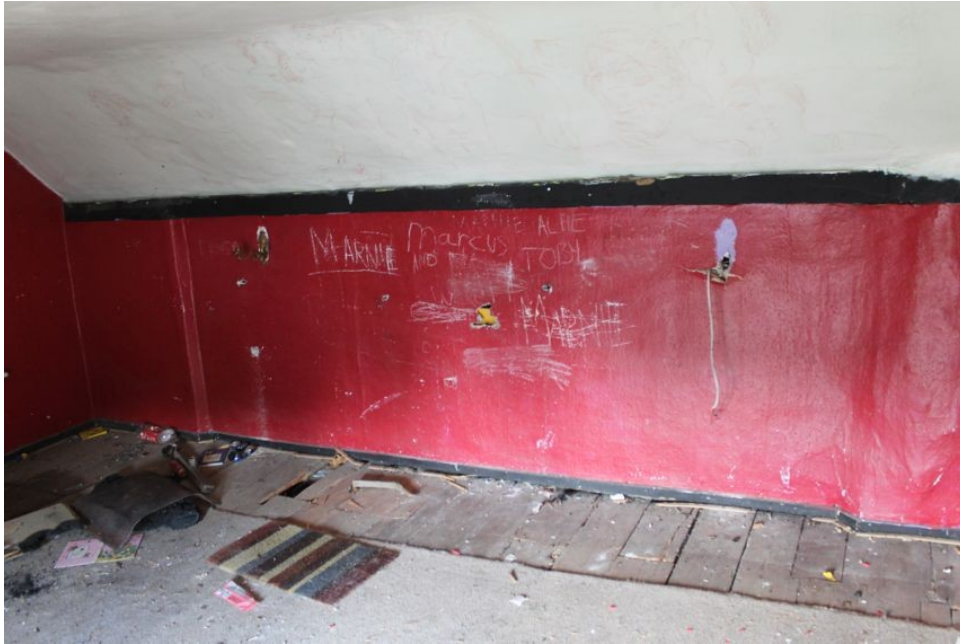
Photograph 28 North-east first-floor elevation of Structure B. Rendered over, but shows end of brickwork (to left) and timber-framing. Photograph taken facing north.

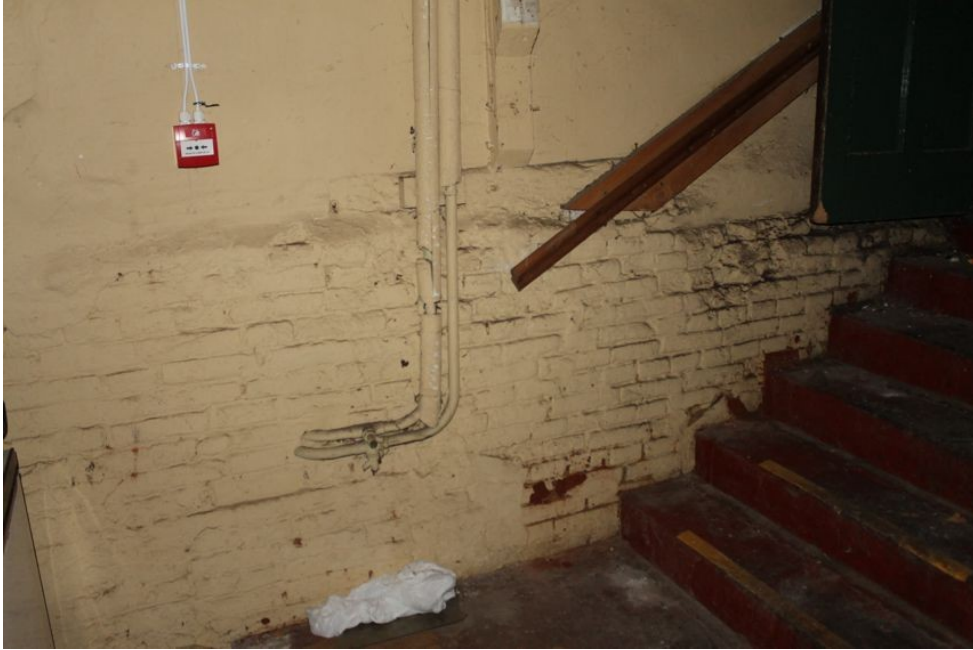
There is a cellar beneath Structure C, which is brick-built, laid in English bond and bonded with lime mortar. The red brick forming most of the cellar has dimensions of 220mm x 110mm x 60mm and is contemporary with the rest of the building. The south-west wall of the cellar is also laid in English bond, but is made of thinner and longer bricks, measuring 230mm x 115mm x 45mm (Photograph 29). These are very similar to the bricks making up the large fireplace in Structure A and appear to be the remnants of an earlier brick cellar associated with a since demolished phase of that building (see discussion pg 34). Supported on this earlier brickwork is a sill-beam and several substantial studs (Photograph 53) which seem to have been reused from elsewhere in Structure A, containing as they do vertical notches seen on the inside of studs around the rest of the building (see Structure A above). This segment of brickwork and timber-frame above is examined in detail in the discussion (pg 34).

Photograph 29 English-bond brickwork on south-west elevation of cellar, probably associated with Structure A. Photograph taken facing south-west.

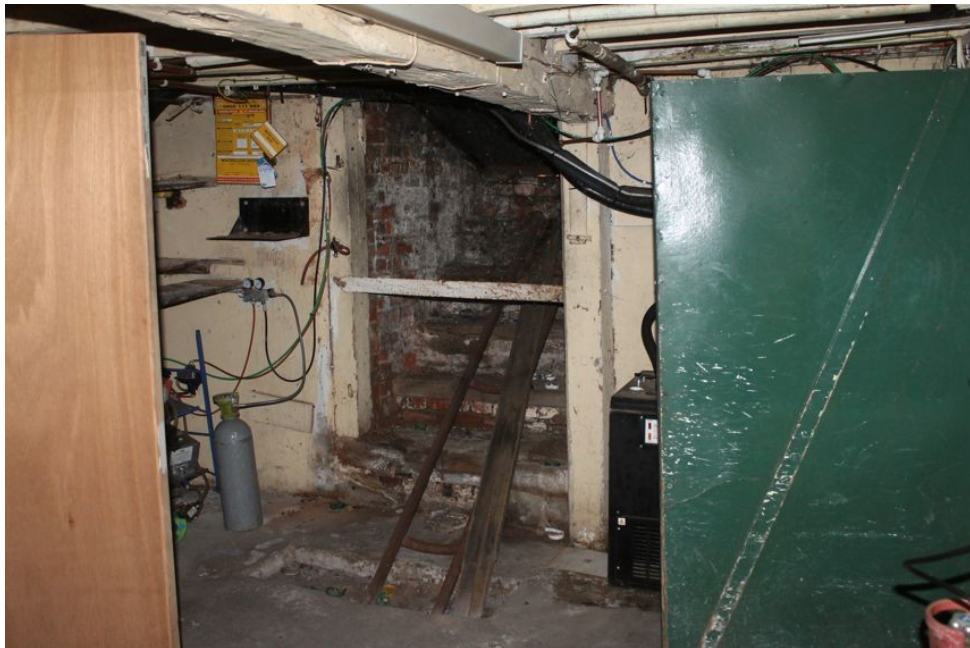
Photograph 30 Cellar below Structure C, showing barrel chute from pavement. Photograph taken facing east.

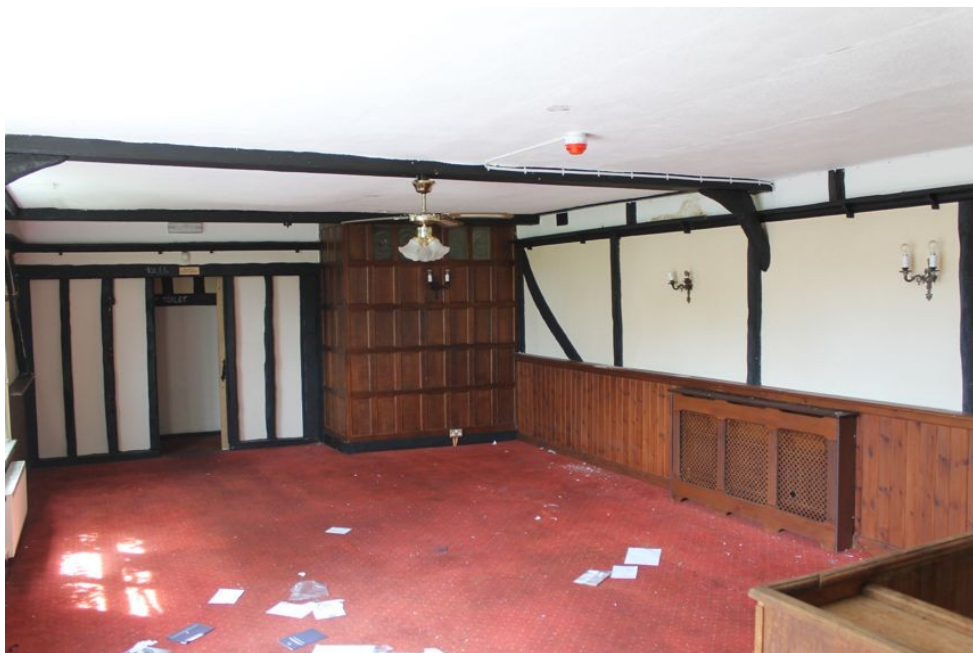
The ground-floor of Structure C is one large open space. The apparent 'timber-framing' visible in this room is in-fact made of a type of foam, and the stud-work and panelling visible to the south-west are all modern additions as well (Photograph 32).

Photograph 32 Ground-floor of Structure C. Photograph taken facing west.

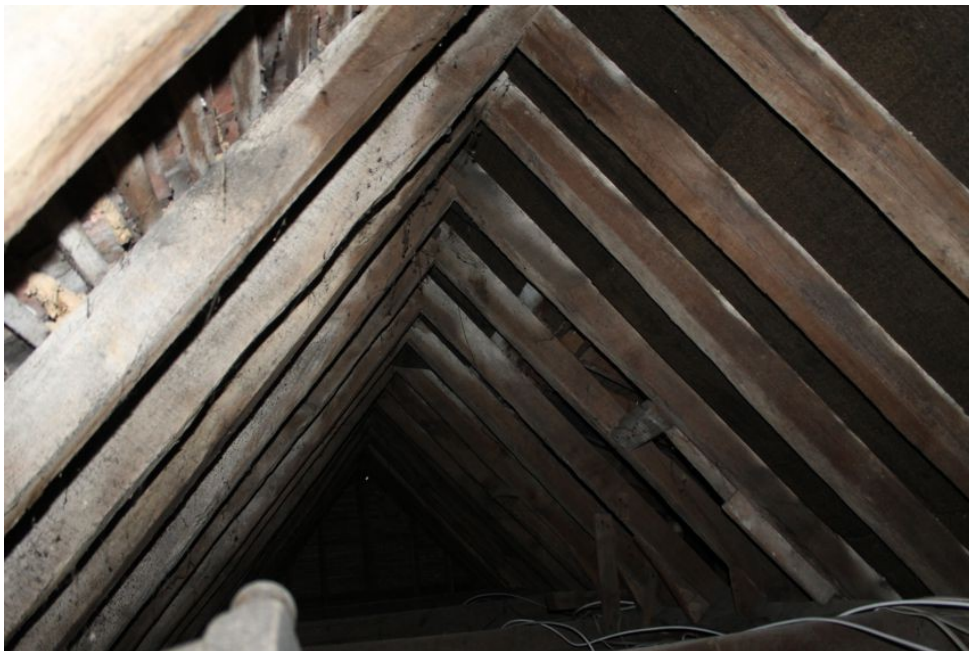
The second-floor of Structure C is a converted attic space, accessed from the first-floor of Structure D (Fig 6). It contains two modern divisions and a modern kitchenette, as well as a fireplace (Photograph 33). The fireplace and associated chimney were probably added to Structure C when this second-floor was inserted into the attic space. The roof timbers of Structure C were observed through a loft hatch and found to be machine-cut, with the rafters pegged at the apex and no ridgeboard (Photograph 34).

Photograph 34 Roof structure of Structure C. Photograph taken facing south-west.

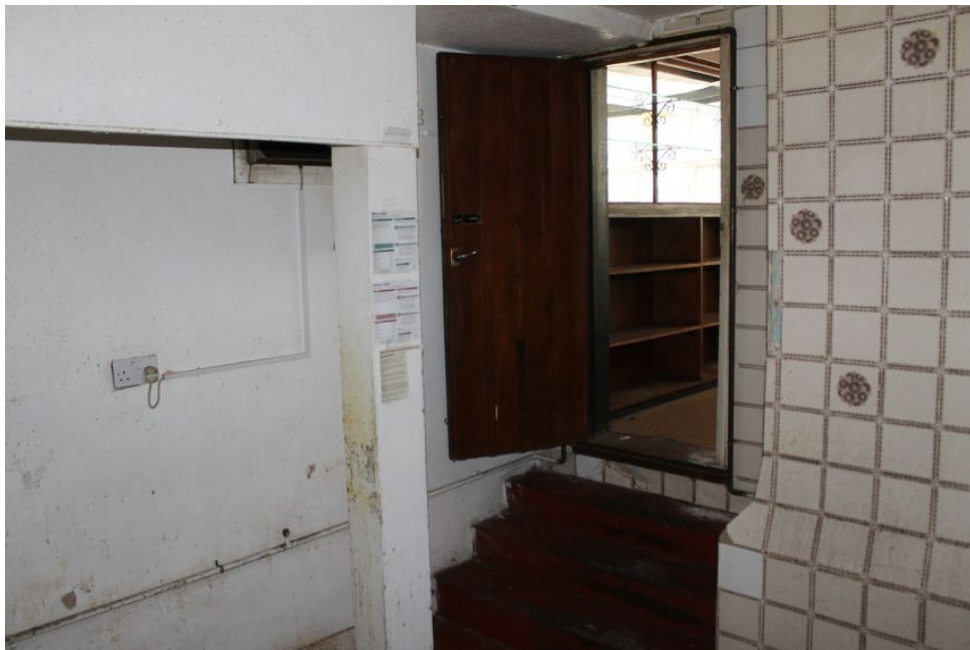
This building, like Structure C, has been heavily altered on the interior. The ground-floor is divided into three rooms, the southern one of which is an entrance hall at the rear of the White Hart. This room has multiple doors leading into Structure A, Structure B, the cellar of Structure C and has a staircase leading up to the first-floors of Structures C and D (Fig 4). The central and northern rooms on the ground-floor have been converted into a kitchen and have tiled floors and walls. Each room has a blocked up fireplace on its south-east wall. As with the first-floor, the floor level of the ground-floor of Structure D is significantly lower than that of Structure C (Photograph 35).

Photograph 35 Photo showing floor-level difference between Structure D and Structure C. Photograph taken facing east.

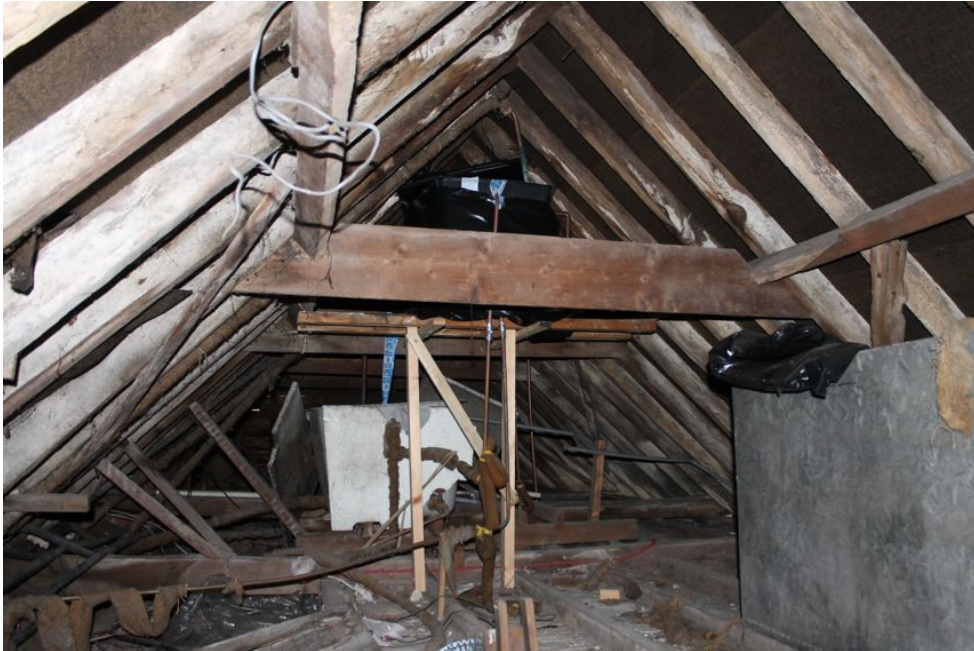
machine-cut timbers, with the rafters supported by collars and clasped purlins (Photograph 36). The rafters are pegged together at their apex, and no ridgeboard is present. A small section on the south-east pitch contains some sarking-boards, which may be original to the building.

Photograph 36 Roof structure of Structure D. Photograph taken facing south-west.

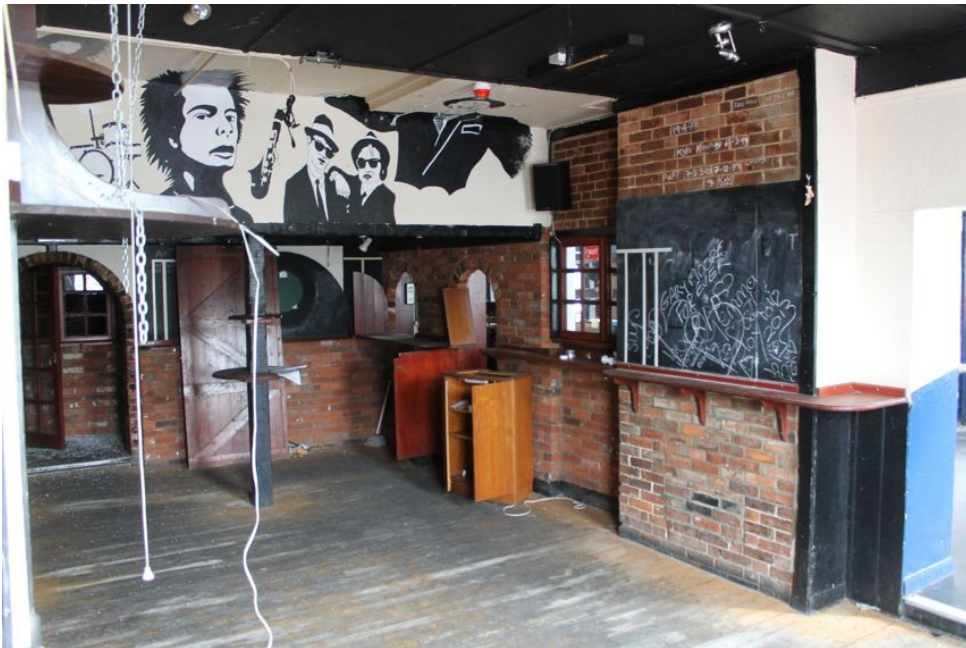
The interior of this single-storey building has several modern additions and alterations. Notably the ceiling has been lowered in the northern part of the building, and several machine-cut timbers that have been altered to look hand-sawn have been inserted to support tables in that area (Photograph 37).

Photograph 37 Interior of Structure E. Photograph taken facing east.

There is a fireplace in the south-east wall of the building that has been bricked up (Photograph 37).

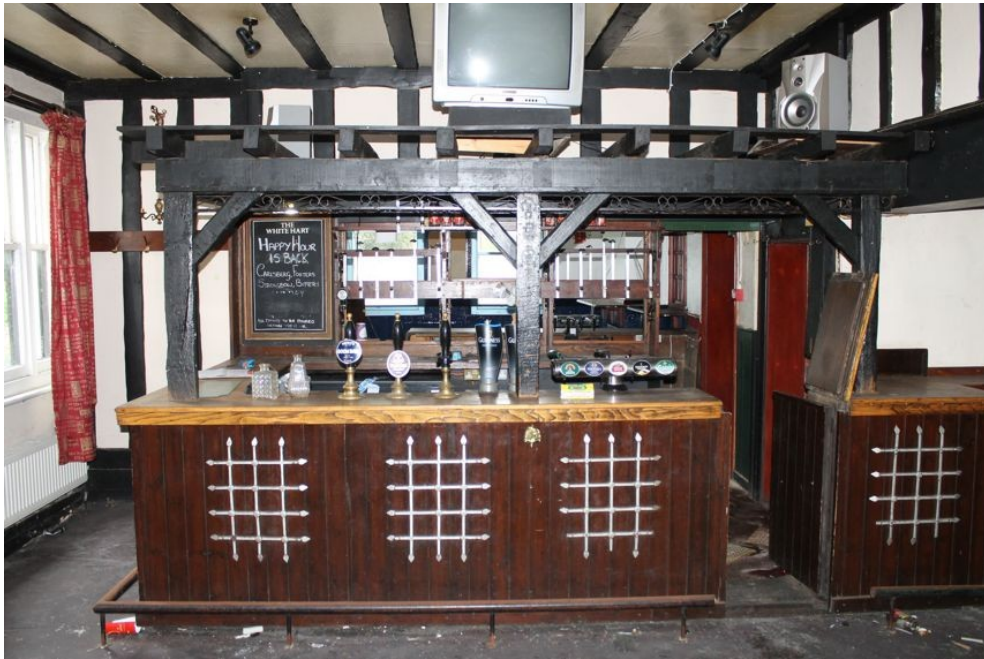
This single-storey building, like Structure E, has been extensively modernised on the interior with very little original features remaining. It has a bar in its centre that is partially constructed from some machine-cut timbers that have been altered to look hand-sawn (Photograph 38), but the blocked doorway in the south-east wall indicates that this bar is a modern insertion. To the north of this building is a section of “L”-shaped wall that contains some imitation stud-work, re-using several sections of legitimately hand-sawn timber, including a substantial timber that appears to have been re-used on multiple occasions, once as a tie-beam (Photograph 39). This section of imitation stud-work is partially supported by a wall made of re-used bricks, laid in stretcher-bond and bonded in lime mortar. The dimensions of these re-used bricks are 220mm x 45mm. The modern additions to this building were probably added at the same time as the toilet block was built (Structure G) and the modern additions were inserted into Structure E (see above). The second visit showed that the stud-work in the north of the building was originally machine-cut, but where visible had been carved to make it appear hand-sawn (Photograph 59).

Photograph 38 Inserted bar into Structure F. Faux timber-framing visible on walls. Photograph taken facing south-west.

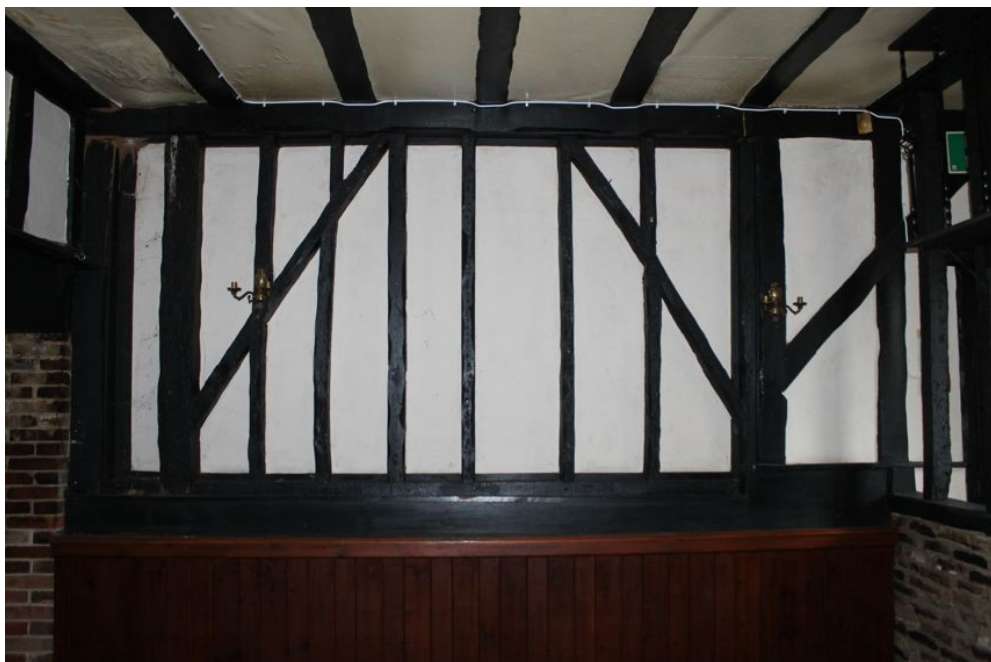
Photograph 40 Stud-work on north-east elevation of Structure F, including some re-used timbers. Photograph taken facing north-east.

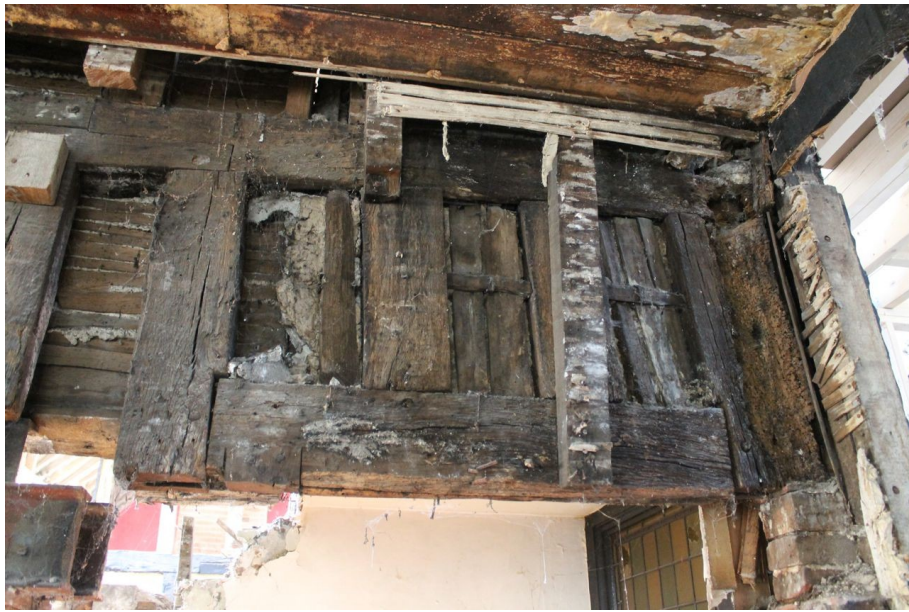
Also visible on the exposed south-east elevation, below the surviving plank infilling, is the lintel of an original doorway (Photograph 43). This doorway is in line with another door on the north-west elevation (see above). The cross-passage between the two doorways has been blocked by the insertion of the fireplace (see discussion pg 32).

Photograph 43 Detail of timber panelling infill on south-east elevation of Structure A, above original doorway lintel. Photograph taken facing north-west.

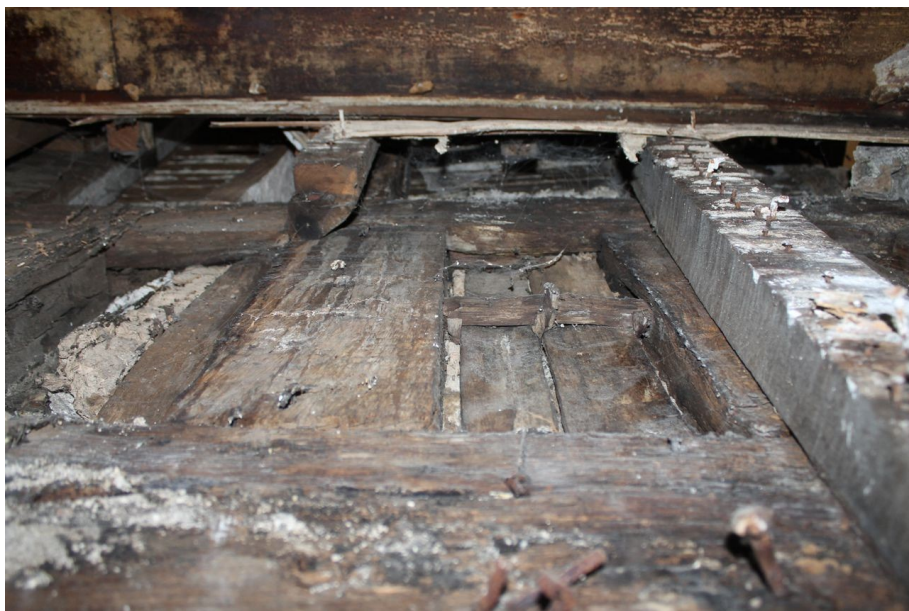
Photograph 44 Detail of timber panelling infill on south-east elevation of Structure A, showing grooves for planks and strap. Photograph taken facing north-west.

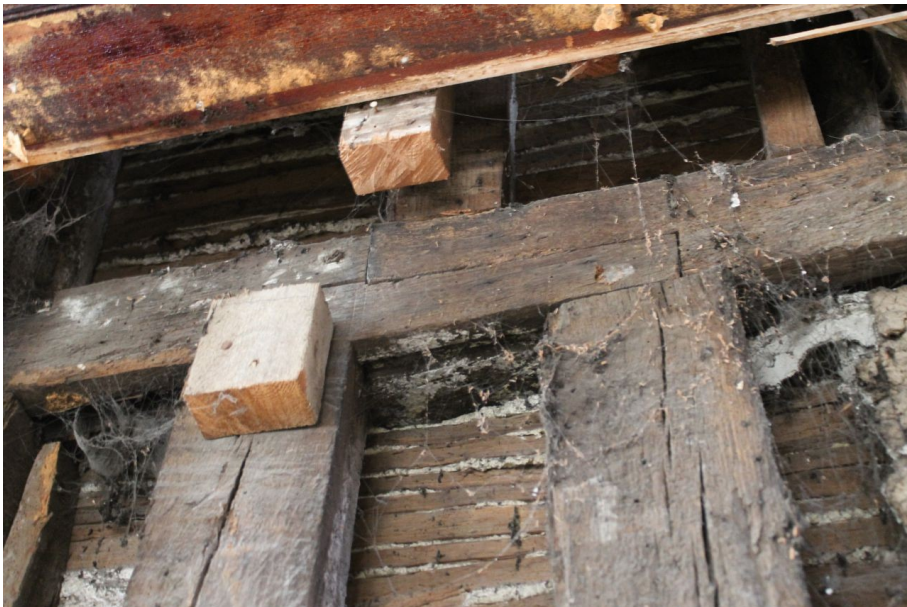
Above the exposed studwork on this elevation a scarf-joint in the girding-beam is visible (Photograph 46). This joint is an edge-halved scarf with two visible edge-pegs and bridled abutments. Also present on the underside of the girding-beam on this elevation are several mortices for diamond mullions, representing the location of an original unglazed window (Photograph 47).

Photograph 46 Detail of scarf joint on south-east girding-beam of Structure A. Photograph taken facing north-west.

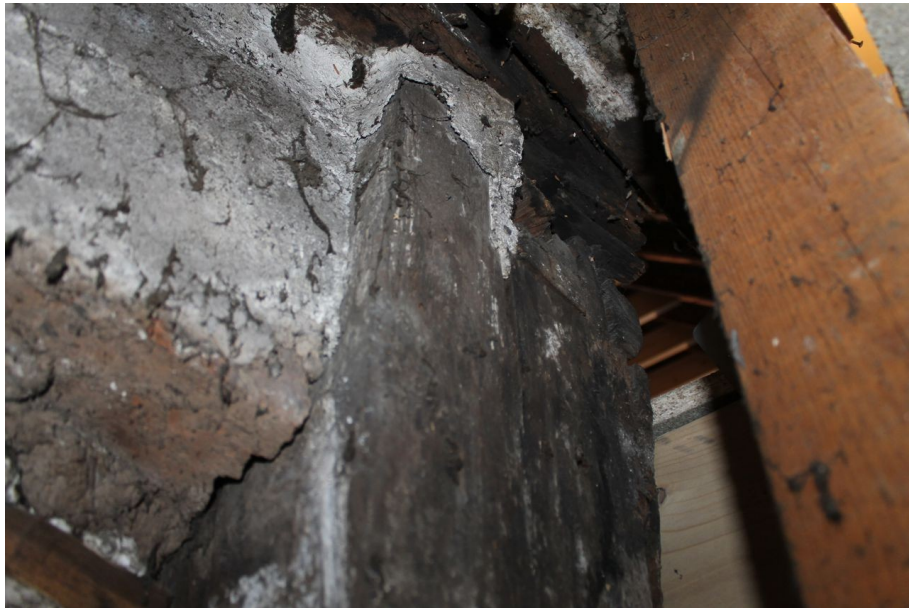
During the second visit, an empty mortice was visible on the north-east side of Structure A's northern corner-post, level with the structure's girding-beam (Photograph 48). This could have supported another girding-beam and suggests that originally Structure A had a wing extending to the north-east. Also visible was what appeared to be original timbers and plaster infill behind the chimney-stack (Photograph 49).

Photograph 48 Detail of mortice on northern corner-post of Structure A, possibly for supporting girding-beam of northern wing. Photograph taken facing west.

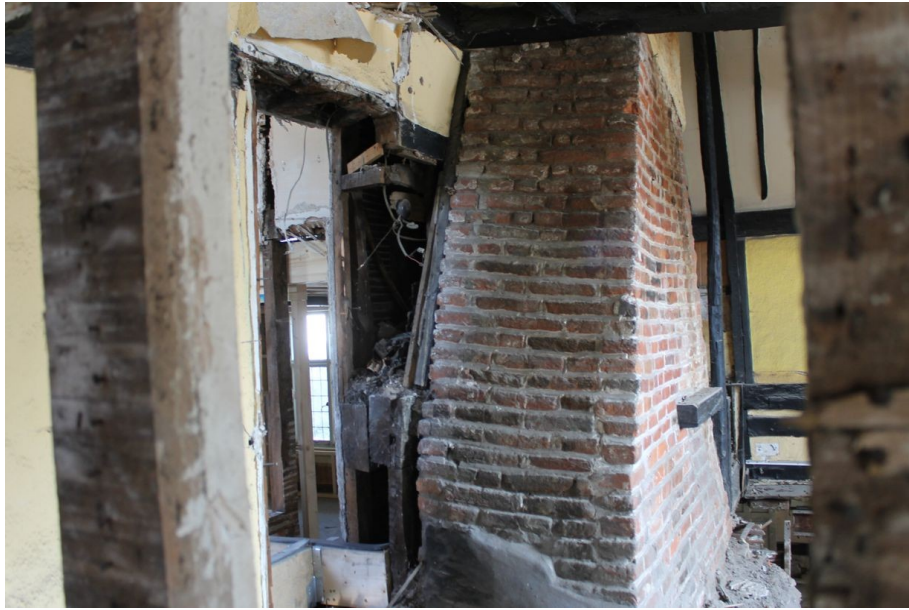
Photograph 49 Detail of north-west side of chimney stack, showing beams and surviving plaster behind in Structure A. Photograph taken facing east.

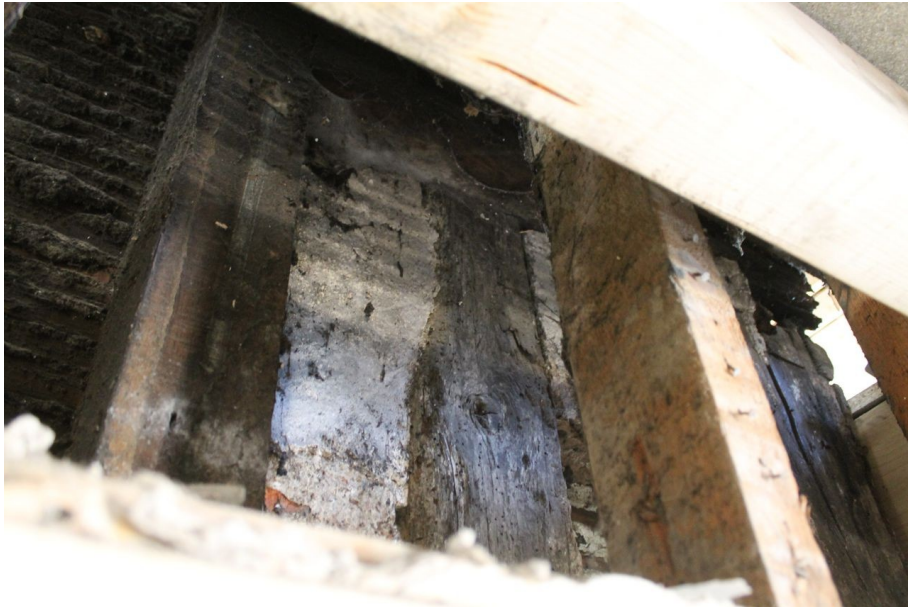
Photograph 50 Timber and plaster behind chimney stack in Structure A. Photograph taken facing west.

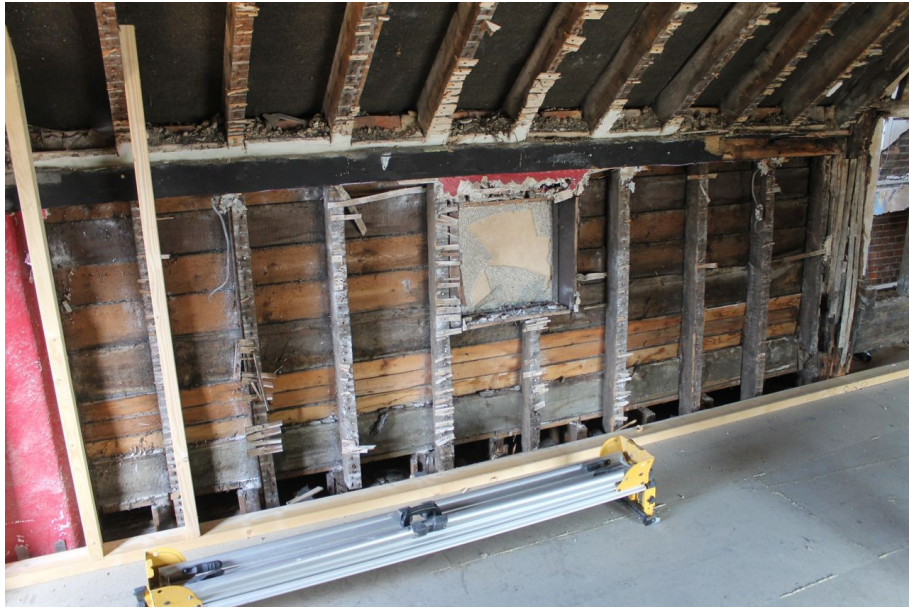
The first-floor has a smaller fireplace in the north-west wall. The interior walls and roof timbers of Structure B were exposed during the second visit, showing that the timber-frame is entirely machine-cut (Photograph 51) and that the brickwork on the ground-floor of the north-east elevation contains another blocked window (Photograph 52).

Photograph 51 Exposed machine-cut timber-frame of Structure B on north-east elevation, including inserted window. Photograph taken facing east.

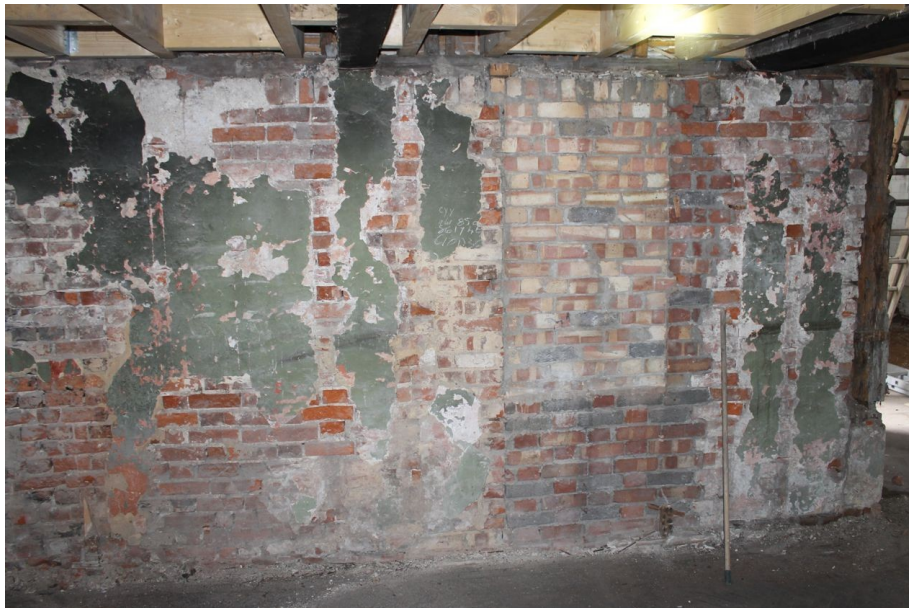
Photograph 52 Exposed brick wall on ground-floor of Structure B, north-east elevation. Photograph taken facing north-east.

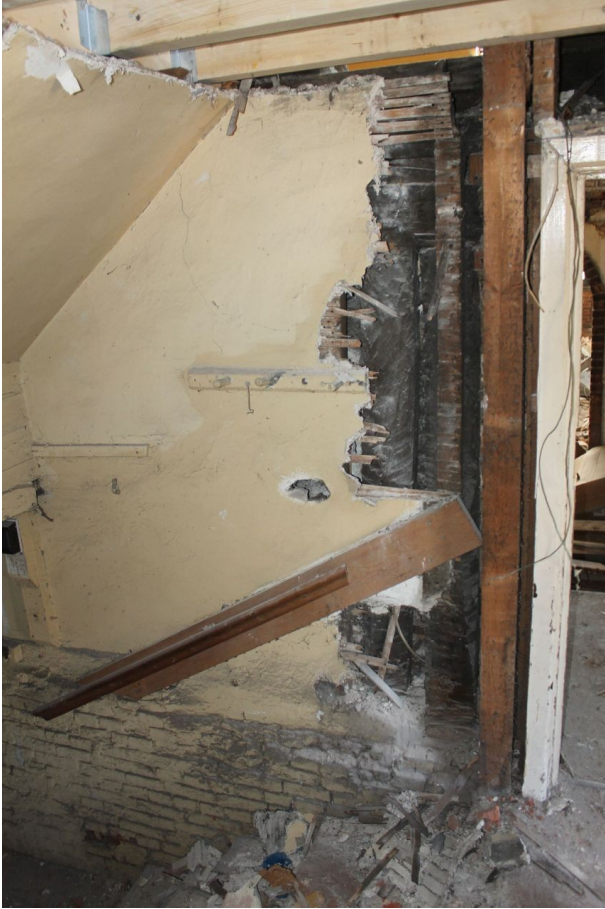
Photograph 53 Partially exposed sill-beam and reused studs behind fireplace in Structure A, supported on the 16th century cellar walls. Photograph taken facing south-east.

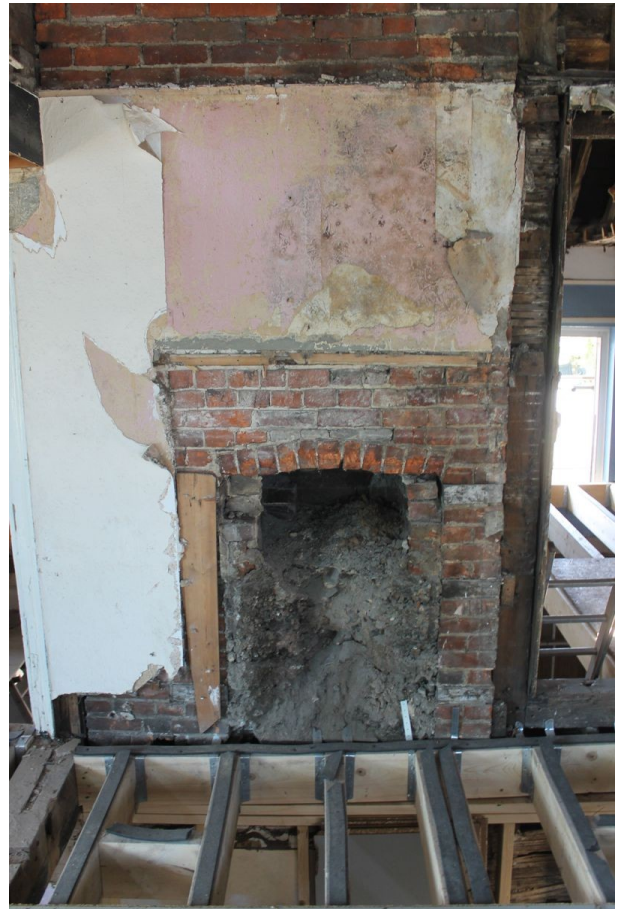
The first-floor of the building is much the same, all the room divisions are modern plasterboard and the apparent timber-framing is purely decorative. The building has clearly been heavily renovated since its construction. The floor level of the first-floor is significantly higher than that of the first-floor of the adjacent building to the north-west (Structure D). The two fireplaces at this level have been blocked up, but they seem to indicate that originally this floor was divided into two rooms, rather than three (Fig 5). During the second visit these fireplaces had been exposed (Photograph 54).

Photograph 54 Exposed fireplace in first-floor of Structure C. Photograph taken facing north-west.

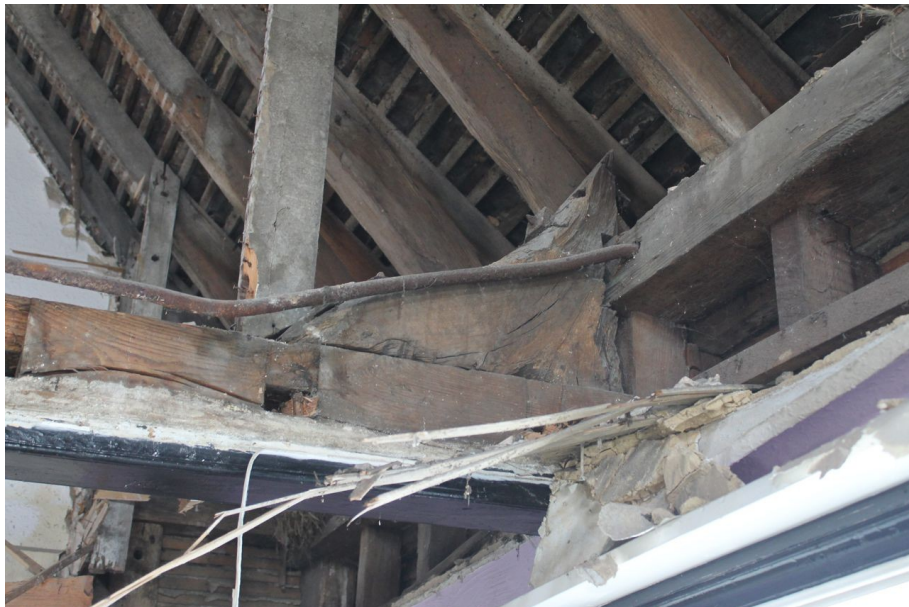
Photograph 55 Detail of inverted knee brace on south-eastern end of the northernmost tie-beam in Structure C. Photograph taken facing north-east.

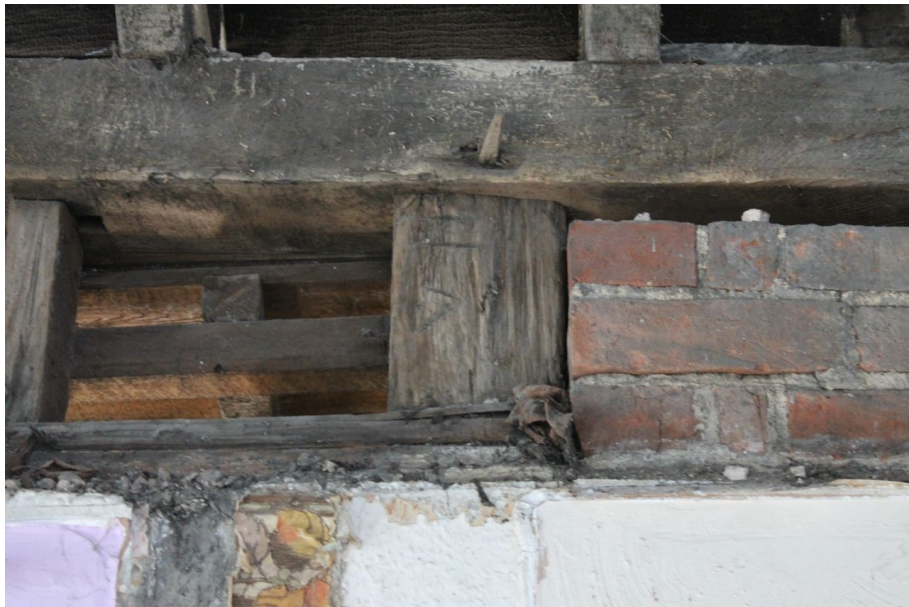
Photograph 57 Detail of carpenter's mark "VII" on stud/storey-post in north-west elevation of Structure C. Photograph taken facing north-west.
