**Historic building recording at
the White Hart Hotel, 1 High Street,
West Mersea, Essex CO5 8QD**

August 2018, April and November 2019

**report prepared by
Mark Baister
with contributions from
Chris Lister**

CAT Report 1324
May 2020

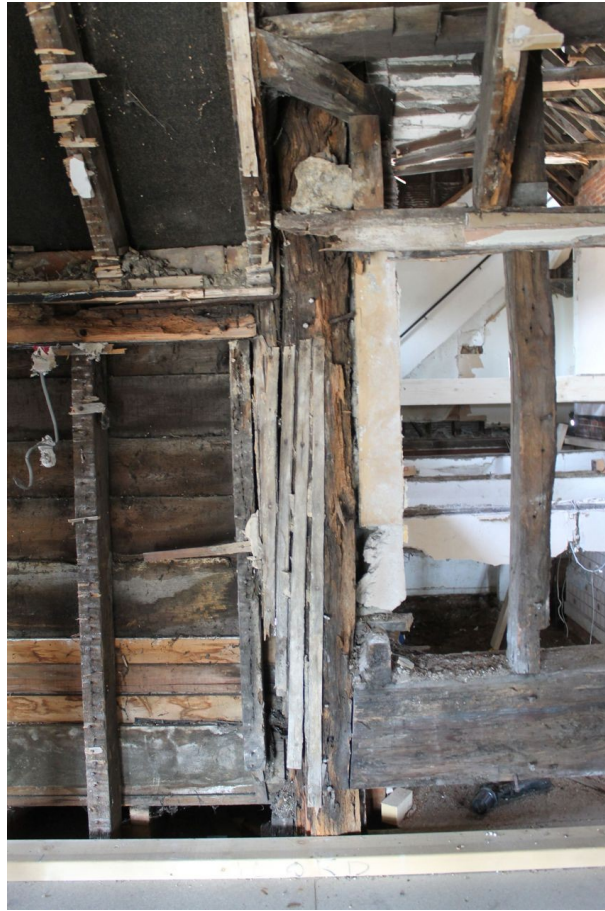
Like Structure C, during the second visit far more of the timber-frame of Structure D was visible, including several reused, hand-sawn, timbers (Photograph 58).

Photograph 58 Detail of west reused corner-post of Structure D, photo taken from within Structure B. Photograph taken facing north-east.

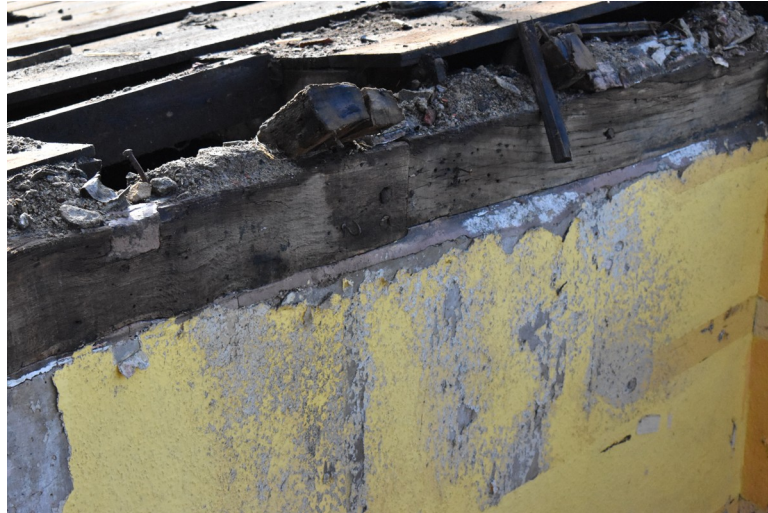
This visit allowed the chimney-stack to be observed in greater detail, and a brick sample to be obtained. Additionally, the presence of scaffolding allowed the roof of Structure A to be examined in far greater detail than previously, allowing for the identification of an edge-halved scarf-joint on the western wall-plate that was not previously observable (Photograph 61), as well as several incised carpenter's marks on the rafters (Photographs 62 and 63).

Photograph 61 Detail of edge-halved scarf-joint on eastern wall-plate of Structure A. Photograph taken facing south.

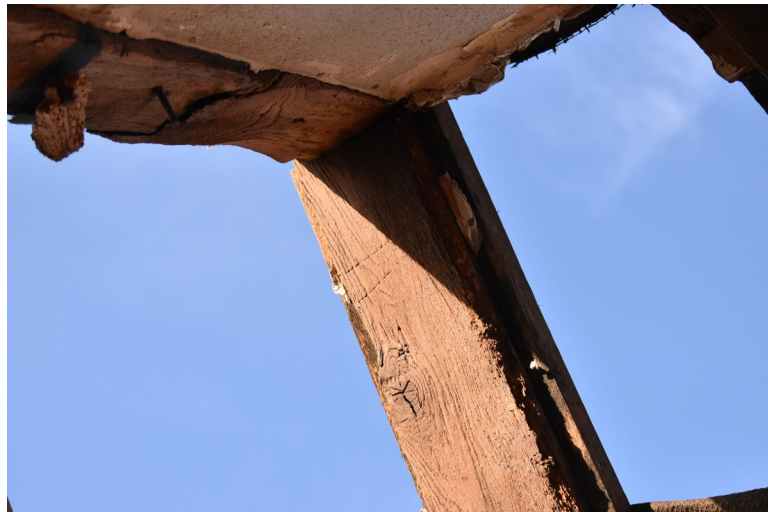
Photograph 62 Detail of carpenter's mark "II" on western rafter of Structure A. Photograph taken facing west.

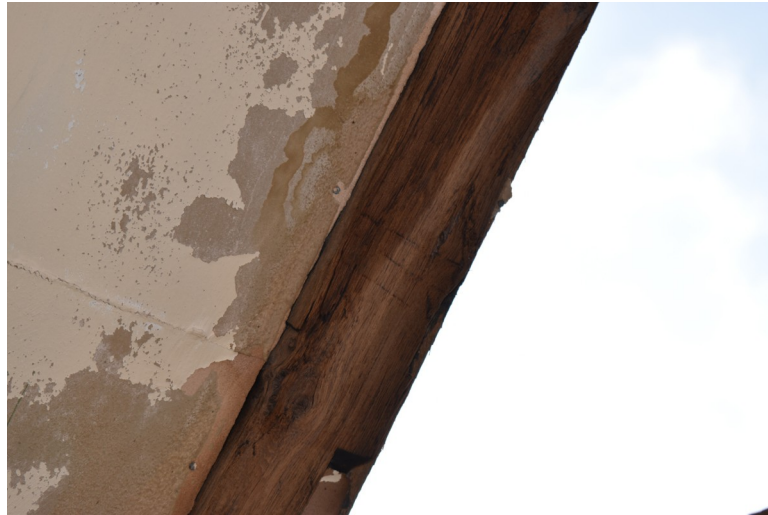
Photograph 63 Detail of carpenter's mark "III" on eastern rafter of Structure A. Photograph taken facing south.

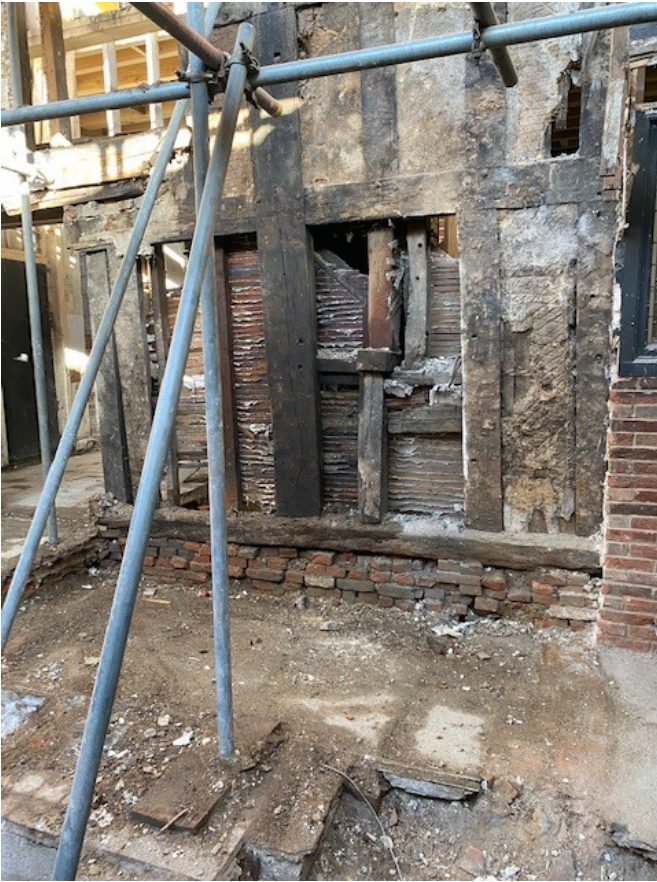
After the chimney had been completely removed, the surviving northern elevation of Structure A was exposed and, as well as containing several modern machine-cut timbers, also had patches of (possibly original) plaster, with timber-panelling infilling partially visible beneath (Photograph 65).

Photograph 65 Northern elevation of Structure A after complete removal of chimney, with plaster and timber infilling visible. Photograph taken facing north.

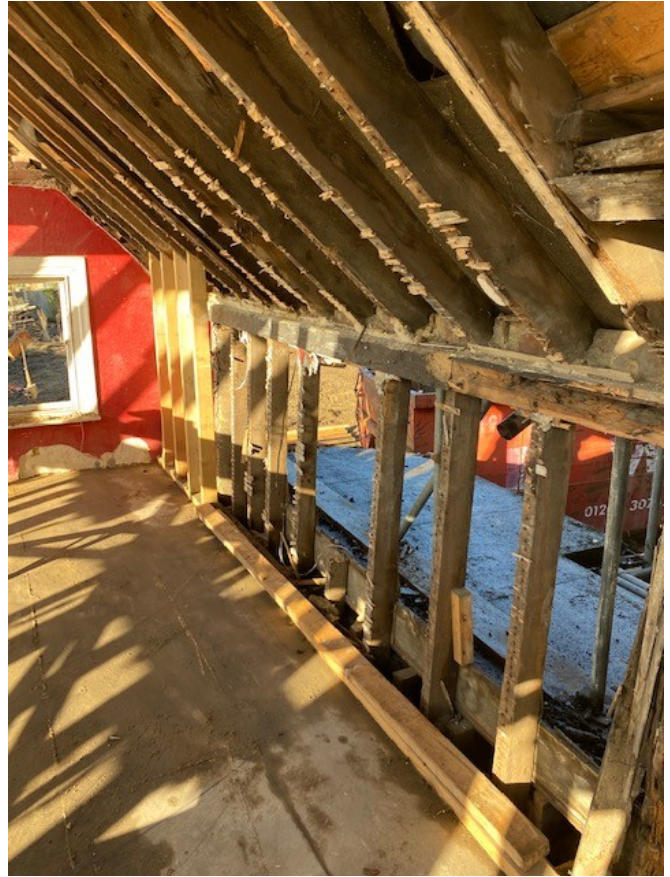
During the visit the first-floor of Structure B had also been removed of its weatherboarding, allowing an observation of its timber-frame, which was shown to be constructed entirely of machine-cut timber (Photograph 66).

Photograph 66 Detail of machine-cut timber studs and rafters of Structure B's north elevation. Photograph taken facing north-west.

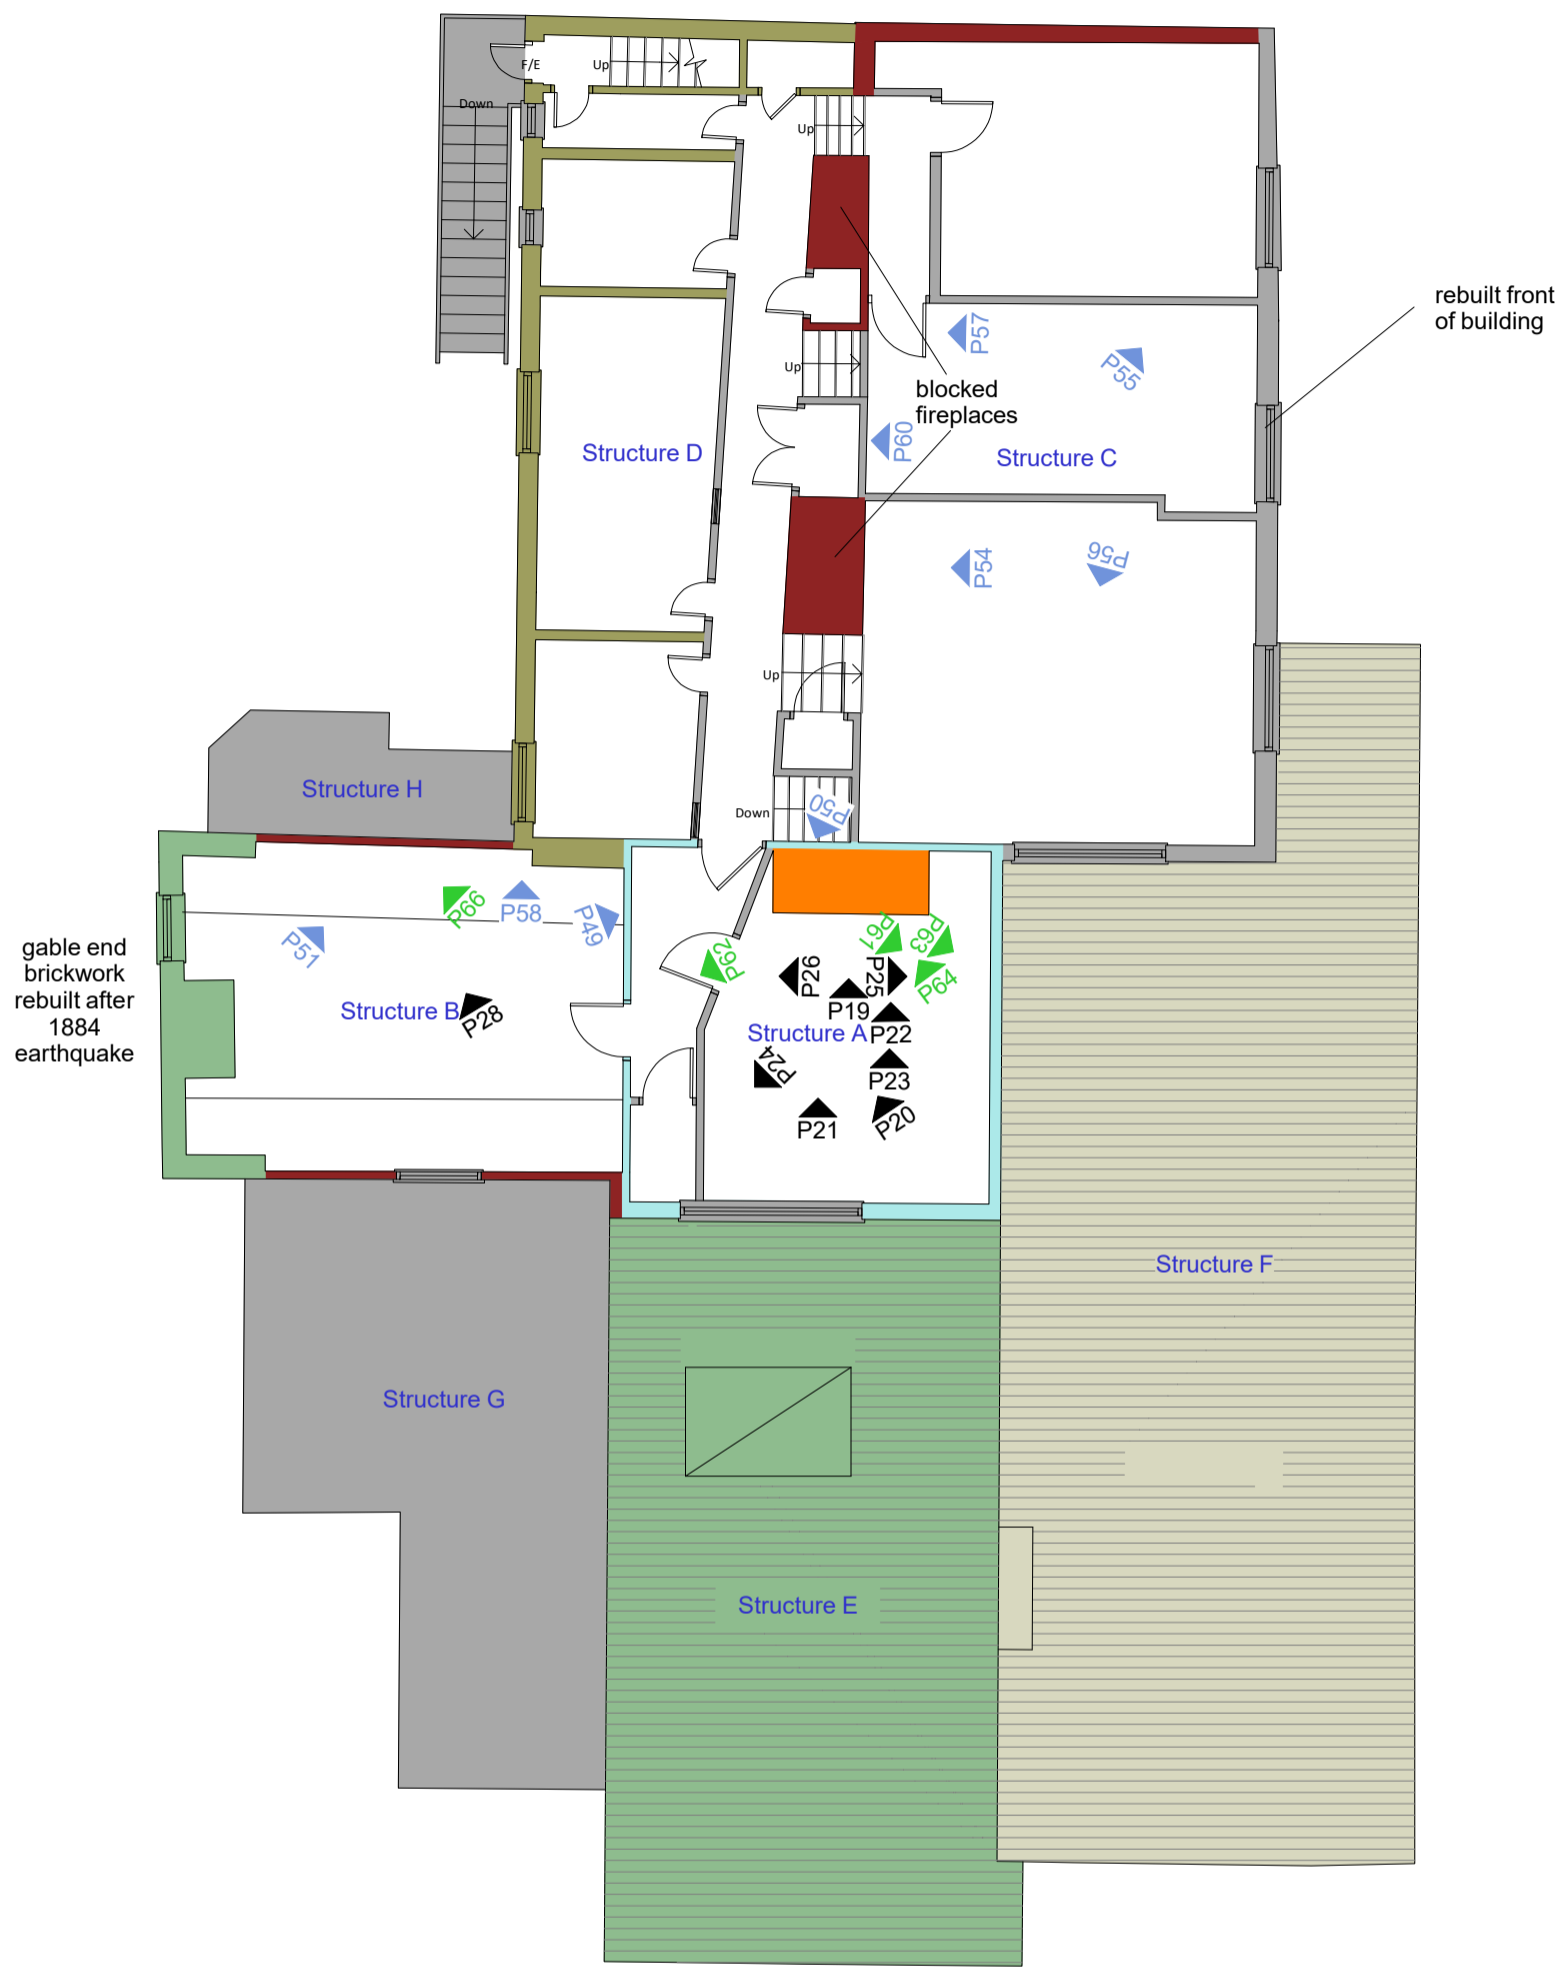
Fig 5 First floor plan of White Hart Hotel, with phasing.
 Location and direction of photographs reproduced in text shown (second visit in blue, third visit in green).

The first-floor of Structure D is also divided into three rooms, but has a modern subdivision forming a corridor on the south-east side of the building (Fig 5). The northern-most of the three rooms is a tiled modern WC, the other two are featureless rooms with faux timber-framing on the walls.

The north-east end of the building contains a narrow stairway leading up to the second-floor of Structure C, as detailed above. The south-western end of the first-floor has a doorway leading into Structure A (Fig 5).

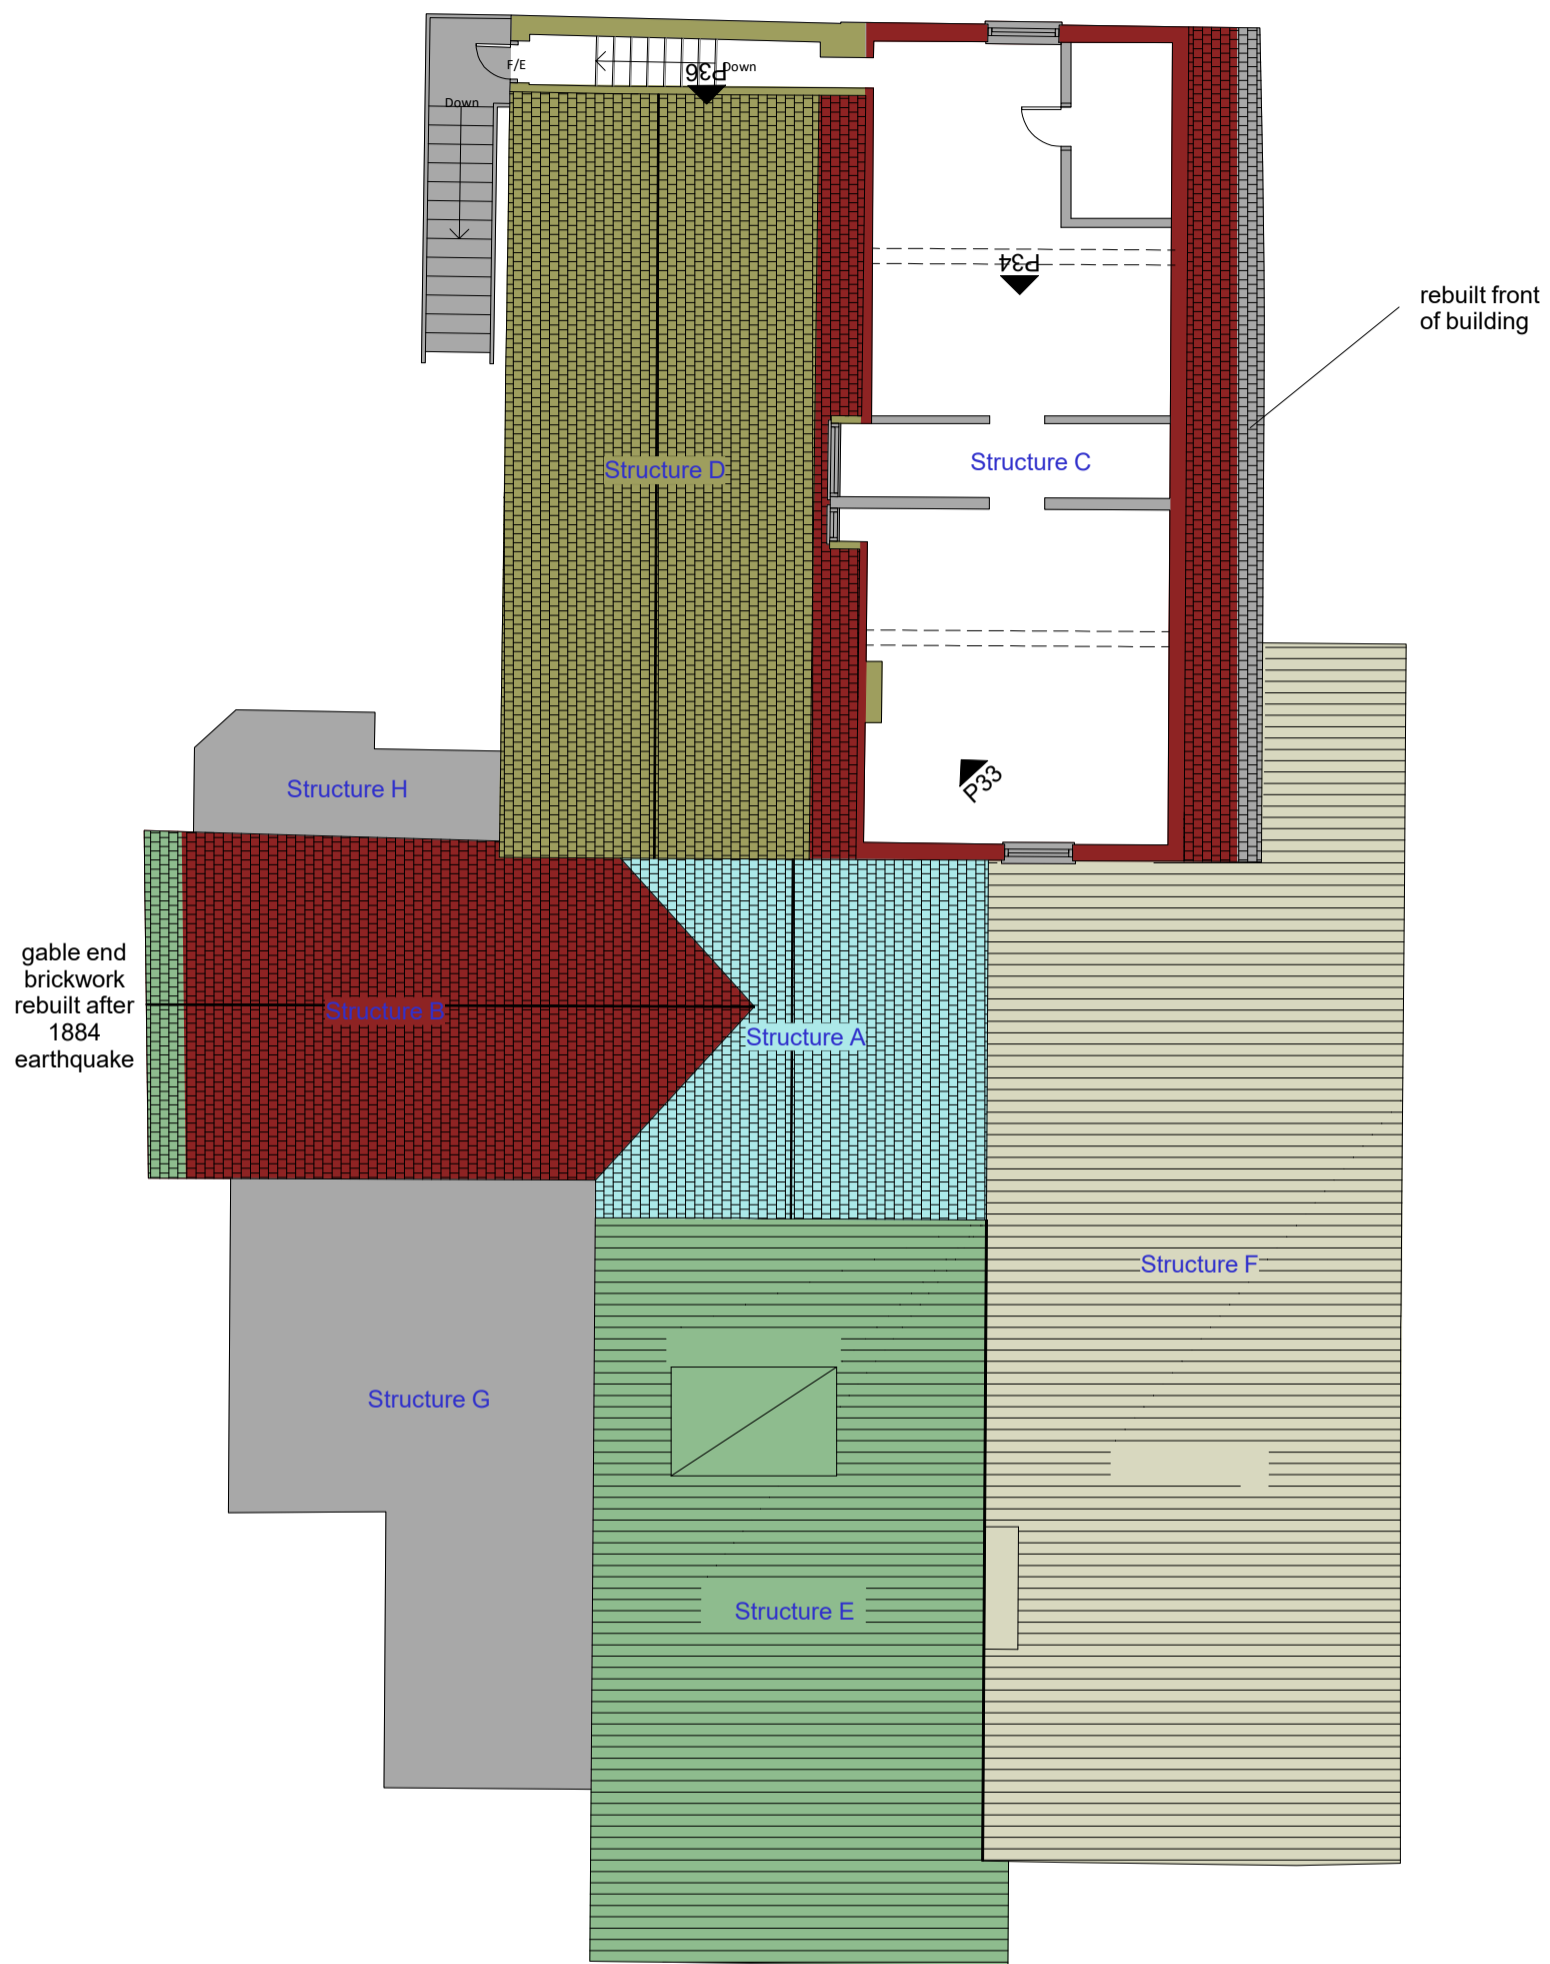
Fig 6 Second floor plan of White Hart Hotel, with phasing.
Location and direction of photographs reproduced in text shown.

The second-floor of Structure C is a converted attic space, accessed from the first-floor of Structure D (Fig 6). It contains two modern divisions and a modern kitchenette, as well as a fireplace (Photograph 33). The fireplace and associated chimney were probably added to Structure C when this second-floor was inserted into the attic space. The roof timbers of Structure C were observed through a loft hatch and found to be machine-cut, with the rafters pegged at the apex and no ridgeboard (Photograph 34).

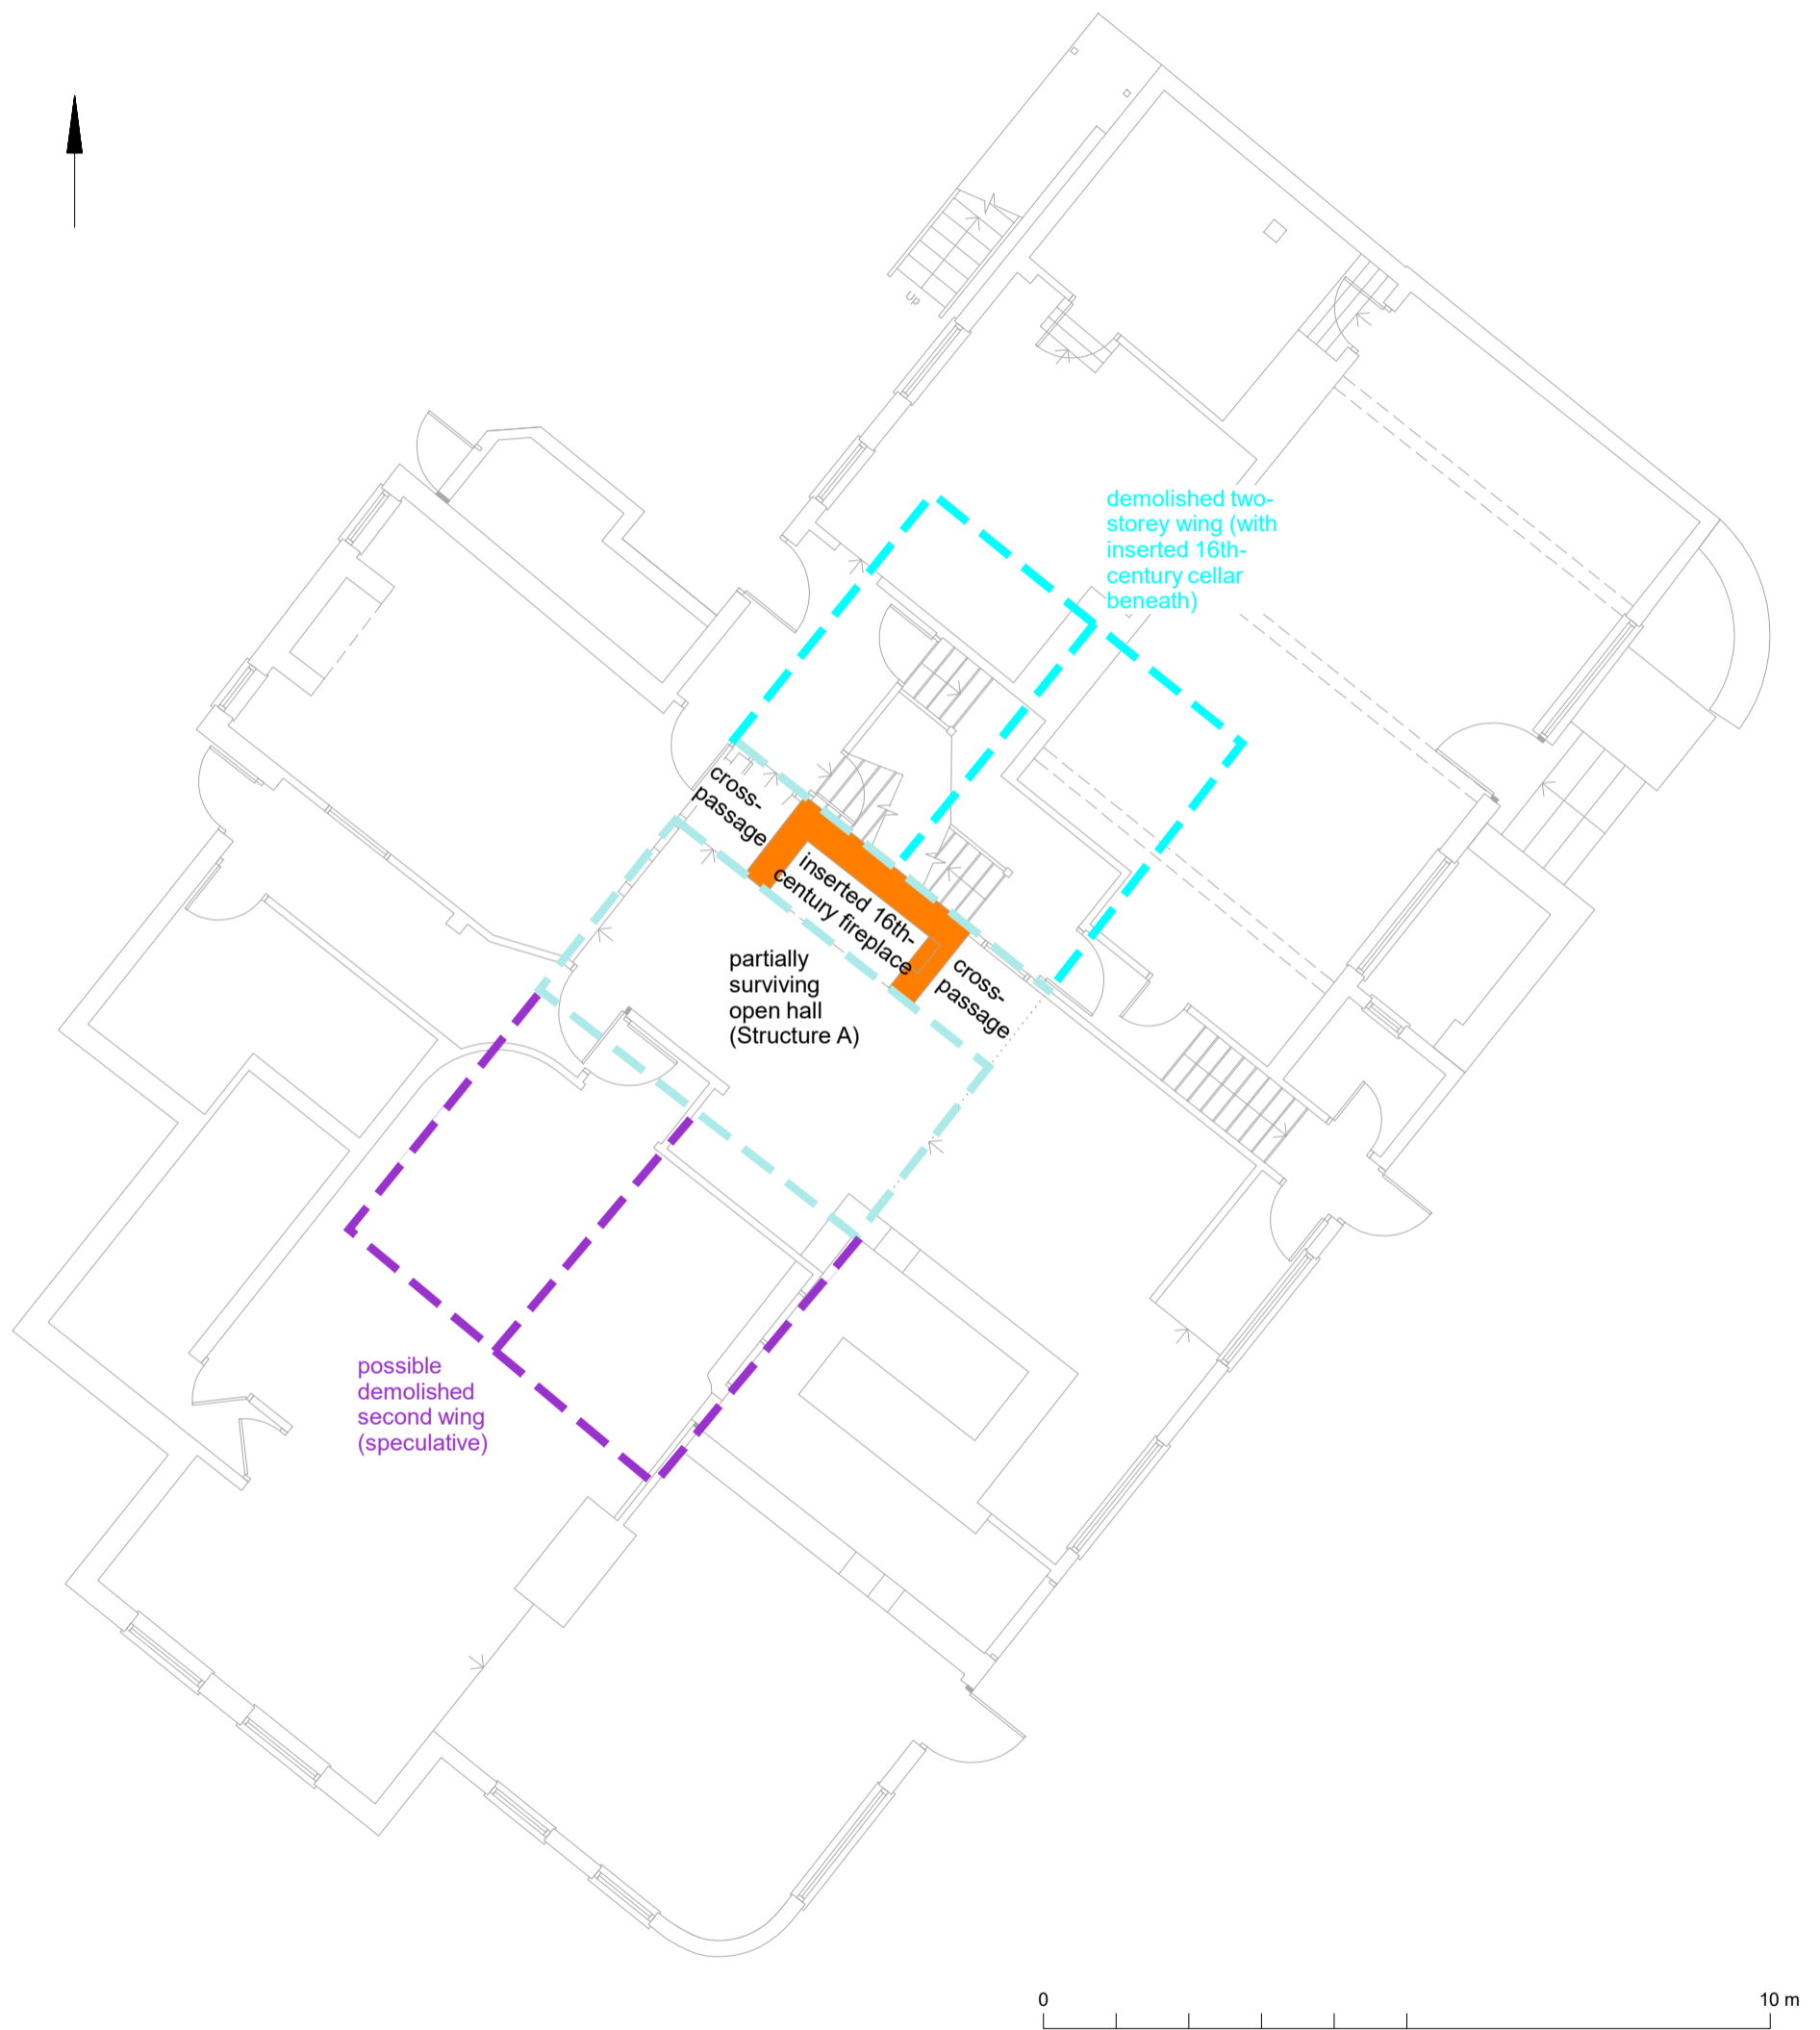
Fig 9 Plan of White Hart Hotel, showing possible original footprint of hall-house (Structure A).

Individually the pieces of evidence detailed above may not be conclusive, but together they at the very least form a compelling argument that Structure A is the remains of the open hall of a medieval hall-house. In all likelihood it was constructed in the 15th century, before having a substantial brick fireplace inserted into its cross-passage, a first-floor added to the hall and a cellar constructed beneath its northern wing in the 16th century. The large amount of later Victorian and modern alterations have resulted in extensive damage to Structure A's fabric, with essentially only the first-floor of the original open-hall surviving, and the cross-wing(s) having been completely demolished with the exception of part of the 16th-century cellar wall, which was incorporated into the cellar of Structure C (Fig 9).
