**Historic building recording at  
79 Magdalen Street,  
Colchester, Essex CO1 2LA**

**February 2019**

**CAT Report 1391**  
March 2019

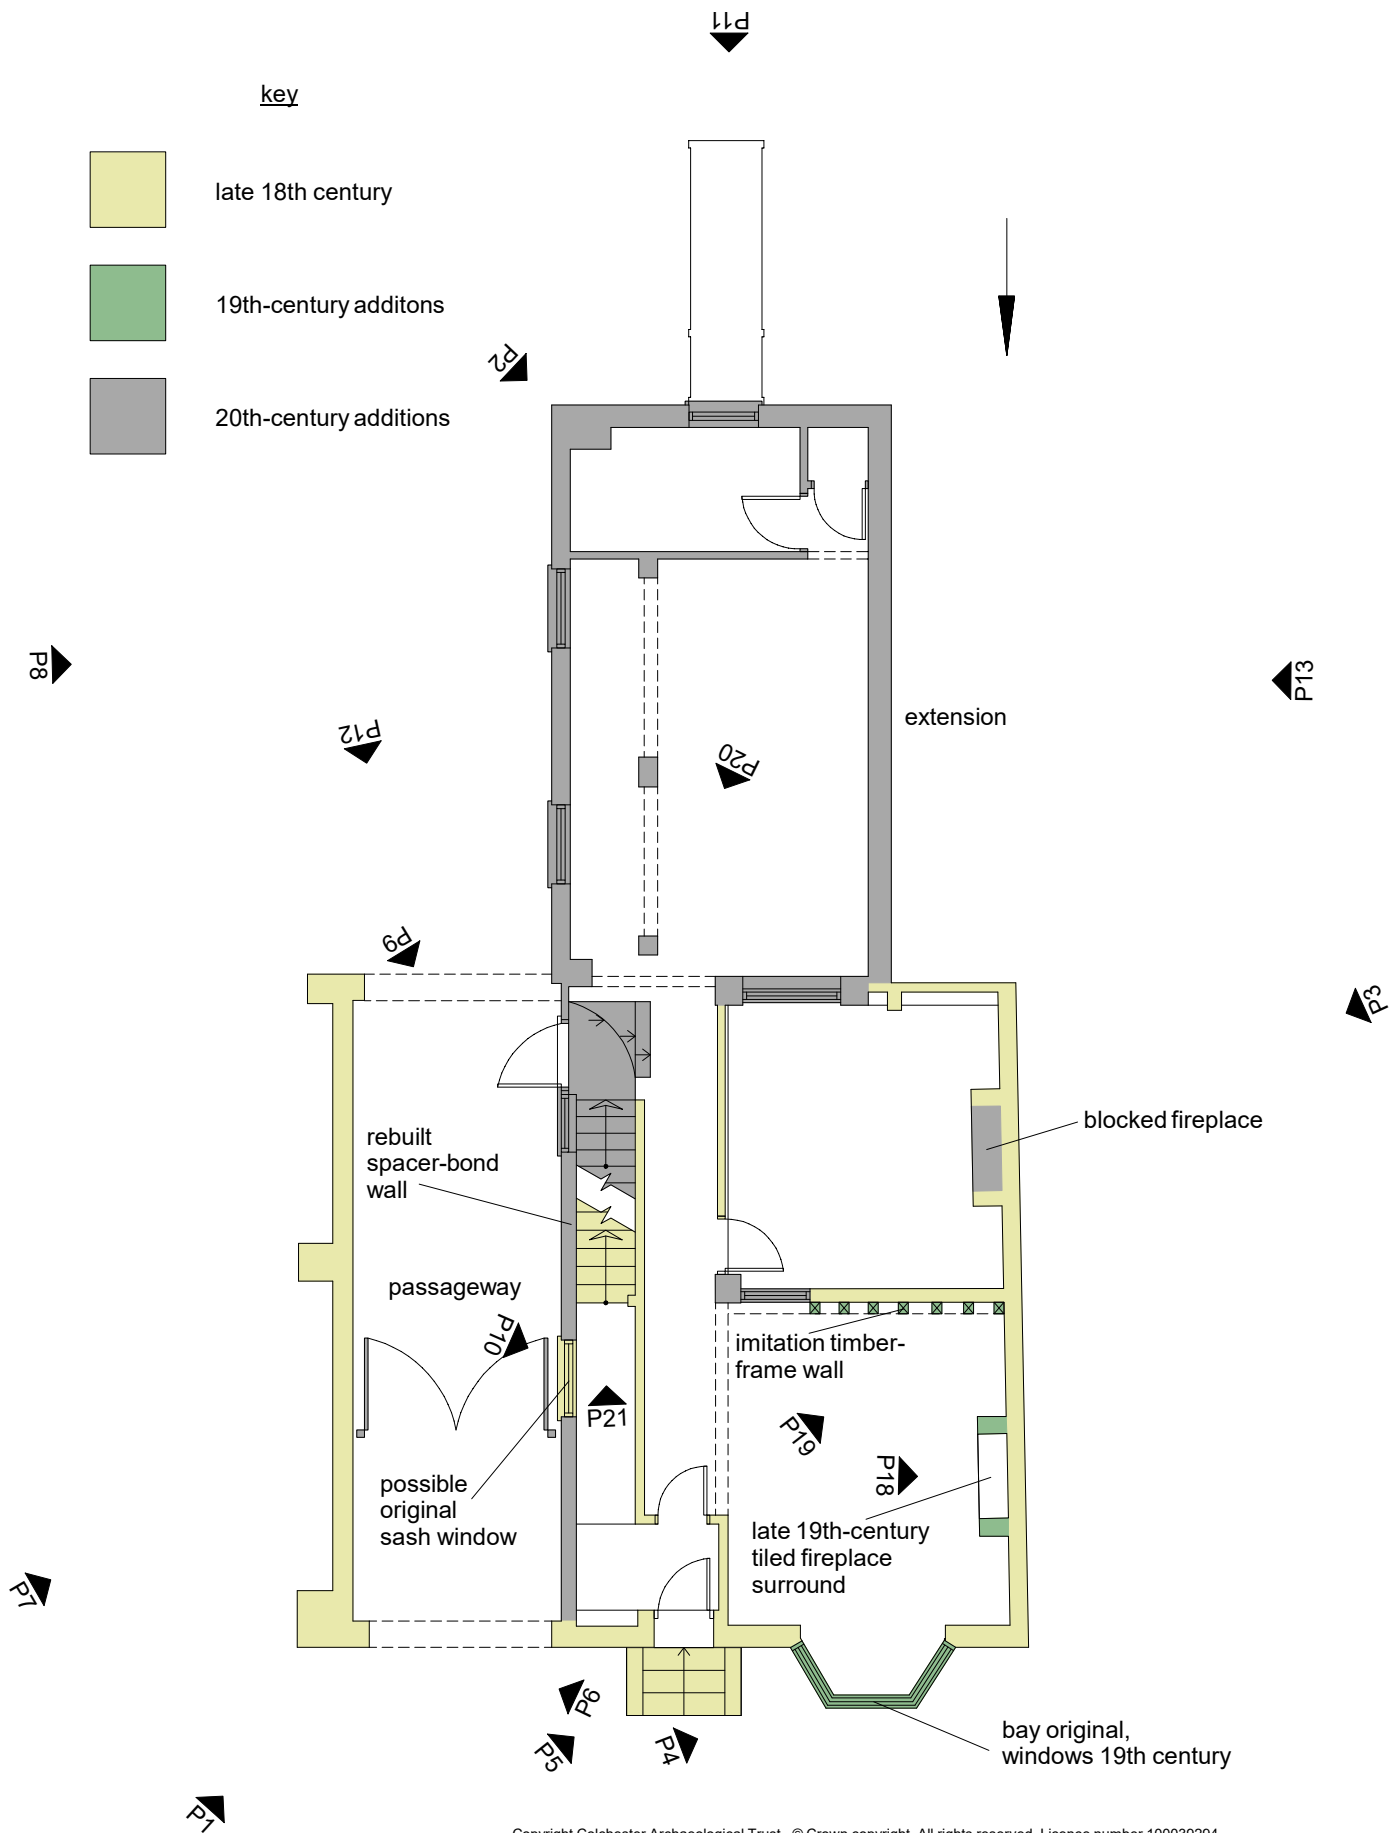
Fig 3 Ground-floor of 79 Magdalen Street with phasing. Location and direction of photographs reproduced with text shown.

79 Magdalen Street is aligned north/south and stands on the southern side of the street. The building measures approximately 9.2m x 16.4m in size and covers around 118 square metres. The main range of the building, fronting onto Magdalen Street, has three-storeys with a cellar below. The east of the ground-floor consists of a roofed passageway leading to the rear of the property (Fig 3).

Although there are no original features, some are still of note. Within the northern room on the ground-floor is an example of a late 19th-century fireplace (Yorke 2005, 75). While the cast-iron fireplace has been removed and replaced with a wood burner, the decorative surround, with its tiles and carved brackets, survives (Photograph 18). The fireplace in the southern room has been blocked (Fig 3).

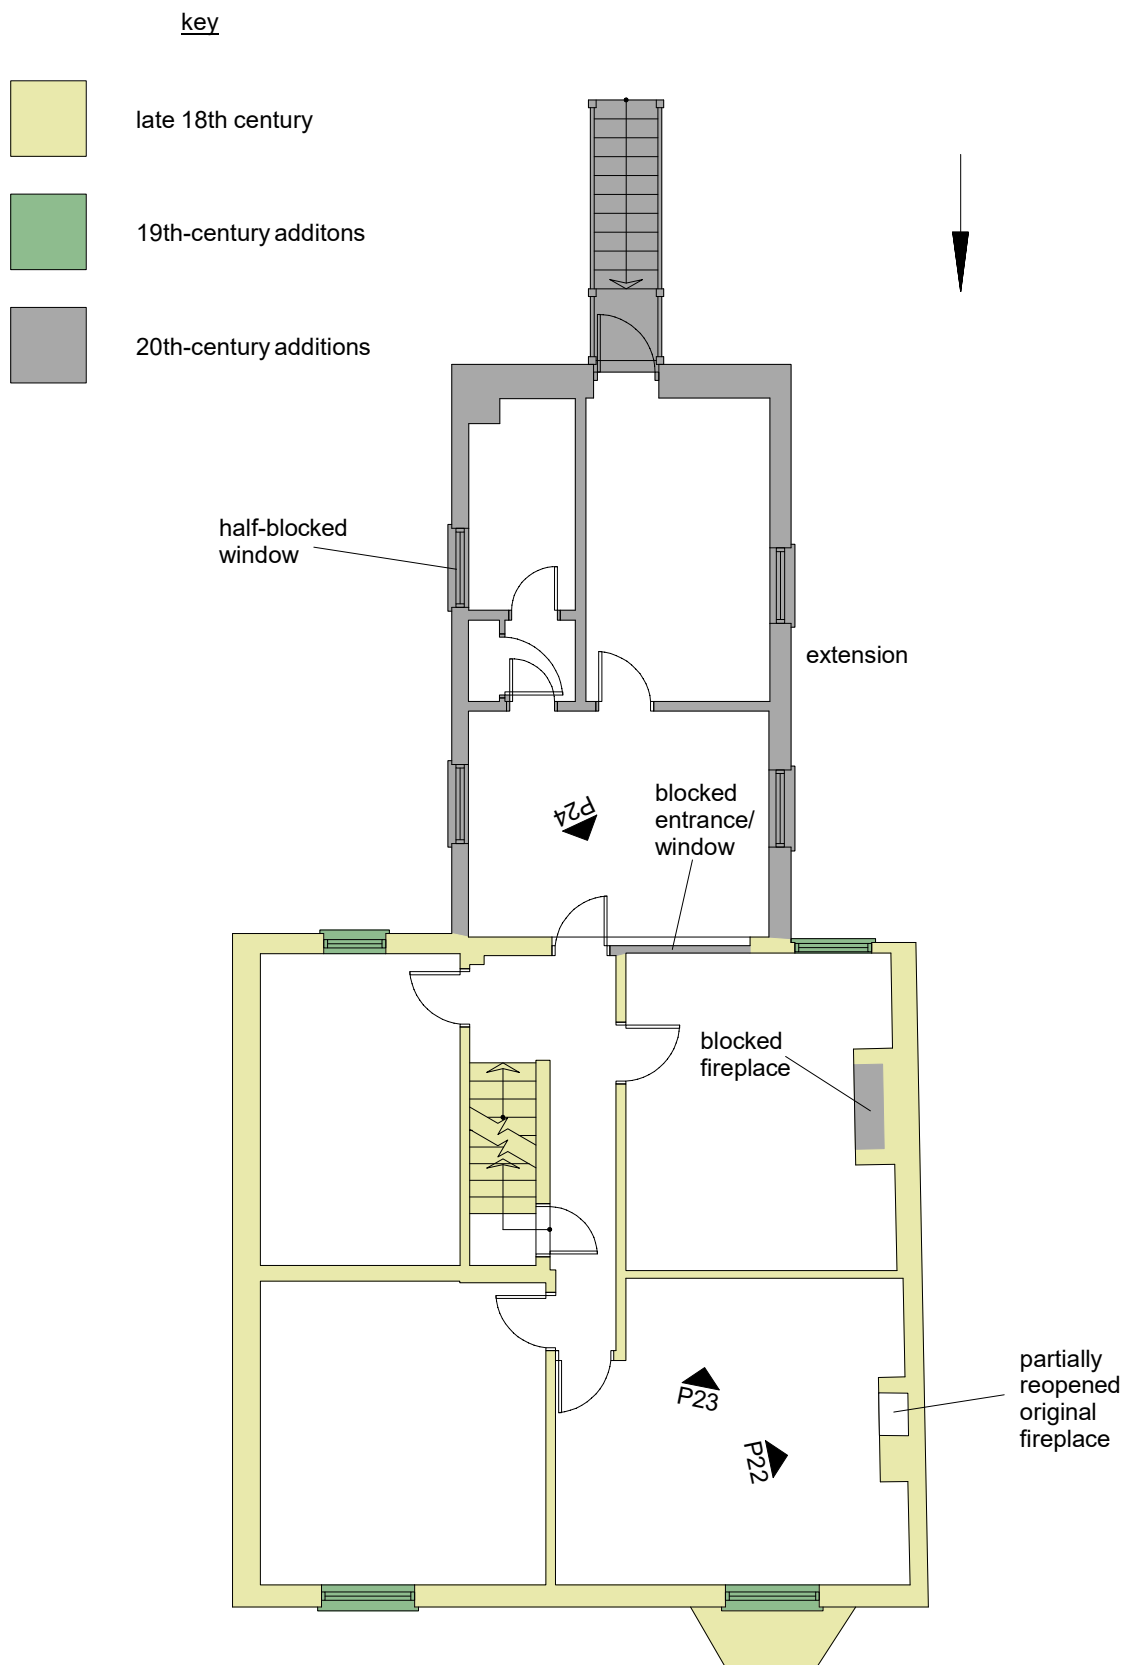
Fig 4 First-floor of 79 Magdalen Street with phasing. Location and direction of photographs reproduced with text shown.

The main range has a fairly uniform four-room floor plan on the first- and second-floors, with a slightly off-centre staircase and hall (Figs 4-5). This is mirrored on the ground-floor, but obviously instead of the eastern two rooms there is the passageway to the rear of the building (Fig 3). The interior walls of the main range are mostly obscured, but appear to be either brickwork or timber.

As with the ground-floor, the first-floor has been heavily altered and little of the fabric of the building is visible. All the doors have been replaced with modern fire doors and the walls are rendered and painted.

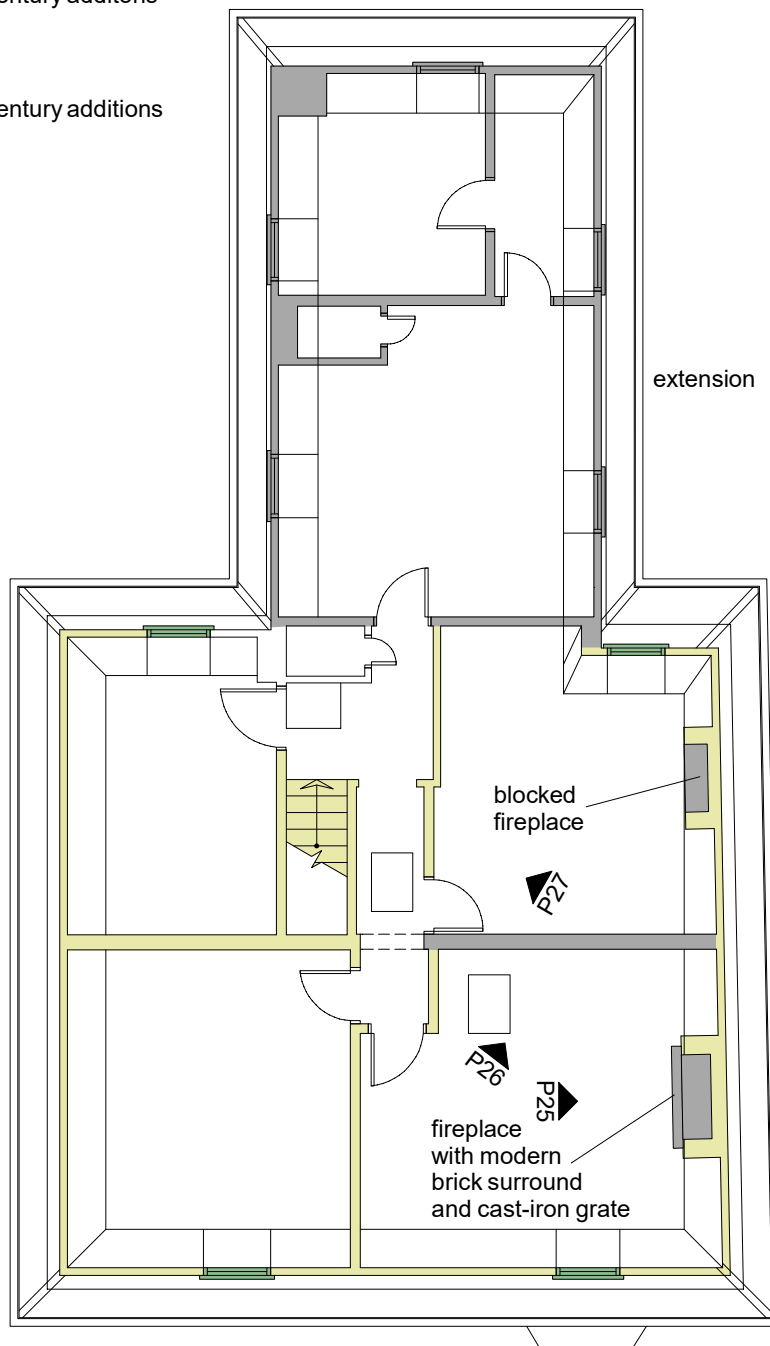
Fig 5 Second-floor of 79 Magdalen Street with phasing. Location and direction of photographs reproduced with text shown.

The southern fireplace has been blocked, but the northern has had a new brick surround built and a late 19th-century cast-iron fireplace within it (Photograph 25). The origin of this cast-iron fireplace is unclear, but it may originate from the ground-floor of this building (in the location now occupied by a wood burner; see pg 18).

Of note on this floor is that the plasterboard has been removed from one of the interior walls, exposing its fabric which consists of a mix of older hand-sawn and very modern machine-cut timber (Photograph 26). The hand-sawn sections of the wall are studs and diagonal bracing supporting them, all resting on a beam below (as observed on the first-floor; see pg 21). The hand-sawn studs are supported by modern metal braces and machine-cut timbers, and all rise to a very modern wall-plate (Photograph 26). Although these hand-sawn timbers are clearly of some significant age, there can be no doubt that the wall they are currently part of is not. The question becomes where these hand-sawn timbers originate from: were they part of the original fabric of 79 Magdalen Street or are they from an earlier structure? This question is examined in the discussion (pg 25).

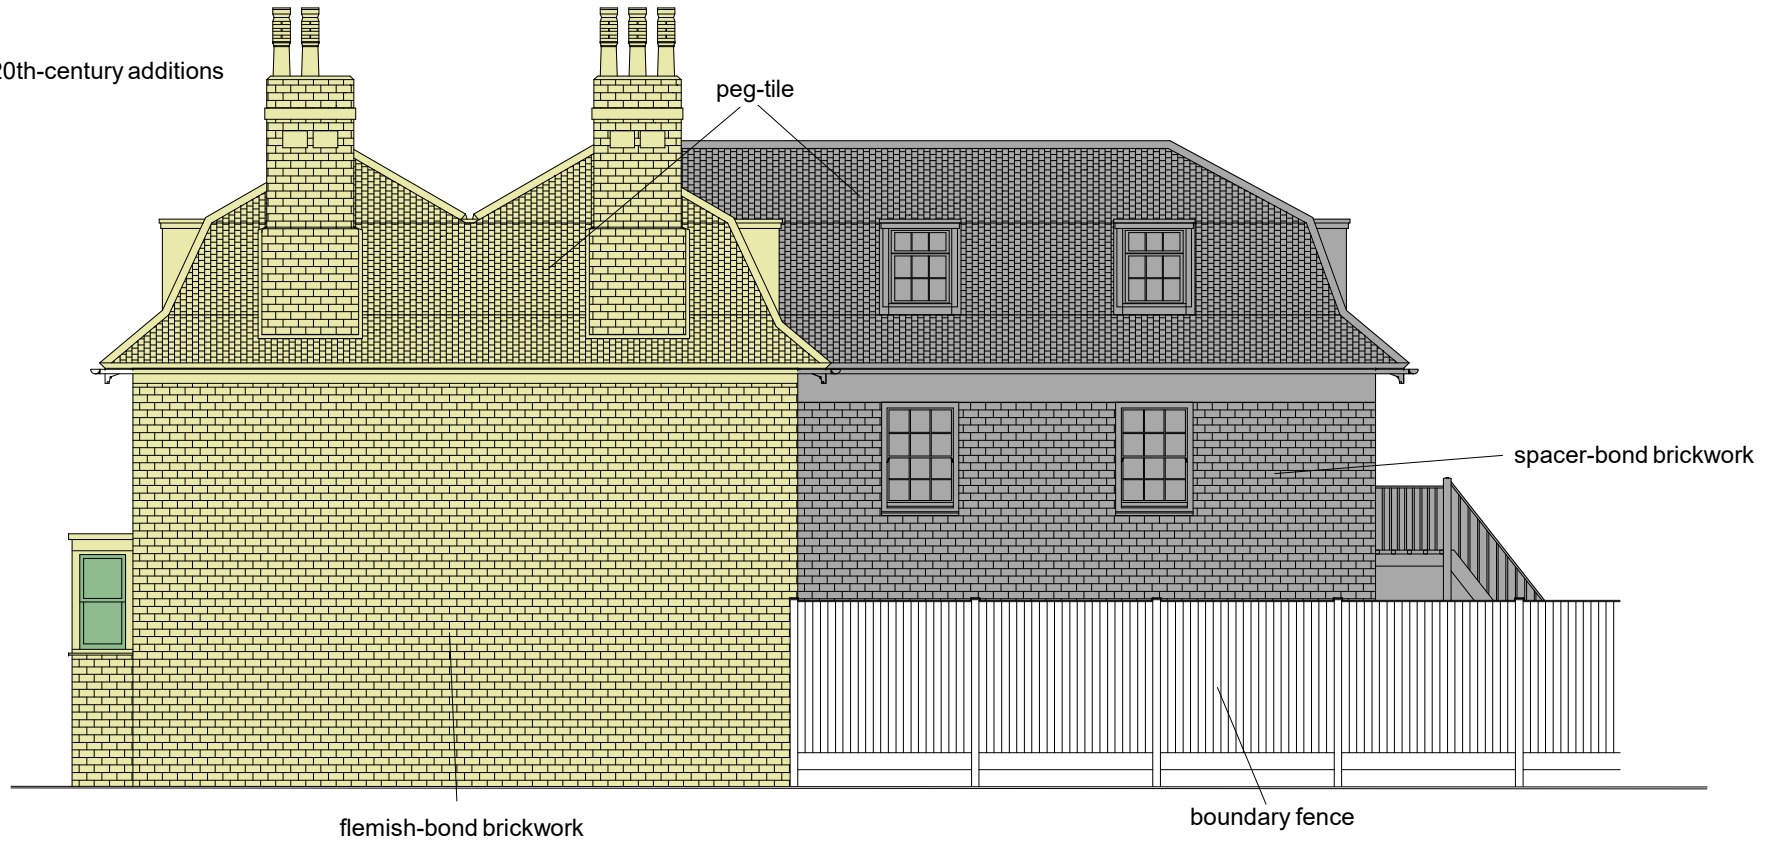
Fig 8 West elevation of 79 Magdalen Street with phasing.

The main range has two chimneys on this elevation, but no other features (Photograph 3). The extension has two six-light horned sash windows on the first-floor, with the usual dormers above, but no windows on the ground-floor (Photograph 13).

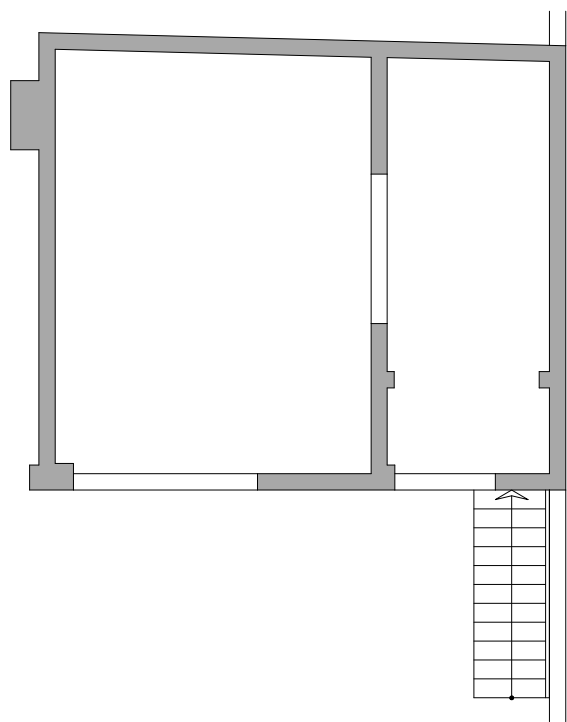
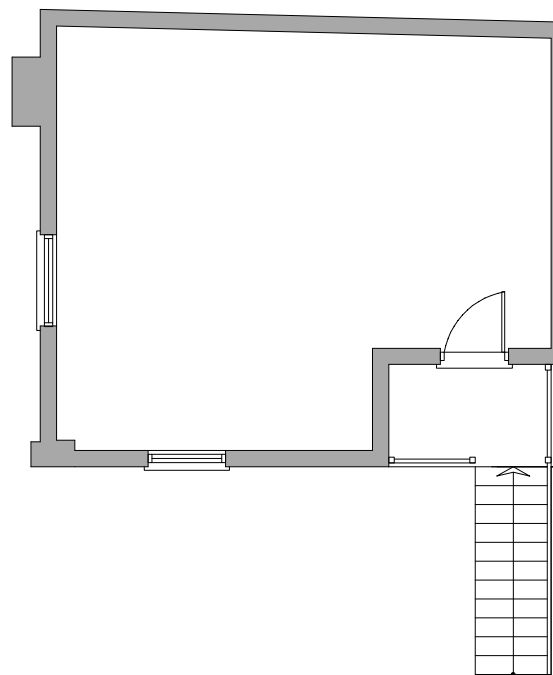
Fig 9 Ground-floor and first-floor plans of outbuilding. Location and direction of photographs reproduced with text shown.

The outbuilding is of very little interest historically. It is constructed of red bricks with a deep frog, laid in Sussex-bond with queen-closers and bonded in cement (Photograph 28). The roof has collapsed and is entirely absent and the remainder of the building is not structurally sound. The double-width garage opening on the ground-floor (Fig 9) appears to be a later insertion judging by the rebuilt brickwork around it (Fig 10). The first-floor is accessed by a set on concrete steps, but could not be examined for safety reasons.
