Bumpstead Hall Farm, Helions Bumpstead, Essex: archaeological record

CAT Report 443
October 2007

This report provides a written and photographic record at English Heritage (2006) Level 3 of a complex of former farm buildings that includes a grade II listed aisled barn. It is intended to fulfil a condition of planning permission for domestic conversion and has been prepared to a brief designed by the Historic Environment Management team of Essex County Council (September 2006) and an associated Written Scheme of Investigation (CAT, September 2007).

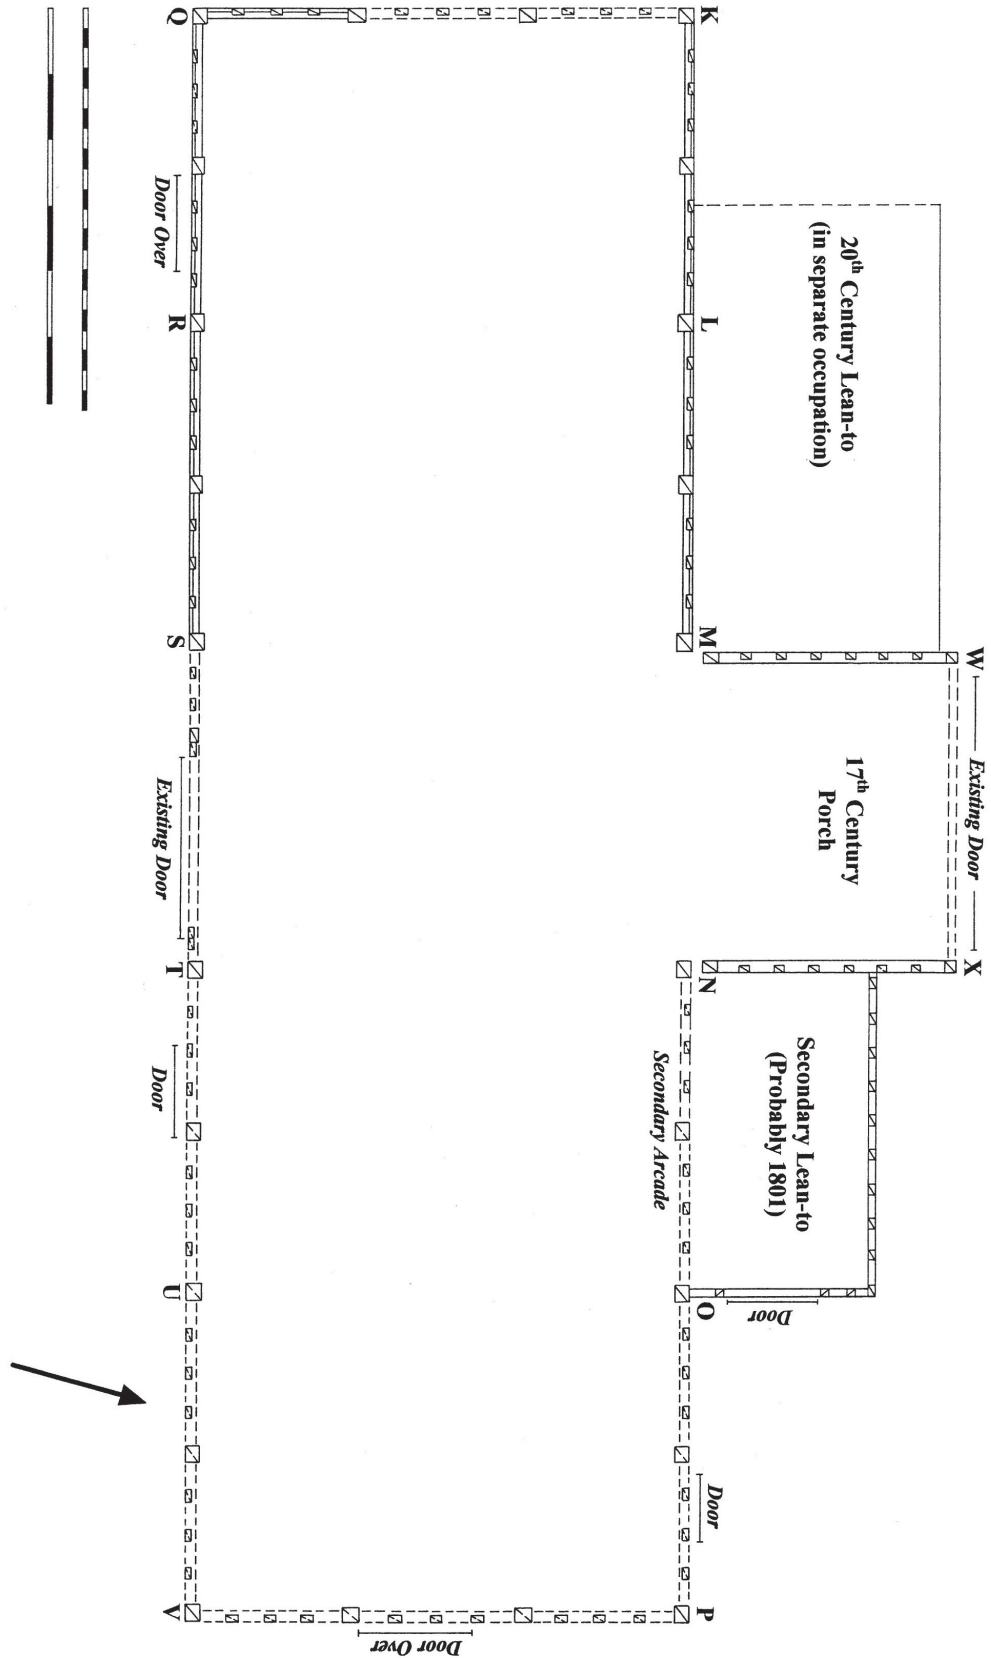
Fig 2 Barn 1: ground-plan.

A lean-to extension lies in the angle of the 17th-century porch and bay N-O, as shown in Figure 2. The original external wall of this bay was entirely removed and a new roof-plate inserted with substantial bolted knee-braces to posts N and O, thereby creating a short aisle. The new outer wall retains its original studs, all of which were re-used from a 15th- or 16th-century building, together with original lath-and-plaster infill which is nailed to the external weather-boarding. A door lies in the eastern gable but this may be a secondary feature. The addition of this aisle or lean-to can probably be dated accurately by an inscription on the western face of post N, which appears to have been renewed at the same time: 'IS / 1801 / July ?18'. The 'I' of this period can also be read as 'J', and may relate to the contemporary owner (Stubbing or Salway). A second lean-to occupies the angle of the porch and bay L-M, but this is currently in separate occupation and was not examined internally. Its outline is shown on the first Edition Ordnance Survey of 1877, but its present fabric appears to date only from the 20th century.

The 20th-century reconstruction incorporated a number of secondary entrances, as indicated in Figure 2, and two high doors that presumably opened onto grain floors of which no trace now remains. The interior has been stripped of any agricultural fixtures or fittings and the barn has most recently served as a machinery and tractor shed with a concrete floor.

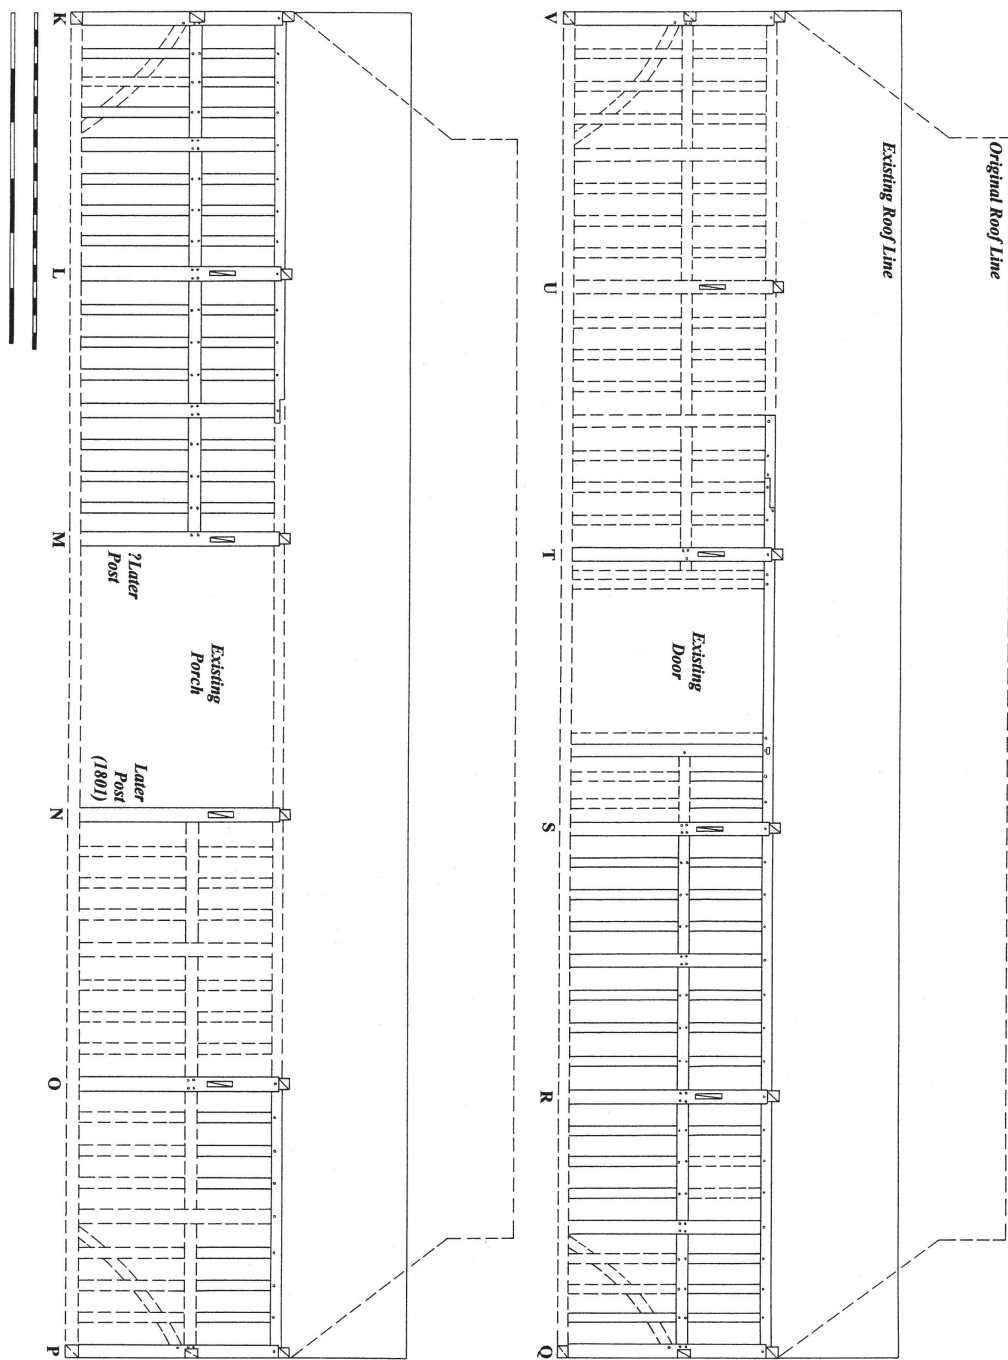
Fig 3 Barn 1: southern internal elevation V-Q (top), and northern internal elevation K-P (bottom).

The roof-plates are currently 3.45 m (11 feet 4 inches) above the present ground-level but several storey posts about the concrete floor and any remaining ground sills are buried; it may therefore be assumed that the plates were originally at least 23 cm (9 inches) higher to account for the likely proportions of these sills. The remaining studs are 1.3 m tall between the roof-plates and mid-rails (52 inches) and 1.9 m beneath the mid-rails (76 inches). The principal storey posts are linked by arch-braces to the tie-beams, as shown in Figure 4, and a pegged mortise in the centre of each tie would have held the crown-posts of the missing original roof structure. The gables were identical, as shown in Figure 5, with two intermediate posts dividing the mid-rails, and appear to have been hipped as neither gable tie-beam contains stud mortises in its upper face. The southern roof-plate preserves an original scarf joint of standard edge-halved-and-bridled form (bay U-T in Fig 3).

The central bay of the barn (M-N-S-T) has been much altered, as usual, by the insertion of secondary entrances and evidence of the original arrangement is limited. The pattern of mortises in the only remaining roof-plate to the south (T-S in Fig 3) suggests the presence of a wide doorway rising to the eaves of the building; the inner surface of the plate is hidden but its soffit contains no stud mortises above the present door as shown; the western jamb is pegged to both plate and mid-rail and may be an original feature, but the present eastern jamb adjacent to post T appears to be secondary.

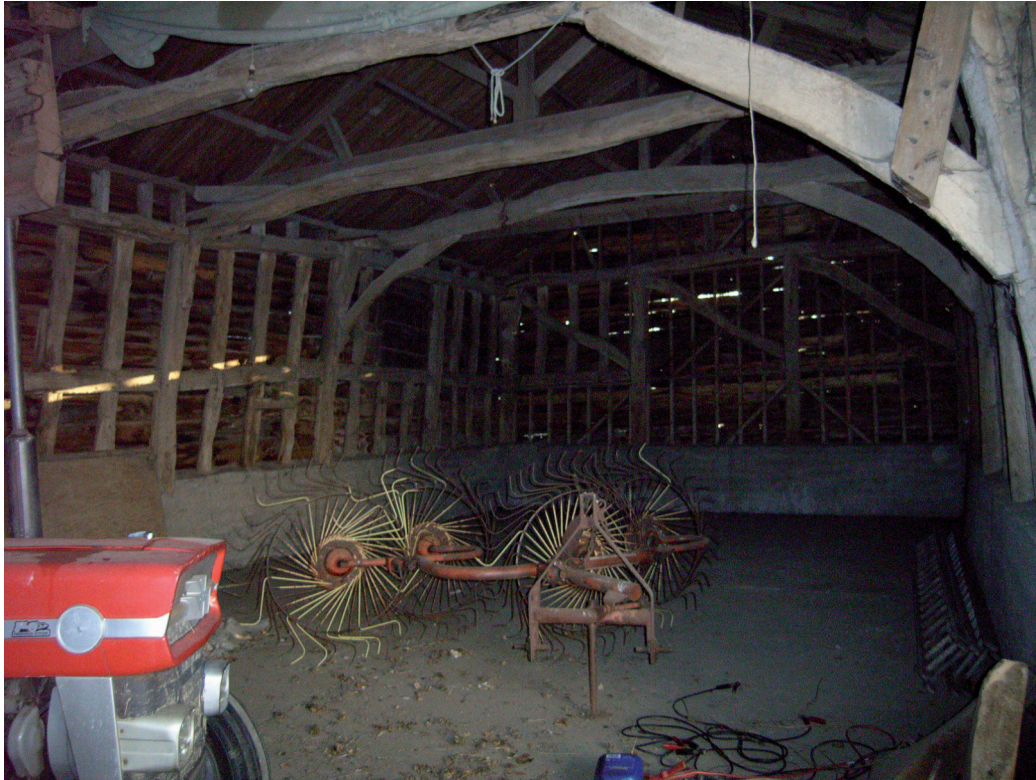
A1.3 Barn 1: general internal view from north-east.

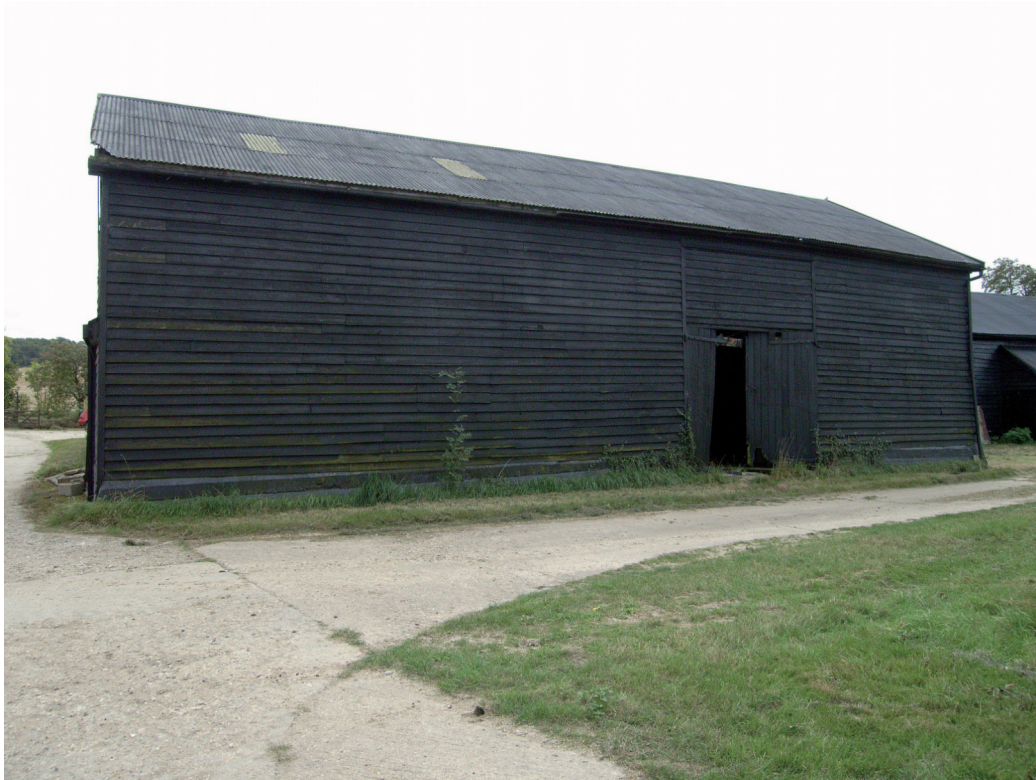
A1.7 Barn 2: exterior from north, showing elevation E-A.

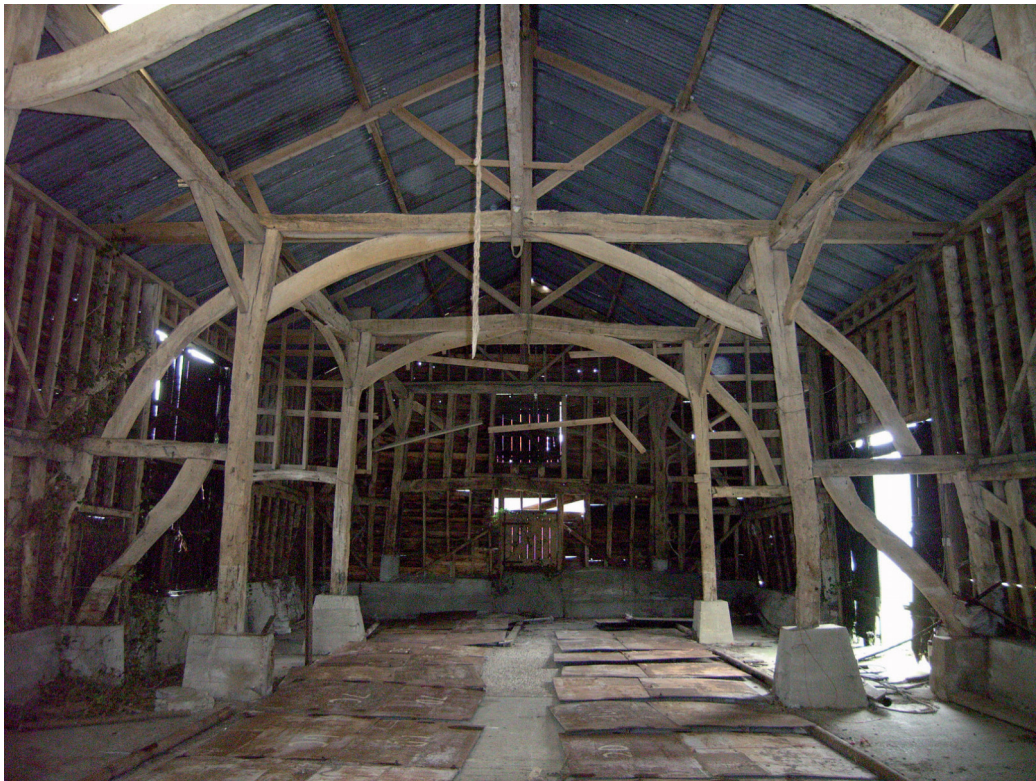
A1.8 Barn 2: general view of interior from east.

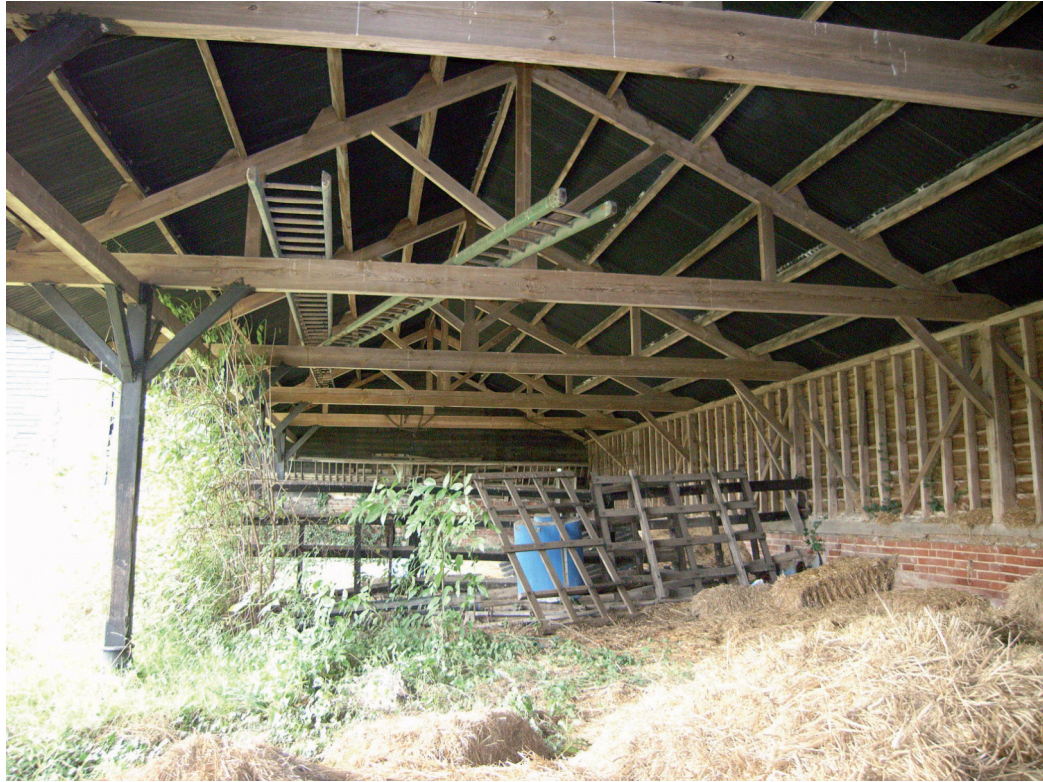
The hay-rack at the shelter's northern end consists of diamond-section rungs in the usual manner, and is 1.6 m (5 feet 3 inches) above ground-level. Its rungs are largely lacking and a number of horizontal rails have been inserted as a repair. Wooden rail fencing and straw bales bear witness to its most recent use as a sheep

A1.15 Shelter 3: interior from south, looking towards hay-rack attached to barn 2.
