**A historic building survey and
archaeological evaluation by trial-trenching at
Belsteads Farm, Belsteads Farm Lane,
Little Waltham, Chelmsford, Essex**

**report prepared by
Leigh Alston, Emma Spurgeon, Adam Wightman**

**on behalf of
the Clifford Group of Companies**

CAT Report 447
December 2007

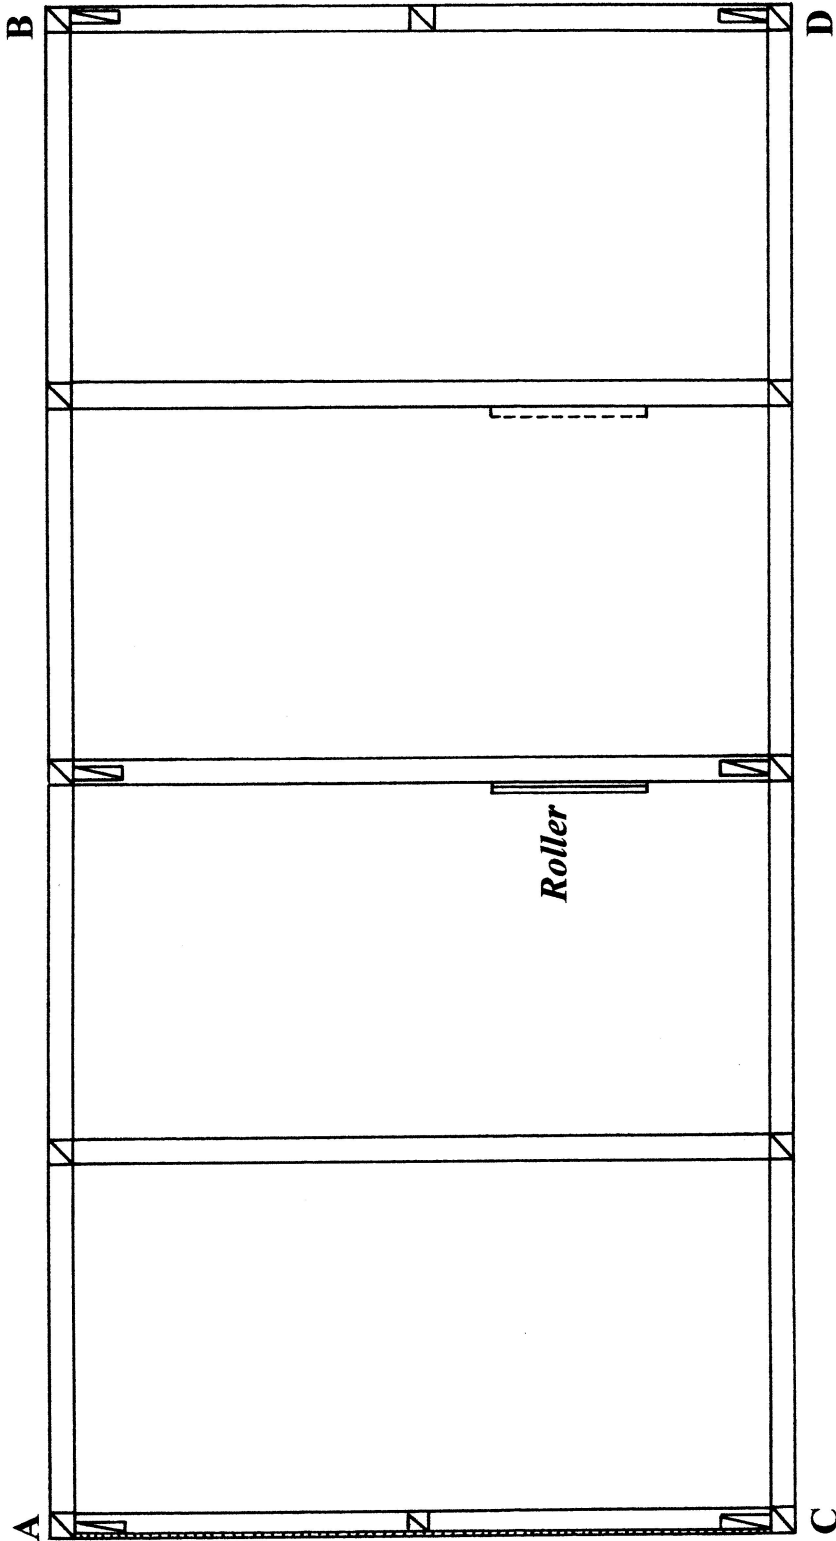
Figure 6. Ground Plan of Building 1

A wooden roller of similar form to that of a modern blind or roller towel is attached by iron spikes to the upper edge of the central tie-beam, as shown in photos A2.7-9. This extends to 1 metre in length and lies slightly to the west of the building's axis, as shown in figure 6. Attachments for a similar feature are visible in the southern tie-beam, but not the northern. Boards and other items were often stored above the tie-beams of open structures such as this, and these rollers, which appear to be original features, were presumably intended to assist in the process of loading and unloading. I am not aware of a comparable example elsewhere.

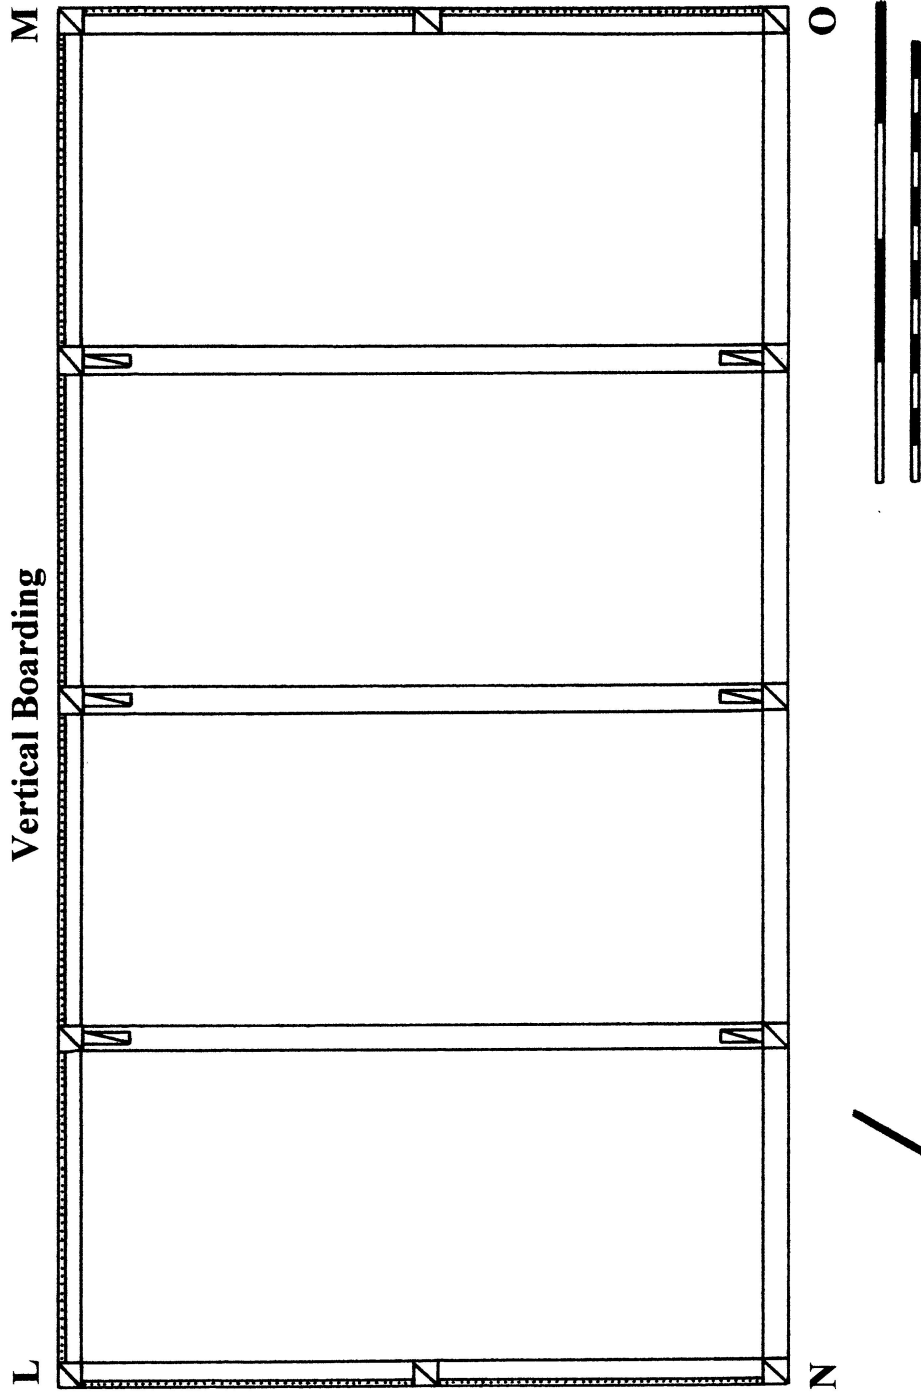
Figure 8. Ground Plan of Building 3

Building 3 lies to the south of the site and initially formed the boundary of an enclosed yard which extended to the south-western angle of the brick barn and porch. It consists of a timber structure of four bays with an east-west axis and extends to 11.4 metres in length by 6 metres in width overall (37.5 feet by 19.75). Its northern elevation (N-O in fig 8), which rises 2.1 metres from ground to roof-plate, is completely open, but its gables and southern elevation are enclosed. This enclosure takes the form of vertical tarred boarding nailed to a pair of triangular-sectioned horizontal rails which are tenoned and housed to earth-fast posts. The joints of the upper rails are pegged, unlike those of the lower tier. The boarding is replaced by brickwork beneath the lower rails, but this is largely hidden by modern cement and may be a secondary alteration. The western gable has been completely renewed in recent years, and previously adjoined a seemingly contemporary structure on a north-south axis as shown in A2.1 and on the Ordnance Surveys above. Each of the three tie-beams is secured to its respective posts by bolted knee-braces, and the gabled roof is covered with pan-tiles. The wall timbers are of hewn oak, but the clasped-purlin roof with a ridge-board and nailed collars is of sawn softwood and is probably a late-19th century replacement of the original.

This building was evidently designed as the shelter of a cattle yard to the south of the barn, and until recently possessed a twin building to its east which served a second, adjacent yard. Its form and structure, with boarded walls and triangular rails, is typical of the region. The building, like the brick barn (2), it is likely to have been constructed in response to the diversification of local agriculture from cereal production into animal husbandry shortly before the tithe survey of 1837 upon which it appears.

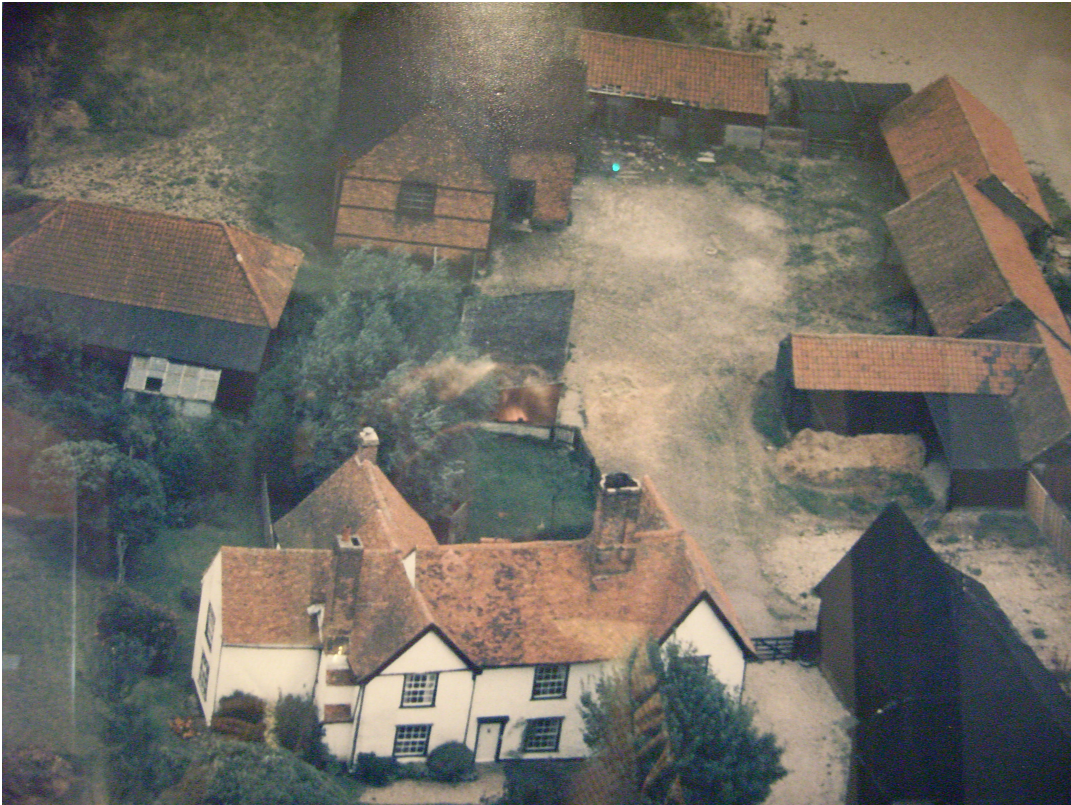
A2.1 Aerial view of site from west taken *circa* 1975 showing the farmhouse prior to restoration (with its original chimney, lacking any obvious initials or date) and several additional farm buildings now demolished. Buildings 1, 2 and 3 are visible from left to right. (photo in possession of current owner)

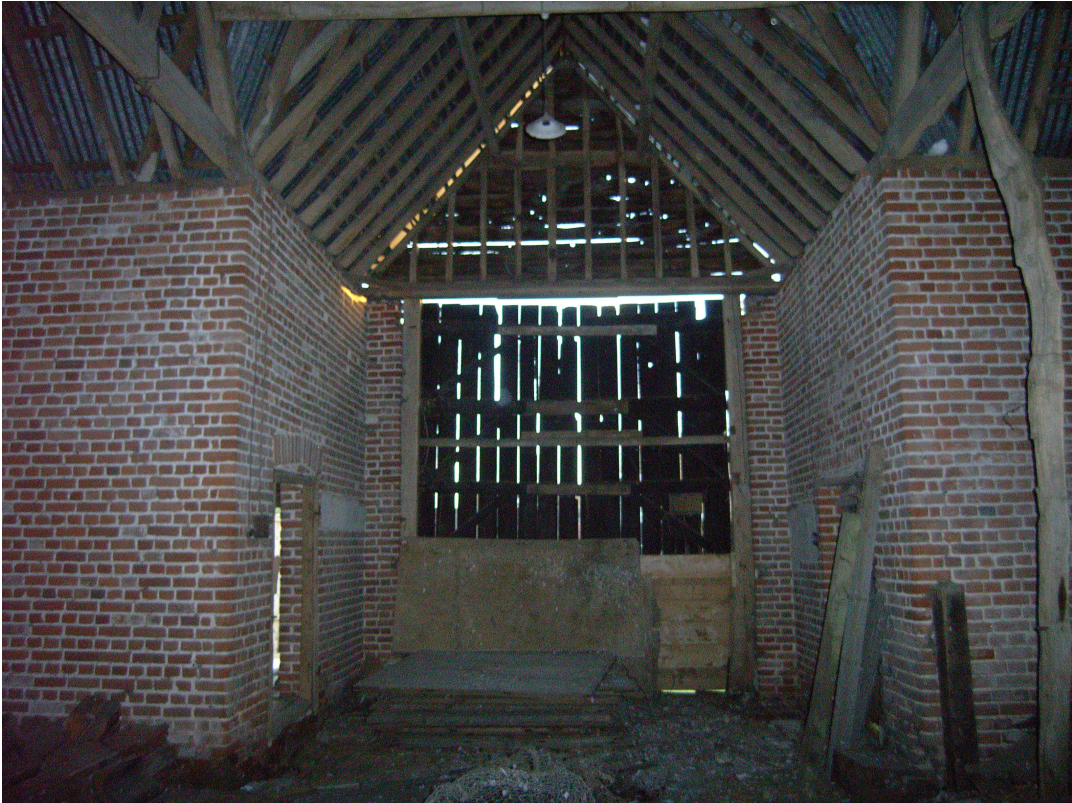
A2.11 Barn (2). Interior looking south to porch in elevation H-G, with doors to granary (left) and exterior (right) in its respective side walls.

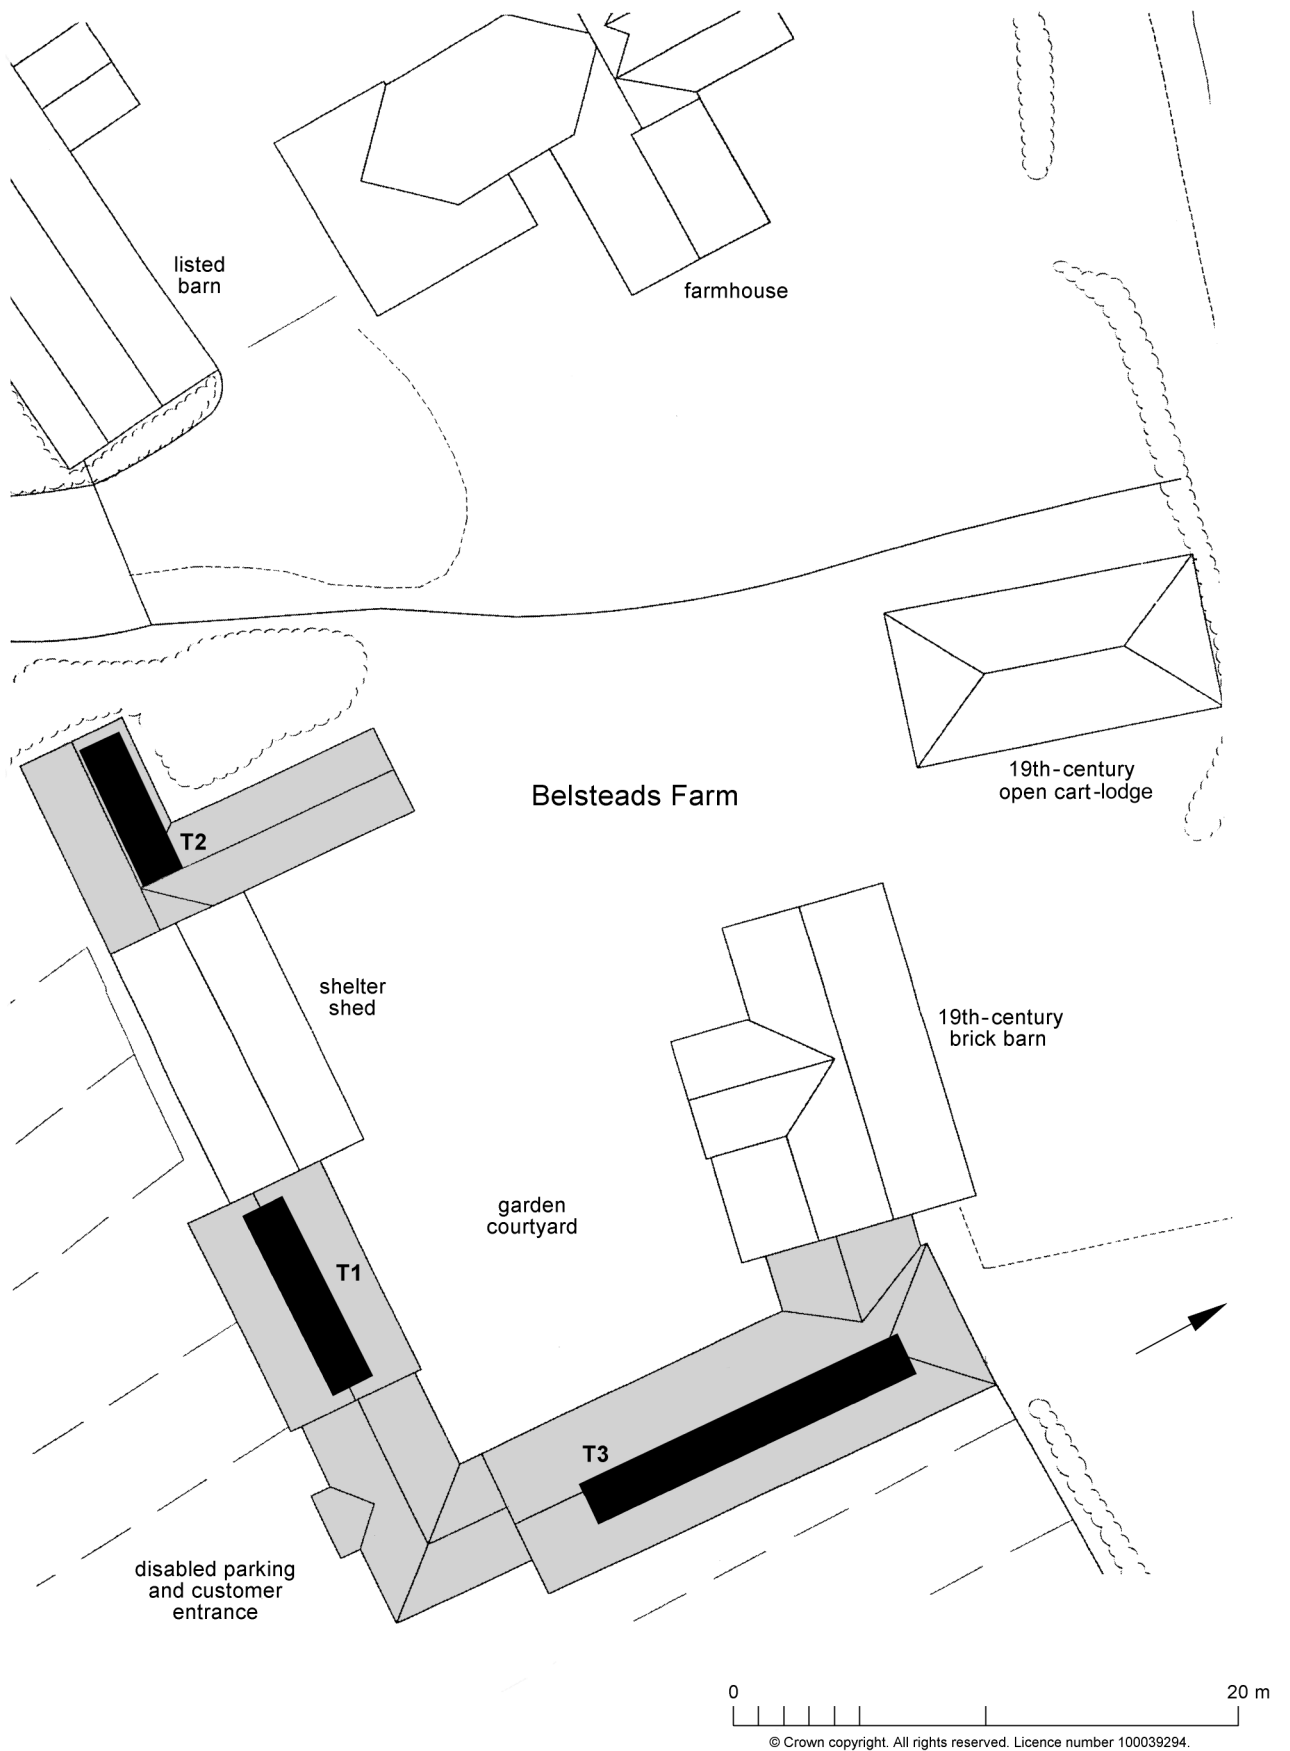
- 7.2** Three evaluation trenches were excavated (ie T1-T3; trench plan shown on Fig 9), to a total length of 28m. All were located within what was a gravelled car-park. All were excavated under archaeological supervision using a 360-degree mechanical excavator fitted with a toothless ditching bucket. The three trenches ranged in size from T1 (8m by 1.8m), and T2 (6m by 1.8m), to T3 (14m by 1.8m).

Fig 9 Location of trenches. (Proposed buildings are shaded.)
