Historic building recording at Glencoe and Sunnyside, Severalls Hospital, Tower Lane, Colchester, CO4 6DF

June 2020

CAT project ref.: 2020/021
NGR: TL 99216 28807 (c)
CHER number: ECC4442
OASIS project id: colchest3-386741

CAT Report 1589
August 2020

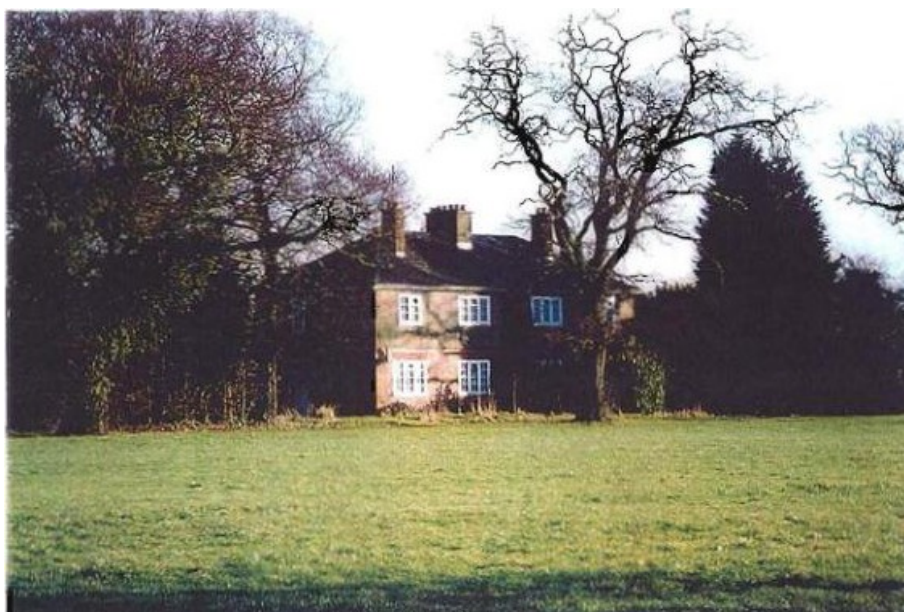
A photograph of Glencoe and Sunnyside taken from a historic building assessment of Severalls undertaken before its redevelopment (Ingram Consultancy 2001), shows the building in much the same state as it is today, albeit with less overgrowth in front (Photograph 1).

Photograph 1 Glencoe and Sunnyside in 2001. Taken from Ingrams Consultancy 2001. Photograph taken facing north-east.

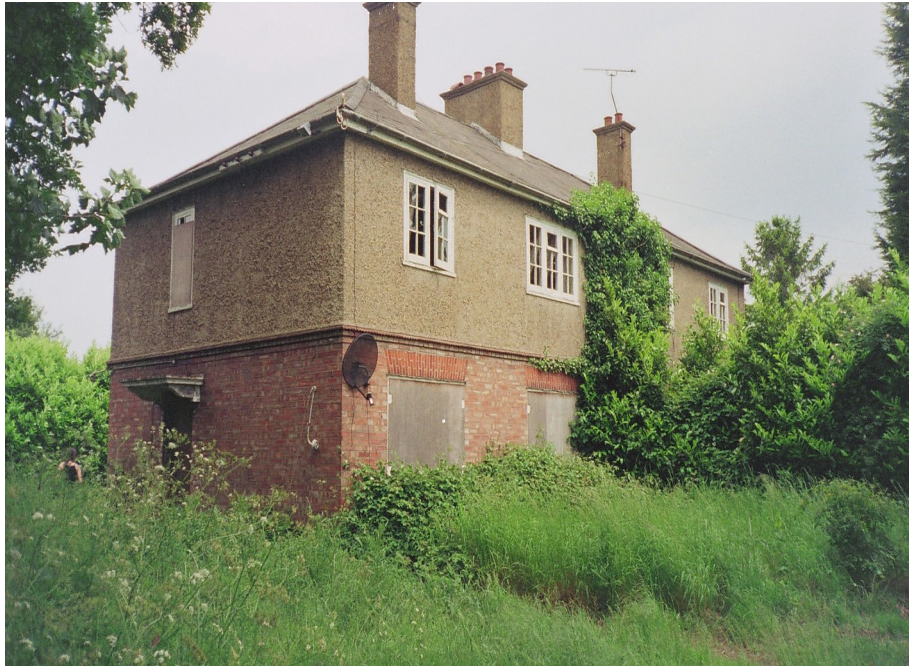
A summary of the Severalls site on www.countyasylums.co.uk includes photographs of Glencoe and Sunnyside, and describes the building as “Engineers Cottages”. A selection of these photographs are reproduced below (Photographs 2-4). Although undated, these photographs show the building in a significantly better state of preservation than seen during the survey for this report (see descriptive record below).

Photograph 2 Glencoe and Sunnyside after closure of Severalls, mid 2000s?. Taken from www.countyasylums.co.uk.

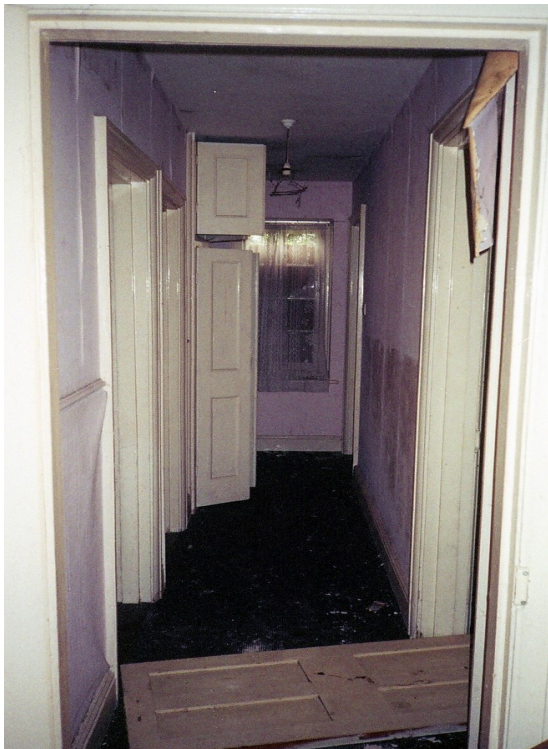
Photograph 3 Interior of building, showing first-floor corridor 12b. Photograph taken facing south-east. Taken from www.countyasylums.co.uk.

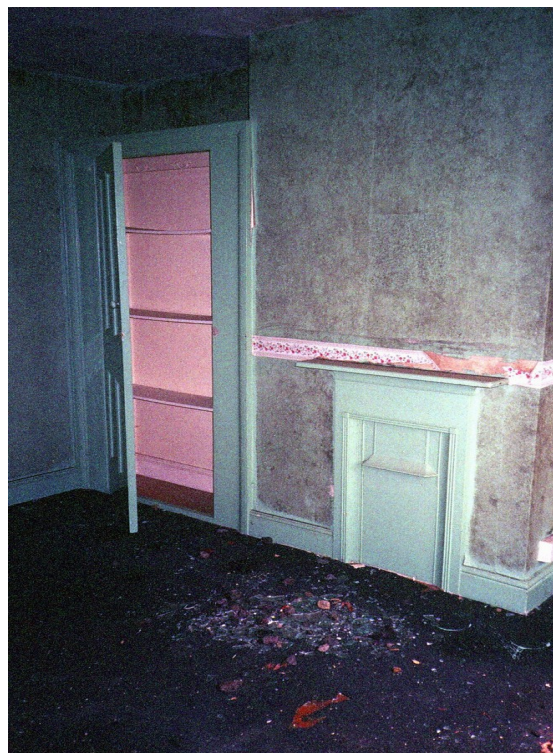
Photograph 4 Interior of building, showing first-floor room 8a. Photograph taken facing east. Taken from www.countyasylums.co.uk.

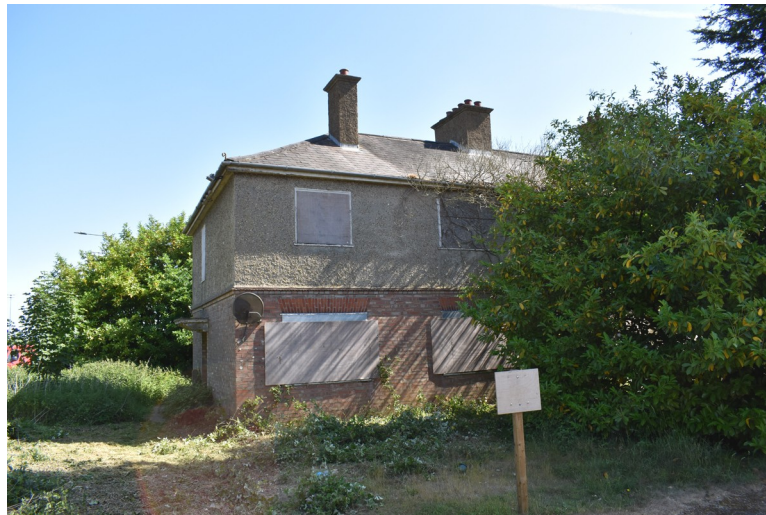
The building has a hipped roof, covered in slate tiles (Photograph 5). Three chimneys project from the building's ridge-line, corresponding with internal fireplaces (Figs 4-5). The brickwork of the building is constructed of red bricks laid in stretcher bond with dimensions of 224mm x 68mm x 109mm.

Photograph 5 South-west elevation of building. Photograph taken facing north-east.

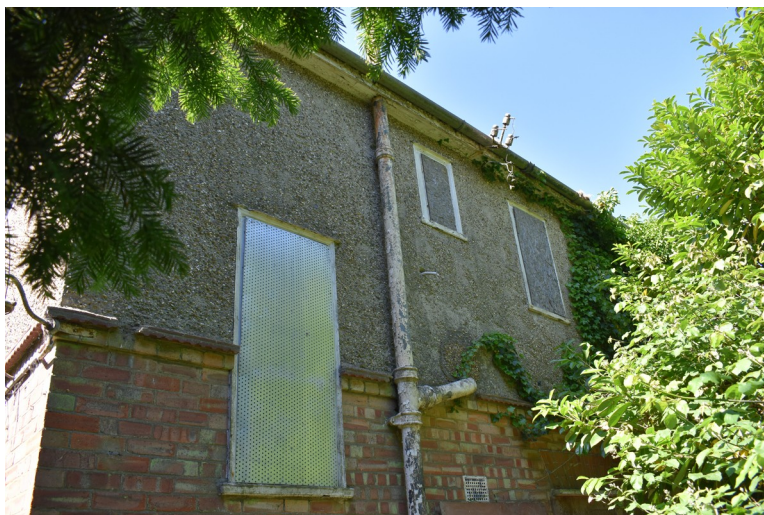
The north-east elevation of the building has ten windows, all of which are a mix of casements and awnings (Fig 5, Photograph 7). The first-floor has, symmetrically placed, two 11-light windows, two six-light windows and two single-light windows (Fig 5). At the eastern and western ends of the building, lighting the interior stairwells (see interior description below), are two windows midway between the ground and first-floors (Fig 5). These windows were completely boarded up externally and internally, so their number of lights and type could not be determined (Photograph 7). The ground-floor of this elevation has two symmetrical four-light windows and two doorways (although no doors survive).

Photograph 7 North-east elevation of building (eastern side).
Photograph taken facing south-west.

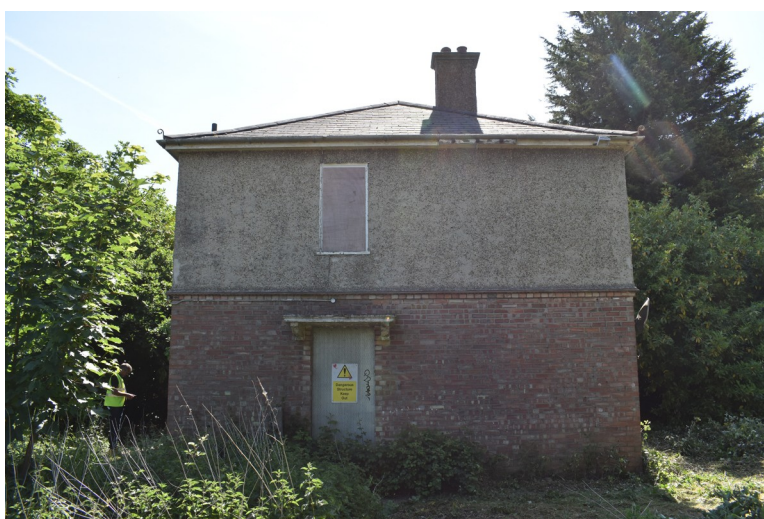
The north-west elevation is a mirror of the south-east, with the same window and door arrangement (Photograph 8).

Photograph 8 North-west elevation of building. Photograph taken facing south-east.

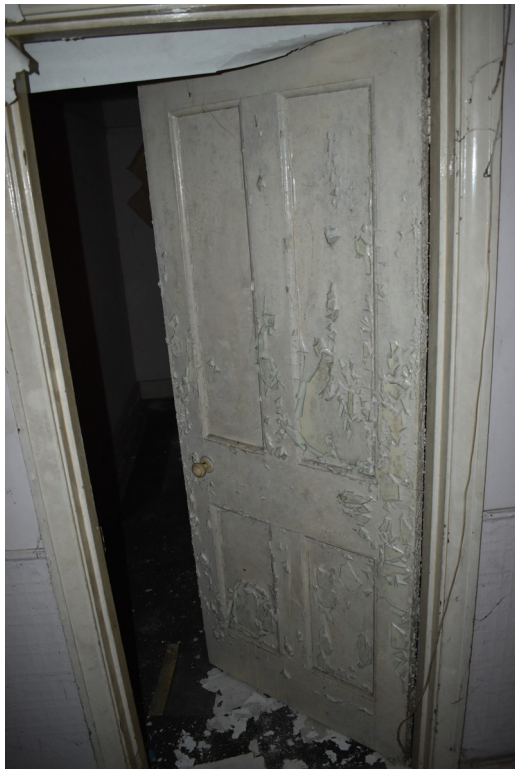
Photograph 9 Example of original door with bakelite handle, leading into room 2b. Photograph taken facing south-west.

All the surviving original internal doors are constructed of four-panels and have bakelite handles (Photograph 9).

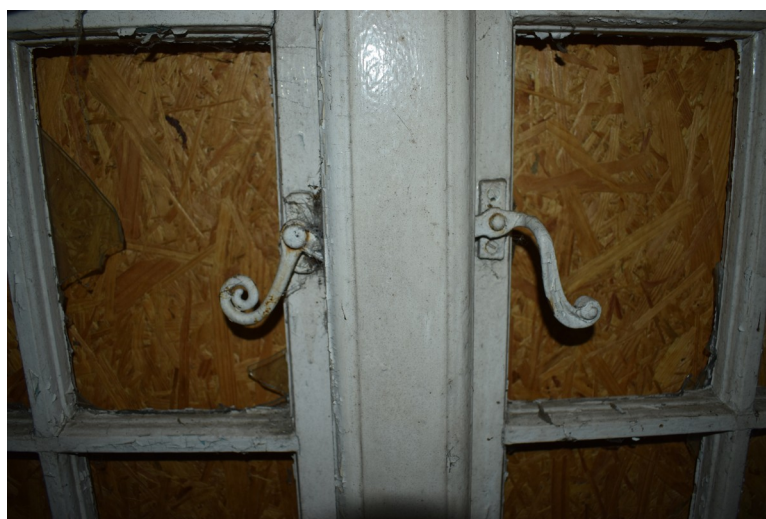
Photograph 10 Detail of spiral handles on windows in room 1a. Photograph taken facing south-west.

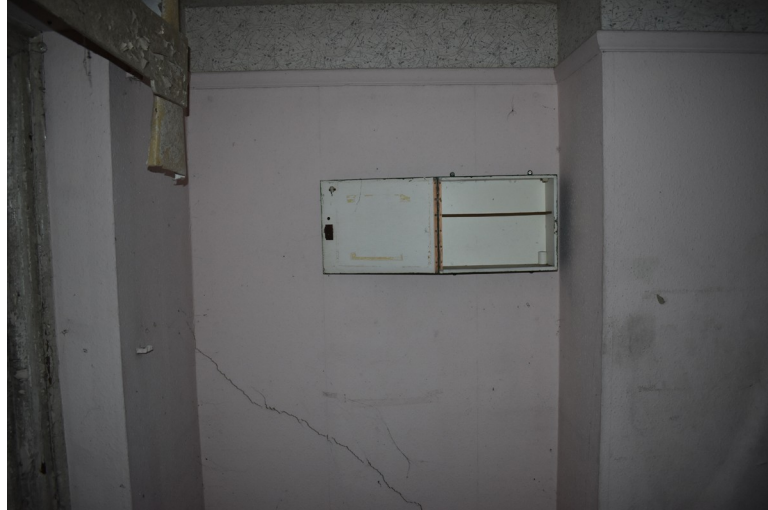
Photograph 13 Detail of medicine cabinet in room 2b. Photograph taken facing north-west.

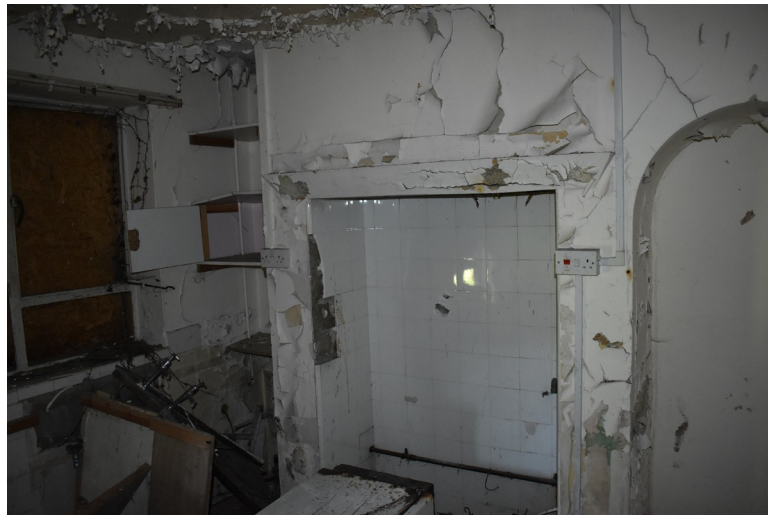
This room is 3m x 2.5m in size and has a large tiled alcove on its eastern wall, alongside a deep arched alcove and a series of shelves (Photograph 14). The tiled alcove seems to have originally been the location of a cooking range that was vented to the central chimney-breast above. The arched alcove's purpose is unclear; it may have originally been for storage, or may have joined with the arch in room 3b to form an access point between the two properties. It is undoubtedly arched to support the fireplace above, in room 9a (Fig 2). Room 3b is identical, but has a medicine cabinet in its north-east corner and has had part of its eastern wall removed, providing access into room 5b (Fig 2). Room 3b also has a surviving stoking hole in the chimney-breast above the tiled alcove (Photograph 15). Both rooms have vinyl flooring.

Photograph 14 Room 3a, showing tiled alcove, arch and shelving. Photograph taken facing east.

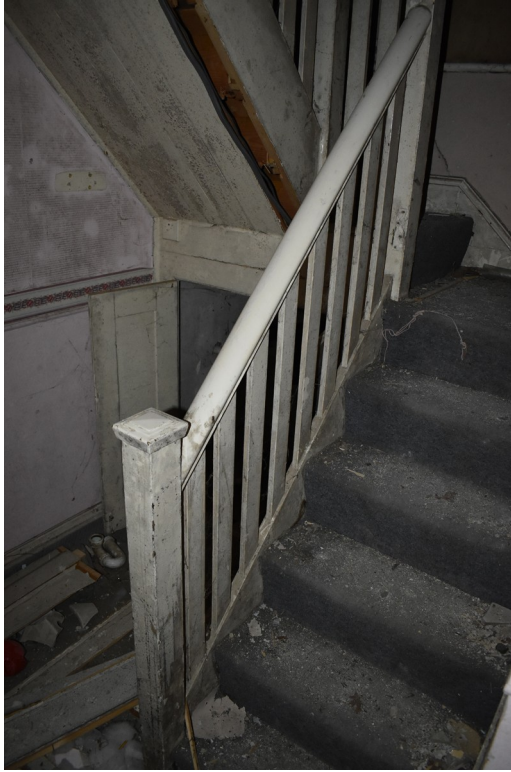
Photograph 16 Detail of staircase leading up to first-floor in room 4a. Photograph taken facing north.

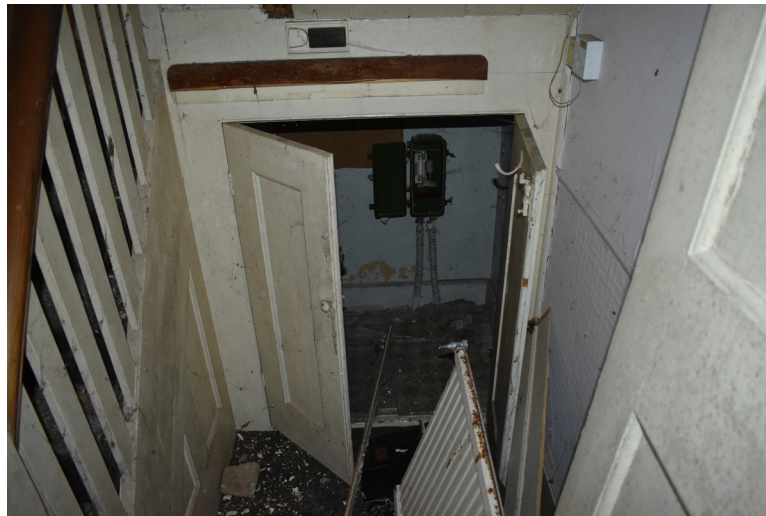
Photograph 17 Detail of cupboard underneath stairs in room 4b. Photograph taken facing north-east.

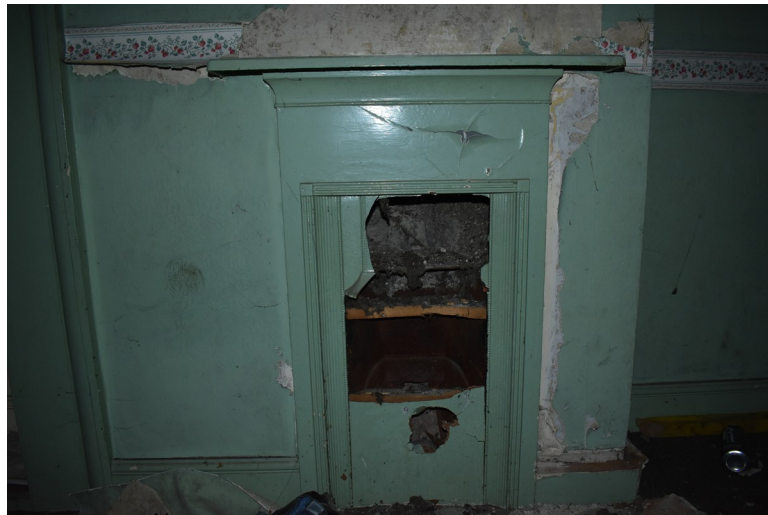
This room is directly above room 2a and is the same size: 3.5m x 3m. The room has a chimney-breast on its eastern wall containing a small off-centre fireplace with a narrow fluted surround and a mantelshelf above. This fireplace is identical to the one in room 7a but has suffered significantly more damage (Photograph 21). Again, like room 7a, to the north of the chimney-breast is an original cupboard with a four-panelled door. Room 8b's fireplace has been blocked (Fig 3).

Photograph 21 Detail of fireplace in chimney-breast of room 8a. Photograph taken facing south-east.

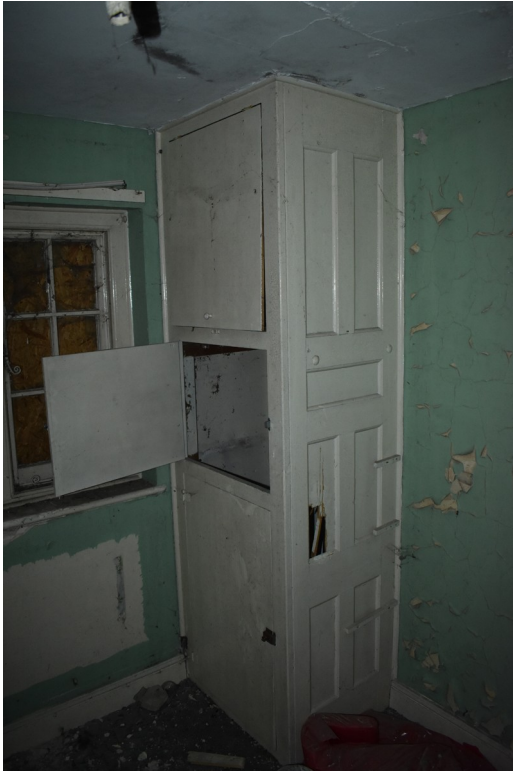
Photograph 22 Original cupboard in room 9a, with modern doors. Photograph taken facing east.

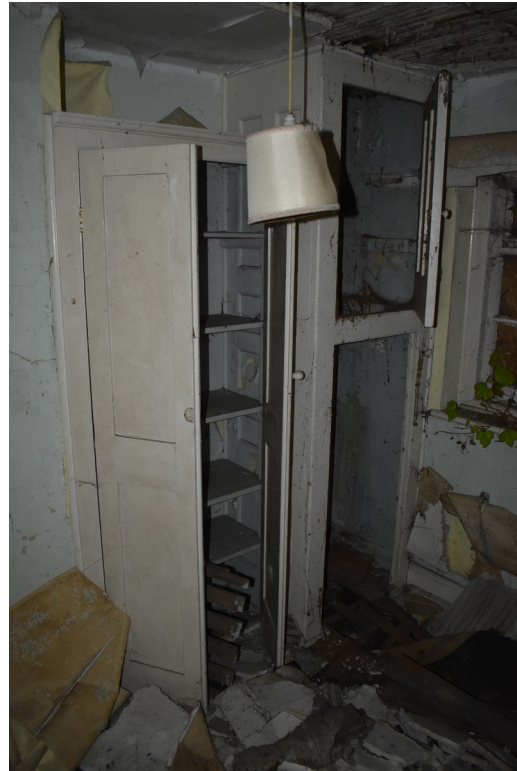
Photograph 23 Original cupboard in room 9b (right), with inserted cupboard alongside (left). Photograph taken facing north.

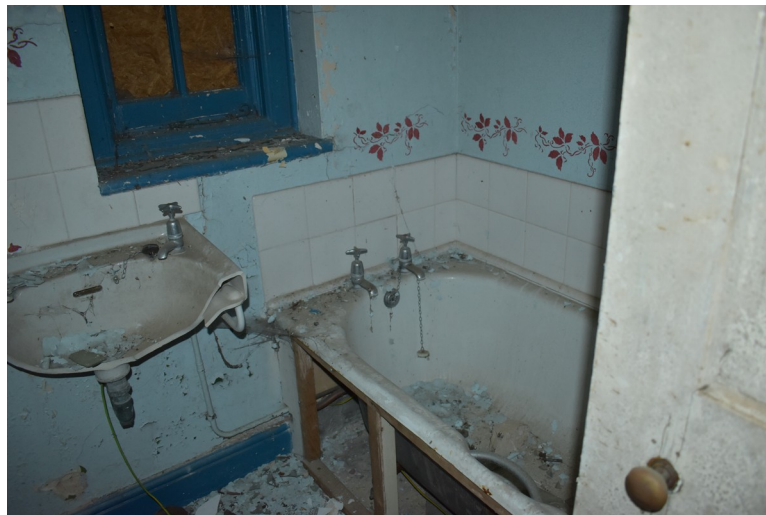
This room is 1.9m x 1.5m in size and is currently partially tiled and contains modern bathroom fittings, including a bath and a wash basin (Photograph 24). The fittings on the bath and basin vary between room 10a and room 10b, but the bathtubs themselves could be original to the building.

Photograph 24 Room 10a, showing bath and basin. Photograph taken facing east.

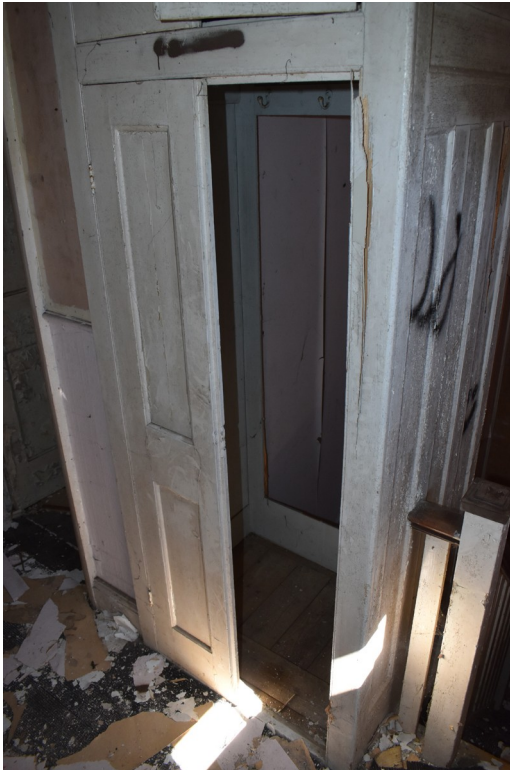
Photograph 25 Original cupboard at top of staircase in room 12b. Photograph taken facing north.

This is a corridor and stairwell, measuring 4.5 long and 0.9m wide, connecting all the rooms on the first-floor with the staircase (Fig 3). On the landing at the top of the staircase is an original cupboard with panelled doors and sides. The example in room 12a is missing most of its sides and doors, but the example in 12b is more intact (Photograph 25).
