**Historic building recording at the
former Great Wigborough Village Hall,
School Lane, Great Wigborough, Essex
CO5 7RJ**

June 2020

CAT project ref.: 2020/05h
NGR: TL 96688 15291 (c)
CHER number: ECC4524
OASIS project id: colchest3-395321

CAT Report 1594
September 2020

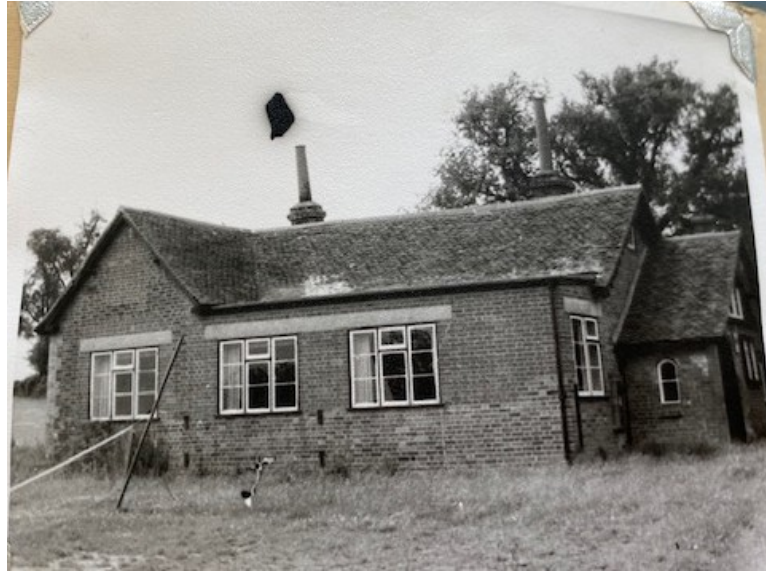
Photograph 5 South-east elevation of the building, taken sometime between 1950-1975. Photograph taken facing north-west. ERO D/DU 1464/42.

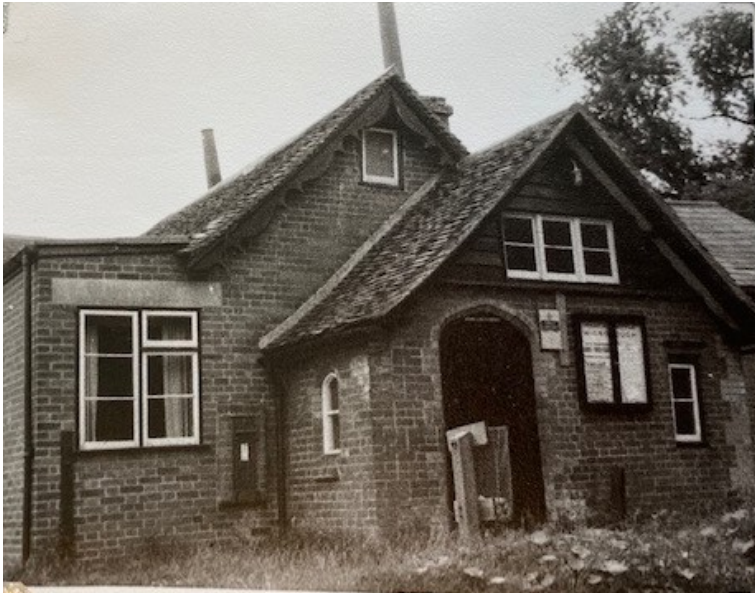
Photograph 6 North-east elevation of the building, taken sometime between 1950-1975. Postbox visible to left of porch. Photograph taken facing west. ERO D/DU 1464/42.

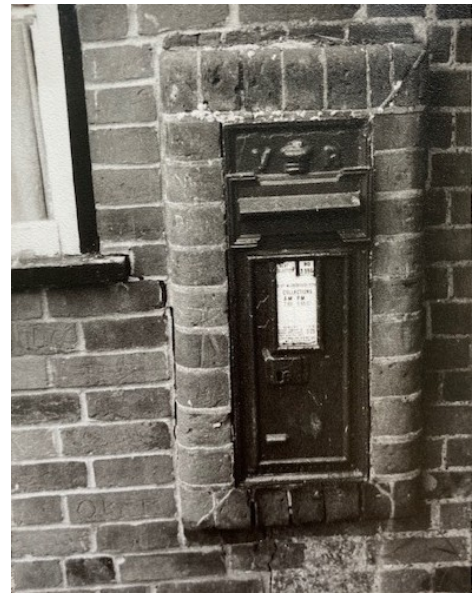
Photograph 7 Detail of postbox on north-east elevation of building, taken sometime between 1950-1975. Photograph taken facing south-west. ERO D/DU 1464/42.

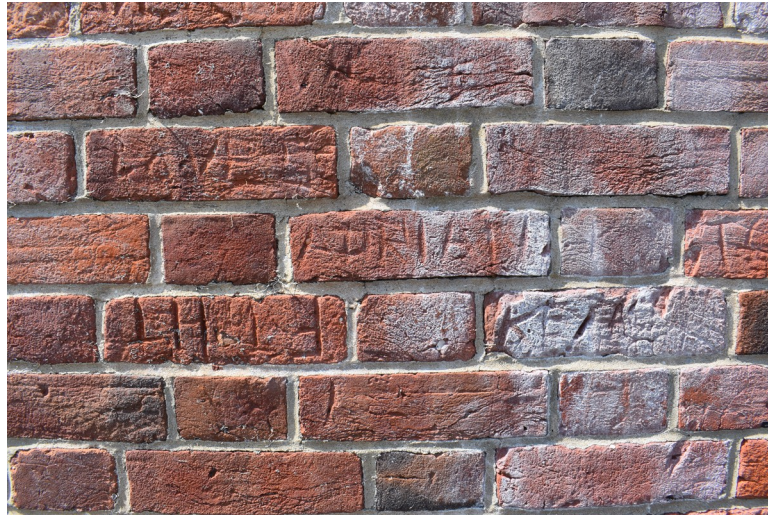
Also visible on this elevation is a series of graffiti marks on the brickwork, consisting of initials and several names (Photograph 9). Whether these are a result of the building's history as a school and were carved into the brickwork by former pupils is uncertain, but it is certainly a possibility.

Photograph 9 Example of graffiti on south-east elevation of building. Photograph taken facing north-west.

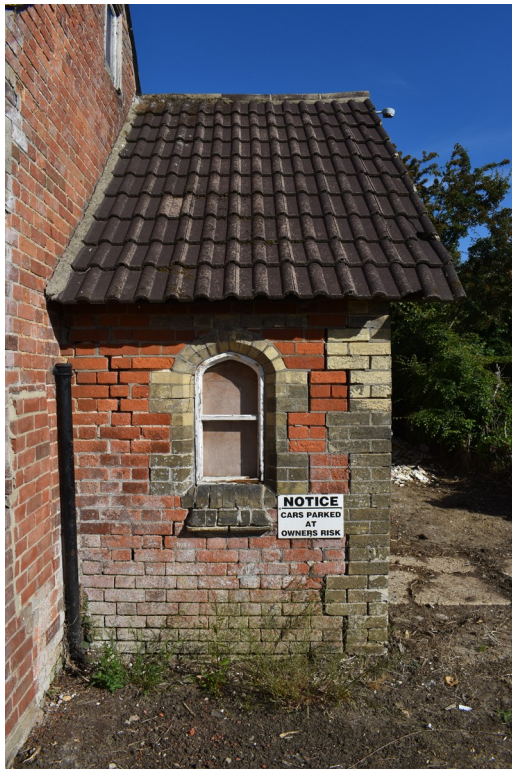
This elevation of the porch extension has a small two-light fixed window, with a moulded yellow brick surround (Photograph 10).

Photograph 10 South-east elevation of porch extension, showing small fixed window. Photograph taken facing north-west.

The external corners of the porch extension are also highlighted with yellow bricks (Photograph 10).

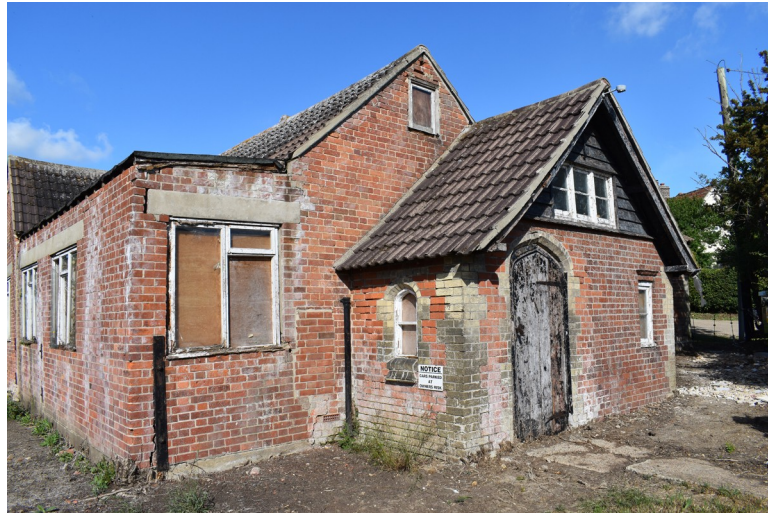
Photograph 11 North-east and south-east elevation of building. Note postbox visible in earlier photographs has been removed. Photograph taken facing west.

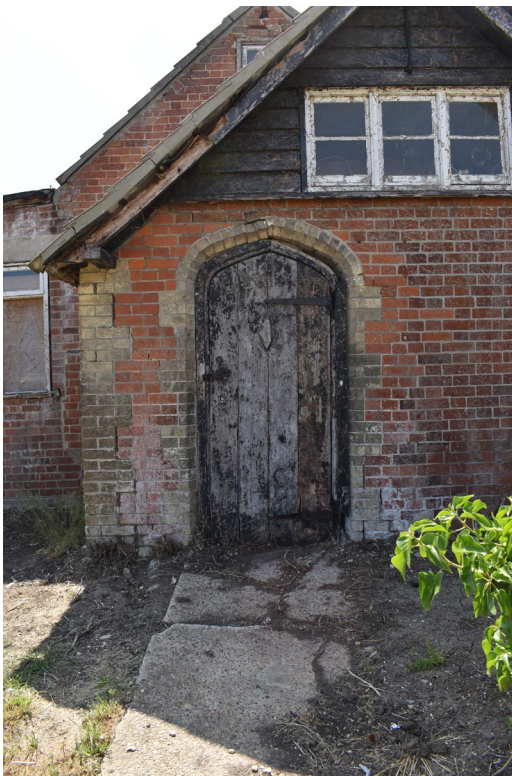
Also on this elevation of the porch extension is a large plank and batten door, constructed of four vertical-planks and with a plain iron latch and hinges. Like the corners of the porch extension and the window on its south-east elevation, the door has a moulded yellow brick surround (Photograph 12).

Photograph 12 Detail of door on north-east elevation of porch extension. Photograph taken facing south-west.

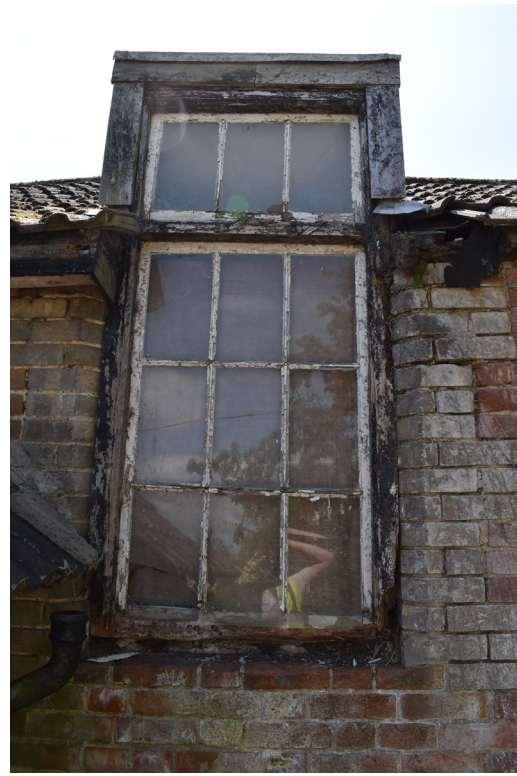
The north-west/south-east range on this elevation has a tall twelve-light fixed/awning window that projects upwards into a flat-roofed dormer on the roof pitch (Photograph 13). Like other windows on this range of the building, it has a moulded yellow brick surround, although the moulded bricks continue below the current modern window; it appears that the lower section of the original window opening has been bricked-up when the modern window was inserted and the dormer added.

Photograph 13 Detail of dormer window on north-east elevation of original range. Photograph taken facing south-west.

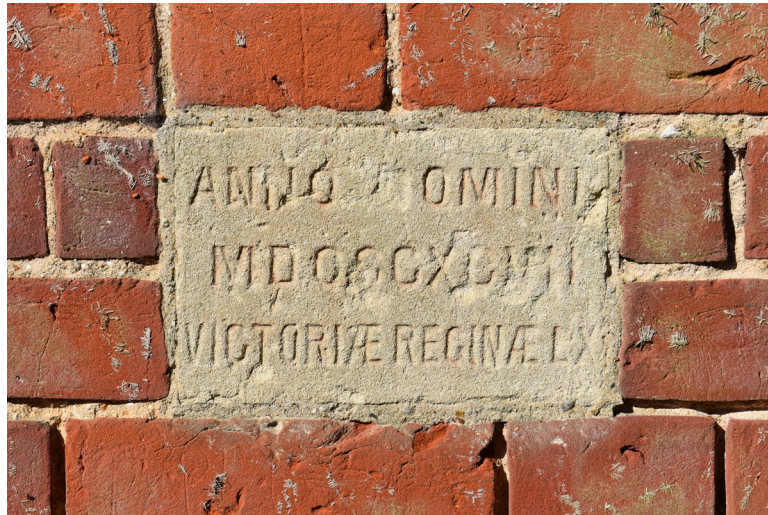
This inserted stone commemorates the Diamond Jubilee of Queen Victoria on the 22 June 1897. It may indicate that the building was renovated around this time, possibly with the addition of the porch extension (see historical background above).

Photograph 14 Detail of tablet stone on north-east elevation of main range, commemorating Queen Victoria's Diamond jubilee. Photograph taken facing south-west.

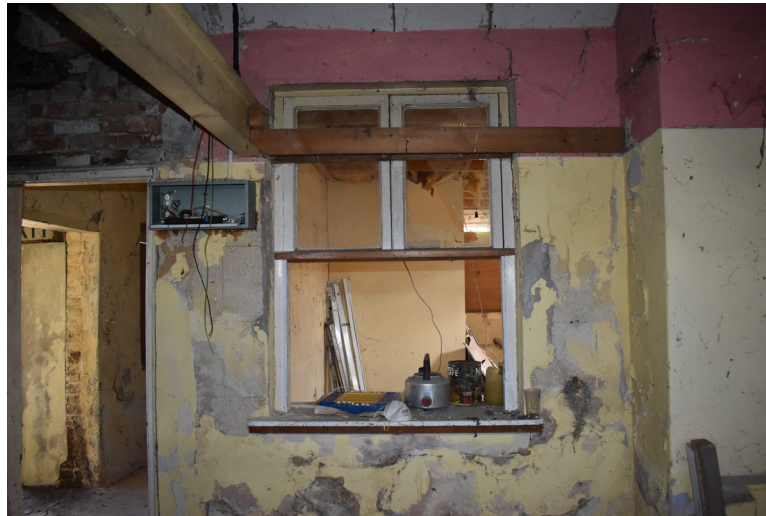
Also on the north-west elevation of this room, looking into the northern room is an adapted fixed two-light window, with a permanent opening in the bottom half (Photograph 18).

Photograph 18 Detail of internal window between southern and northern room in building. Photograph taken facing north-west.

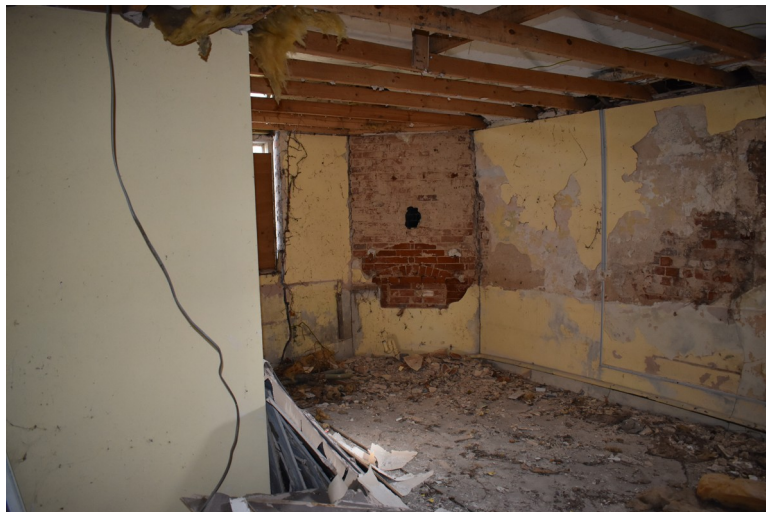
The northern room comprises the entirety of the northern range of the building, and measures 6m x 6.3m in size (Photograph 22). It is partially subdivided by a section of modern stud wall to form two bathrooms in its north-west corner (Fig 2). A section of original brick walling survives in the centre of the room that seems to be the remnants of a short corridor that lead to doorways into the northern and southern rooms (Fig 2). A short section of scarring on the floor at the end of this section of wall suggests it turned and joined the south-west wall of the northern room, presumably in the location of an original (since blocked) entrance into the building (Photograph 23).

Photograph 22 Northern room in building, with modern stud wall to left. Photograph taken facing north.

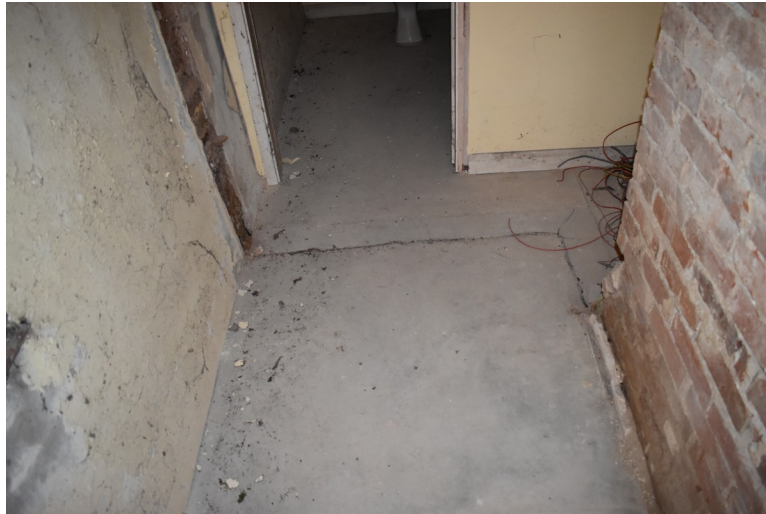
Photograph 23 Detail of scarring on floor of north room, showing location of original brick wall forming end of corridor. Location of original entrance into building to the left. Photograph taken facing north-west.

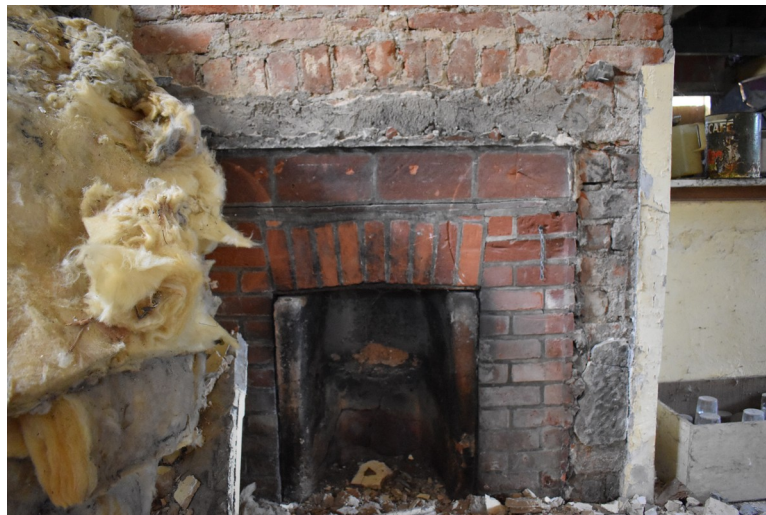
The floor of the northern room is rendered over with a concrete screed, but through the observation of damaged sections, it appears to be laid over floorboards. This room has a chimney-breast to the south-east, containing a modern fireplace. A sizeable amount of render has been removed from the brickwork of the chimney-breast, however, exposing the arch of the original fireplace above the modern insertion (Photograph 24). There is also a chimney-breast in the northern corner of the room. The fireplace is blocked, but again enough render has been removed to expose the original arch (Photograph 22).

Photograph 24 Detail of inserted fireplace in chimney-breast on south-east elevation of northern room. Arch of original fireplace visible above. Photograph taken facing south-east.

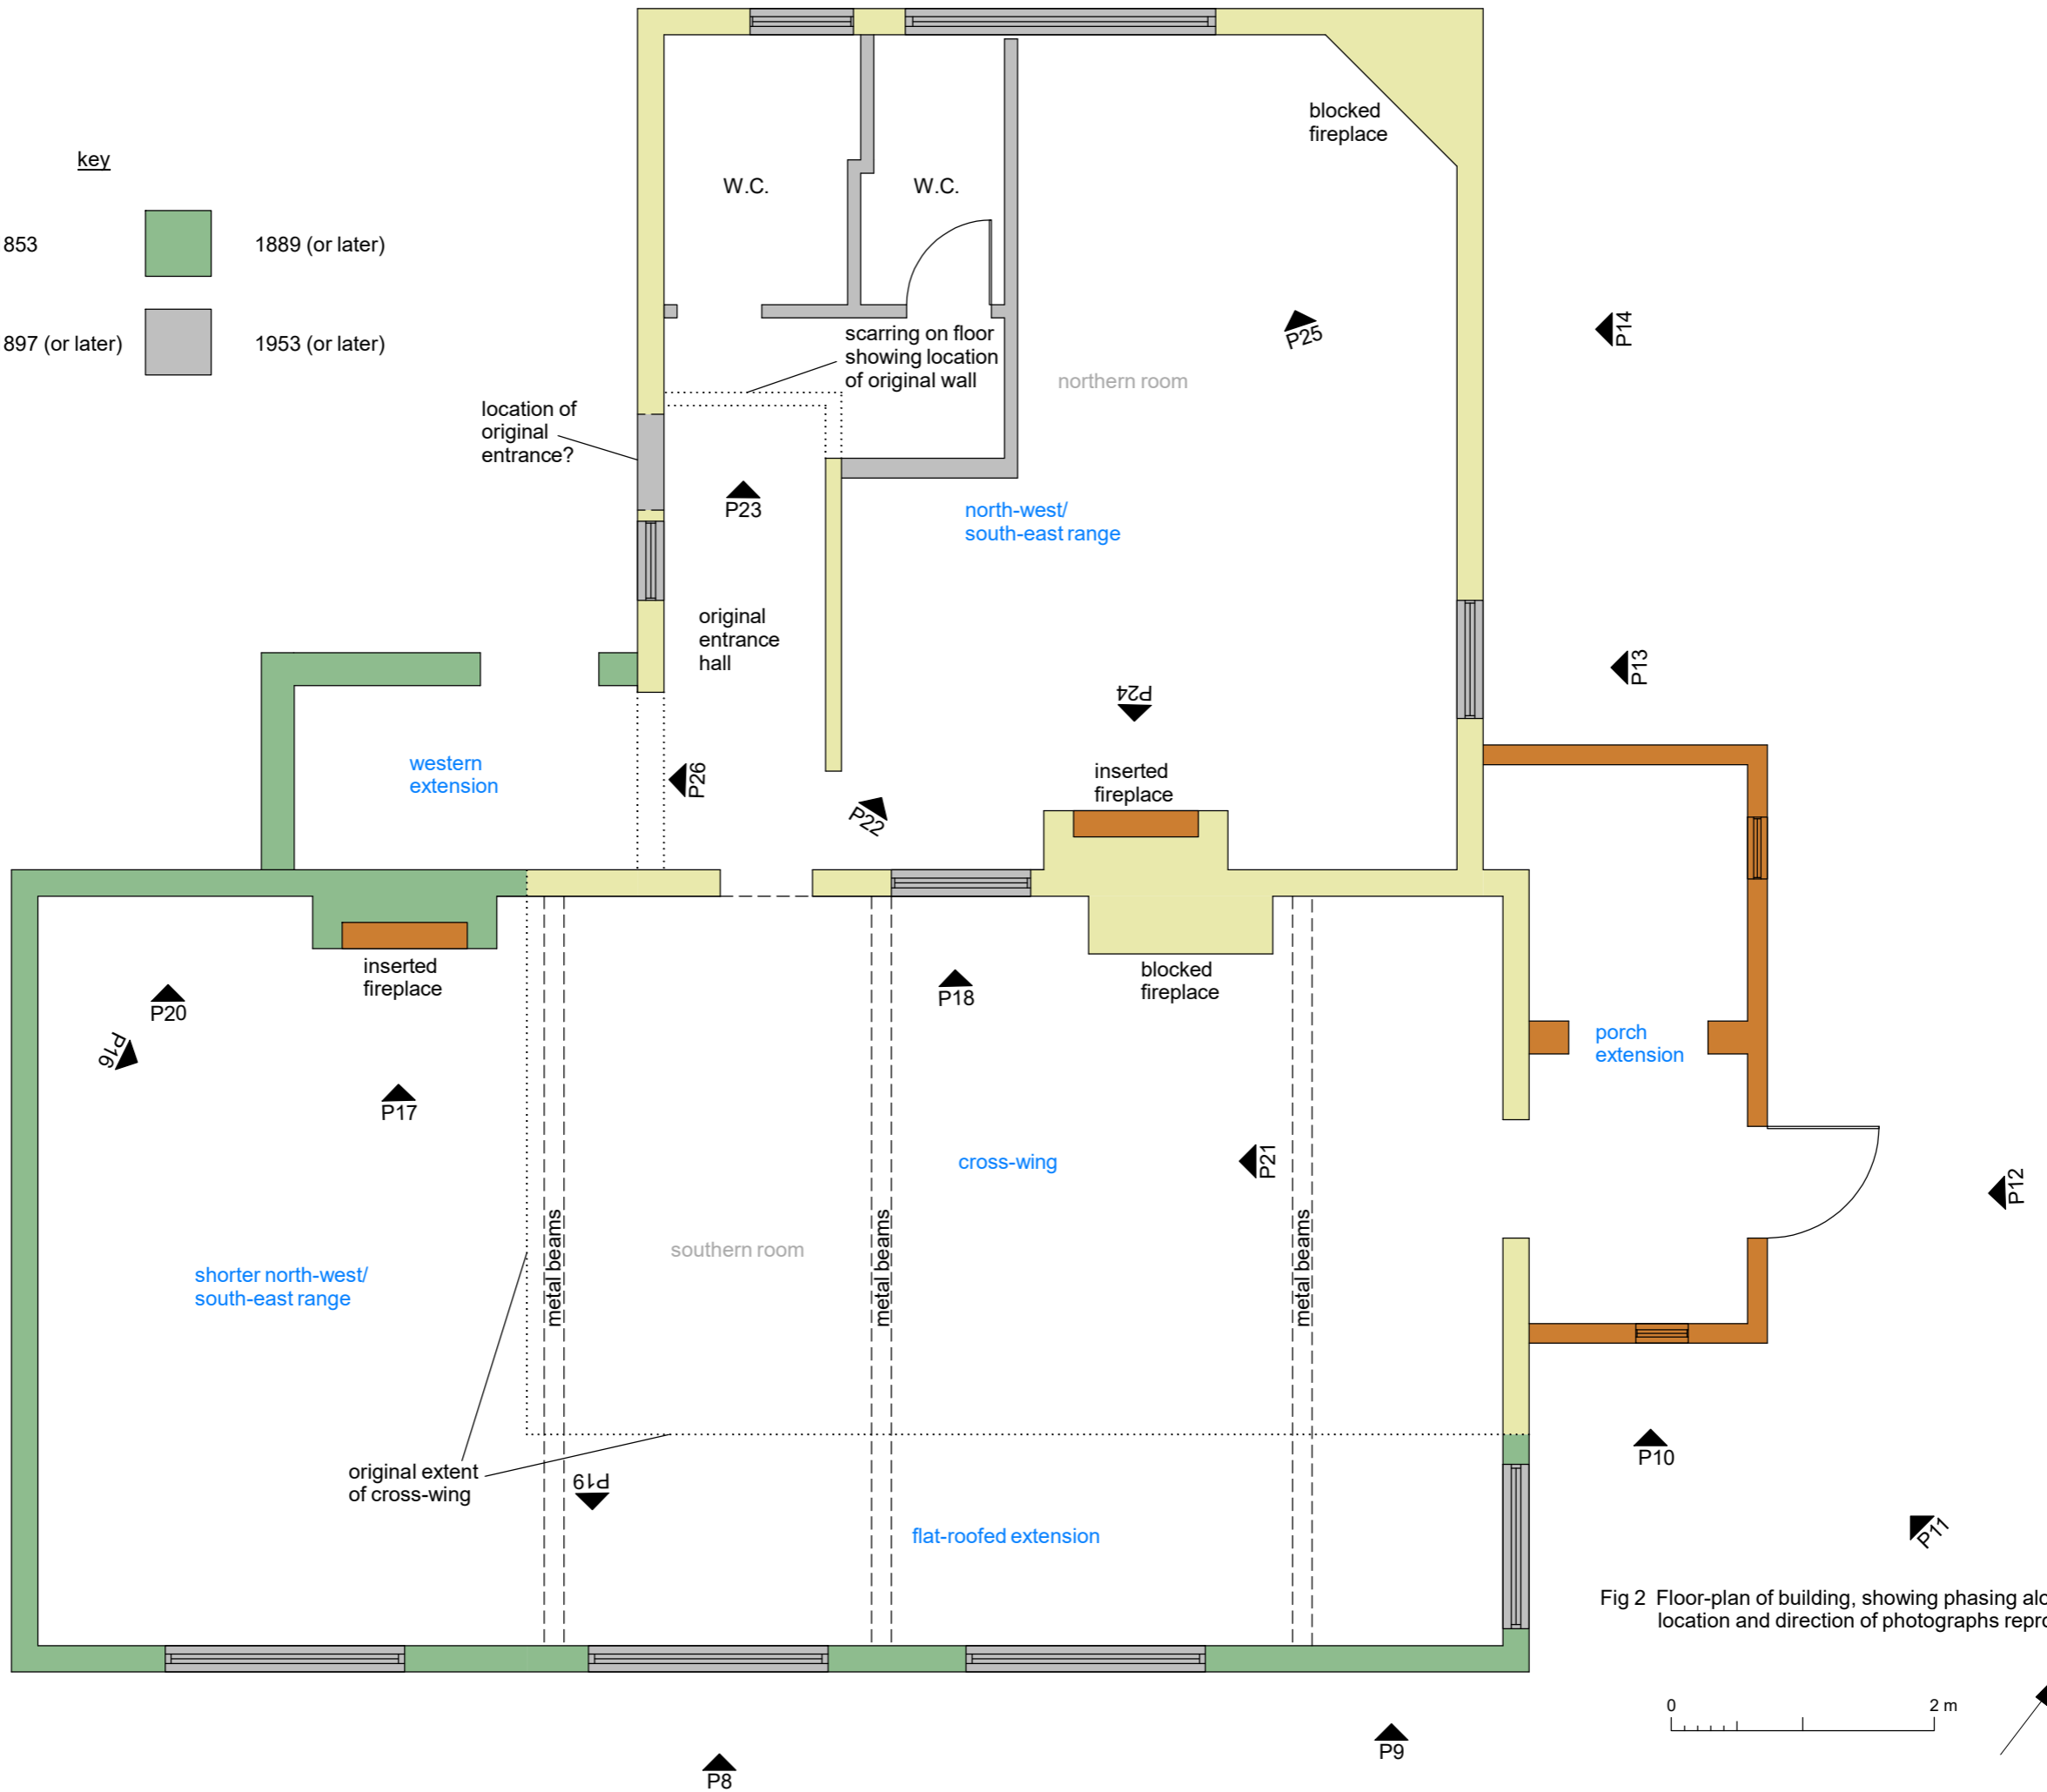
Fig 2 Floor-plan of building, showing phasing alongside location and direction of photographs reproduced in text.

The interior of the building is dominated by two large open rooms, one to the south and one to the north (Fig 2). Both of these rooms are the result of several phases of alteration and are examined below.

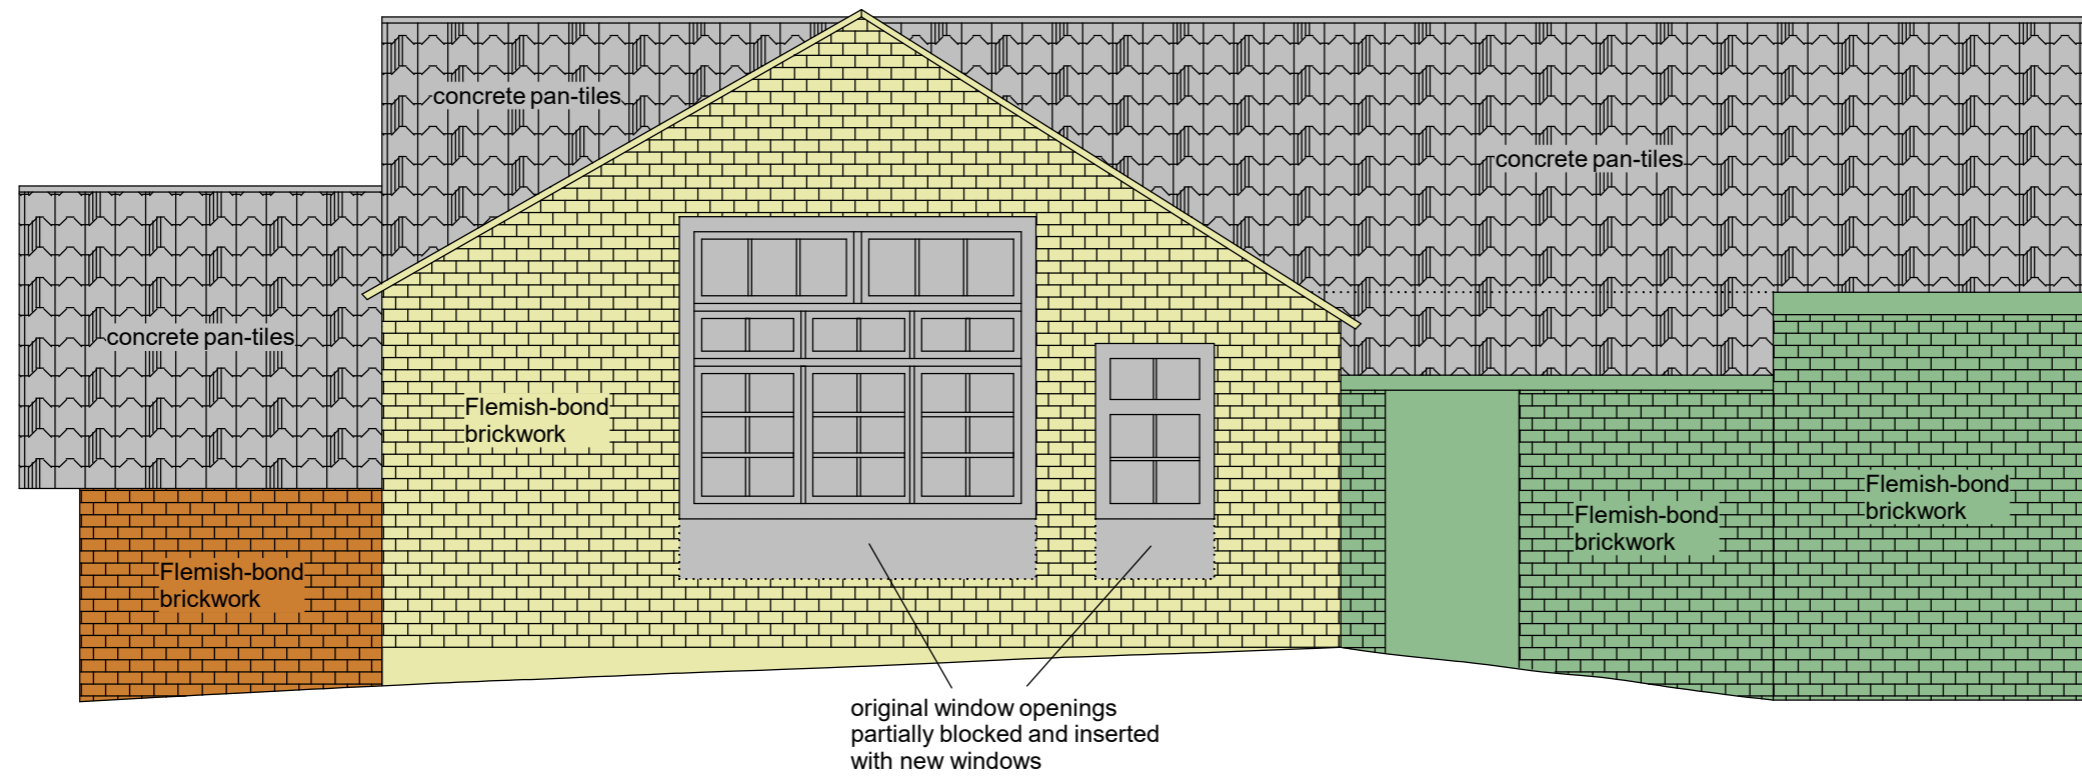
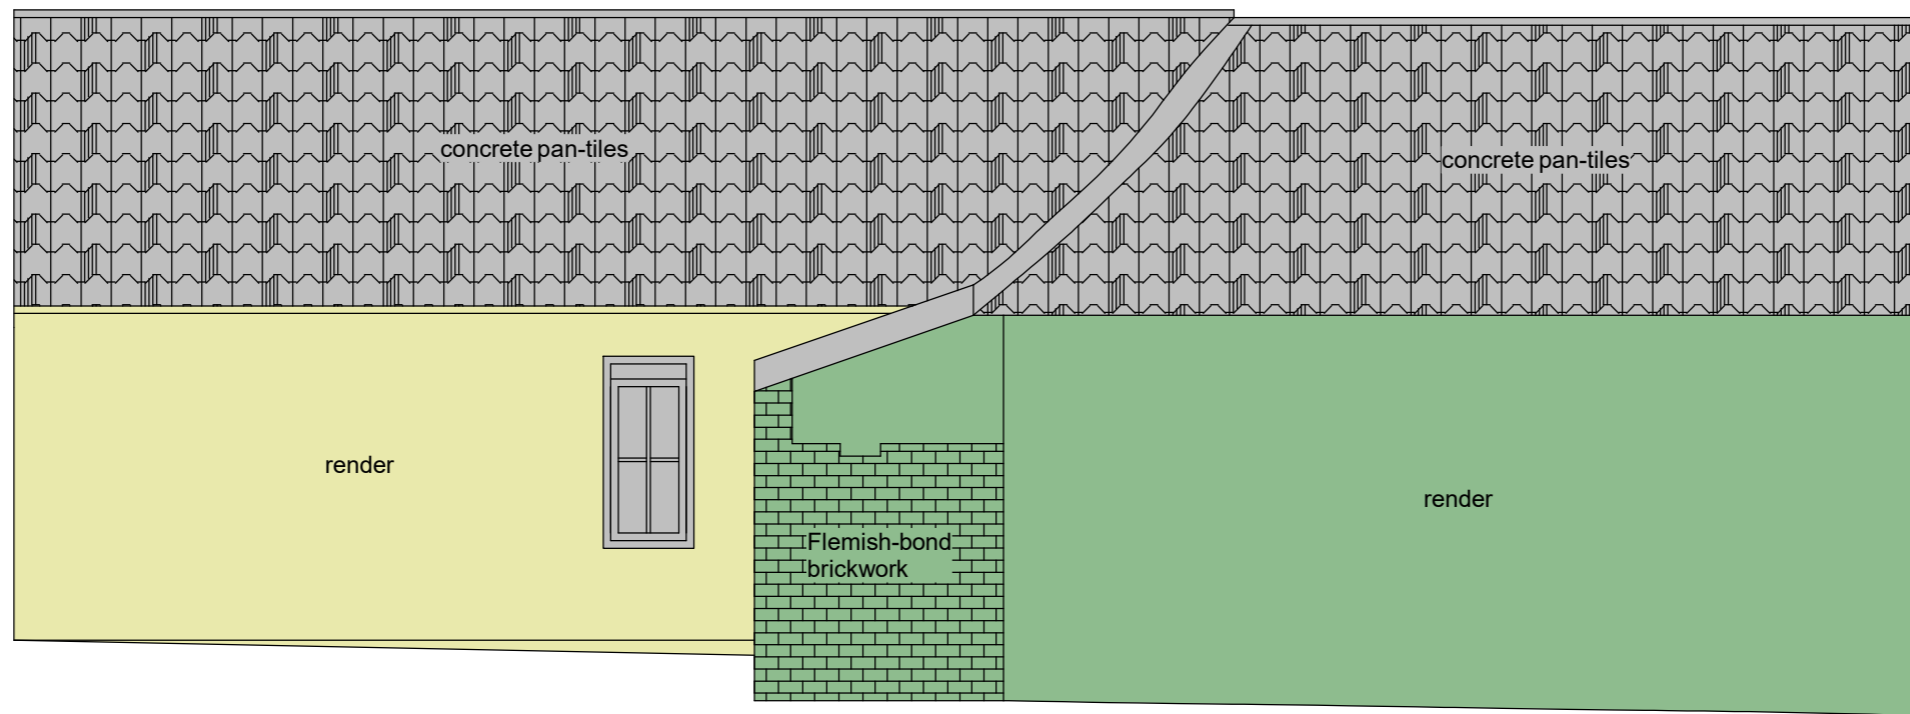
Fig 4 North-west and south-west elevations of building, with phasing.

The south-west elevation of the building is largely featureless apart from a single four-light fixed window on the northern range (Fig 4). In addition, the small western extension has a substantial amount of its brickwork missing from this elevation (Fig 4).
