**Historic building recording at
Princes Halfyards,
Stebbing Road, Felsted,
Essex CM6 3LG**

**report prepared by
Mark Baister**

CAT Report 1601
October 2020

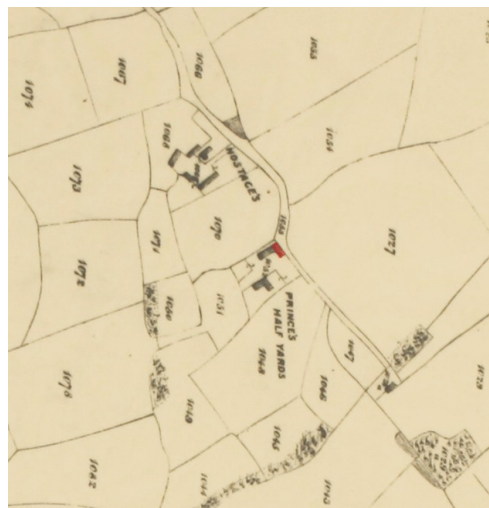
Map 2 1845 Felsted tithe map. Map has been rotated so that north is up.
Structure in location of current outbuilding highlighted in red. ERO D/CT 138B.

The 1845 tithe map (Map 2) shows the farmstead for the first time, including a structure in the location of the current outbuilding, on the same alignment. The tithe apportionment accompanying the map lists Prince's Halfyards farm as being owned by a Benjamin Grey and occupied by a John Harrison Jnr.

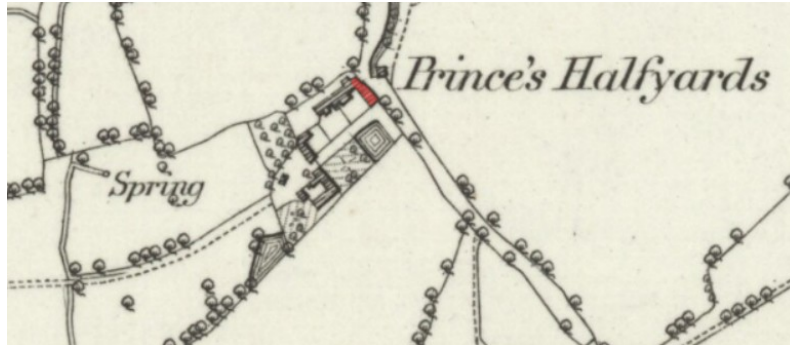
Map 3 1875 6-inch OS map. Outbuilding highlighted in red.

The first edition OS map of 1875 again shows the site in detail, with several additional buildings (Map 3). The outbuilding detailed in this report is clearly visible, and appears to have a larger footprint than the structure in this location on the tithe map, projecting further to the south-east and being narrower at its north-western end. This could indicate a period of rebuilding of the outbuilding between the tithe and first edition OS maps.

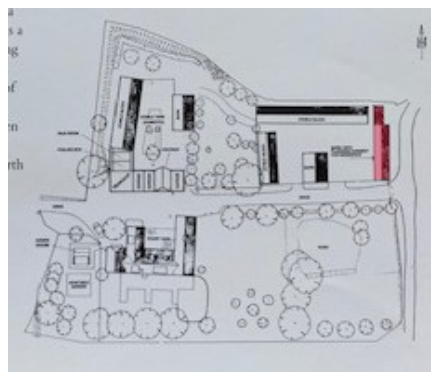
Map 7 Site plan included in the 1993 sales catalogue of Princes Halfyards (ERO SALE/D1640). Outbuilding detailed in this report shown free-standing and highlighted in red.

A sales catalogue two years later in 1993 (ERO SALE/D1640) details the site as much the same, but also includes a plan, showing that by this point the outbuilding was free-standing and the north-east/south-west range shown on earlier mapping had been demolished and replaced (Map 7).

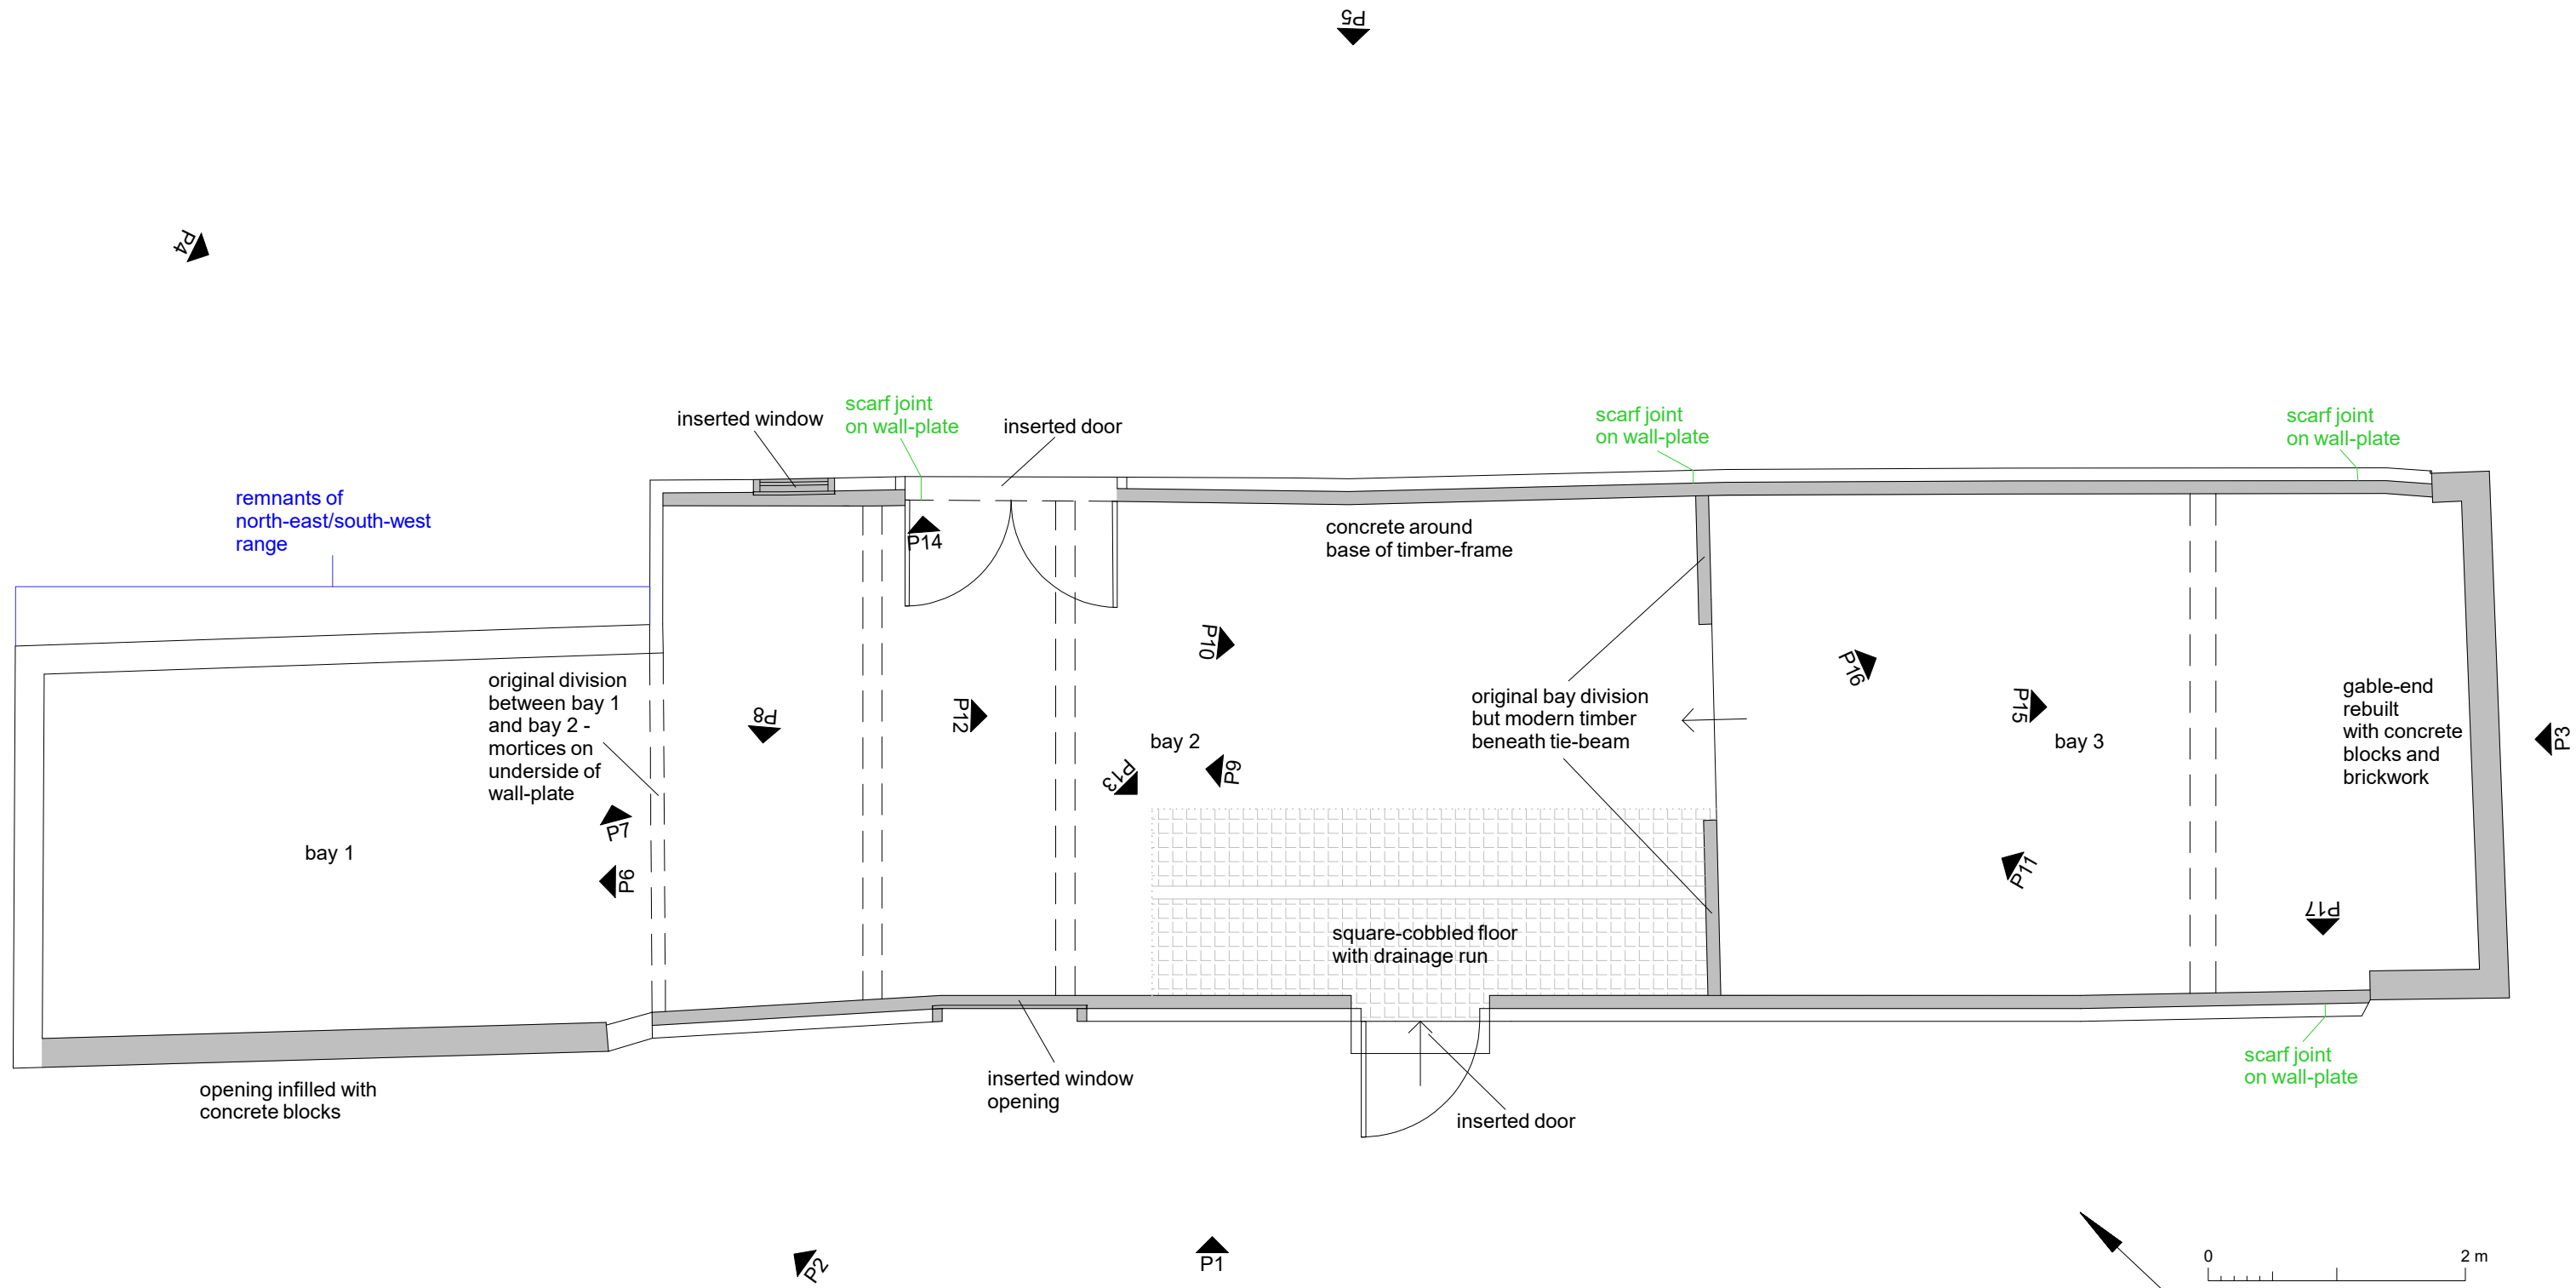
Fig 2 Ground-floor plan of outbuilding, with location and directions of photographs reproduced in text shown. Modern additions in grey.

Although, as discussed above, the northern element of this building clearly used to belong to a separate structure, for the ease of description the outbuilding has been divided into 3 bays, all of which vary in their construction methods (Fig 2).

Two scarf joints were observed on the wall-plates of this bay. One is above the double-door on the north-east elevation and, although partially obscured, appears to be a face-halved and bladed scarf with two edge-pegs (Photograph 14). The other scarf joint is just to the north of the tie-beam separating bays 2 and 3, and is a much more rudimentary edge-halved scarf with square abutments (Fig 2).

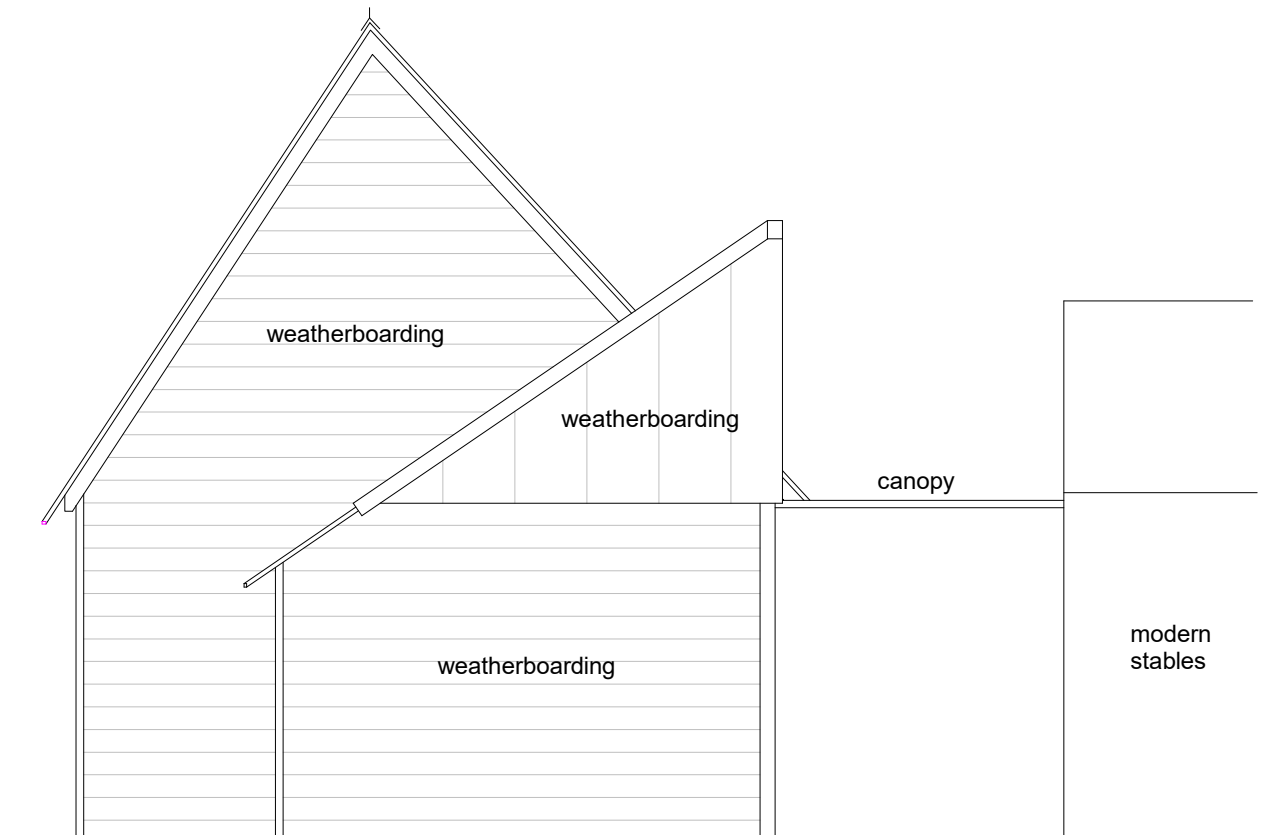
Fig 5 North-west and south-east elevations of outbuilding.

The north-west elevation of the outbuilding is largely obscured by overgrowth, but appears to be featureless (Photograph 4; Fig 5).
