**CAT Report 1934
issued May 2023**

**Historic building recording of two WWII-era huts at
Great Easton Manor, Dunmow Road, Great
Easton, Essex, CM6 2DL**

**CAT project ref.: 2023/03f
ECC code: GEAGE23**

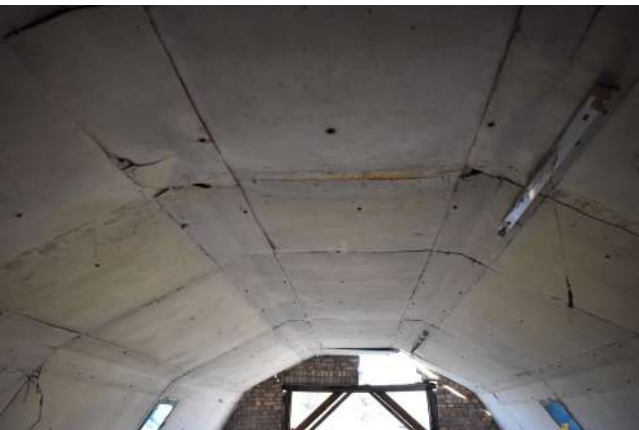
GEAGE23_PhotoGraph_026.JPG Detail of roof of the handcraft hut. Photograph taken facing north-east.

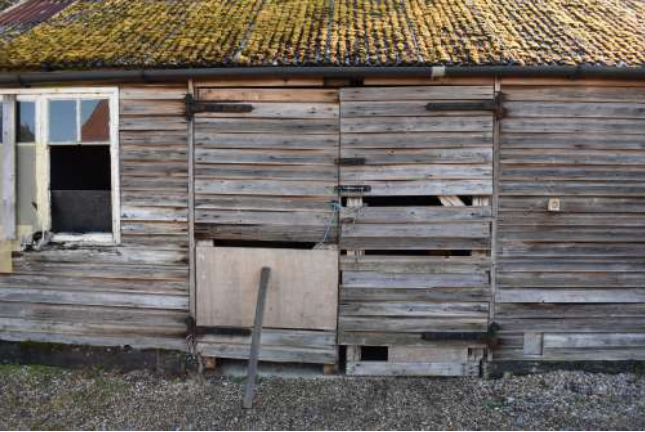
The western elevation is clad in weatherboard. There are two twelve-light casement windows, one at each end of the elevation, and a set of double timber doors which are offset from the centre. The doors and windows are all replacement.

GEAGE23_PhotoGraph_028.JPG Western elevation of the sectional timber hut. Photograph taken facing north-east.

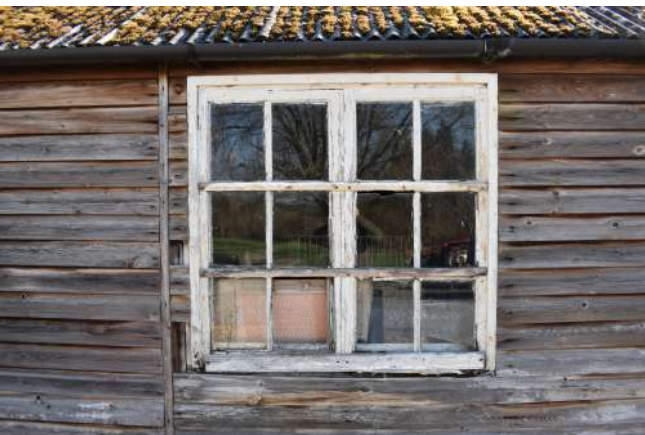
GEAGE23_Photograph_030.JPG Detail of window on western elevation of the sectional timber hut. Photograph taken facing north-east.

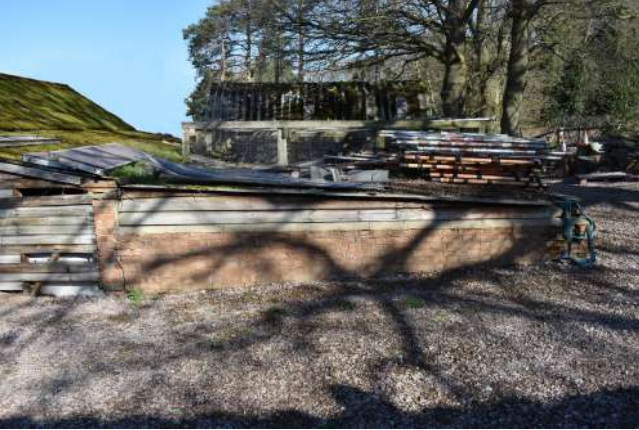
GEAGE23_Photograph_032.JPG Southern elevation of the sectional timber hut. Photograph taken facing north-west.

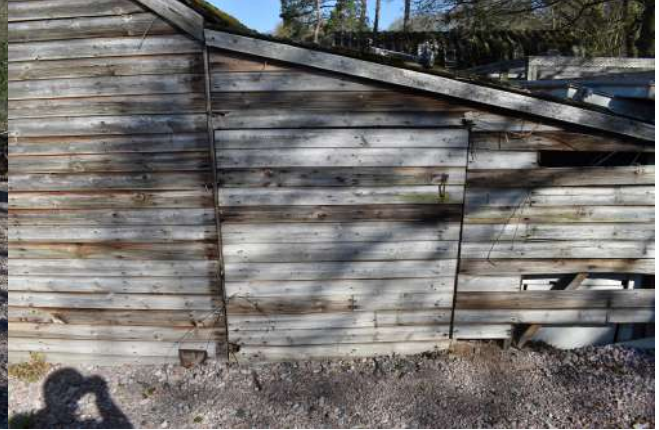
GEAGE23_Phograph_033.JPG Southern elevation of sectional timber hut showing modern extensions. Photograph taken facing north-w est.

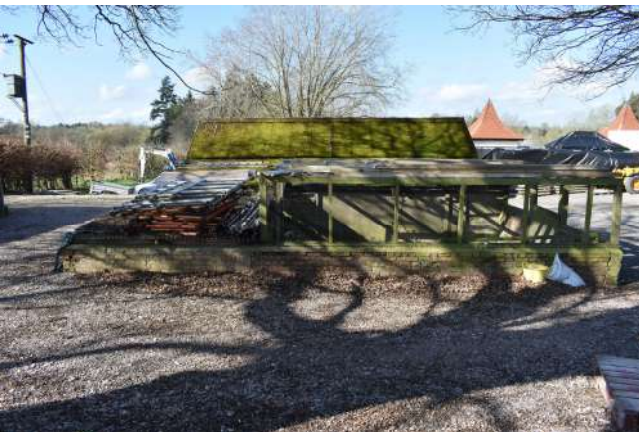
GEAGE23_Phograph_034.JPG Detail of doorway on southern elevation of modern extension of sectional timber hut. Photograph taken facing north-w est.

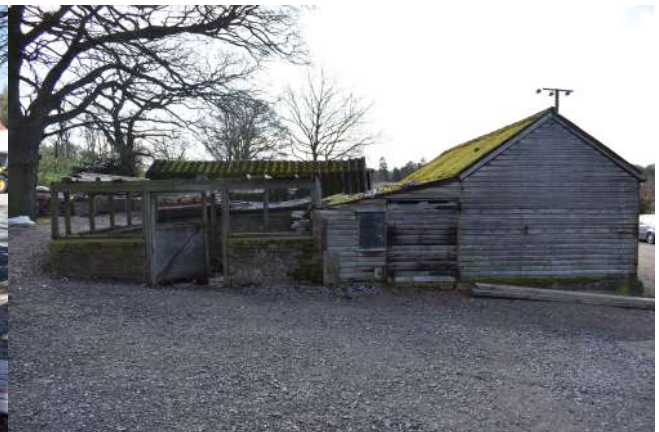
GEAGE23_Phograph_035.JPG Eastern elevation of sectional timber hut. Photograph taken facing south-w est.

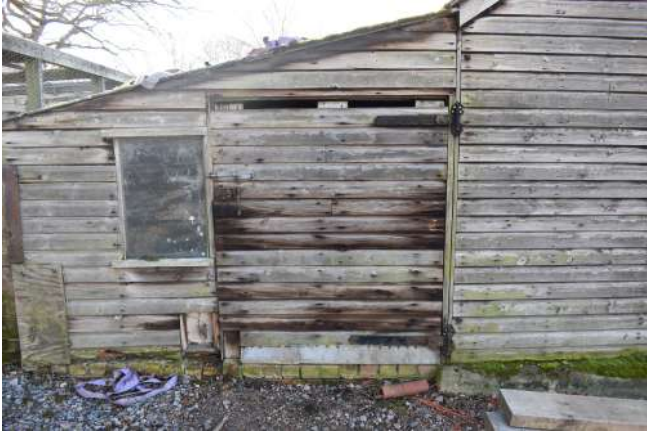
GEAGE23_Phograph_036.JPG Northern elevation of sectional timber hut. Photograph taken facing south-east.

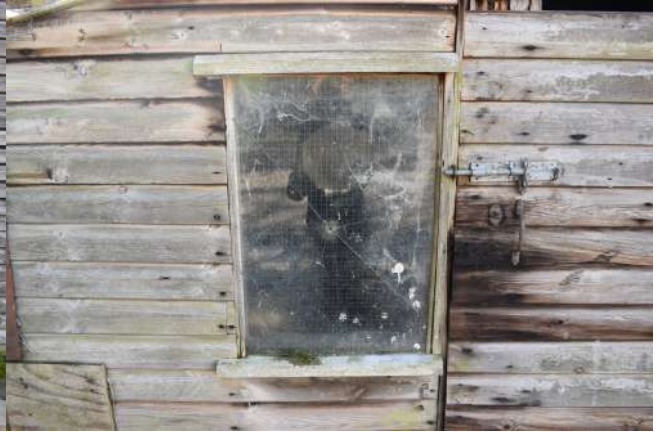
GEAGE23_PhotoGraph_037.JPG Detail of doorway on northern elevation of modern extension of sectional timber hut. Photograph taken facing south-east.

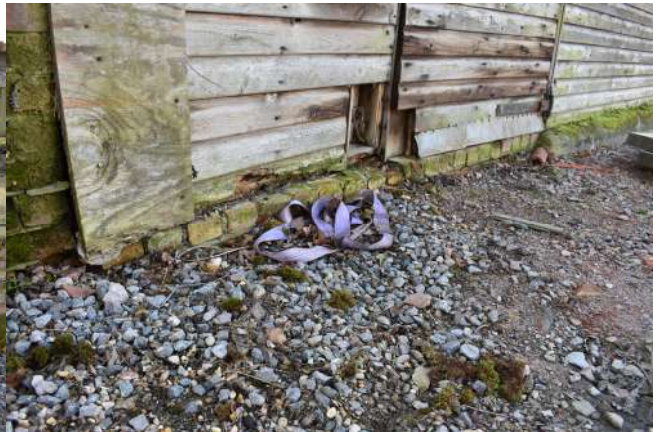
GEAGE23_PhotoGraph_039.JPG Detail of doorway on northern elevation of modern extension to sectional timber hut. Photograph taken facing south-east.

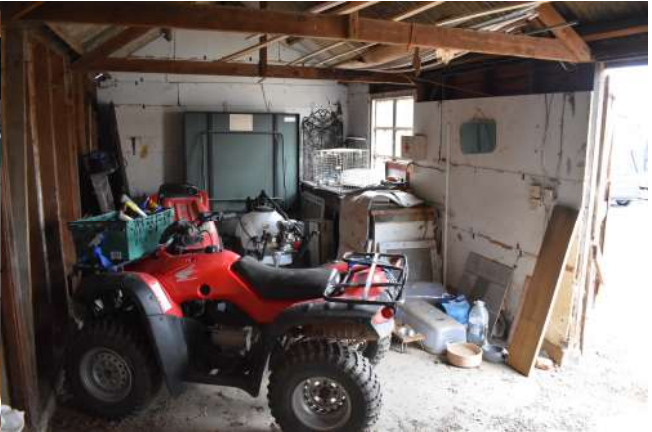
GEAGE23_PhotoGraph_041.JPG Internal view of sectional timber hut. Photograph taken facing east.

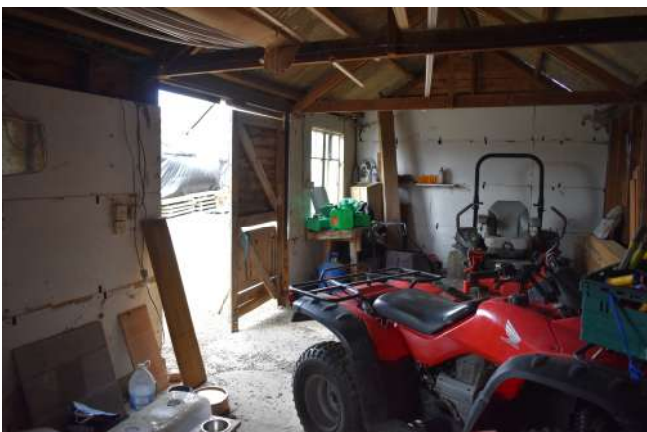
GEAGE23_PhotoGraph_042.JPG Internal view of sectional timber hut. Photograph taken facing south.

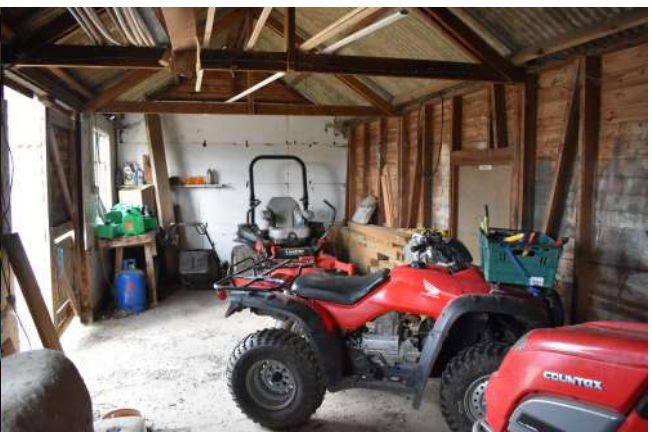
GEAGE23_PhotoGraph_043.JPG Internal view of sectional timber hut. Photograph taken facing north-w est.

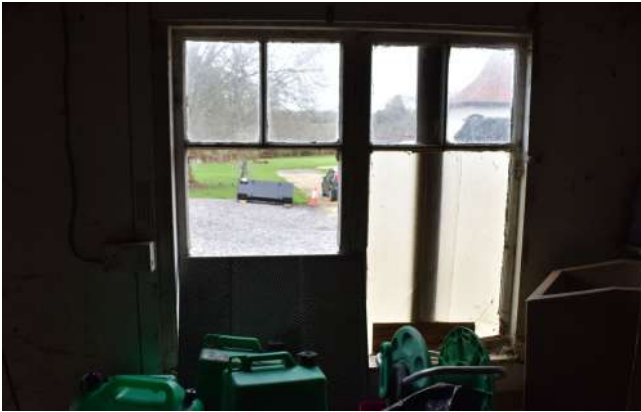
GEAGE23_PhotoGraph_044.JPG Internal view of sectional timber hut. Photograph taken facing north.

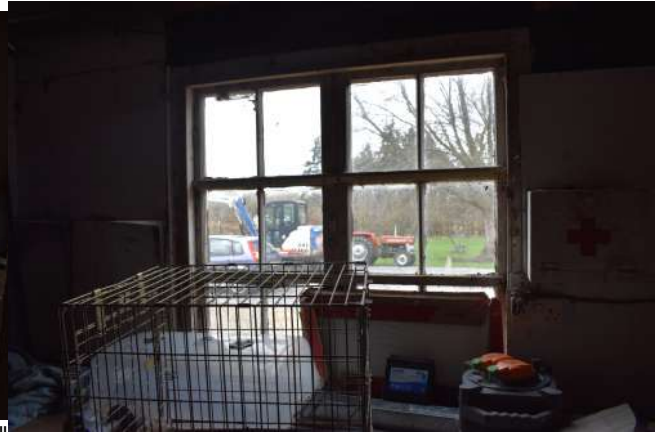
GEAGE23_Photograph_045.JPG Detail of window in western wall of sectional timber hut. Photograph taken facing south-west.

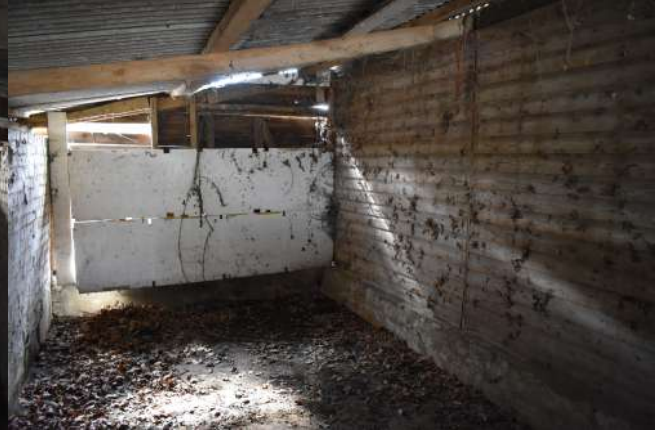
GEAGE23_PhotoGraph_053.JPG Internal view of extension 1. Photo taken facing north-w est.

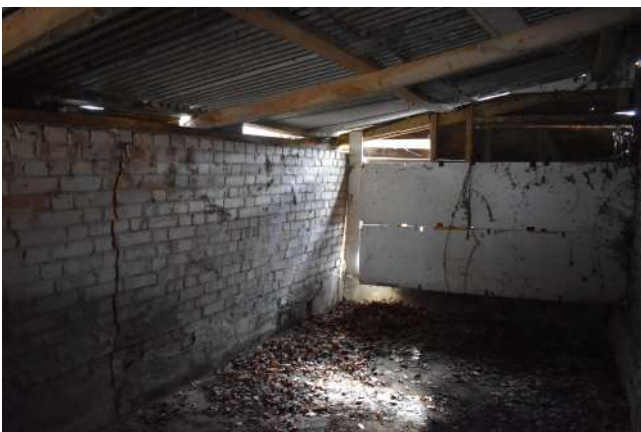
GEAGE23_PhotoGraph_054.JPG Internal view of extension 1. Photograph taken facing south-east.

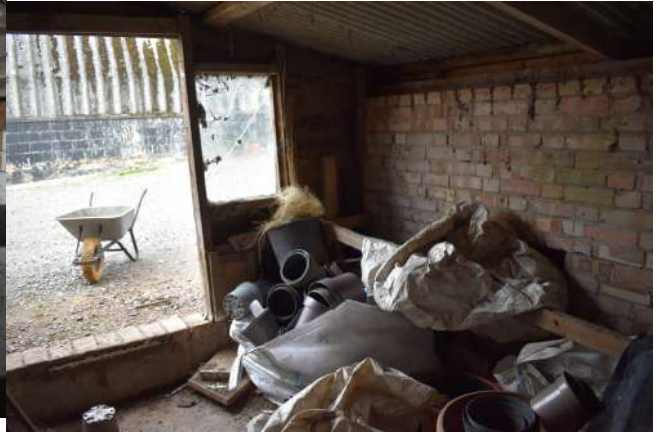
GEAGE23_PhotoGraph_057.JPG Detail of original exterior w all of sectional timber hut w ithin extension 1. Photograph taken facing south-w est.

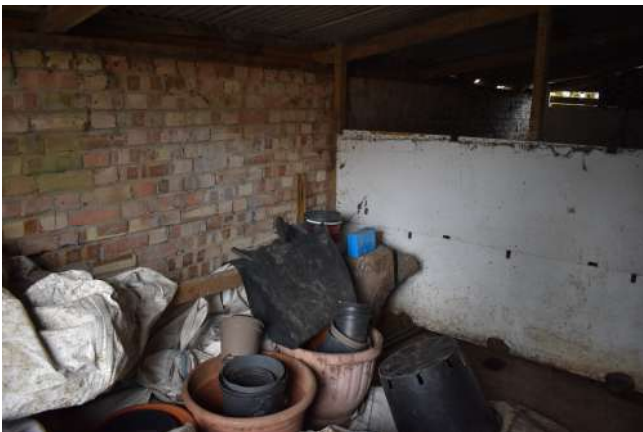
GEAGE23_PhotoGraph_058.JPG Internal view of extension 1. Photograph taken facing north.

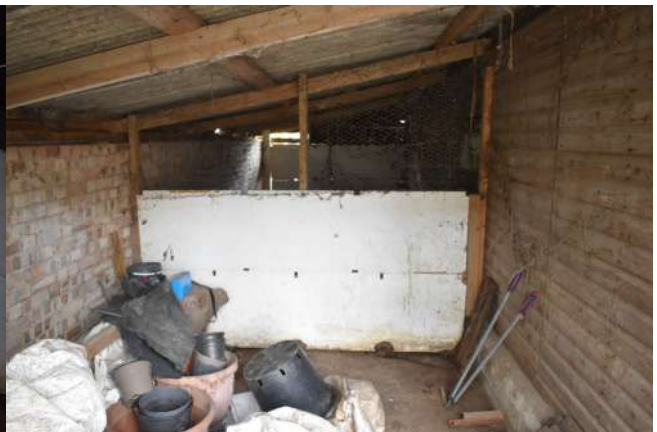
GEAGE23_PhotoGraph_059.JPG Internal view of extension 1. Photograph taken facing east.

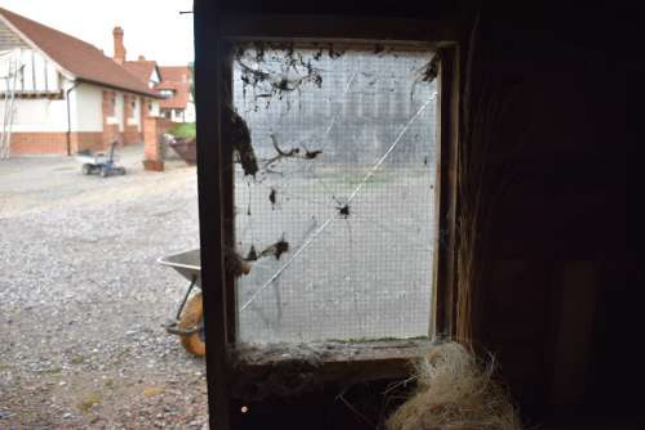
GEAGE23_PhotoGraph_060.JPG Detail of partition w all in extension 1. Photograph taken facing south-east.

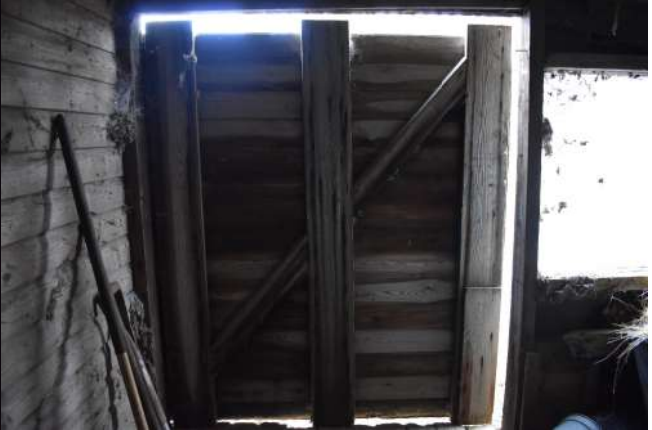
GEAGE23_PhotoGraph_061.JPG Detail of window of northern wall of extension 1. Photograph taken facing north-west.

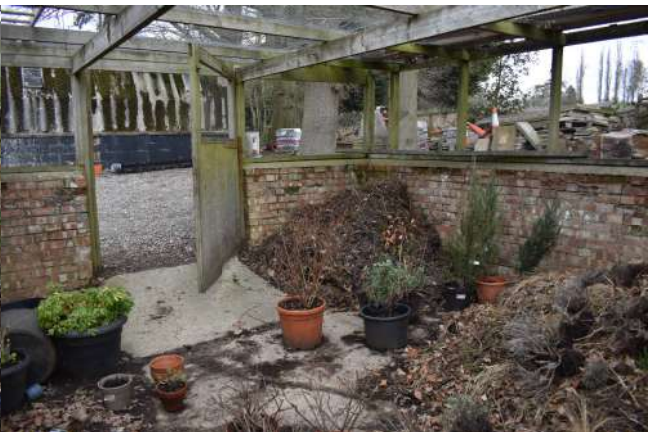
GEAGE23_PhotoGraph_063.JPG Internal view of extension 3. Photograph taken facing south.
