## Bruiach Farm, Kiltarlity

## Desk-based Assessment and Building Recording

Report No.	HAS120301
Site Code	KBF12
Client	J Martin
OS Grid Ref	NH 5014 4118
HCAU / Planning Ref	06/00273/OUTIN
Date	30/03/2012
Author	L McKinney

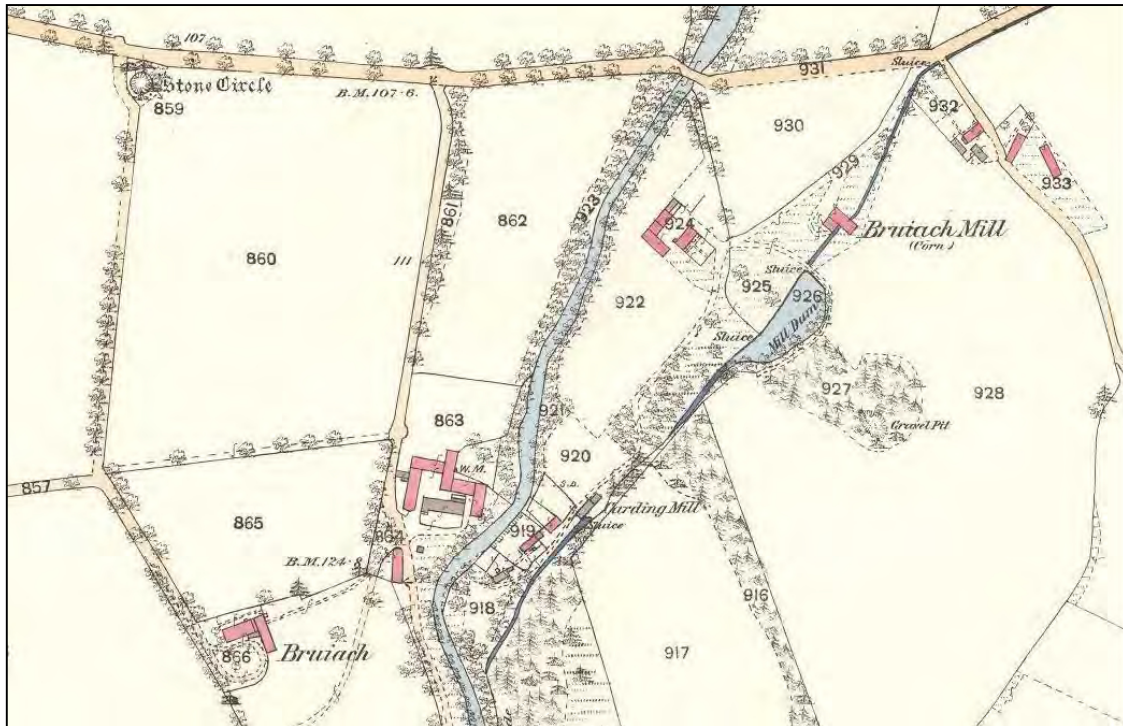
Figure 2 Extract from 1<sup>st</sup> edition OS 1:2500 map (Inverness Mainland Sheet X.15 surveyed 1872)  
Courtesy of National Library of Scotland. Not reproduced to original scale

The steading is first depicted on the 1<sup>st</sup> edition OS map c.1874, part of which is annotated as weighing machine with a smithy later incorporated into the site (Figure 2 above). The 2<sup>nd</sup> edition OS map of 1904 shows a phase of demolition and rebuilding has occurred: an east-west southern building has been replaced by a southern extension to the central north-south range. A new roofed area has appeared and new stock yards have been set out (Figure 3). A smithy has been built to the south.

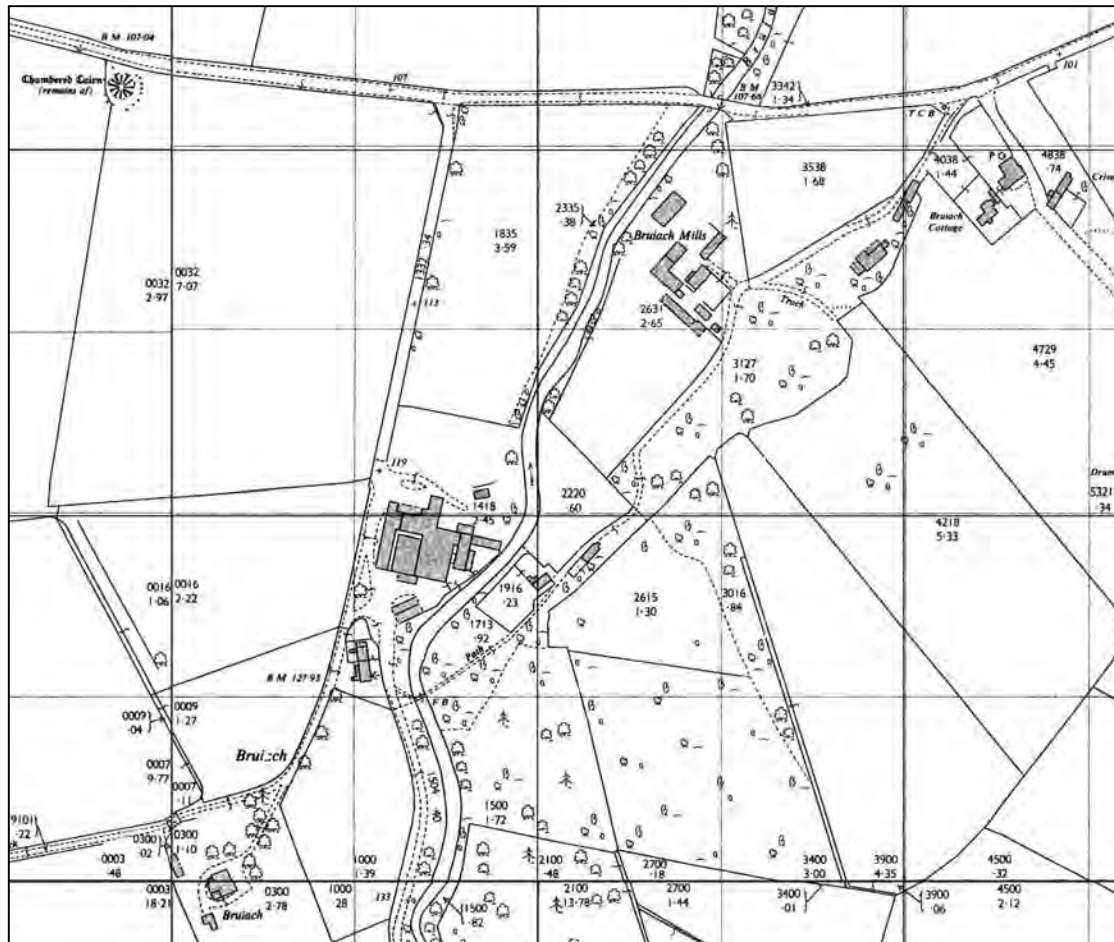
**Figure 4 Extract from Ordnance Survey 1:10,000 series, surveyed 1967-1970**  
 Derived from digital data supplied by Landmark Information Group. Not reproduced to original scale

By 1970 the 1:10,000 map depicts the whole steading as roofed and in generally the same form as its current configuration, with some of the outbuildings still in existence. However the smithy and the northern part of the central north-south range have disappeared.

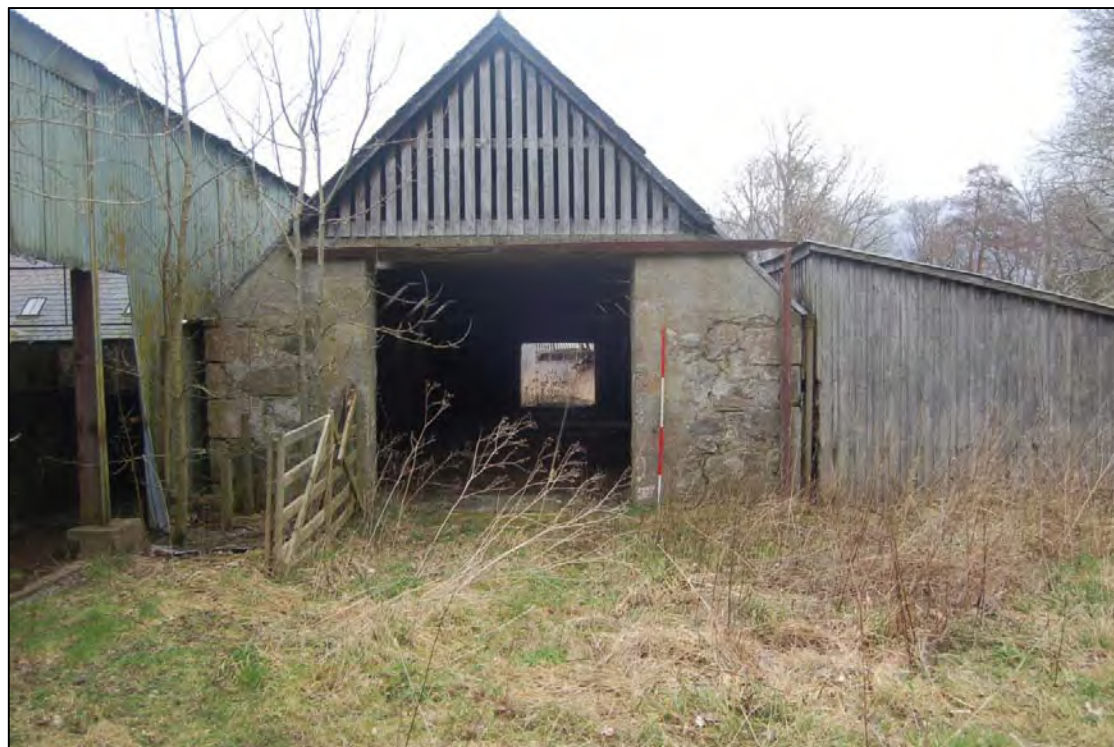
Plate 12 House 6 (S gable)

It is an L shaped stone built structure, the walls roughly constructed out of various shaped and sized stones, with no real courses. The walls vary between 0.5m and 0.55m thick. No foundations are exposed but it is assumed that if any are present they are more than likely based on large boulders. The external elevations have patches of cement render surviving, but it is in poor condition.

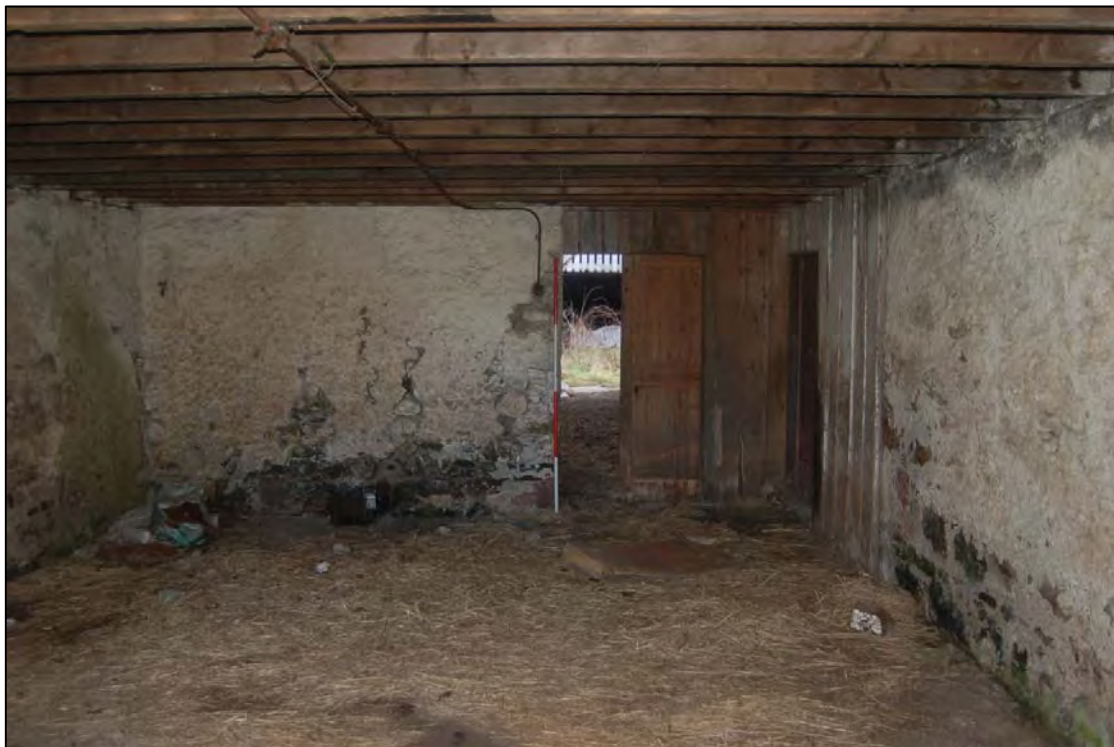
Plate 19 House 8, internal timber partitions and floor joists above

House 8 is a rectangular stone built structure (20.6m x 8.6m at its widest). The walls are roughly built out of varying sized and shaped stone and are in general 0.5m thick. Currently the building is divided into 3 rooms by the addition of two modern timber partitions (Plate 19). These take the form of two main rooms, one in the E the other the W, and a small annex to the S.

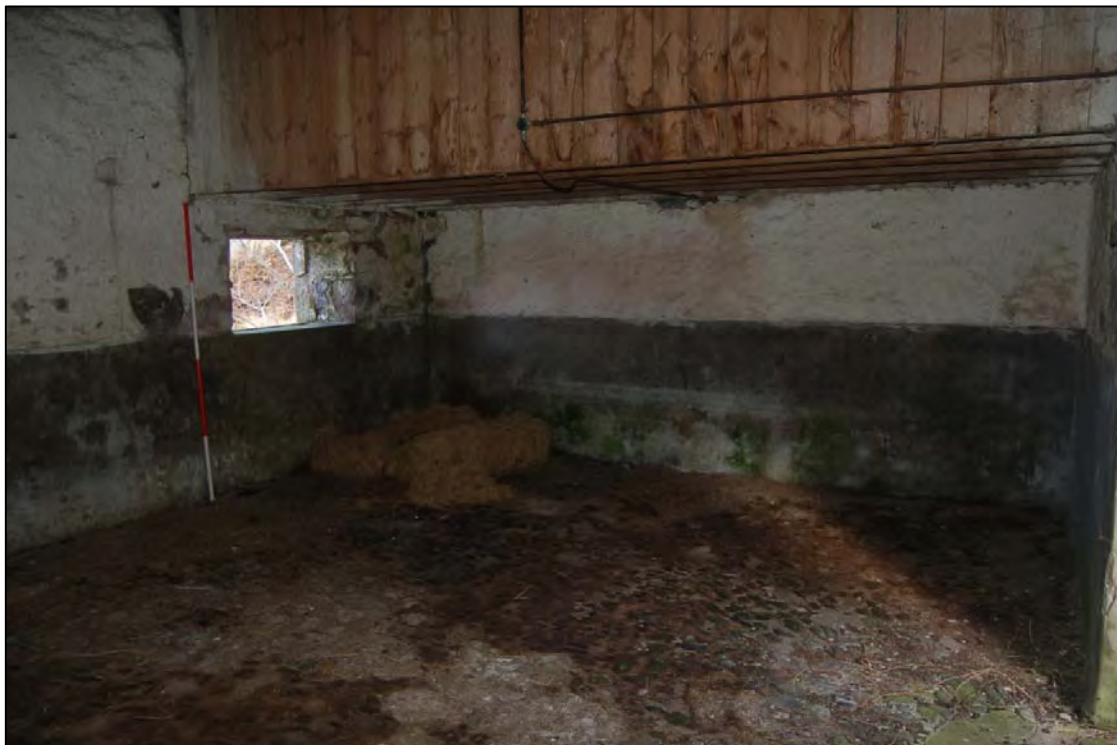
Plate 23 House 9, N room floor joists and upper timber partition forming 1<sup>st</sup> floor room

Internally the northern room is cement rendered to a height of 1.1m, with the rest of the wall covered in lime render. It has a door in its east elevation which is identical to the other doors in the steading (1.2m wide x 1.9m high) with quoins visible on the external wall and a timber lintel. Its W elevation has window which is set 1.3m above floor level; the opening is 0.8m wide and 0.5m high. It seems to be part of the original build. There are floor joists tied into each elevation wall, which stop in line with S edge of the window, but continue in House 8. These joists have a perpendicular stud wall attached to them which can be seen from below (Plate 23) and form a first floor room that could be accessed by the dormer like doorway in the external W elevation of the building.

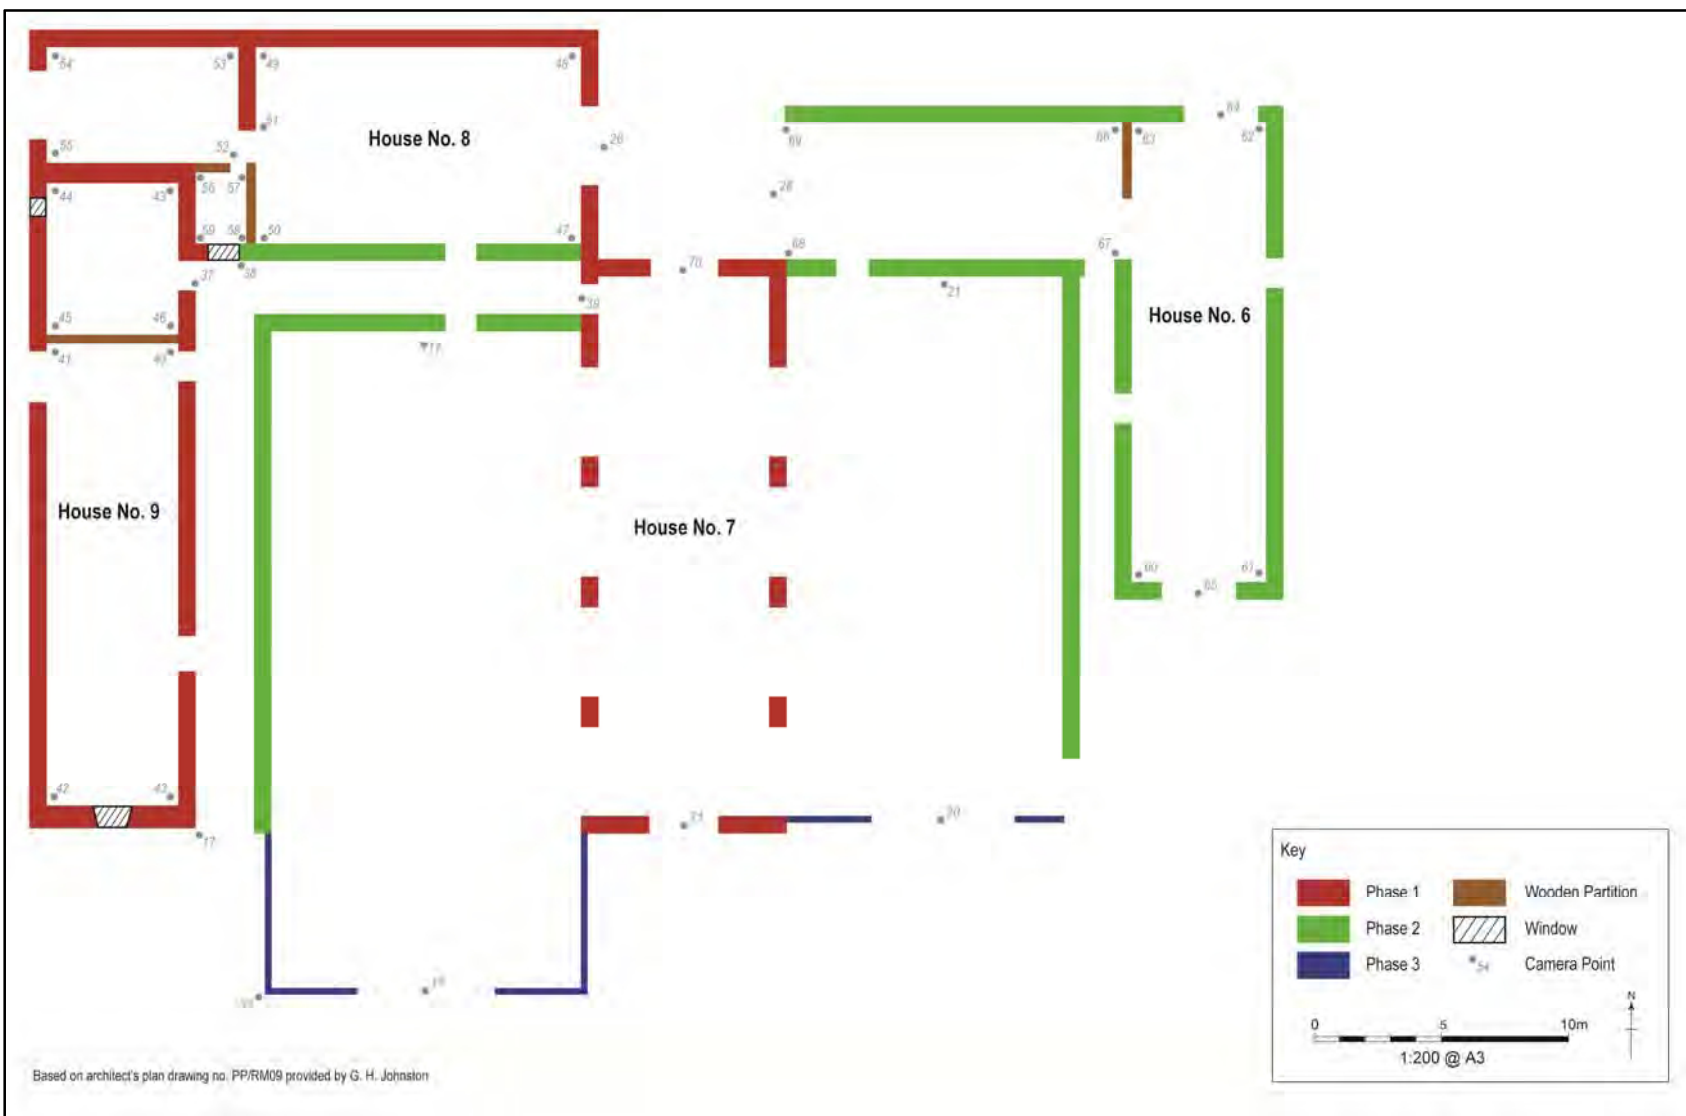
Figure 12 Phase Plan of farm buildings, with Camera Points (L McKinney / K Clarke)

3 broad phases of construction have been identified (see Fig.12 below).
