Cromarty East Church

Archaeological Evaluation

May 2007

Report No.	HAS070611
Project	HAS-CEC07
Client	Scottish Redundant Churches Trust
Planning Ref	N/A
Date / revised	13 July 2007
Authors	Gemma Shannahan and John Wood

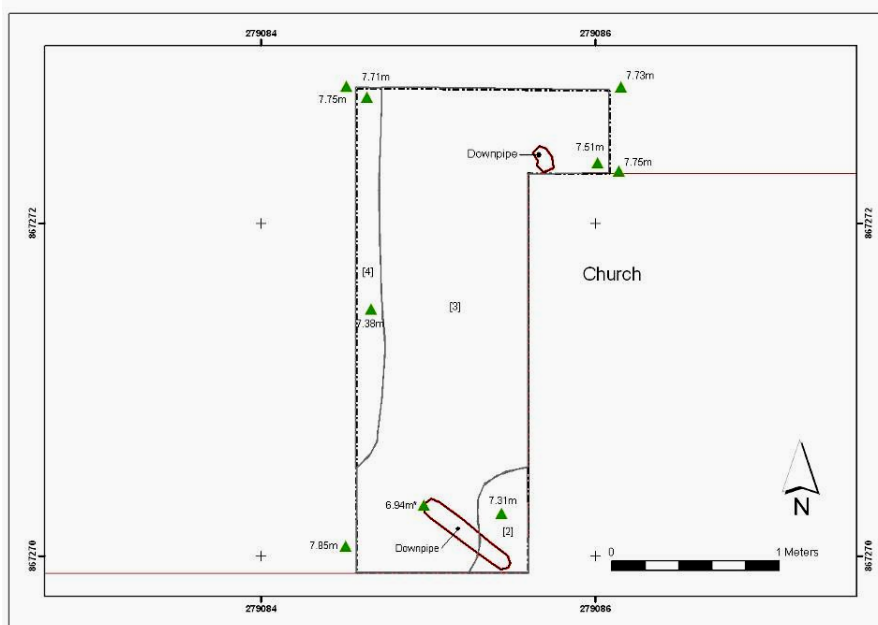
Figure 4 Trench A plan

Note: Asterisk level on downpipe is following excavation of [3] – this is as far as we traced this. Other levels are on surface of each context.

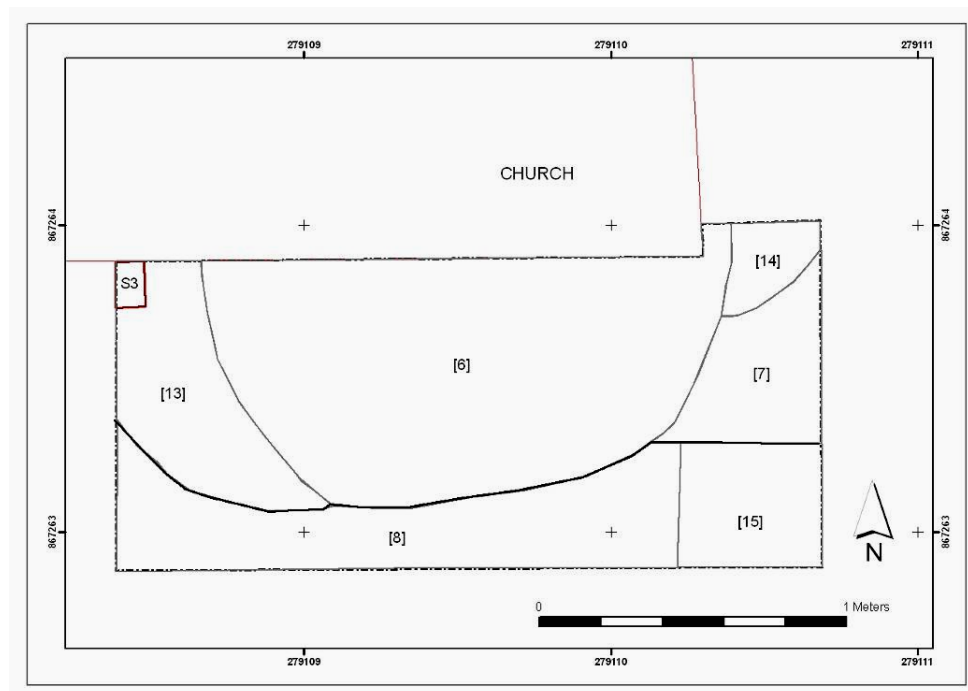
Figure 6 Trench B: plan (after removal of turf)

As in Trench A, the church foundations were found to consist of large sandstone boulders that have been concreted over and covered in a black waterproofing substance.

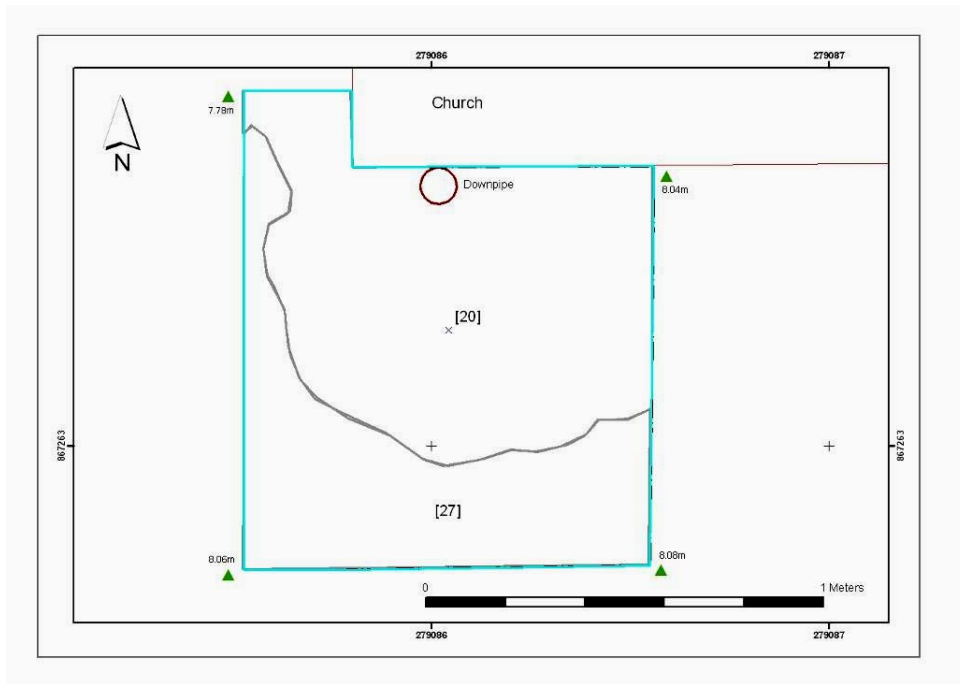
Figure 8 Trench C

The turf and topsoil [9] here contained a lot of large fragments of bone, some metal and slate. They were removed to reveal an intact layer of polythene around the down-pipe and alongside the church wall. Beneath the polythene, the fill of the French drain was seen as medium stones [20] around the down-pipe. The French drain cut [26] through the surrounding disturbed churchyard soil [27], within which a fragment of human skull could be seen in the south west corner of the trench. The ground in this area was particularly disturbed. After concluding that the drainage design and make-up reflected that found in Trenches A and B, the finds from Trench C were photographed on site and replaced in the ground before backfilling and reinstating the turf.

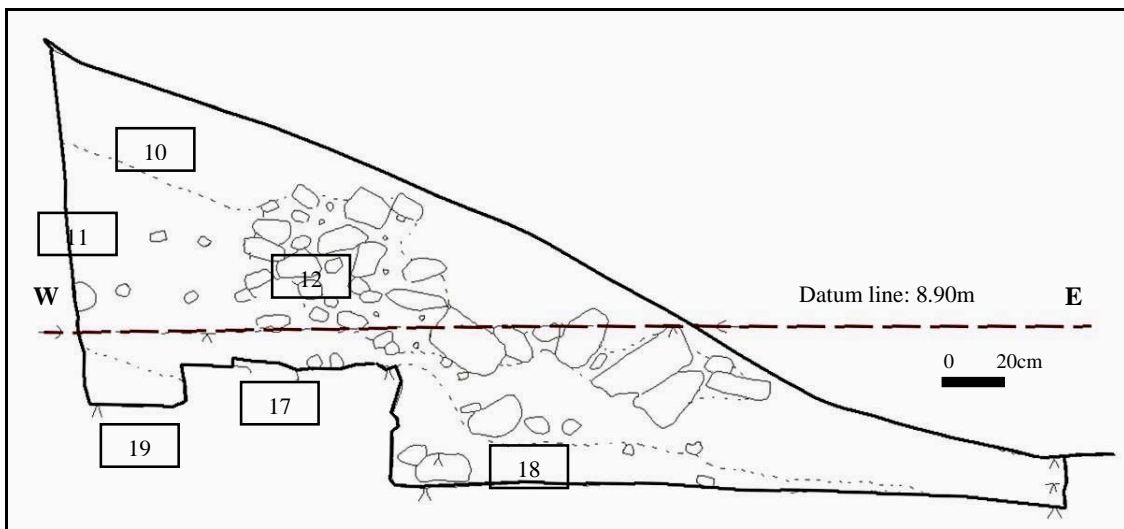
Figure 13 Trench D: N Section

Beneath the stones [12] were the foundation courses of wall [17]. This may be faced on the downhill side only (see Fig 11) – if this is correct perhaps the wall was built at least partly torevet the slope. It soon became clear, particularly when looking at the sections, that [11] had slumped onto and partially over the wall, probably causing its collapse [12]. Also beneath the wall tumble, to the east of [17], is a reddish coloured re-deposited soil [18], with some red/orange clay inclusions as well as charcoal, coal, pot, bone and slate fragments. To the west of the wall feature [17], in the north west corner of the trench is a small area of silty mid-brown soil [19] with some clay inclusions.

It should be noted that the area to the west of wall [17] was waterlogged during the excavations, with water actively seeping from the hillside, and the contexts here could be difficult to distinguish owing to the amount of moisture in the ground.

Trench 4 was excavated only far enough to clarify the nature and location of the churchyard boundary wall. It is possible that graves could exist below this level if slope material has come down over the centuries to cover former graveyard areas. Nevertheless a considerable amount of water could be seen in the trench seeping from the base of the slope and ponding back behind the remains of the wall foundations after a period of rain, and there are several known springs along this line at other places in Cromarty, so some form of intervention drain may be advisable. If this is decided on, an archaeological watching brief should be maintained to record any evidence that is uncovered.

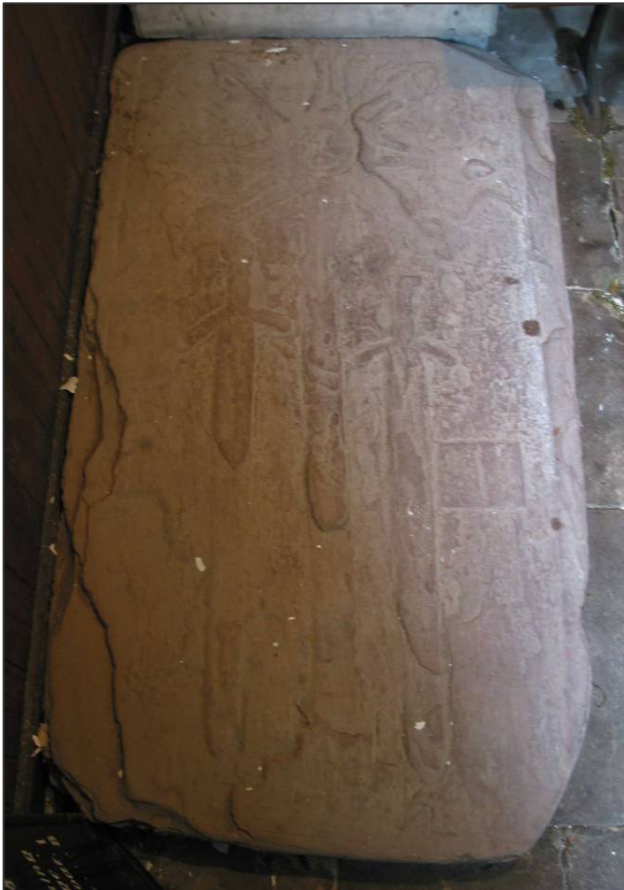
The carved surface is heavily weathered and decayed, but considerable detail is still visible even in poor light. The ornamental stepped cross and sword symbols are relatively rare for the eastern Highlands, but bear a marked resemblance to those on grave slabs from Cullicudden which have been dated to the 14th century, although the slab itself is quite different in size and shape.

The sandstone is severely laminated, due to general weathering and frost damage. This has resulted in the loss of large areas of the top surface, in some places down to a depth of several centimetres. The worst areas are shown in red overleaf, but most of the surface has suffered some degree of flaking and consequent loss of detail.

- The slab will need some accompanying interpretation, probably in the form of a small panel with a line drawing of the symbols as they can be seen now and showing how they might have been when complete, together with an explanation of the slab's history and significance.
- Strong lighting coming at a shallow angle from the side will increase the contrast and visibility of the carving. This could be on a time switch so that it stays on for a couple of minutes at a time. If the slab is mounted horizontally, finding a position where the lighting gives the desired result but is not obstructed by the visitor might be difficult.
- If mounted horizontally, the slab would lie flat on a strong solid surface at a height of about 900mm. Ideally this would not be against a wall so as to give access right round the slab.

- If mounted vertically, the slab would slope back slightly to lean against a solid wooden backing built against an existing wall. If the back of the slab is very uneven, the backing might need to be padded with Plastazote to stop the slab rocking. A shallow lip would prevent the bottom edge of the slab sliding forwards. Stainless steel brackets would be mounted about two thirds of the way up the sides to stop the slab falling forwards. The brackets and the lip would be padded with Plastazote so that they were not in contact with the stone.
- An alternative to displaying the slab in the church would be to offer it to Cromarty Courthouse Museum, which might be in a better position to provide suitable conditions and care.
