Highland Archaeology Services Ltd

Field Monitoring

Kyle Water Main Renewal

Report No.	HAS070711
Project code	KYL07
Client	Halcrow PLC
Planning Ref	N/A
Date / revision	14 August 2007
Author	John Wood

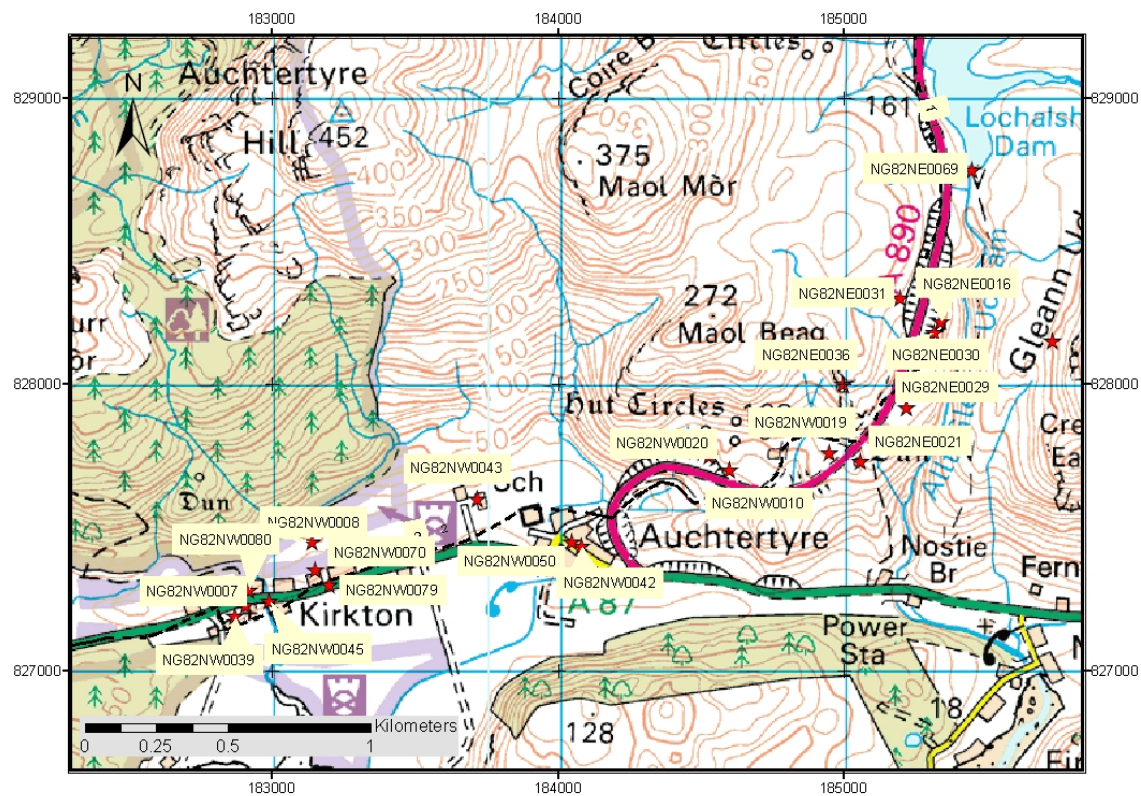
Figure 5 Kirkton / Auchtertyre sites

The line of the new pipe runs along a section of old road just north of Auchtertyre, where it was thought recorded Bronze or Iron Age roundhouses and field systems could be affected. However excavations for the pipeline in this area were observed in July 2007 and the line taken did not affect any archaeological sites.

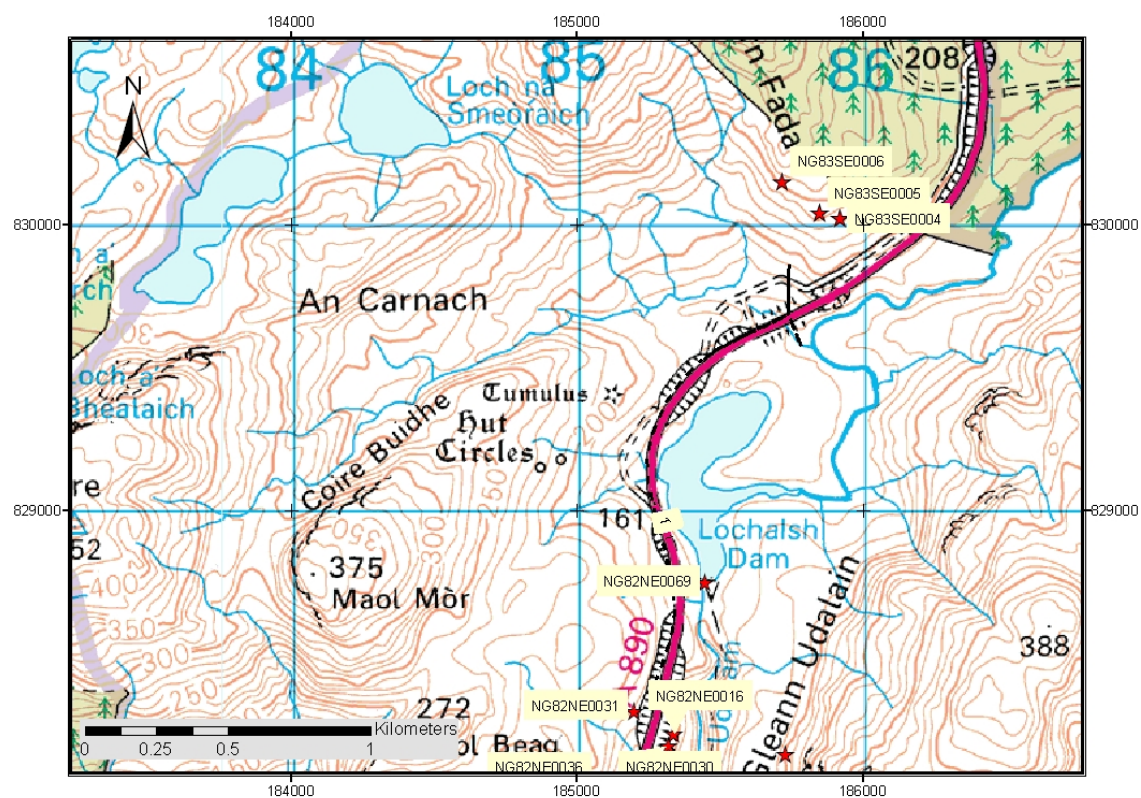
Figure 6 Carn Fada sites

Surveys have noted some features near the north-eastern end of the pipeline south of Carn Fada. It was difficult to establish from the records whether these would be affected, but a site visit clarified that these were well away from the proposed works.
