# **Chequers Dredging Work, Buckinghamshire**

## **Interim Archaeological Watching Brief Report**

**December 2019**

**Client: The Chequers Estate**

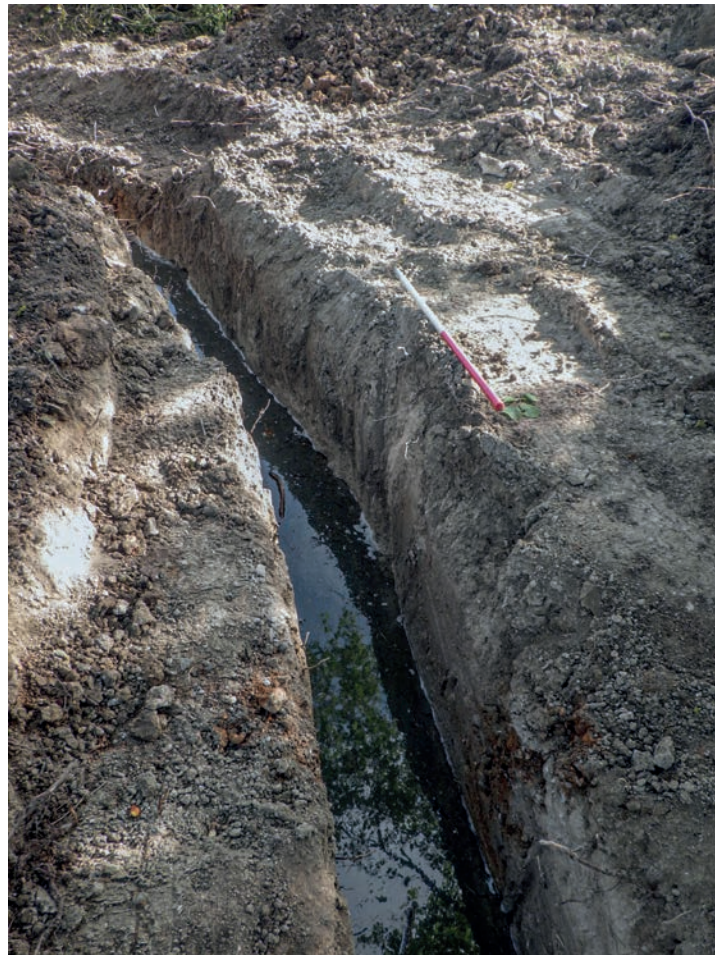
Plate 1: Channel

- 3.2.1 A channel was excavated from the southern side of the dam around the eastern side to the north. Starting within the centre of the pond, the channel measured 1.8m wide and continued to the eastern bank, c 12m to the south of the dam. The channel then continued around the eastern side of the dam at a width of 0.6m for a distance of approximately 26m (Plate 1). The channel was designed to enable water to flow from the southern side of the dam to the north. Therefore, the depth varied from 0.6m below ground level (bgl) in the south to 1.4m bgl in the north.
