Navapan Hall

27 Holywell Street

**Historic Buildings Recording
and Watching Brief**

September 2011

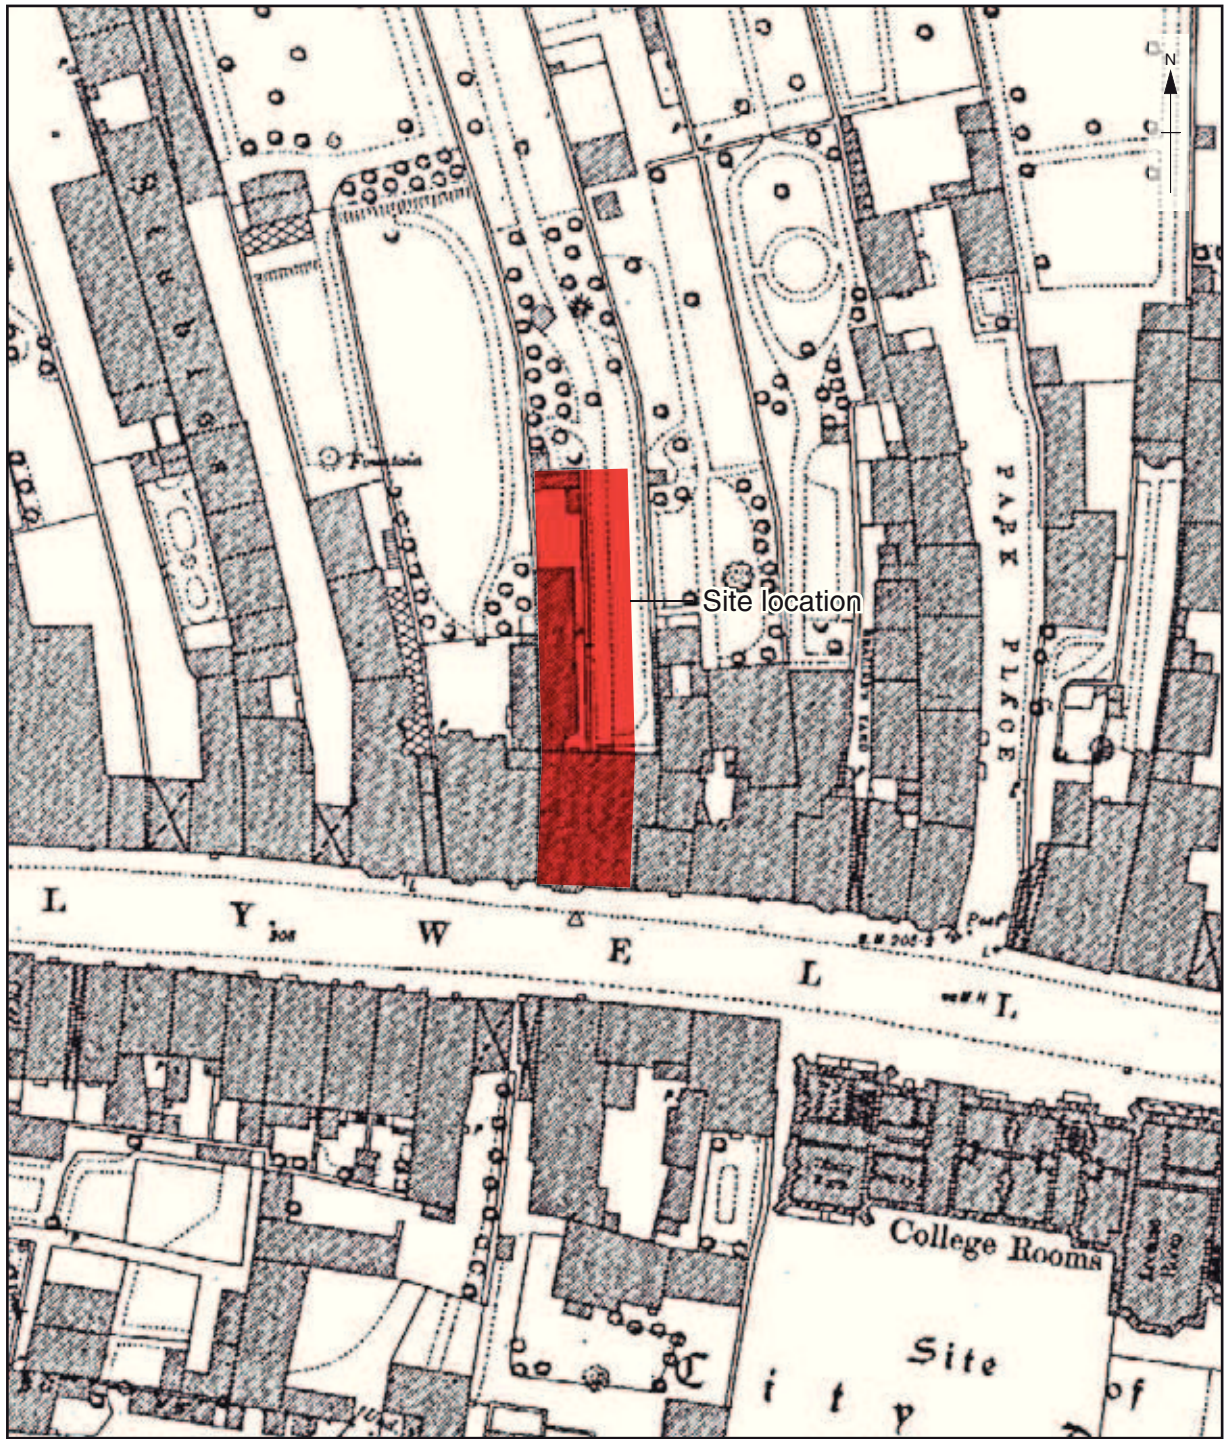
Figure 7: Detail from 1st edition OS plan of Oxford (1878)

- 2.1.3 A clearer depiction of the buildings in the second half of the 19th century is found on the 1st edition OS map of 1878 (Figure 7). This is also the first depiction of the bay windows at no. 27 and neighbouring no. 28 with its double bay window frontage, however, this is probably due to the level of accuracy given to each plot for the first time. The rear of no. 27 appears to have a small porch covering the rear entrance

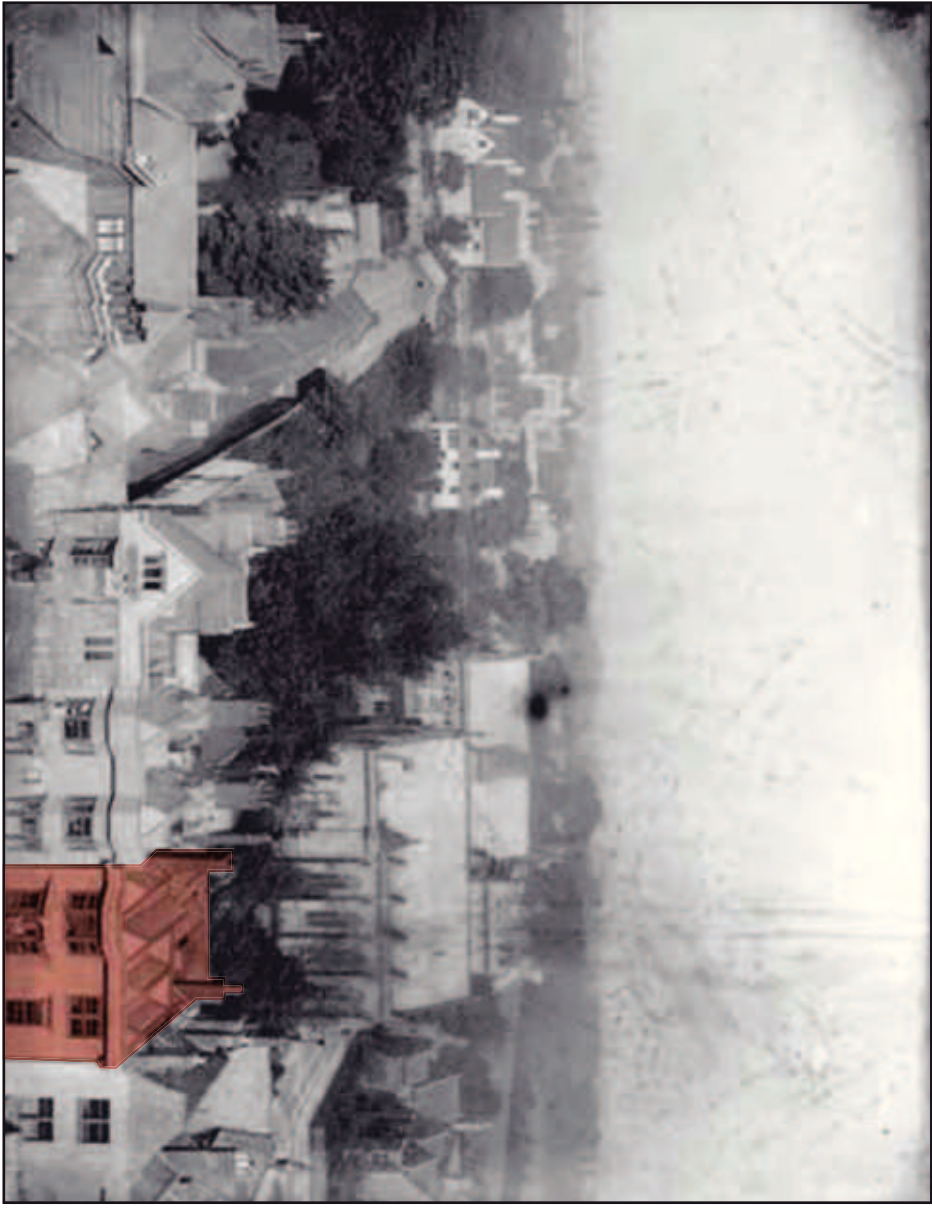
Figure 8: Photograph showing the roof structure of 27 Holywell in 1907

- 2.1.4 The nearby house nos. 22 and 23 were demolished in the 1860's to form Mansfield Road on which the main college entrance now stands. Buildings to the rear of nos. 24 to 28 on the north side of Holywell Street were demolished 1891 to make way for the new college buildings of Manchester College (now Harris Manchester College) following its relocation to Oxford. The new college can be seen on the 1900 OS map and the footprint of no. 27 Holywell Street on the 1939 OS map suggests the rear extensions had been shortened in the first part of the 20th century. An early 20th century photograph shows the roofline to be the same as seen today (Figure 8).

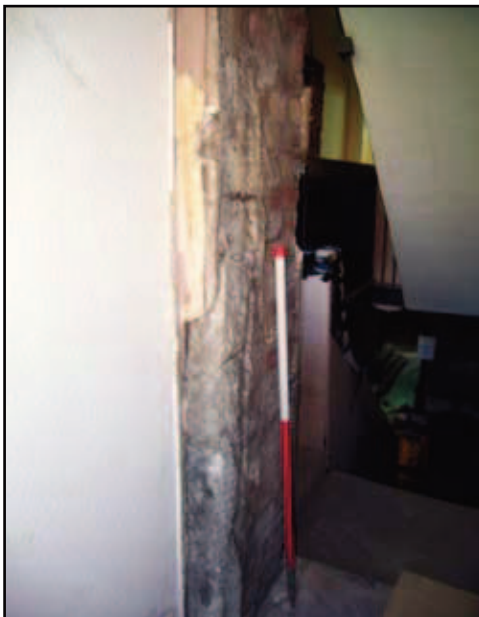
Plate 23: 27 Holywell, detail of first floor extension door reveal

- 4.2.3 The panelling removal continued up the stairwell and there were two areas of interest. The removal of timbers around the doorway on the mid stairwell leading to the first floor of the rear extension that is to be demolished revealed the stonework of the primary construction. The west jamb is entirely of stone construction but the eastern jamb has a mix of stone and brickwork, the brickwork probably added to repair the jamb at the same time as the opening was created (Plate 23). The stonework has clearly been cut back to form the opening and the faces within the reveal are heavily scarred by chisels marks. Also beside the stairwell at first floor level some panelling had been removed revealing a section of the floor construction for the adjacent bedroom (Plate 24).
