St. Mary's Church Guildford Surrey

Archaeological Investigations

August 2012

**Client: PCC St Mary's Church,
Guildford**

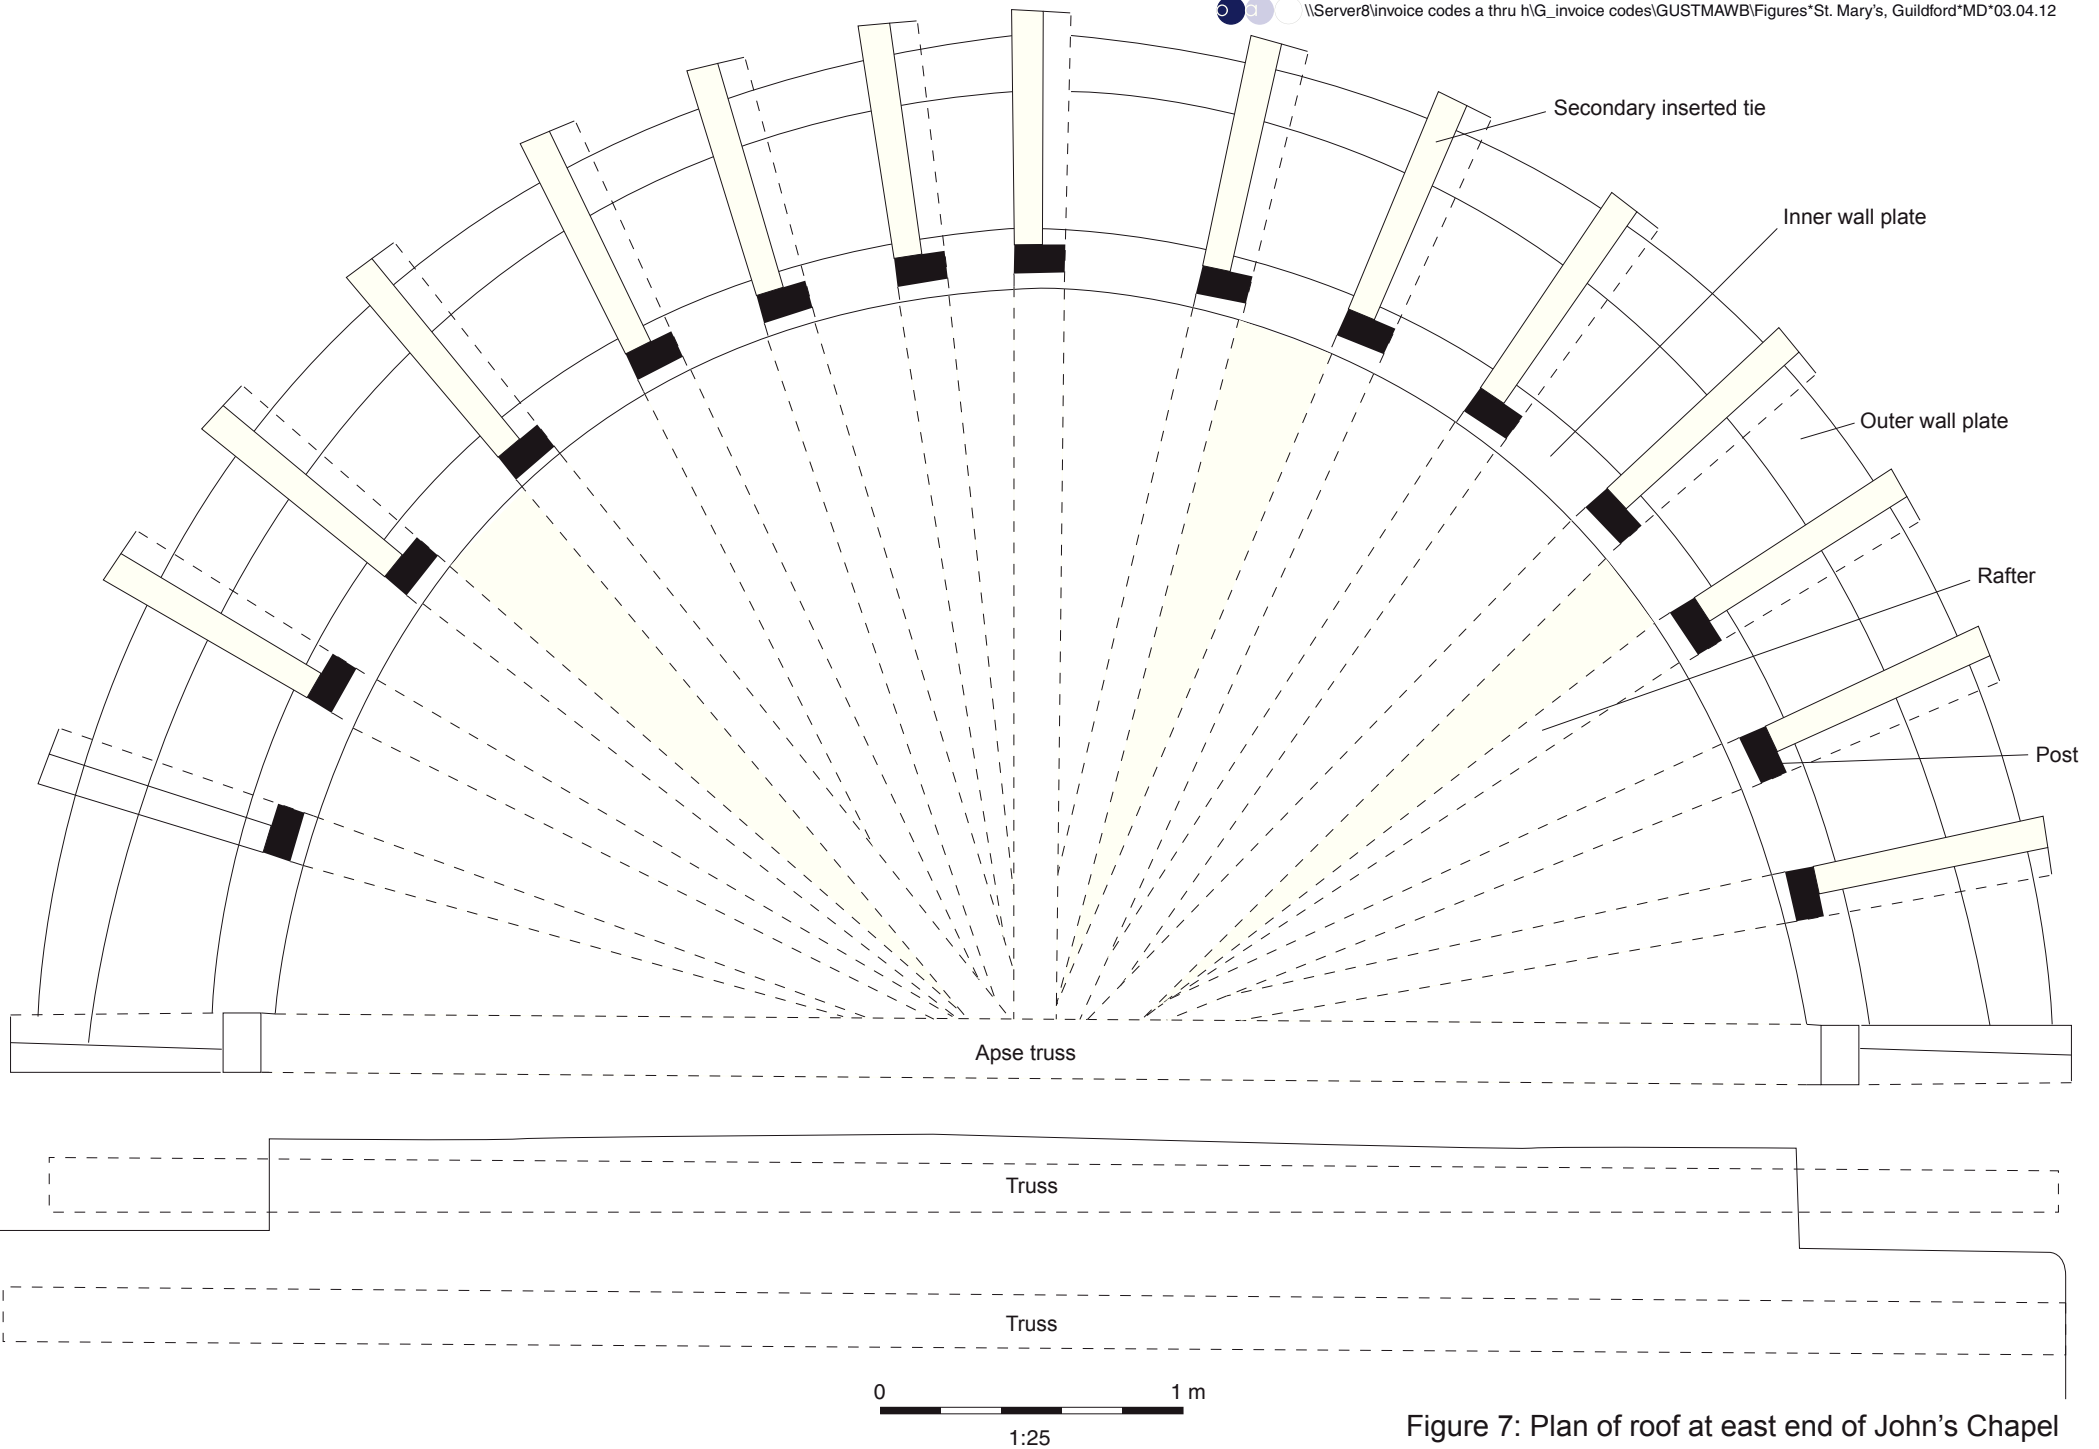
Figure 7: Plan of roof at east end of John's Chapel

- 4.2.14 The apse roof structure comprises two timber ring plates set on top of the semi-circular wall, one at the inner edge of the wall and one at the outer edge (see Fig 7). Each plate is c.20 cm wide by 15 cm tall. There are a series of rafters the base of which rest on the outer ring and which are supported by vertical struts which sit on the inner ring. The struts appear to sit in mortices in the upper face of the inner ring and the height of the struts varies considerably depending on their position in the roof. The rafter feet and struts are secured together by a short timber tie which is a secondary insertion and sits on top of the wall. This tie is half lapped and nailed over the side of the strut and rafter.

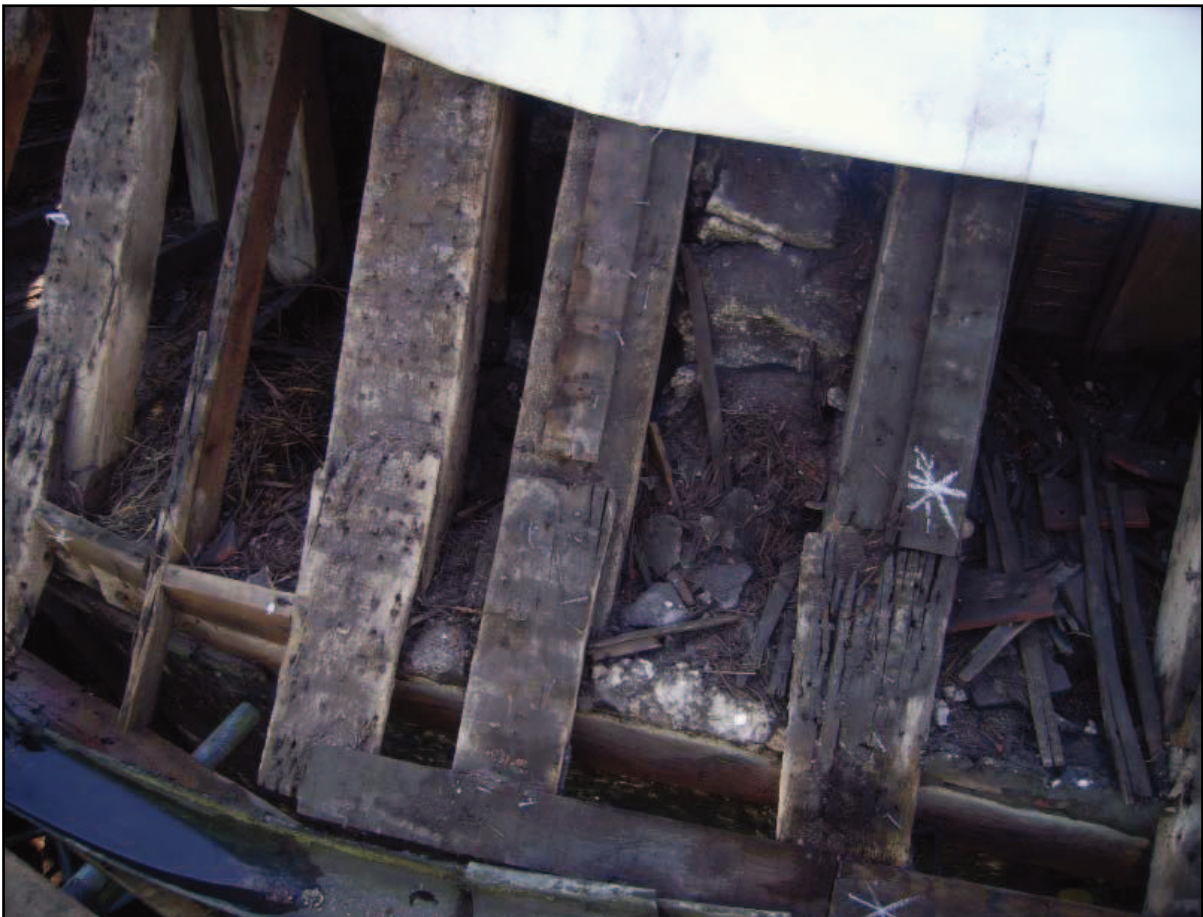
- 4.2.11 *Apsidal east end***
- 4.2.12 The semi-circular roof structure at the east end is separate from that of the rest of the chapel and is from a different phase of construction. There are three trusses adjacent to each other at the junction between the apsidal and end the main range (see Plate 14). The two western trusses relate to the main chapel roof while the eastern truss supports the semi-circular roof structure.

Plate 14: Three principal rafters at junction between apsidal roof and main roof.

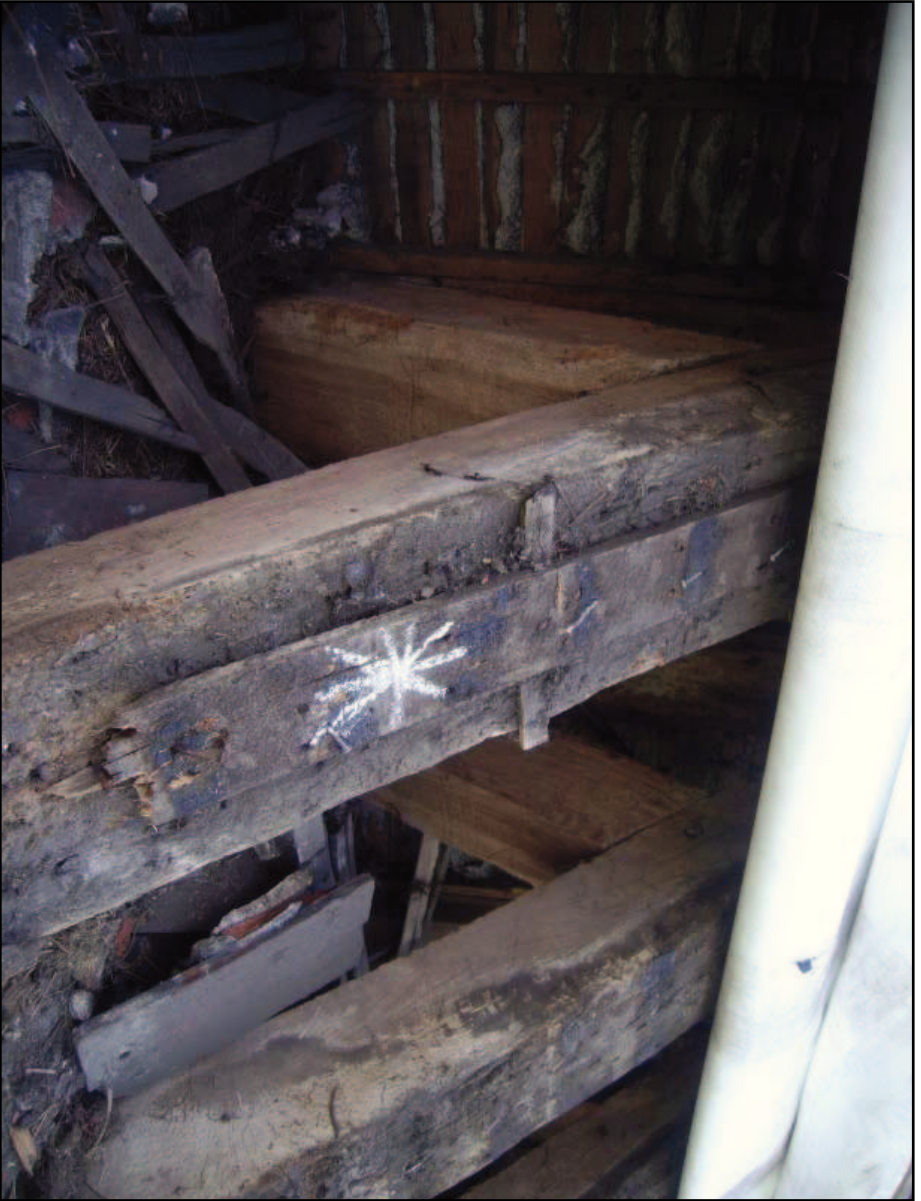
- 4.2.9 Another feature of interest is that towards the eastern end of the roof there is a horizontal bearer or trimmer between the 2nd and 5th rafters from the east end while on the 3rd and 4th rafters there are raking struts which clearly support this feature (Plates 15, 18). The base of the raking struts rest on the inner wall plate and at their heads they are tenoned into the common rafters. The trimmer is set immediately above this and it appears that it was the base member for a roof light or dormer window. It is interesting to note that the underside of a similar bearer between the 2nd and 5th rafters is also visible from within the church (Plate 28). This is at a higher level than the bearer identified in the current work and was presumably the top of the former roof light. As the base and top of the probable former window are either side of the vertical lath and plaster this is further evidence that the lath and plaster is secondary. The raking struts appear primary and the trimmer is morticed into the sides of the 2nd and 5th rafters. There is no evidence of other former trimmers or former windows in the roof.

Plate 15: Rafter feed towards east end of main roof

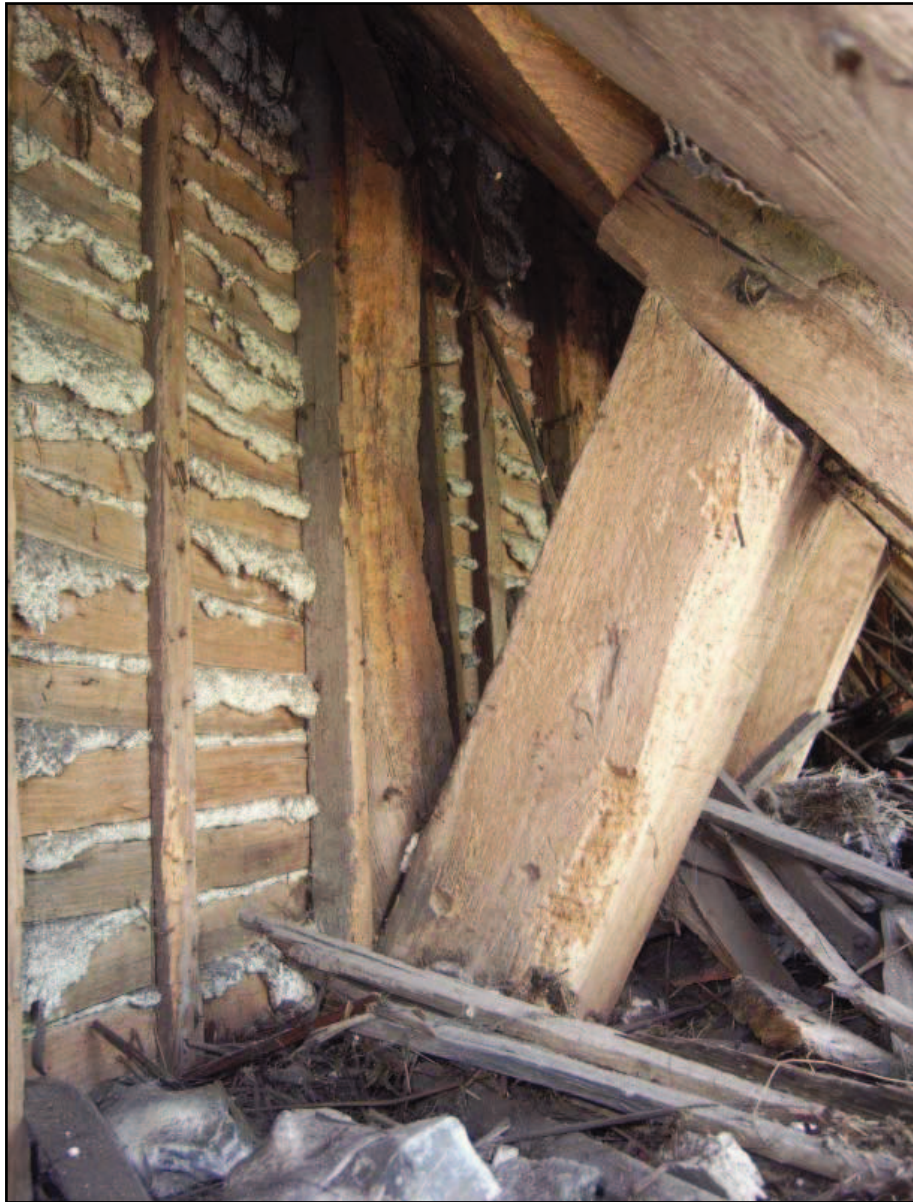
Plate 18: Strut supporting trimmer from former light

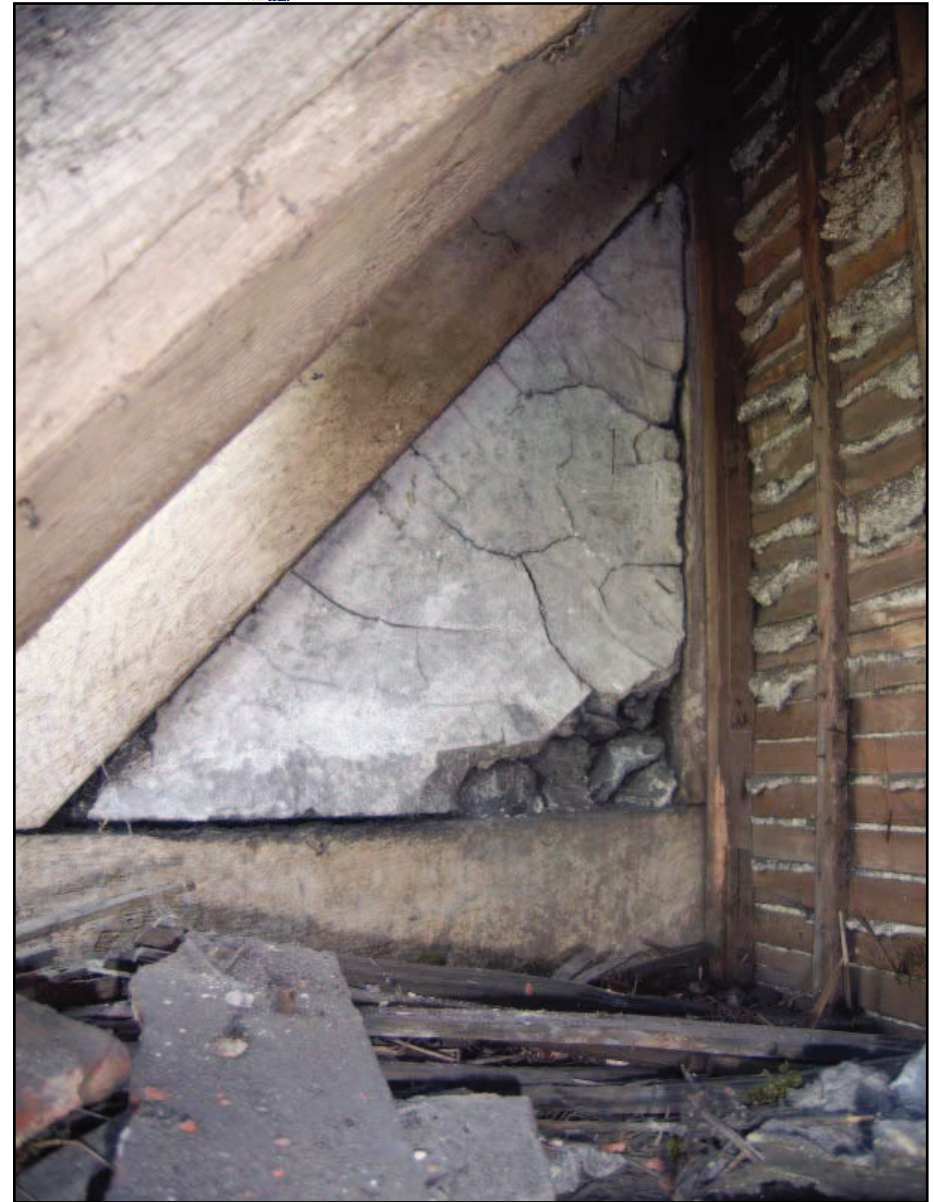
- 4.2.7 The ashlar pieces appear to be secondary additions (or replacements). This is partly based on their different colour and weathering to the rafters but also because at the east end of the void there is what appears to be a small fragment from an older plaster surface behind the ashlar pieces (Plate 17). This plaster is on the west side of the stone wall which divides the apsidal end from the main chapel, and as it is now entirely hidden by the lath and plaster between the ashlar pieces it presumably survives from an earlier arrangement. The section of old plaster is rough and cracked and fits neatly in the triangular shaped panel formed between the rafter, the tie-beam and the ashlar piece. The laths supporting the plaster between the ashlar pieces are generally thin and suggestive of a possible 18th or 19th century date although some are wider so it may be that an older section of plaster was repaired rather than entirely replaced.

Plate 17: Plastered wall at east end of main roof
