# The Tiltyard Tower Hampton Court Palace

## Historic Building Recording

February 2006

**Document Type:** Historic building investigation and recording

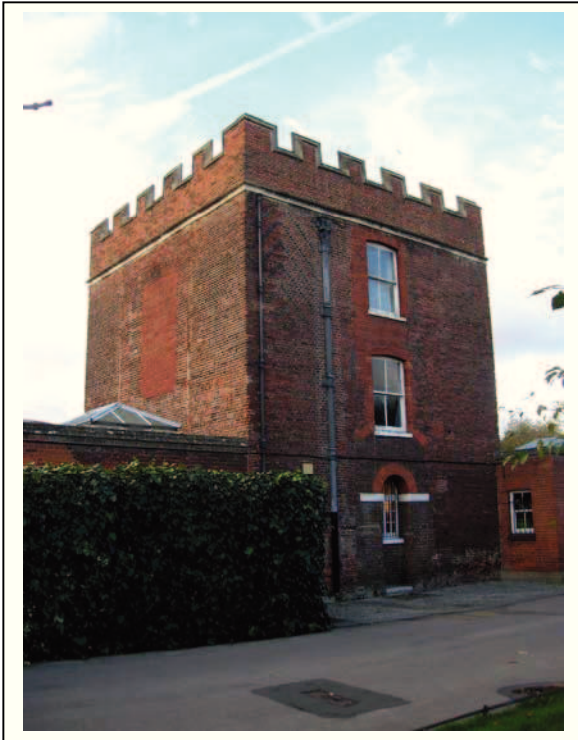
Plate 1: The South and east elevations, December 2005

- 2.1.4 The tower is mostly 16th-century in date, although even a cursory look at the exterior brickwork reveals that it has undergone numerous stages of addition and repair, including several phases of re-fenestration. Old pictures show that the tower once had an external stair turret and large projecting bay windows.
