Hampton Court Palace The Tiltyard Tower

**Historic Building Recording and
Investigation**

July 2008

Client: Historic Royal Palaces

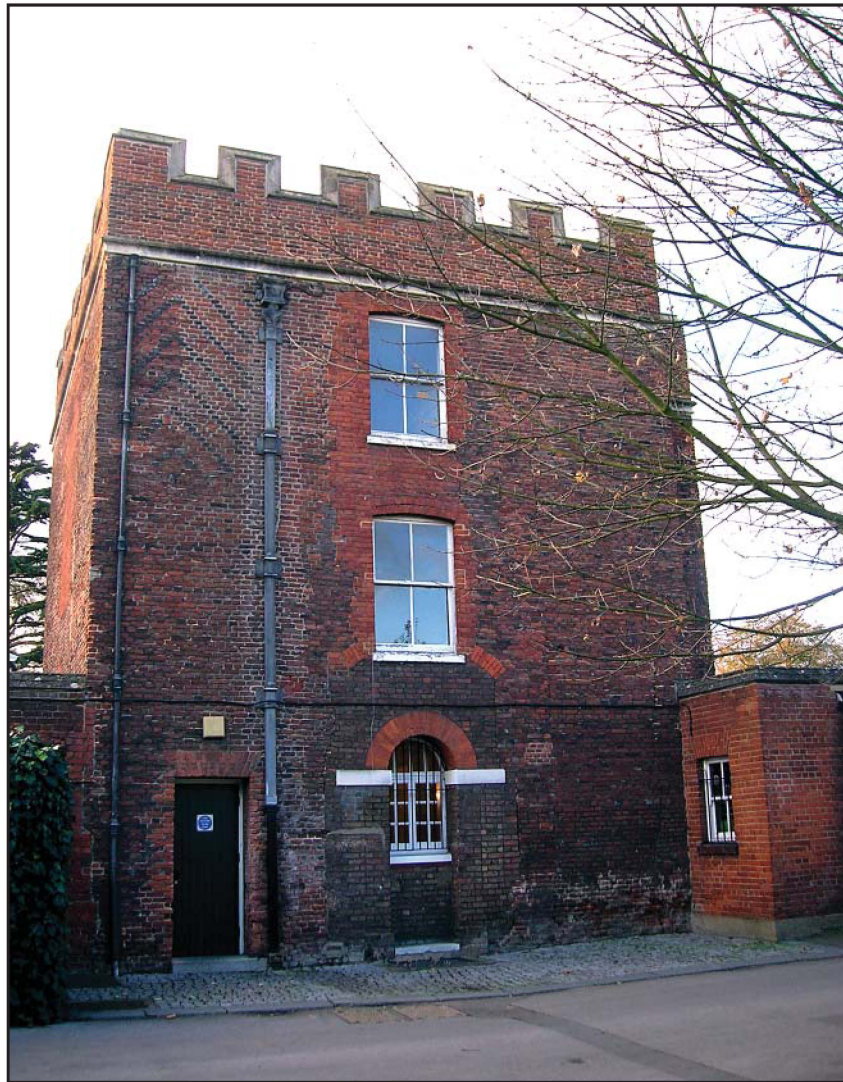
Plate 1: East elevation, external view (pre-works)

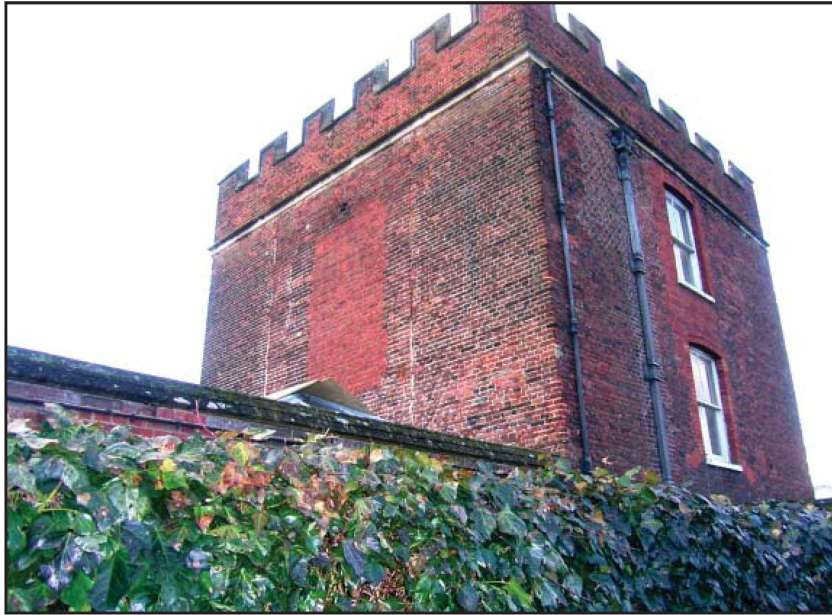
Plate 3: South (and east) elevation, showing central panel of infill and location of former window (pre-works)

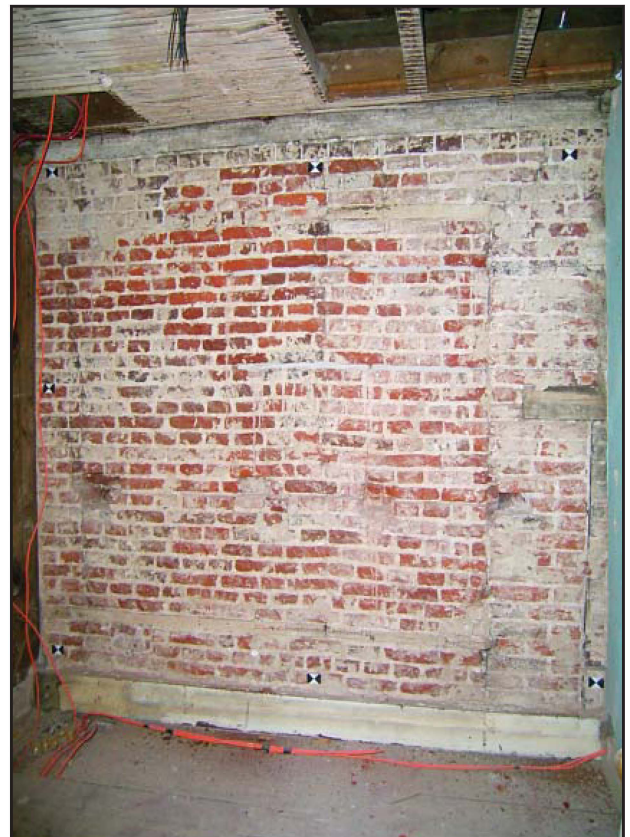
Plate 5: East elevation, internal view, second floor, illustrating vertical Tudor break to south

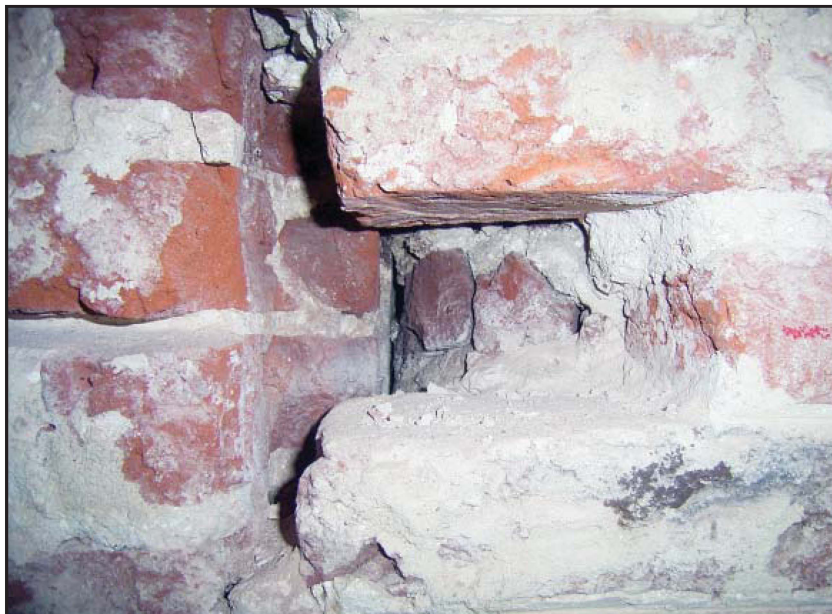
Plate 8: East elevation, internal view, second floor, showing Tudor plaster reveal

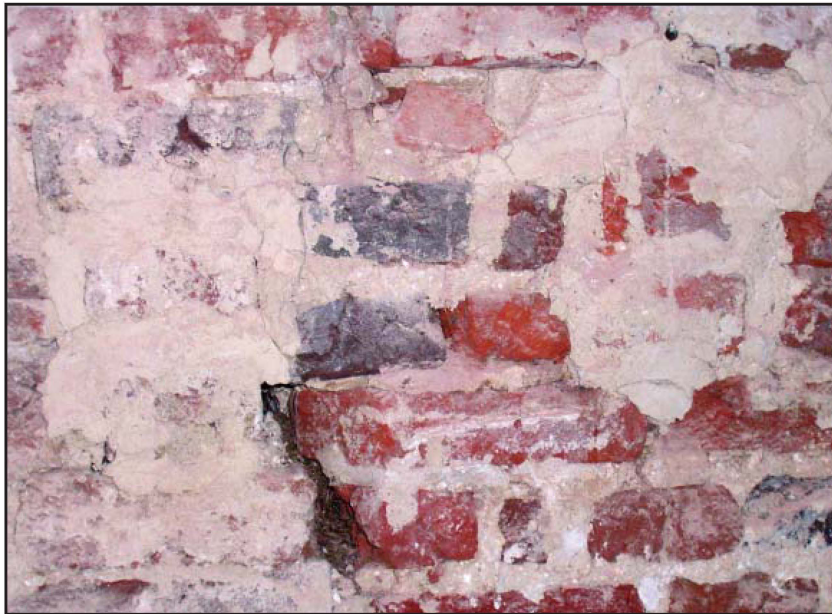
Plate 9: East elevation, internal view, first floor, showing chamfered Tudor brick

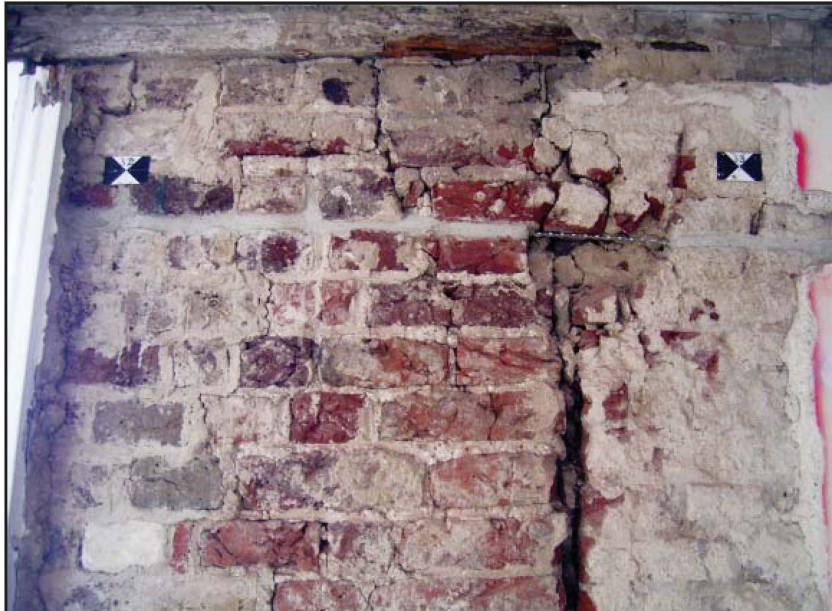
Plate 10: East elevation, internal view, second floor, illustrating truncated Tudor break below ceiling

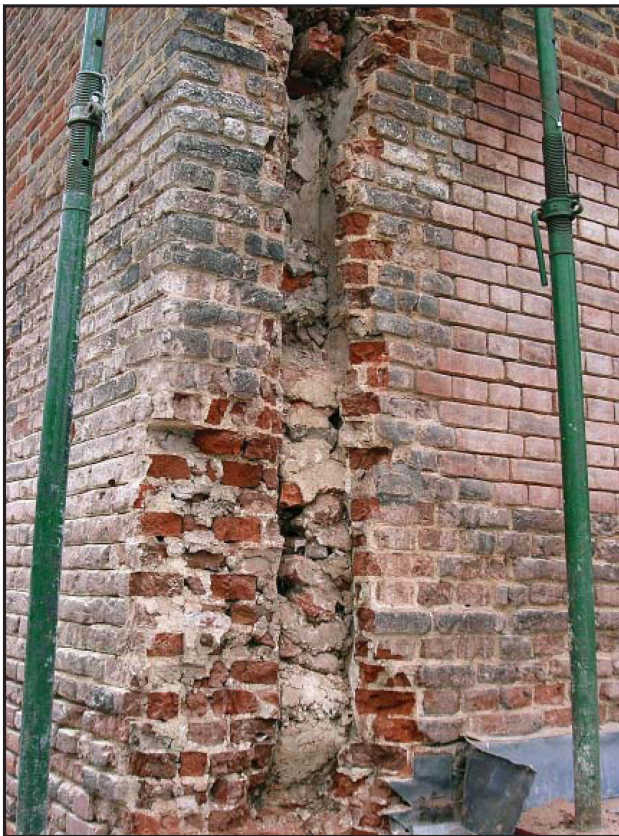
Plate 13: West elevation, external view, showing vertical shaft during removal of rubble infill

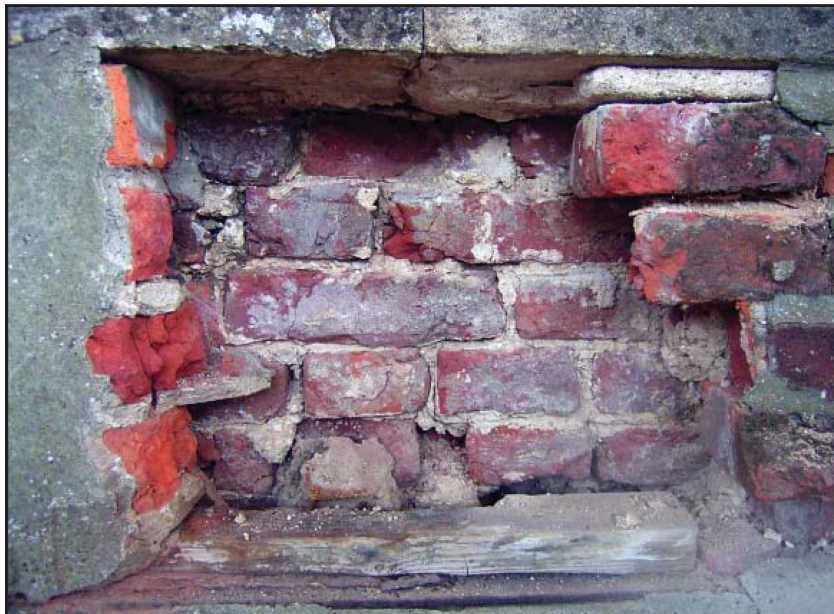
Plate 39: North elevation, first floor, external view, showing brick repair

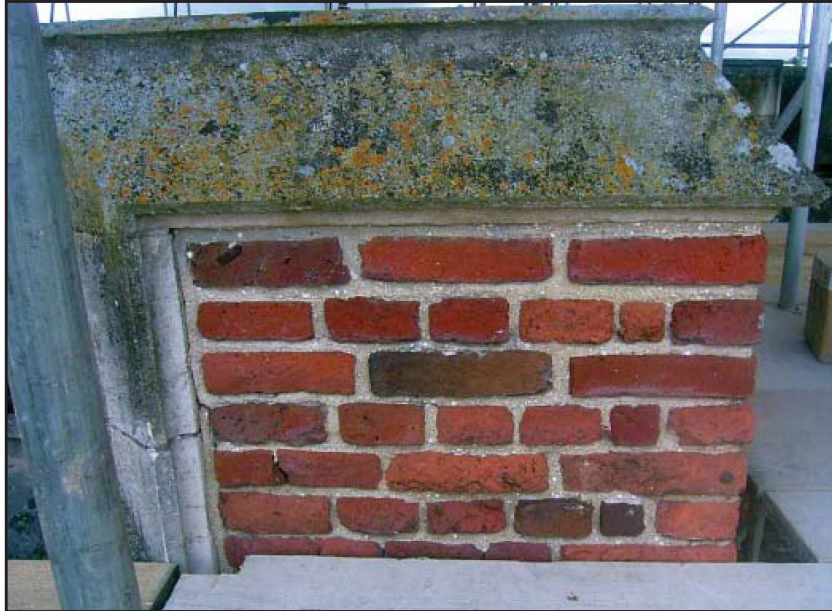
Plate 41: East parapet, internal face, north end illustrating earlier consolidation

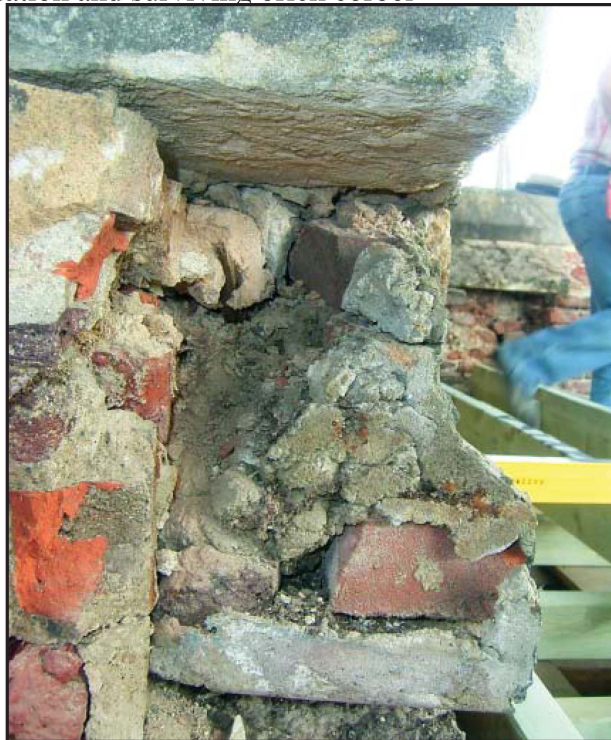
Plate 43: North parapet, east section, internal face, showing consolidation and surviving brick corbel

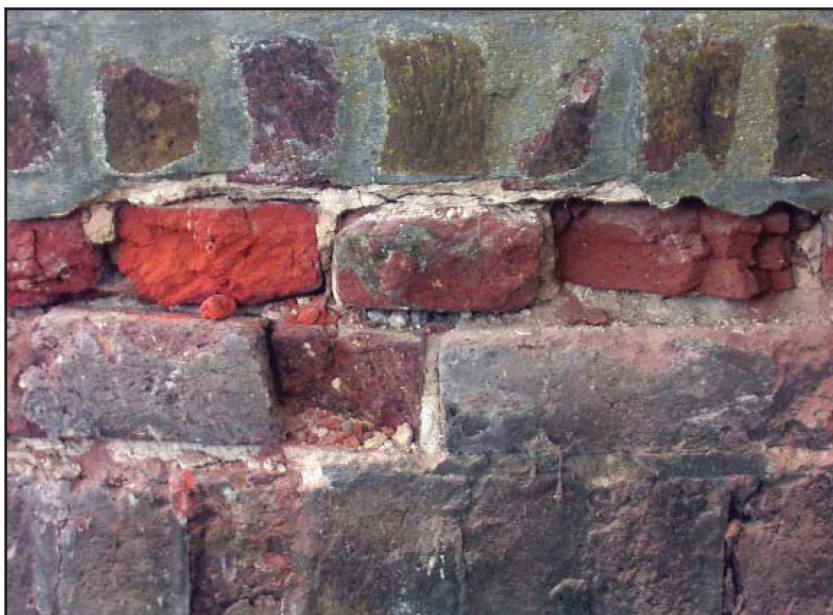
Plate 46: South parapet, internal face, illustrating 20th century rebuild

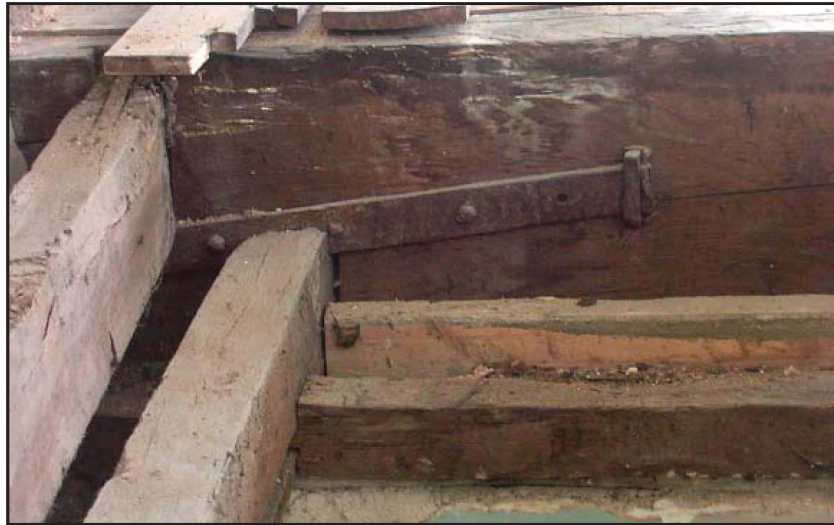
- 9.3.16 The area between the chimney and west elevation revealed softwood joists on a north/south alignment which have been reinforced with additional elements, and these are *c.*0.26 m apart and measure *c.* 0.10 by 0.13 m (Plate 56). They sit on large trusses projecting on an east/west alignment, which are secured with large iron straps (no foundry markings were identified; plate 57). The roof is a somewhat ad

Plate 56: Parapet floor, north view

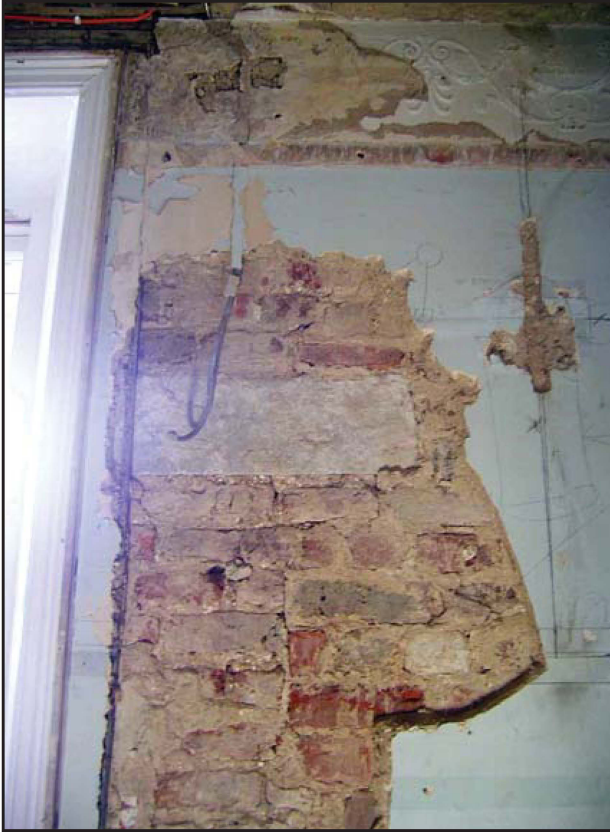
- 9.3.20 The consolidation work is however most clearly shown within the brickwork of the south elevation at first floor level (Plate 58). Here two distinct phases of patching are evident, predominately consolidating the Tudor break to the west and east. The mortar is clearly later and cementitious, but the variation in colour and bricks illustrates that it does not all relate to one phase of works. These phases of patching are also evident on the west and north elevations at first floor level.

Plate 58: South elevation, first floor, internal view, showing 19th and 20th century patching

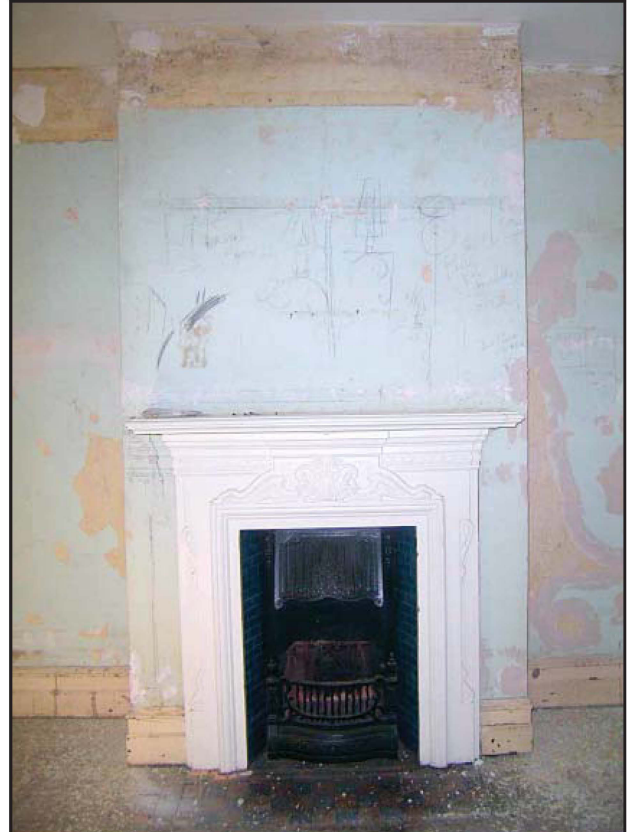
Plate 60: Fireplace, first floor, internal view, room TYFF01

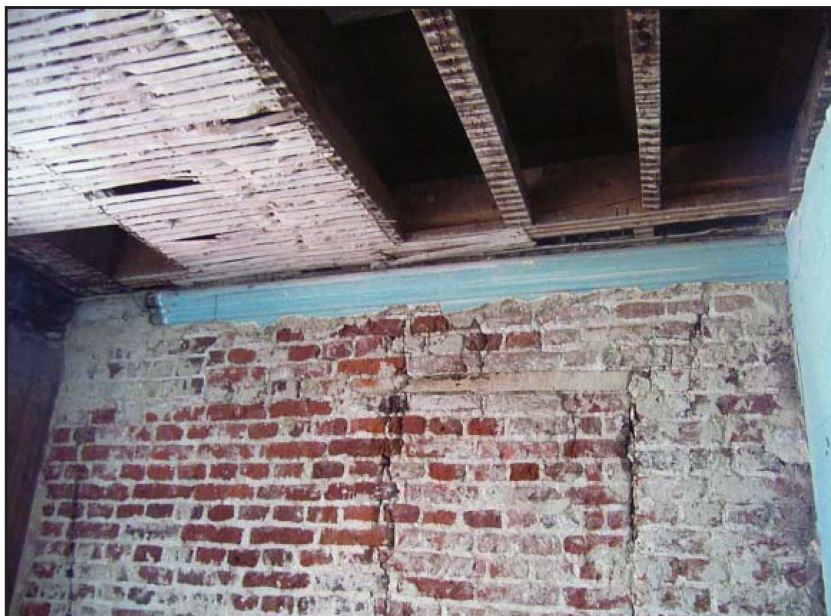
terminating in a tap. At the north end an additional pipe extends down through the floor boards, where it has been cut off to allow for the insertion of later pipes. (Plate 61).

Plate 61: East elevation, internal view, second floor, pipe exposed below ceiling

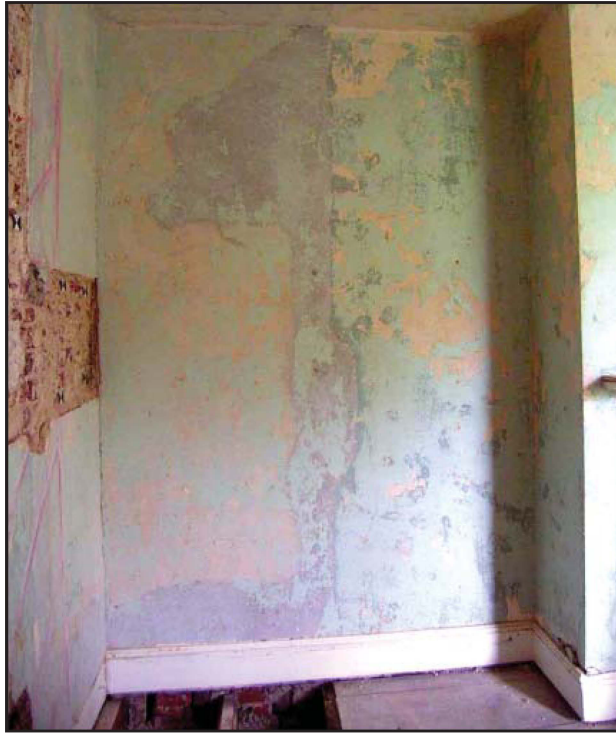
Plate 62: Internal west wall, first floor level, illustrating wall scar from dumb waiter

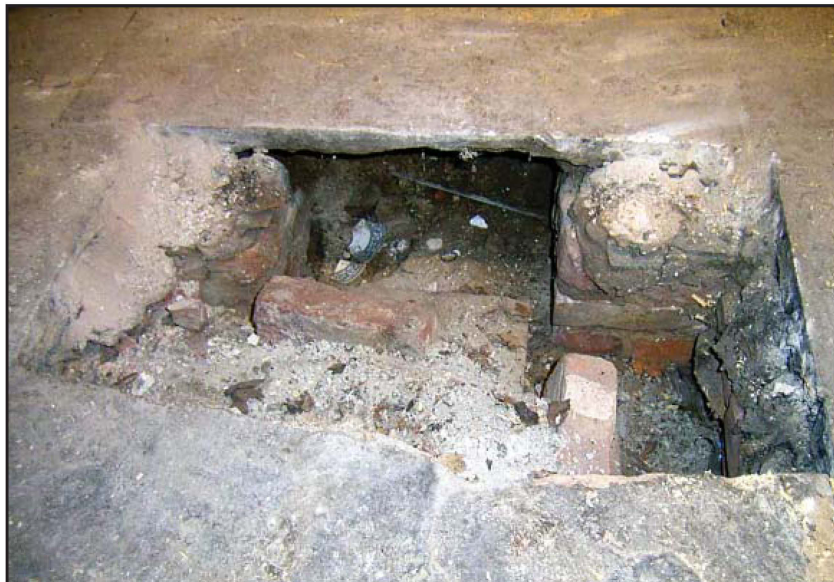
Plate 63: Culvert, internal view, exposed in basement

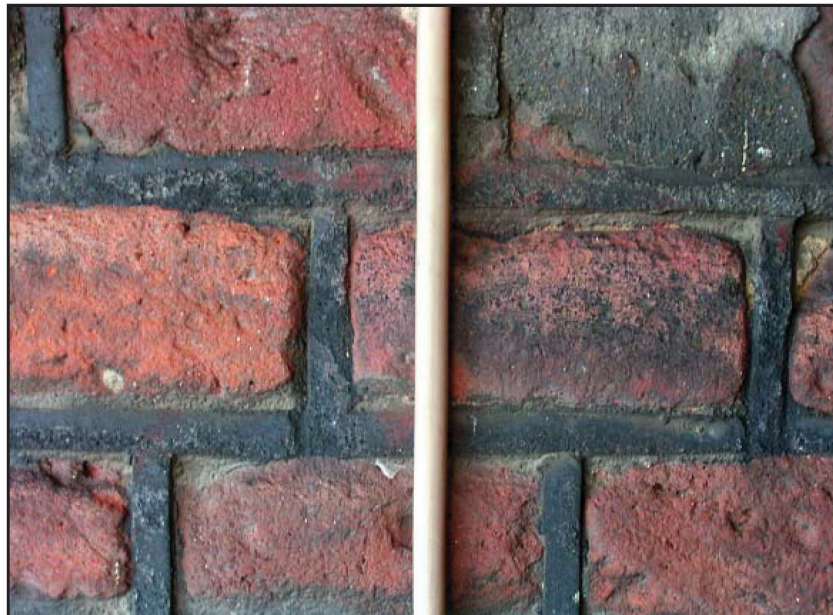
- 9.3.39 Red paint was again used to improve the definition of the building, particularly on the later brickwork surrounding the windows. It seems likely that this area was covered in a layer of red paint following the infill, and subsequently has been pointed in a thin layer of ash coloured mortar. To the north of the windows at first floor level red paint is also evident overlying the black ash pointing (Plate 66). Although this red paint underlies the ribbon pointing, overall the two events are probably contemporary, and the paint has been used to brighten the appearance of the bricks and add contrast to the dark pointing.

Plate 66: West elevation, first floor, external view, illustrating red paint on black ash pointing

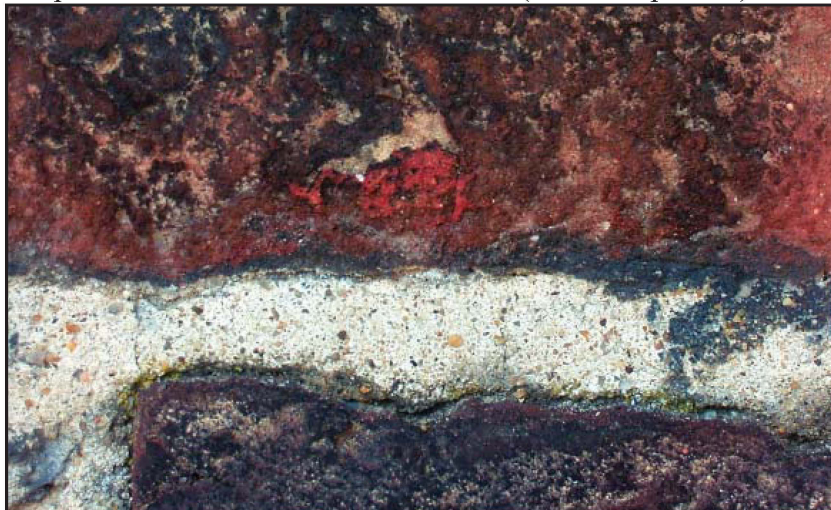
- 9.3.44 The pointing of the *south elevation* is the same type as that to the north of the window on the east elevation, and is of a creamy friable consistency with small pebble inclusions. This has also been darkened to a charcoal colour although it has faded in many places leaving darkened edges around the outline of the bricks only. Red paint is evident on the surface of the bricks, as well as the surface of the mortar, which demonstrates that the pointing and paint scheme are contemporary (Plate 69). It was probably intended to paint the bricks and this is a ‘slip of the hand’ by the workman. The differential cracks between the phases have also been patched up and again this is contemporary with the pointing. The mortar has been coloured to conform with the surrounding bricks in an effort to provide a straight alignment to the coursing.

Plate 69: South elevation, external view, red paint evident on brick (centre of picture)
