School End Farm, Great Horwood

Historic Buildings Recording and Archaeological Watching Brief

Client Name: Mrs Chrissie Cheshire
Document Title: School End Farm, Great Horwood, Buckinghamshire

Document Type: Historic Building Recording and Archaeological Watching Brief
Issue Number: 1

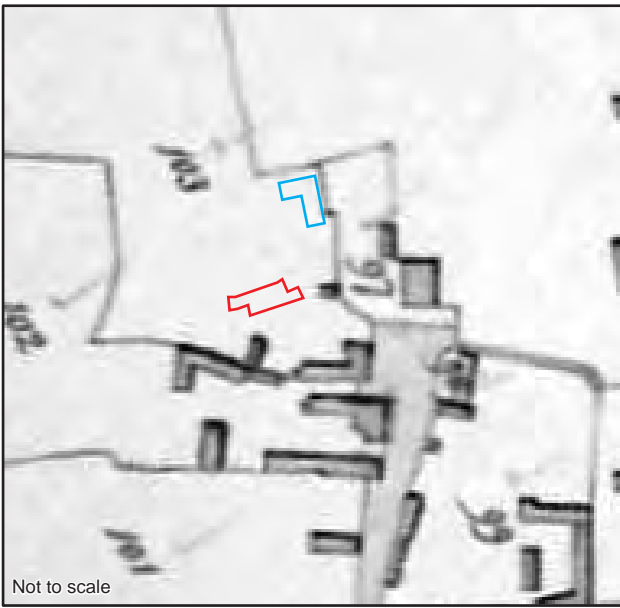
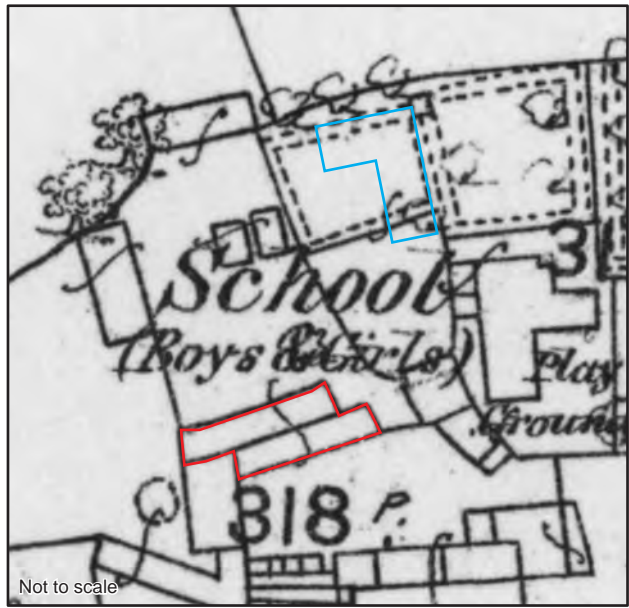
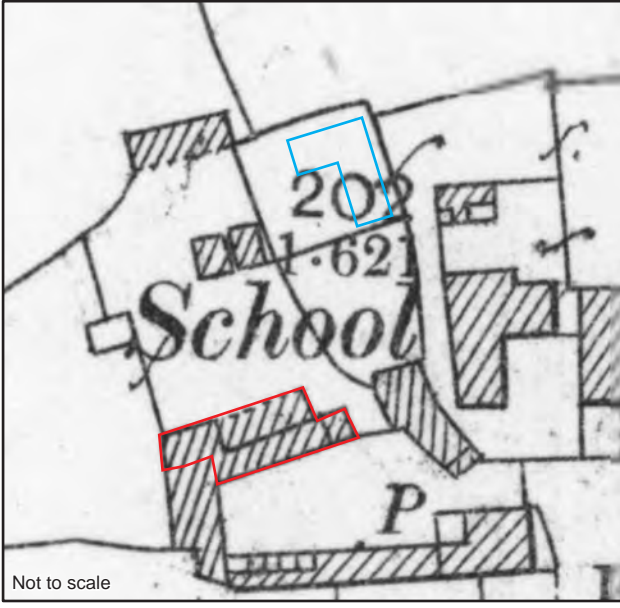
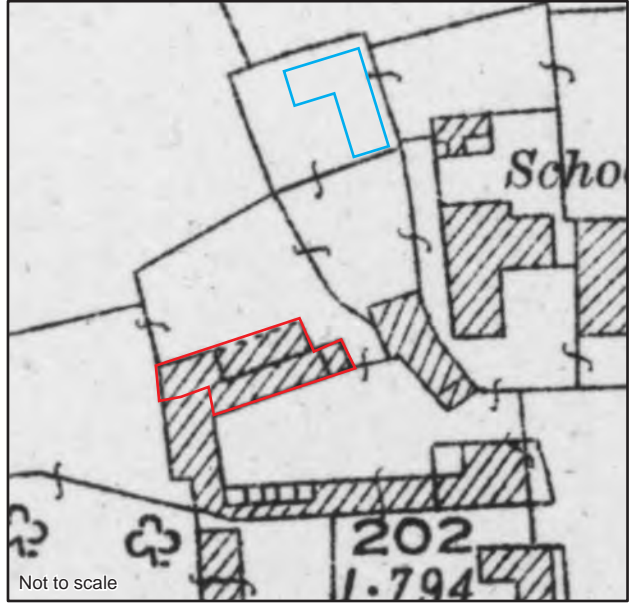
Figure 3: Map regression

- 4.2.2 The first Ordnance Survey map of this area was surveyed and published in 1880, the second and third editions were revised in 1898 and 1923 and each published two years later. Each edition depicts several changes in the boundaries of the site and the evolution of the outbuildings, none of which are now extant (Fig 3).

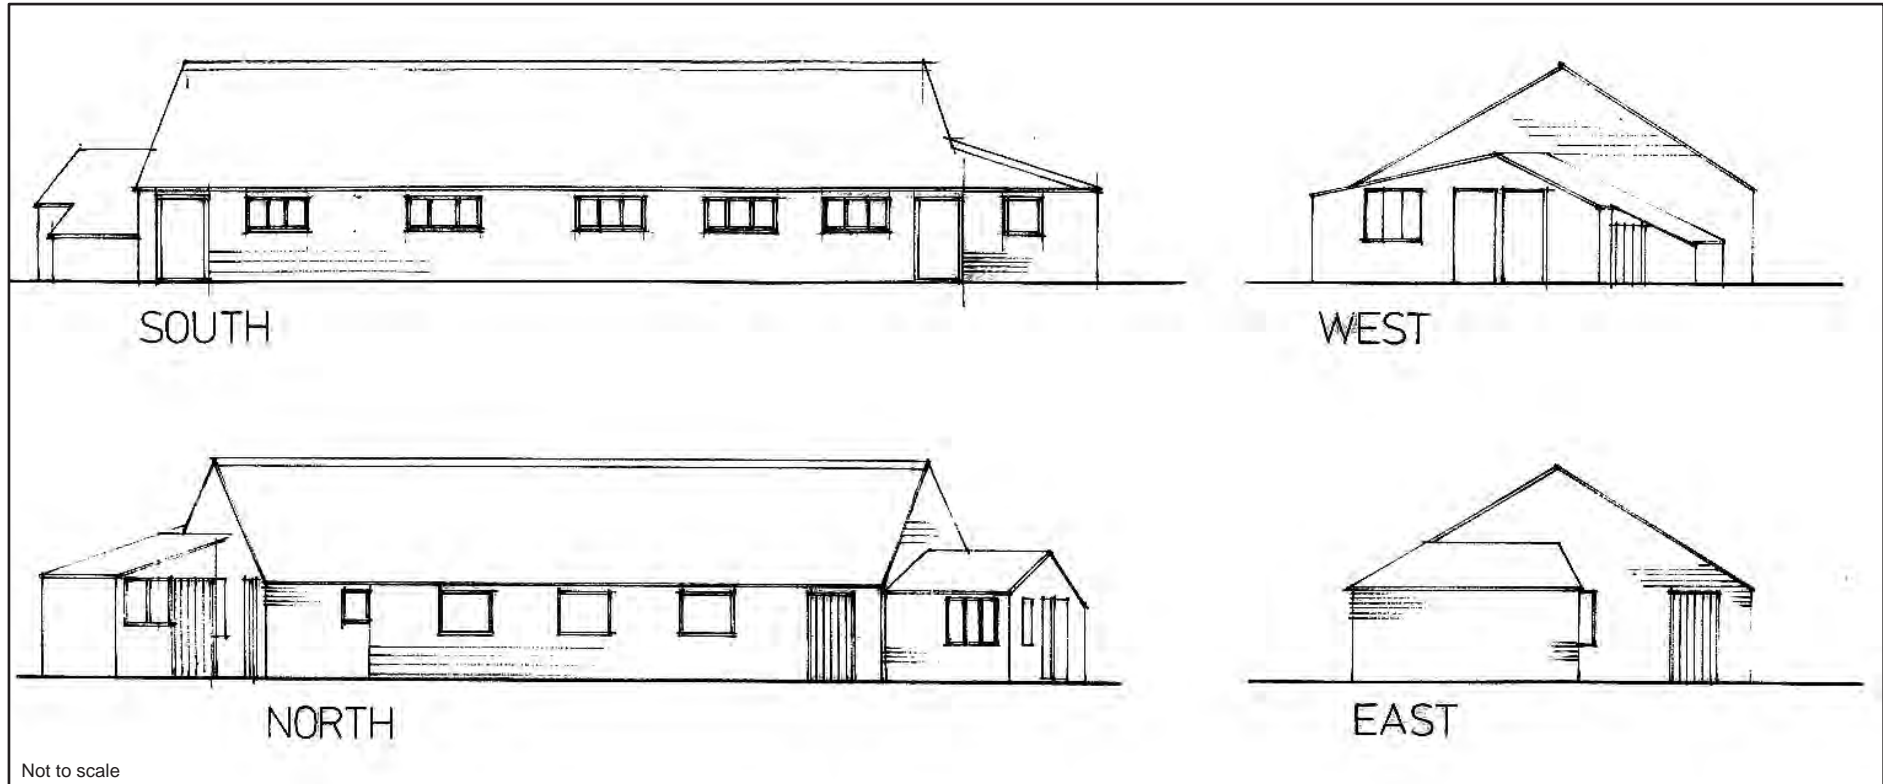
Figure 4: Elevations of the barn, based on drawings by Blenheim Design and Management

- 5.2.1 The barn is a trapezoidal in plan, single-storey timber-clad, timber-framed building with a slate-covered roof (Pls 6-9). The north elevation of the east bay, the east wall to eaves level and plinths in various places are of brick. It is extended to either end: by a brick-built lean-to with a slate roof to the east end and a timber-clad lean-to with a double-pitched corrugated metal-roof to the west end (Figs 4&5).

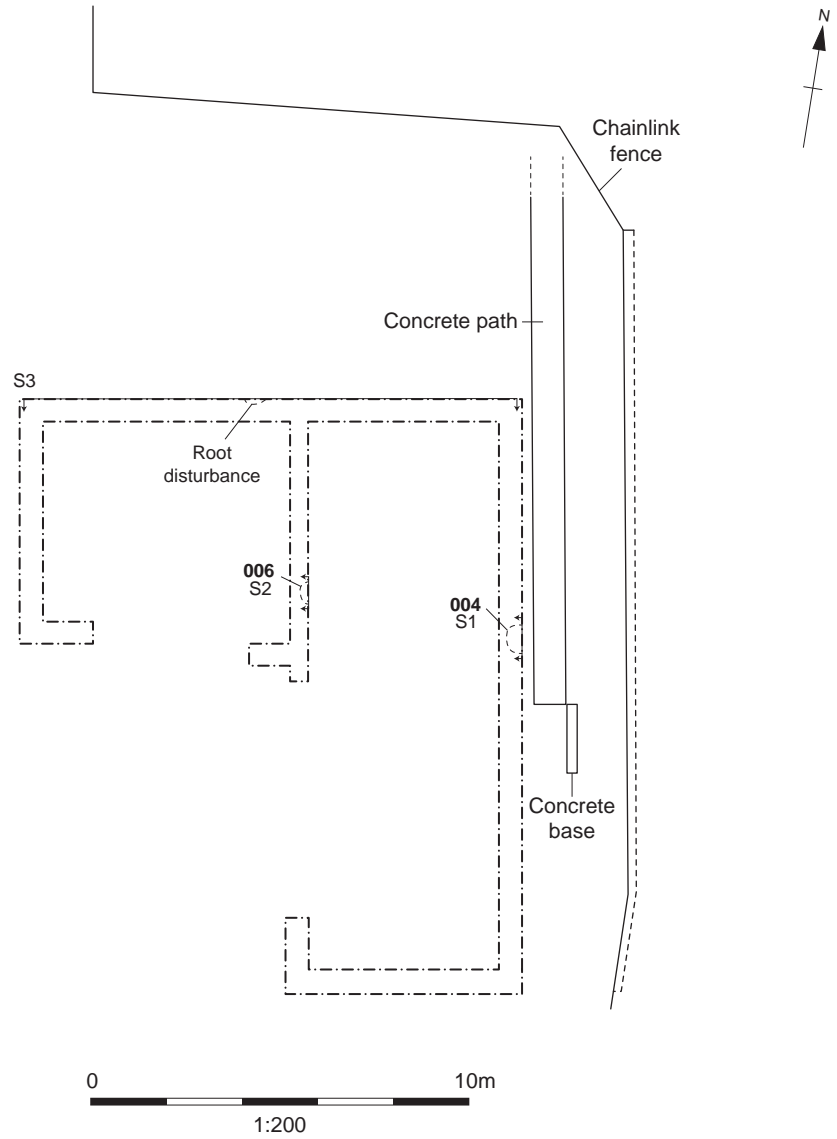
Figure 6: Plan of foundation excavations

- 6.1.2 The foundation trench, as previously discussed, was excavated by machine during the course of one dry day (Fig 6). The well-drained subsoil and natural were undisturbed in the main, with only one instance of fairly minimal tree-root disturbance to the northern edge of the foundation trench, close to the tree-lined boundary (PI 30). Only two cut features were observed in the excavated area: one possible posthole [004] at the eastern edge, close to the concrete path and base, and a pit [006] close to the centre of the site which contained early 20th-century domestic rubbish (Fig 7). Occasional pieces of 19th-century pottery, some fairly large, and 20th-century rubbish, including lost toys, were found in the topsoil.
