Baldwins Farm P e b w o r t h Worcestershire

Historic Building Recording and Archaeological Watching Brief

July 2007

Client: Dean Park Contracts

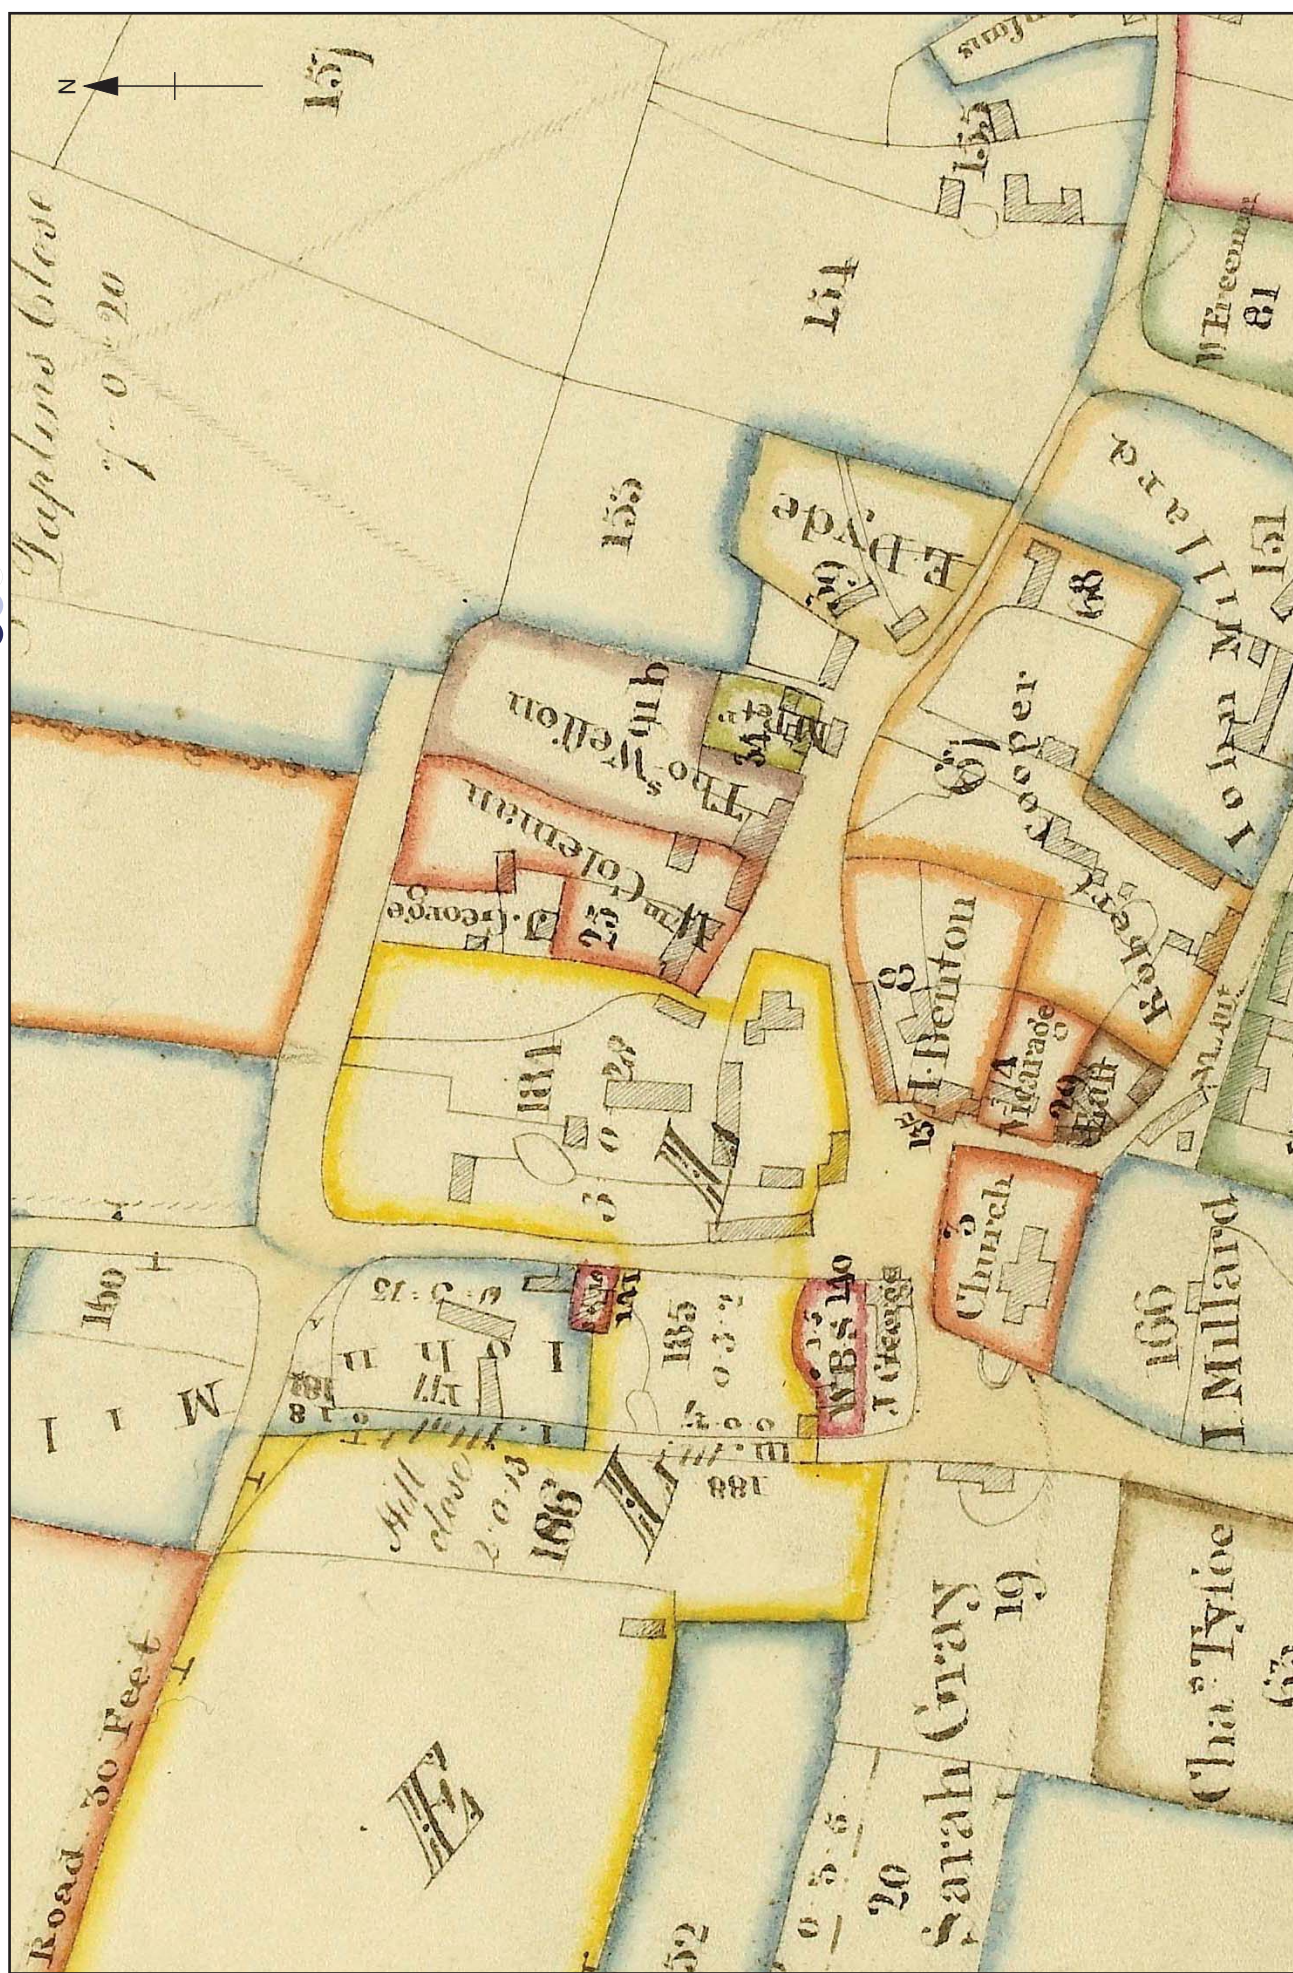
Figure 4: Detail from Pebworth Inclosure map of 1814, Baldwins farm is outlined in Yellow. (Courtesy of Worcestershire & Gloucestershire Record Office)

- 2.1.3 There is little historical material relating directly to the farm. An Inclosure map of Pebworth of 1814 shows the farm and buildings but not in enough detail to add much to the understanding of the buildings' development (Figure 3). The map shows a long east to west range which must represent the main barn and 'dovecote' (blocks A & B) a north to south range south of this probably represents the '1831' barn (block D) before the 1831 rebuild although the spacing of these on the map is not exactly as on the ground. The two ranges are not connected suggesting that shelter shed (block C) was not yet constructed. The stone building adjoining the north-west corner of the '1831' barn is also not shown and therefore probably later. There is an irregular block to the east which has gone and other ranges to the south west and north that no longer exist.

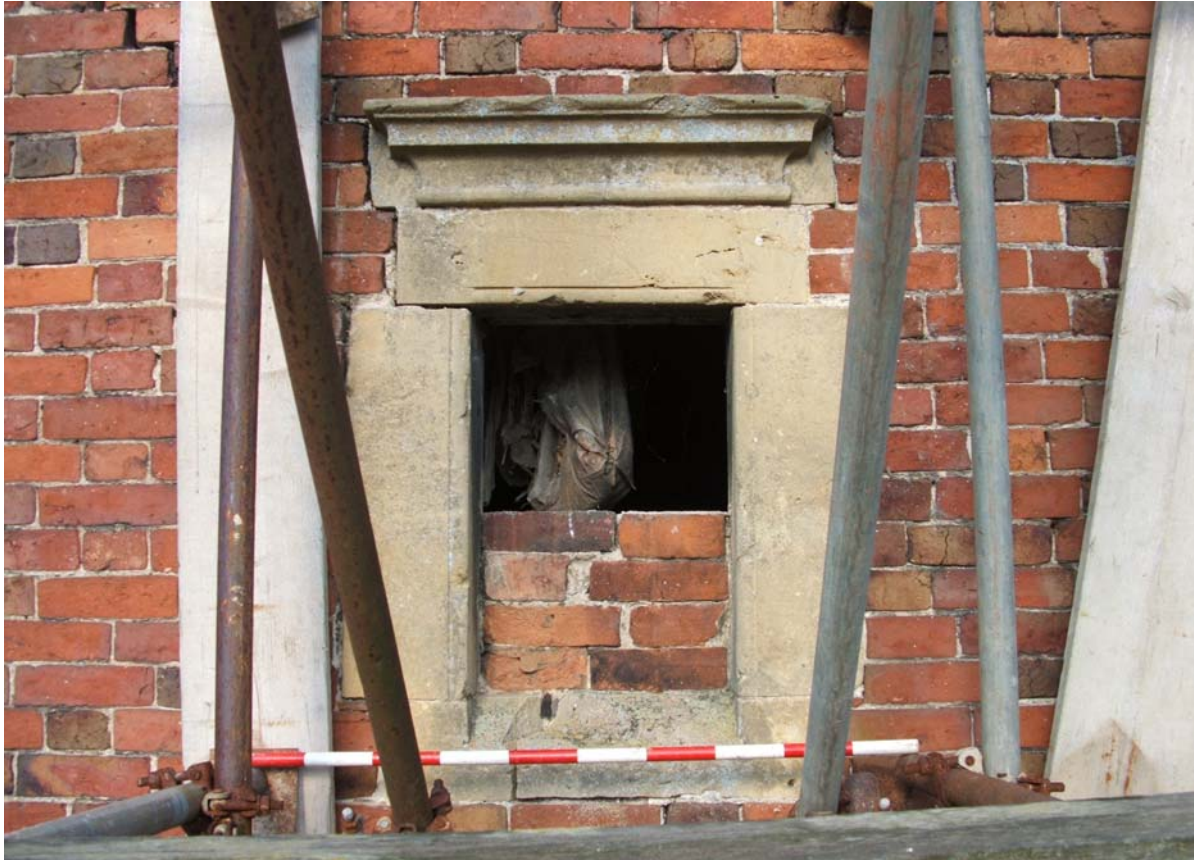
Plate 2: Block A, South window

- 3.1.5 The main front of the building faced south into the yard and had a central wide stable door with a small rectangular stone surrounded window to either side (Plate 1). The door had a segmental brick arch which was a later insertion. The stone window surrounds consisted of a single sill block with a chamfered splay and plain jambs and a lintel each of one block with a slight beading detail (Plate 2). Above the plain lintel was a slightly wider stone over lintel or cornice with a decorative projecting compound moulding which effectively functioned as a drip moulding. The window openings measured 0.38m x 0.50m and were not glazed but there was evidence that there had formerly been two vertical iron bars set into the surrounds. These may have been glazing bars or just security bars. The lower half of the west window had been blocked later in brickwork.
