# Vanners, Bucklebury

## Historic Building Recording

May 2017

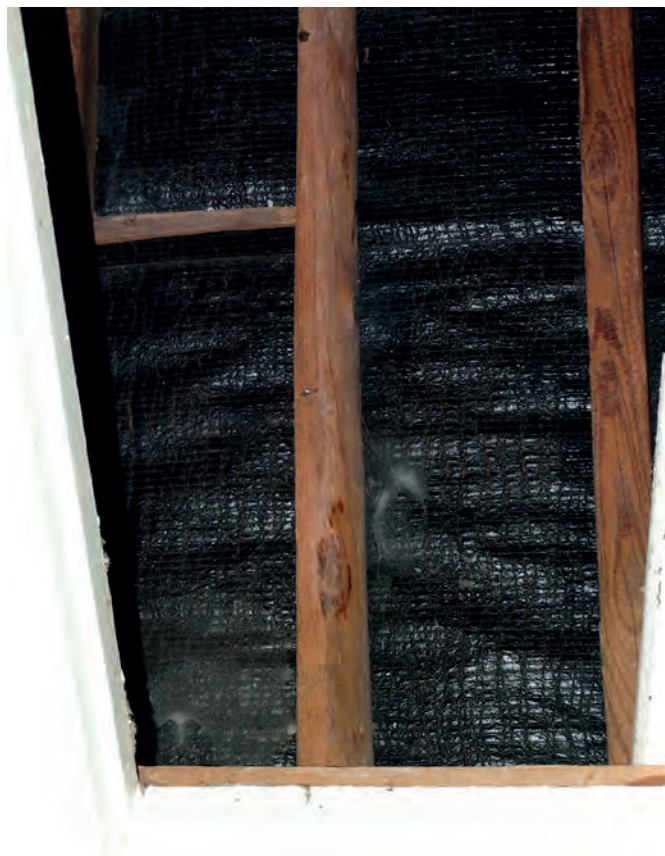
Plate 7: The modern sarking felt to the roof above the Study

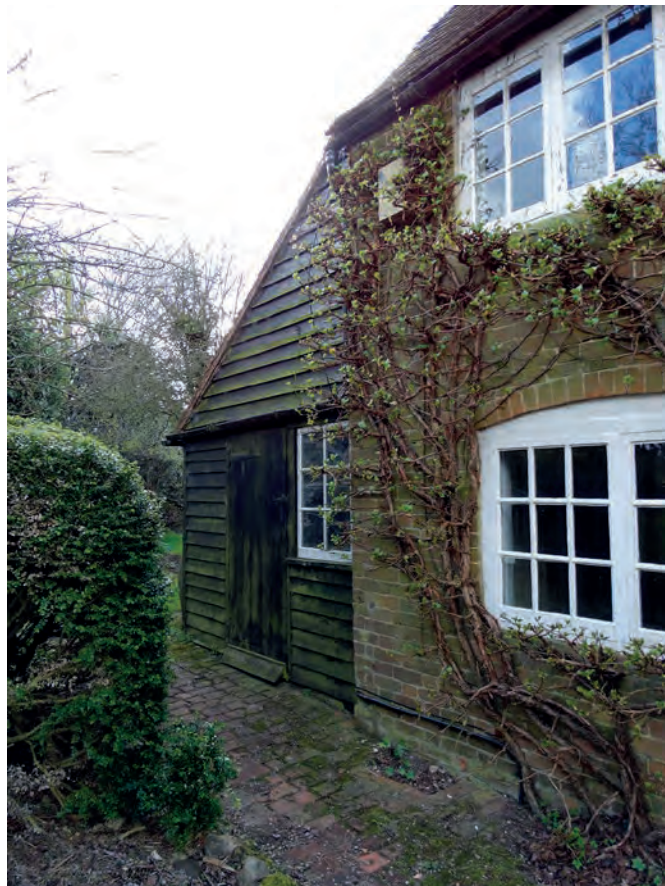
Plate 9: The timber-clad lean-to to the south elevation

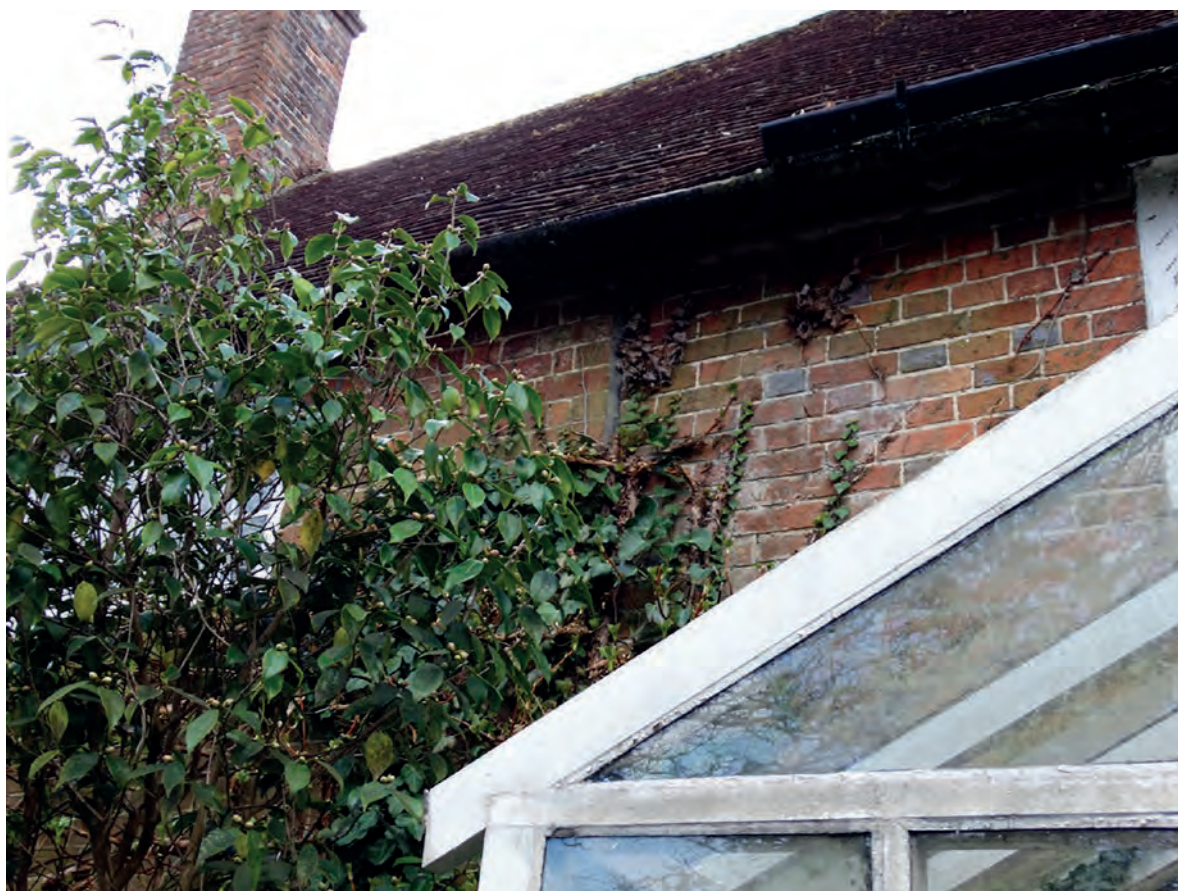
The 19th-century brick façade replaced the timber frame of the east wall in two phases, although both fairly close in date. The brickwork fronting the central and southern bays is continuous; the brickwork of the northernmost bay of the original building is very

Plate 11: The join in the brick façades of the central and north bays

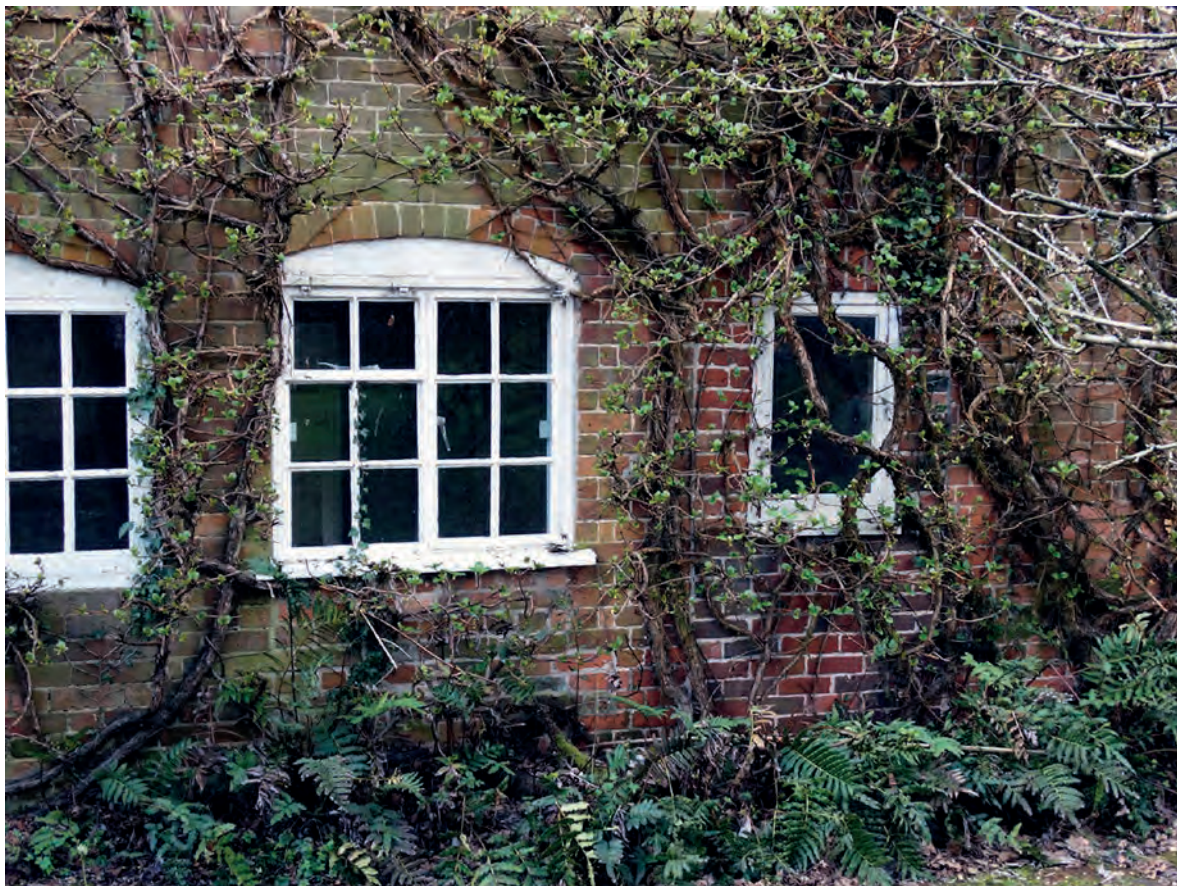
Plate 12: The two partially blocked openings in the east elevation

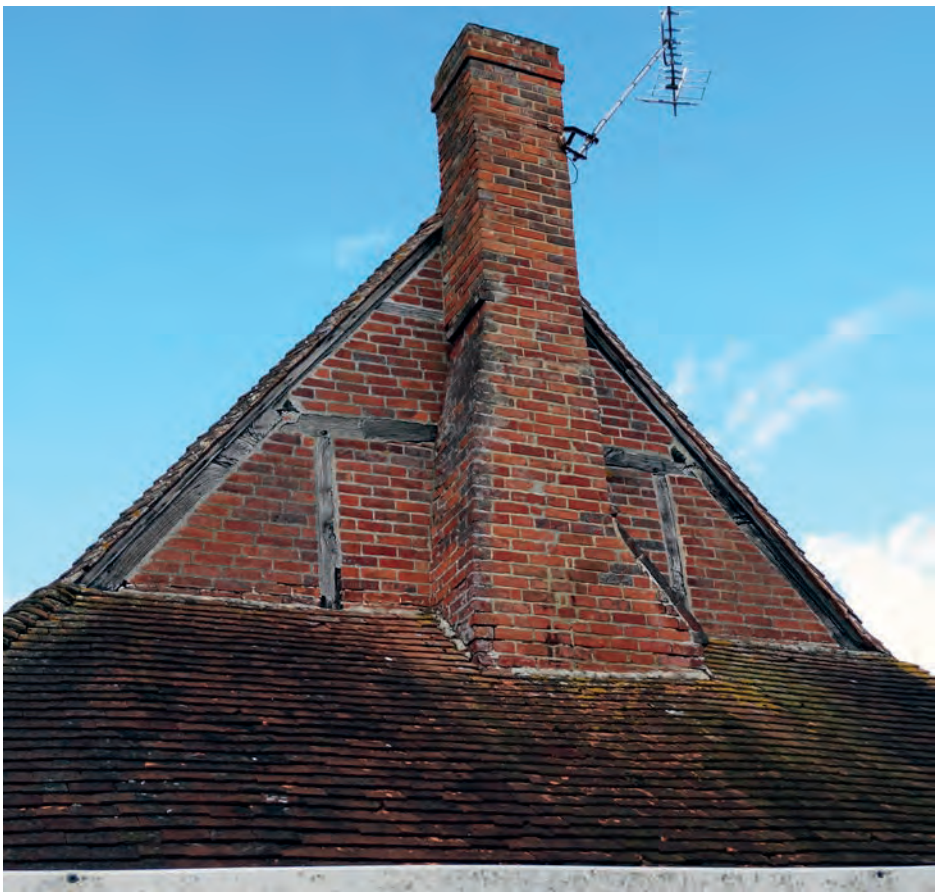
Plate 18: The timber frame visible in the south elevation
