# The Abbey Sutton Courtenay Vale of White Horse Oxfordshire

**Historic Building Investigation  
and Recording**

October 2007

**Client: Westwaddy ADP for  
The Abbey, Sutton Courtenay**

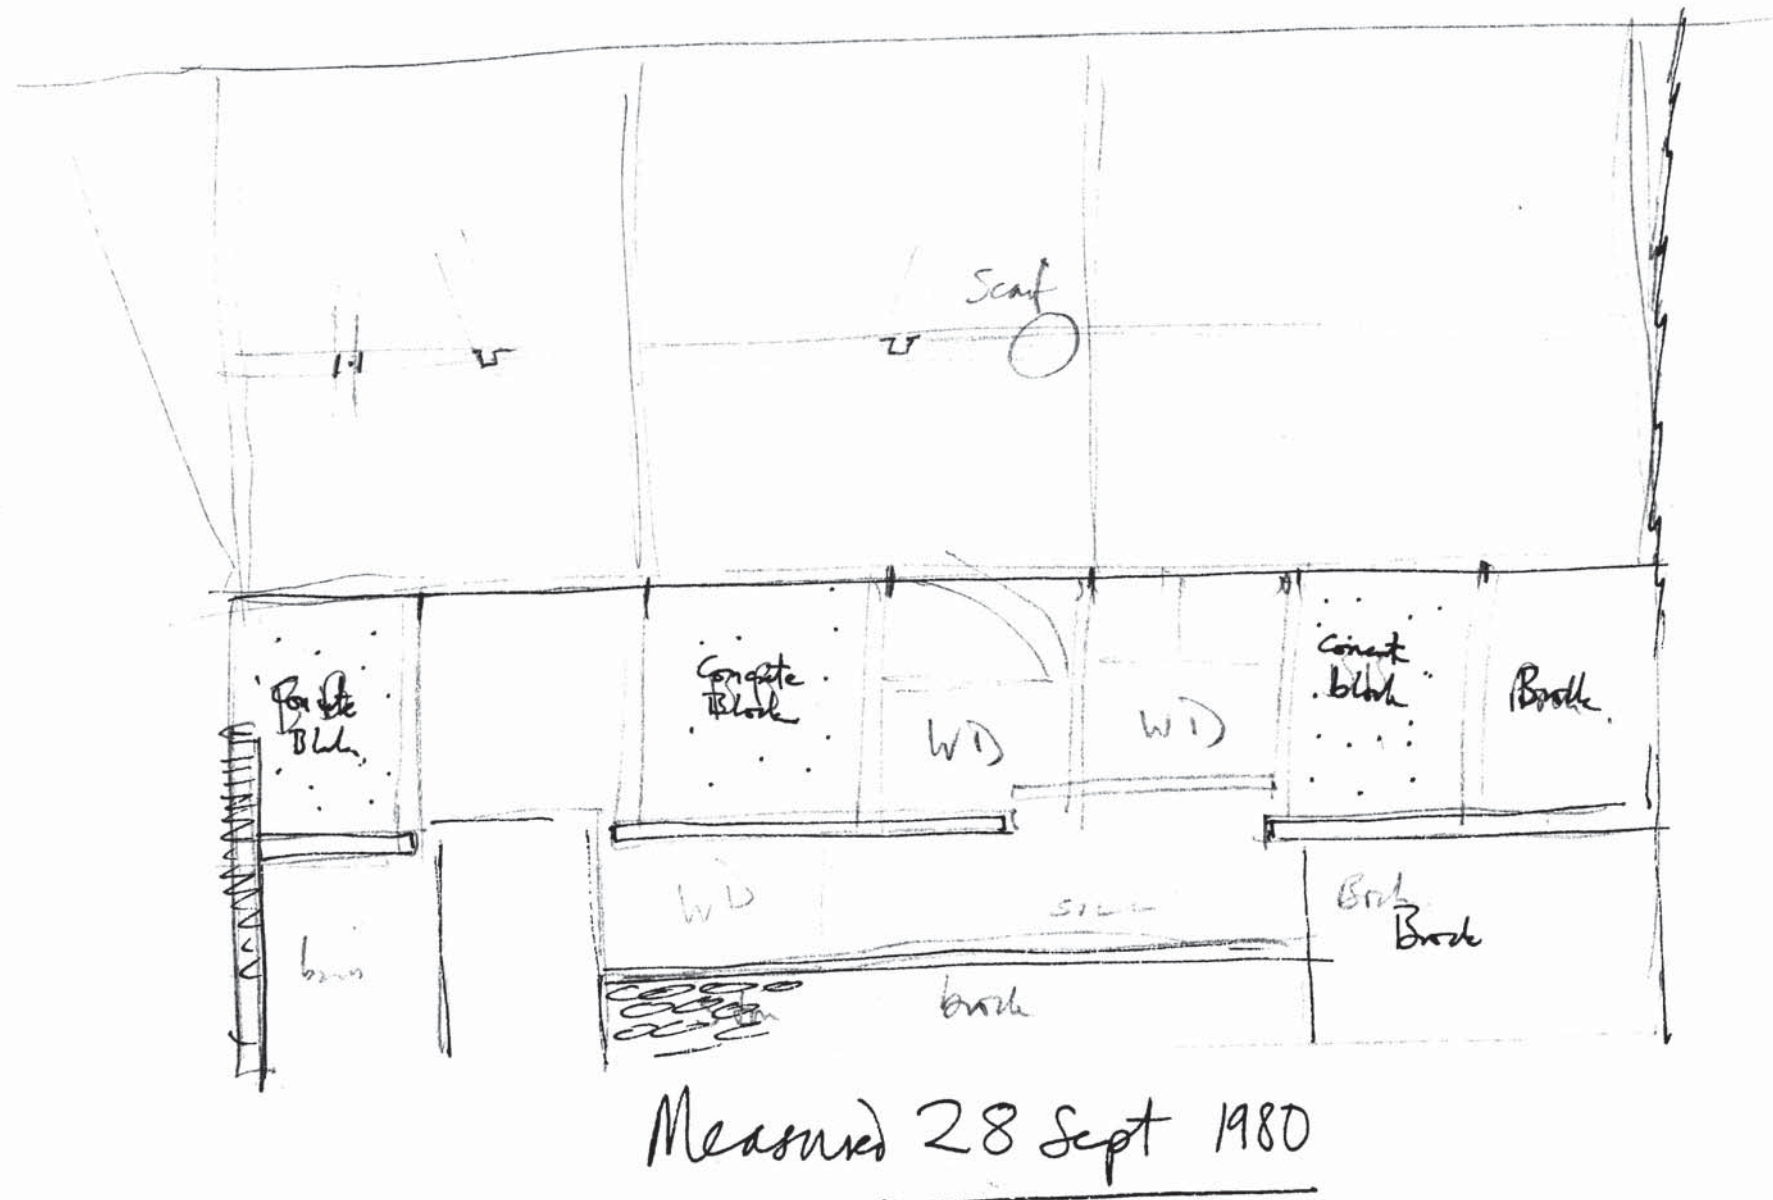
Figure 1: Sketch of south courtyard elevation during 1980s work (courtesy of Julian Munby)

- 4.1.5 The sketch of the south courtyard wall (Figure 1) shows that some wattle and daub infill survives (WD on the drawing) along with later brick infill panels and three upper panels filled with modern concrete blocks. This information will be useful particularly when removing large areas of render from the wattle and daub infill as this may be primary and of great historic significance as well as being more fragile.

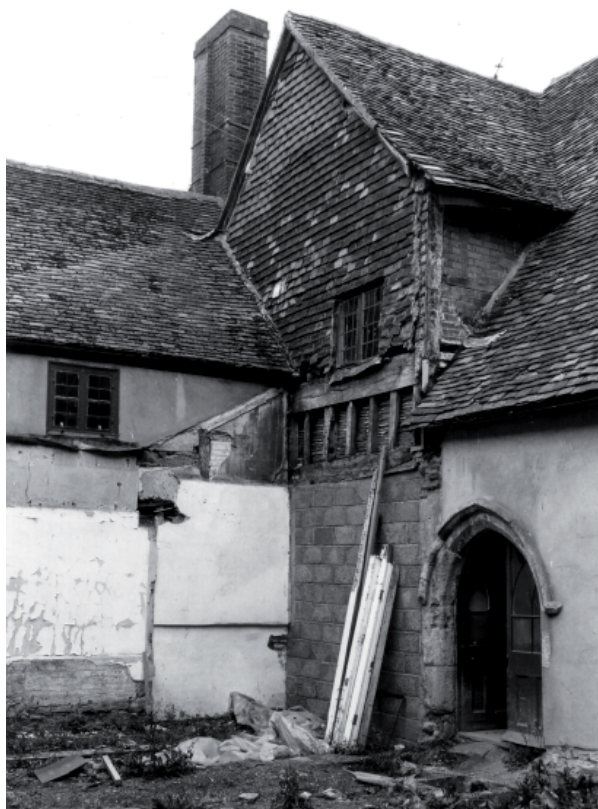
Plate 66: South-west corner of courtyard during works c1981

was subsequently tile hung to match the upper gable. Several intermediate posts can be seen rising from the substantial plate. The wall below the plate is infilled with concrete blocks and possibly this had been open into the lean-to but previous to the lean-to being added there would have been some framing here (Plate 66).
