Dorchester Abbey Dorchester on Thames Oxfordshire

Historic Buildings Analysis

Oxford Archaeology

July 2004

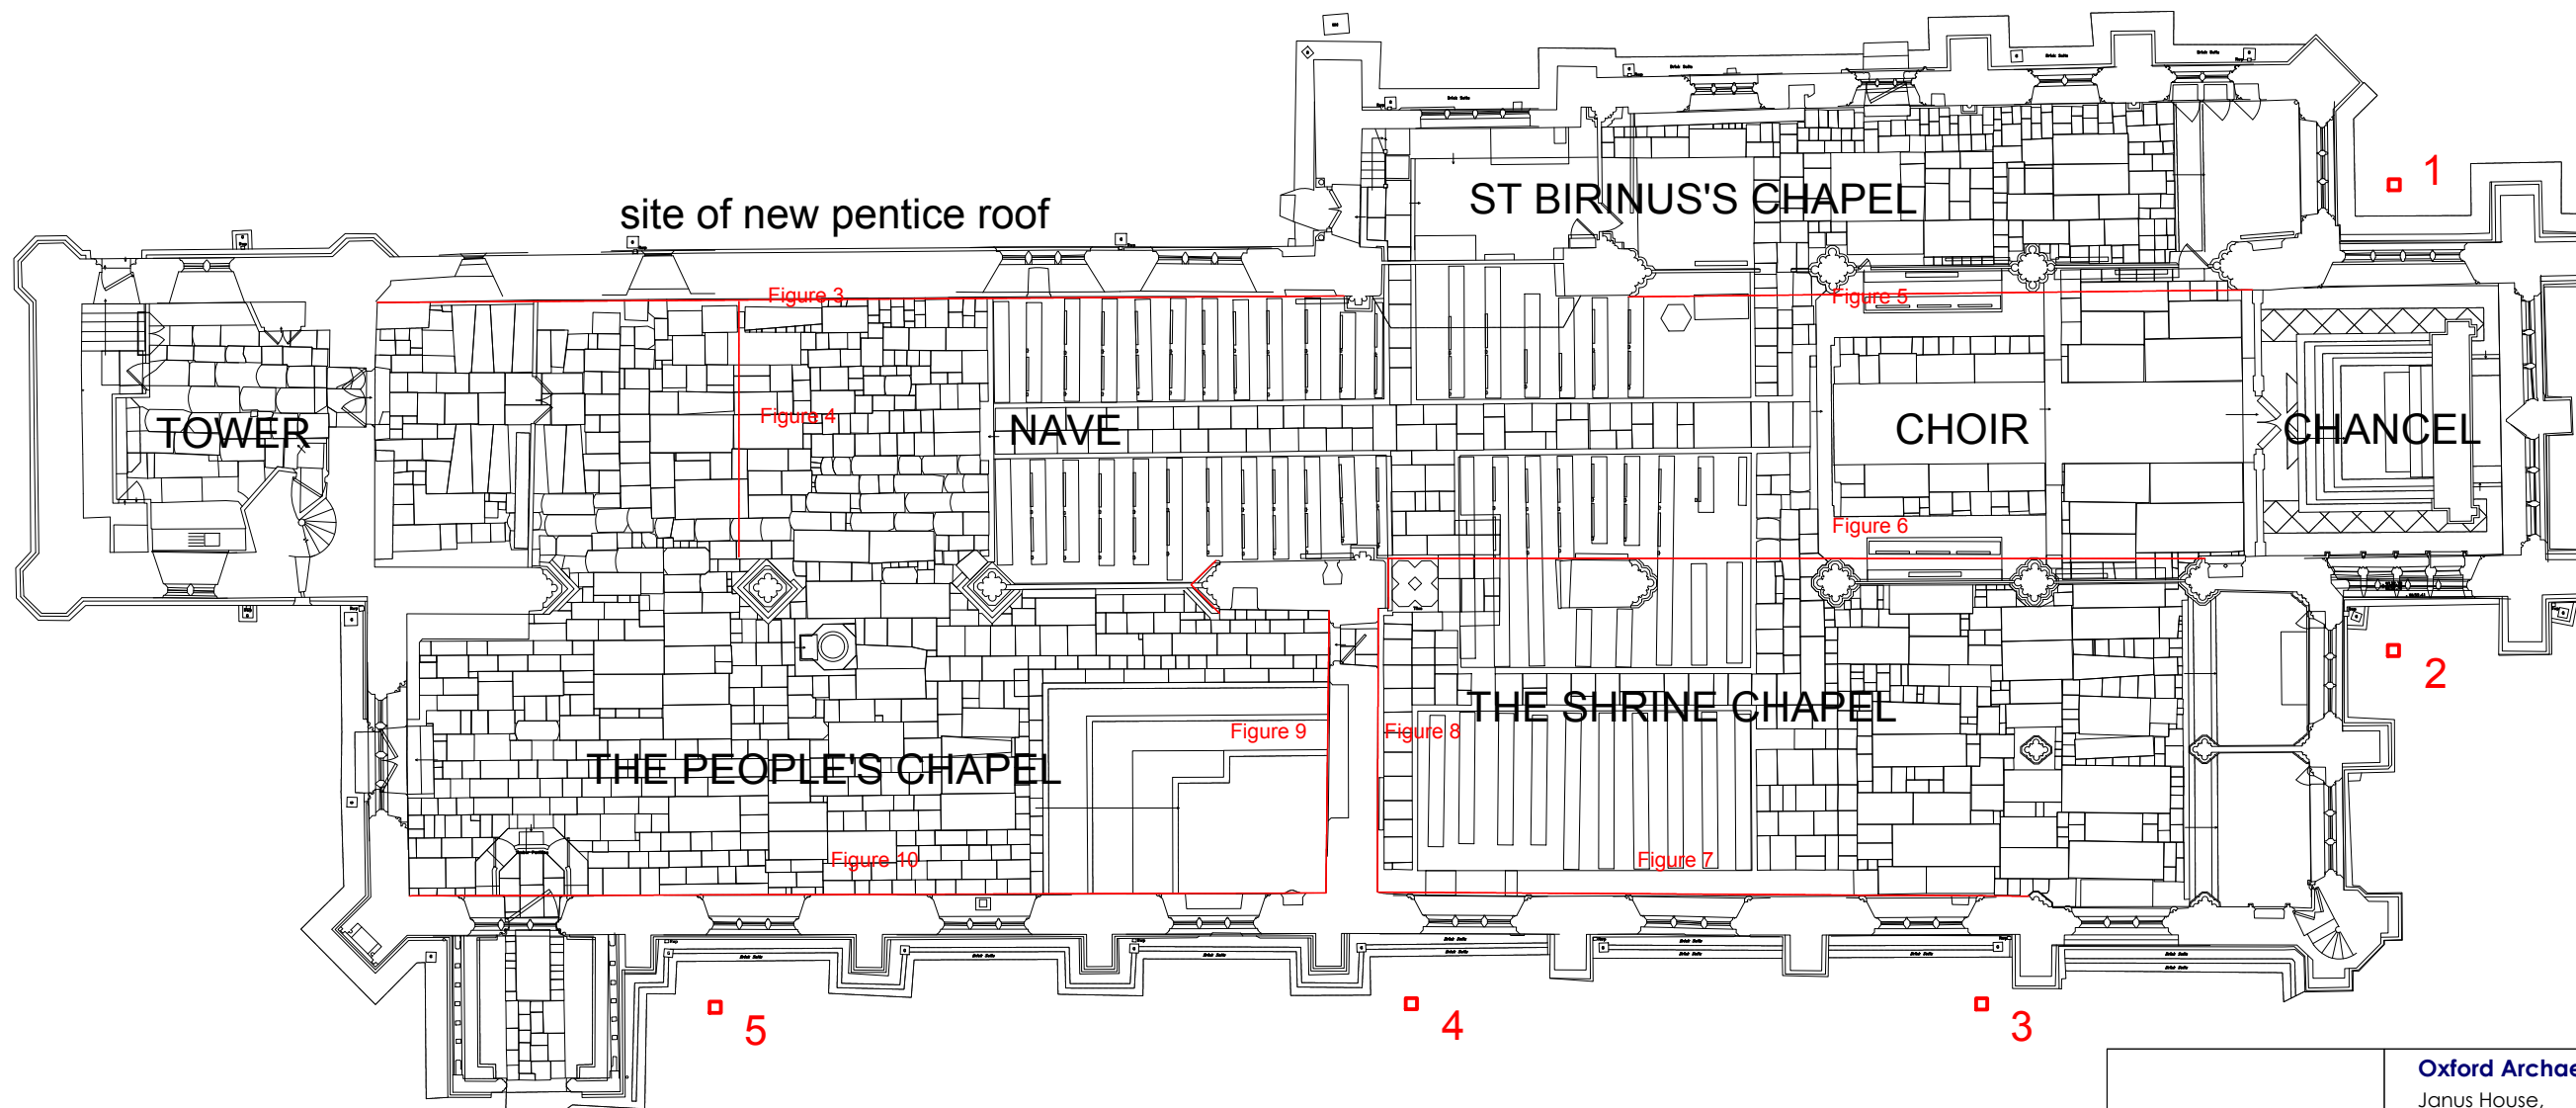
Five small pits were excavated around the exterior of the church by the contractors (see Fig 2). These were designed as earthing points for lightning conductors. These were inspected by OA on 10 April 2003. Each hole was 30cm by 30cm and up to 30cm deep. One was sited on each side of the projecting chancel and the remaining three were along the south wall between the east end and the porch.

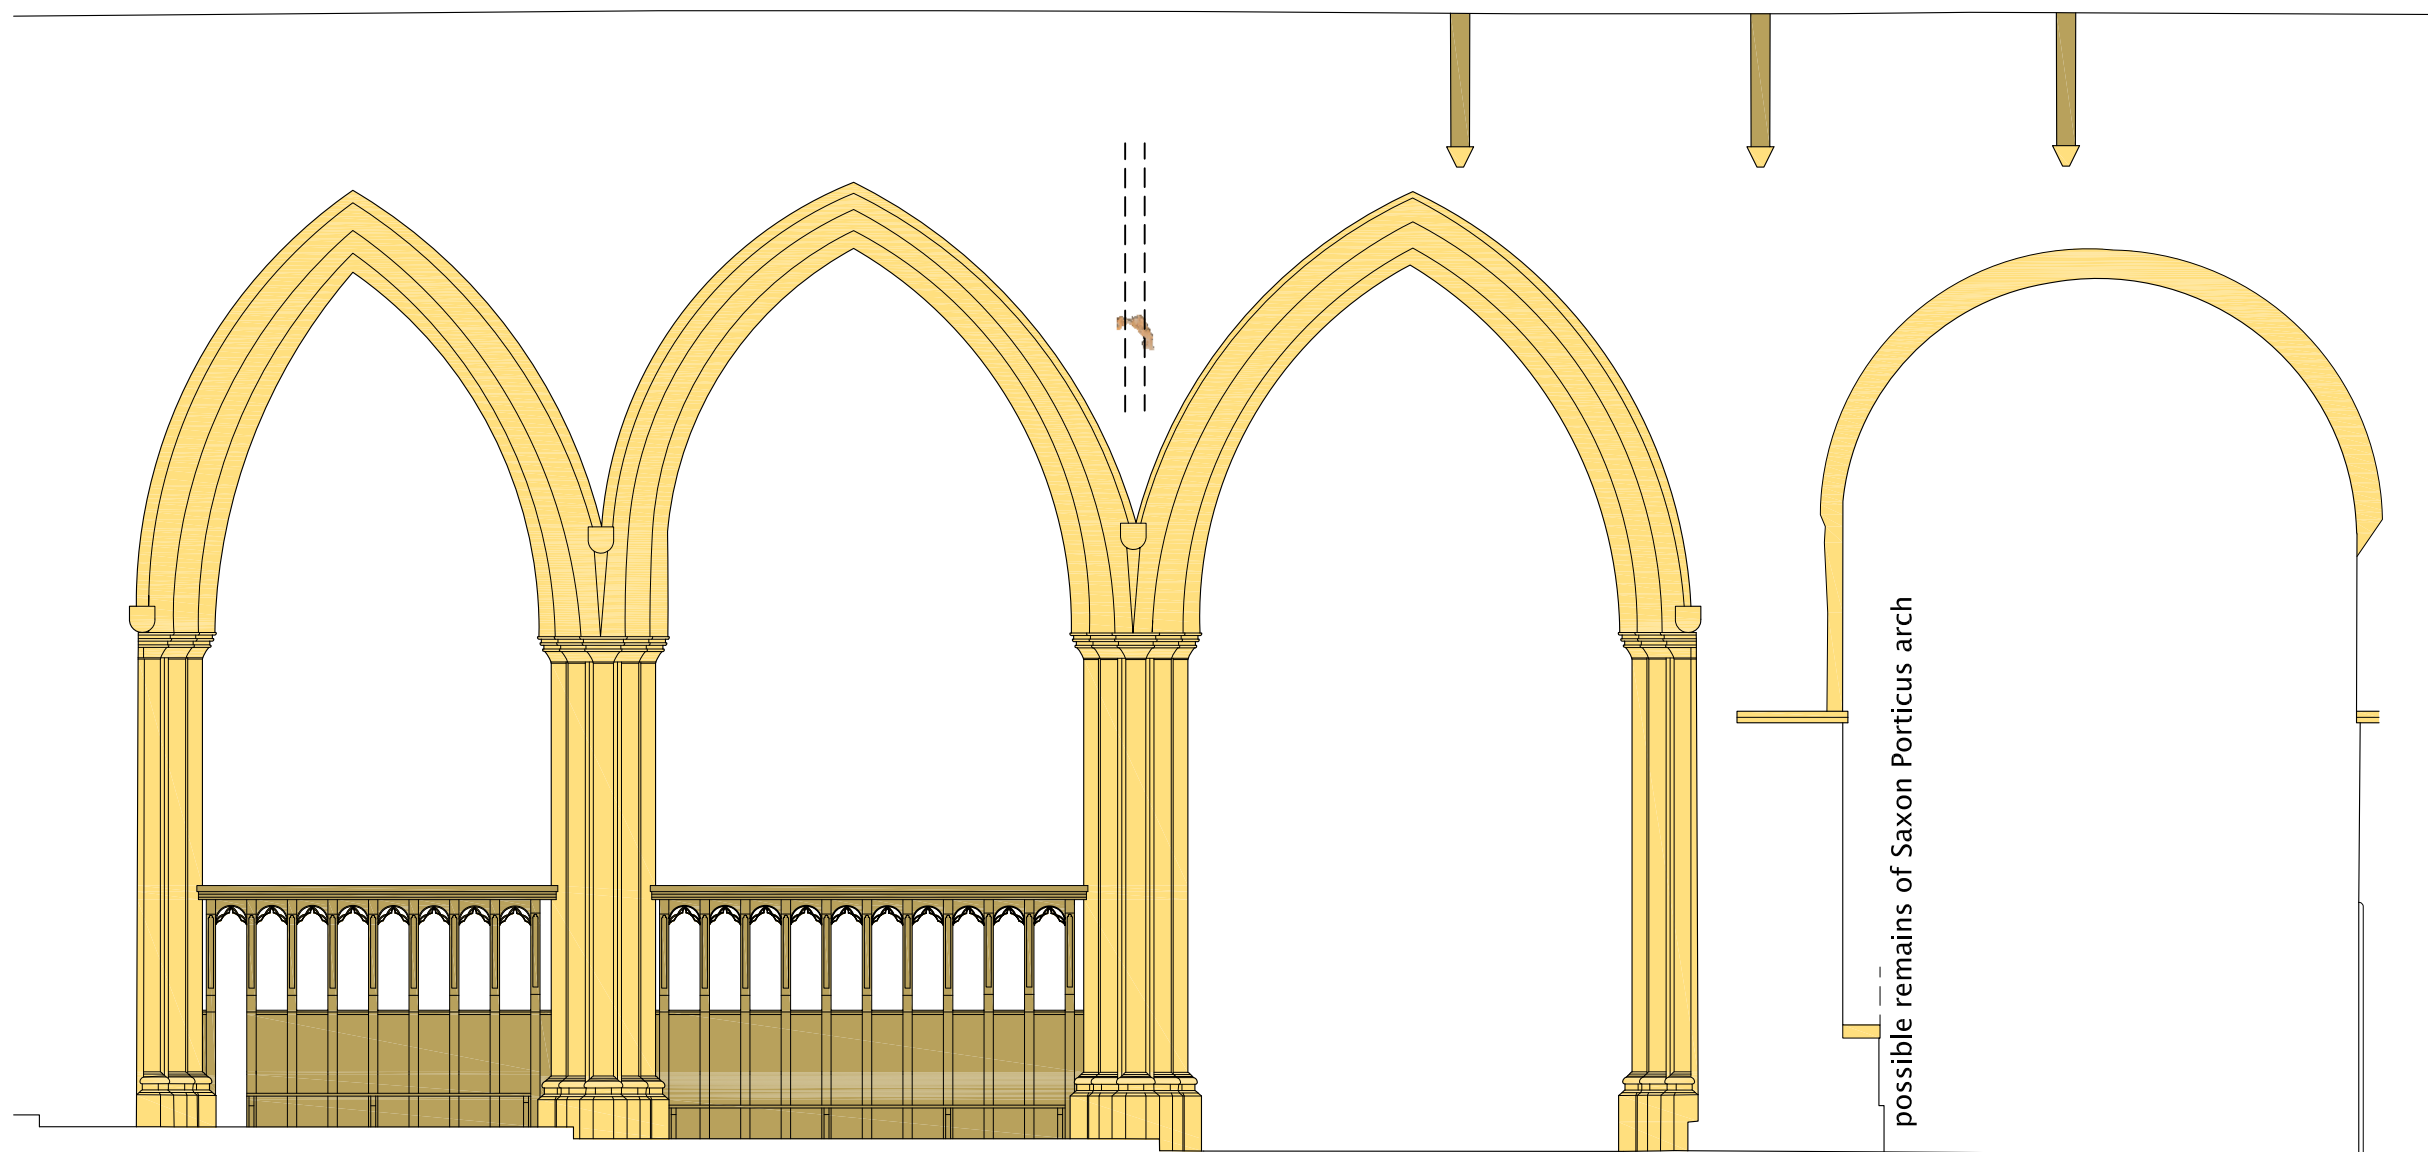
sanctuary to the east.” Rowley (et al) discuss the relevance of a ledge which survives low down on the crossing walls and which may be a survival from this 11th-century church and may indicate the entrance to the transeptal chapels (See Figure 6).
