Stoneleigh Abbey River Landscape Warwickshire

**Archaeological Recording and
Investigation of River Structures**

February 2013

Client: CGMS Limited

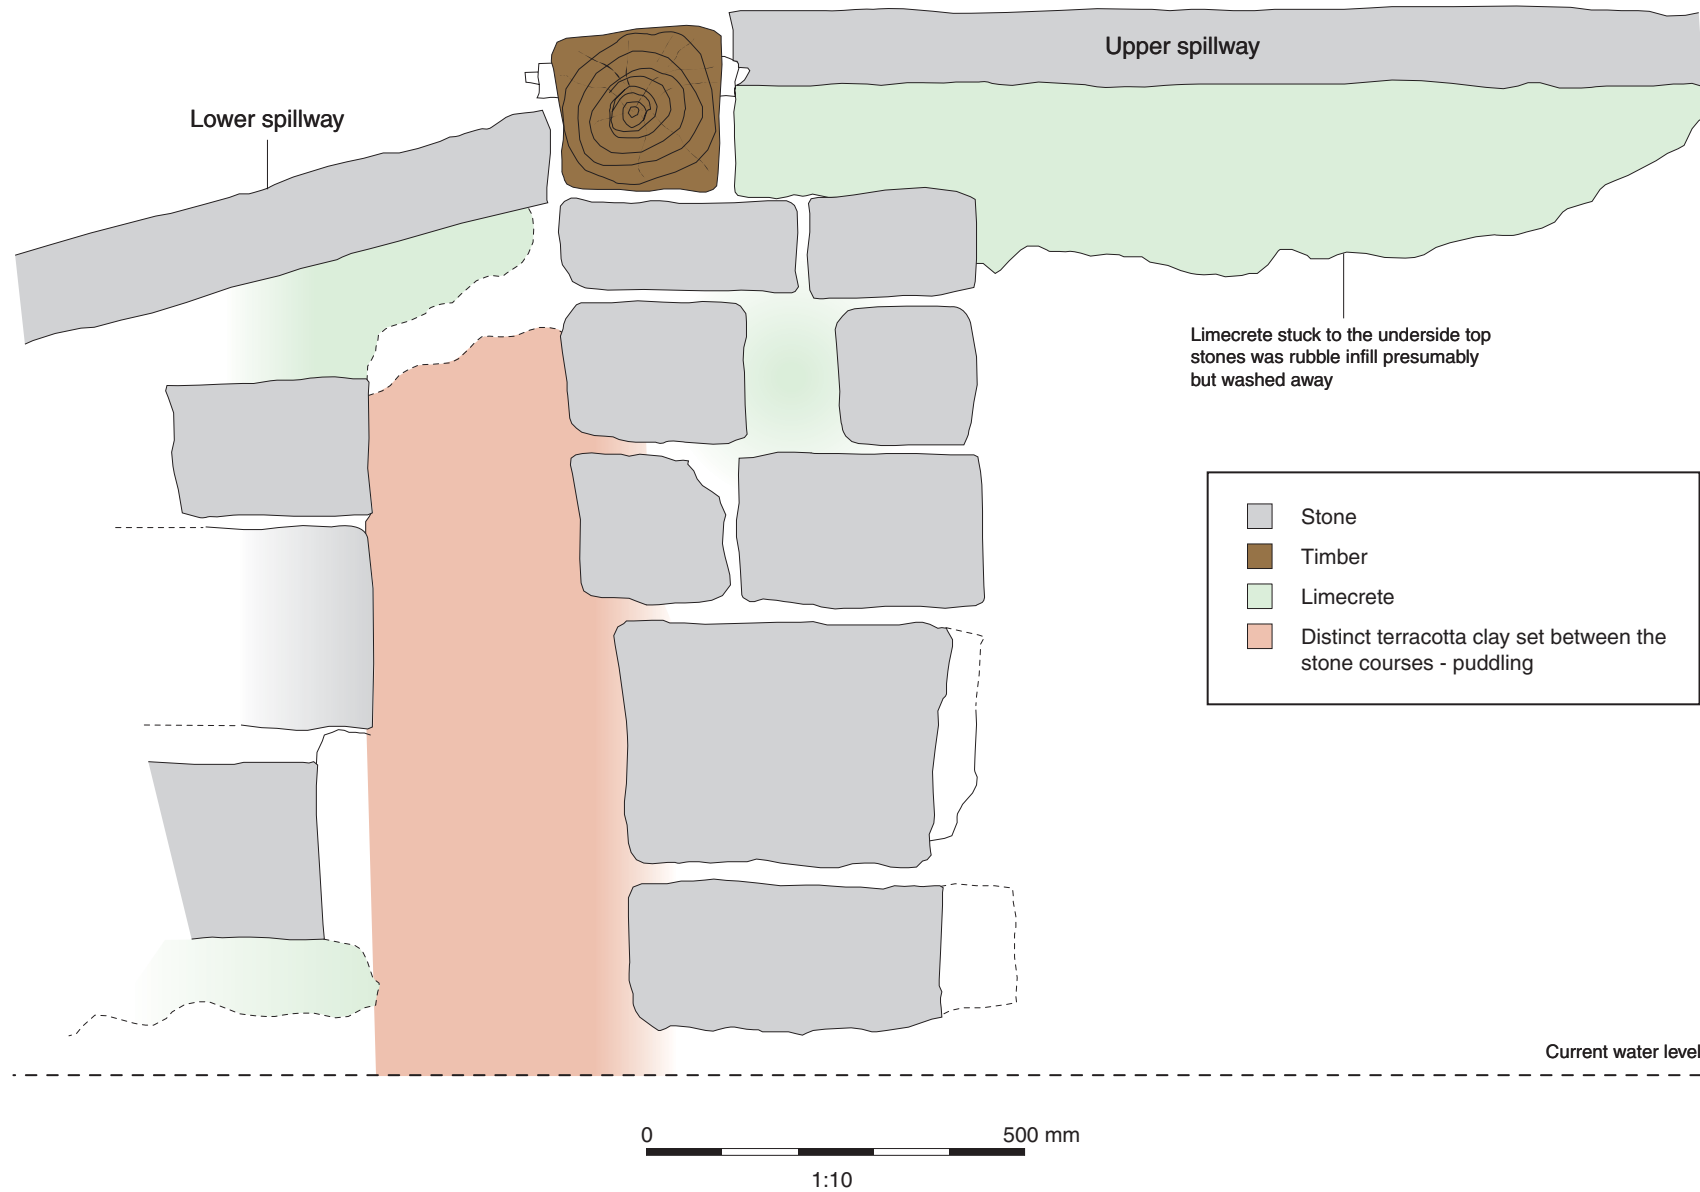
Figure 11: Section detail through spillway on east side of the island weir, looking south

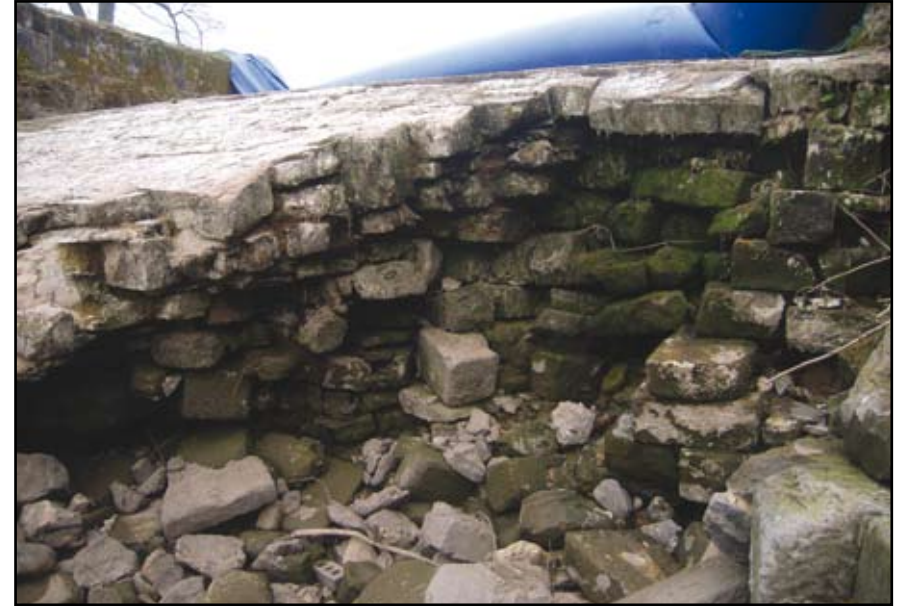
Plate 6: West Park Weir spillway detail prior to works

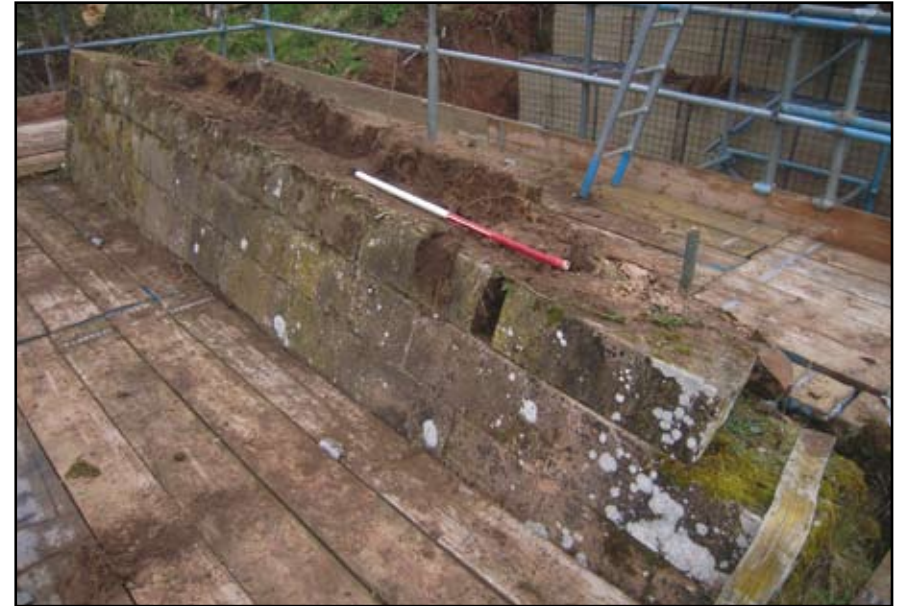
Plate 10: West Park Weir top of wall to west of weir during dismantling

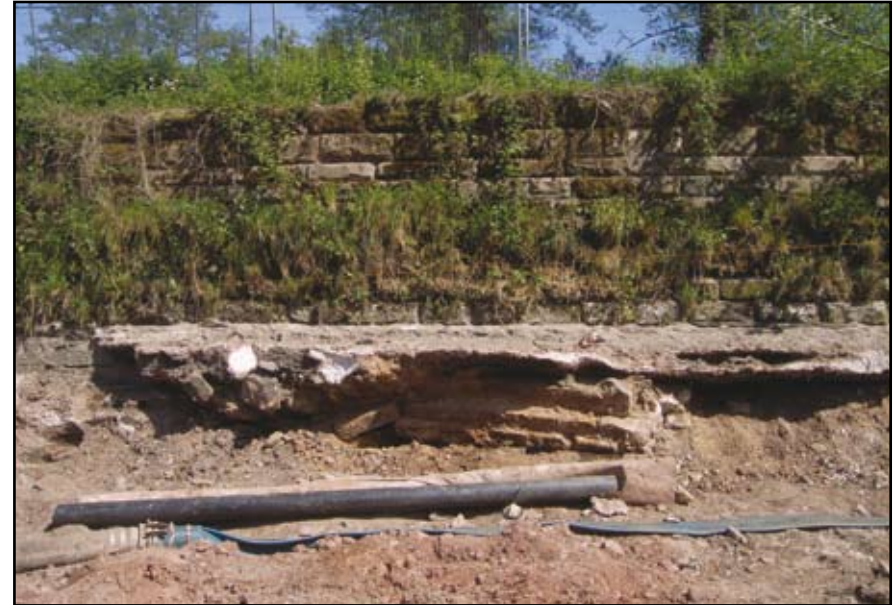
Plate 16: West Park Weir, east wall during works showing surviving block at base

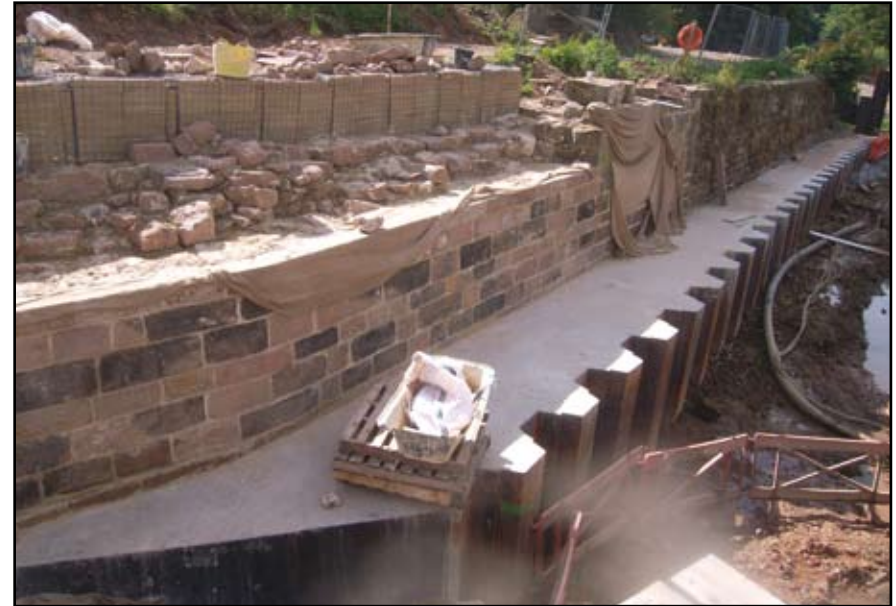
Plate 18: West Park Weir west wall during reconstruction with new concrete apron

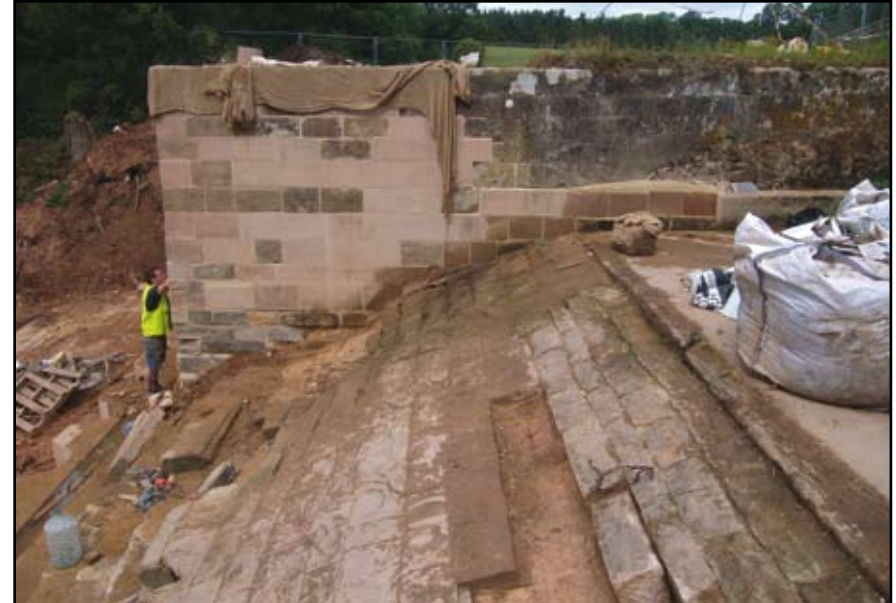
Plate 20: West Park Weir, spillway and rebuilt west wing wall

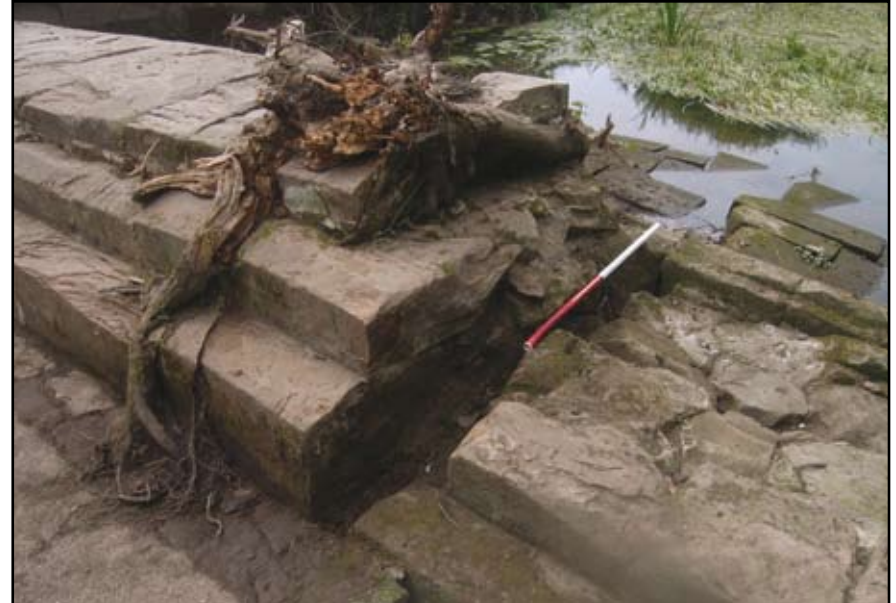
Plate 28: Island Weir, detail of truncated weir prior to works

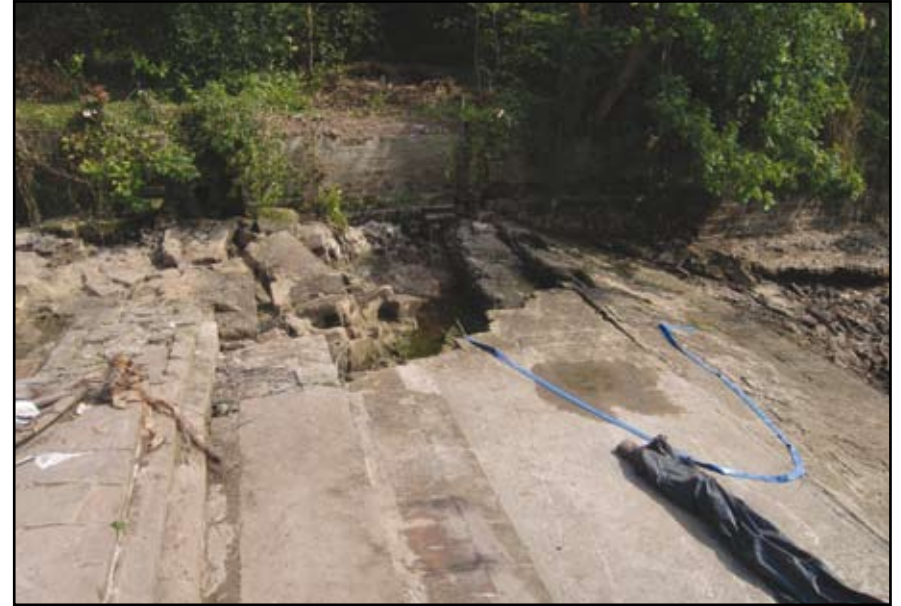
Plate 29: Island Weir, collapsed section of weir prior to works

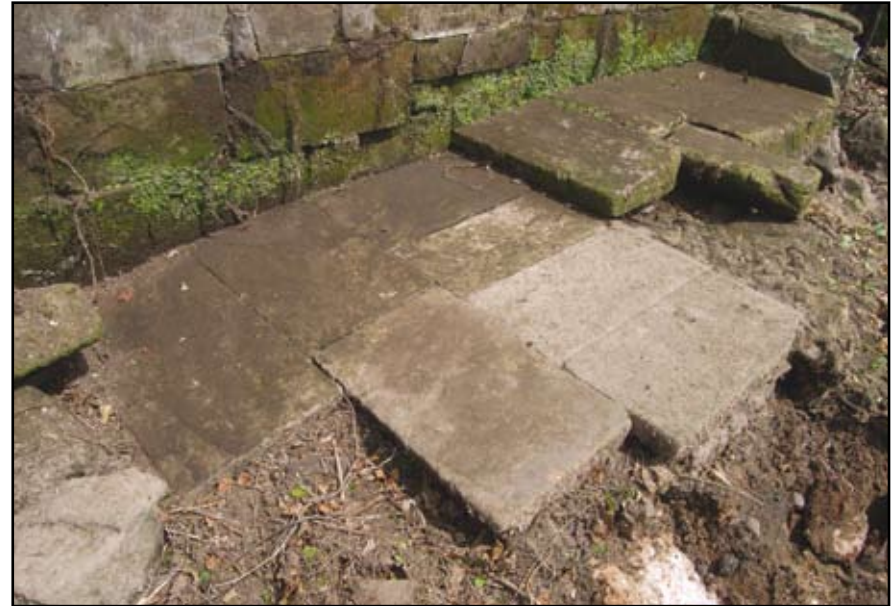
Plate 33: Island Weir, scar on north wall from lost weir

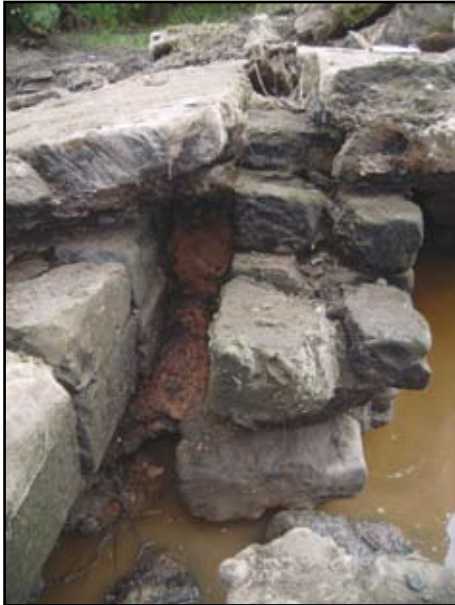
Plate 38: Island Weir, collapsed weir between upper and lower spillway

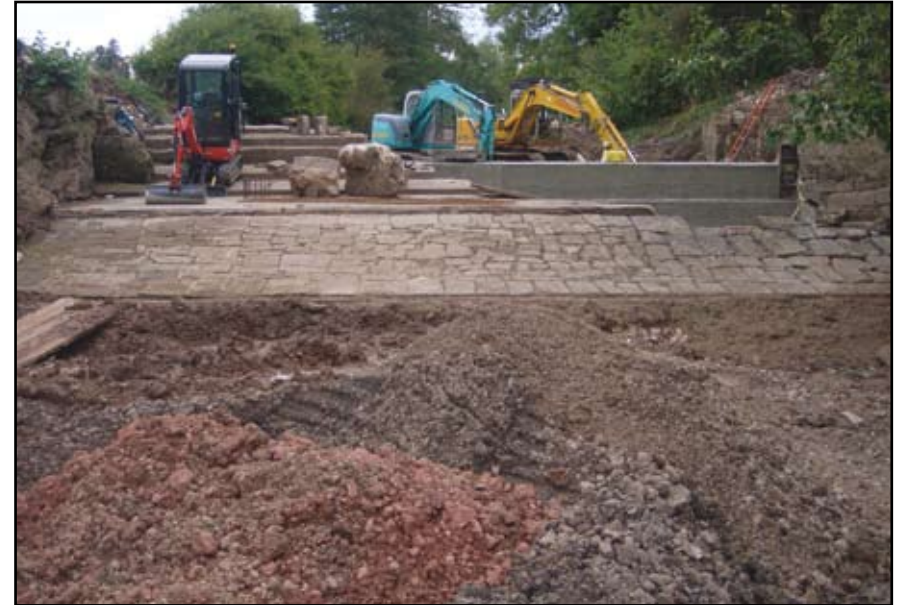
Plate 39: Island Weir, clay puddling between the upper and lower spillways

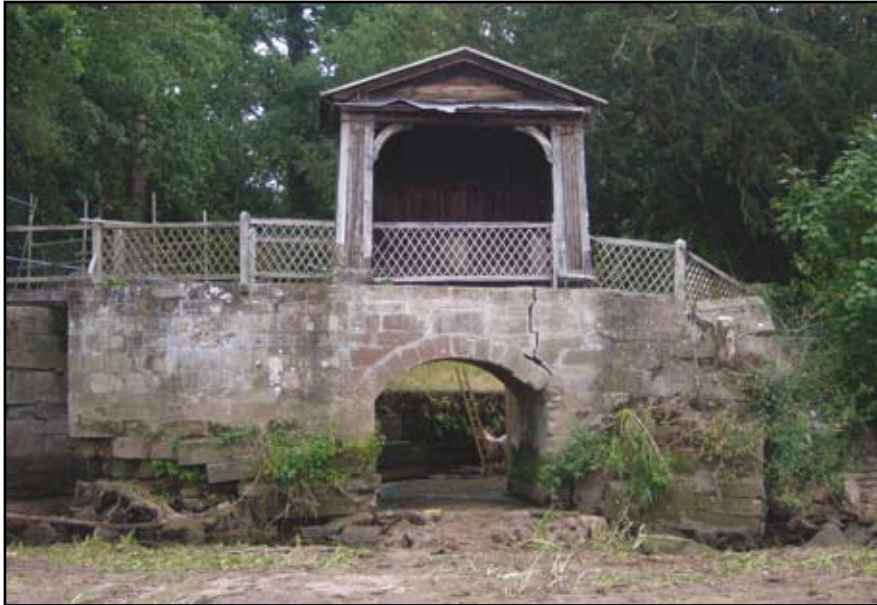
- 7.3.8 The remains of the sluice gates structure span the river channel (6.75 m at this point) and comprise three fixed, free-standing timber posts (possibly Baltic pine) together with a further similar post recessed within each river wall. Each of the five posts is c.50 cm deep by c.20 cm wide and at the front edge of each is rebated to both sides to allow the former gates to butt-up against the post. Four of the five posts are heavily worn but the northernmost one, which would have been within a recess is remarkably well preserved, probably having been sunken within mud, and from this we know the depth of the posts. Two of the other posts survives for approximately three quarters of their full length while little survives from the final two. At their base the posts would have been tenoned into a sill beam although this lower section only survives to the northern post. Each of the posts is bolted to a pair of head beams which are set c.20 cm apart from each other and would have spanned above the river with each post projecting c.20 cm above it. The front head beam is set on a curved bracket on the face of the post while the larger rear beam is set on a ledge created towards the top of the main posts.

Plate 62: Gazebo Bridge, decayed remains of sluice gates

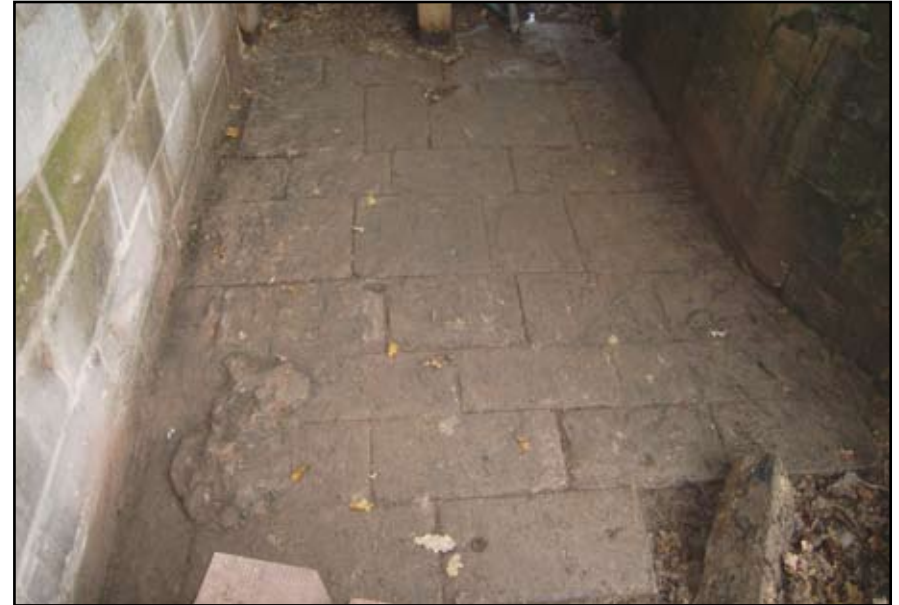
Plate 71: Gazebo Bridge, floor at SE corner

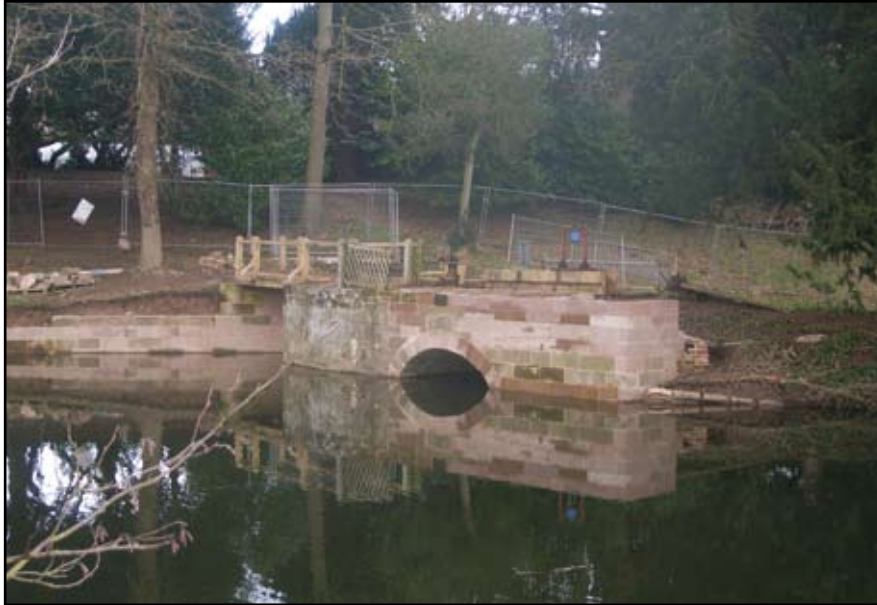
Plate 74: Gazebo Bridge, general view during works

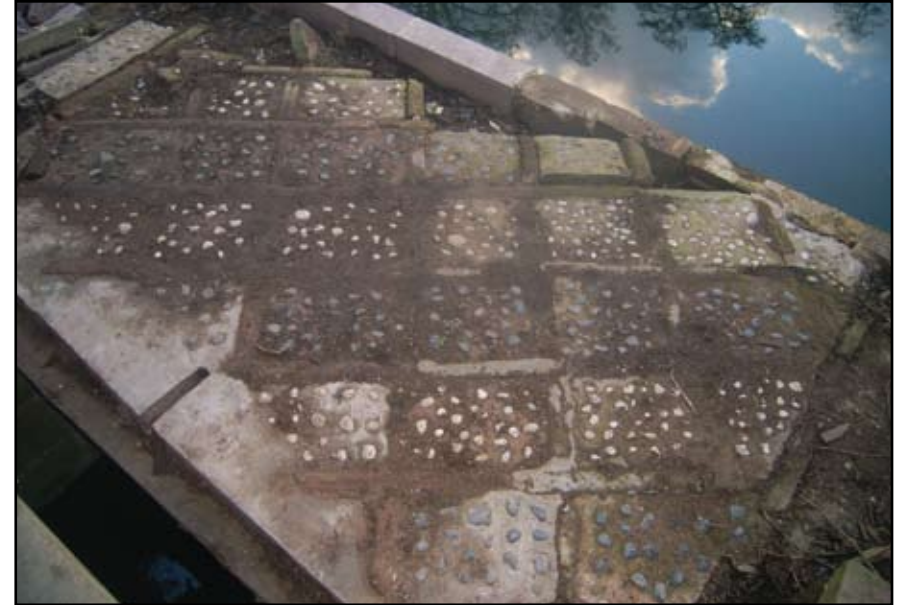
Plate 75: Gazebo Bridge, view after conservation works

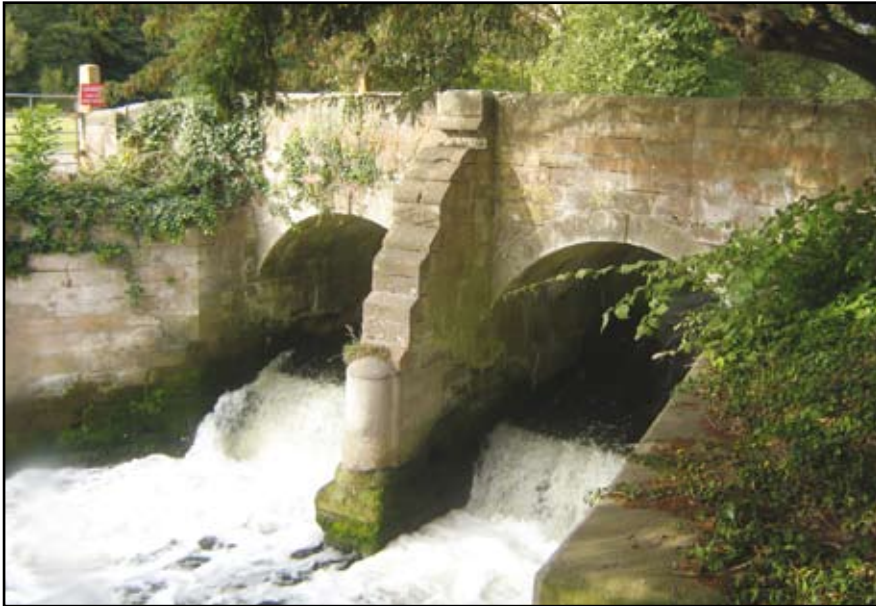
- 7.3.16 The walls flanking the channel to the east side of the bridge are of ashlar and there are various cracks or substantial areas of missing stones. On the north bank the channel fans gently out towards the lake whereas on the south side it takes two clear steps to form the wider channel. There is a substantial area where the stonework on the south side has collapsed and it appears that this was due to a long timber bearer having been built into the wall but rotting

Plate 80: Abbey Mill Bridge, south wall to east of bridge

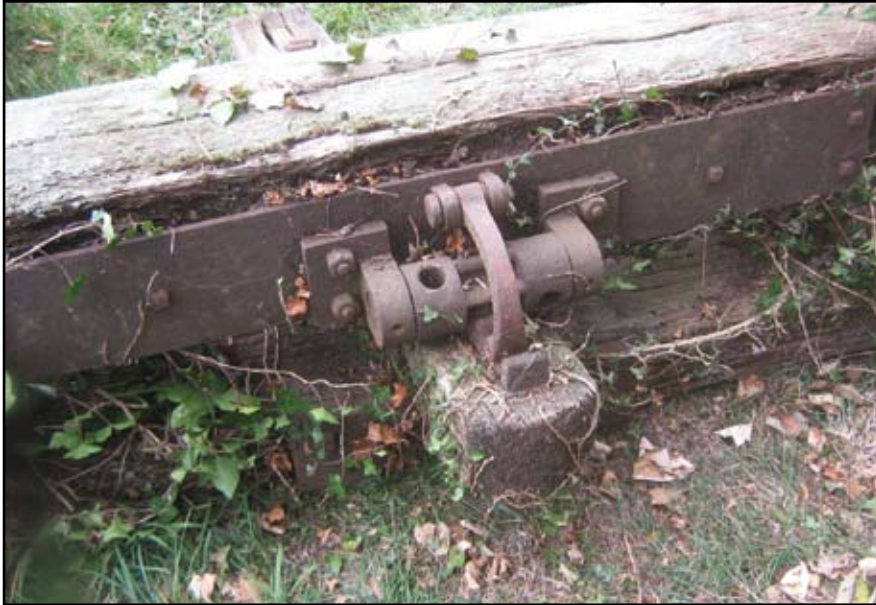
Plate 82: Abbey Mill Bridge, ex-situ sluice gate structure

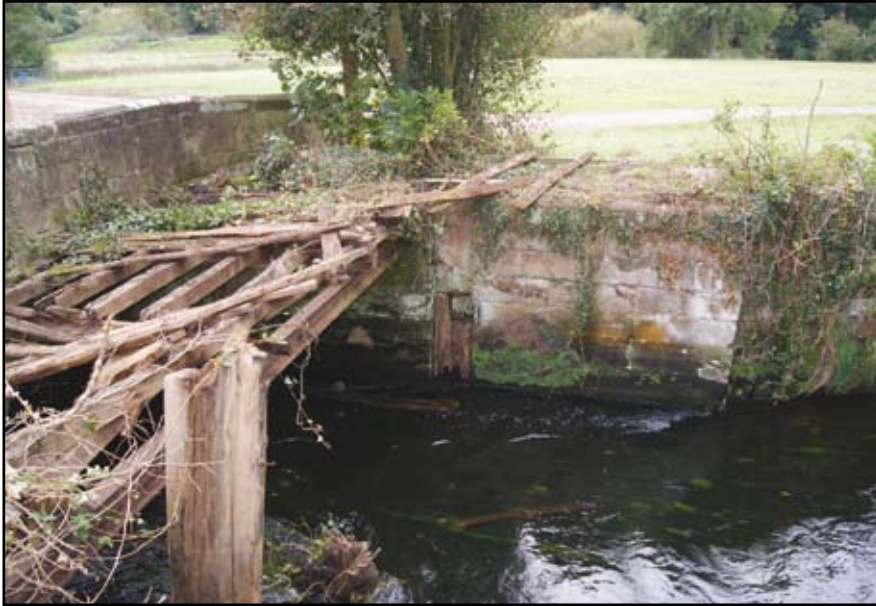
Plate 84: Abbey Mill Bridge, north wall to west of bridge

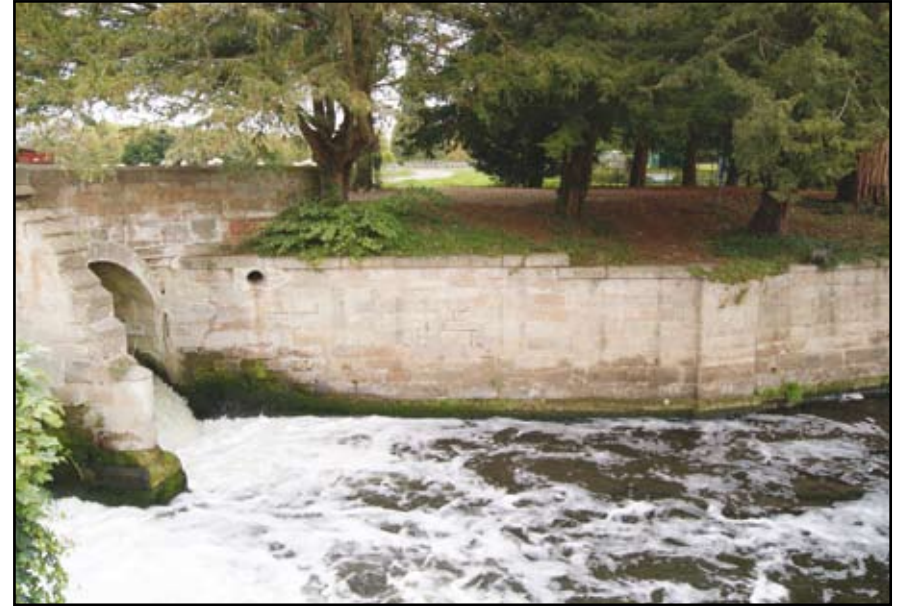
Plate 85: Abbey Mill Bridge, general view to south prior to works

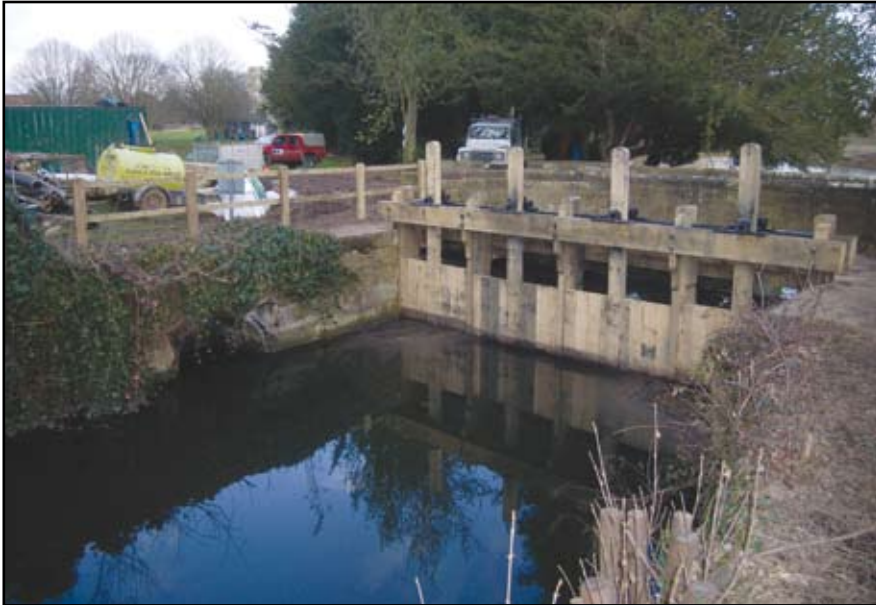
Plate 86: Abbey Mill Bridge, north wall to east of bridge

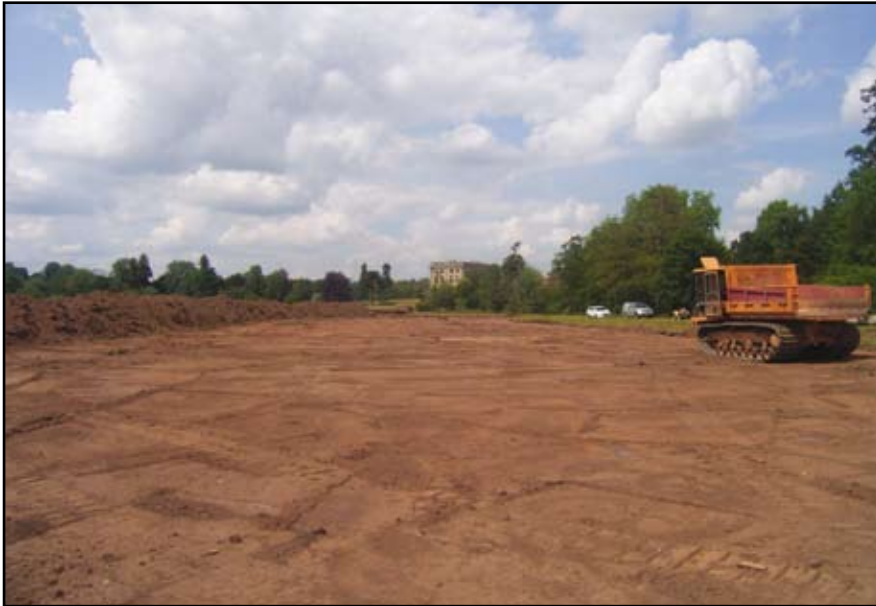
Plate 88: Abbey Mill Bridge, view from bridge after lake works

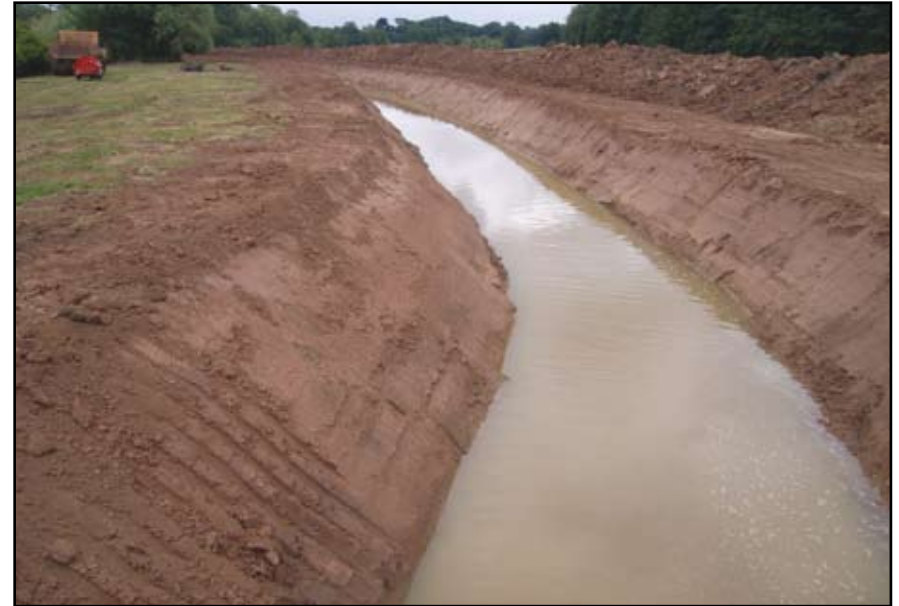
Plate 89: General view during top soil stripping for new channel

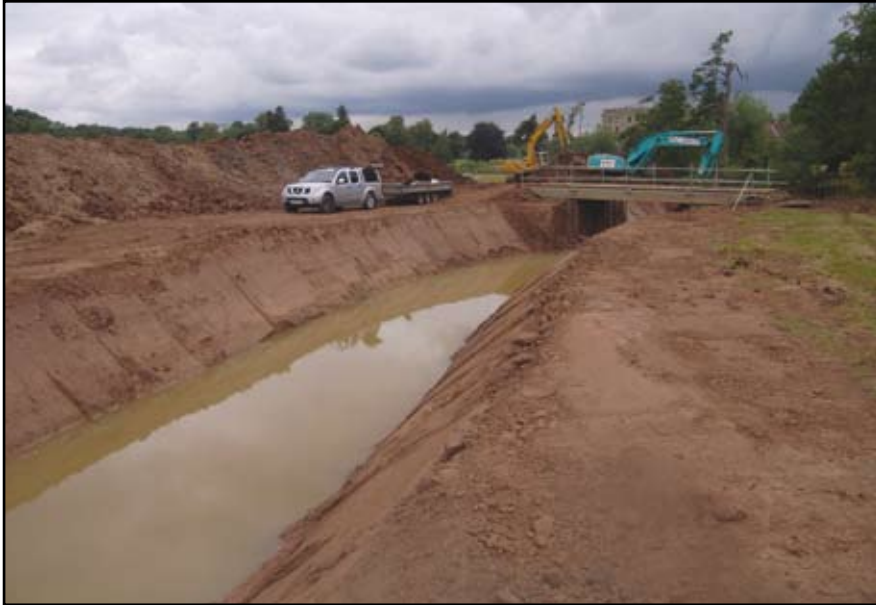
Plate 90: View of bypass channel looking east

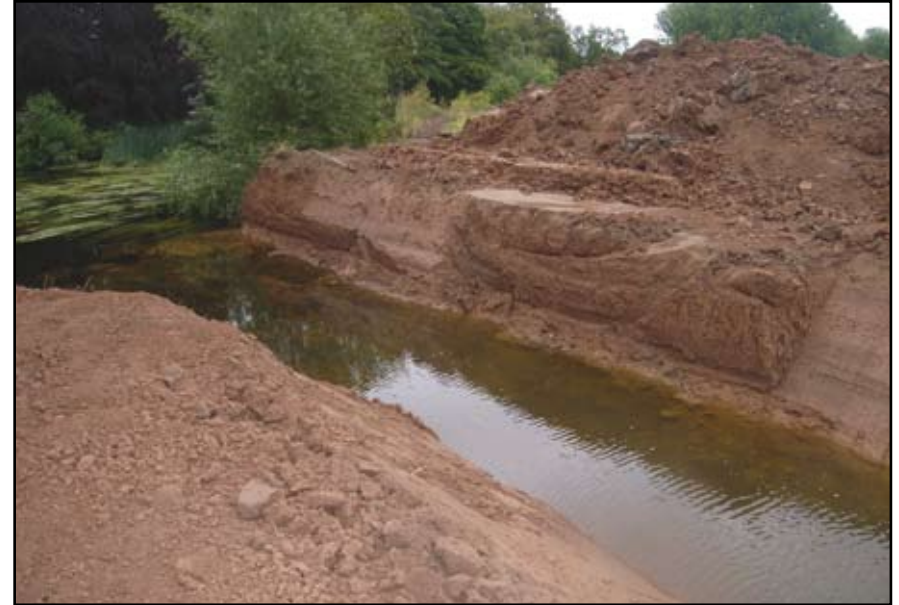
Plate 91: View during construction of bypass channel looking west

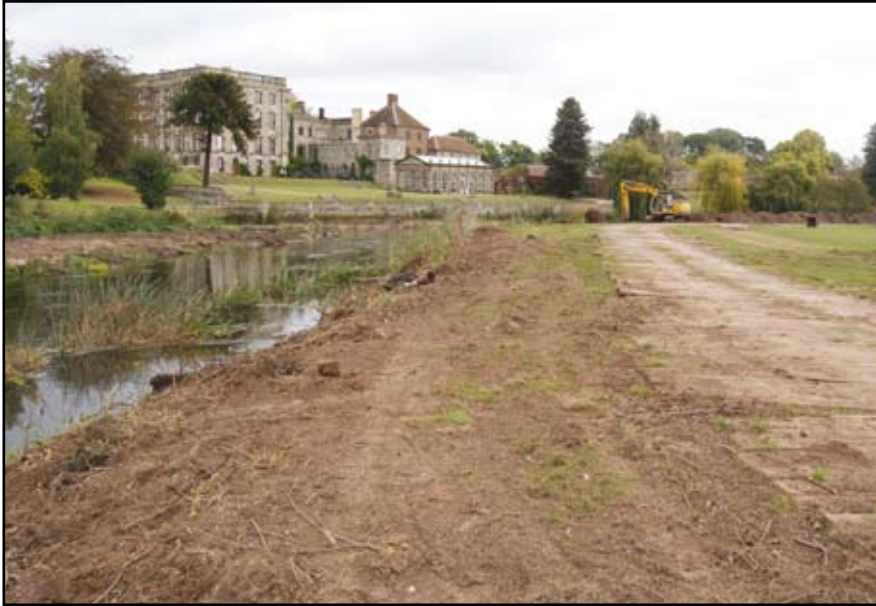
Plate 92: South-eastern end of bypass channel

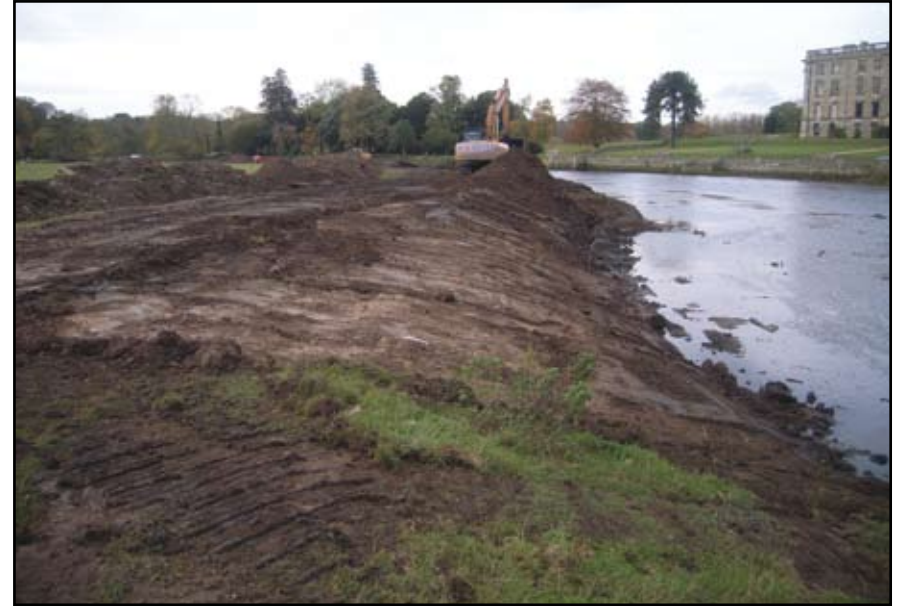
Plate 93: General view during re-profiling of river bank

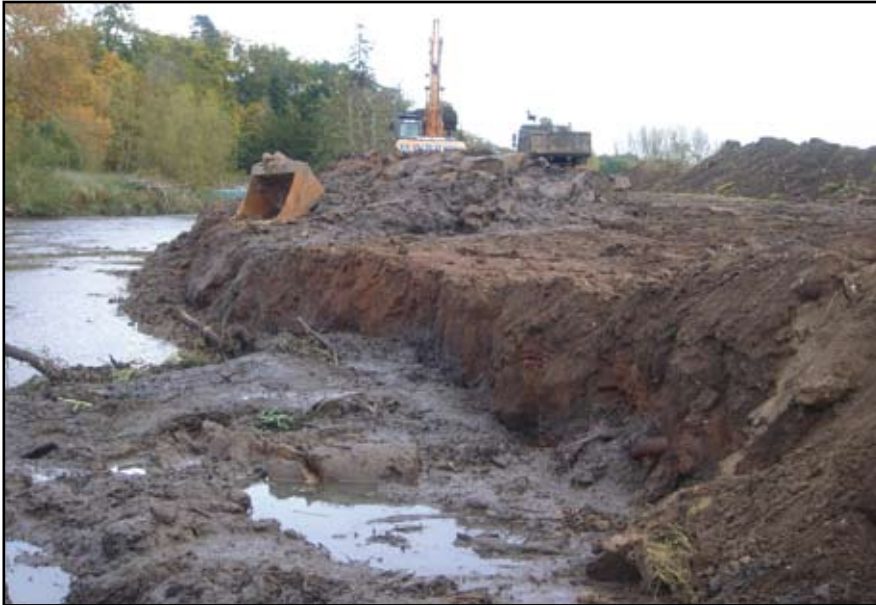
Plate 94: General view during re-profiling of river bank

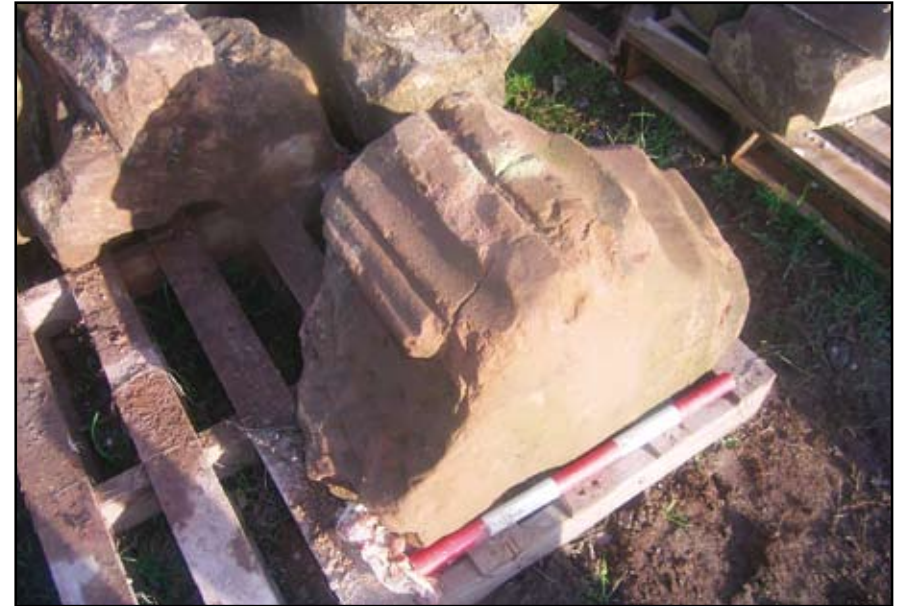
Plate 97: Former section of wall retrieved from West Park Weir pool
