Valentines Park Ilford

London Borough
of Redbridge

**Historic Building Recording and
Archaeological Watching Brief**

April 2009

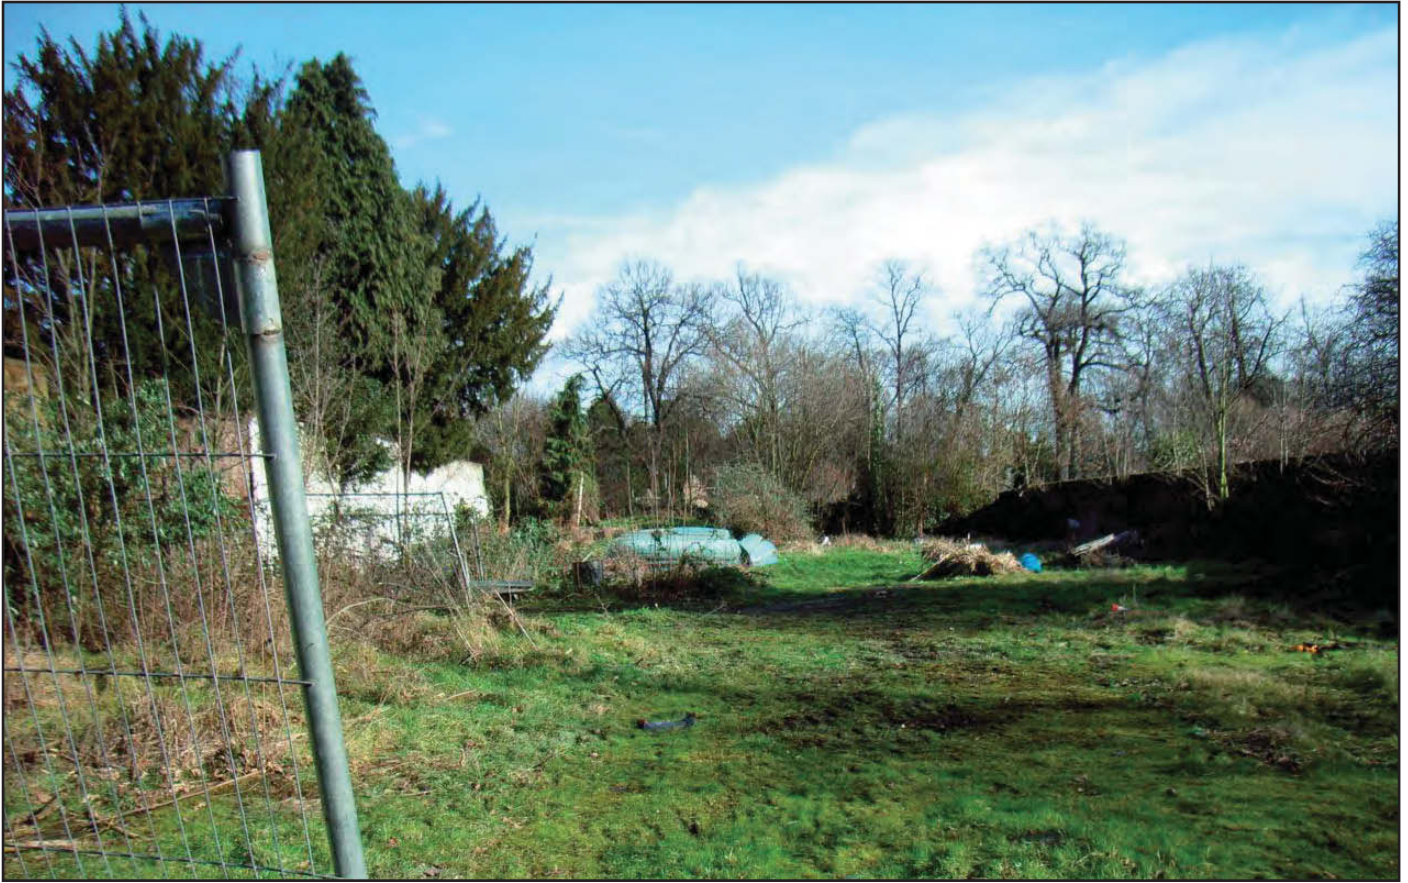
Plate 1: General view of Kitchen Garden from SW prior to start of works

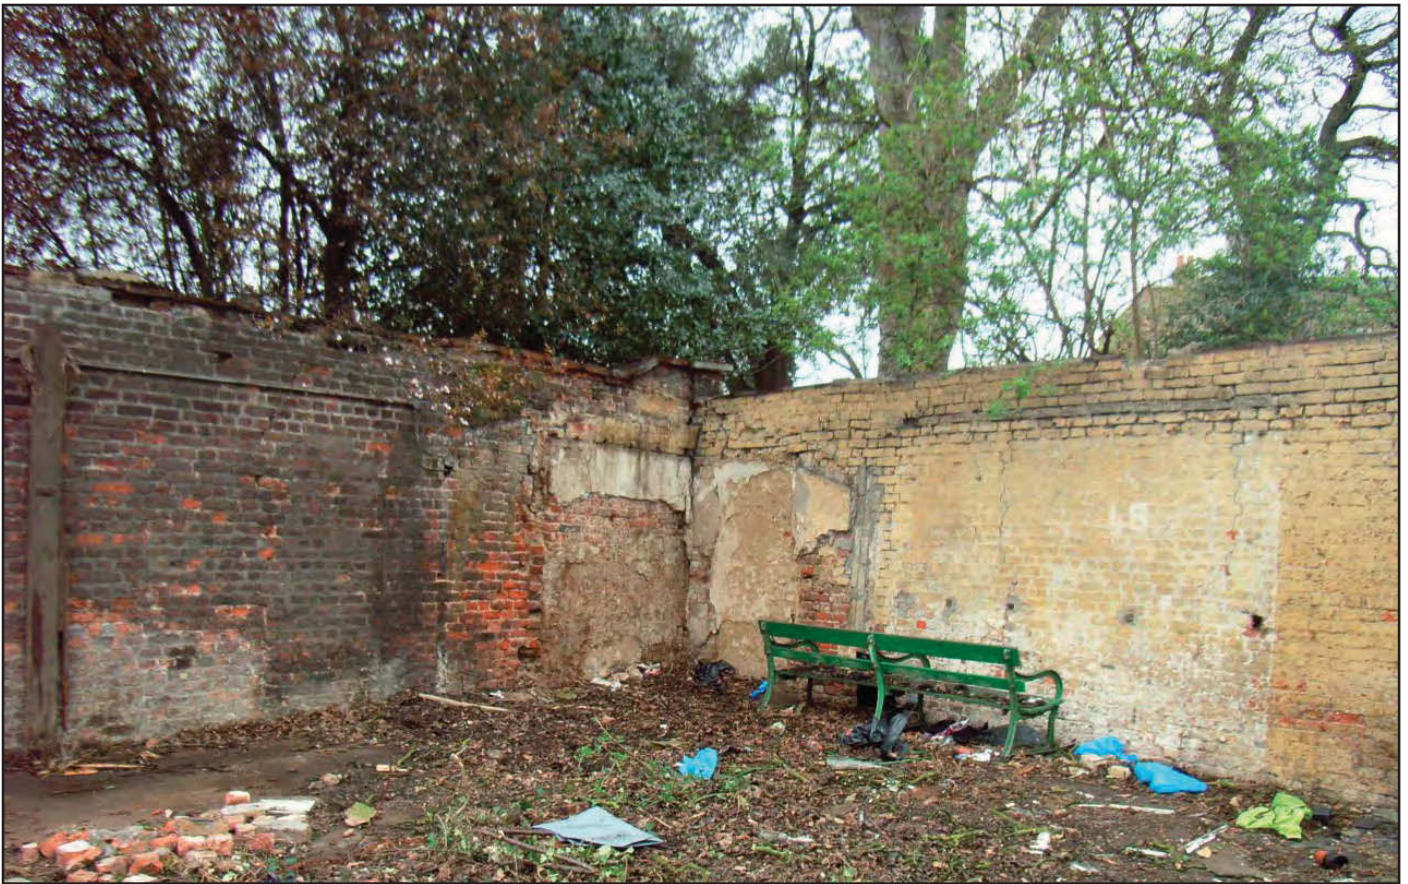
Plate 3: South corner between Walls 2a and 3

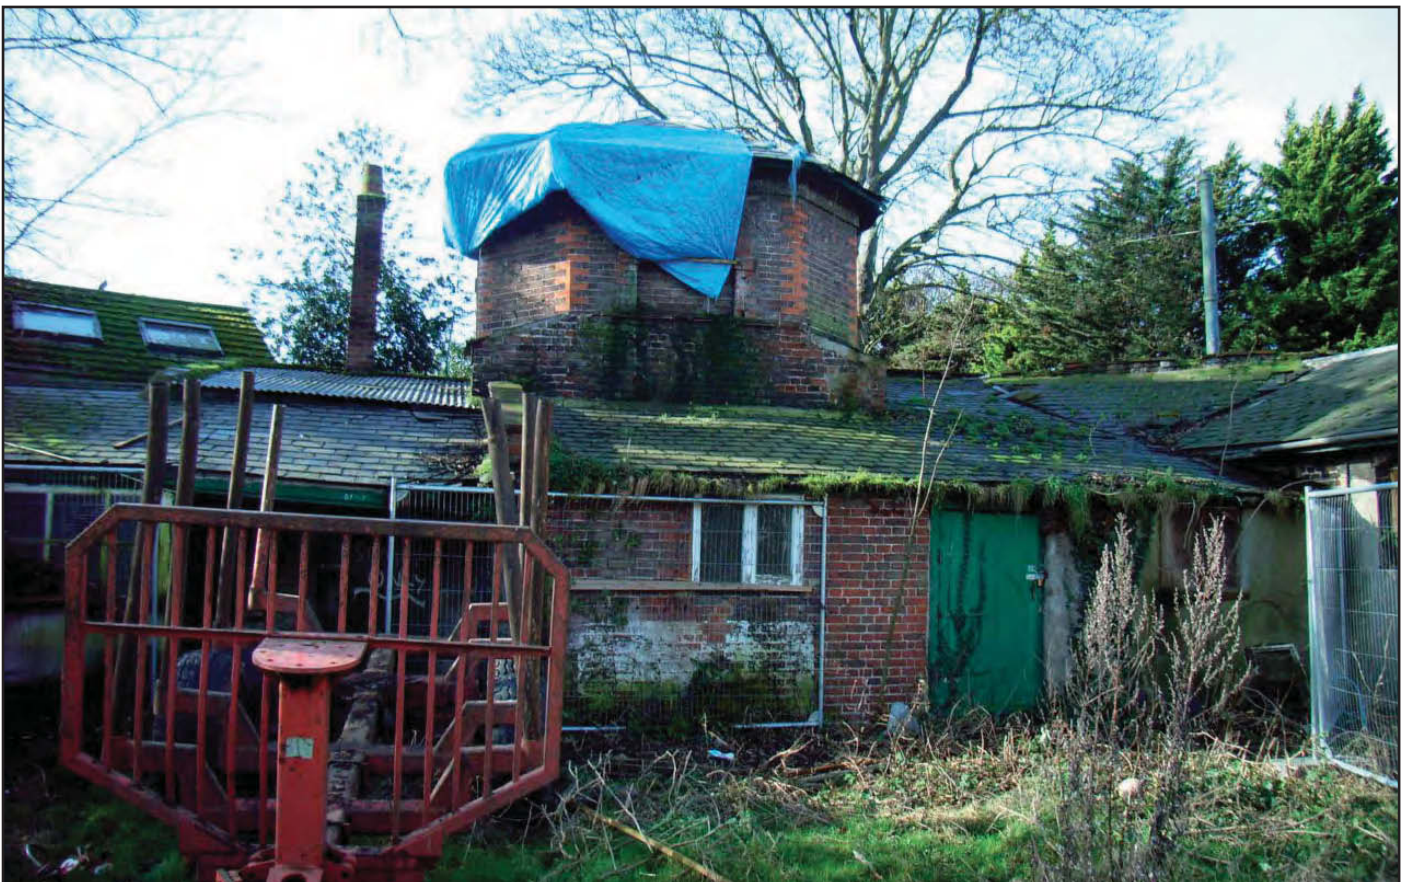
Plate 10: NE view of Dovecote before start of works

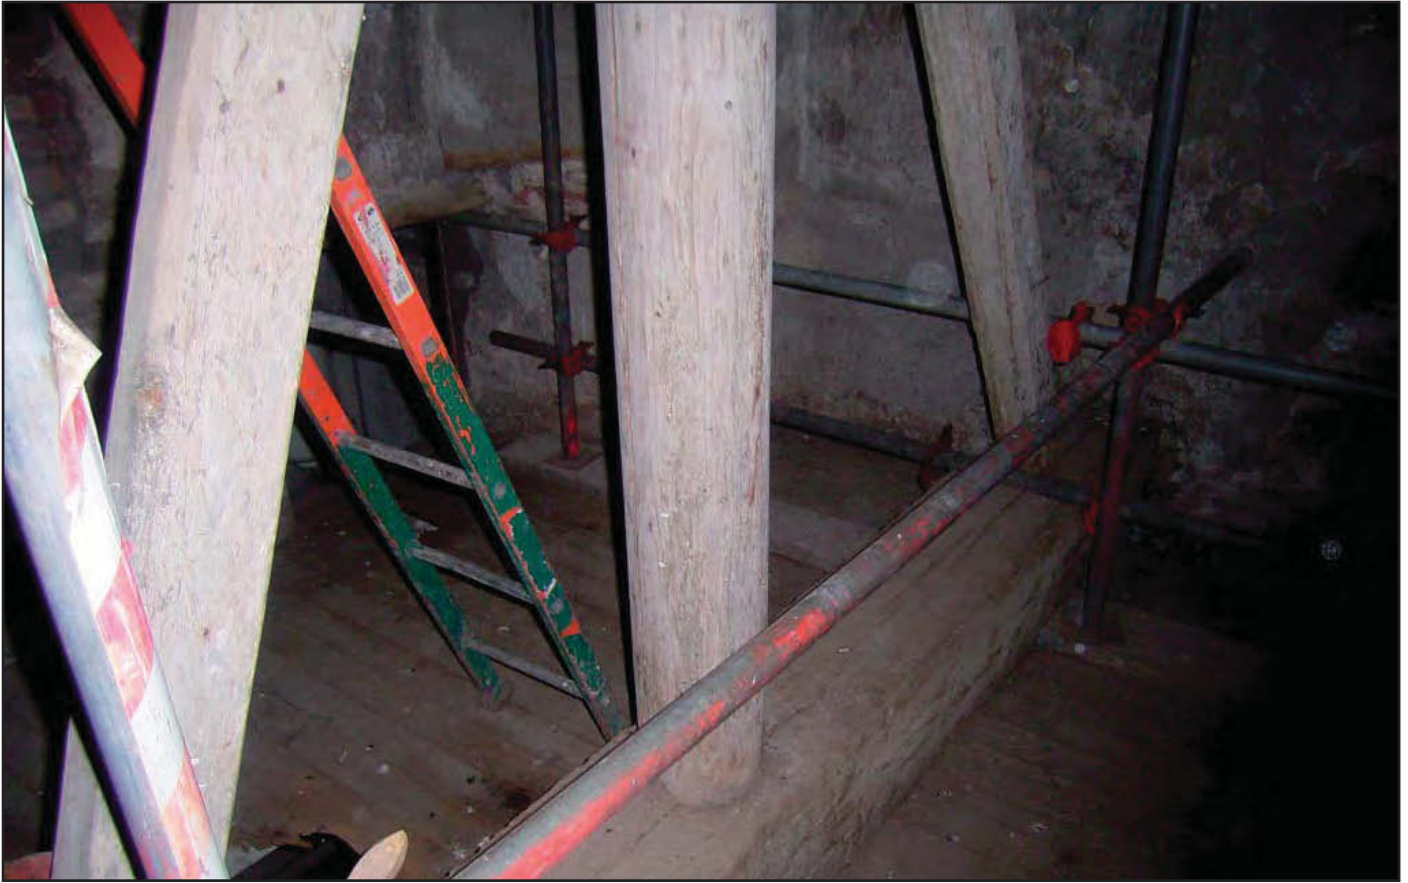
Plate 27: Bearer across floor in Dovecote supporting central post

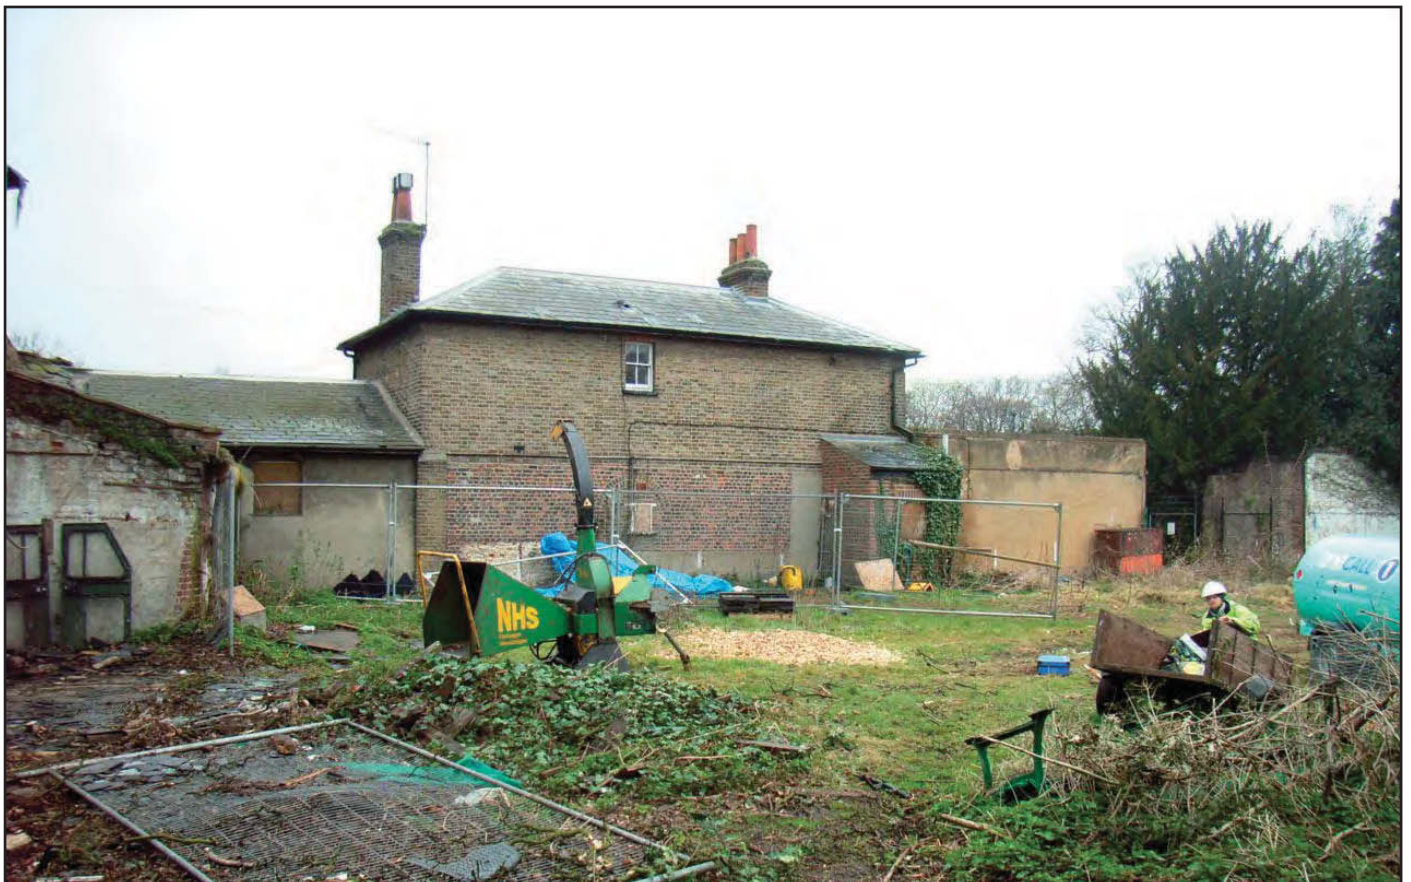
Plate 32: General view towards cottage before start of works

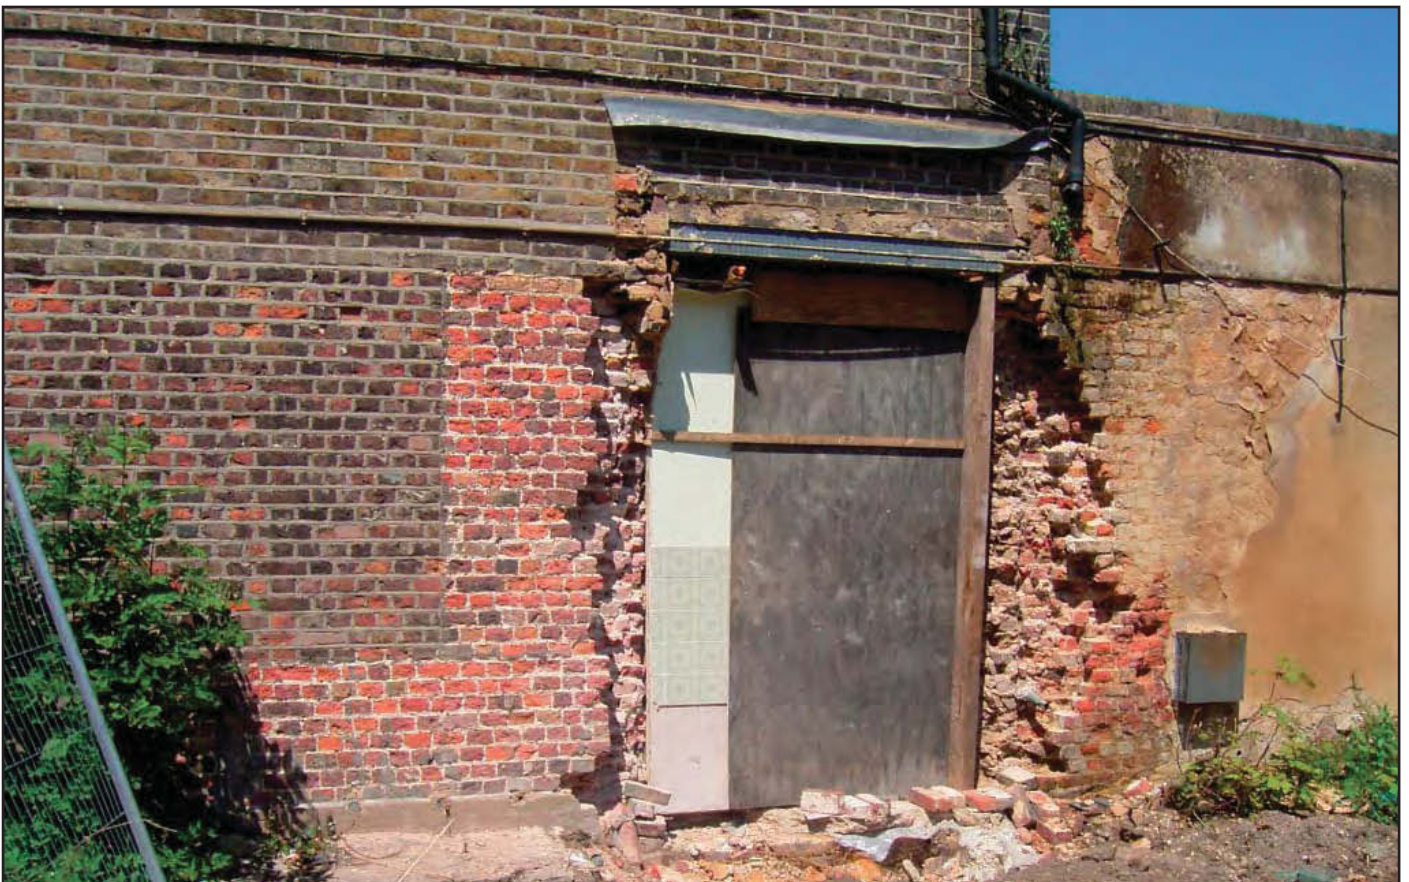
Plate 34: SE wall of Cottage after removal of WC lean-to

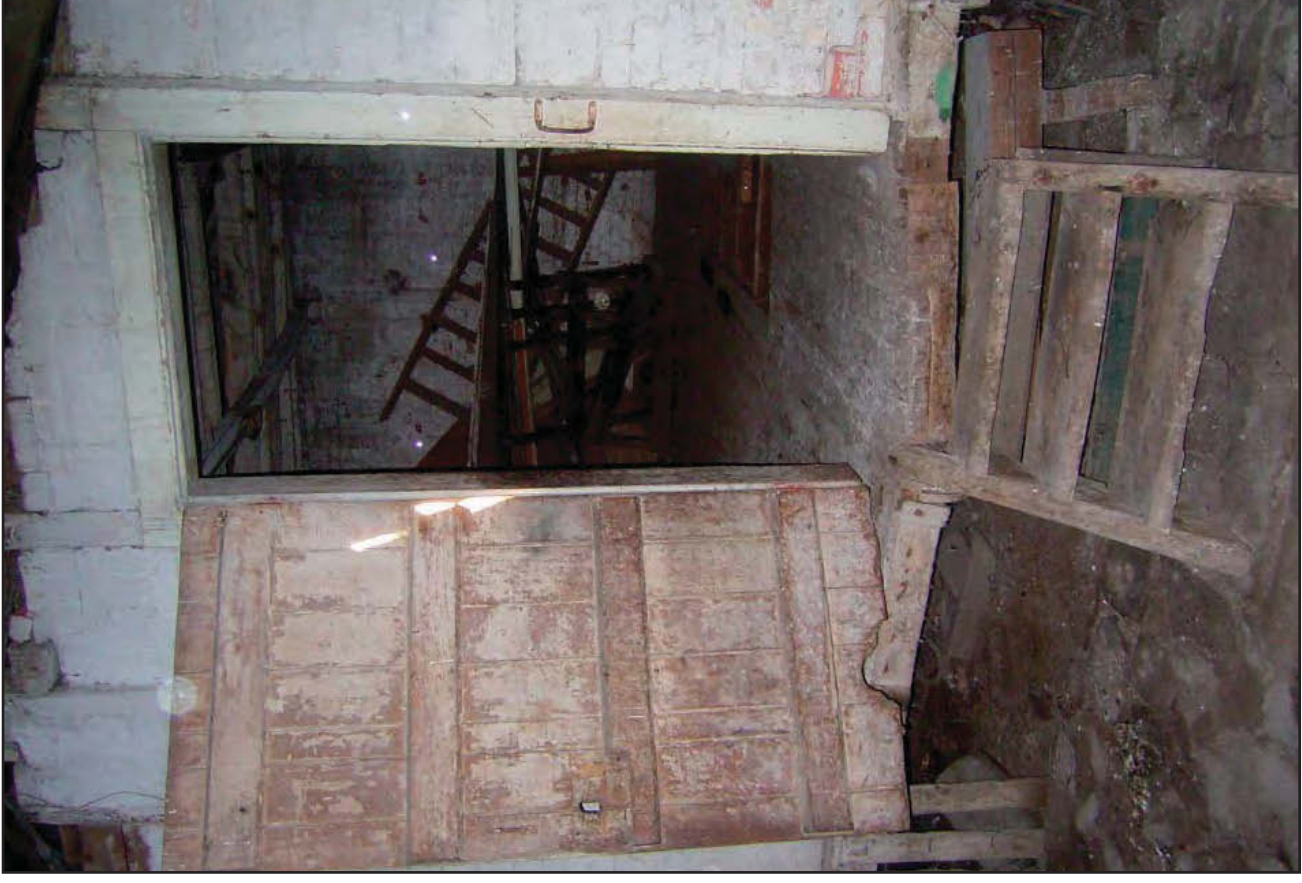
Plate 36: Access door to Granary

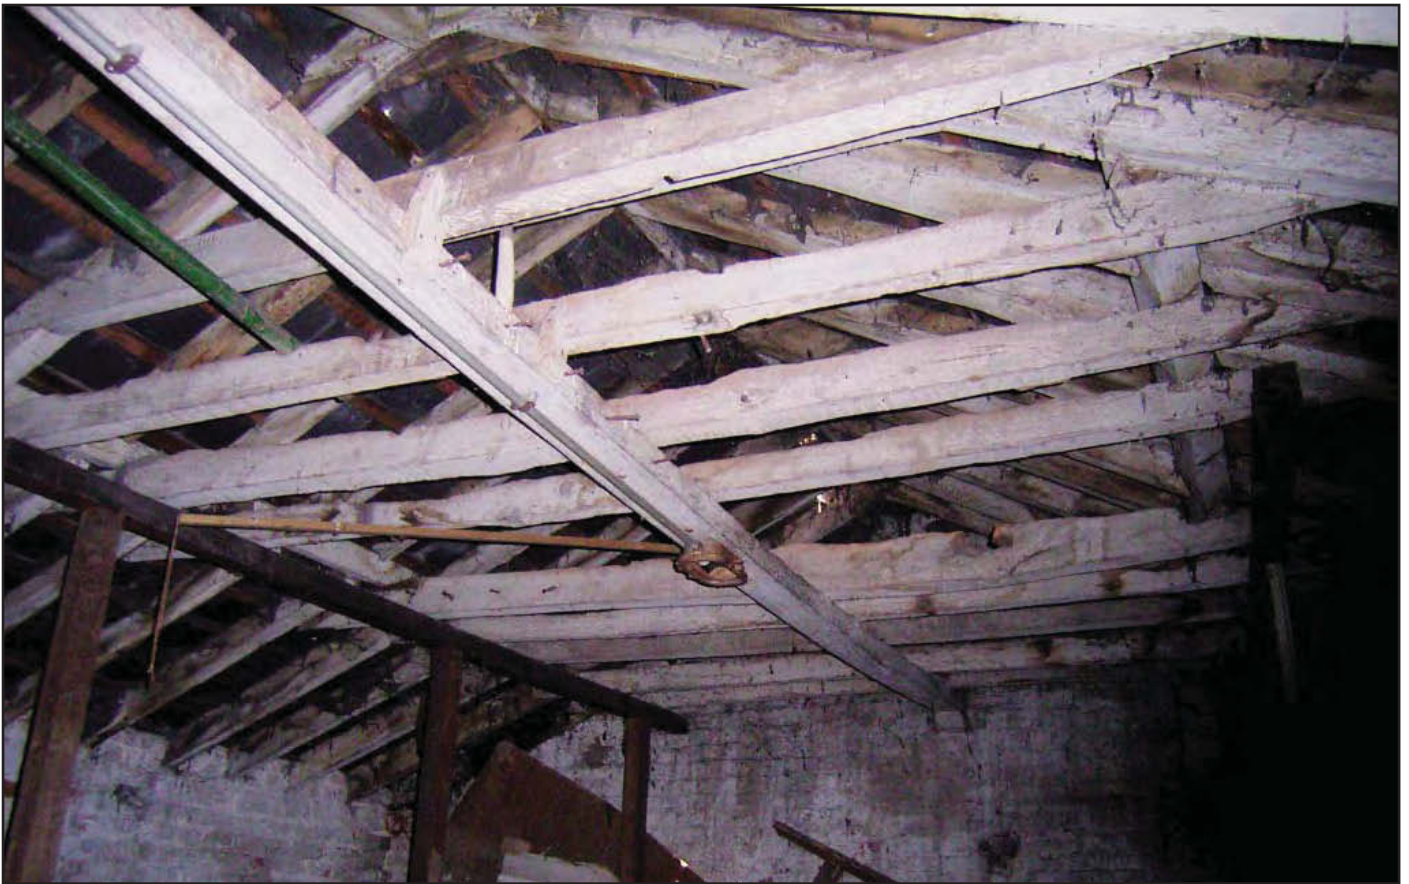
Plate 39: Roof in Granary

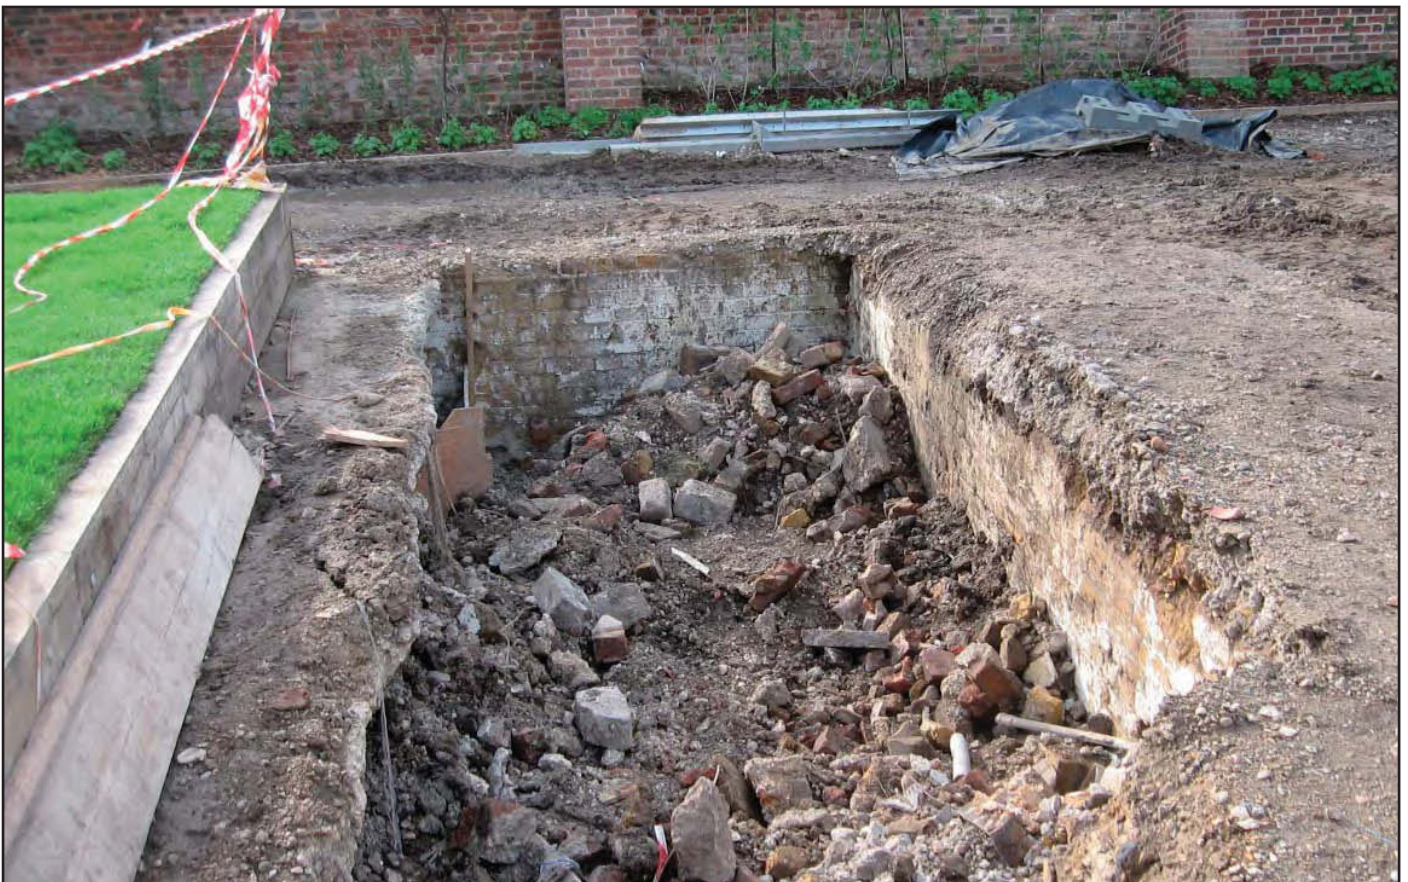
- 6.4.13 Hole number 4 which was located centrally within the Kitchen Garden, towards Wall 2, revealed a substantial wall, comprising of the same hard yellow later 19th-century bricks with cement mortar seen elsewhere on the site (Plate 50). The wall initially exposed within the tree pit was approximately 10 courses high, a single brick (c.10 cm) thick and aligned with the south-east edge of Pit 4. An area of 1.5 m wide and 1 m high was uncovered within the Pit but this excavation continued for a short distance beyond the line of the pit and this revealed that the wall exposed formed the corner from a larger feature. Two similar walls were exposed, at right angles to each other forming a corner just to the south-west of Pit 4. One wall was aligned SE-NW and although the visible section was c.4 m long the wall appeared to continue beyond the line of the excavation. The other wall was c.3 m long, orientated SW-NE and again it appears to have continued beyond the line of the excavation.

Plate 50: Brick (later 19th century) walls exposed in Tree Pit 4 in Kitchen Garden

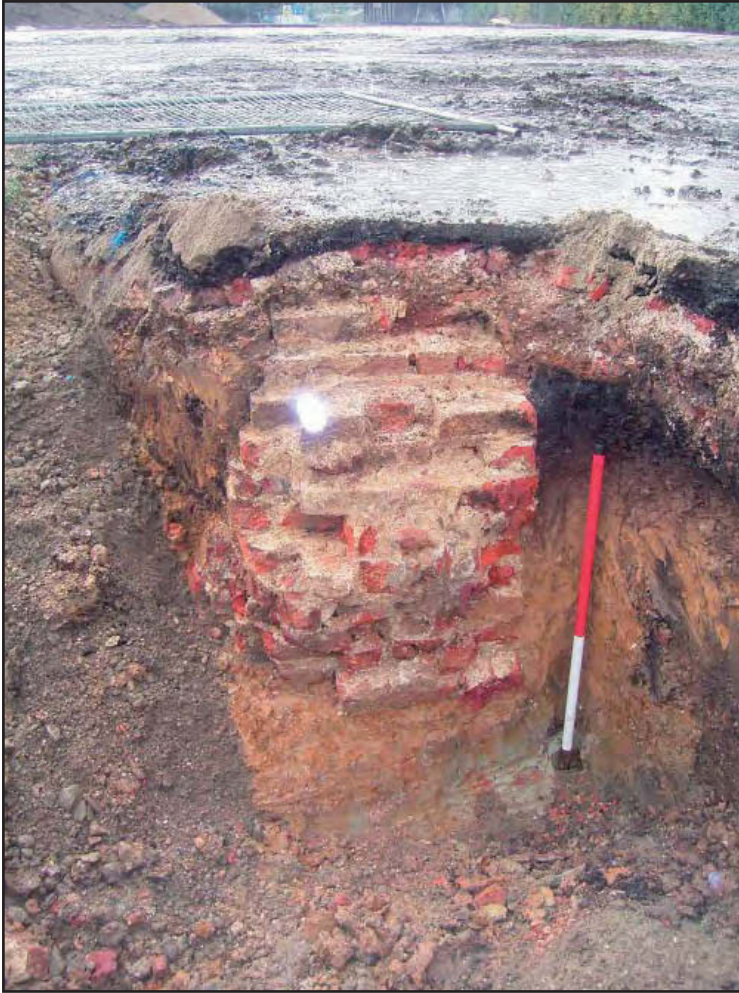
6.4.18 **Trench 31** was located in the southern half of the tennis court area (Figure 15, Plate 51). It measured approximately 4m x 2.5m on a roughly north-south alignment and two short sections of wall foundation were revealed (5021) and (5022) which it appears were once connected but are now truncated by the machining in the current works. Each wall is between 0.6 and 0.7m wide and approximately 0.95m tall. They are cut into the natural which is a greyish yellow silty clay. Directly overlying both walls is approximately 0.10m of demolition/levelling material on which the modern tarmac surface of the tennis courts lies.

Plate 51: Truncated stub of wall (5021) in Trench 31 in Tennis Court Area
