Parterre Gardens Witley Court Great Witley Worcestershire

Archaeological Investigation Report Volume I

Oxford Archaeology

May 2004

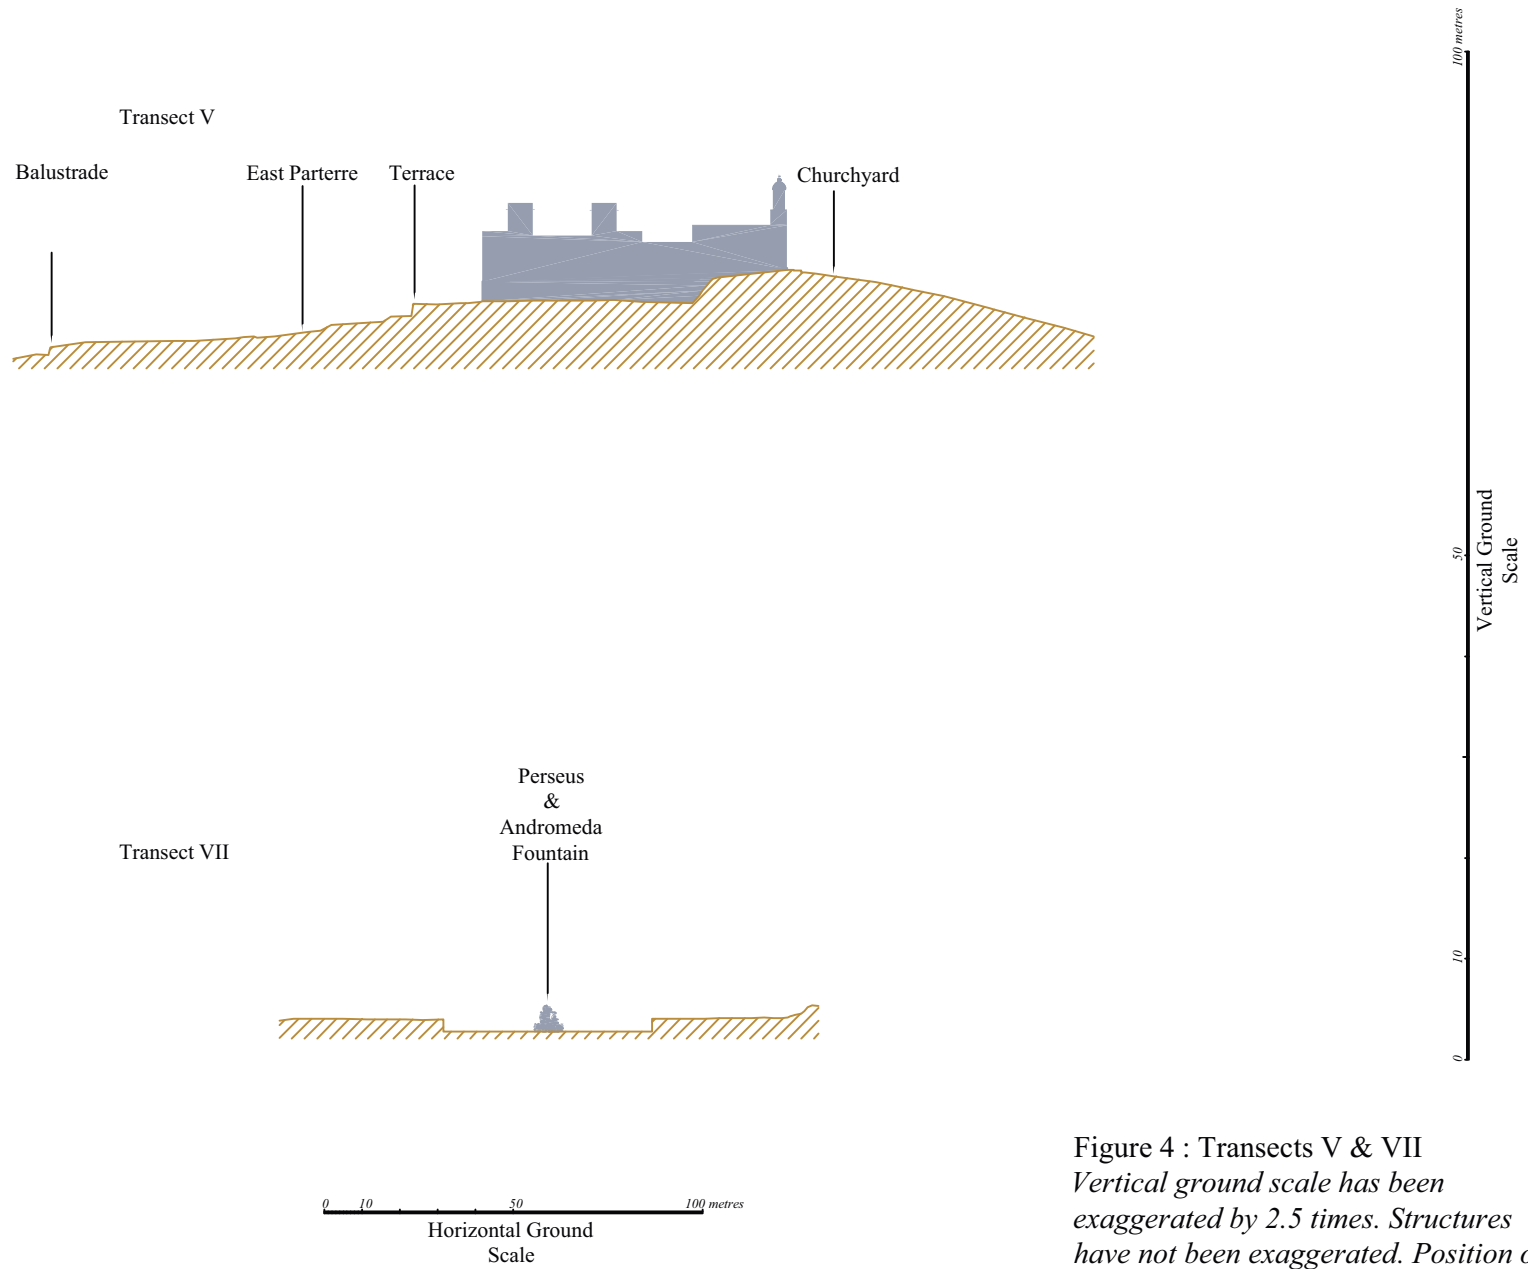
Figure 4 : Transects V & VII
 Vertical ground scale has been exaggerated by 2.5 times. Structures have not been exaggerated. Position of fountain is approximate

5.2.10 Running from east to west this section cuts through the flanking wings of the house and the churchyard (Fig. 2). In the east it starts with the gently rising natural slope beneath the east parterre (Fig. 4). This rises to the two terraces which lie beneath the east front. The house itself is flatter but beneath this lies a number of basements (omitted for clarity). The church is sited on a hill which on this side (as in Transect I) has been terraced away to accommodate a number of buildings. On this side of the hill this must have been completed by the start of construction of the late 17th century house. To the west lies the gently descending approach to the church.

5.2.12 A short east to west section across the south garden (Fig. 2). The gentle slope on either side represents the original depression which has been filled by the raised fountain and garden (Fig. 4).

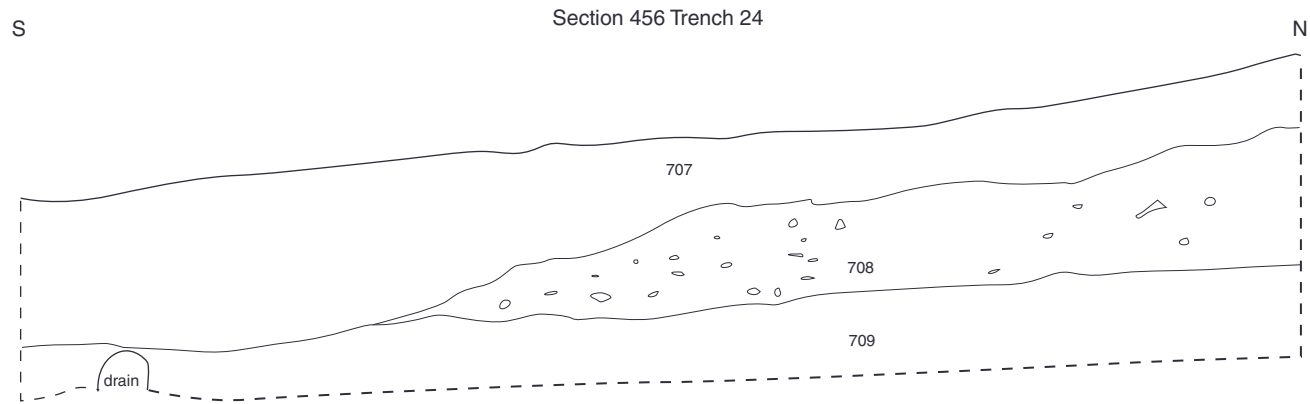
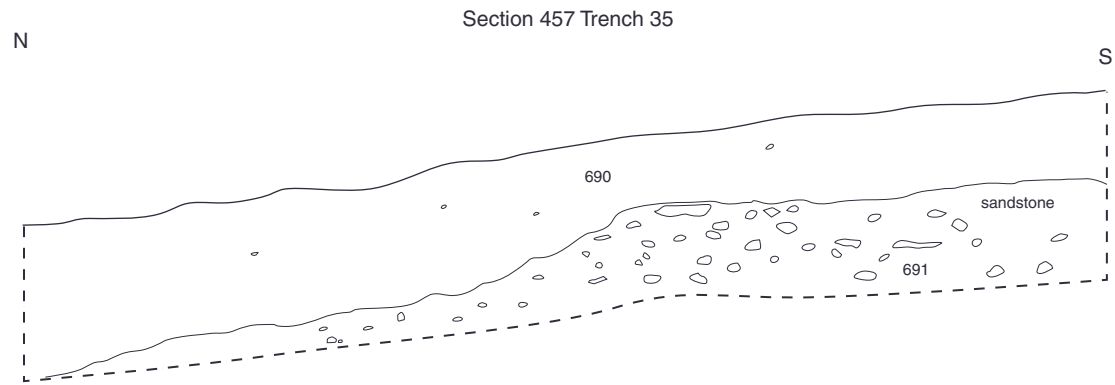
Figure 7 : Representative sections of former North and South Terraces in South Parterre, Trenches 27 and 35

were confirmed and the terrace survives as a compacted reddish brown sandy silt that contains sandstone rubble. In all trenches the terrace was seen to have been subject to slumping (Fig. 7; Trenches 27 and 35). The terrace survived to a height of approximately 0.25 m to 0.30 m. The two southern terraces required reappraisal after the discovery of two further flights of steps (S30 and S31) to the north of the West and East pavilions. Visible earthwork remains and the results of the survey indicated that the lower of the two terraces ran between these steps. This location is more geometrically accurate as would have been expected of Nesfield's design. The upper south terrace, thought originally to be located between steps S25 and S26, is actually focused between the West and East pavilions. Trenches 30 to 35 recorded the profile of both terraces. A single course brick foundation was recorded in Trench 33 on the upper south terrace and this is thought to represent the edge of a former bed (Plate 59). This interpretation has been suggested due to its similar construction to bed footings recorded on both the tapered beds and quarter beds within the garden.

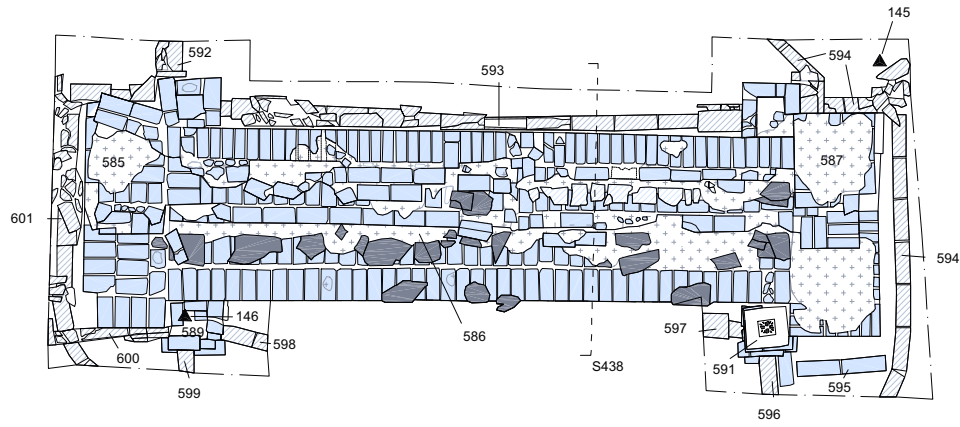
Plan No. 436: Steps S31
South Parterre - Trench 22

located to the north of the West pavilion had been heavily damaged (Plate 42), whilst Steps S31, situated to the north of the East pavilion, appear not to have been subject to such similar disturbance (see Fig. 6; Plates 37-38 and 40).

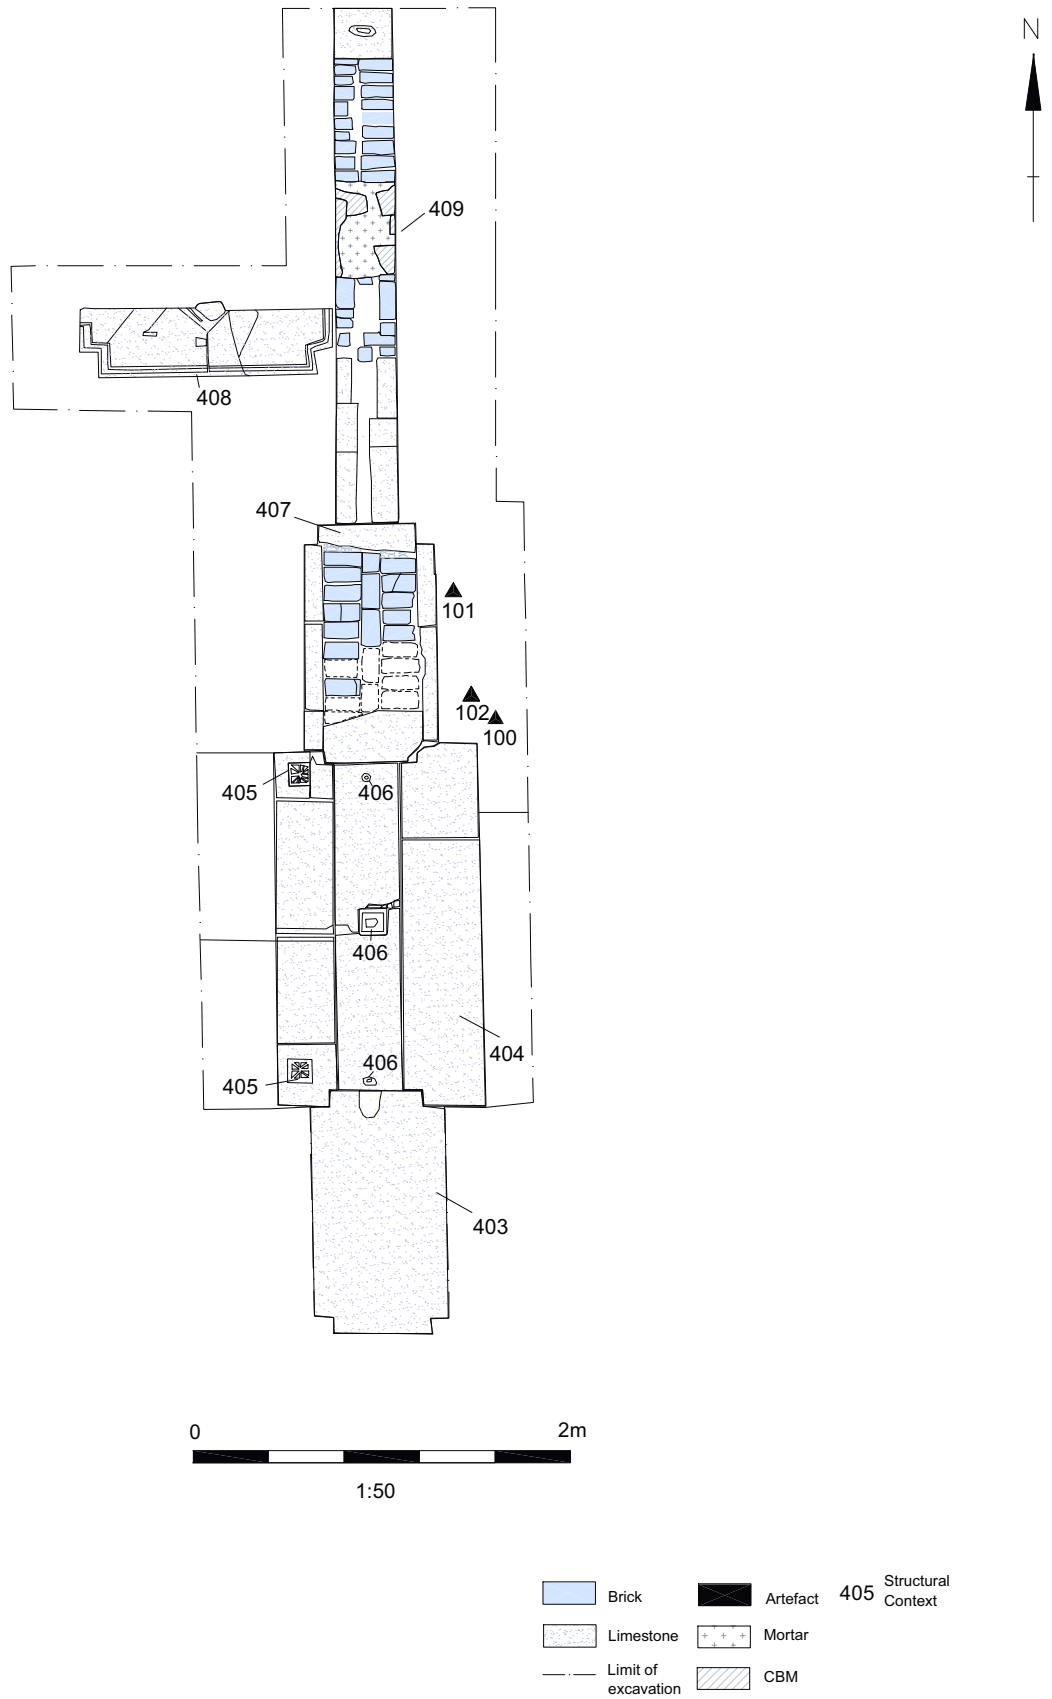
Figure 9 : Plan of north west gated entrance to Sout parterre gardens, Trench 2.

overburden revealed the foundations of the former wrought iron gates, currently retained in the Witley Court store, and as illustrated in Shirley Evans' book (Evans, 1994; page 27) (Plates 2 and 3). The gated entrance consisted of a stone paved platform with gate fittings (Fig. 9). The brick footings of a counter part pier-base to that which is still extant to the south was recorded as was a continuation from this pier base of the balustrade, constructed as a brick wall, that butts the east to west wall surrounding the Stableyard and Winter garden. The disturbed remains of part of the dressed stonework of the former northern gate pier was also recorded lying approximately 1.50 m to the northwest of its original footings. The surviving surface of the former path was also recorded to the east and west of the gate platform.

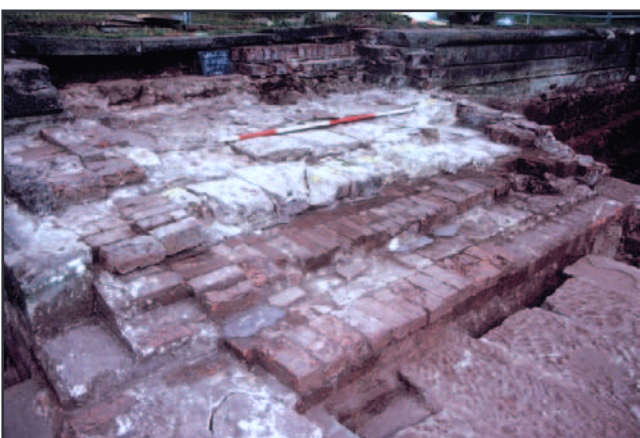
Plate 47 - Trench 20, excavation of step foundations S7 with exposed top of fountain tunnel in foreground. Looking north west.

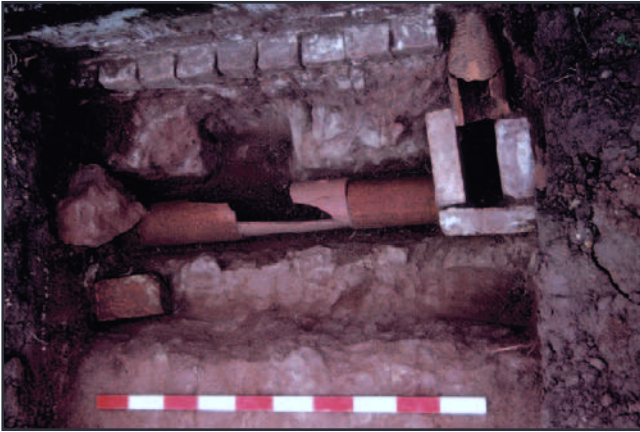
7.1.3 An inclined slope around the eastern balustrade was shown to survive, however, excavation did not reveal any evidence of an associated in-filled ditch within the trial trenches. A drainage channel revealed in Trenches 12 to 14 was, however, located flanking the balustrade (Plate 49). It was fed by ceramic out-pipes from the balustrade and was constructed from the same cylindrical piping material encountered during investigations of the paths and steps within the parterre gardens. The drainage channel flowed north to south terminating at the soakaway tower located at the pump house. Monitoring works undertaken during the excavation of the pumphouse service trench situated approximately 3 m to the east of the eastern balustrade of the East and South parterre gardens revealed no further evidence of these drainage runs. A man-hole access for the Flora fountain was however exposed, of which, a brief examination of the interior was made (see paragraph 7.11.4 below).

Plate 49 - Trench 13, excavated trench to examine ha-ha that revealed drainage from East Parterre garden through balustrade. Looking south.

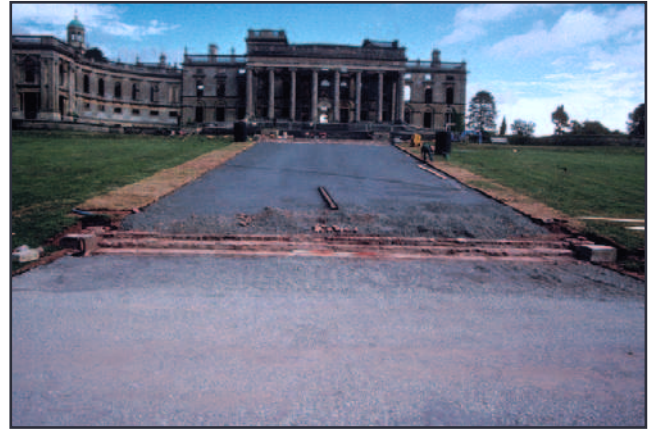
Plate 50 - Preparation of paths for re-surfacing with steps S5 in foreground. Looking north.

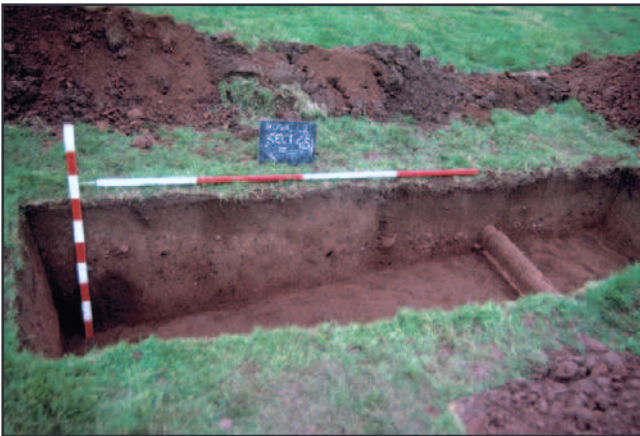
Plate 51 - Trench 26, examination of former South Parterre terrace. Looking east.

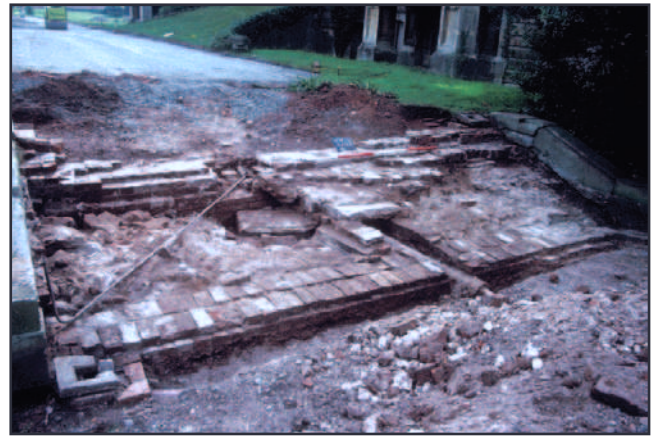
Plate 52 - Trench 100, excavation of step foundations S16 in East Parterre garden. Looking south west.

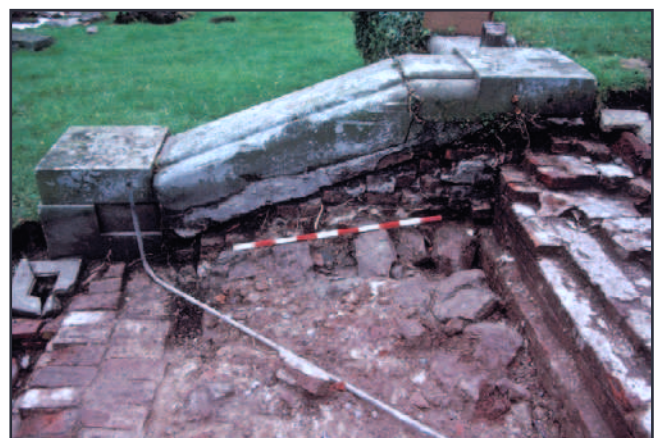
Plate 54 - Trench 100, detail of surviving stringer of steps S16. Looking east.

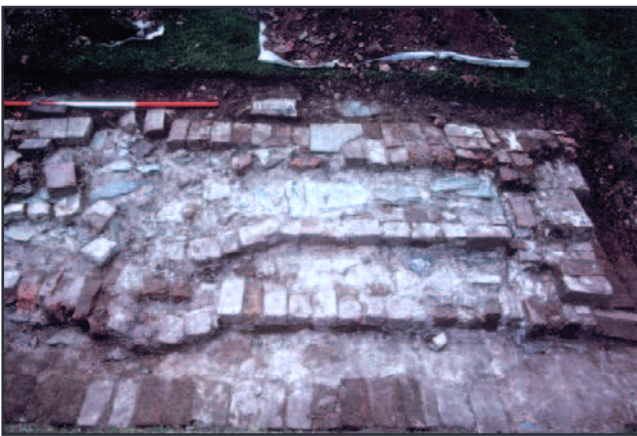
Plate 57 - Trench 101, excavation of step foundations S18b. Looking east.

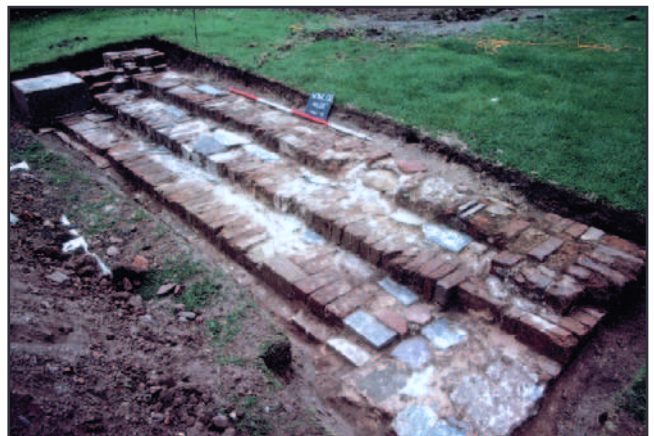
Plate 58 - Trench 104, excavation of step foundations S18a. Looking south west.

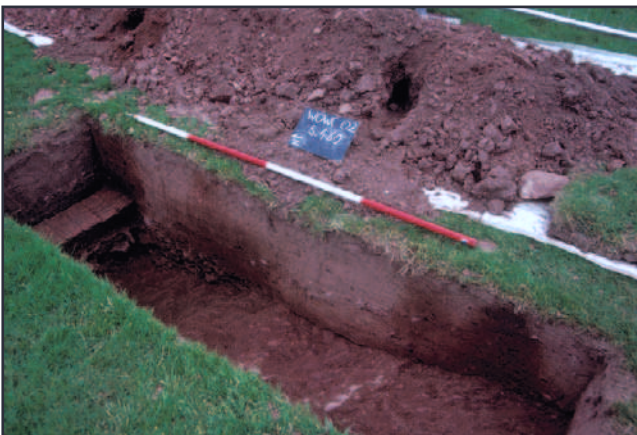
Plate 59 - Trench 33, showing excavation of trench to examine surviving terrace. Single course brick footing exposed. Looking north east.

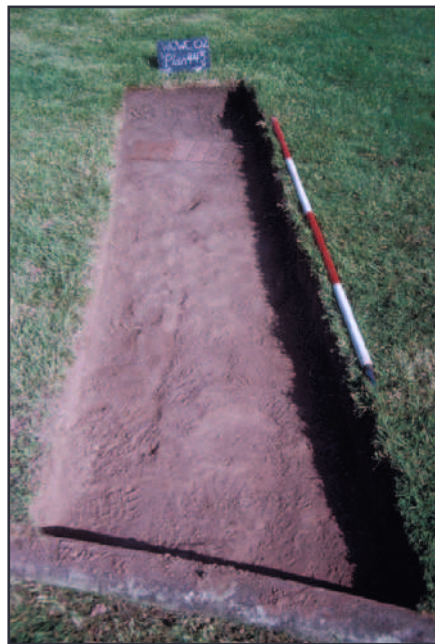
Plate 60 - Trench 18, excavation to reveal inner edge of north west quarter bed. Single course brick footing exposed. Looking north west.

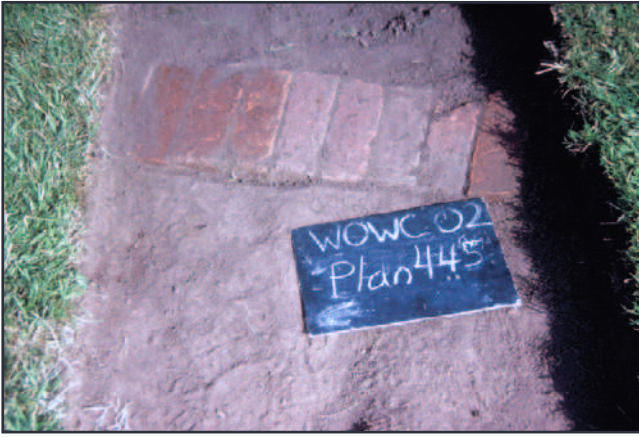
Plate 61 - Trench 18, detail of brick footing of north west quarter bed. Looking north west.

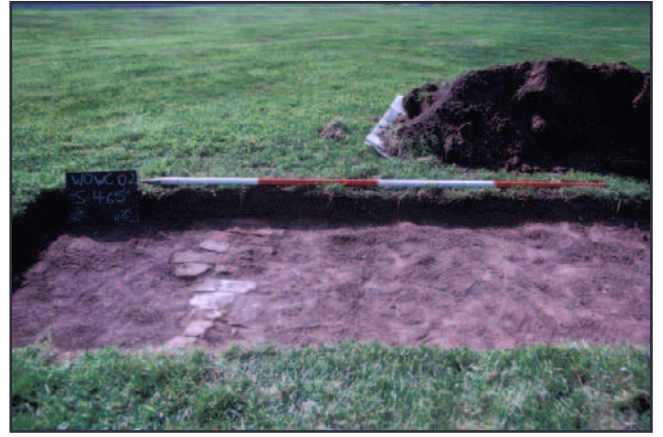
Plate 62 - Trench 19, excavation to reveal inner edge of north east quarter bed. Single course brick footing exposed, but fragmentary. Looking north west.

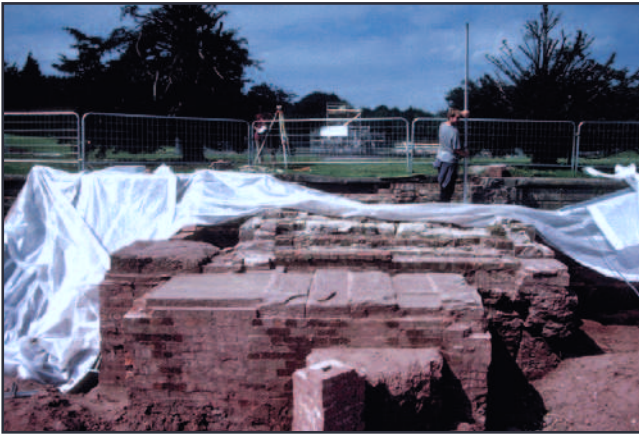
Plate 63 - Trench 20, fountain tunnel entrance exposed. Looking west.

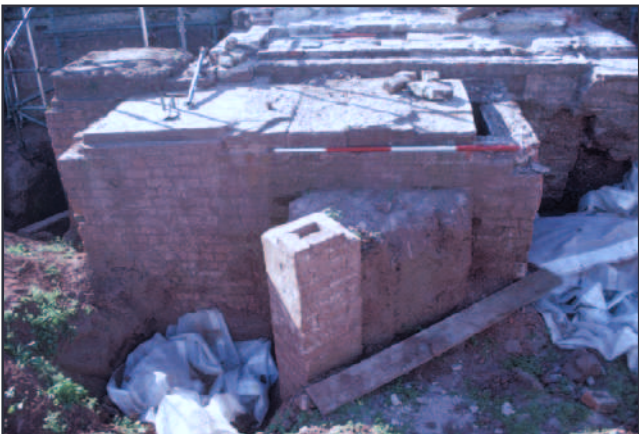
Plate 65 - Trench 20, detail of tunnel entrance structures. Looking west.

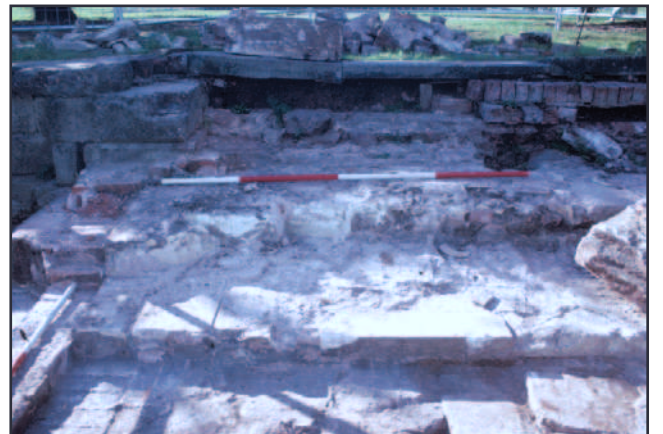
Plate 66 - Trench 20, continued excavation of steps S7. Looking west.

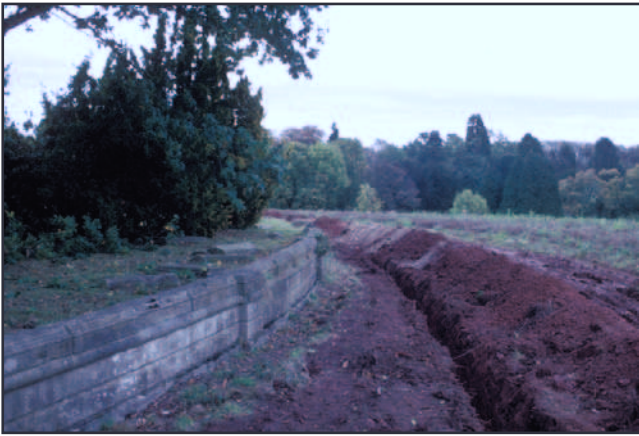
Plate 67 - Service trench excavated along east side of eastern balustrade of gardens for new pumphouse. Looking north.

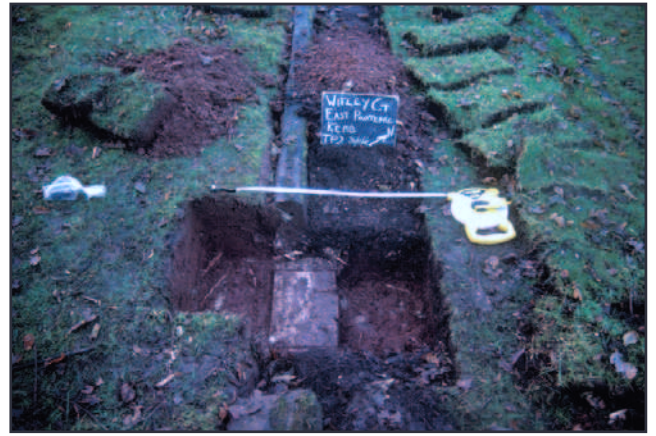
Plate 68 - Trial Pit 1 (East Parterre), examination of construction and survival of bed kerbing in east parterre. Looking north west.

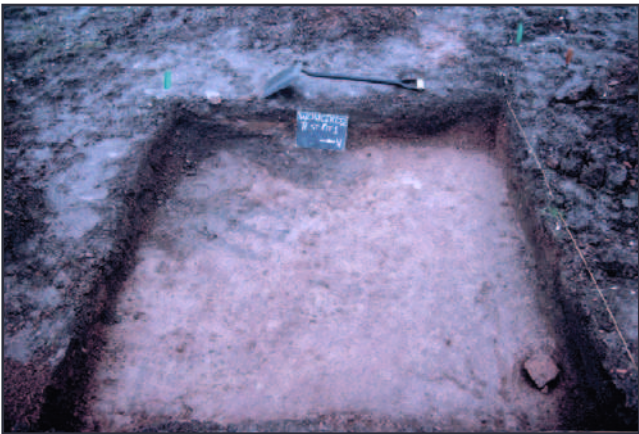
Plate 69 - Trial Pit 3, excavated in north west oval bed that revealed no evidence of former inner design. Looking west.

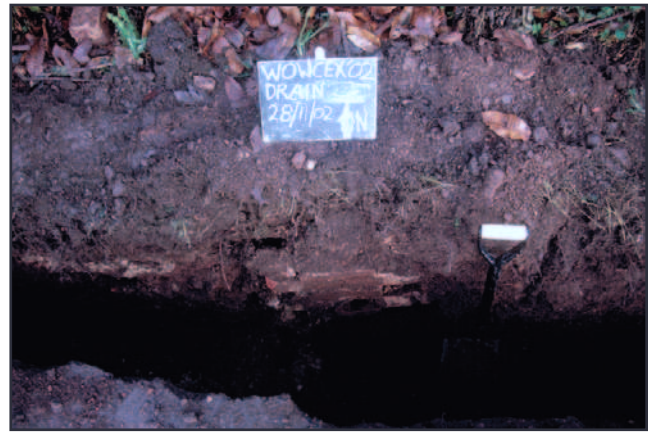
Plate 70 - Drain recorded during monitoring works carried out along service trench excavated to the north of the house. Looking north.
