Church Farm
Lewknor
Oxfordshire

Historic Buildings Recording
and Investigation

October 2009

**Client: Regeneration Holdings
Limited**

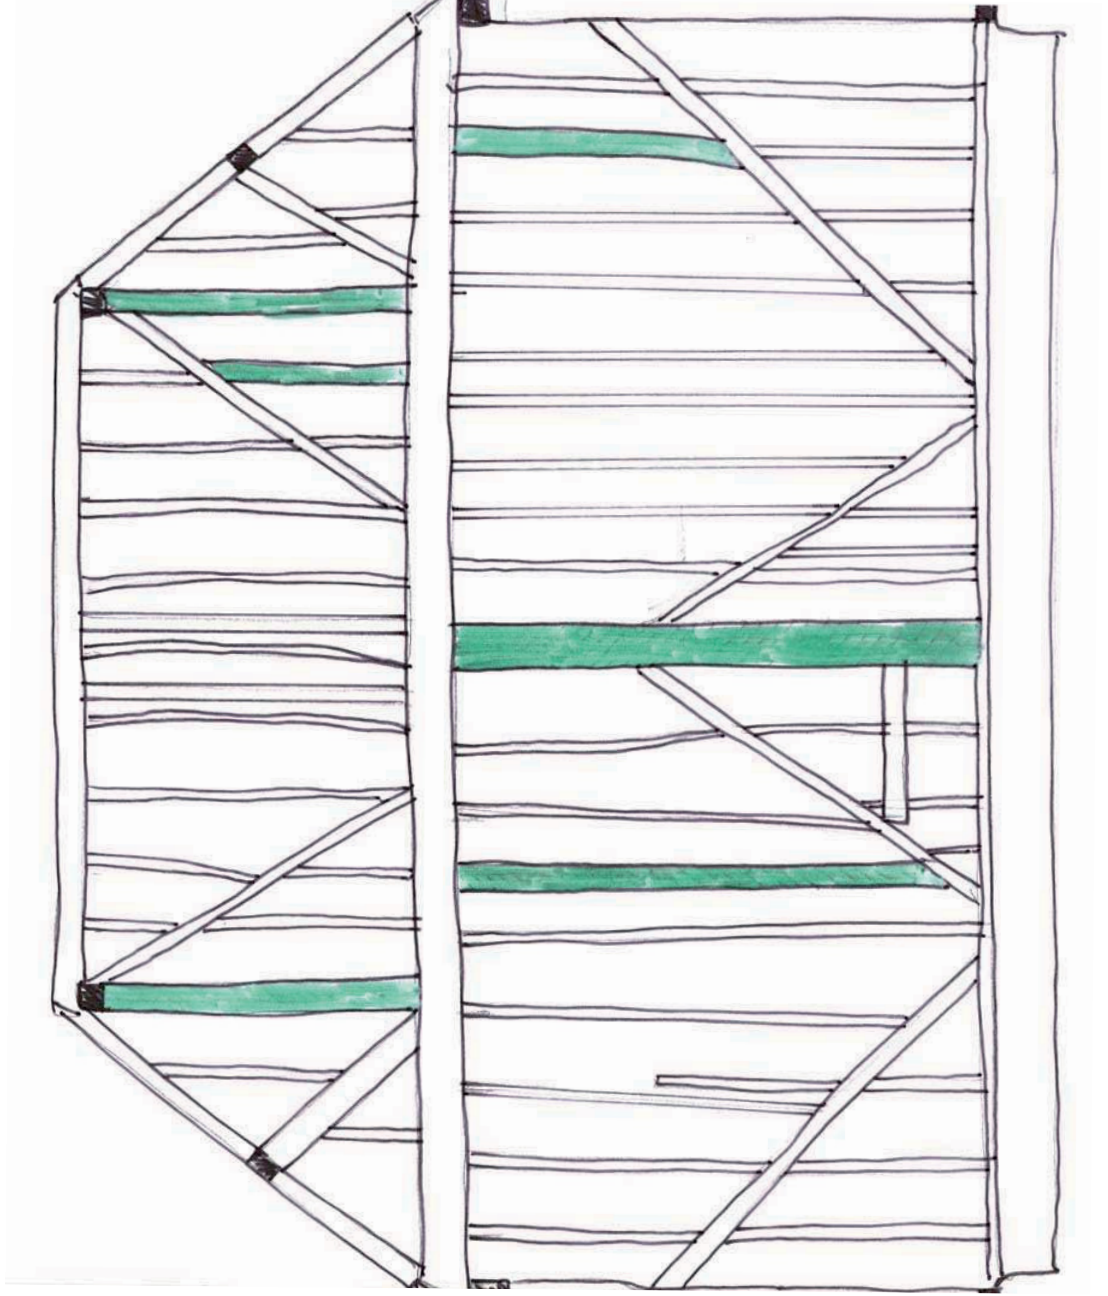
Figure 8: Sketch elevation of west wall showing re-used medieval timbers, (approx 1:50)

- 3.6.16 *West end Frame 4***
- 3.6.17 The west end wall has been entirely reconstructed (together with the western ends of the north and south walls) and we know very little about the original form of this end of the building (Fig. 8). The primary structure may have had a similar footprint to that existing today or it may have extended further west. Alternatively it may have ended further east, a short distance west from Frame 3 if the construction of the building was unexpectedly curtailed at this point (possibly for example by the Black Death) or it may have adjoined a separate (or proposed) building at this point.

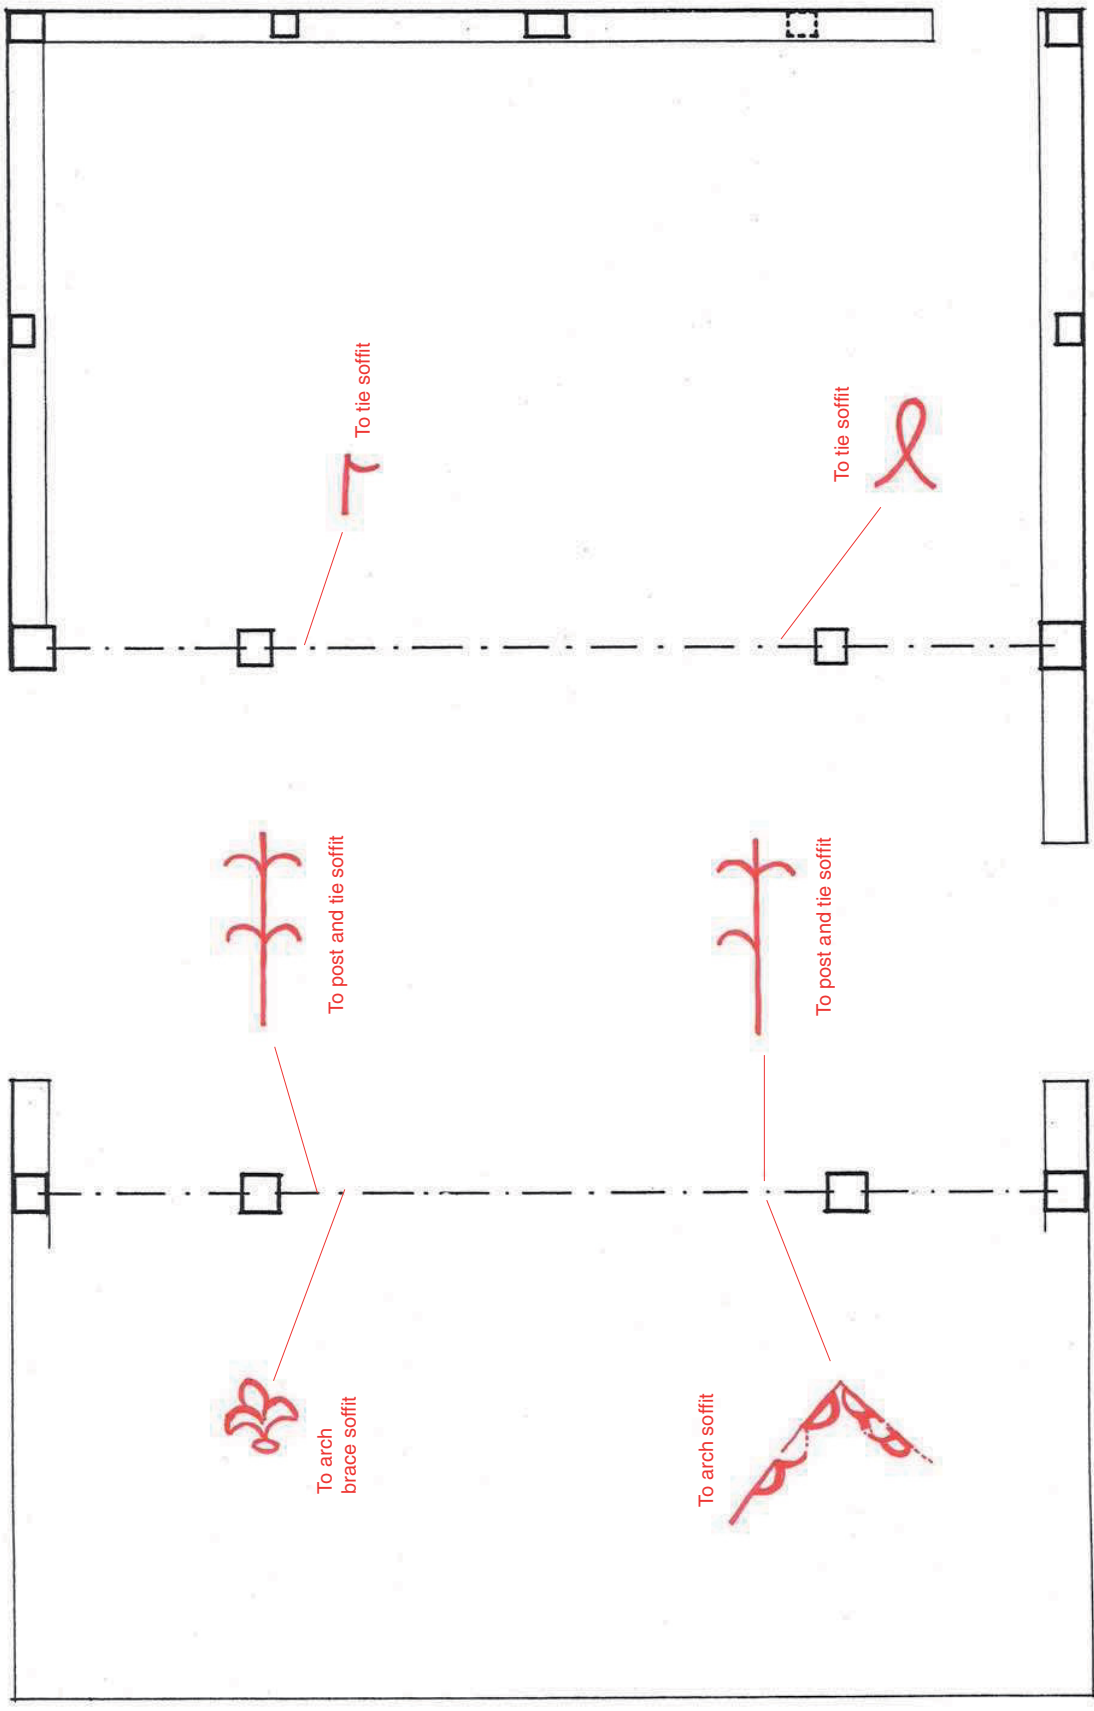
Figure 9: Plan of barn showing carpenter marks (based on RCHM survey)

3.8.2 Among the interesting features of the barn identified during the current works have been a number of unusual and distinctive carpenters marks (Fig 9). At the east end of the building there are a series of Roman numeral marks (Fig. 3) scratched to the underside of the tie-beam and these are interesting but conventional setting out marks whereas on the two main trusses of the hall (particularly the spere truss) there are a number of more individual marks which may have had symbolic value or formed a carpenter's 'signature'.

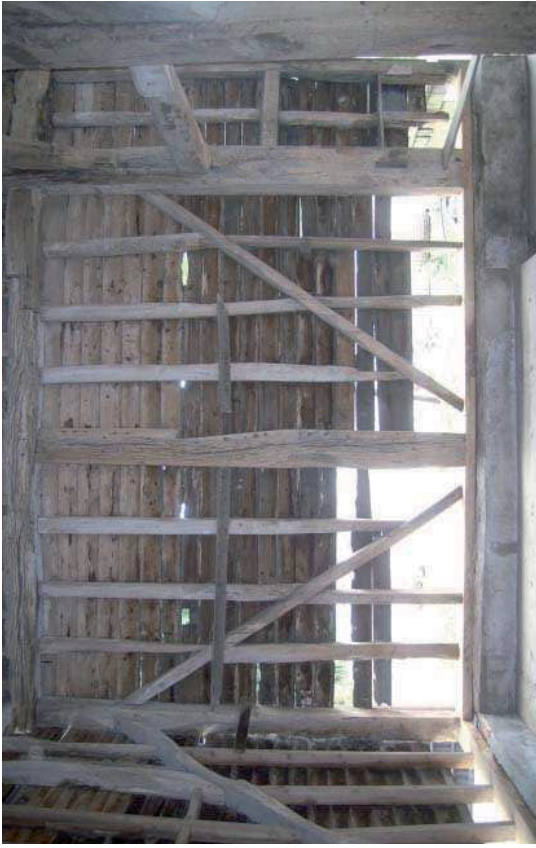
- 3.5.8 *North wall (recorded by OA)***
- 3.5.9 The north wall framing (Fig 7) is also broadly similar to the south wall. The eastern bay of the north wall incorporates concrete blockwork (post 1972) to the lower section and secondary elm stud framing above. One of the members in this frame (the sloped eastern bearer or plate) may be a reused medieval member.

Plate 13: Secondary framing and possibly reused tie at W end of N wall

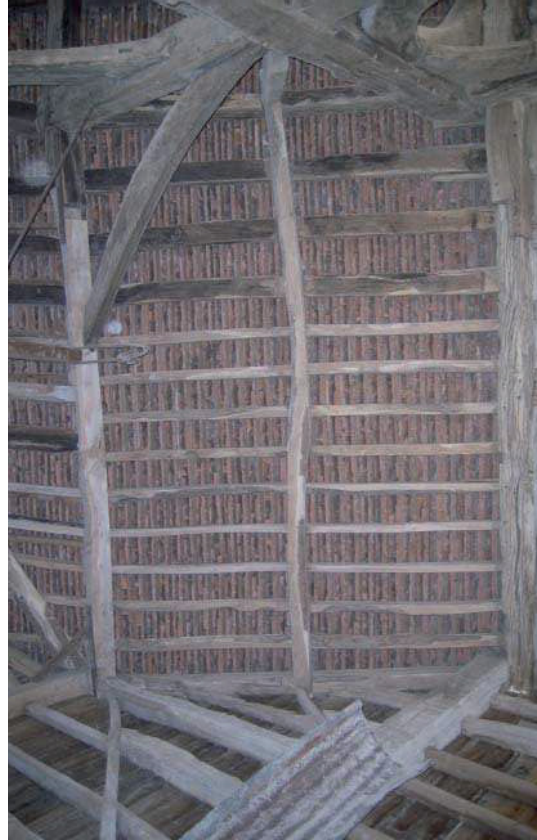
Plate 14: Roof at W end. Rafters to left secondary. Primary smoke blackened rafters to right

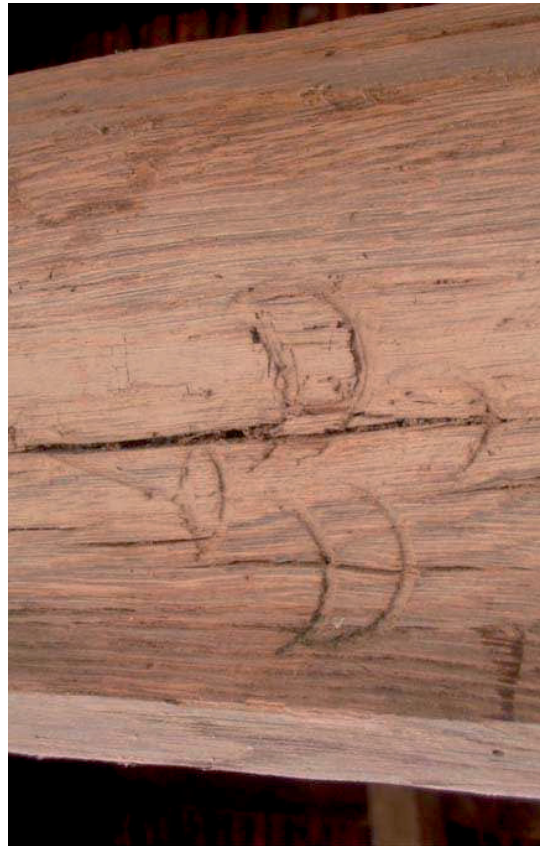
Plate 19: Fleur de Lis carpenters mark

- 3.8.4 The marks at Lewknor include a *Fleur-de-lys symbol* on the soffit of the northern arched brace of the spere truss (Frame 3). This had been scribed with a circular race knife with approximately 40mm diameter on the circle. The central point can clearly be seen on photographs (Plate 19 and Fig 5). This is an unusual mark and probably an individual piece of decorative graffiti or with some symbolic purpose rather than forming part of a series of assembly marks.
