King Henry's Parlour Bracewell, Lancashire: Supplementary Report on Archaeological Building Recording

June 2008

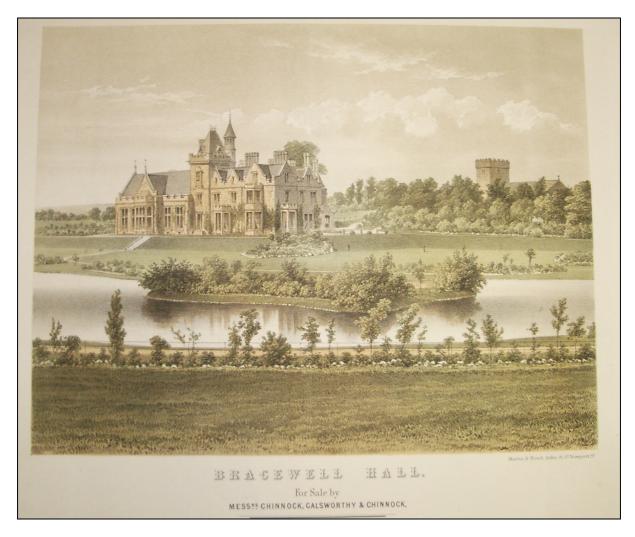
Figure 1: Drawing of the Bracewell Hall built *c*.1869, now mostly demolished. The drawing is stylised and does not show King Henry's Parlour. From the sale document of 1874⁸.
