Former Corn Mill  
Mill Lane, Low Bradley, North Yorkshire:  
Historic Building Recording

May 2010

# Former Corn Mill Mill Lane, Low Bradley, North Yorkshire: Historic Building Recording

### HISTORIC BUILDING RECORDING

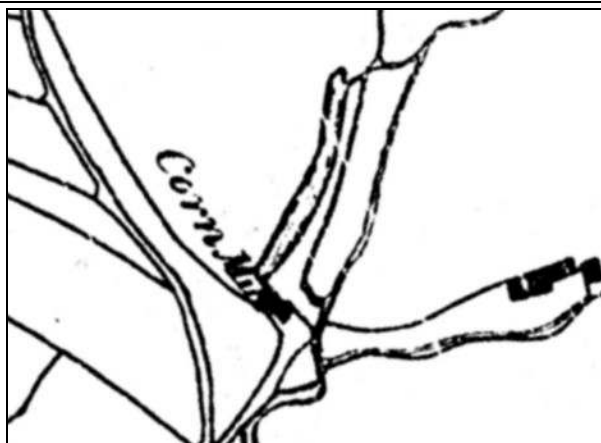
- 5.2 The earliest known depiction of the site on a historic map is from 1791 when the enclosure map shows a rectangular building named as "Corn Mill" on the site, served by a long narrow pond to the north (Figure 4). This no doubt represents the present building, although it may have changed in size since.

**Figure 4:** Extract from the 1791 enclosure map of Bradley (NYCRO MIC 604)  
Shows a rectangular building with long pond running to the north

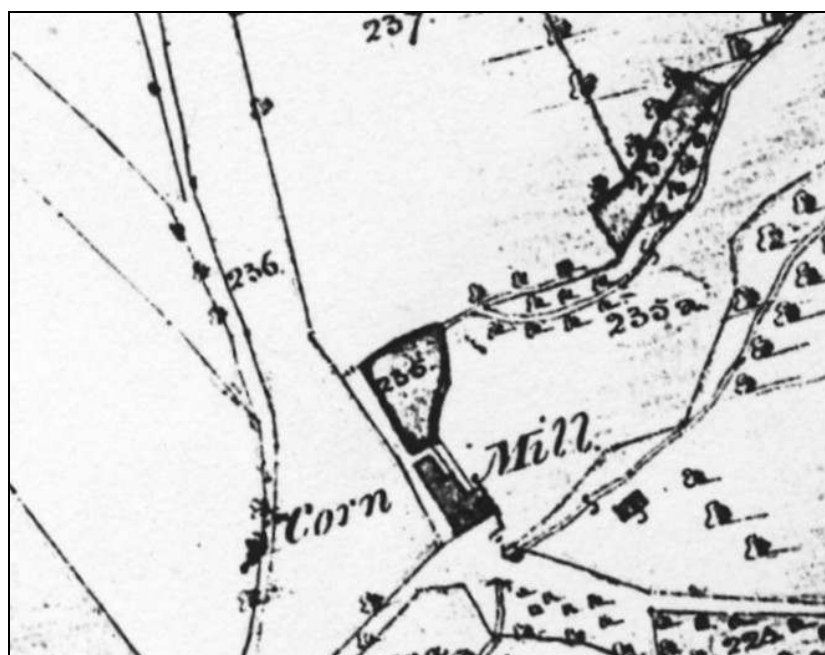
(Figure 5). The mill building itself (still named “Corn Mill” on the map) was served by a head race running parallel to its north-east side, and appears to comprise three different parts. Its outline differs from the present one in the fact that at that date, the wheel-house appears to have been shorter than at present, possibly suggesting that the wheel was then centred further to the south-east. However, it is possible that the map is schematic to some extent and should not be taken as a wholly accurate record. It is worth noting that the tithe award lists enclosure 235 as “Corn Mill and two reservoirs”, owned by George Greenwood Esq, and occupied by Jonas Sugden<sup>5</sup>. The nearly contemporary 6” to the mile Ordnance Survey map, surveyed in 1850, gives no additional information, and is of too small a scale to allow accurate comparison (Figure 6).

- 7.13 The 1842 tithe map suggests that at that date the wheel-house was shorter than at present and has been extended to the north-west since, but no evidence for this was observed in the building, so this may well arise from inaccurate mapping.

**Figure 5:** Extract from the 1842 tithe map of Bradleys Both, by Sam Swire (NYCRO MIC 1772/461-467)  
Shows a more irregular building, with the head race apparently leading to a shorter wheel-house, and two separate ponds

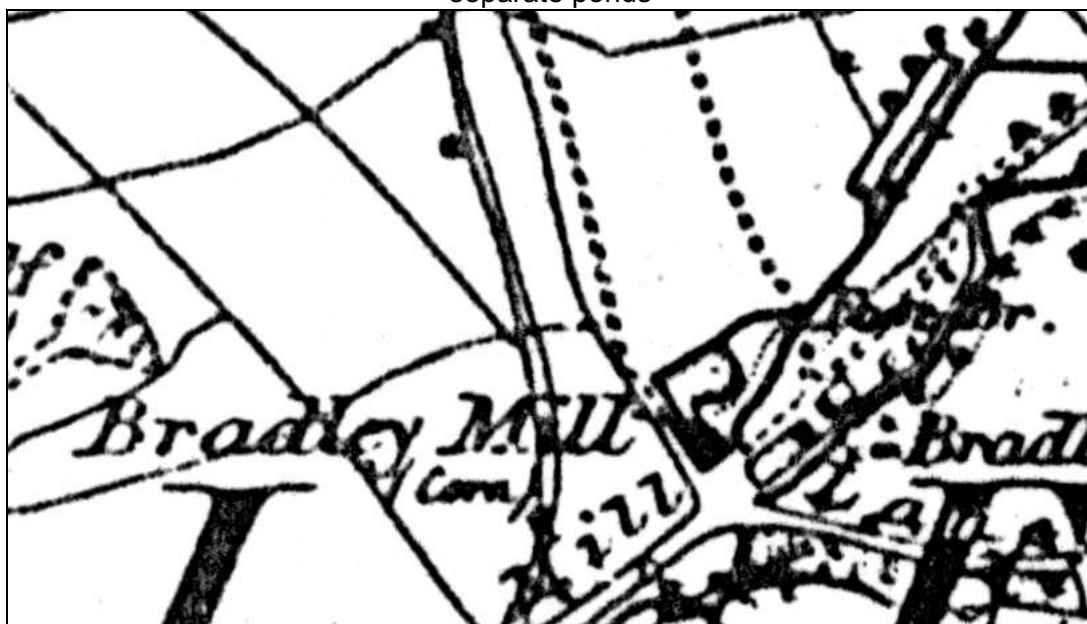
**Figure 6:** Extract from the Ordnance Survey 1st edition 6" to the mile map, surveyed 1850, published 1854  
(Yorkshire, sheet 168) (here enlarged)  
Shows essentially the same arrangement, but in less detail than the tithe map

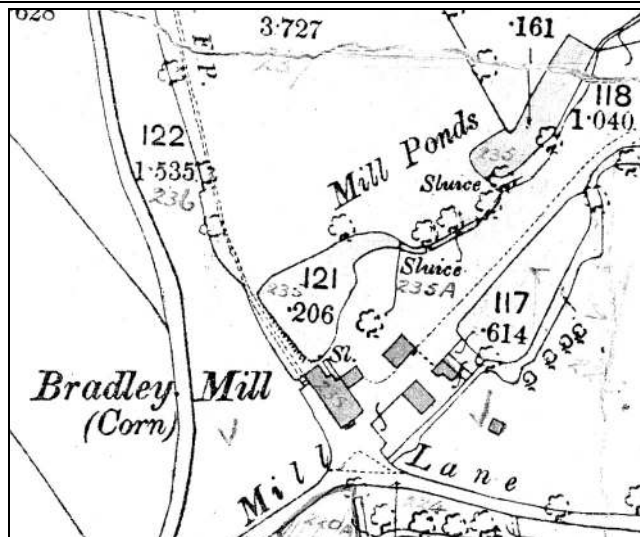
- 5.4 The earliest detailed depiction of the building was made in 1889 (Figure 7). At this time the mill was almost certainly still working (it is named “Bradley Mill (Corn)”). The two ponds are still extant and the outline of the building is the same as at present, with the addition of an appendage on the north-east side, which is no longer present. During the following 18 years the buildings and water supply did not change (Figure 8), but the map of 1907 does not name the building, perhaps an indication that milling ceased during this time. By 1938 the buildings did not change except for the demolition of the north-east structure, but the ponds and leats were removed or filled, so it is clear that the building was no longer in use as a mill (Figure 9).

**Figure 7:** Extract from the Ordnance Survey 1st edition 1:2500 map, surveyed 1889, published 1891 (Yorkshire, sheet 168.13)

Shows a slightly shorter head race and longer wheel-house, possibly attributable to the larger scale. Also note the building on the north-east side which is no longer extant.

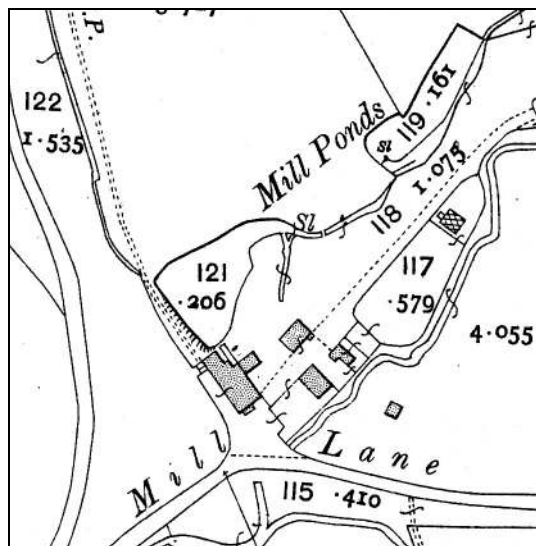
**Figure 8:** Extract from the Ordnance Survey 1:2500 map, revised 1907, published 1909 (Yorkshire, sheet 168.13)

The map shows no significant changes except the absence of a name for the building, possibly suggesting it had fallen out of use.

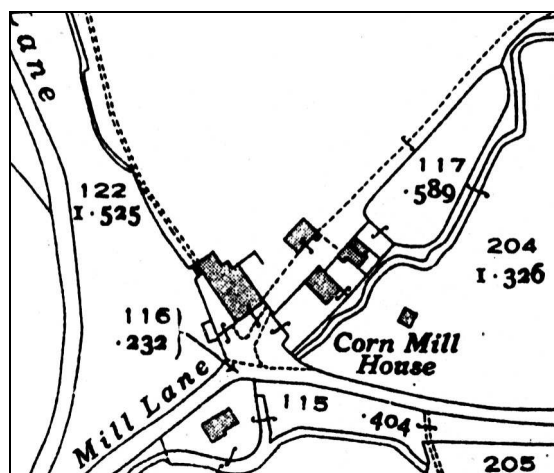
**Figure 9:** Extract from the Ordnance Survey 1:2500 map, revised and published 1938 (Yorkshire, sheet 168.13)

By this date the ponds and head race were no longer present and the north-east building demolished. The mill was evidently no longer in use at this time.
