REPORT ON ARCHAEOLOGICAL FIELDWORK PITFODELS, NEW INTERNATIONAL SCHOOL, ABERDEEN

Alison Cameron Assistant Archaeologist Aberdeen City Council Archaeological Unit Whitespace 60 Frederick Street Aberdeen AB24 5HY (01224) 523654 alcameron@aberdeencity.gov.uk

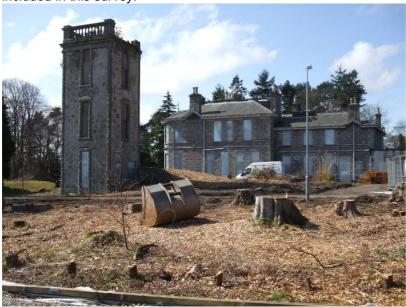
Buildings 1 and 2 The 19^{th} -century Pitfodels House (Building 1) and the tower with the 1633/1692 armorial panel (Building 2) are being retained as part of this development and were therefore not included in this survey.

III 6 Pitfodels House (Building 1; right), tower (Building 2; left) facing W

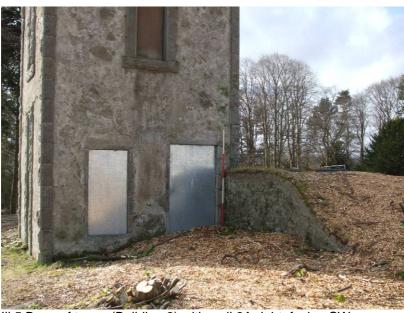
III 5 Base of tower (Building 2) with wall 2A right; facing SW

See Trench 7 (below) for details of Building 2 following removal of soil from around the base of the tower.

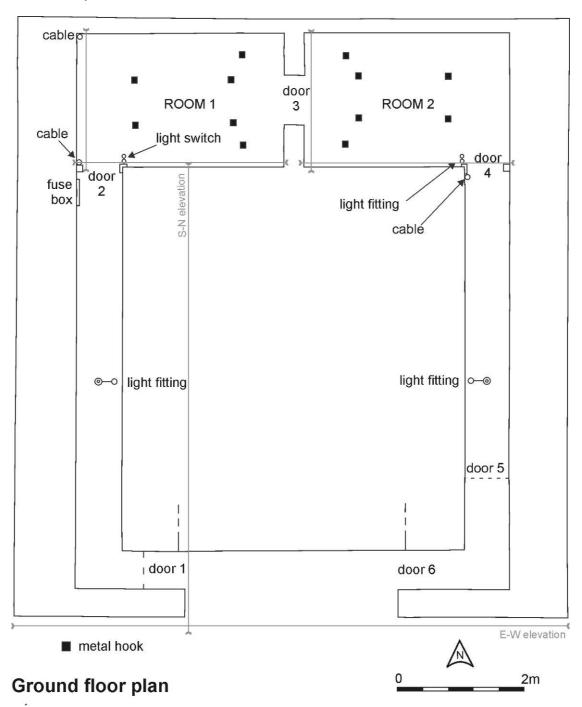
III 6 Ground floor plan

The bunker (III 6) is 8.82 m along the south-facing frontage and 9.34m along its N-S axis. The south wall is 0.42m thick and faced with granite blocks.

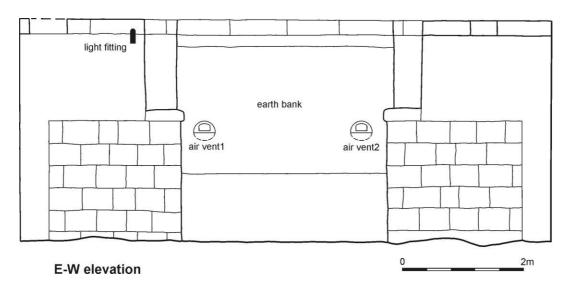
III 8 W-E South-facing elevation

The west and east walls, partly built into the earth bank, are 0.93m thick. A corridor runs along both the west and east sides of the building; they are 8.9m long and 0.70m wide. The corridors lead to two rooms (Room 1, 2) at the north of the structure; the rooms are divided by a partition wall with low door (Door 3; Ill 25, 26). The walls and frontage of the structure are made from blocks of granite.

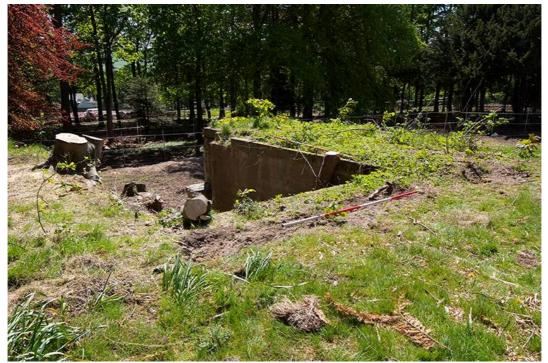
III 9 View of top of bunker showing top of mound with grass, tree cover removed

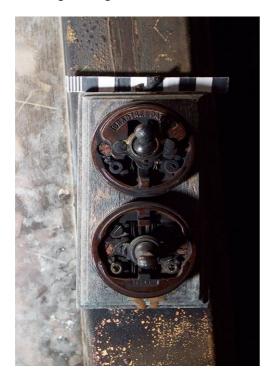
III 13 Light switches, room 1

Bakelite light switches are positioned at the entrance to Rooms 1 and 2 and some electricity cabling survives.

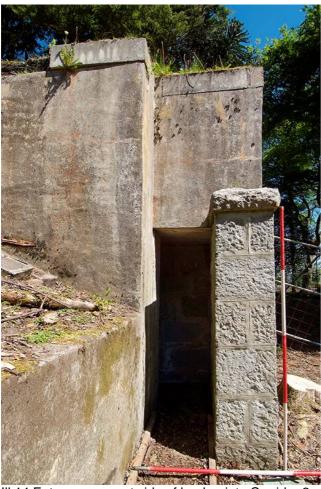
III 14 Entrance on east side of bunker into Corridor 2

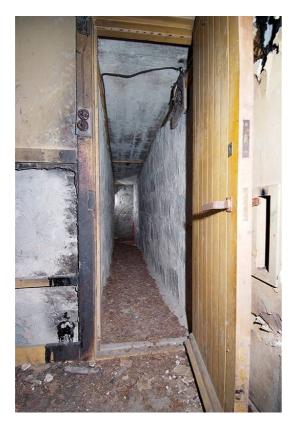
III 15 Corridor 1 facing south out of Room 1

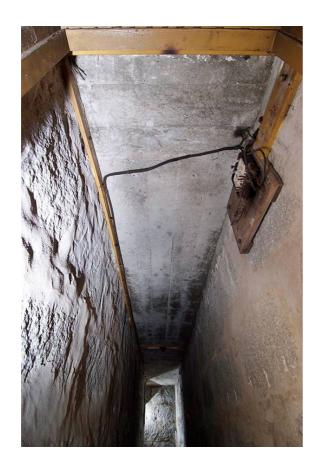
III 21 Detail of shuttering marks on ceiling of Corridor 1

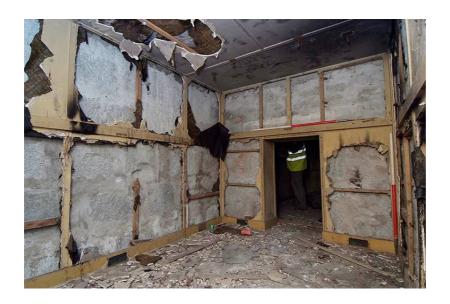
III 26 Room 1 facing north-east showing wall and low door between Rooms 1 and 2

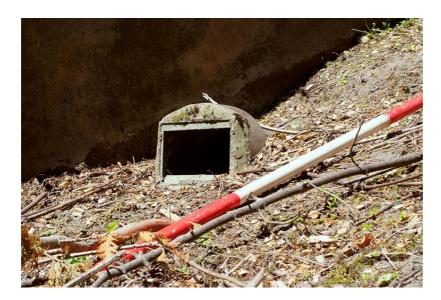
III 28 Ventilation shaft exterior

Fresh air diffused into the rooms by two vents (Vents 1 and 2;) consisting of 0.18m diameter concrete water or sewage pipe laid just below ceiling level in each room and exiting the structure in the earthen roof.

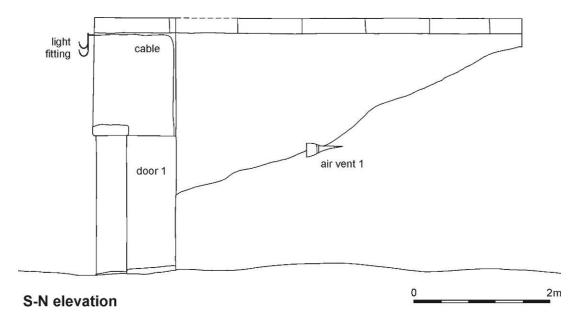
III 30 S-N elevation through bunker

During the demolition of the building, it was determined that the roof was constructed of layers of reinforced concrete and layers of sand which would have been a very bomb-proof structure.

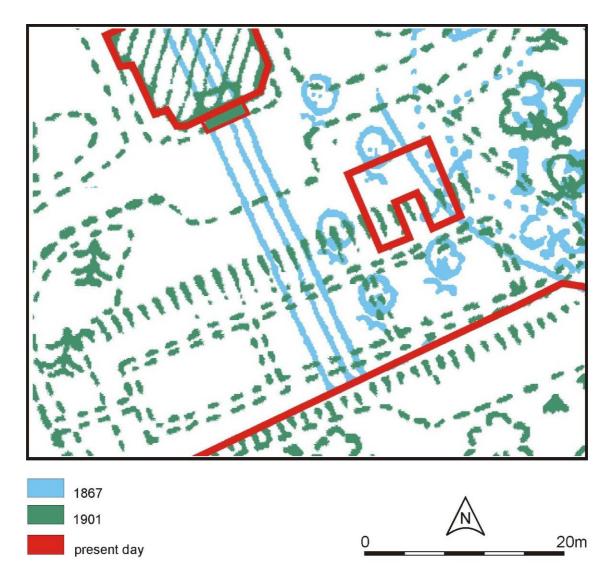
III 31 1867 and 1901 Ordnance Survey maps overlain on plan of house and bunker in June 2008, showing landscaping

Building 3 was built into an earthen bank which can be seen on the 1901 and 1925 Ordnance Survey maps; this building does not appear on either of these maps, however. Prior to that date the drive up to Viewbank House ran through the area now occupied by Building 3 suggesting that the area had been heavily landscaped between 1867 and 1901. The building does not appear on the 1926 Ordnance Survey map. It is possible that the granite structure is the first phase of the building and that the concrete superstructure was added later. It is more likely, however, that either there was a ready source of granite blocks in the area (possibly from the demolition of Viewbank or another building in the vicinity) or that the owners of Pitfodels at the time of building required a decorative granite frontage as the building was on the main drive up to the house and would therefore have been readily seen by all visitors. The concrete roof was then partly covered by earth and trees and was therefore mainly hidden from view. The rough-dressed granite used as a decorative element on the frontage of Building 3 is very similar in style to that of the quoins on the tower (Building 2; the remains of Viewbank) which might support the theory that this is re-used stone from the original Viewbank.

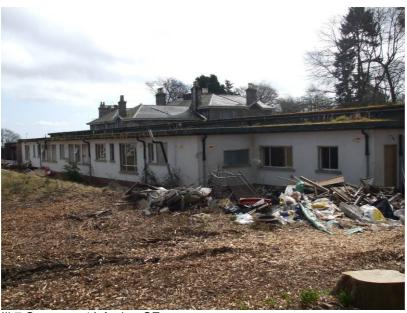
Building 4
These buildings were being demolished at the time of the walkover survey.

III 7 Structure 4A facing SE

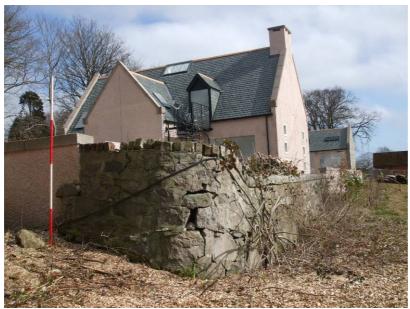
This modern house retained in its boundary wall part of an earlier drystone dyke (Wall 22). This wall is on the 1867 and 1901 Ordnance Survey maps and appears to be a boundary within the original Viewbank estate.

III 8 Structure 5 showing wall 22 (foreground) facing ENE

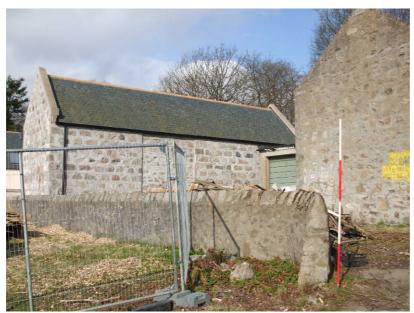
Structure 6 This granite agricultural building, to be demolished during the current work, is presumably the building seen on the 1867 and 1901 Ordnance Survey maps (III 3).

III 9 Structure 6 (left) Structure 7 (right) and east end of Wall 22 (foreground); facing NW

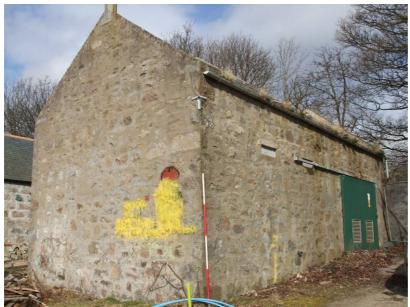
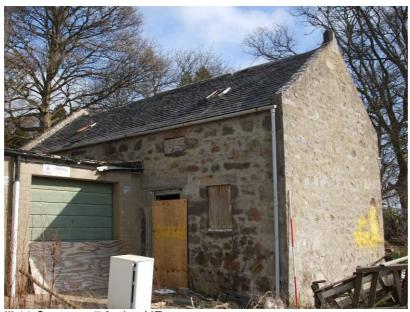
This granite agricultural building is to be demolished during the current work. It is presumably the building seen on the 1867 and 1901 Ordnance Survey maps (III 3). It is in use as an electricity sub-station.

III 10 Structure 7 facing NW

III 11 Structure 7 facing NE

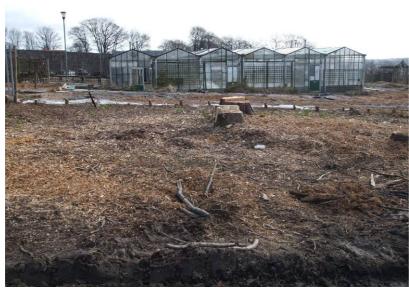
Structures 8-15 These structures, to be demolished during the current work, are all associated with The Fox Lane Garden Centre and are all late 20th century in date.

Ill 12 Glasshouse Structure 11 (background) with area cleared of trees east of Tower (Structure 2 (foreground) facing E.

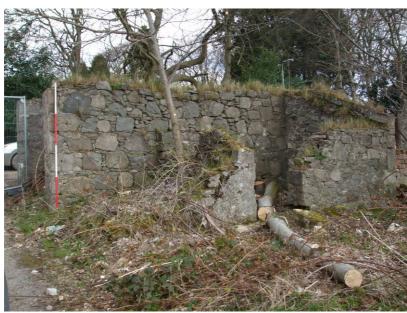
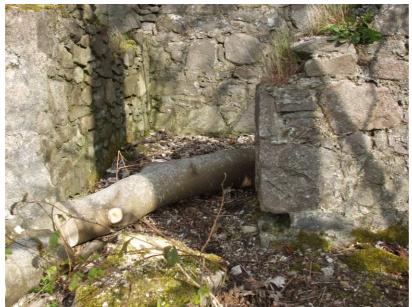
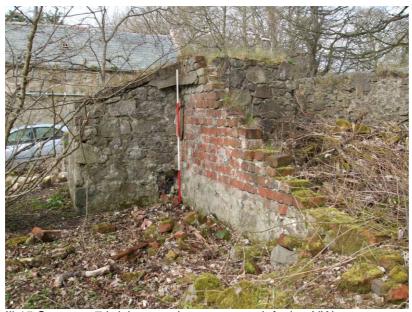
This ruinous building, planned but not numbered on drawing A3927/L(-)05, is to be demolished during the current work. It appears on the 1867 and 1901 Ordnance Survey maps and appears to be an agricultural building. The main structure (west end) is granite and this has a brick extension to the east. The building had been in use as a leaf store and composter and so full access to these structures was not possible.

III 13 Structure 7 west end, facing NE

III 14 Structure 7 west end, door; facing N

III 15 Structure 7 brick extension to east end, facing NW

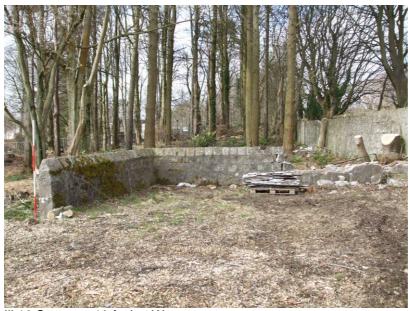
Structure 18 This L-shaped fragment of wall, constructed between 1867 and 1901 (according to the Ordnance Survey), appears to be the remains of a garden or enclosure wall.

III 16 Structure 18 facing W

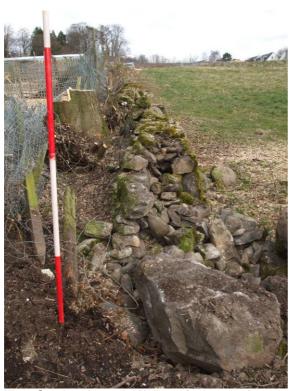
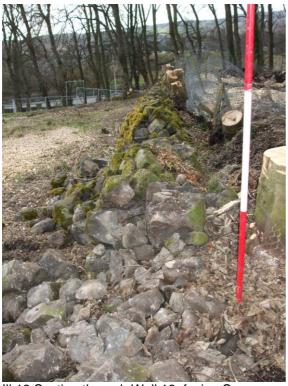
Structure 19
This main N-S drystone wall originally dividing Viewbank from the neighbouring field. A gate (feature 24) near its north end allowed access through the wall.

III 17 Section through Wall 19, facing north

III 18 Section through Wall 19, facing S

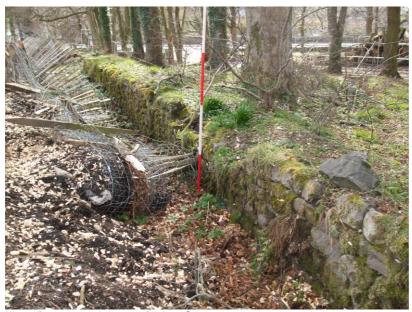
Structure 20 This drystone wall formed the east wall of the driveway of Viewbank and Pitfodels House.

III 19 Drystone dyke 20 facing S.

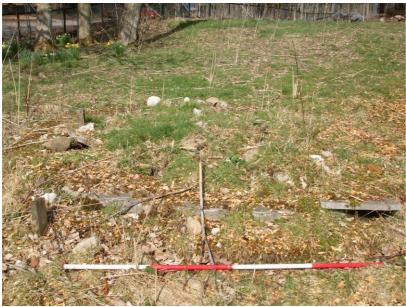
Structure 21 A series of structures within a rectangular boundary is the remains of a play park. This includes circular stone Structure 21.

III 20 Stone base of circular Structure 21 facing W.

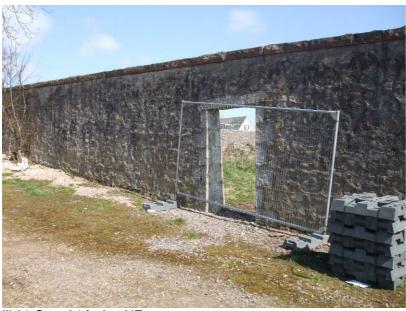
Structure 24 This is a gate towards the north end of Wall 19.

III 21 Gate 24 facing NE

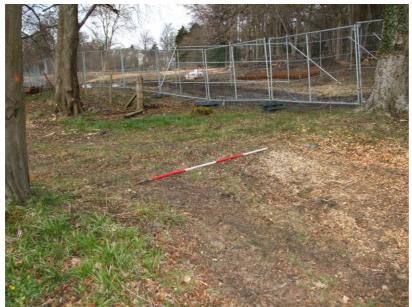
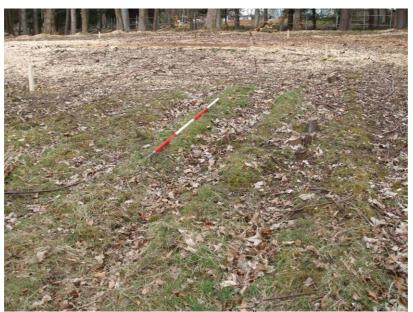
Several areas of ridges for tree planting were recorded. Within the area of trees at the extreme south of the site, ridges were recorded which were associated with the mature trees in the area. To the north of this area, where the new drive and car parking area was formed, narrower rigs were recorded which were associated with more recent tree planting in the late 20th century.

III 22 Ridge formed during planting of mature trees at extreme south of site, facing NW

III 23 Ridges formed by planting, in late 20th century, of recently felled trees, facing N.

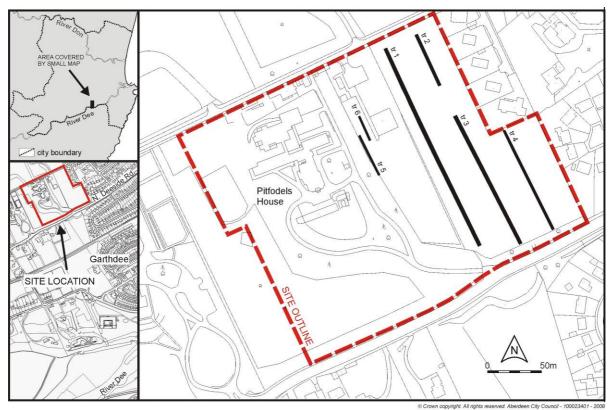
Plan of trenches and site location III 24 Site location and plan showing trenches excavated

The topsoil strip along the line of the new road off North Deeside Road (DWG A3927/P(0)02) (III 24) revealed humic topsoil 10-30cm deep over a very stony light brown sandy natural subsoil including large boulders up to 50cm diameter.

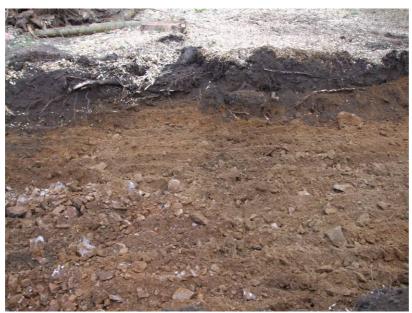
III 25 Stripping topsoil for new road into site facing N

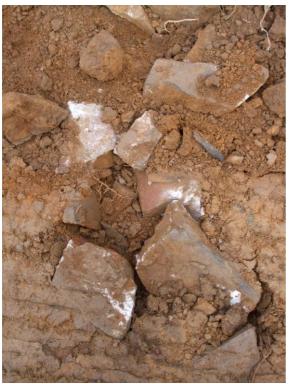
III 26 Stone-filled drain AA uncovered during topsoil stripping for new road and car parking, facing N

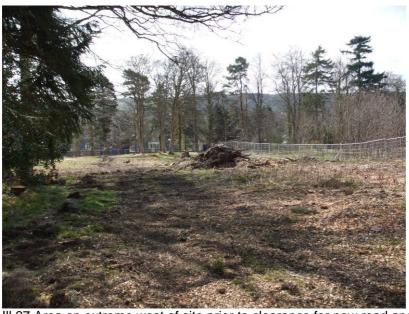
III 27 Area on extreme west of site prior to clearance for new road and car parking facing S.

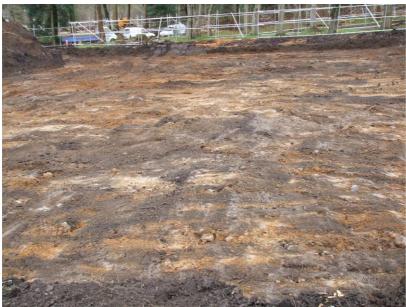
III 28 Area cleared for coach waiting area facing W

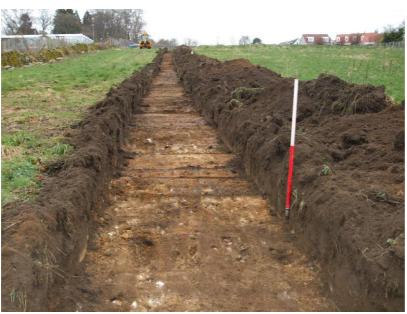
Trench 1
This was located along the full length of the west of the field. Topsoil varied from 20-40cm in depth. No archaeological features were recorded. A modern service trench, AD, was recorded.

III 29 Trench 1 facing N

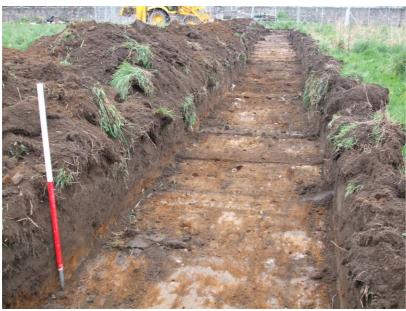
Trench 2 This was located in the centre of the field, north of ménage Structure 23. Topsoil varied from 20-40cm in depth. No archaeological features were recorded.

III 30 Trench 2 facing N

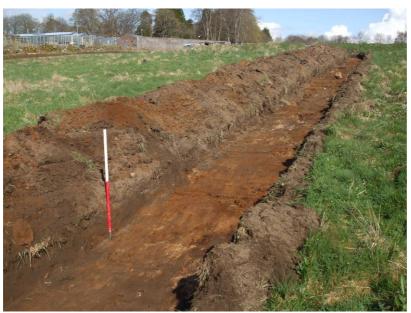
Trench 3
This was located in the centre of the field south of ménage Structure 23. Topsoil varied from 20-40cm in depth. No archaeological features were recorded. A modern service trench, AD, was recorded.

III 31 Trench 3 facing NW

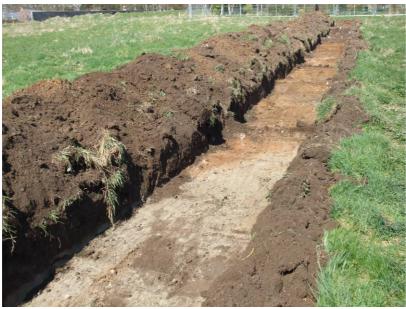
Trench 4
This was located in the east of the field. Topsoil varied from 20-40cm in depth. No archaeological features were recorded.

III 32 Trench 4 facing NW

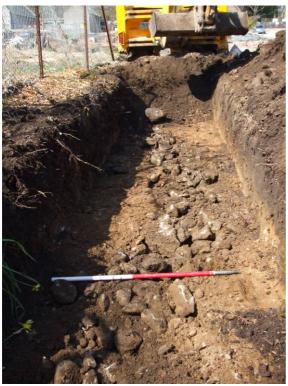
These were located in the area of the new swimming pool. Both had topsoil of 40-50cm depth. Trench 5 contained two drains, one a stone-filled cut in the natural subsoil, AB and one a small-bore ceramic drainpipe, AC, cut into a trench in the natural subsoil.

III 33 Trench 5 stone drain AB, facing S

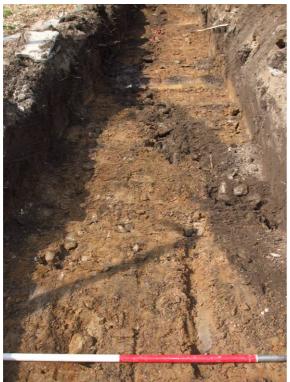
III 33 Trench 5 cut for ceramic water pipe, AC, facing S

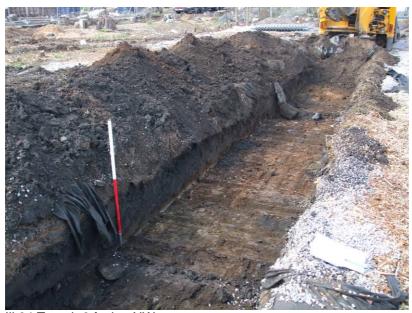
III 34 Trench 6 facing NW

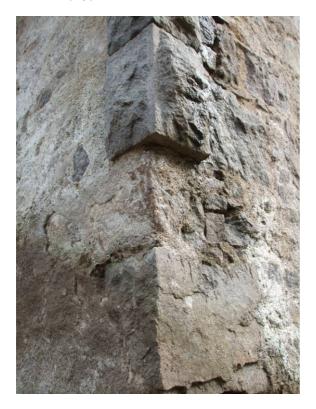
III 39 Detail of inserted Phase 2 quoin (top)

After the demolition of the original Viewbank House, this part of it was left as a stand-alone structure. At this time the quoins were replaced with rustic granite examples standing proud of the wall faces (III); the quoins have been inserted the full height of the tower on the SE and NE corners, but on the remaining two corners they were only inserted from the roof line to the point where a soil mound was created around the base of the tower as a garden feature. The walls which were being covered by the soil mound were also harled with a mid-grey stony harling (III), presumably as damp proofing. The same rustic granite stones used for the quoins were also used for the window surrounds (III).

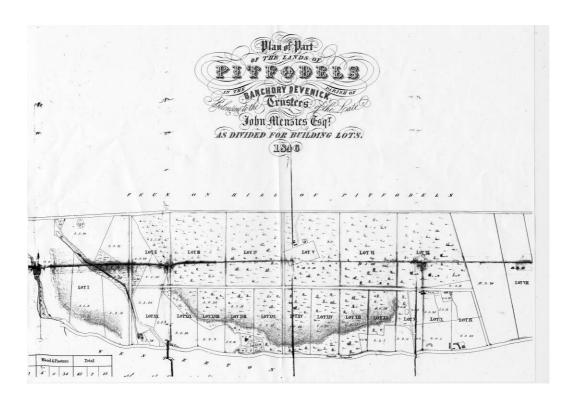
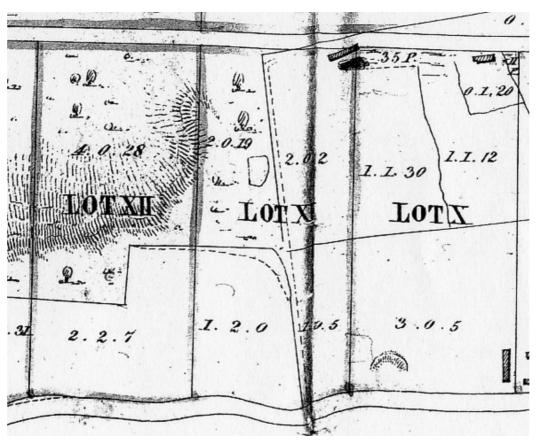
The area of land under development was feued from John Menzies in 3 lots (III 46).

III 46a (above) Feuing plan of 1846 (courtesy of Robin Brodie, Ledingham and Chalmers) and b (below) Detail of above
