**WALLS, GATES AND TOWERS**

**LINCOLN CASTLE**

**ARCHAEOLOGICAL  
INVESTIGATION**

**REPORT  
NOVEMBER 2015**

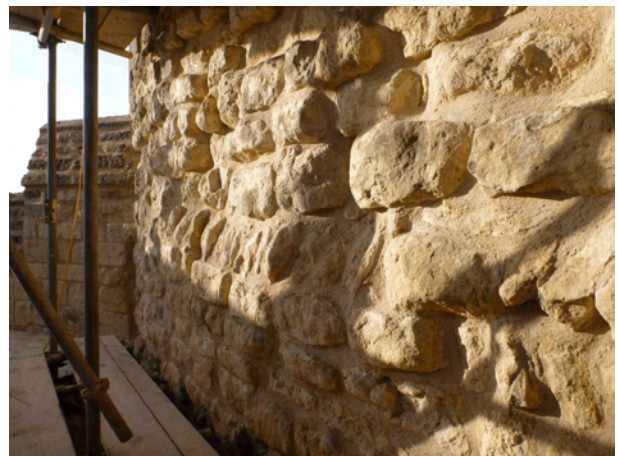
**Plate 4** Herringbone masonry in the south curtain wall to the west of the Observatory Tower

The exterior of the east end of the curtain wall descends the Observatory Tower mound to where the ground has been levelled (Figure 3). The first c.1.3m of walling attached to the corner of the Observatory Tower was refaced in the 1830s and retains no features of note. However, the adjacent c.5.7m of wall facing is largely medieval with later work to the bottom and top of it. Bonded with a brown lime mortar the main features of the medieval work are two putlog holes set at the same level and two courses of pitched masonry forming a herringbone pattern (*opus spicatum*)(Plate 4). The herringbone courses correspond in terms of position with a similar feature on the interior of the

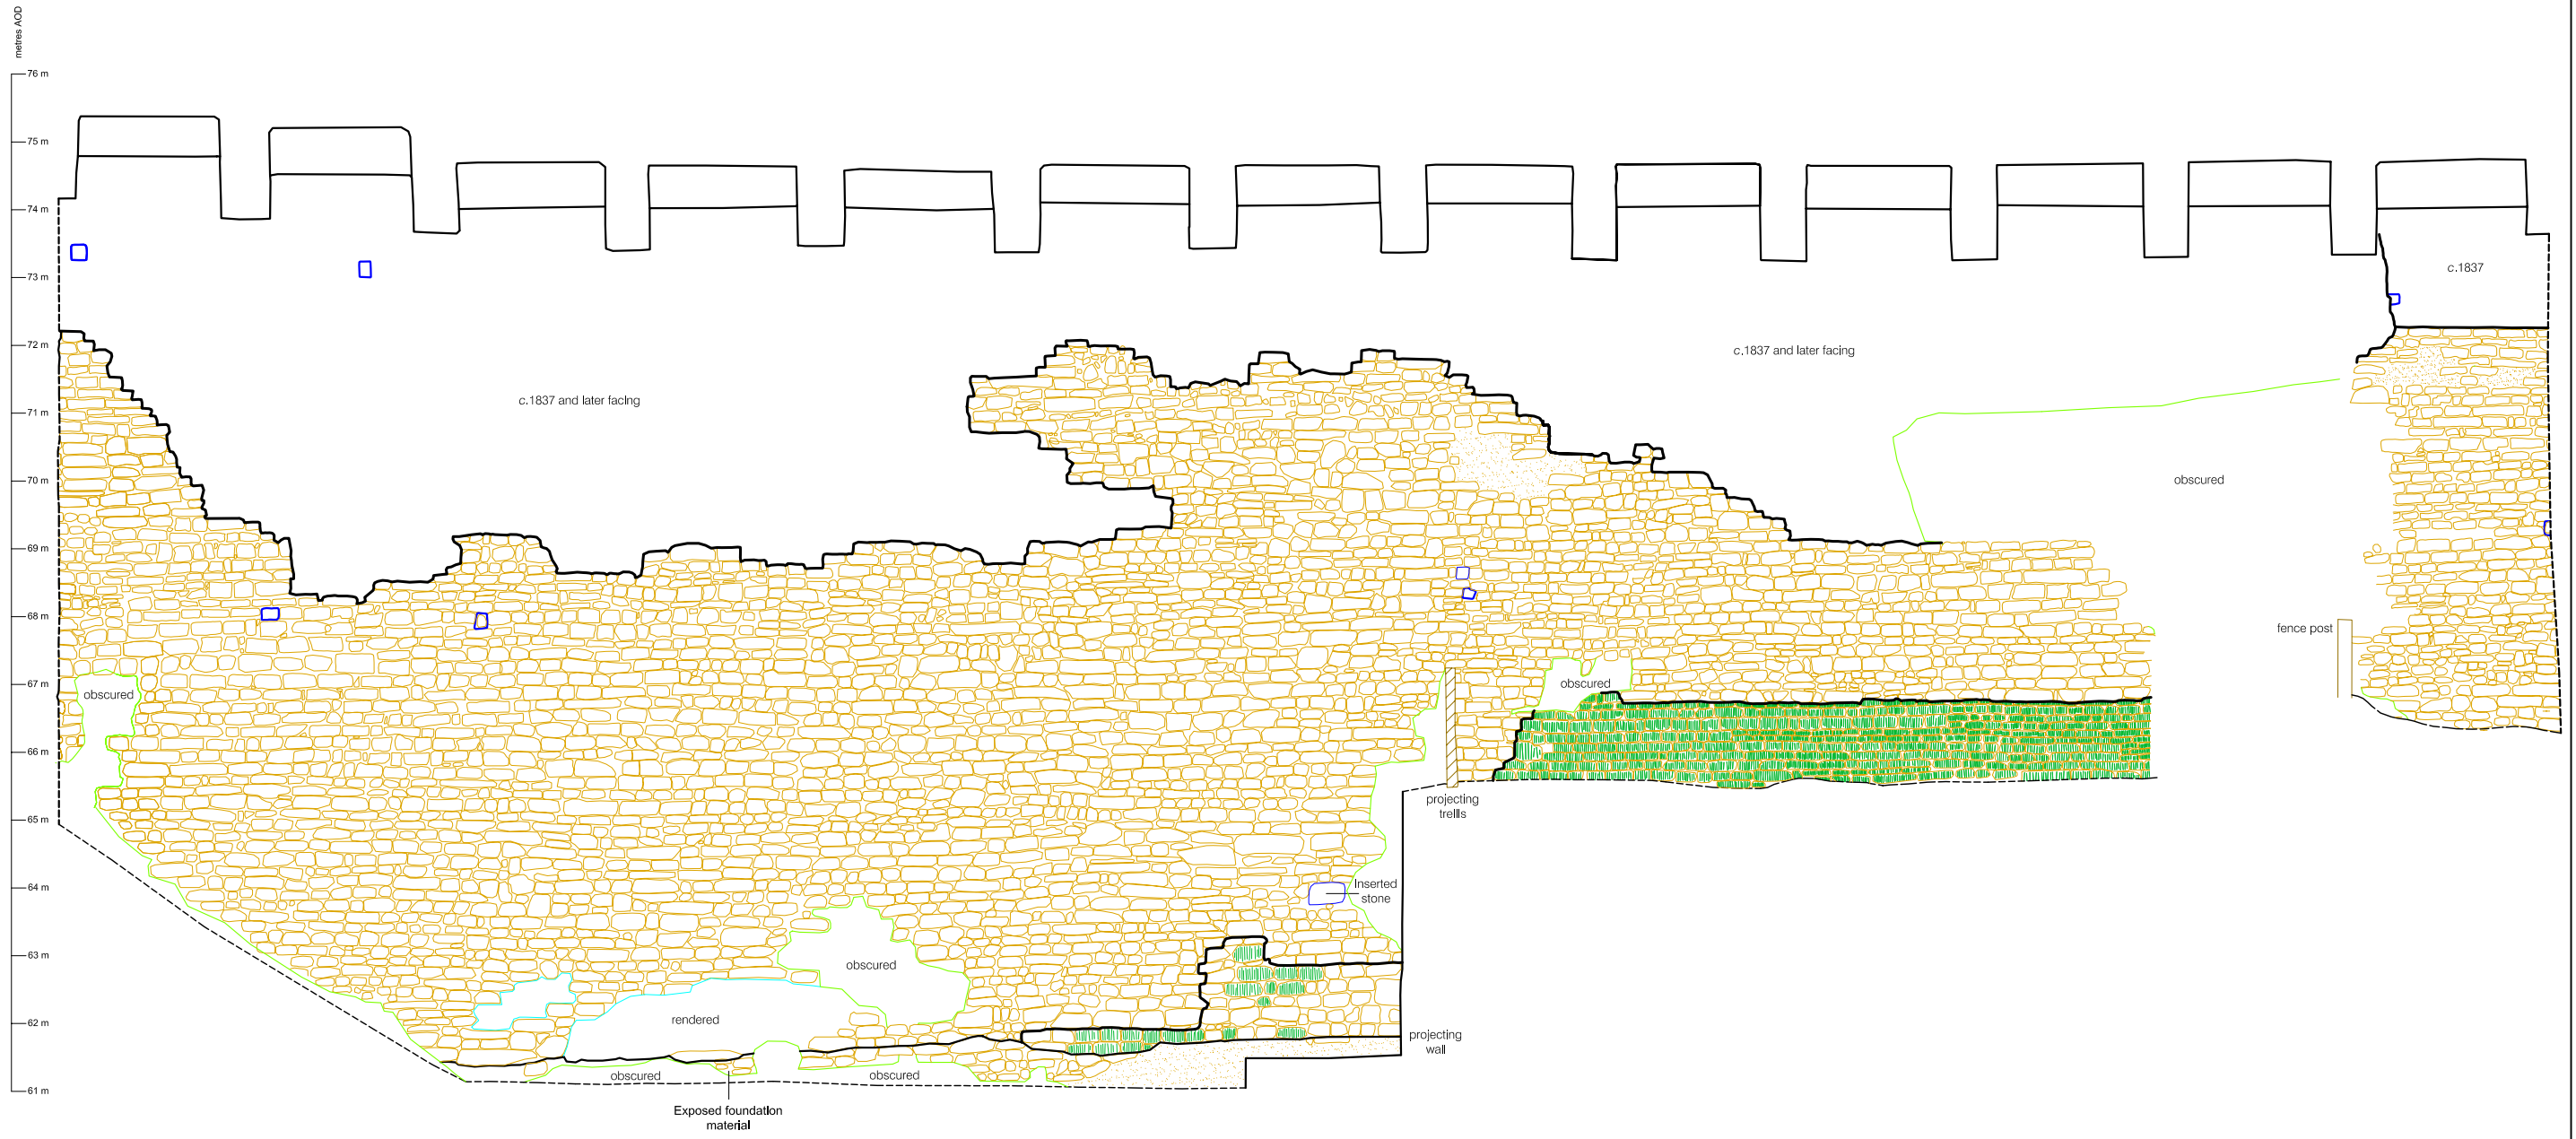
Figure 4

To the west of the door opening the medieval masonry is generally of smaller roughly dressed blocks and of a different phase which extends around the change of alignment (Figure 4). It appears that this section is a later medieval refacing or possibly rebuilding, perhaps at a point of structural weakness or lost feature.

Exterior of the south curtain wall east, central section

To the west of the refacing along the bottom of the wall there is a substantial vertical drop in the ground level of c.4.0m (see Figure 4). The change in level is fossilized within the current property boundaries by a retaining wall and must reflect the edge of the lower area that formerly surrounded the Lucy Tower motte. While the drop in level is now nearly vertical, there is some evidence in the curtain wall facing to suggest that it was formerly a steep slope with a profile close to that of the motte slope. Cutting back of the slope to form a vertical edge would have exposed the curtain wall footings and foundations which would have required stabilization. It is notable that there are areas of 1830s refacing, with distinctive vertical tooling, adjacent to the west of the retaining wall which might reflect where the profile has been cut back.

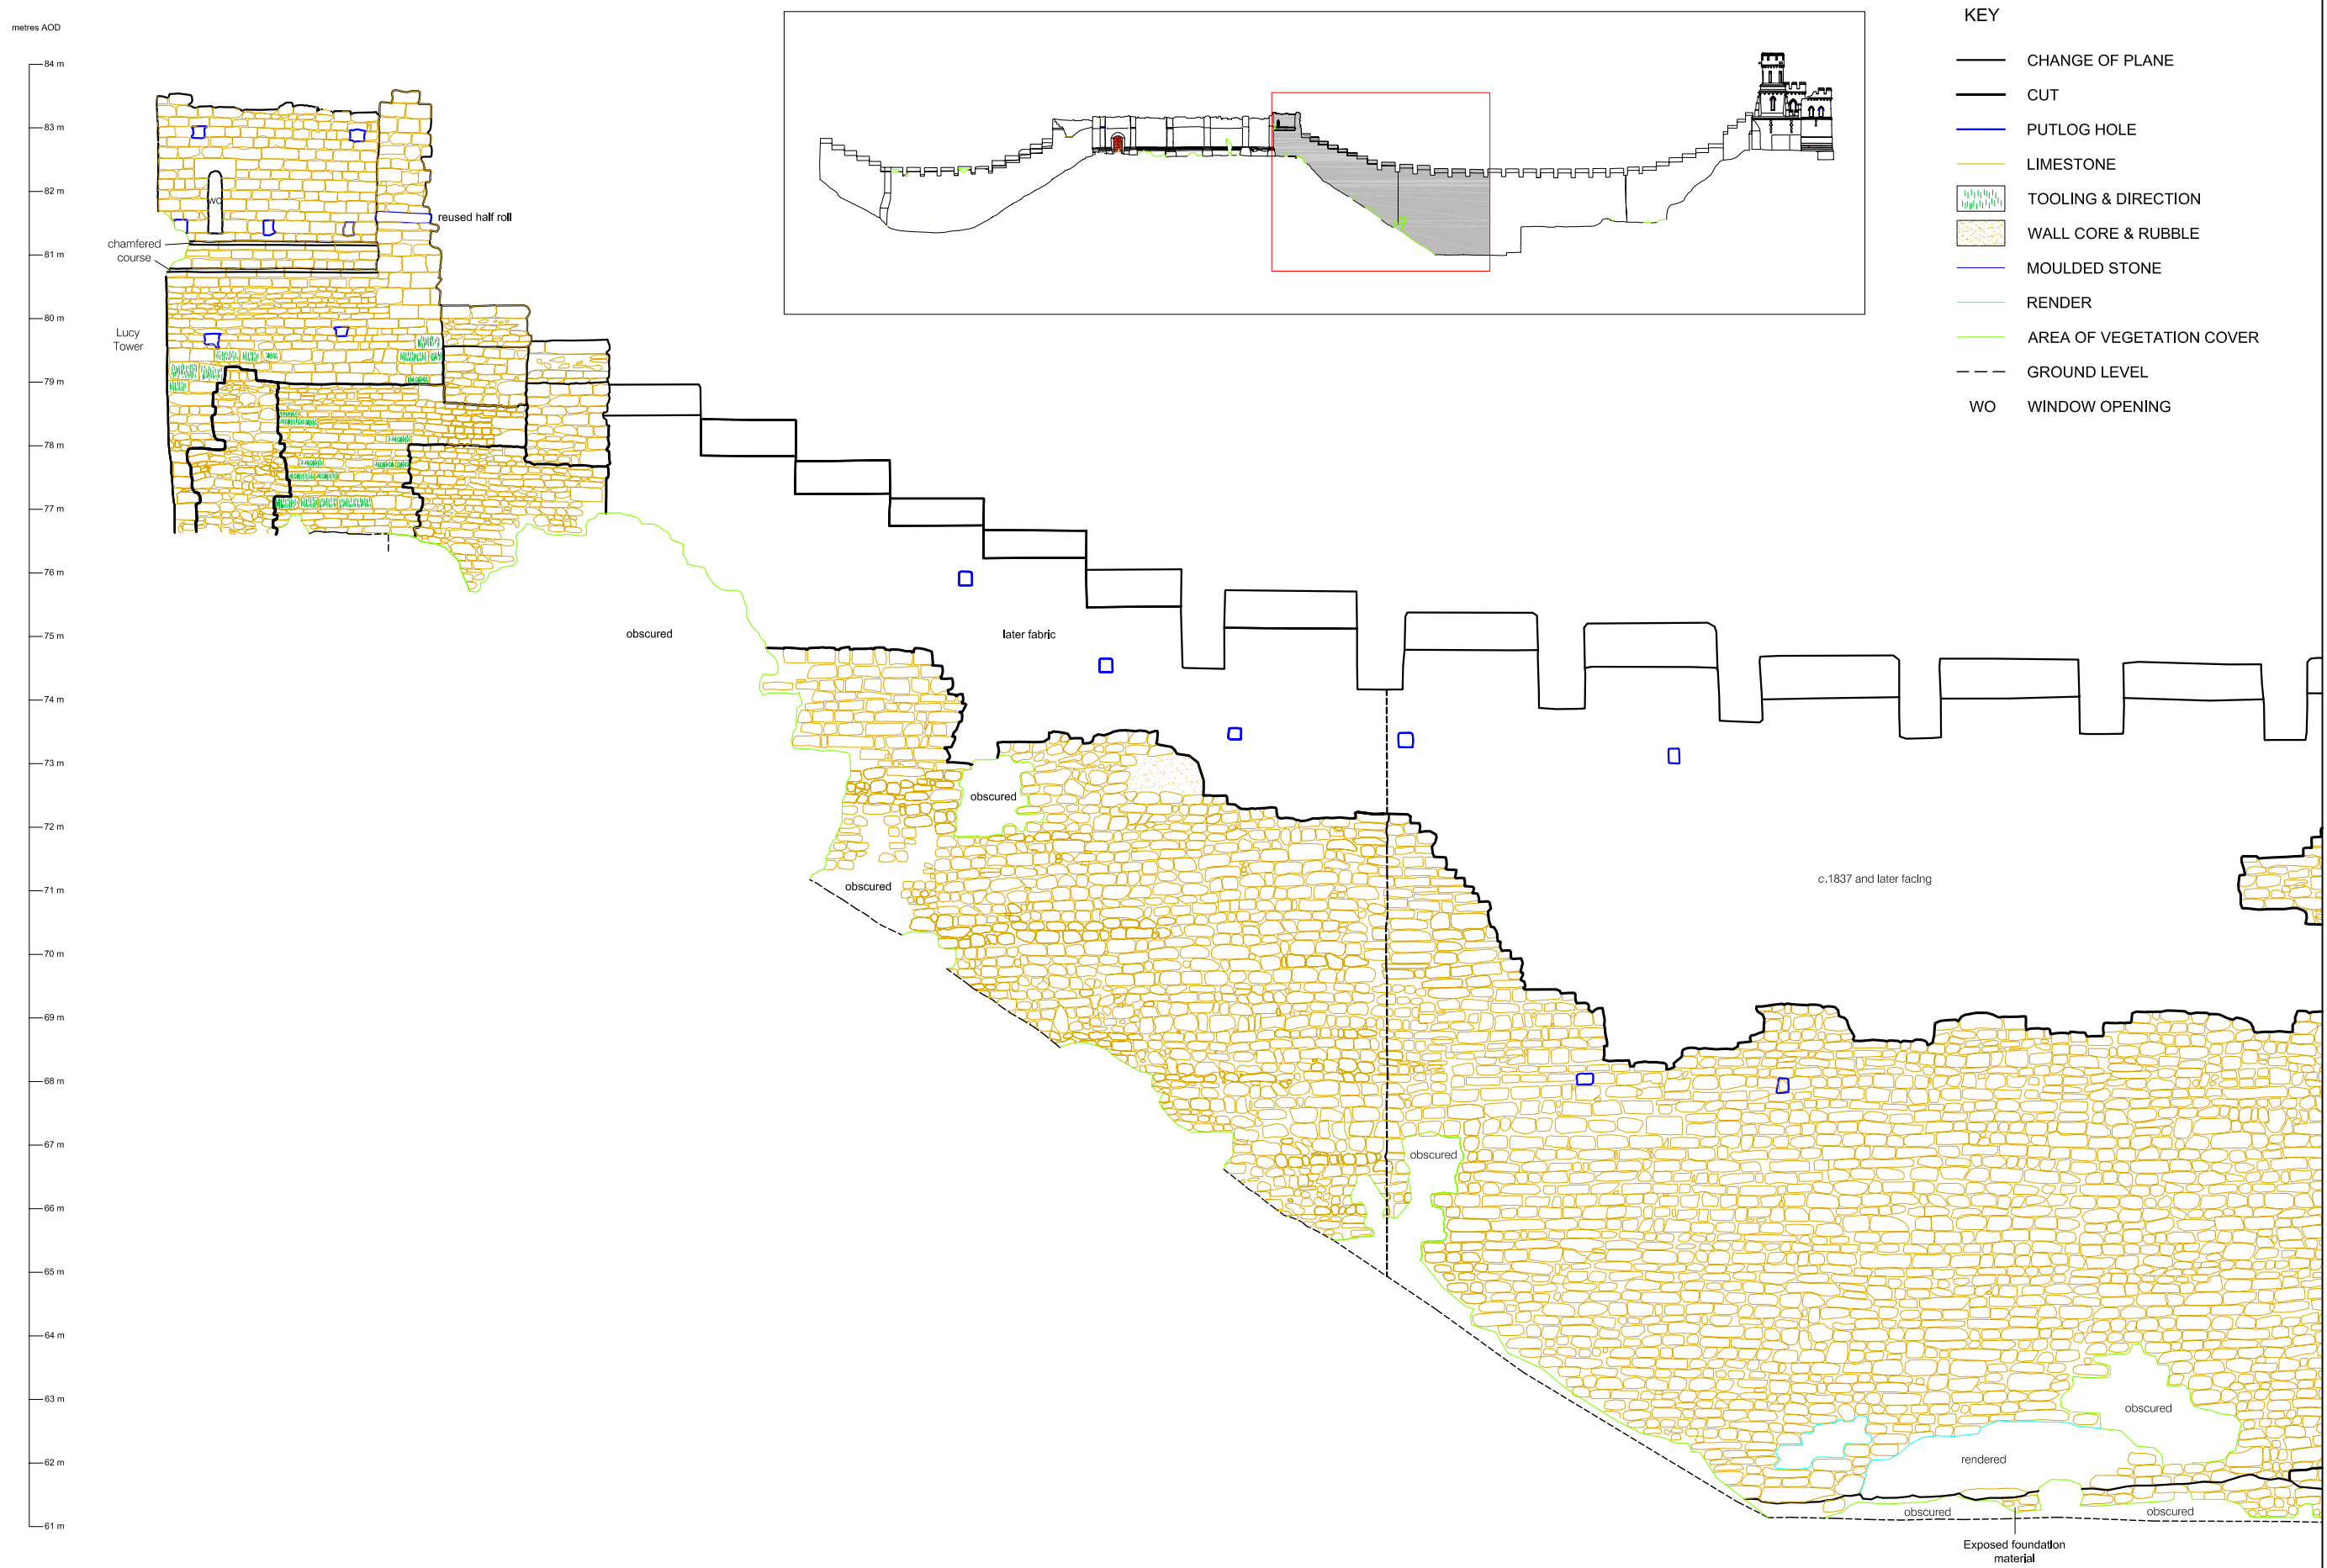
Figure 5

Beyond the change in alignment, the curtain wall follows an undiverting alignment towards the base of the Lucy Tower motte (see Figure 4 and 5). The surviving areas of medieval facing are quite extensive and appear to be fairly uniform, with putlog holes appearing at regular intervals in the same course levels, until the wall ascends the motte. This would suggest that the medieval fabric up to the Lucy Tower motte is largely of one period of construction. It is notable that evidence for such features as herringbone laid masonry are entirely absent on this section of wall, although present (in recreated form) on the interior (northern) elevation. There are no surviving areas of the medieval wall head until close to the east wing of the Lucy Tower, all having been rebuilt and refaced in 1837 and later.

Exterior of the south curtain wall east, adjacent to the Lucy Tower

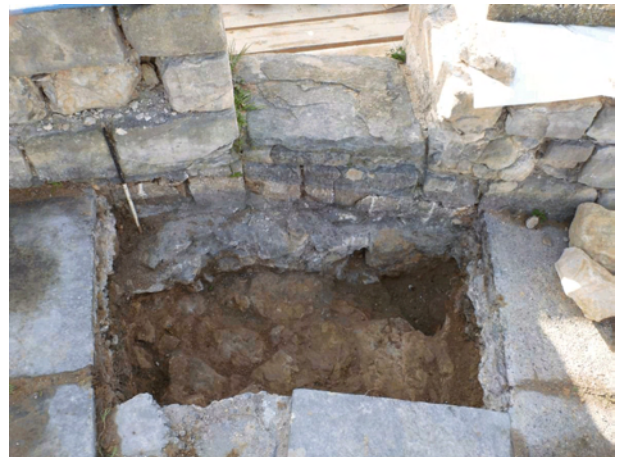
**Plate 9** Test pit cut into the south curtain wall walk, east end

Both test pits revealed the same sequence. Removal of the modern concrete slabs and their associated bedding material exposed the top of the medieval core-work at a depth which varied between c.0.35m and 0.55m (Plates 9 and 10). The parapet wall could be seen to have been constructed upon rubble work bonded with a mixture of hydraulic type lime mortar and grey Portland cement. The Portland cement was generally close to the surface of the rubble and probably represents a consolidation of the rubble face before the modern concrete slabs were laid.

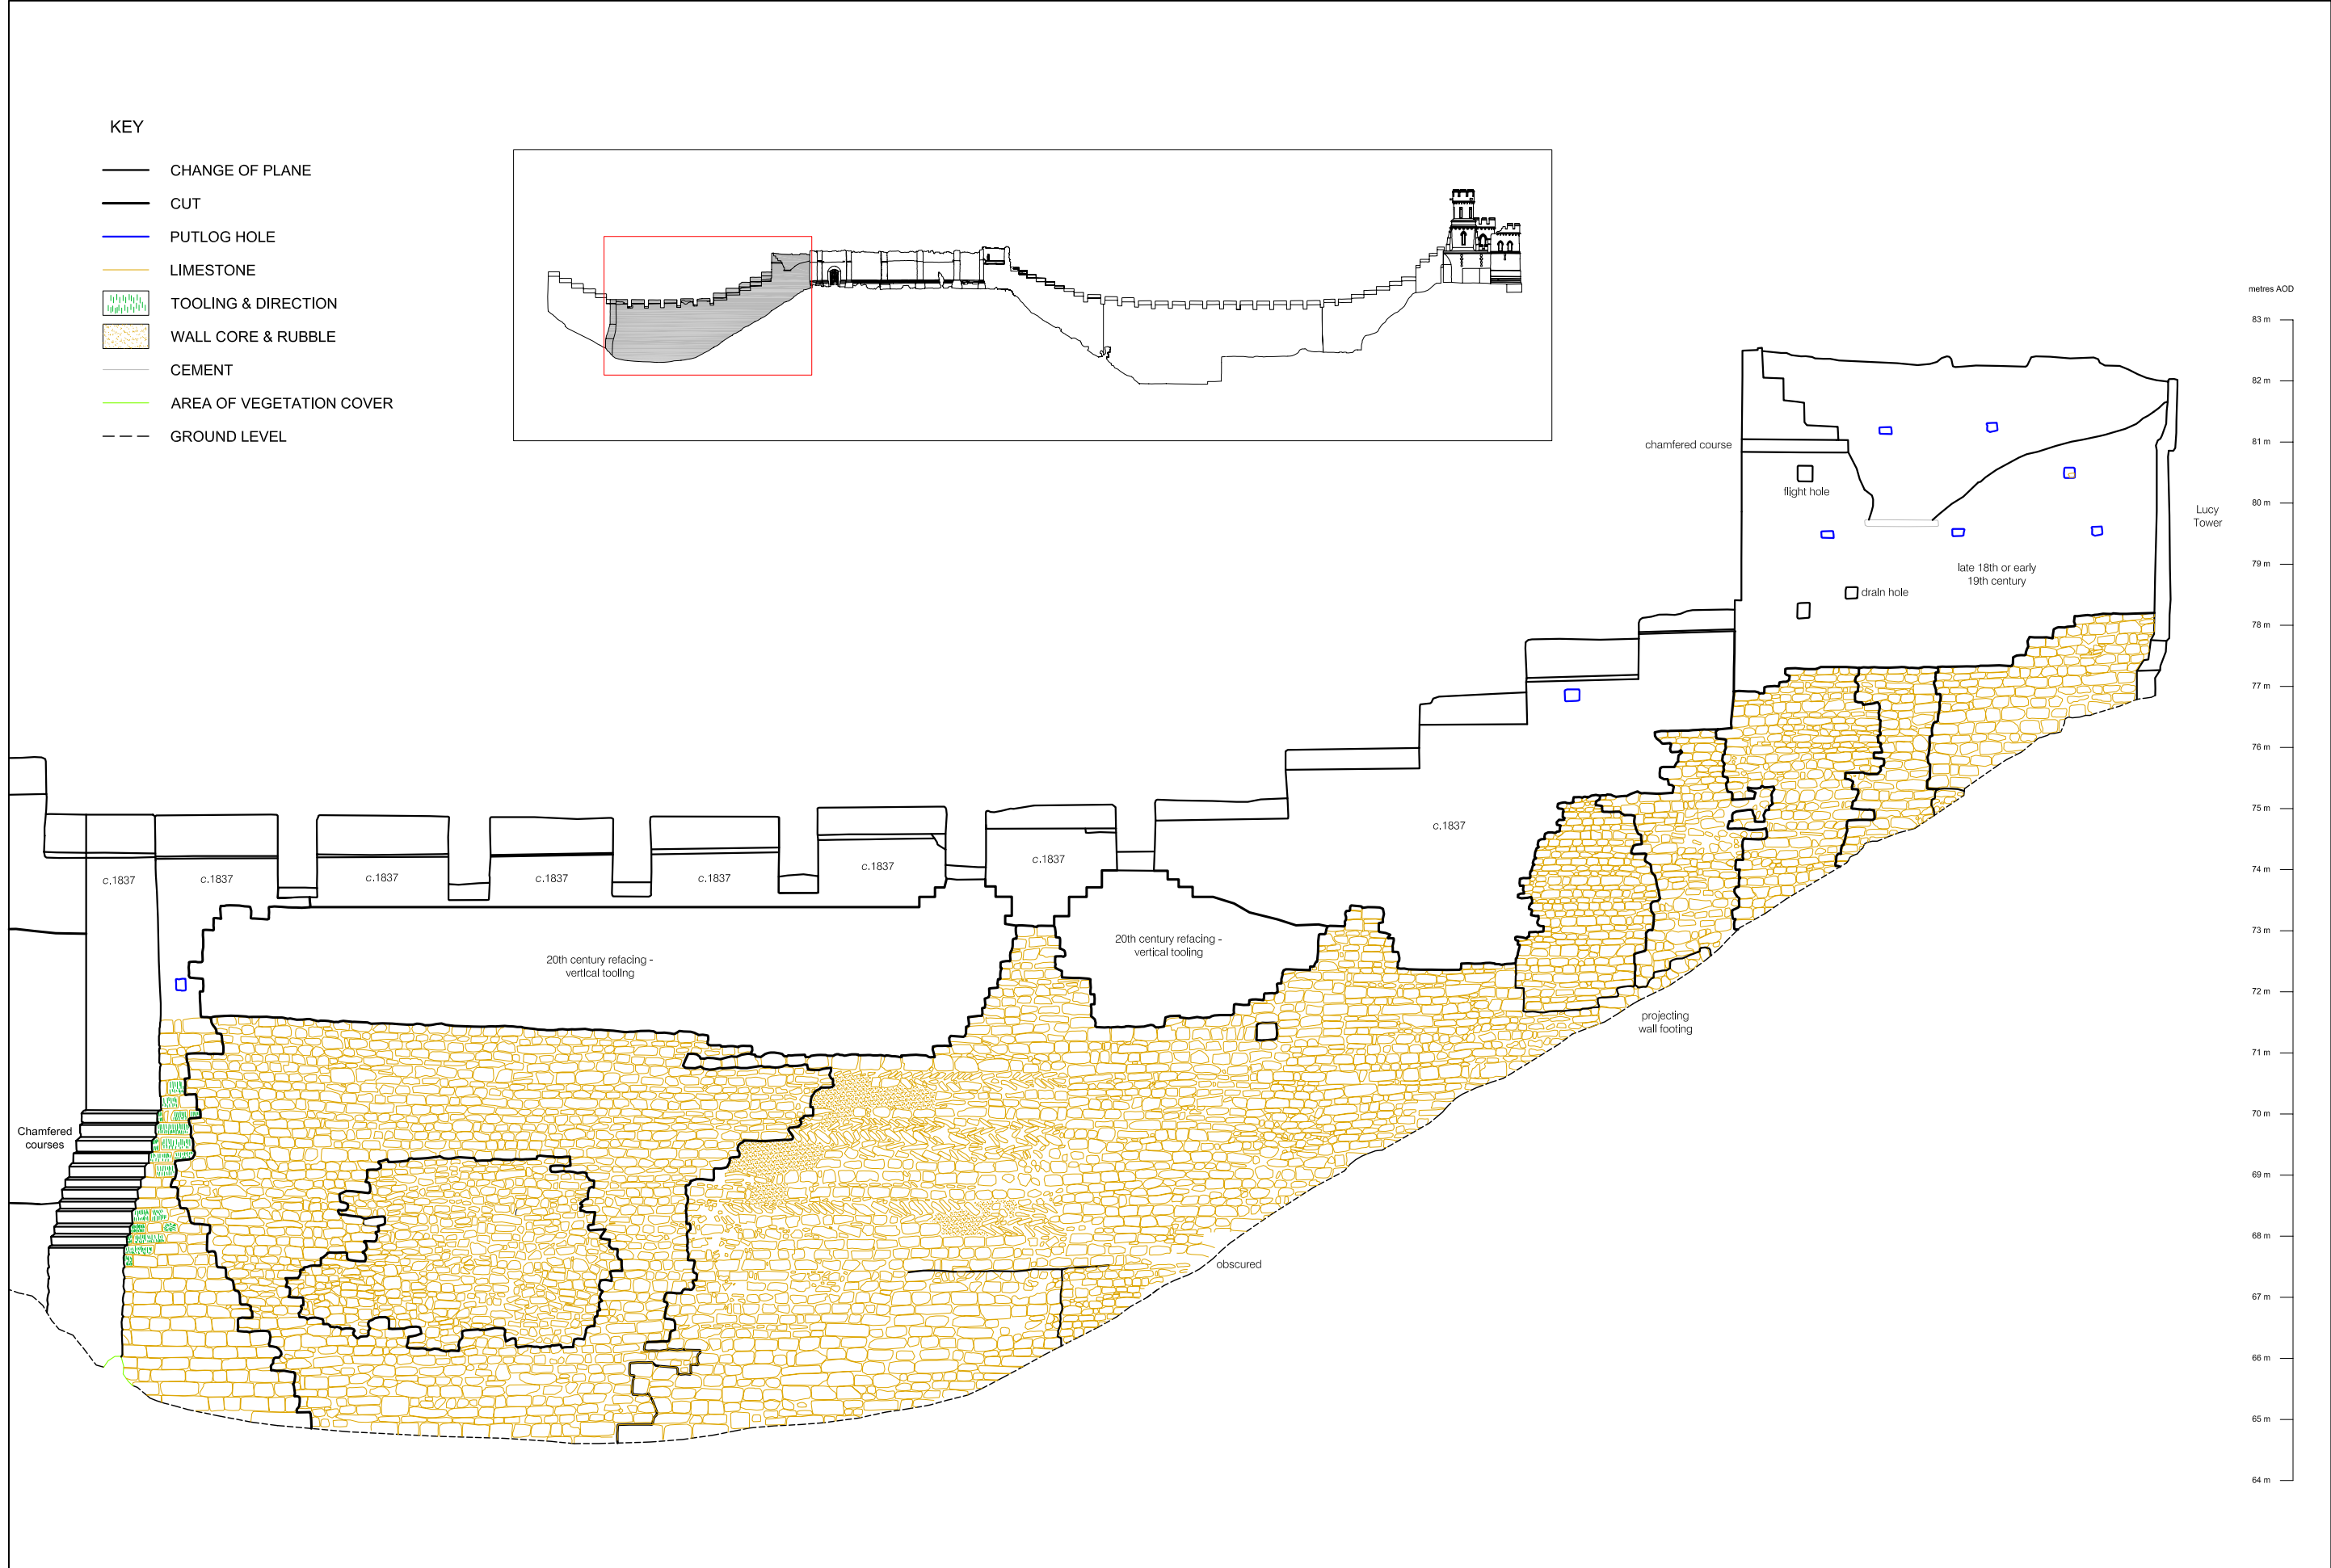
Scale 1:100 Figure 8

Exterior of the south curtain wall west, adjacent to the Lucy Tower

The base of the west wing divides into three distinct areas of fabric. Closest to the Lucy Tower is an area of facing masonry consisting of regularly coursed, large, roughly squared limestone blocks, in total c.3.5 in length, surviving to a height of c.1.5m in height (see Figure 8). It contains no features of note but is clearly medieval judging from the bonding mortar.

To the west of the area of medieval work is a sequence of three vertical joins in the masonry, defining a further two phases of masonry. The first of these forms a vertical strip, a maximum of c.1.4m in width, bonded with a dark brown lime mortar and consisting of large roughly squared blocks of limestone. This appears to represent either the infilling of a feature or the facing over of a wall scar. To the west is a further phase of masonry, a maximum of c.2.5m wide, more irregular in coursing and of smaller stones bonded with a light brown sandy mortar. This area might also represent a wall scar and accords with a wall footing that was discovered in the evaluation of the Lucy Tower motte surface (FAS 2010, Fig.4). The western junction also accords with the west end of the super structure of the west wing, although this had been largely reconstructed in the late 18th or early 19th century judging from internal evidence (FAS 2011).

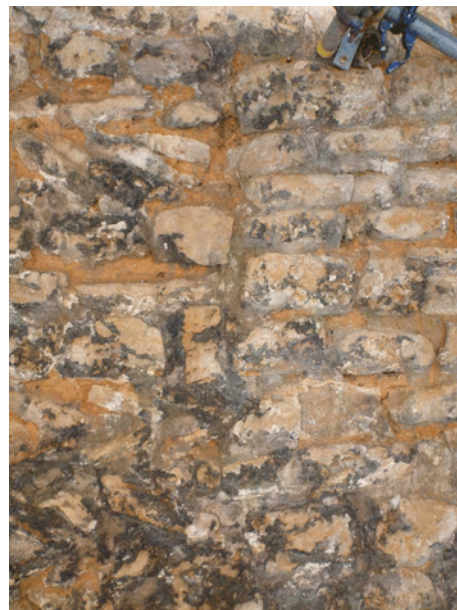
**Plate 14** Relationship between coursed blocks and herringbone stonework, south curtain wall, western section

The herringbone is arranged in three bands towards the top of the surviving fabric. The upper band has two courses of pitched stones, the middle band has five courses of pitched stone, while the bottom band has three courses. Above the bottom band there is a course of small flat stones, a further course of large stones and above these a course of small stones. The lower c.3m of walling consists of large coursed stones. The overall effect would have originally been highly decorative. The Grimm view also indicates that there were a row of putlog holes in the upper part of this segment of the fabric, now lost (see Plate 13).

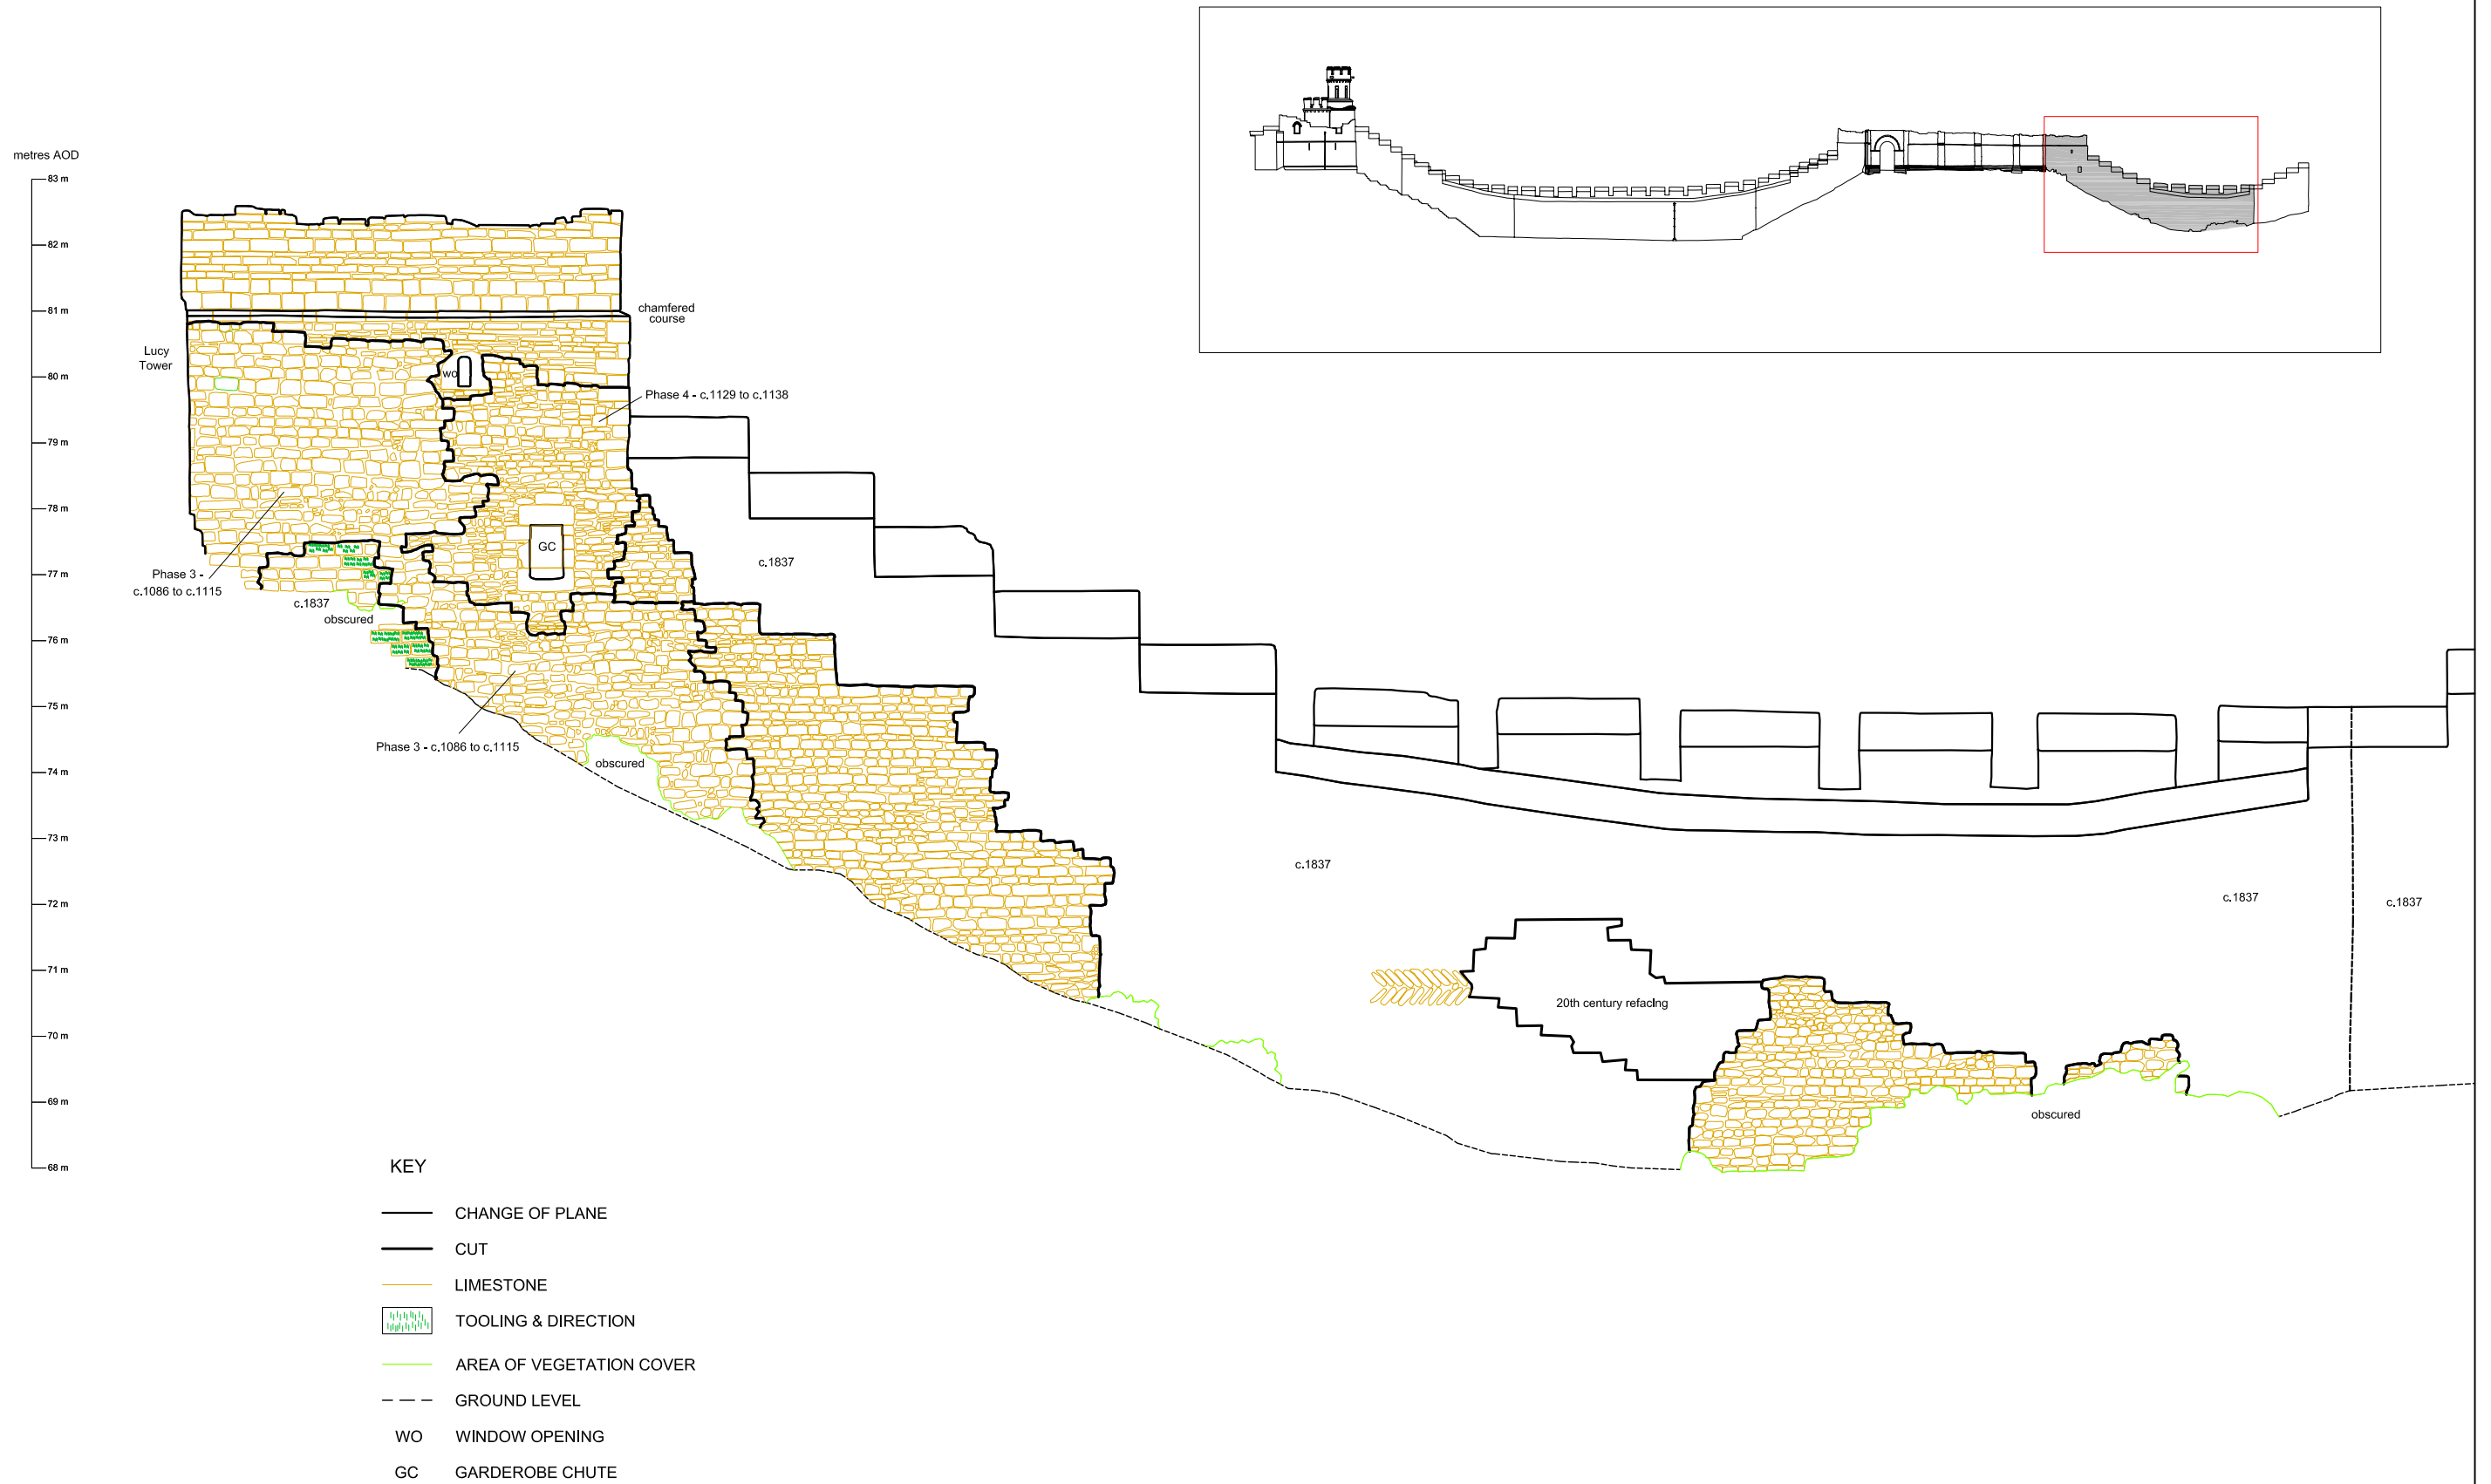
Scale 1:100 Figure 10

As visible in the interior elevation of the south curtain wall west, the exterior of the west chamber of the Lucy Tower has the most complex sequence of medieval development of all the Lucy Tower elevations, with three phases being clearly defined (Figure 10). The earliest phase is linked with the Lucy Tower and extends c.8.7m to the west and forms the majority of the fabric in the lower part of the elevation below the level of the chamfered course. It is generally constructed of large well squared blocks of masonry in regular courses, although there are areas where the blocks have either fragmented or where there has been some localised patching and repair. No putlog holes were identified in the course of examining the fabric, although the masonry joints had not been raked-out before the survey making their identification difficult. This first phase of the fabric contained no features of note.

Above the first two medieval phases the elevation has been re-faced, or rebuilt, as part of the 1835 repairs to the chambers by Willson. Incorporated into this work is a chamfered course and a small arch-headed loop window. It is not now clear whether the window copied a medieval feature or is entirely a creation of the 19th-century restoration; Willson does not record precisely what alterations he undertook on this part of the castle fabric.

Interior of the south curtain wall west, adjacent to the Lucy Tower

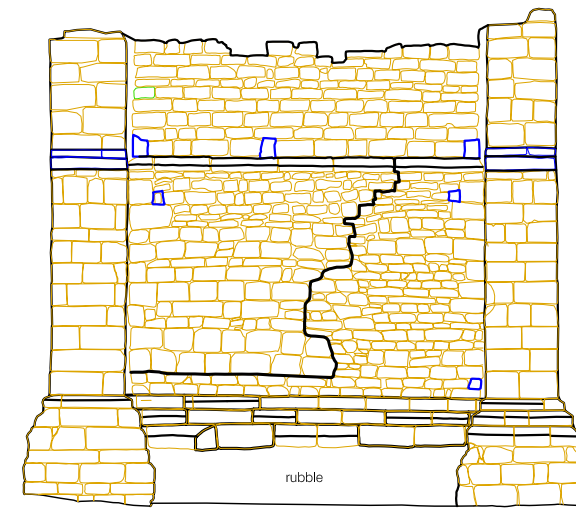
Elevation 13 incorporates the southwestern doorway of the tower. The masonry of the door jambs and head has largely been replaced with stonework of the 19th century making it difficult to establish whether the current form of the opening reflects its medieval form. Significantly, the large blocked sockets at the top of the elevation are carried around above the opening, suggesting that the opening was in a building within the tower. This arrangement is in contrast with the main northeast entrance.

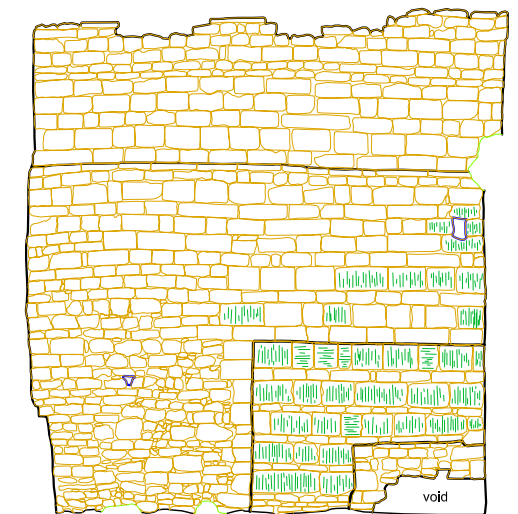
Elevations 12 to 13 retain no particular features of note, but Elevation 14 retains evidence for a feature having been blocked. The blocking appears to relate to an arch-headed window or door opening that Willson planned and sketched on a plan of 1832 and evidence for the blocking can be observed internally. Elevation 15 retains evidence for a further blocked door opening the internal arrangement of which was identified by evaluation excavation (FAS 2008).

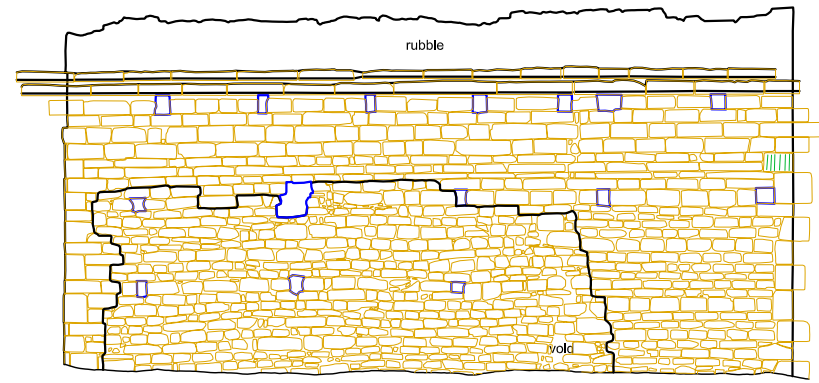
Elevation 01

Elevation 1 retains medieval fabric to the height of c.2.5m, above which the elevation has been refaced. Both the western end, which forms the corner of the western recess, and the eastern end, adjacent to the elevation which forms the main entrance to the tower, have been refaced from top to bottom. The latter refacing might represent the making good of a wall scar of a former wall projecting to the southwest. The postulated wall would have formed the gable of a range of buildings around the interior of the tower, terminated by the presence of the main entrance.

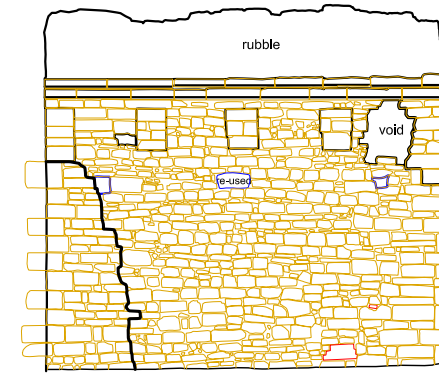
Elevation 04

Elevations 3 and 4 both incorporate large sockets around the top of the elevation which probably acted as seatings for the roof structure. The sockets on Elevation 4 have been blocked with stone as opposed to the majority in the tower which have been blocked with brick. Either end of Elevation 4 has been refaced, the southern refacing either relating to the insertion, or repair of the eastern recess.

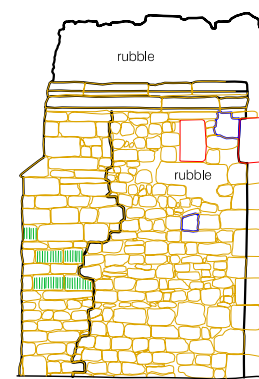
Elevation 08

Elevation 8 has undergone similar treatment to Elevation 4 with its northern end having been refaced or repaired for the corner into the eastern recess.

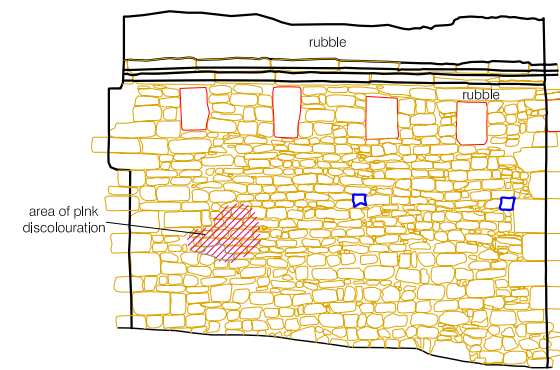
Elevation 10 retains most of its medieval face work, although rather degraded. An area of burning is detectable on the stonework towards the eastern end which might reflect the position of a former fireplace against the wall.

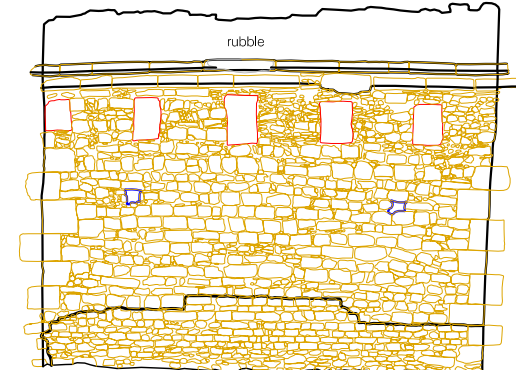
The bottom c.1m of Elevation 11 has been refaced using small stones. The masonry is uncharacteristic of the 19th-century repair works, and is possibly a medieval or post-medieval

alteration. The re-facing might relate to removal of a feature along the bottom of the wall or simply be a repair.

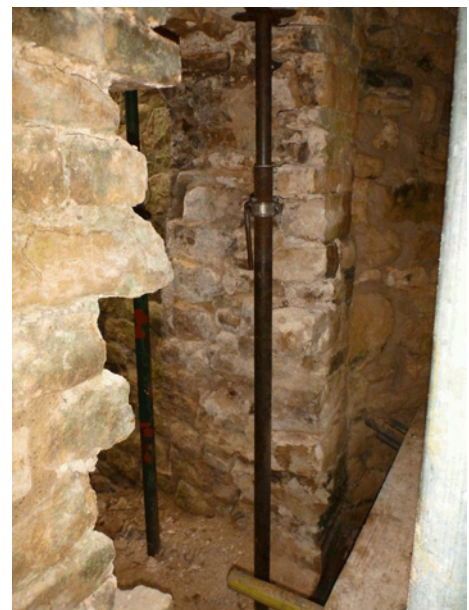
**Plate 16** Unblocking of west chamber door opening

As part of the scheme to improve access from the curtain wall into the Lucy tower a section of 19th-century blocking was removed between the west wing and the interior of the tower. The entire unblocking operation was carried out under archaeological supervision in order to ensure that no medieval fabric was removed.

It was evident that all the blocking material was of 19th-century date and that a substantial amount of rebuilding had taken place to this area of the tower. However, medieval facing masonry remained along the north side of the opening, forming a continuation with that in the north wall of the west wing (Plate 16). A single stone retaining a chamfer remained *in situ* - the chamfer facing into the interior of the Lucy Tower (Figure 16). Evidently the north side of a medieval door opening, the fabric had been subject to some alteration in the 18th century removing the remaining chamfered stones and, probably, the rebate for a door. However, some medieval core-work, c.1.9m

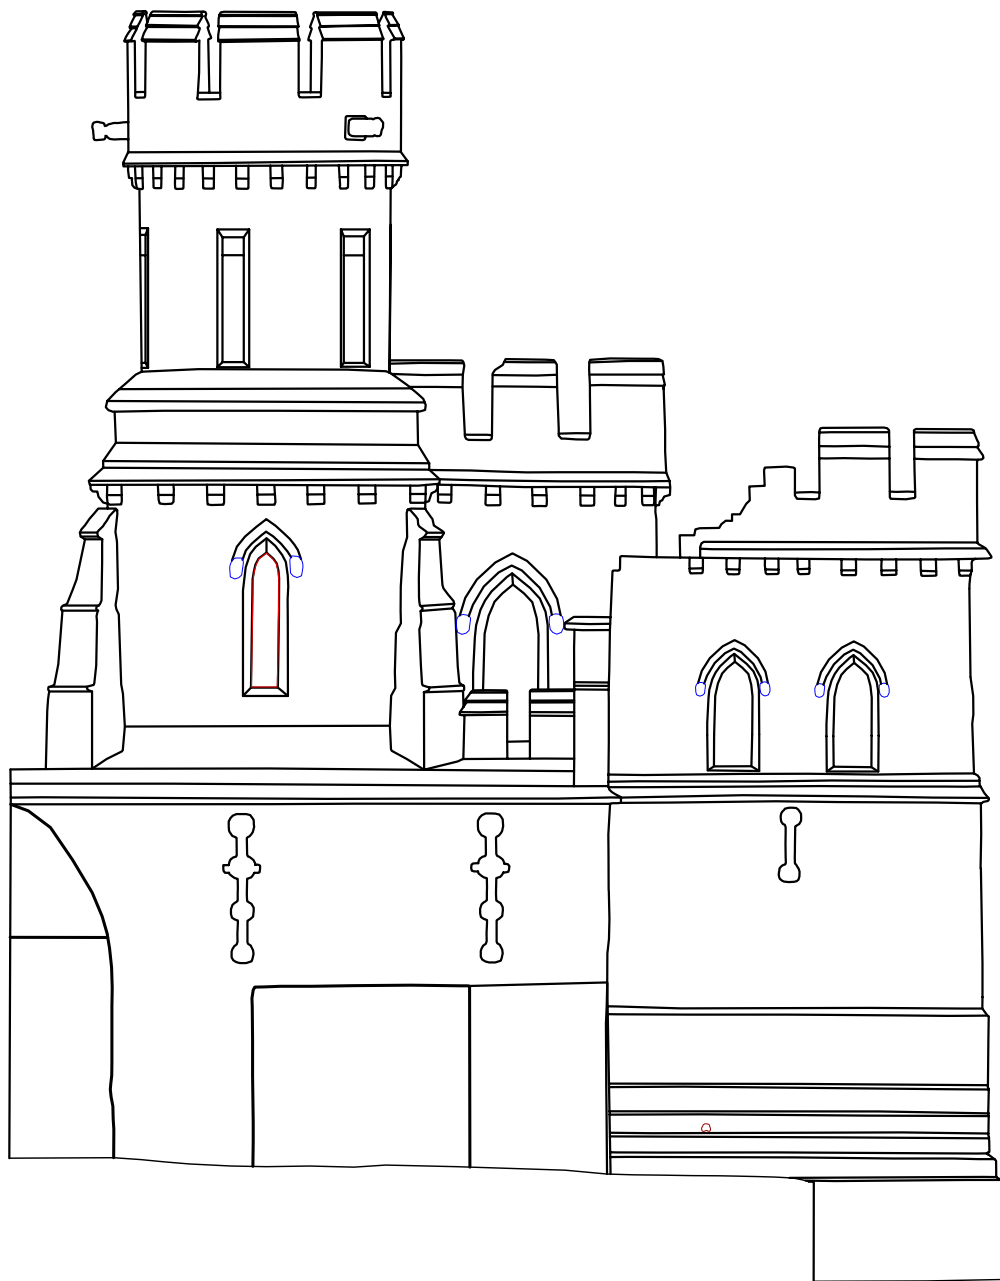
Figure 19

In contrast to the interior face there appears to be no exposed medieval work on the external south elevation of the tower (Figure 19). The south wall has been entirely re-faced in two phases of work. The eastern end appears to have been subject to the same refacing work as the east elevation in 1840, while the western end appears to be work of 1815. The south elevation features three fanciful arrow slits at ground-floor level, all part of the 1840 restoration work, and three two-centre headed windows with hood mouldings and stops at first-floor level, being the result of work in 1815. The pair at the eastern end is of the 1840s, replacing a single window of 1815, while that at the western dates

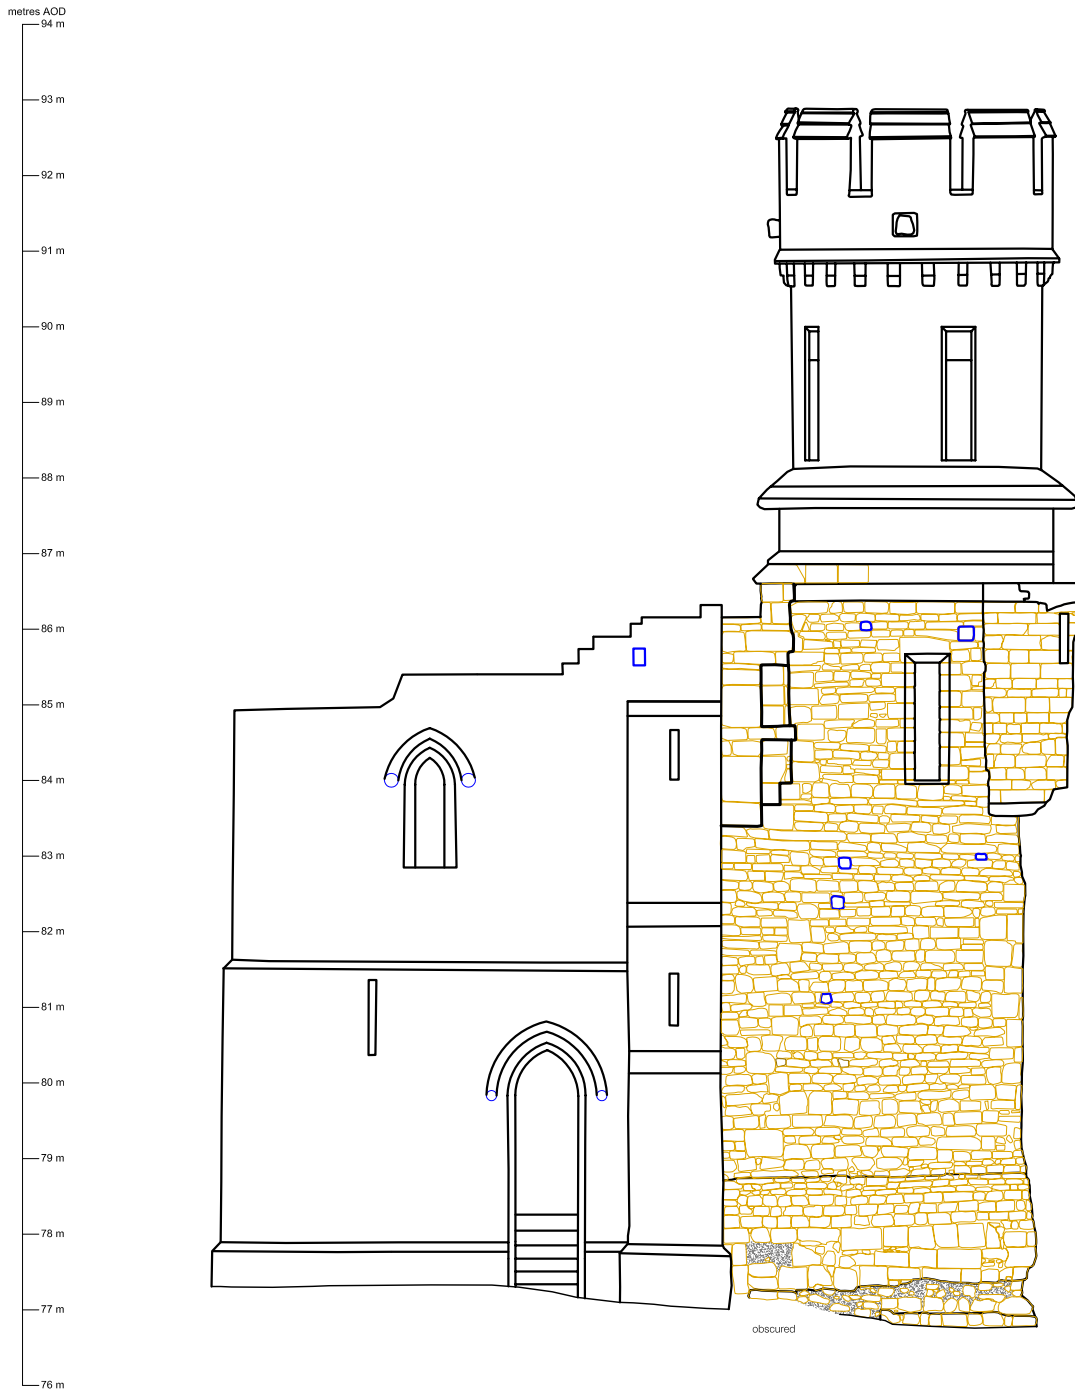
Figure 20

In the west elevation it can be seen that the extent of early fabric is between the southwest corner, where the curtain wall meets the tower, and the central stair buttress (Figure 20). The bottom of this fabric retains a heavily degraded chamfered plinth. Above the plinth there are two main phases of masonry, with the lower part of the elevation (roughly to first-floor level) consisting of blocks of widely differing size, roughly coursed, and the upper part of the elevation to stringcourse-level of more consistently sized blocks of stone.
