**WALLS, GATES AND TOWERS**

**LINCOLN CASTLE**

**ARCHAEOLOGICAL  
INVESTIGATION**

**REPORT  
NOVEMBER 2015**

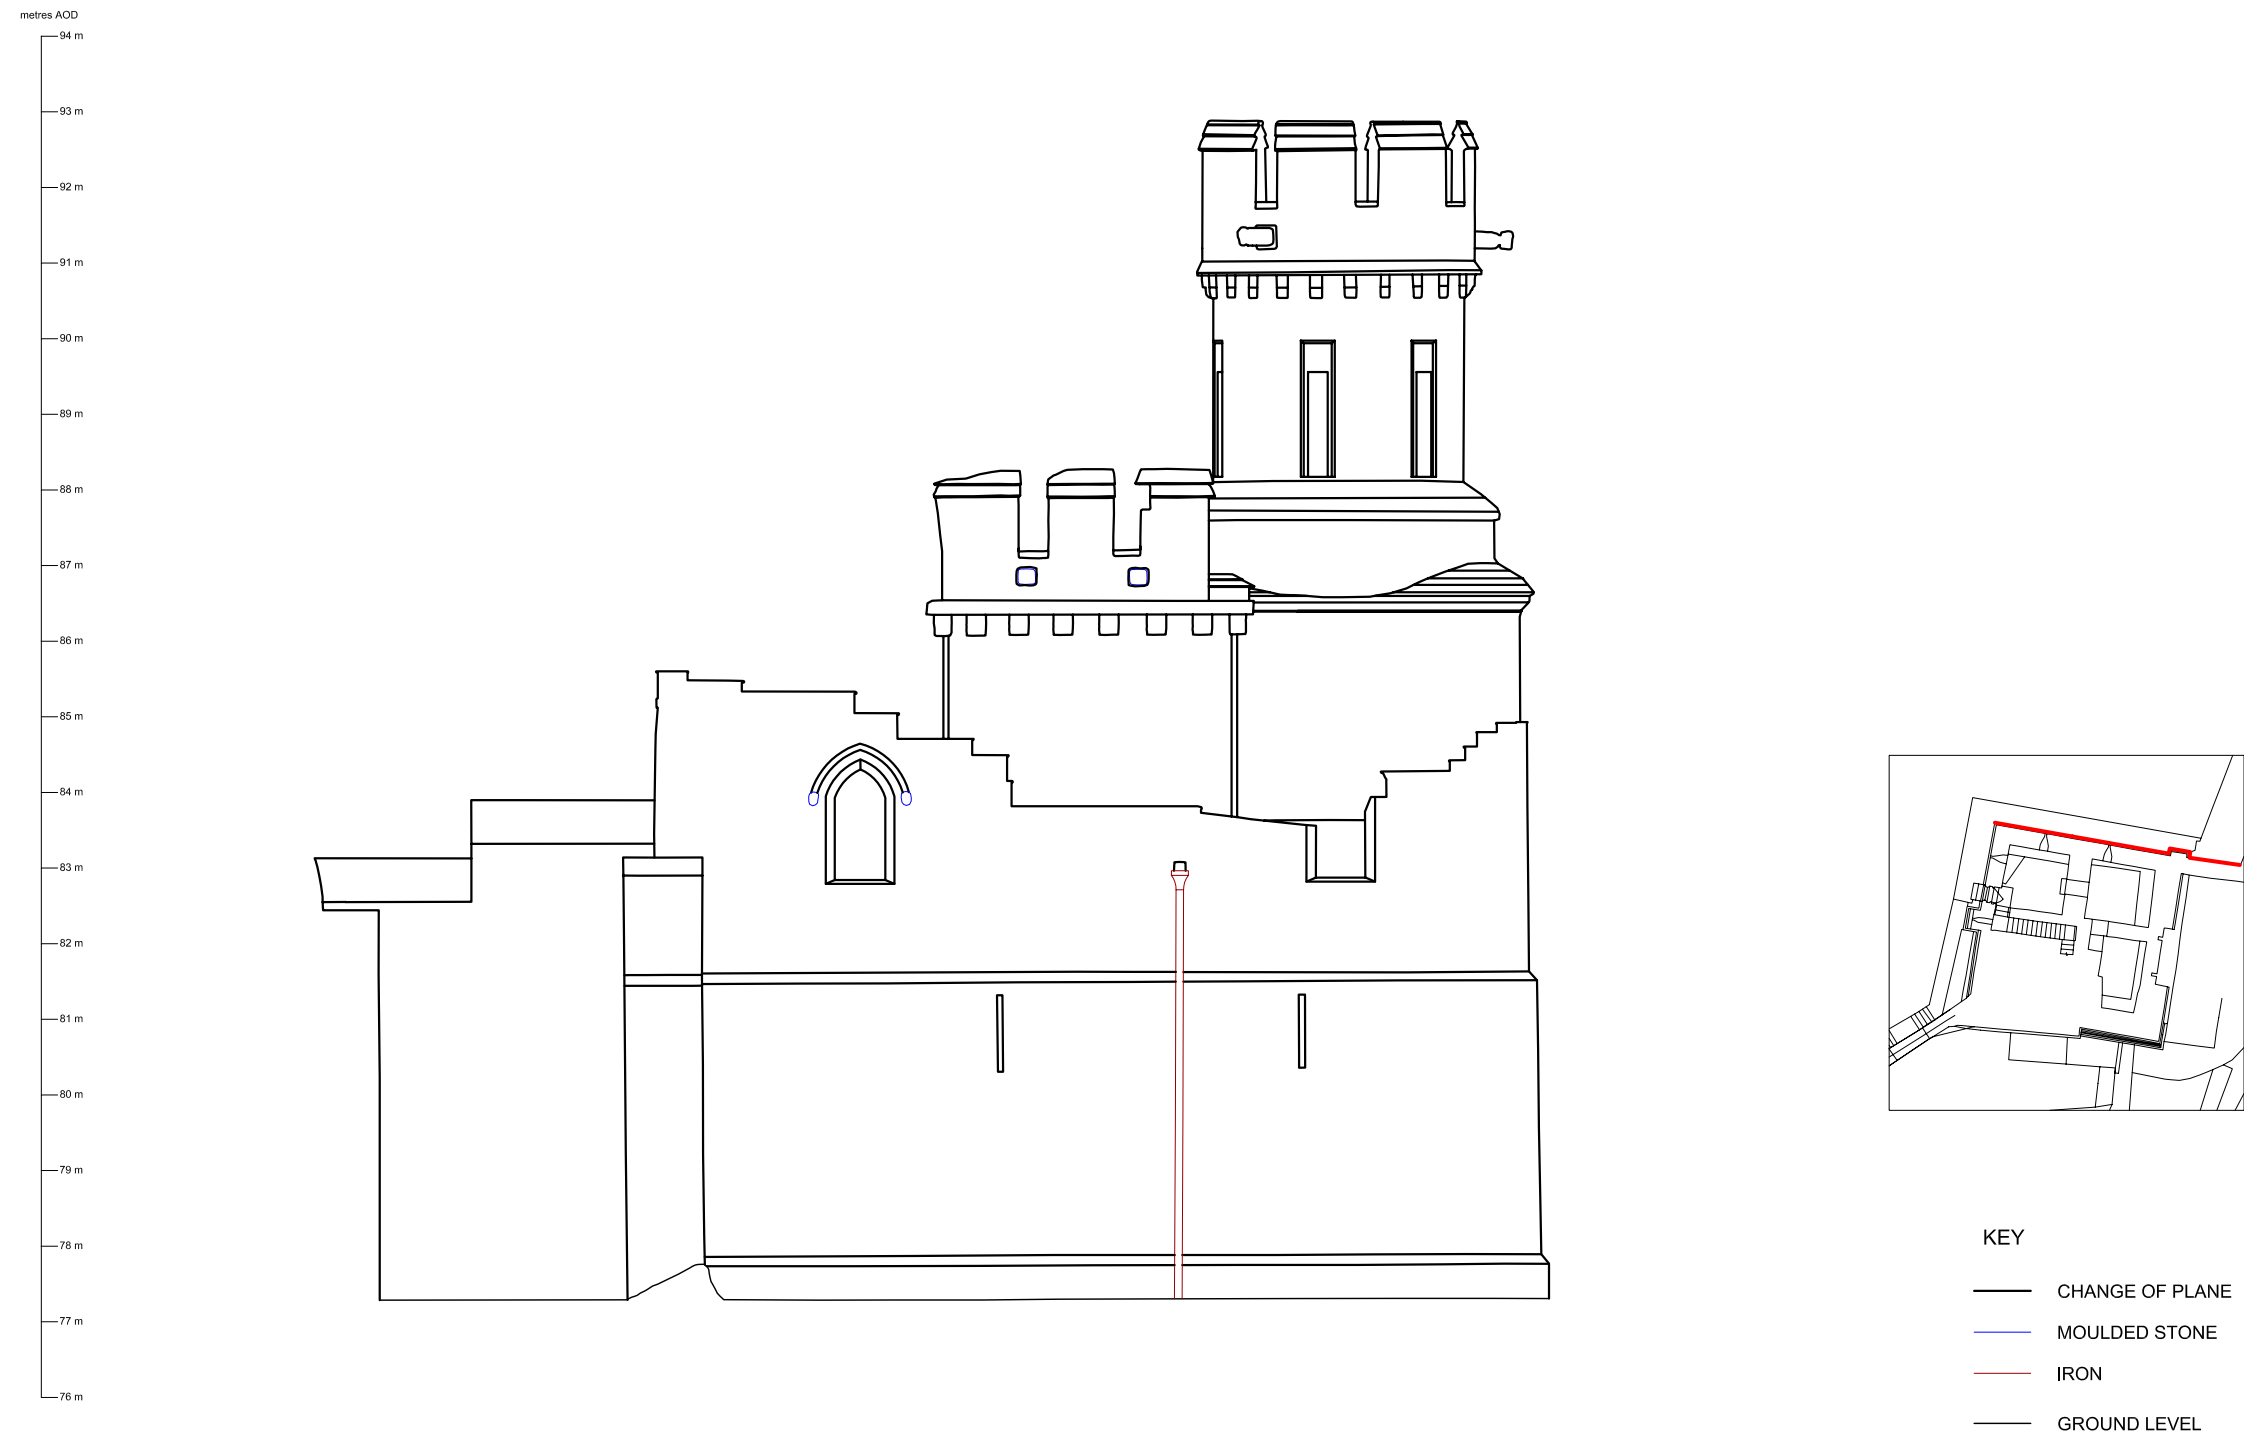
Scale 1:100 Figure 21

The current appearance of the north elevation of the Observatory Tower is largely the result of the partial rebuilding of the structure undertaken by Willson in 1840 (Figure 21). Prior to 1840, when the tower was planned by Willson, the north wall did not exceed the height of the ground floor storey and had no openings within it.

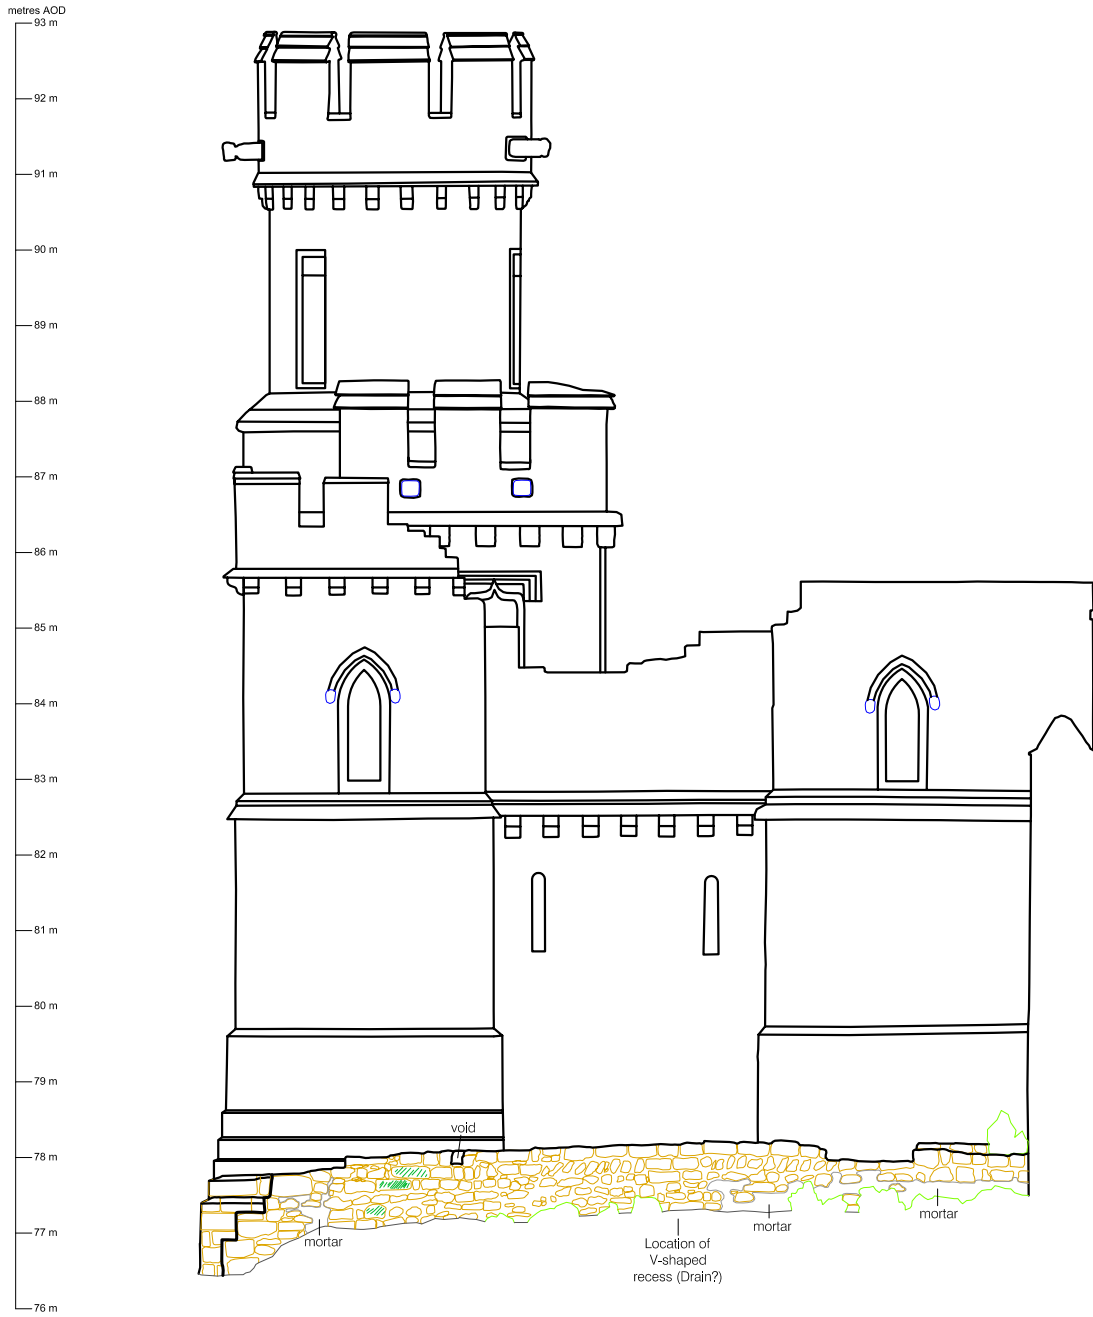
Figure 22

Willson undertook the restoration of the east elevation of the tower at the same time as the north elevation (1840) and the current appearance of the east side of the tower is largely the result of his work (Figure 22). Willson provided before and after restoration drawings of the tower's east elevation (Plate 17) and helpfully observed that most of the previous restoration work dated to Merryweather's and 1815. However, the lowest part of the elevation, which projects out from the upper wall face, does appear to retain some medieval masonry of coursed rubble with some partial courses of pitched

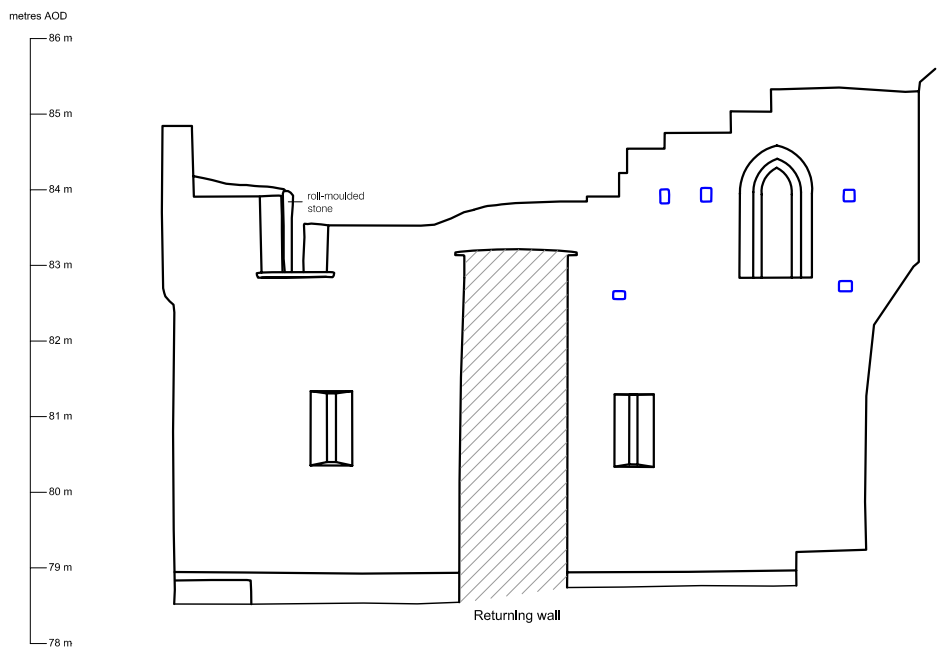
Figure 23

The exposed fabric of the north wall is almost entirely the work of Merryweather in c.1815 and contains no features of note (Figure 23). Unfortunately there are no historic illustrations or plans which show the fabric before Merryweather's reconstruction of the wall. However, at the base of the wall are footings which have been encased in modern masonry, apparently exposed after the removal of the floor in the tower during the 1970s excavations. If the external, 19th-century, wall face is close to the position of the earlier tower wall then this would suggest a wall thickness of c.1.75m.

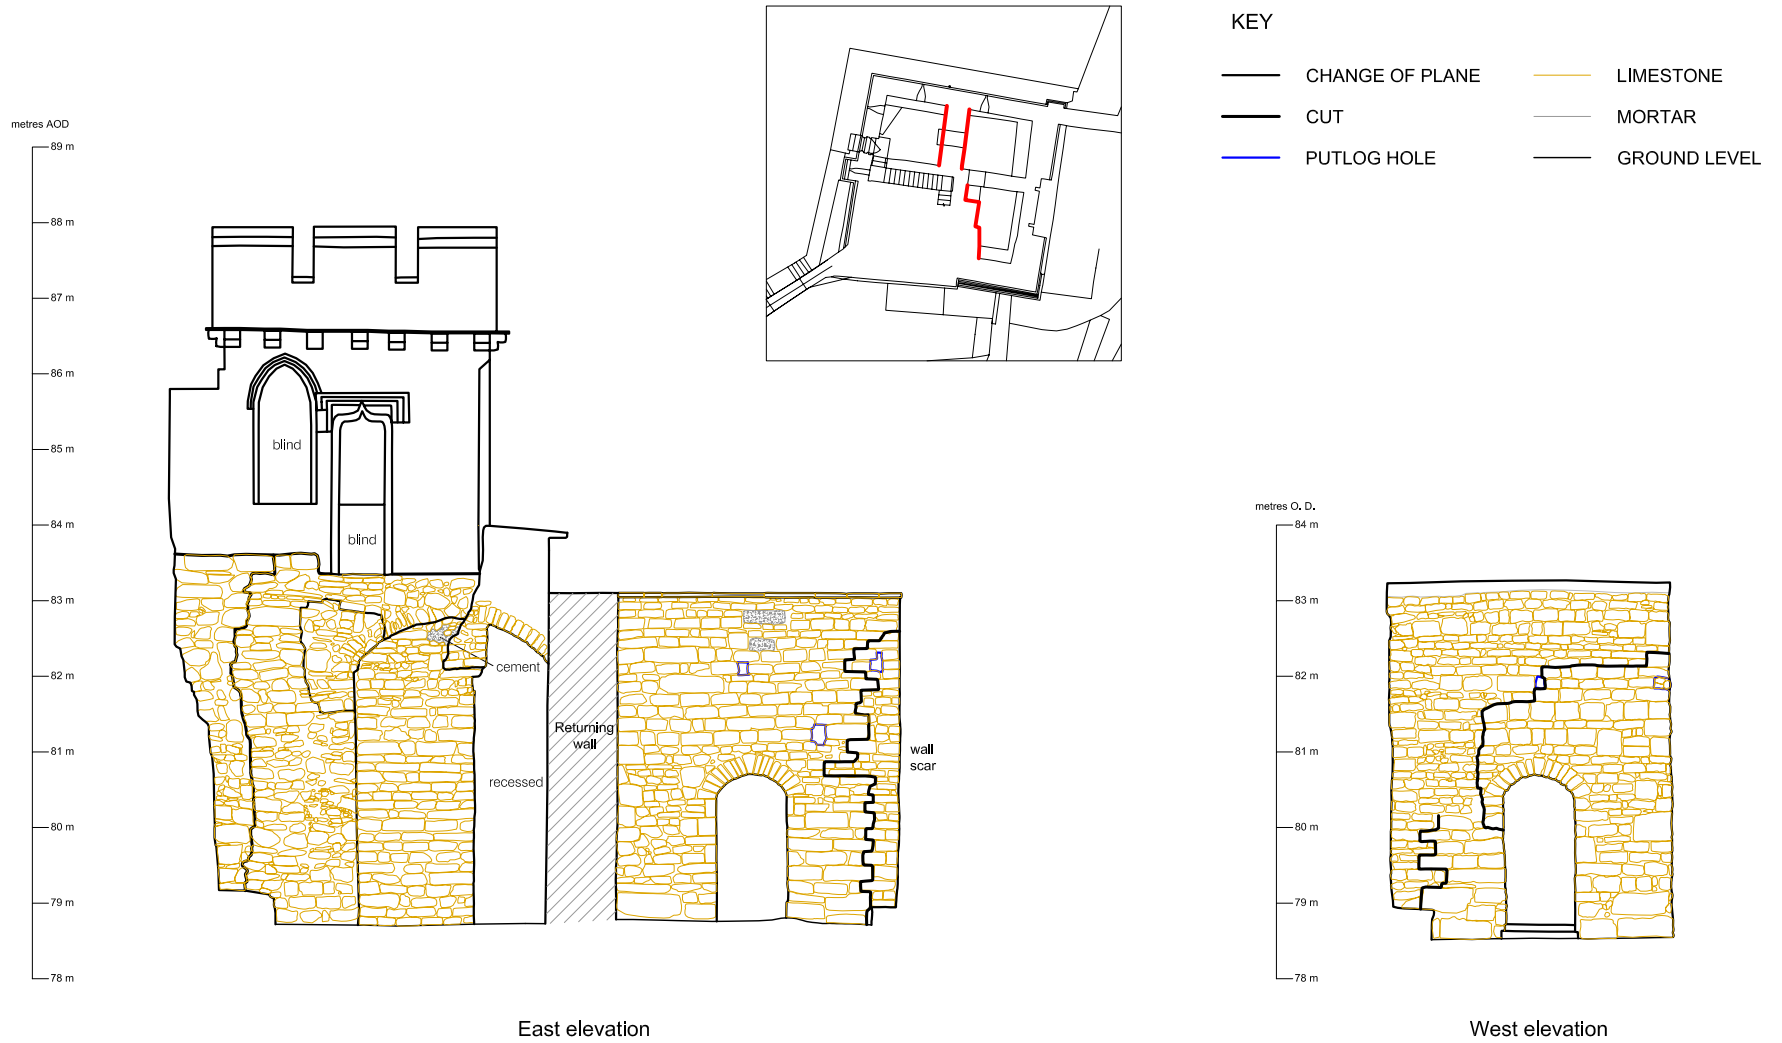
Figure 24

The north-south lateral wall forms a spine through the centre of the tower. The northern end incorporates an arch-headed door opening between the northern, east and west rooms (Figure 24). The current repair works were limited on this section of the fabric and, thus, the examination was limited to what additional information could be gathered from a close examination from the scaffolding.

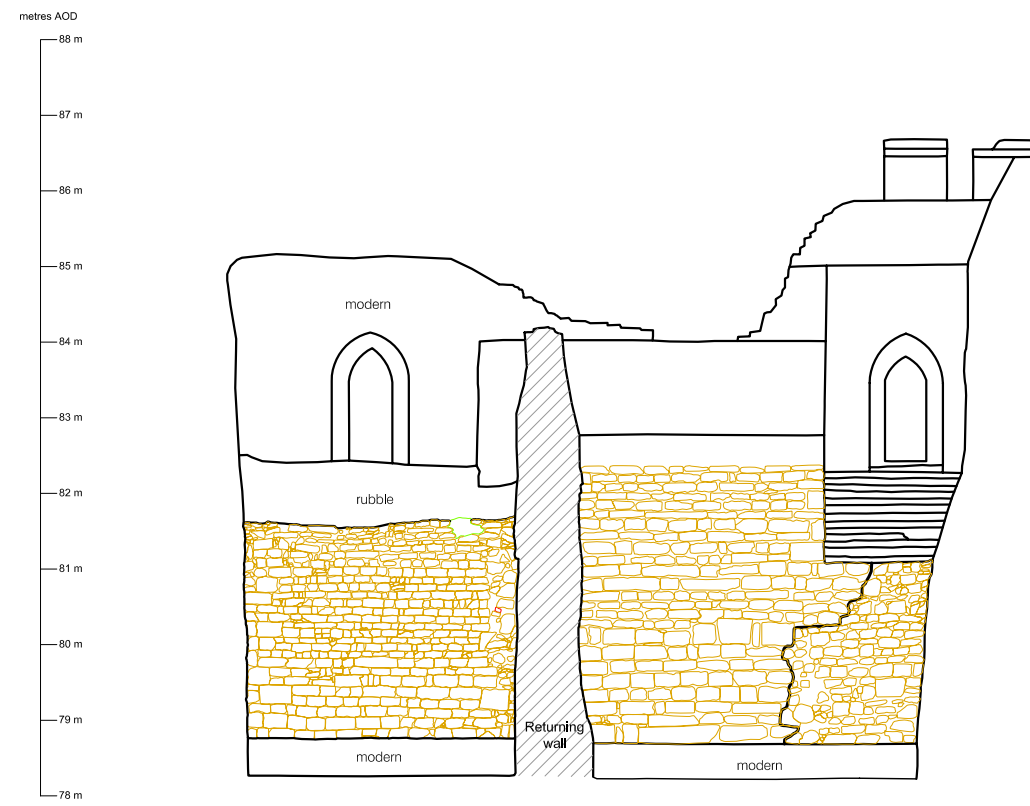
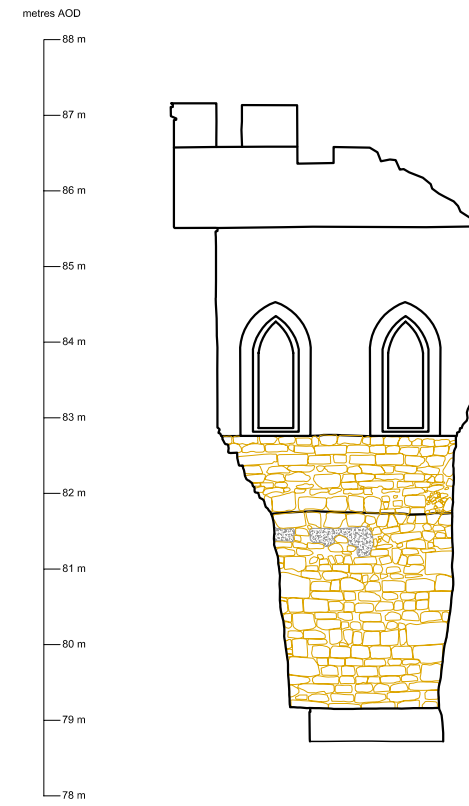
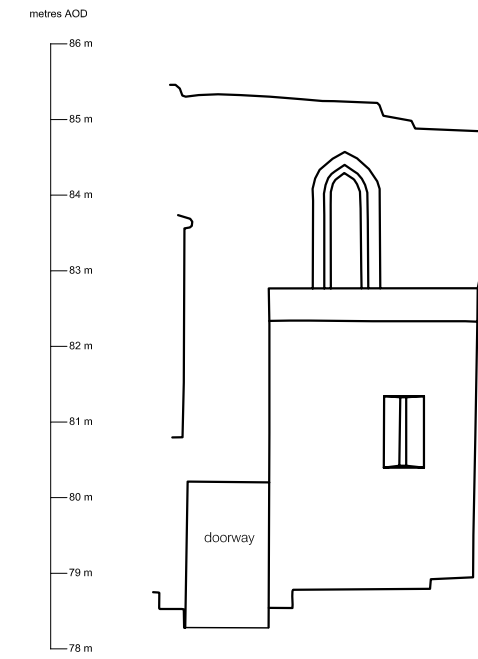
Scale 1:100 Figure 25

The internal east wall is interrupted by an east-west spine wall (Figure 25). The northern end of the wall (which is within the northeast room) appears to be early fabric with evidence for the springing of vault c.3m above the current ground level. A wall scar is evident along the southern edge of this section of wall the origins of which are unclear. Along the bottom of the elevation is a projecting section of masonry which is part of the original tower, now encased in modern masonry.

The lower part of the south wall retains medieval masonry to a height of c.3m, with the refaced scar of the springing of a vault also being evident (see Figure 25).

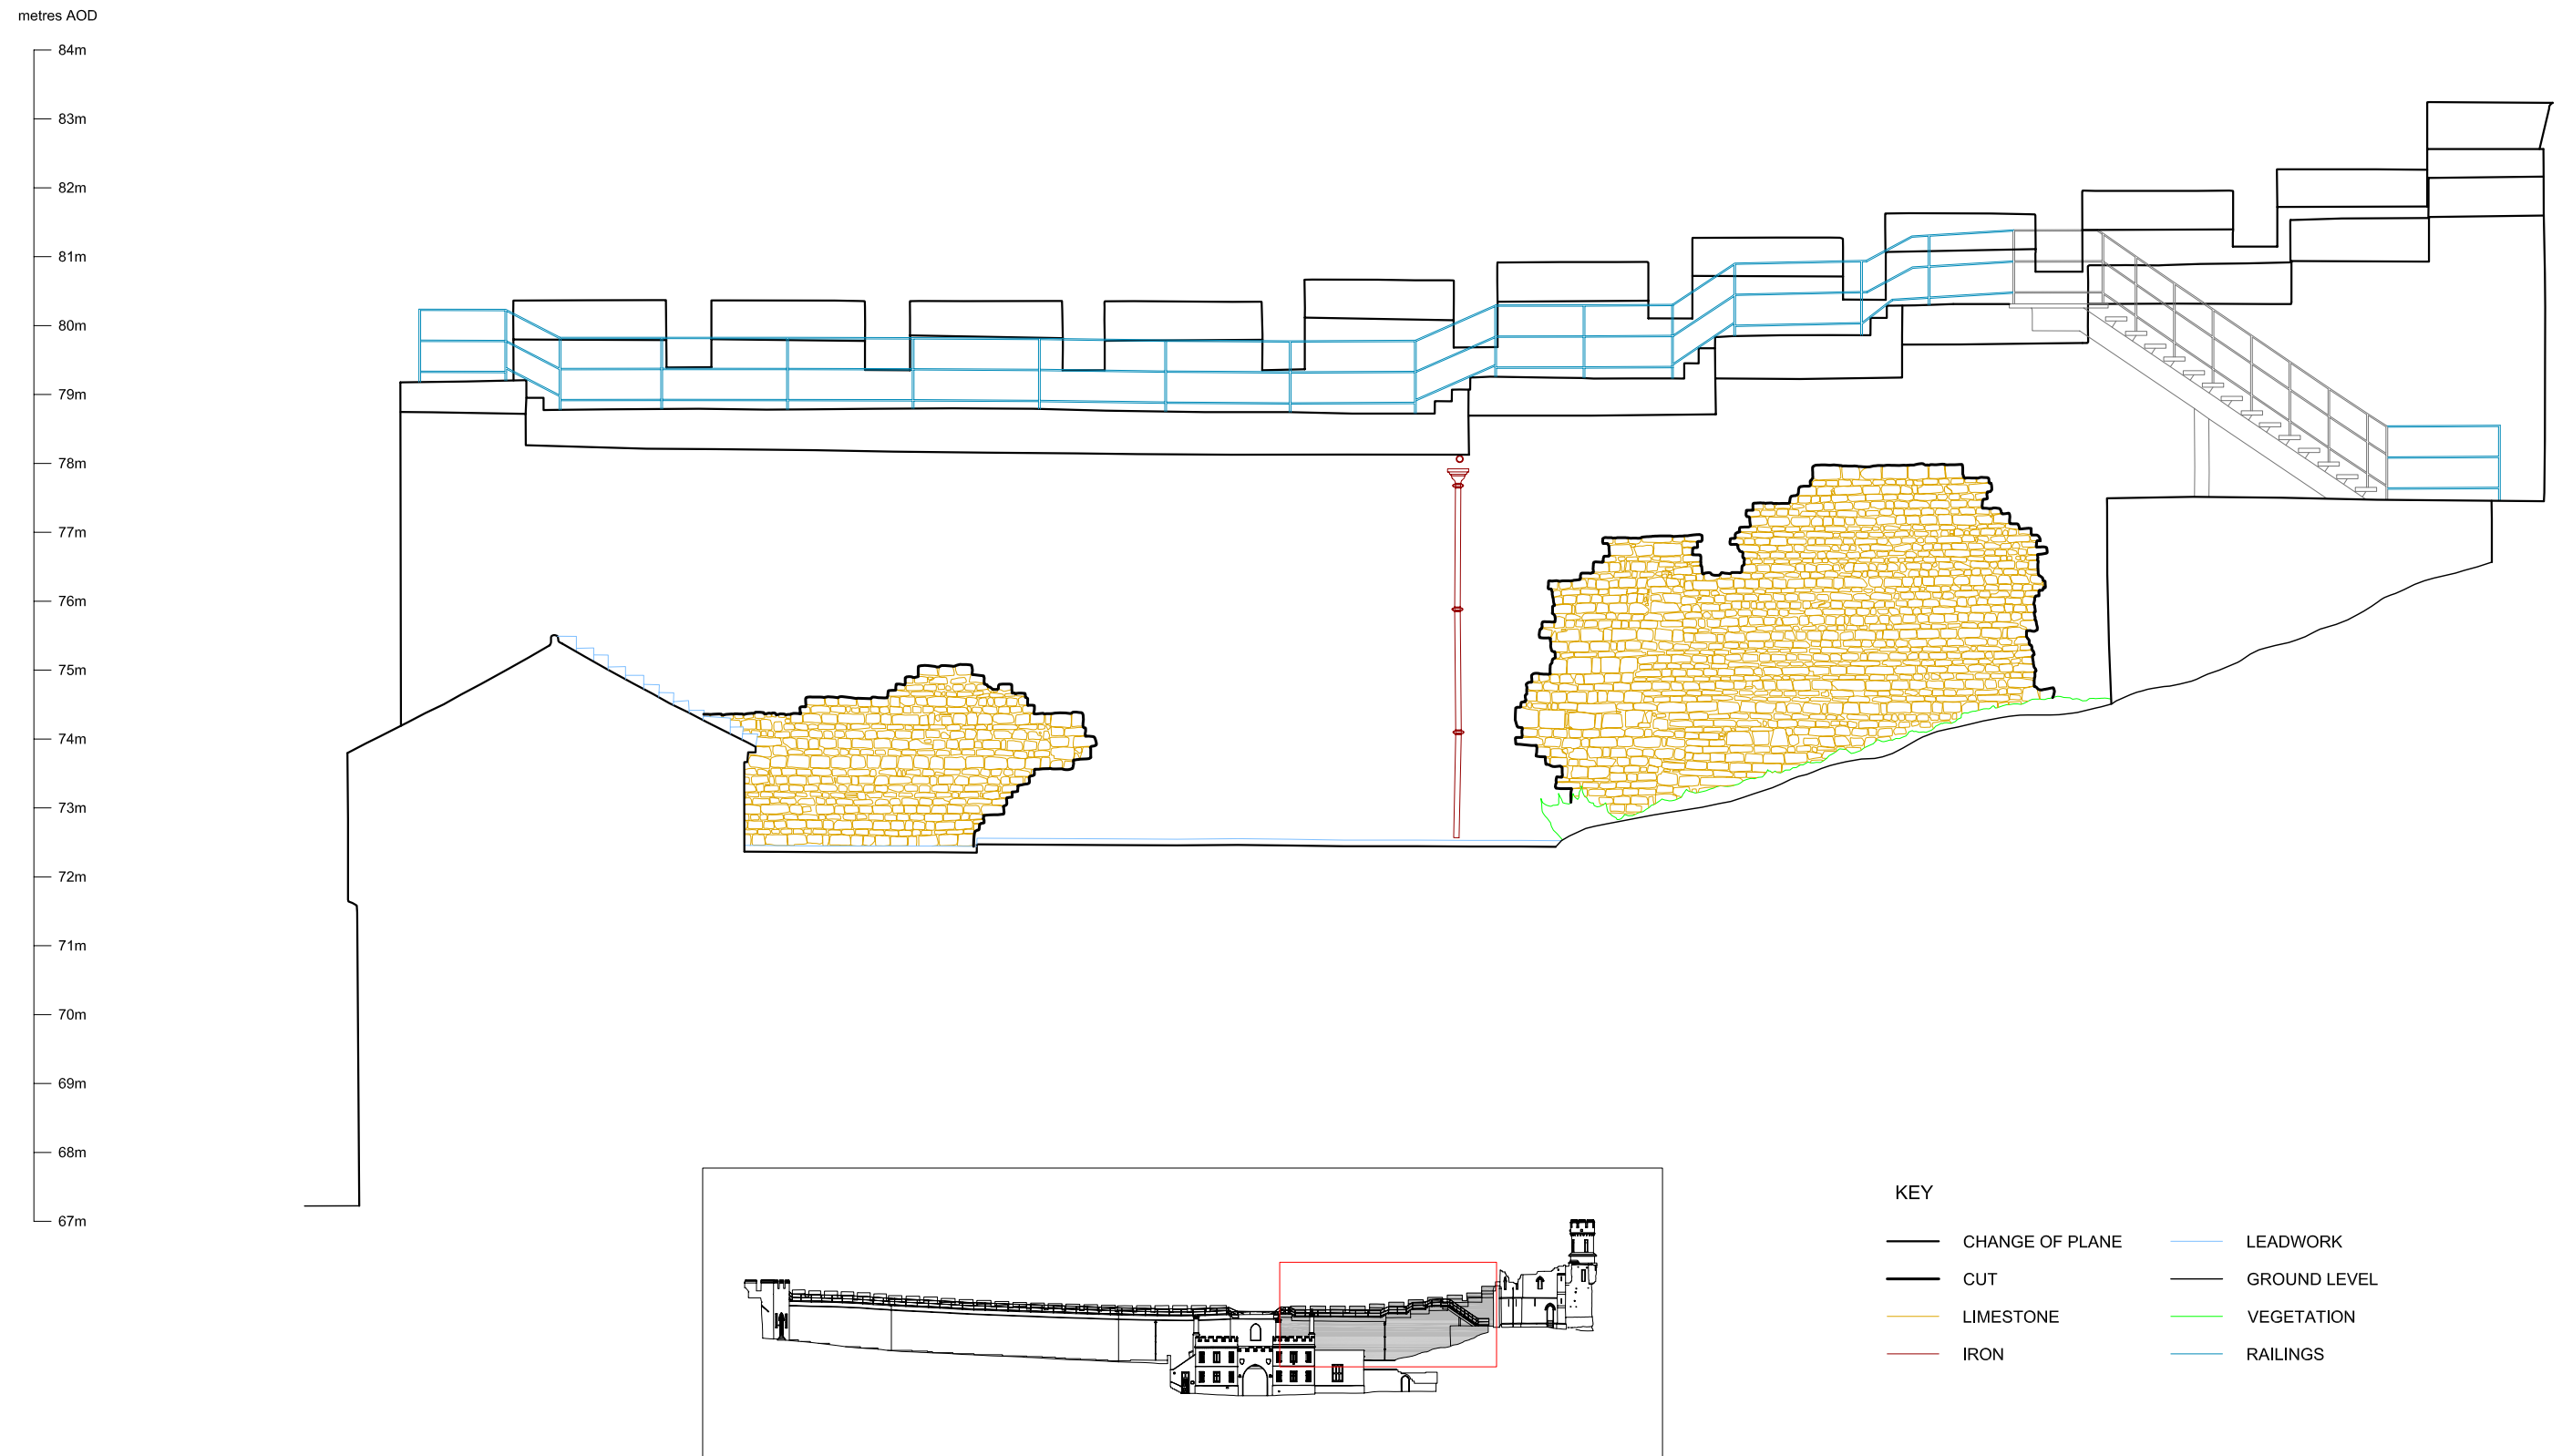
Scale 1:100 Figure 29

Much of the internal elevation of the curtain wall has been refaced leaving two discrete areas of medieval facing (Figure 29). Both surviving areas of medieval facing retain evidence for blocked openings which can be related to features visible externally and probably represent window embrasures.

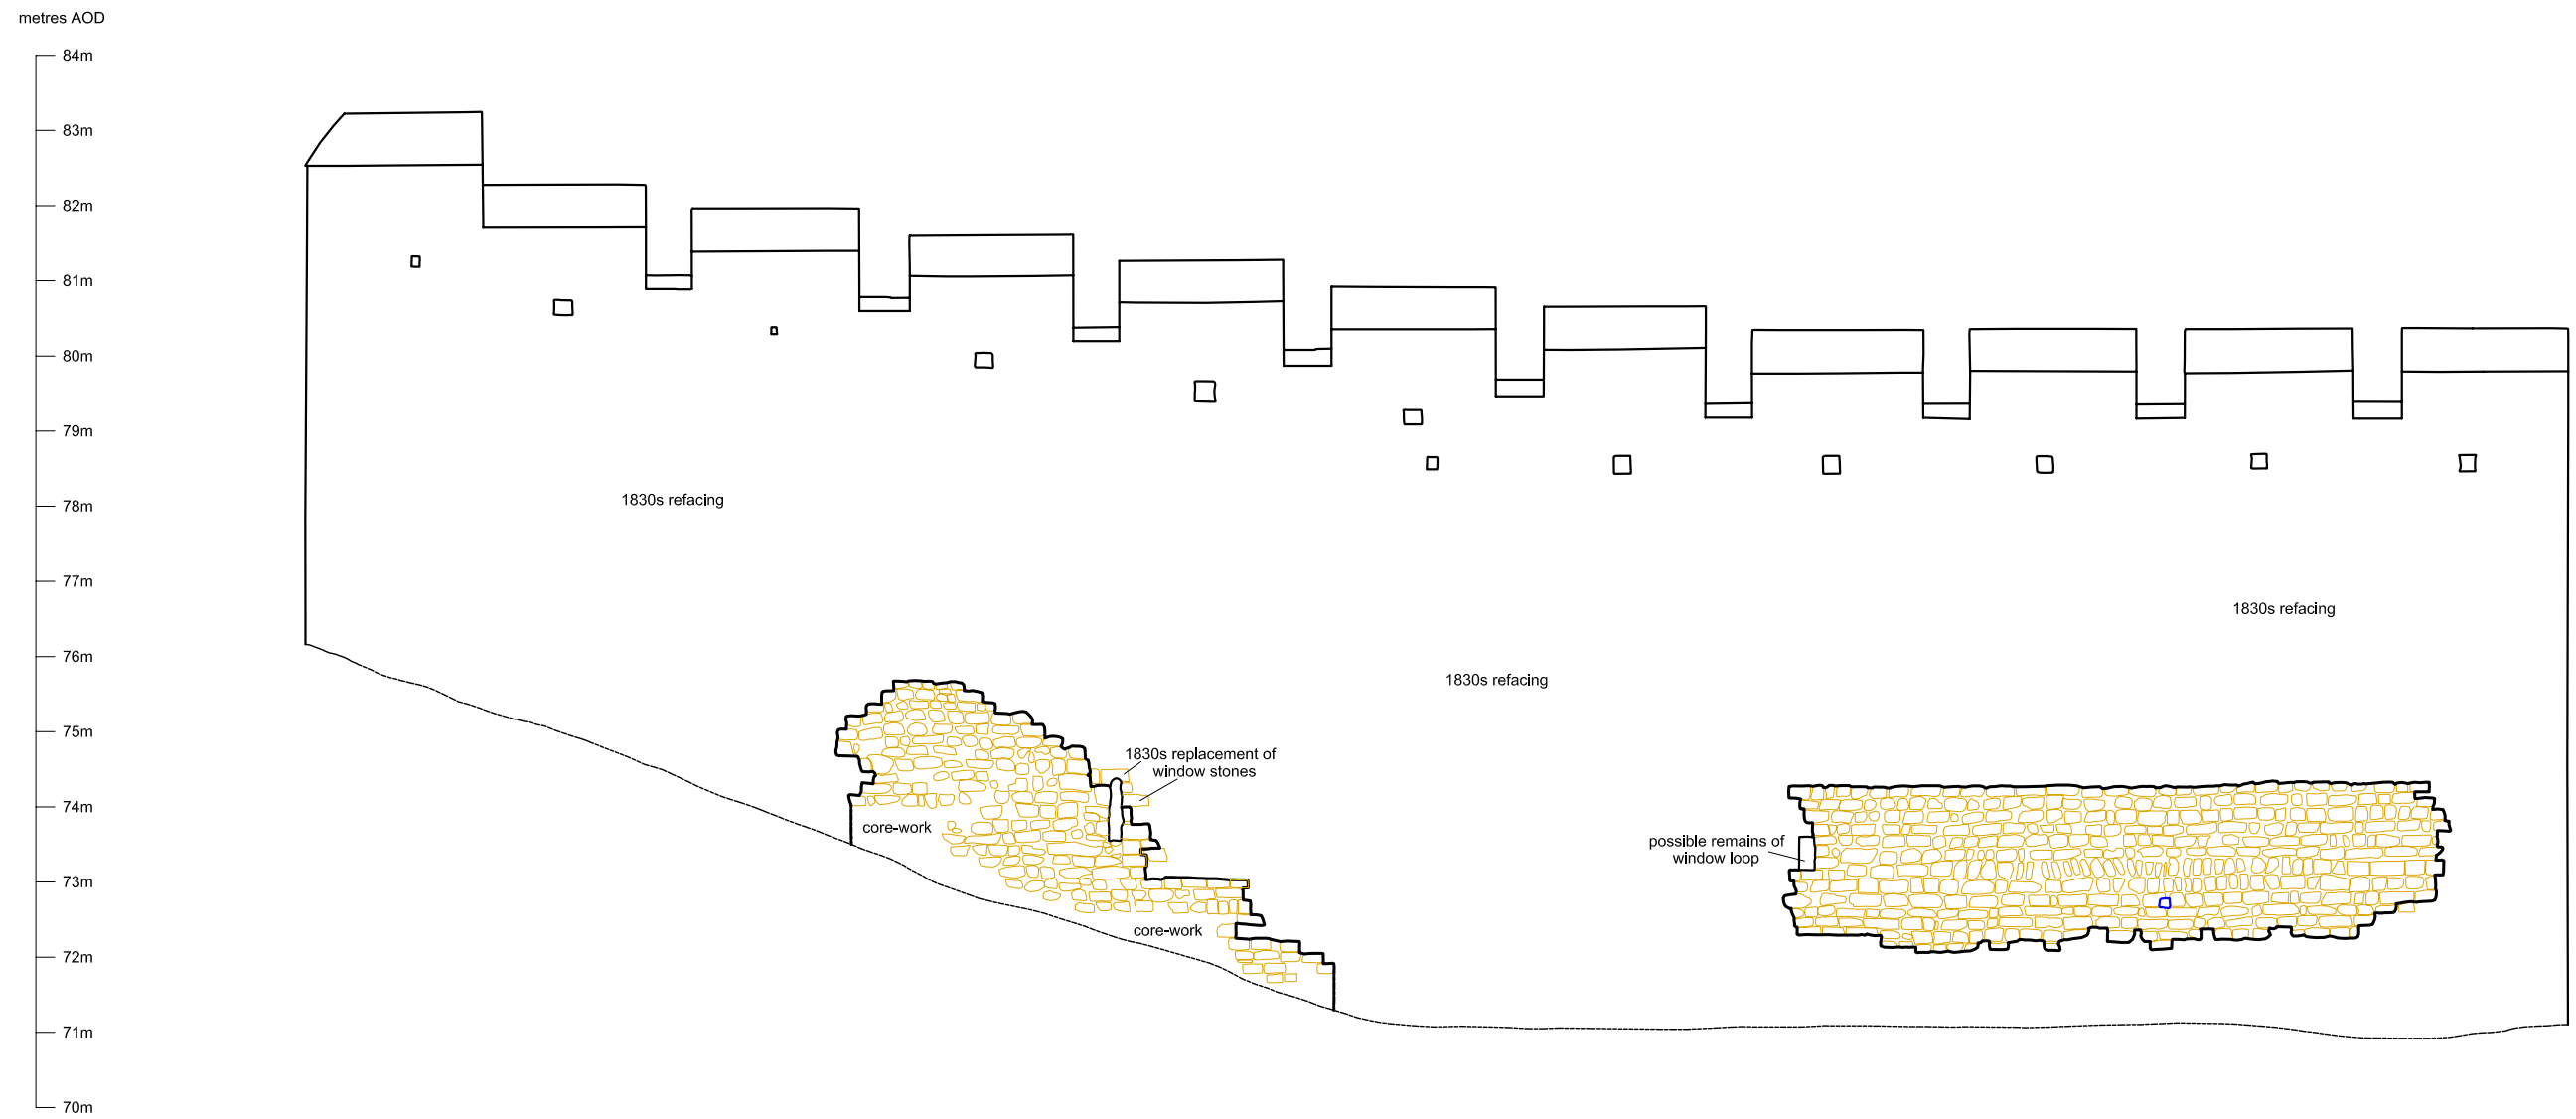
Scale 1:100 Figure 30

A close examination of the external fabric revealed that most of the extant face-work, bonded with a hard hydraulic lime mortar, dated to the repairs undertaken by Willson in the 1830s. However, two sections of medieval facing survived towards the bottom of the elevation; a section towards the bottom of the Observatory Tower mound and a further section to the north directly above the Memorial Garden (Figure 30). These two sections appear to have been left because of the presence of a terrace and stairs against the wall at the time of the re-facing work.

The section on the Observatory Tower Mound is the most interesting because of the presence of a narrow arch-headed loop opening. Although much of the masonry forming the jambs of the opening and its head is replacement stone from the 1830s, sufficient original work remains to indicate that it is an accurate restoration of the feature, other than it appears to have originally been taller; the dressed ashlar blocks of the northern side of the window can be seen to extend down below the current sill level.

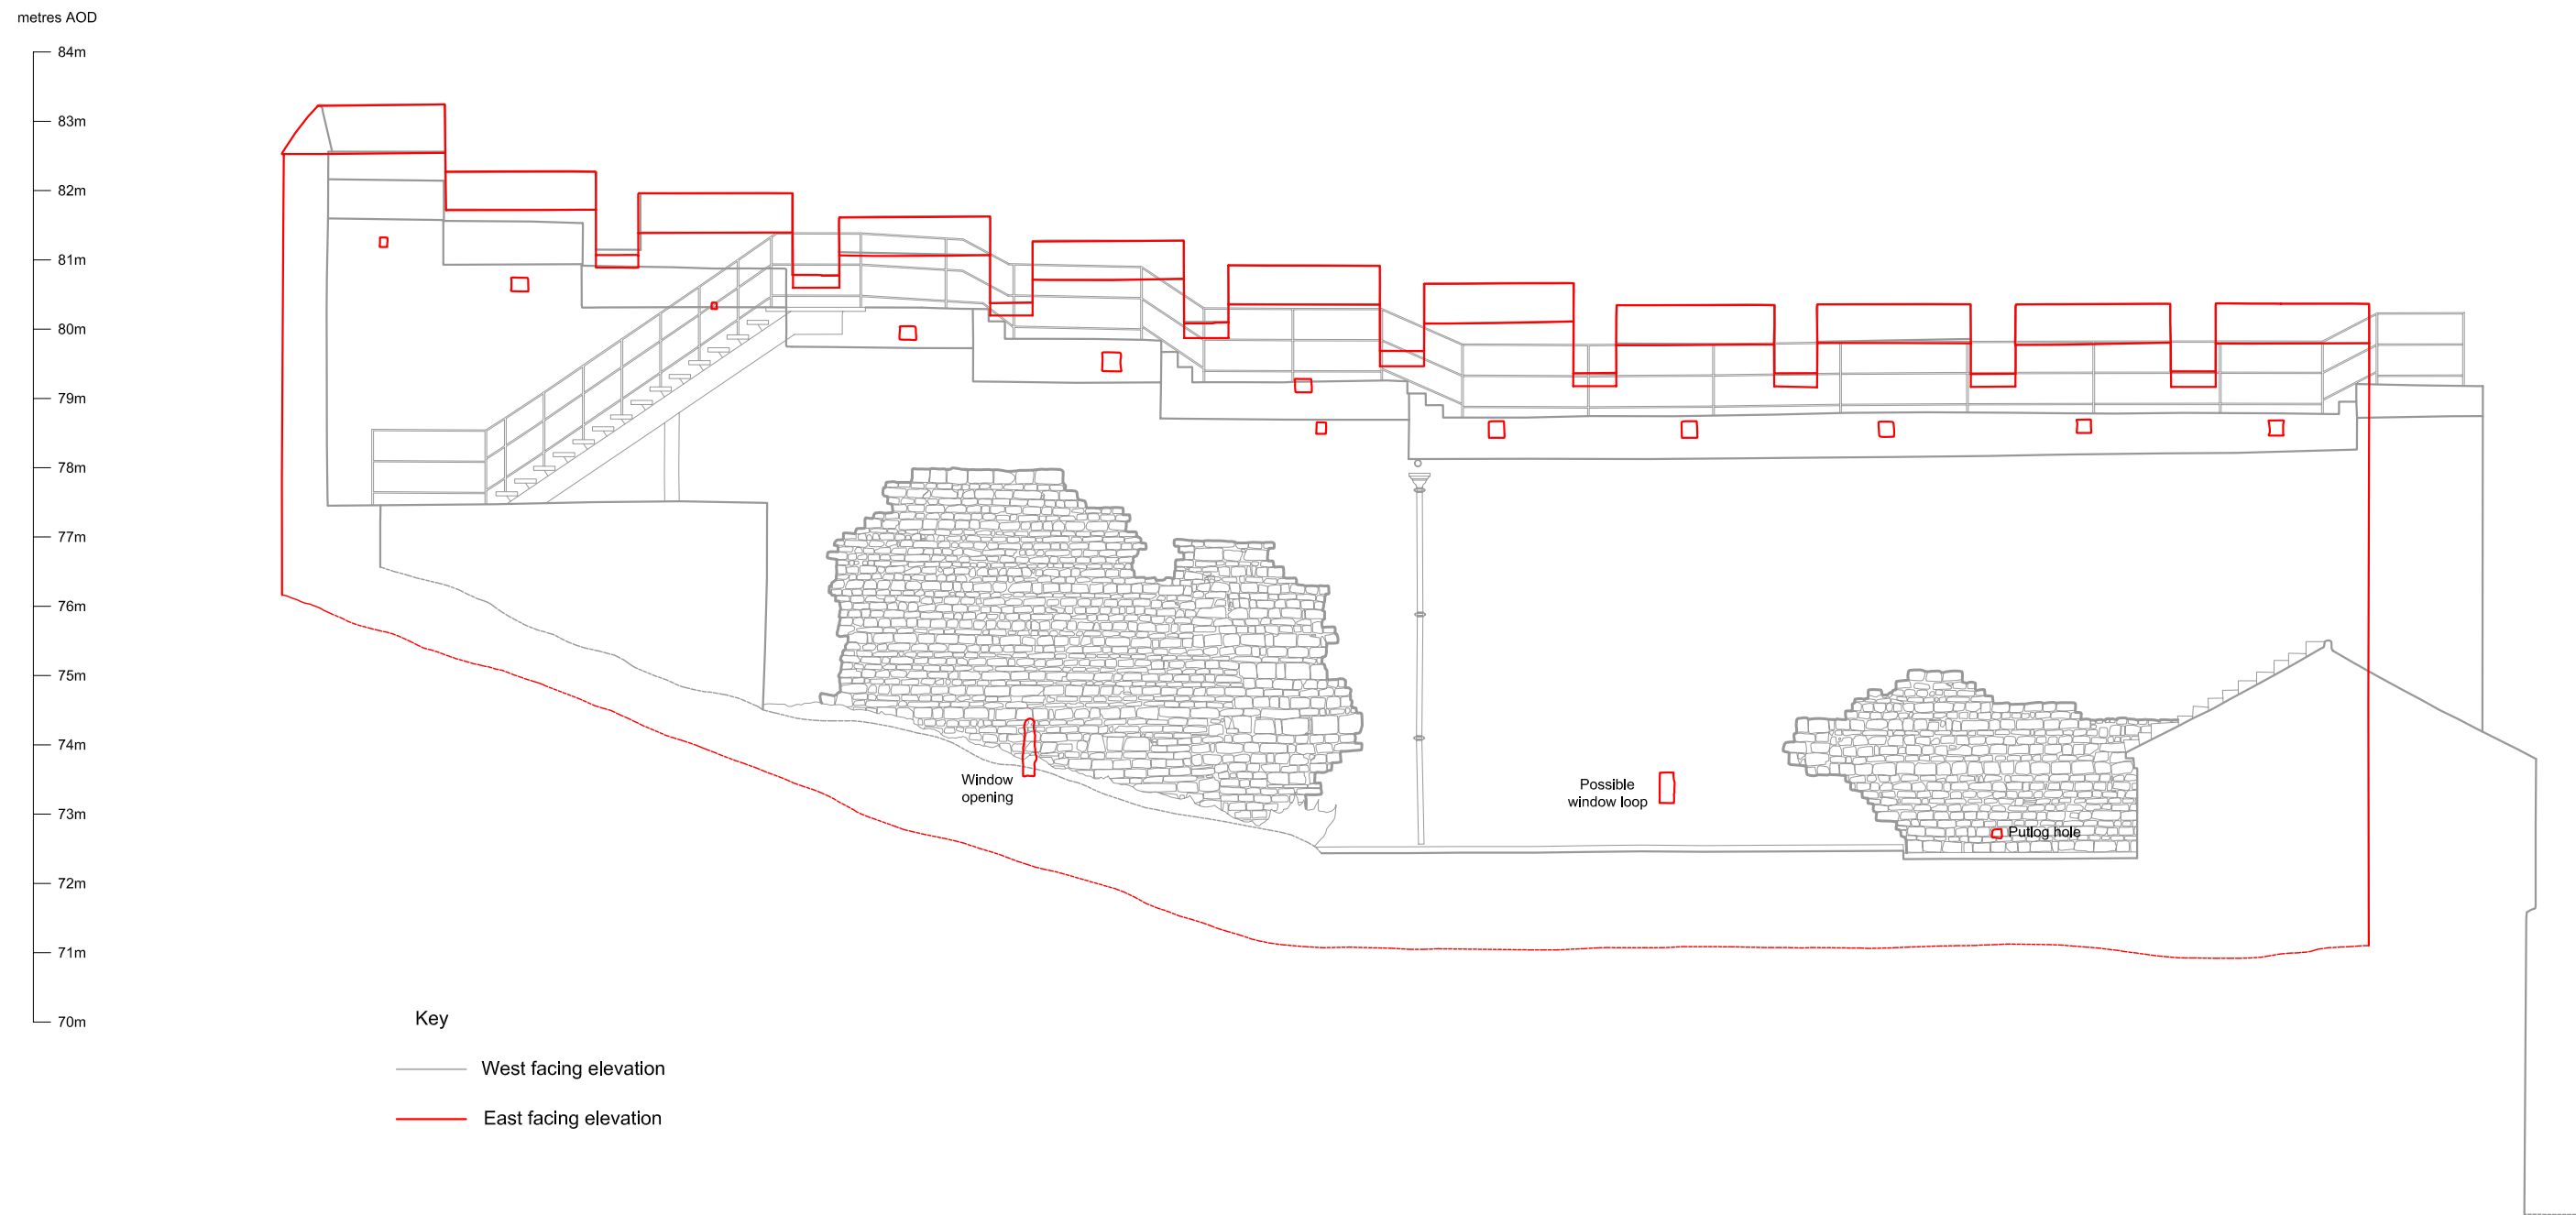
Scale 1:100 Figure 31

On the internal face of the curtain wall, despite a substantial area of medieval face-work surviving where the embrasure should be, there is no evidence for the opening. Further, a comparison of ground levels indicates that the feature would have, at least in part, been covered by the Observatory Tower Mound (Figure 31). The implication of this sequence is that the opening must have been
