**WALLS, GATES AND TOWERS**

**LINCOLN CASTLE**

**ARCHAEOLOGICAL  
INVESTIGATION**

**REPORT  
NOVEMBER 2015**

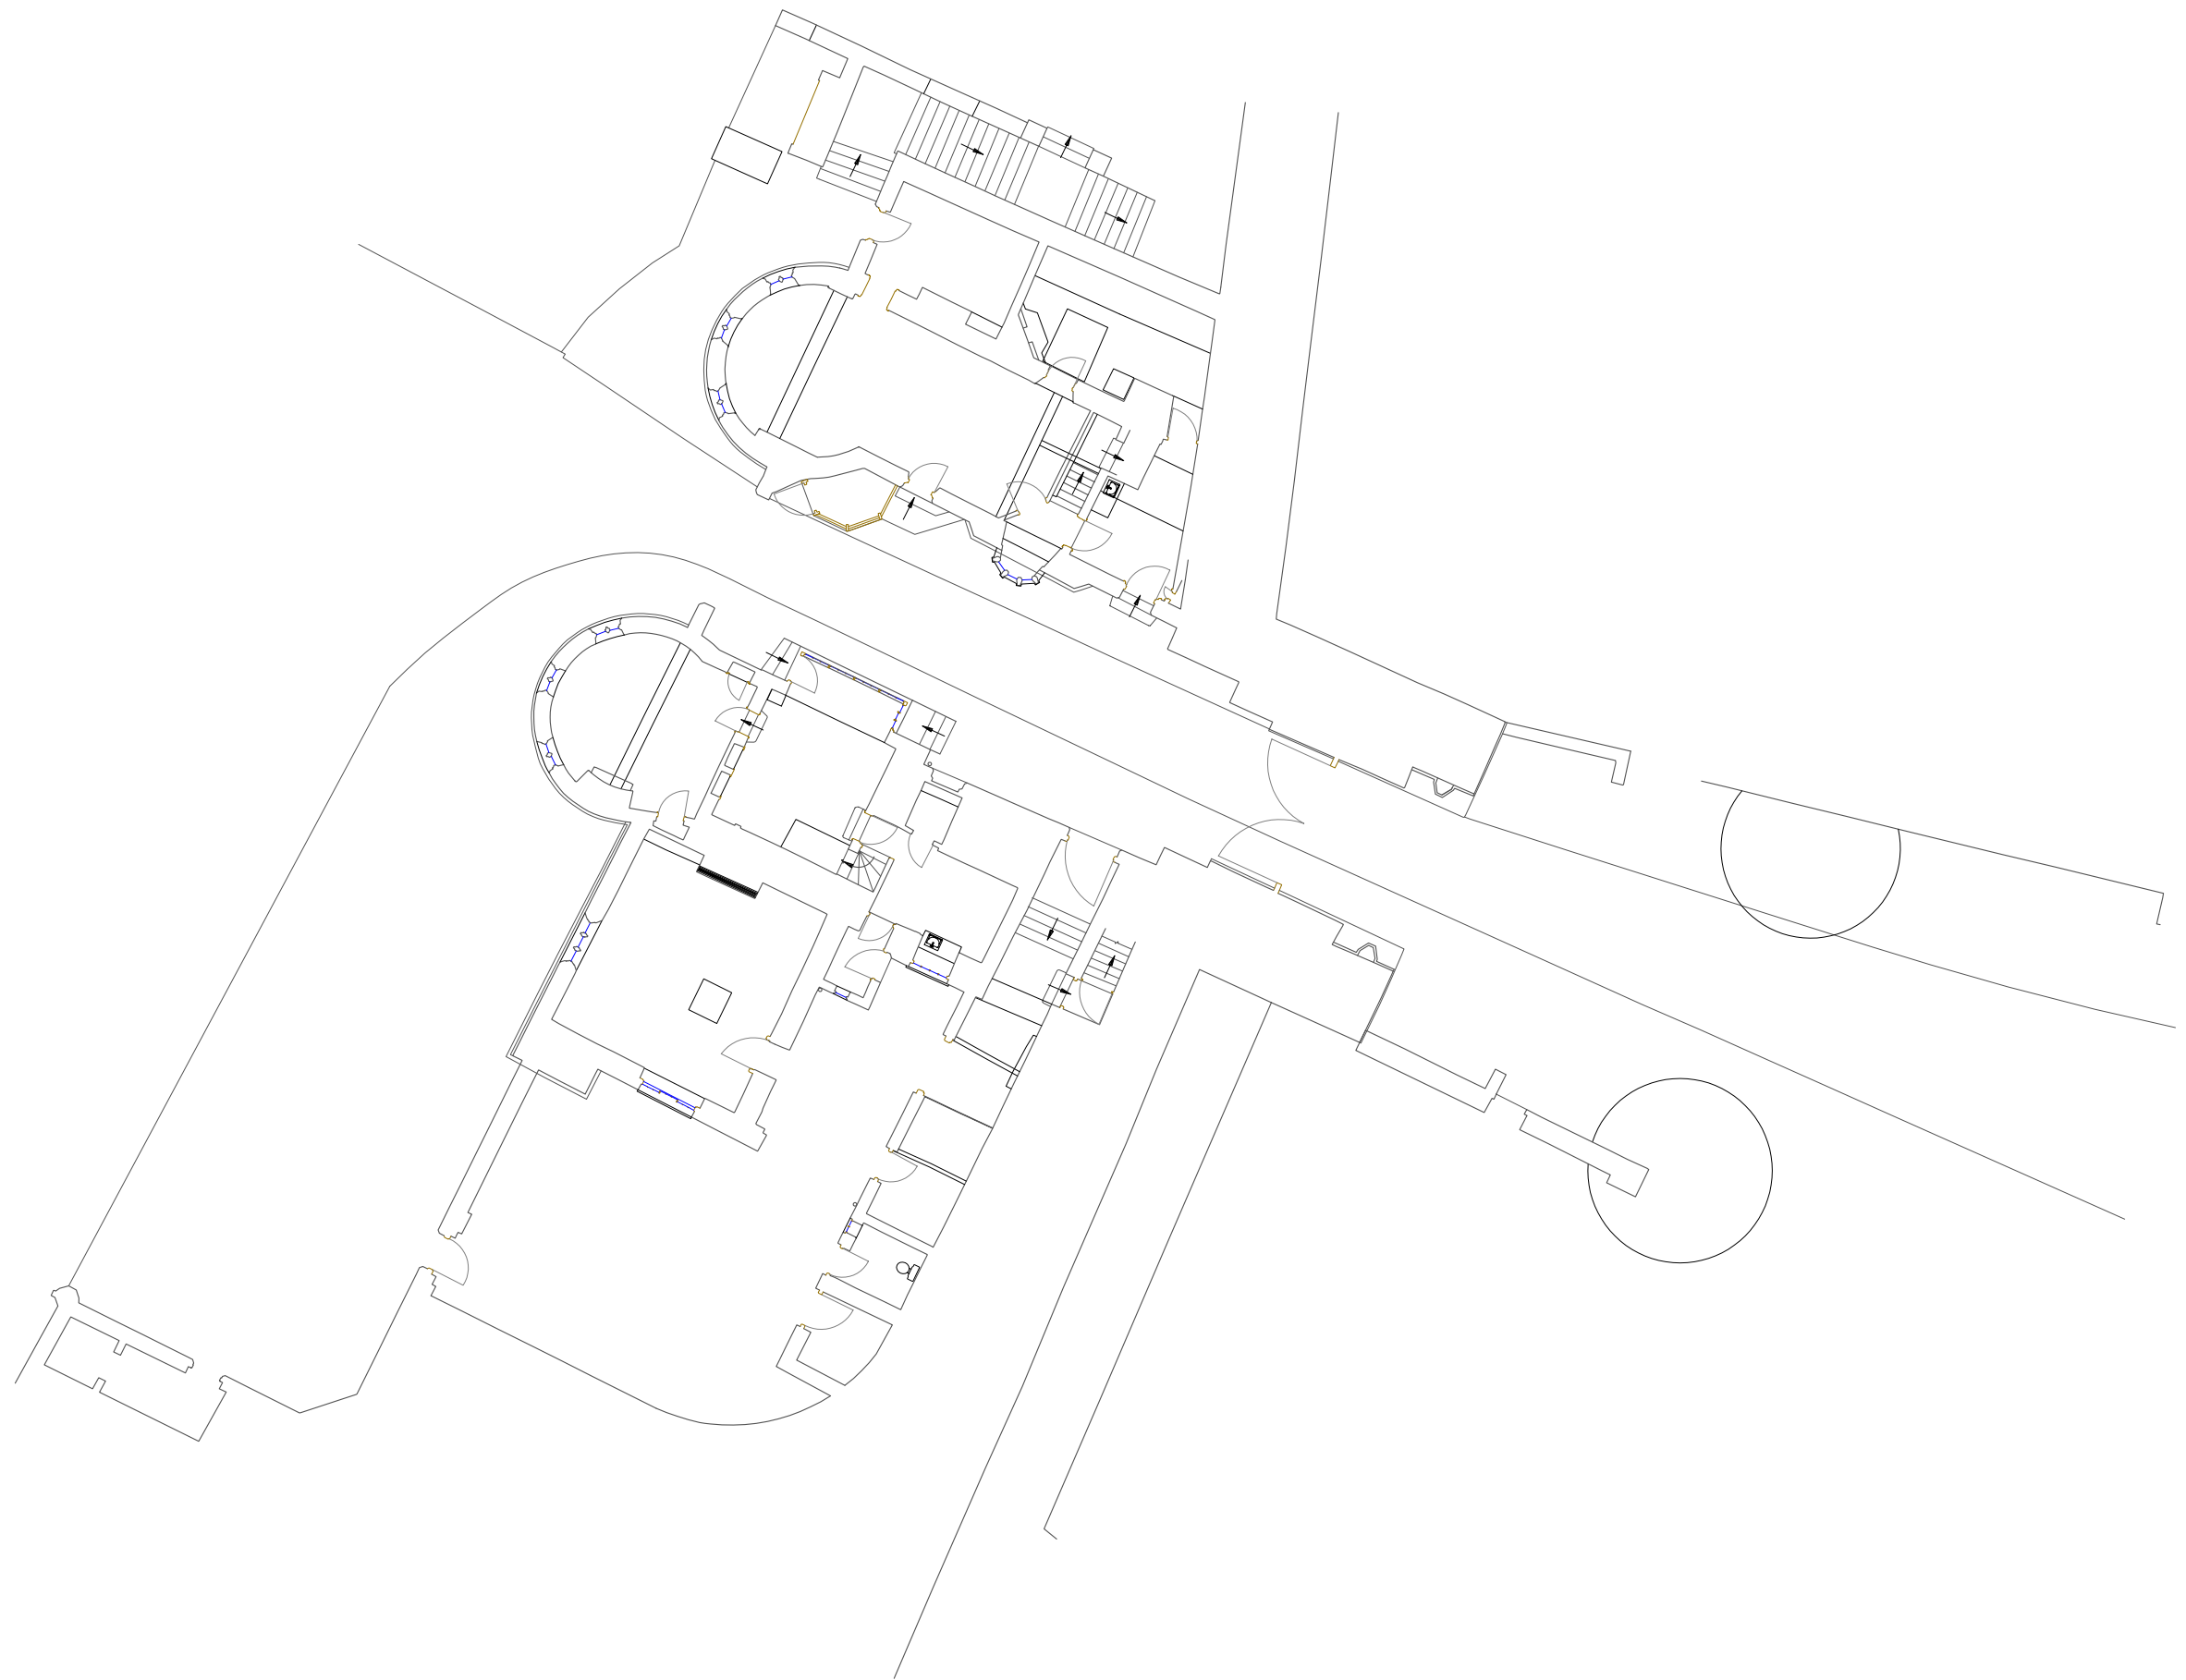
Figure 33

Entering the gatehouse from the east the layout of the Norman gatehouse can be traced with a pair of square section piers, with a low chamfered course; the chamfered course to the south has been largely cut back (Figure 33). The chamfered course can be traced most clearly on the north side of the gate passage where it returns to the north and then, in a cut back state, continues within the recess beneath the 13th-century gate arch. The chamfer and Norman gate arch is identical to the outer arch that survives on the West Gate. To the west, beyond the current modern doors, there is evidence for a further gate arch of identical form, although the upper part of the arch has long since disappeared. Between the two, in the space now occupied by the modern doors, is a portcullis groove, with no obvious evidence that this feature has been inserted.

East Gate, ground floor plan

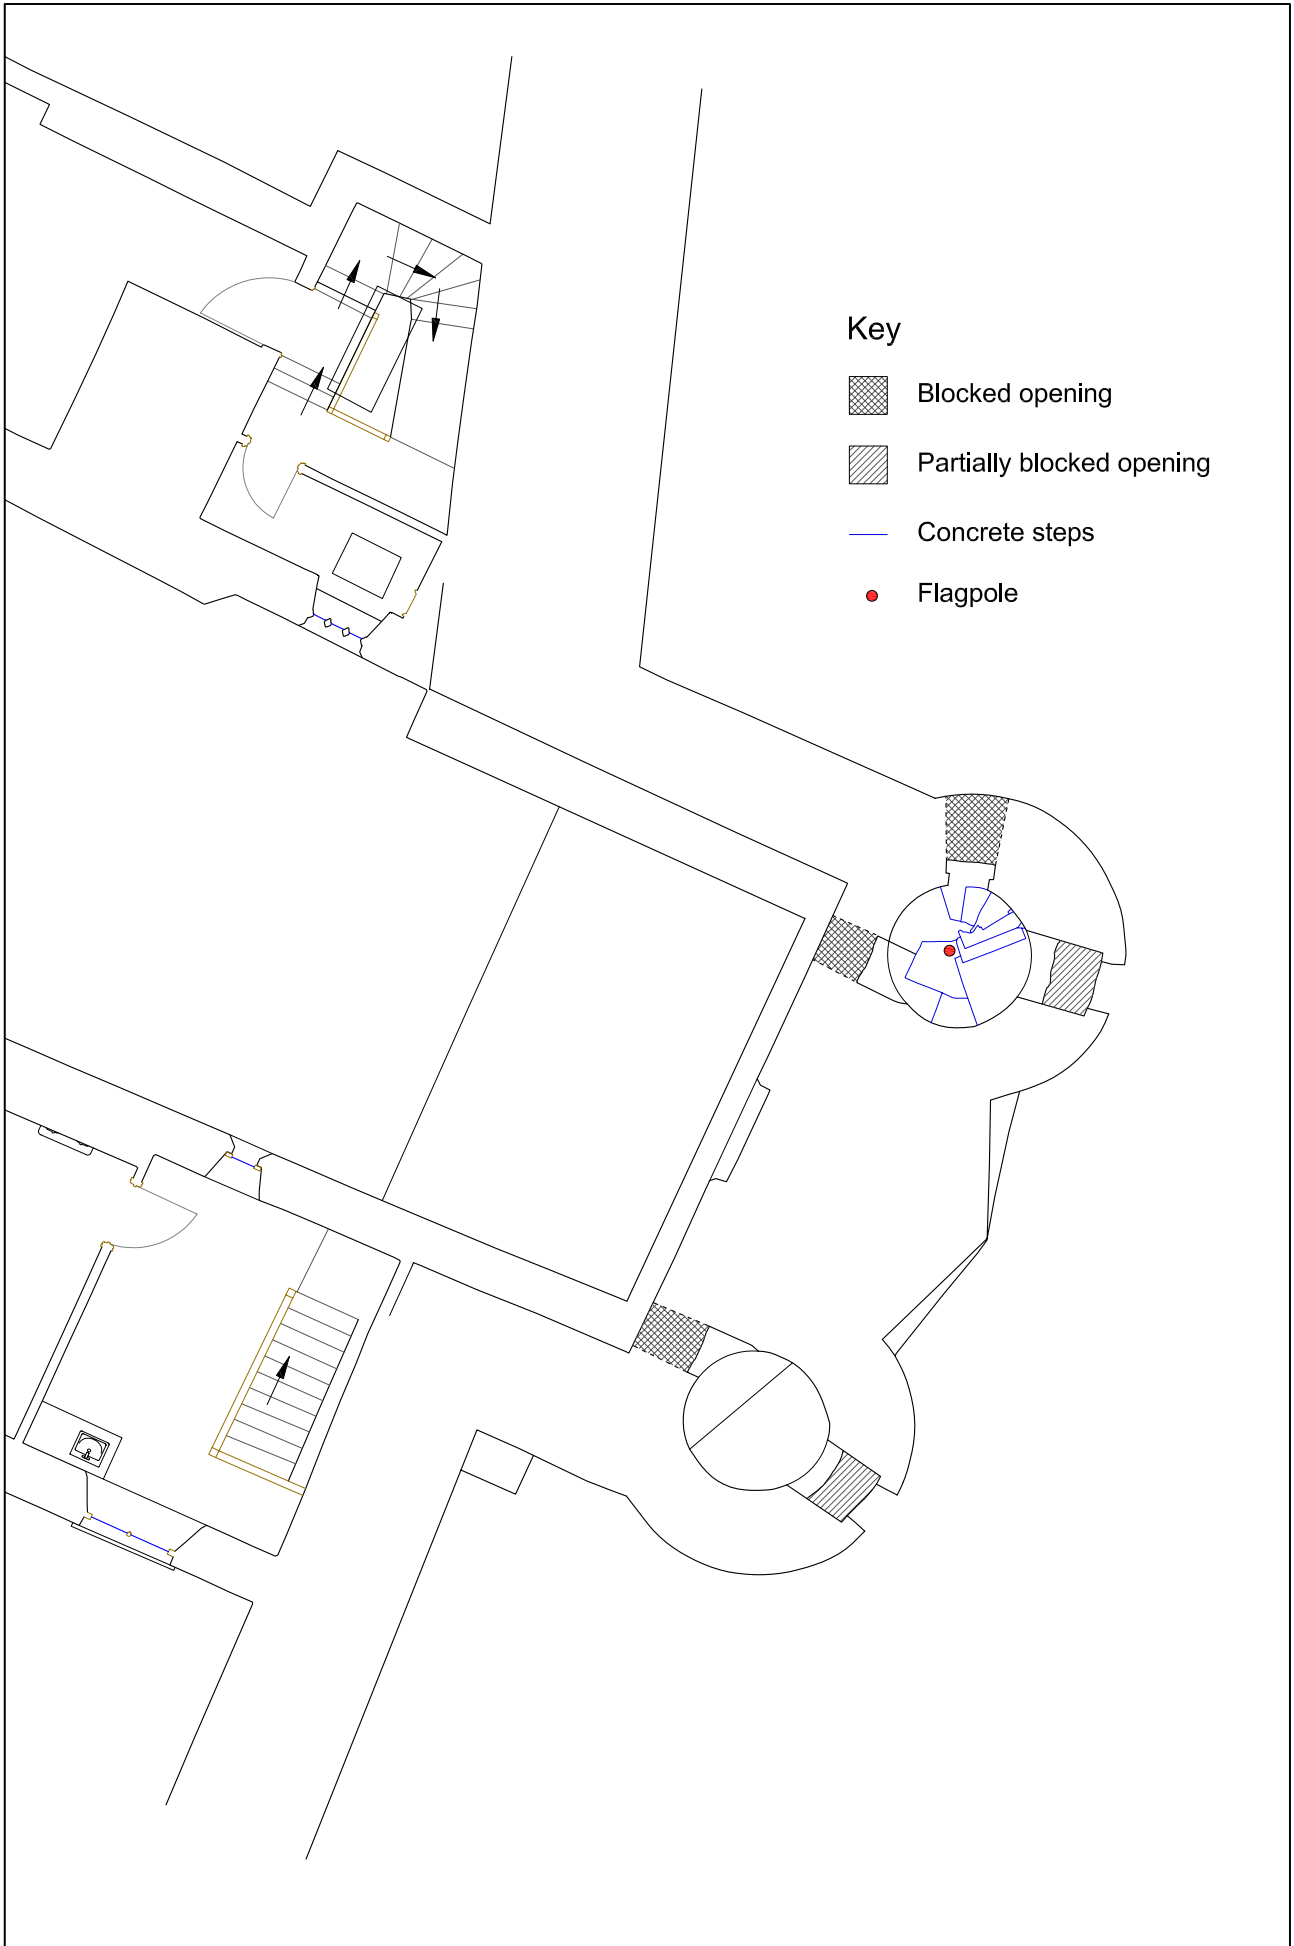
Figure 34

During repair works, it was possible to examine the interior of the bartizan turrets. The turrets contained internal stairs which provided access to both the barbican doors and the upper parts of the turrets (Figure 34), which have been cut down from their full height; in both turrets several risers remained *in situ*. Access to the turrets, from the interior of the first floor of the gatehouse, was

East Gate, first floor plan

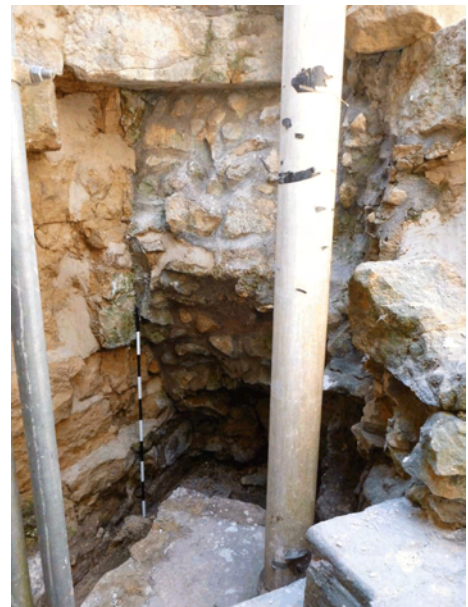
provided by doorway in the rear (west) wall of each turret; the blocking of each doorway was evident in both turrets (Plates 20 and 21). Within the first floor of the East Gate the position of the door openings have been comprehensively covered over by refacing, although drain pipes (for the interiors of the turrets) are visible protruding through the wall.

**Plate 21** East Gate, blocked doorway in south bartizan turret

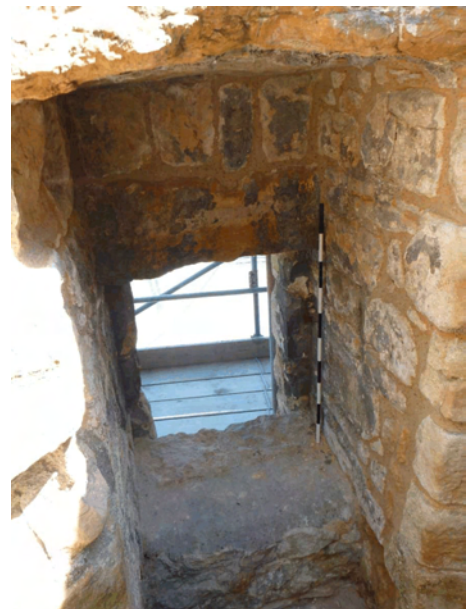
**Plate 23** East Gate, interior of north bartizan turret

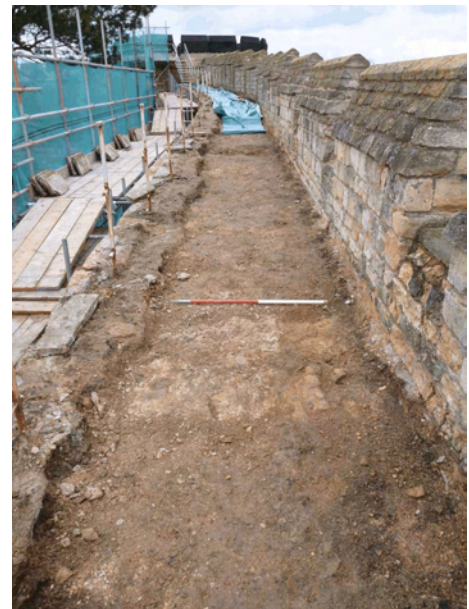
During stripping and replacement of the parapet walkway and improvements to the wall-head drainage, it was possible to examine the composition of the exposed fabric. As with the other sections of curtain wall examined it was evident that extensive works had been carried out to the wall-head during the 19th and 20th centuries. Removal of the existing parapet slabs, and removal of the modern bedding material, exposed the wall-core of the curtain wall. The wall-core was bonded in a soft brown lime mortar identical to that which had been identified in the medieval work on the eastern half of the south curtain wall. As with the south curtain wall it was apparent that the medieval parapet had been taken down in its entirety and replaced in the 19th century with the current parapet. More recently, the rear (inner) edge of the curtain wall had been heavily cut into for the insertion of a rough concrete

ring beam and the fixings for the railings, all work that appears to date to the 1970s (Plate 24).

**Plate 24** East curtain wall north, wall-walk removed

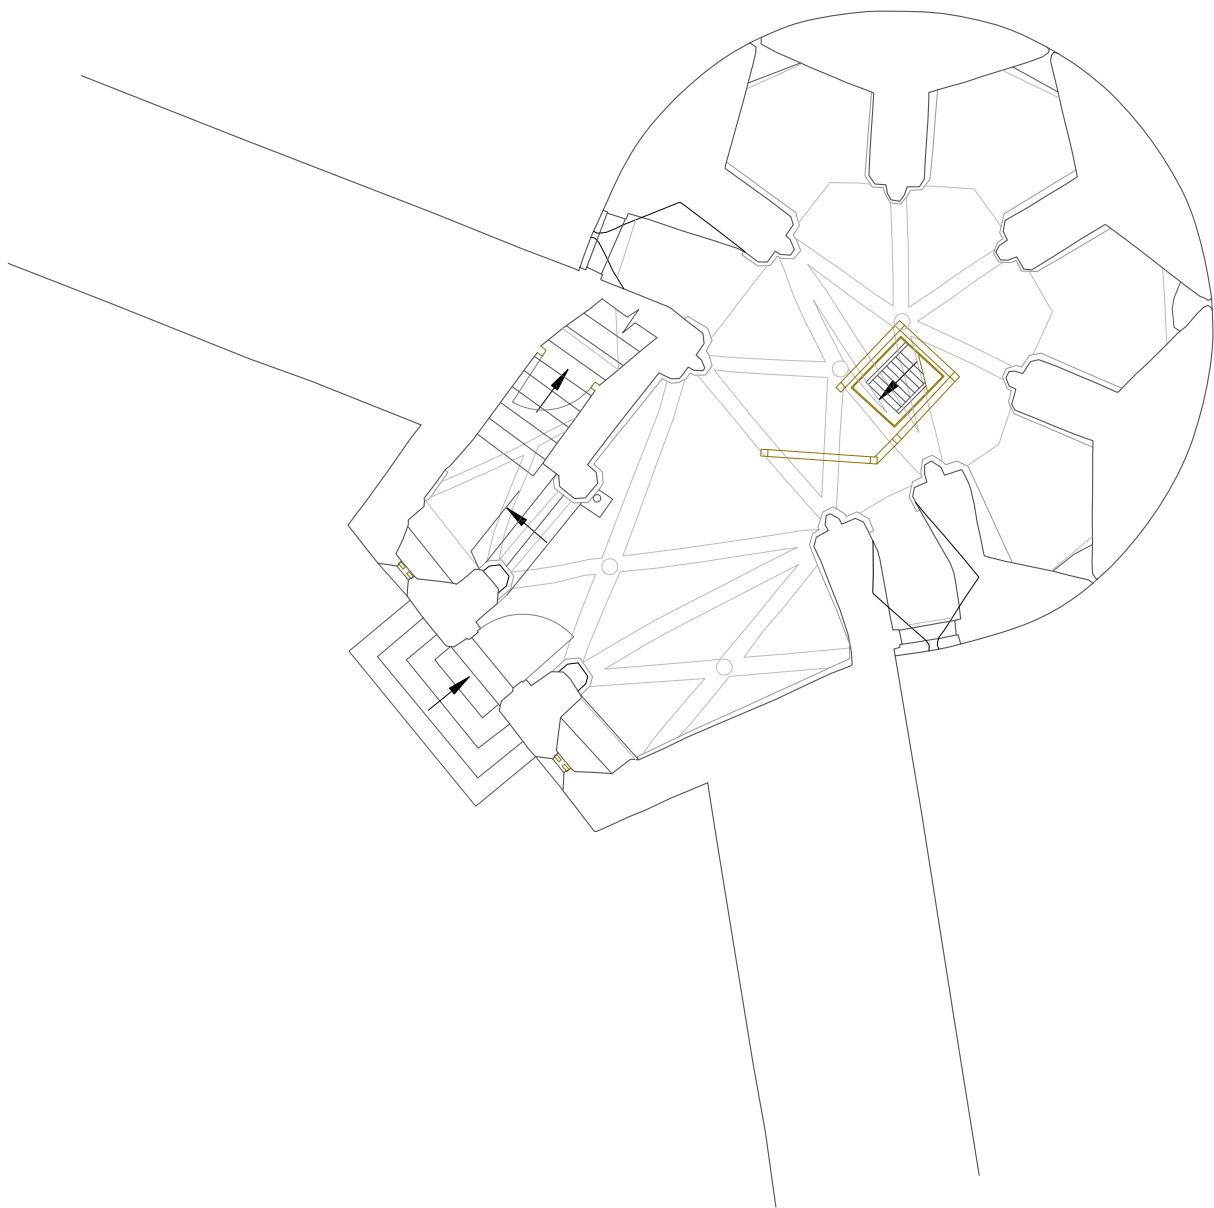
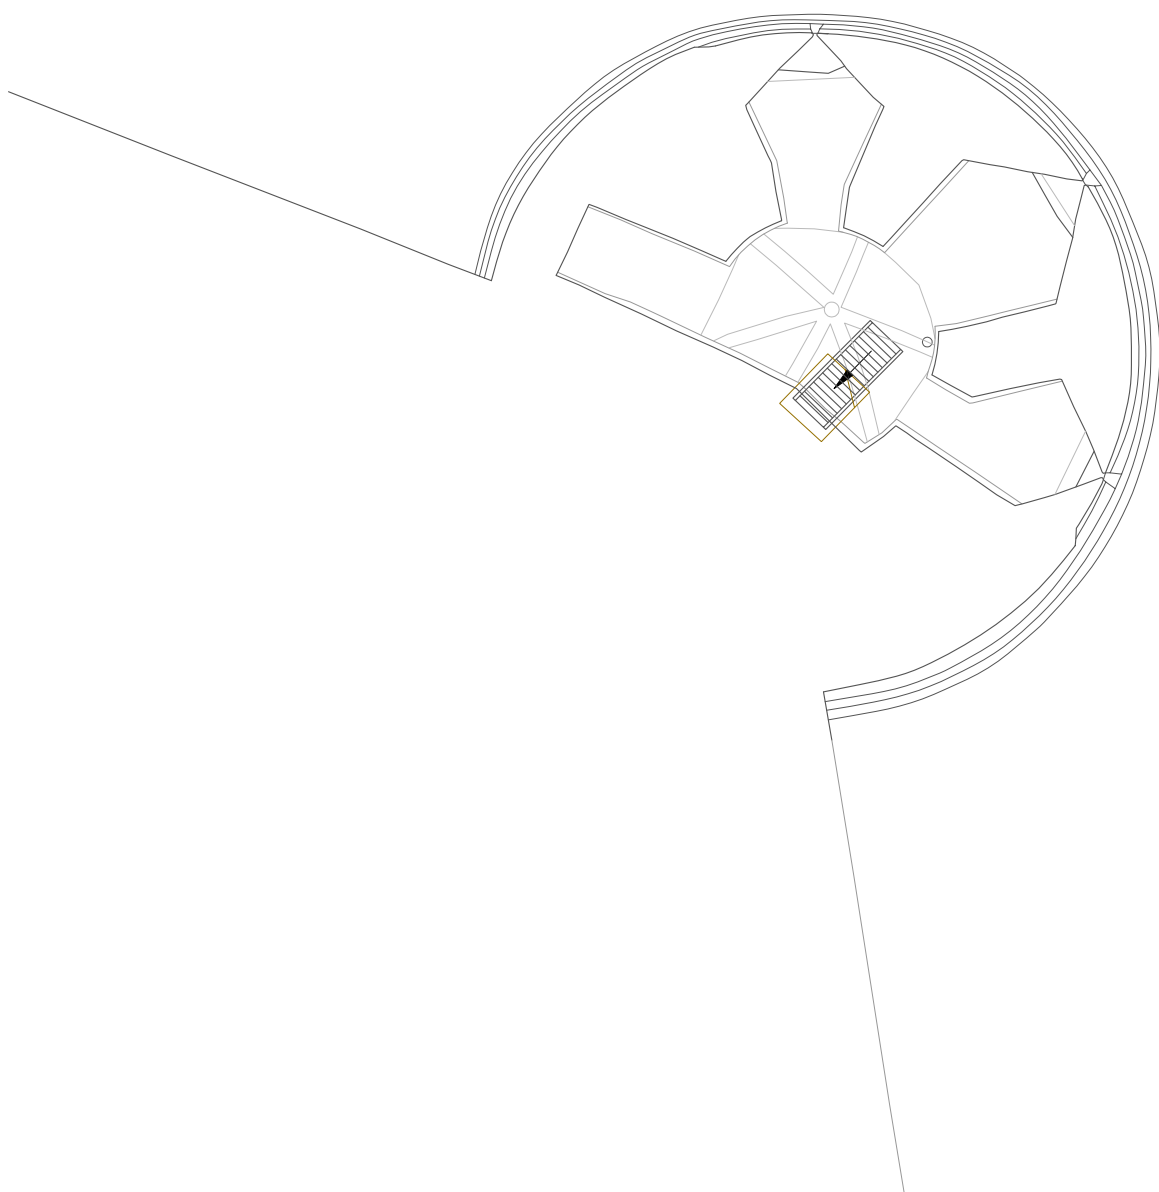
Figure 35

The basement is now reached through an opening in the floor of the ground floor; a feature which has clearly been cut into the rib vault that covers the basement room (see Figure 35). The vault divides the ceiling into six sections; the ribs spring from a chamfered stringcourse that runs around the room in the same manner as the ground floor and meet with a boss. There are three arrow loop

Cobb Hall, ground floor and basement plan

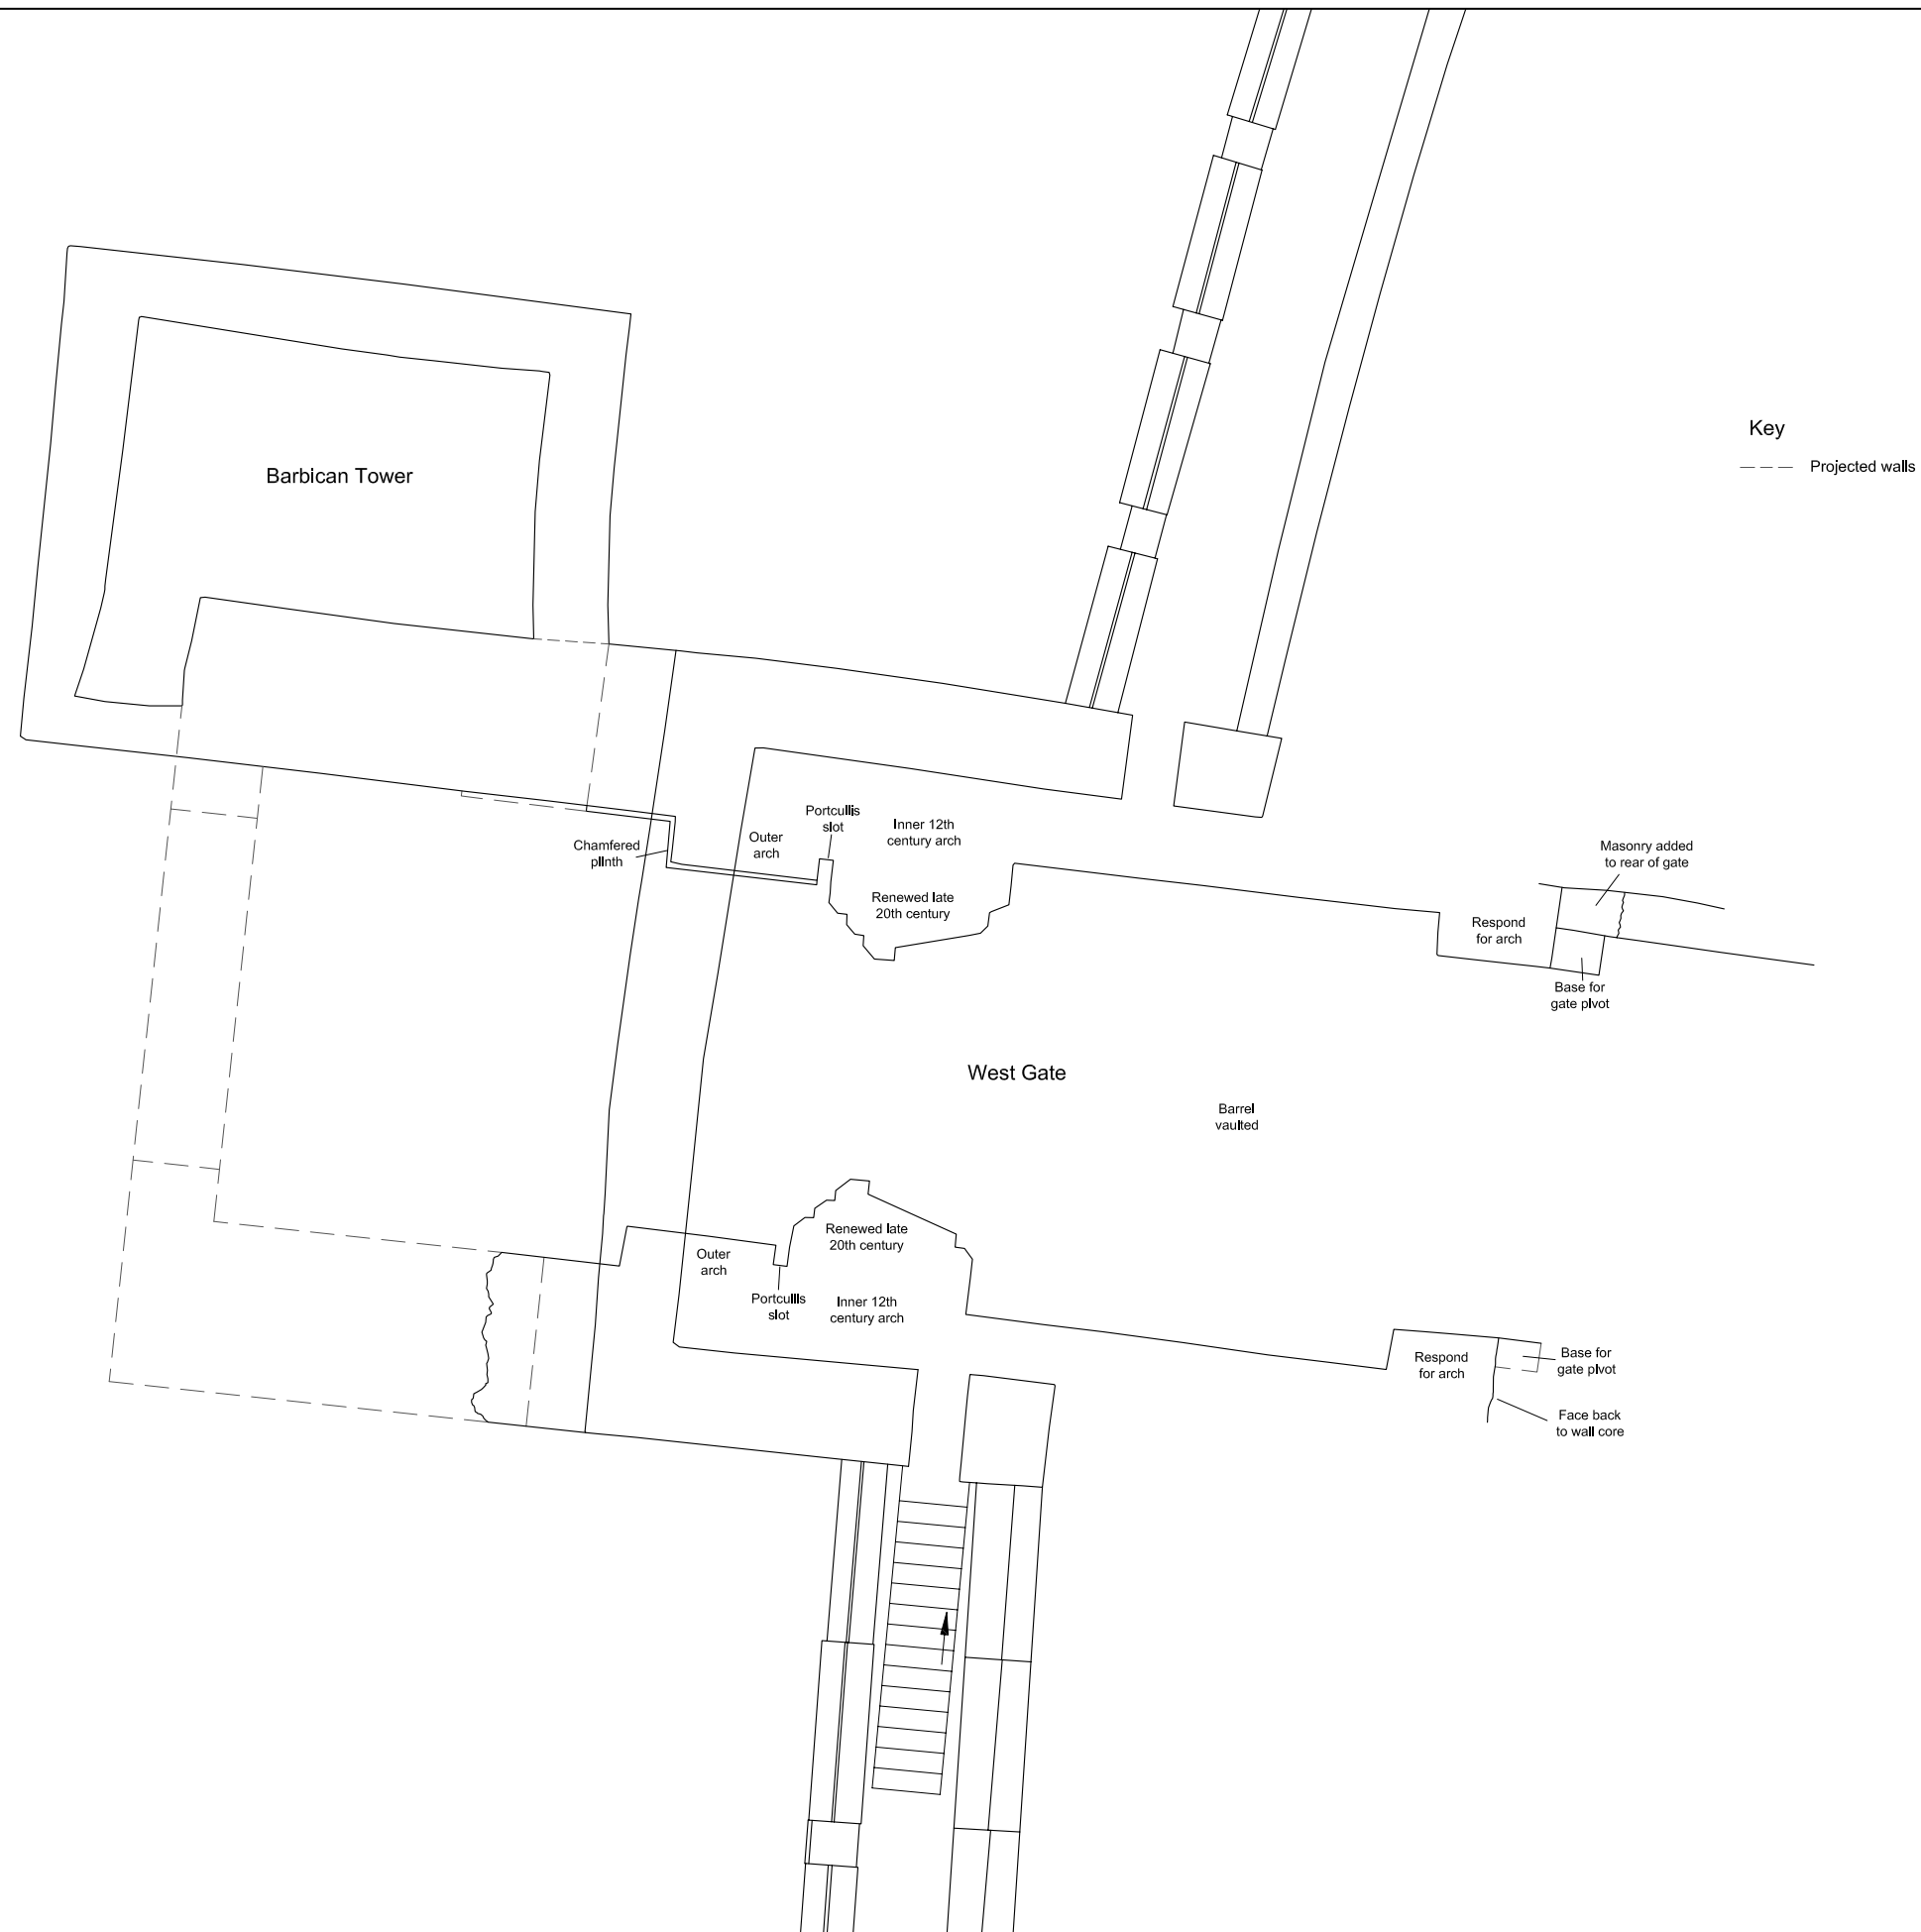
Figure 38

The barbican tower is a rectangular structure on the north side of the approach to the west gate. Externally the structure measures c.7.6m west-east and c.6.7m south-north (Figure 38). The external faces of the east and north walls are largely buried within the castle rampart, while the south wall forms an extension to the West Gate barbican structure. Where the external masonry is exposed it

West Gate, ground floor plan

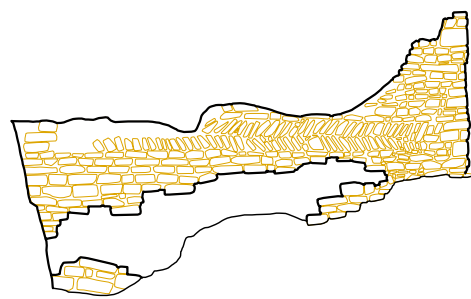
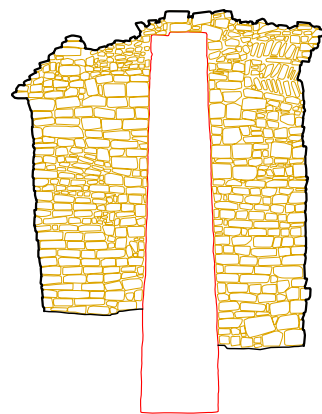
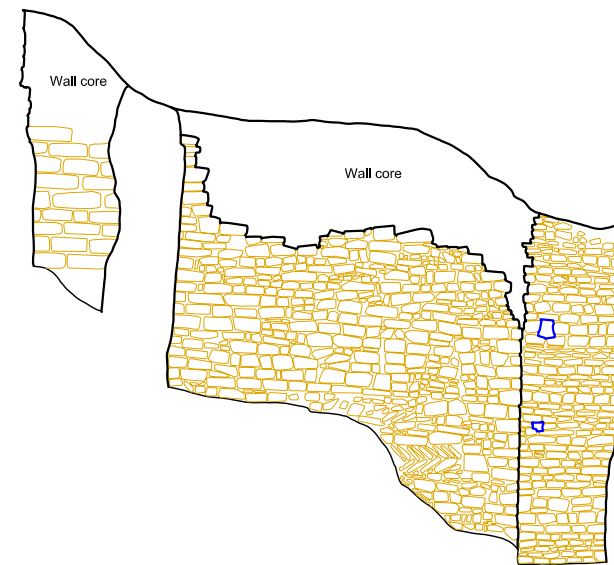
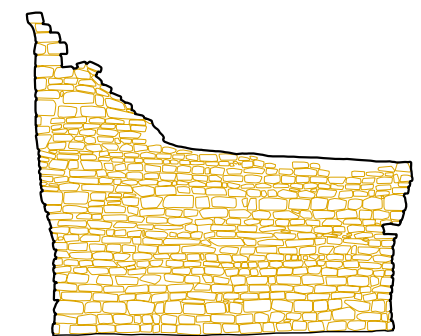
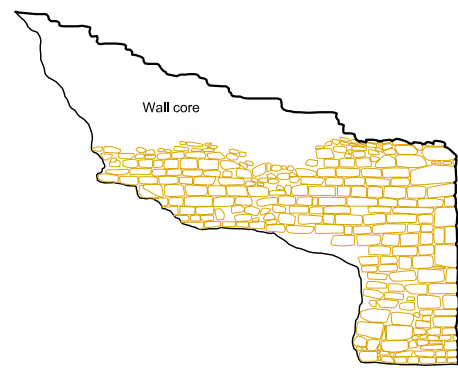
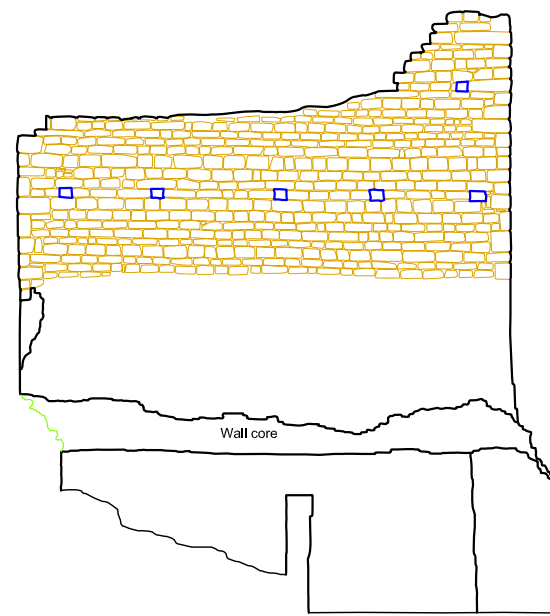
Scale 1:100 Figure 40

In height, only a small section of the internal north elevation is exposed (see Figure 40). The lower half of the elevation consists of exposed rubble foundation, increasing in depth to the west, suggesting that the internal floor level within the structure has been lowered or dug out. Above the rubble

External and internal elevations of the barbican tower

The internal east elevation has a centrally positioned, raking brick buttress of 19th- or early 20th-century date (see Figure 40). The buttress was evidently installed to prevent the wall collapsing. With all the mass of the castle rampart to the east of it, the wall has clearly suffered partial failure on numerous occasions and has evidently had several phases of repair. The main area of surviving original fabric is in the bottom half of the elevation, executed in small regular blocks of stone; in contrast to the exterior facing the stone blocks employed are generally of slightly greater size. The upper half of the elevation appears to have been largely refaced.

The earliest phase of masonry on the internal south elevation is at its western end where it retains evidence for the original north face of the Norman buttress of the West Gate (see Figure 40). Nine courses of large dressed stones remain, of identical character to those forming the south side of the buttress, forming a strip of masonry c.1.2m wide. The upper part of the facing has been lost and taken back to wall-core, while the western edge of the facing, where the expected return for the buttress should be, is masked by the east wall of the barbican tower.

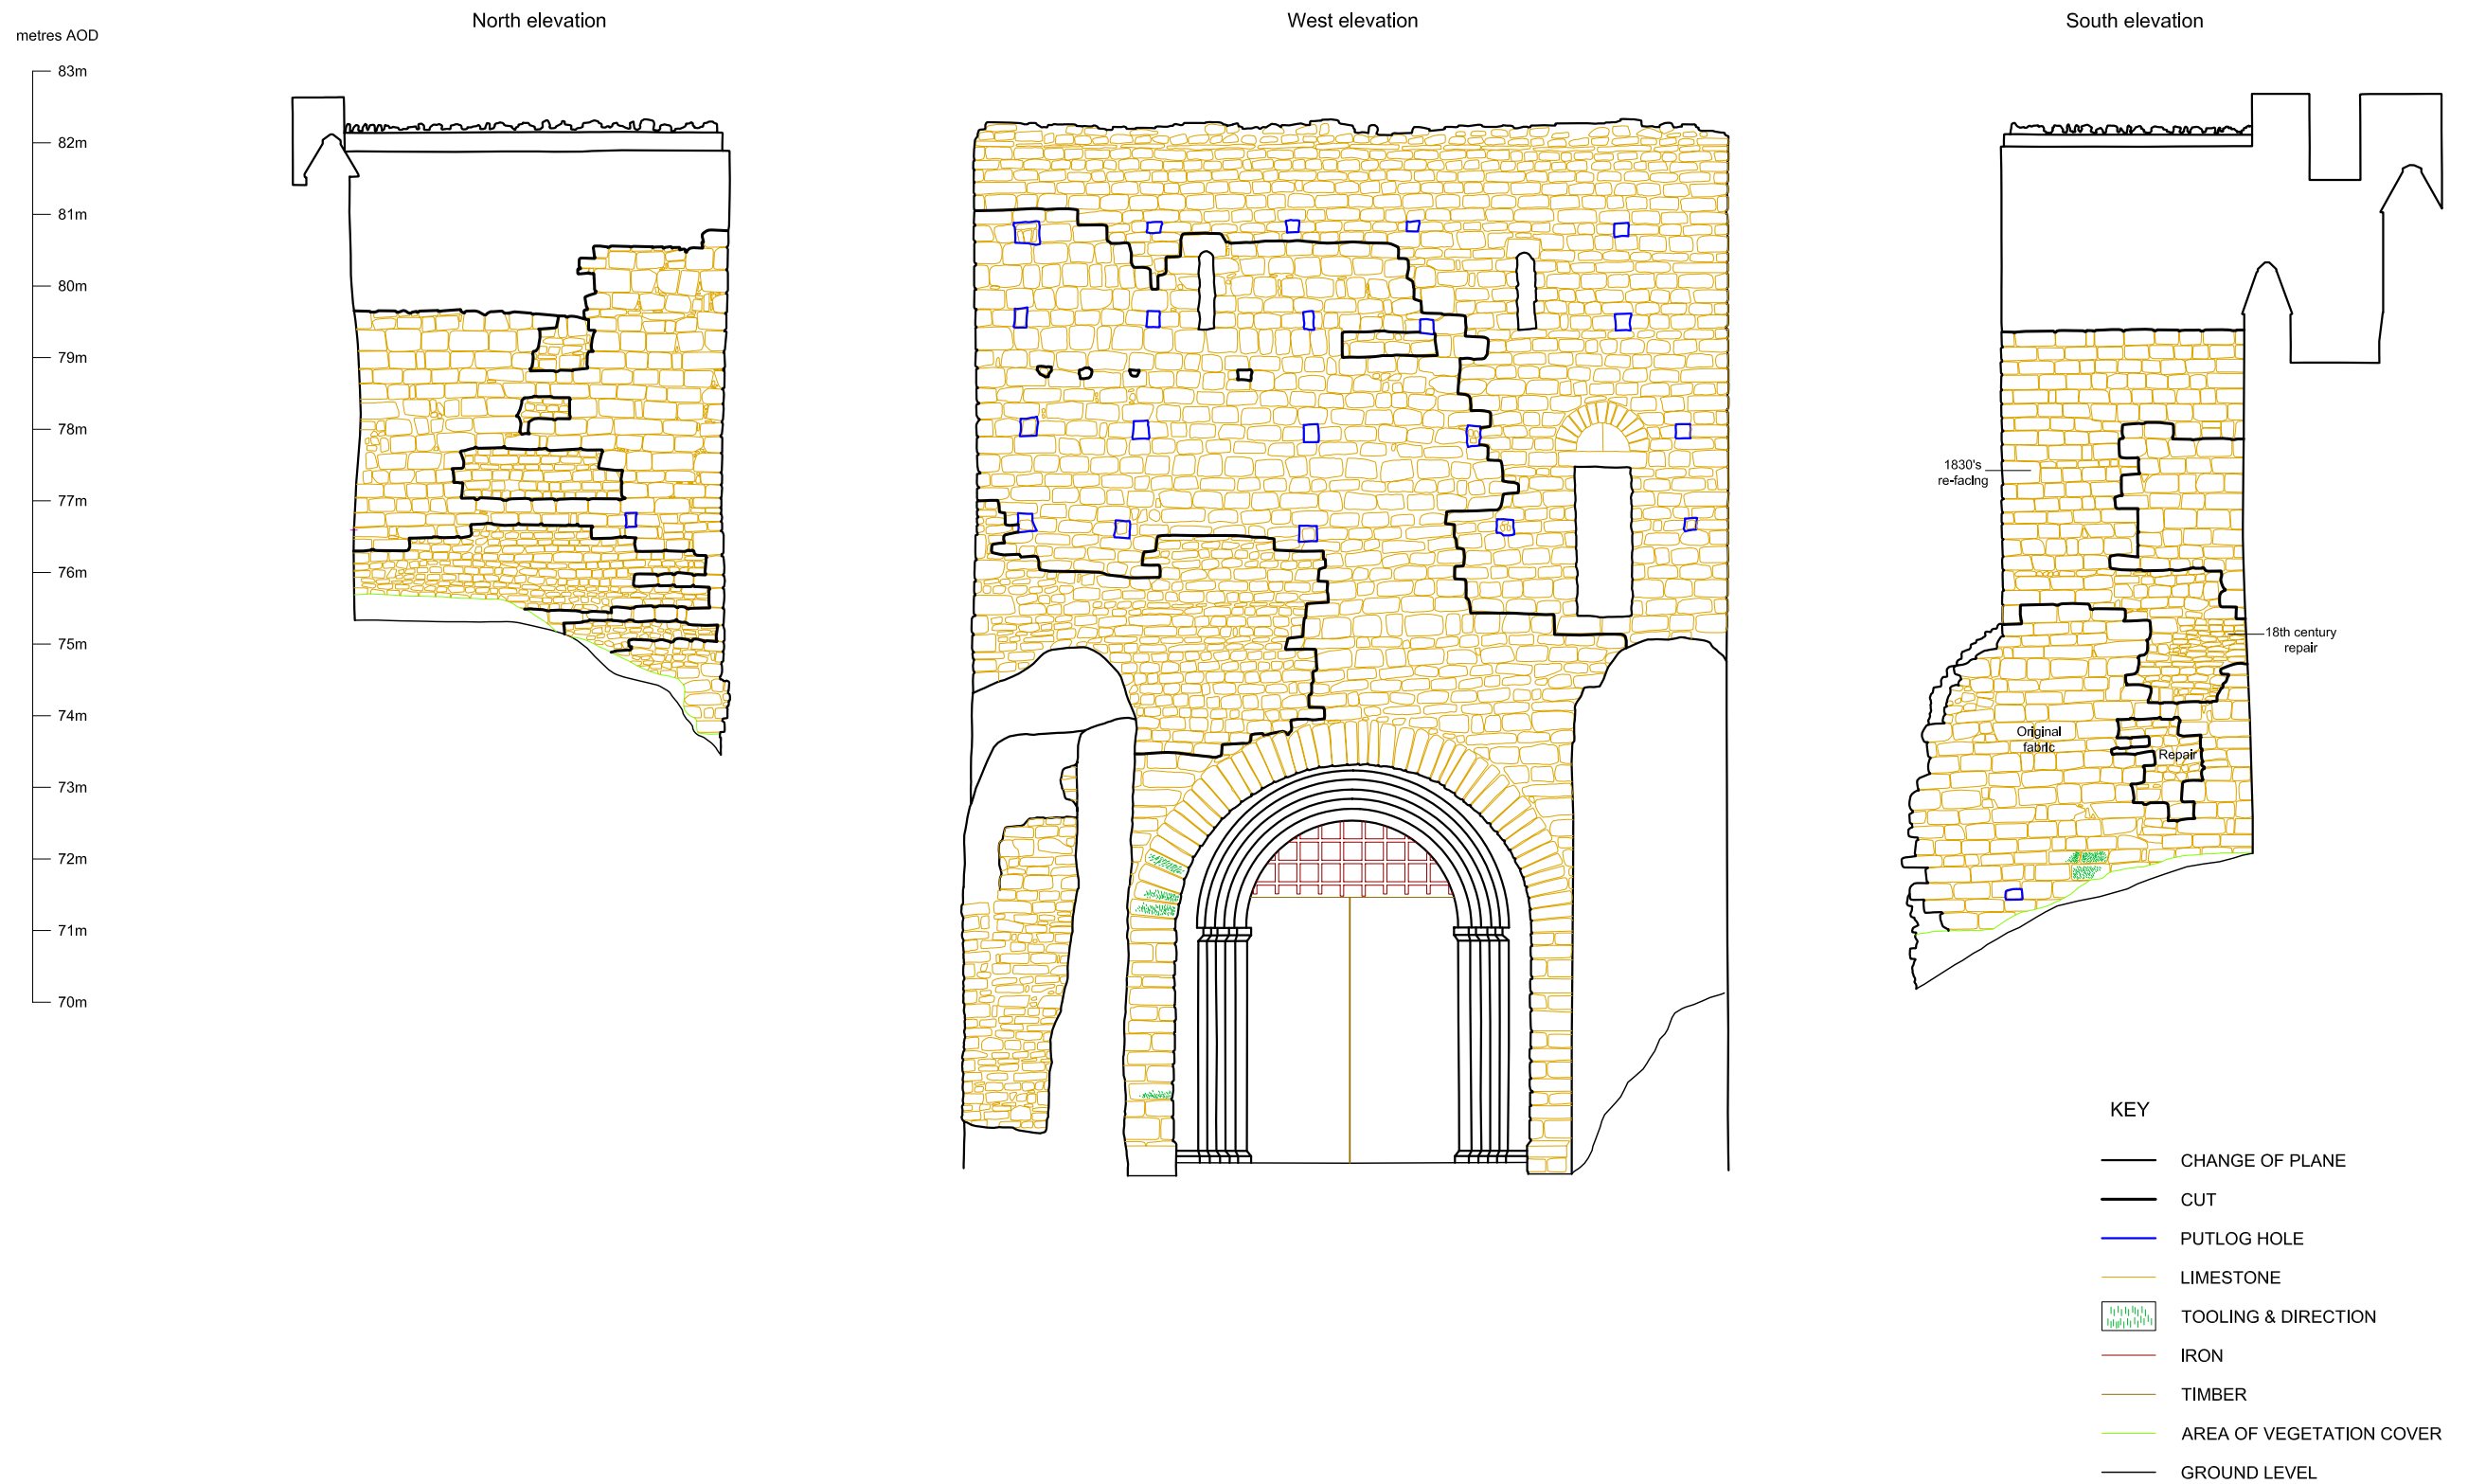
Scale 1:100 Figure 41

Externally the gatehouse is now approached by a modern bridge which spans the site of the castle ditch. The west elevation of the gate has two small loop windows set high at first-floor level and a doorway with a round-headed relieving arch beneath them (Figure 41). The main gate arch is round headed and formed of a single row of voussoir stones. To the north of the approach is a substantial flanking wall which incorporates a rectangular structure at its western end, presumed to be a tower. There are remains of a further flanking wall to the south. Both flanking walls and tower are thought to form a barbican defending the approach to the gate; a later enhancement to the defences.

The second phase is a repair located above the gate arch on the north side, a roughly rectangular area of smaller stones. A view by S. H. Grimm of the castle from the northwest, thought to date to 1784, shows a large aperture on the gatehouse in this position (see Plate 25), and the patching is likely to date to between 1785 and 1838, the latter year being when Willson undertook a major restoration of the gatehouse.

The final phase is represented by the extensive refacing/rebuilding that is evident along the north side of the elevation. Given that the extent of these repairs can be traced internally it is likely that this was

West Gate, north, west and south elevations

The surviving Norman work on the south elevation is mainly concentrated towards the bottom half of the elevation with a further substantial section extending higher adjacent to the west curtain wall (see Figure 41). Despite some patching in smaller stones the general character of the Norman masonry is identical to that on the west elevation with some small areas of oblique short chisel tooling remaining on the lower stones. A putlog hole less than c.0.4m above the current rampart level indicates the rampart bank has been heaped against the masonry of the gate after the gatehouse's construction. It is notable that the Norman masonry courses through into the stub of the southern flanking wall, or buttress, indicating a contemporary date and thus part of the original design.

The north elevation retains a significant amount of Norman facing masonry, although much patched with repairs executed using small stones similar to the work on the west elevation of the period 1785-1838 (see Figure 41). The relationship between the facework of the west curtain wall and the north elevation of the gatehouse would suggest that the curtain wall postdates the construction of the gatehouse. The Norman facing stones of the gatehouse can be seen to pass beneath the facing stones of the west curtain wall.
