**WALLS, GATES AND TOWERS**

**LINCOLN CASTLE**

**ARCHAEOLOGICAL  
INVESTIGATION**

**REPORT  
NOVEMBER 2015**

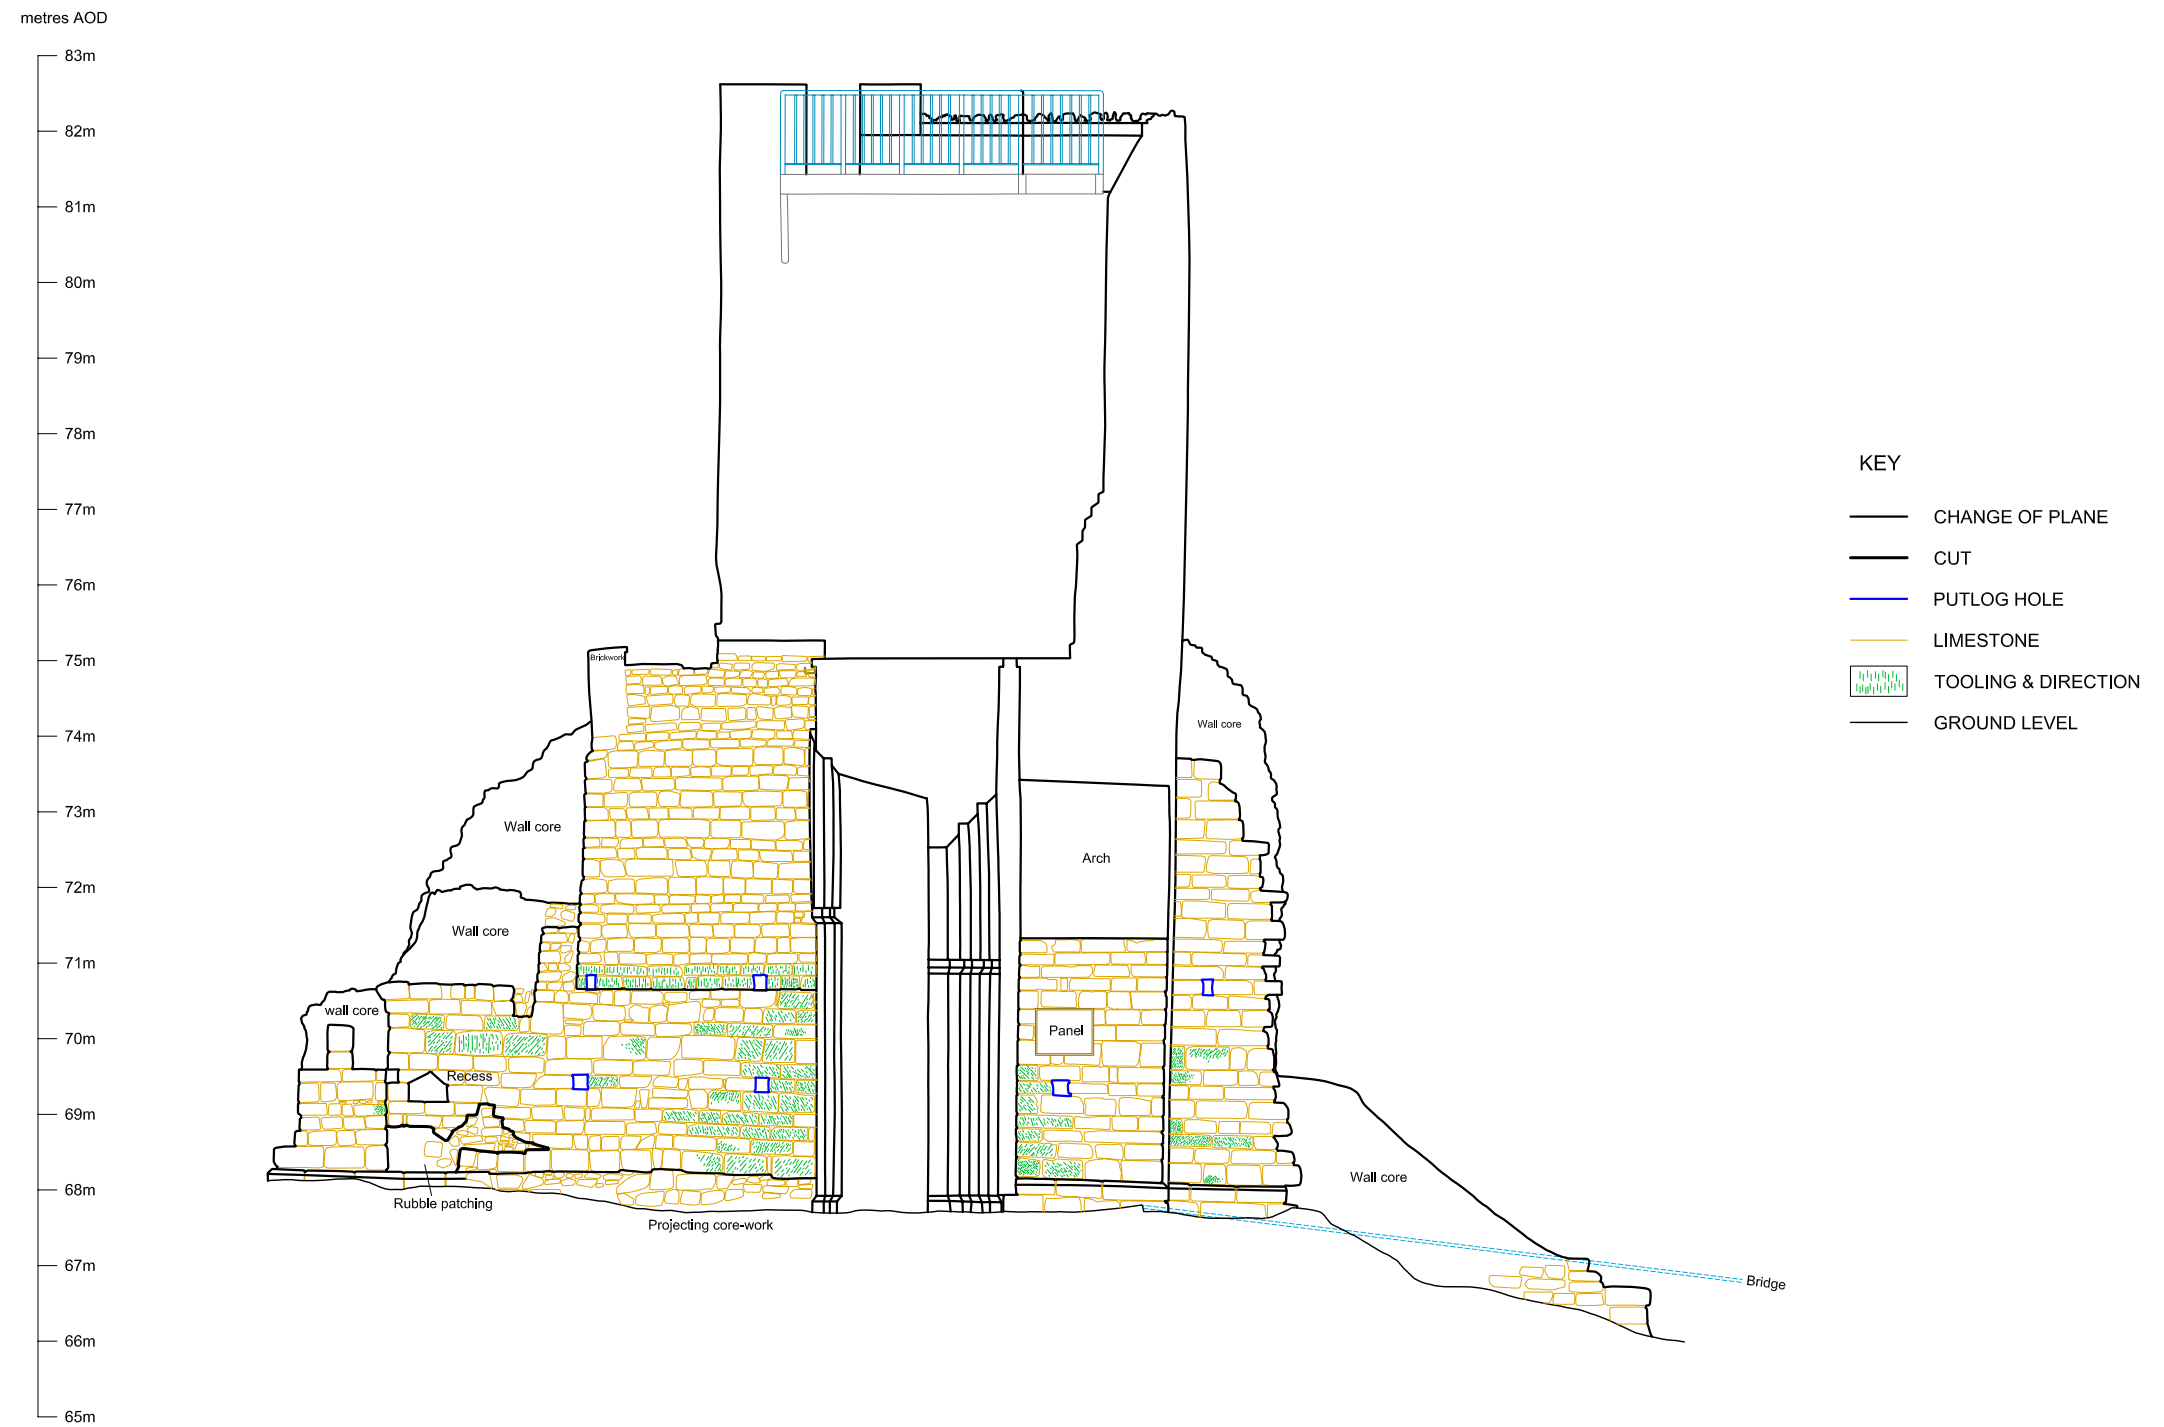
Scale 1:100 Figure 42

The gate passage retains its Norman outer arch which has a chamfered course in its lower part - a similar arrangement is seen on the east gate (see Figure 39 and Figure 42). Also, as seen on the east gate, there appears to have been a further gate arch, reformed in the early 13th century with chamfered jambs, but retaining the Norman round-headed form. Further work to this arch in recent

West Gate, north-facing sectional elevation

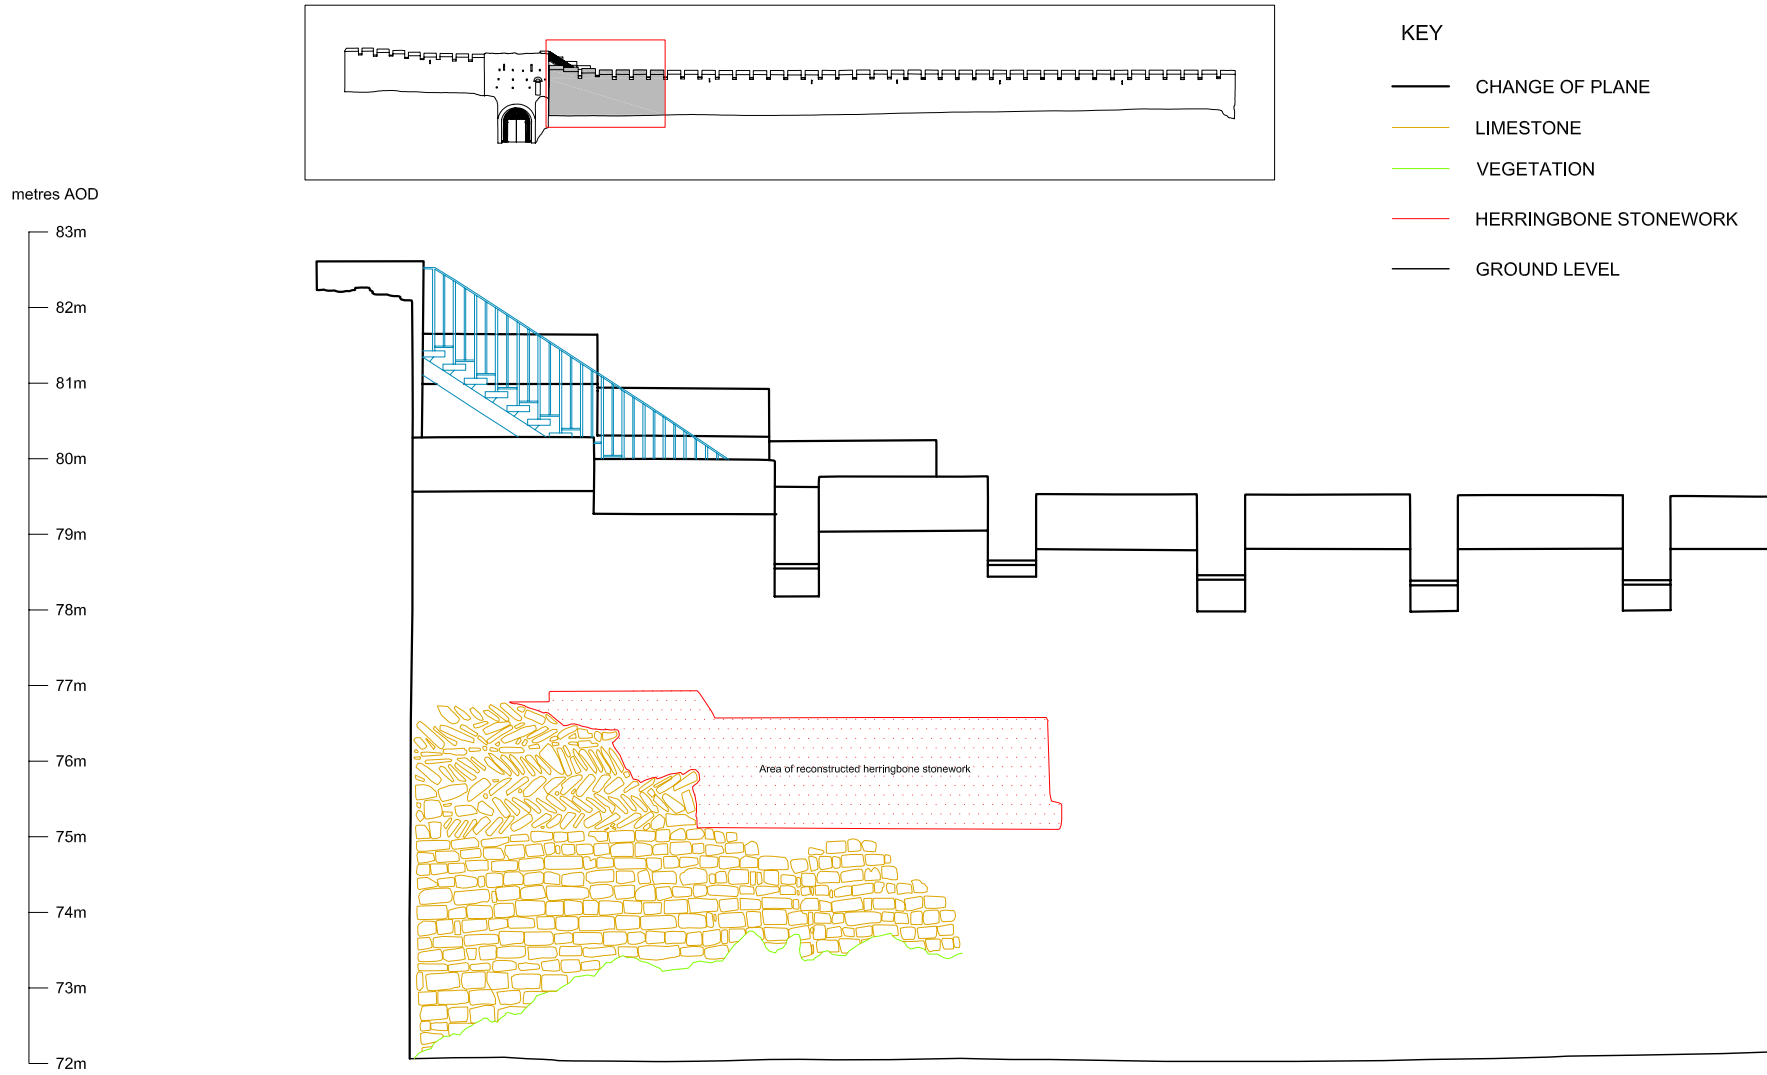
Figure 44

Only a fairly small area of the exterior of the west curtain wall south retains medieval face-work which has not been the subject of extensive repair and replacement. The main area of interest is adjacent to the West Gate where a small area of original herringbone work survives (Figure 44). The slightly irregular form of the herringbone compares with that which is visible on the interior of the wall. Fortunately, the relationship between the West Gate fabric and the curtain wall is relatively clear and indicates that the gatehouse was constructed before the curtain wall.

The northern end of the wall, adjacent to the West Gate, retains a large area of medieval masonry with a considerable area of herringbone masonry. Surprisingly, there are evidently three phases of herringbone masonry. The earliest herringbone, more correctly described as pitched, is in the lower part of the elevation and contemporary with much of the horizontally laid stonework evident in the lowest c.1.6m of the wall. The herringbone, or pitched stonework, is not of the highest quality and has not been laid in a regular alternating pattern. This section of early fabric is terminated to the south by a trapped corner, the quoin stones forming a well-defined vertical feature. To the south of the corner there is a further area of fabric incorporating herringbone laid in alternating pitched courses but still not of the highest quality and probably representing an early second phase to the fabric to the north. The third phase is represented by a further area of herringbone of much higher quality work, evidently added as both a repair and heightening of the original wall.

In summary it would appear that the earliest phase of herringbone masonry related to the construction of a building, aligned north-south, which might have predated the construction of the west curtain wall. The second phase work appears to have been the construction of the curtain wall to the south of the original building, while the third phase was the repair and heightening of the curtain wall.

External elevation of the west curtain wall, south, north end
