Trinity Leigh, East Leigh, Coldridge, Devon
(SS 6099 0523)

Results of historic building recording

Mid Devon District Council ref. 08/01363/LBC

Document No: ACD360/1/0

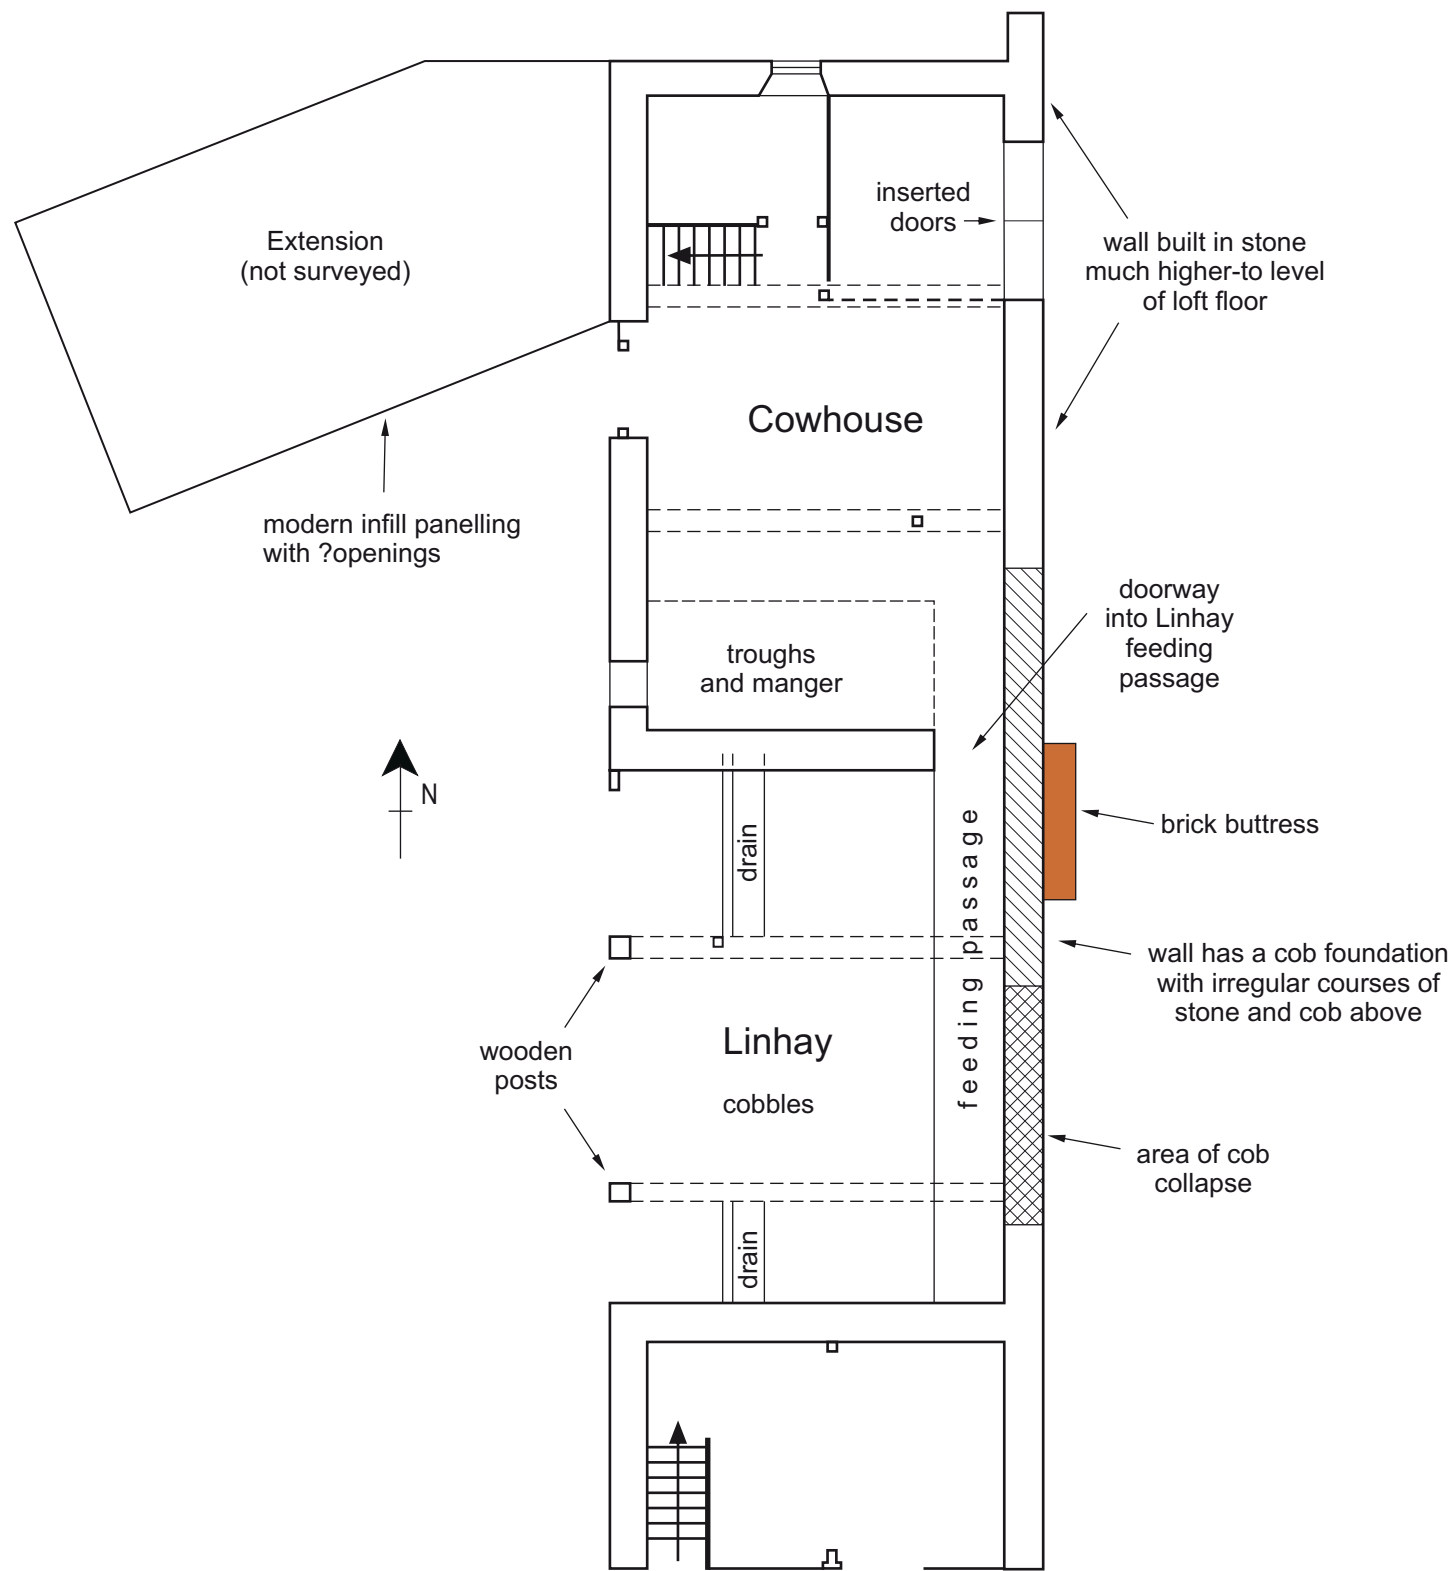
a) Ground Floor Plan

The building is rectangular, two-storeyed, and arranged in three working spaces – a cowhouse, a linhay, and a store. The barn is constructed mainly of cob upon a stone dwarf wall (Plates 1-2) with a number of late 19th- and 20th-century elements (described below). The roof is hipped and covered in corrugated sheeting. The long west side, fronting the farmyard, is partly open, whilst the other three are closed. The building represents a type of cow-house and linhay found to extend from East Devon over a wide area north of Dartmoor (Alcock 1963).

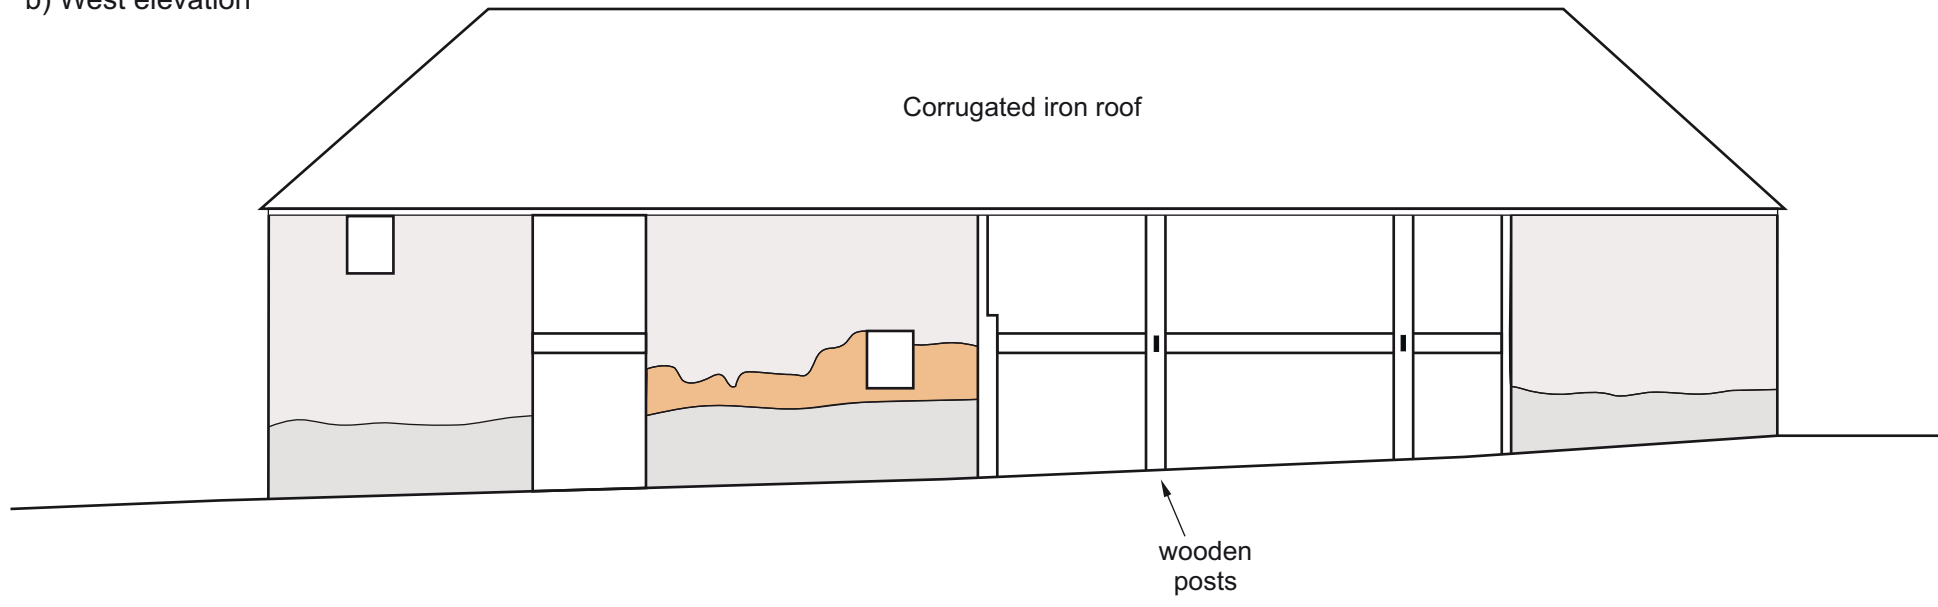
b) West elevation

In the west cowhouse elevation is an area of c. early 20th-century brick repair, laid in stretcher bonded faced over the primary cob (Plate 1). To the left of the elevation is a later, single storey lean-to constructed mainly of cob upon a low level stone wall.

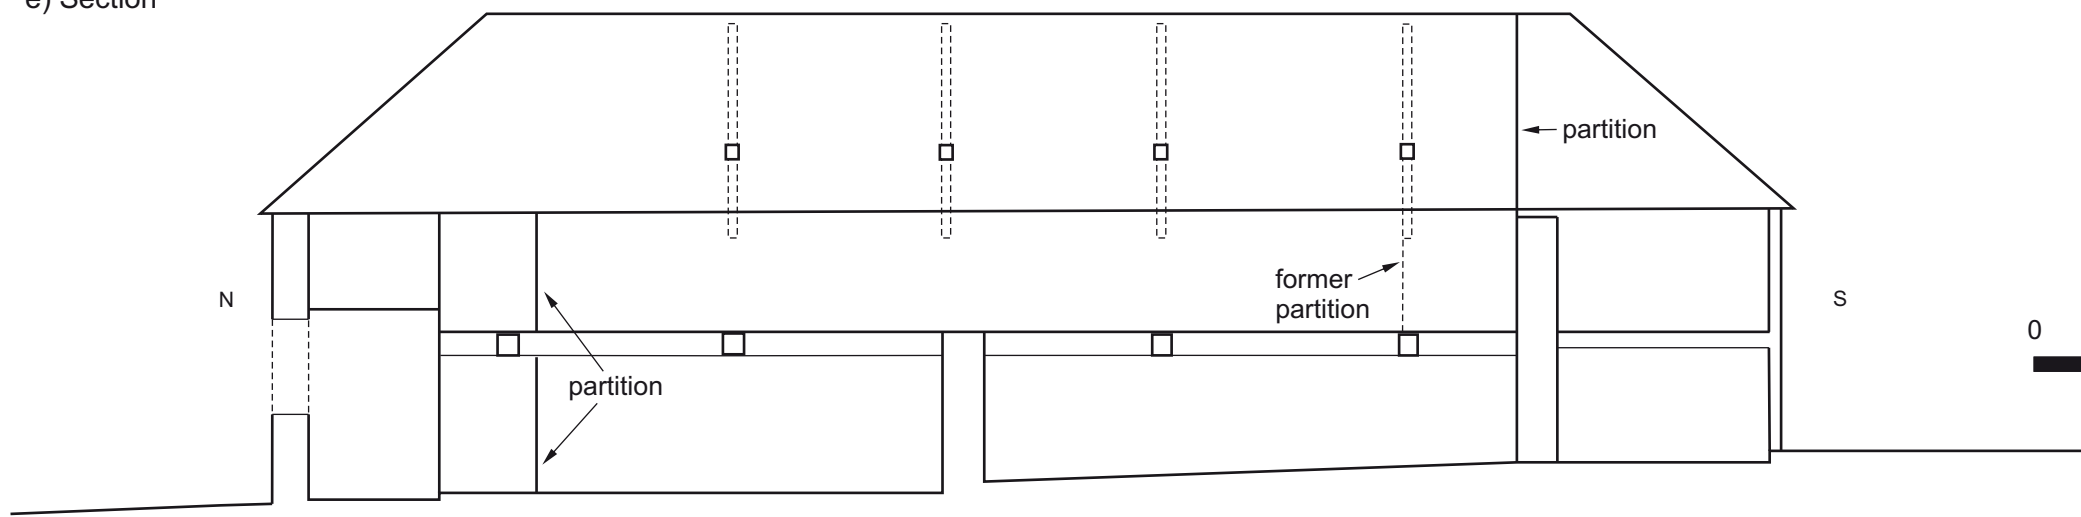
e) Section

Most of the roof structure (including the rafters, purlins and covering) has been replaced in the 20th century, although several crudely-cut principal rafters survive. These are pegged at their apex. The majority of the feet of the principal rafters are set within the east and north walls, although the feet of two trusses rest individually
