# Lower Molinnis Pan Kiln Chimney, Near Bugle, Treverbyn, Cornwall

Results of historic building recording

Document No: ACD566/1/0

Date: October 2012

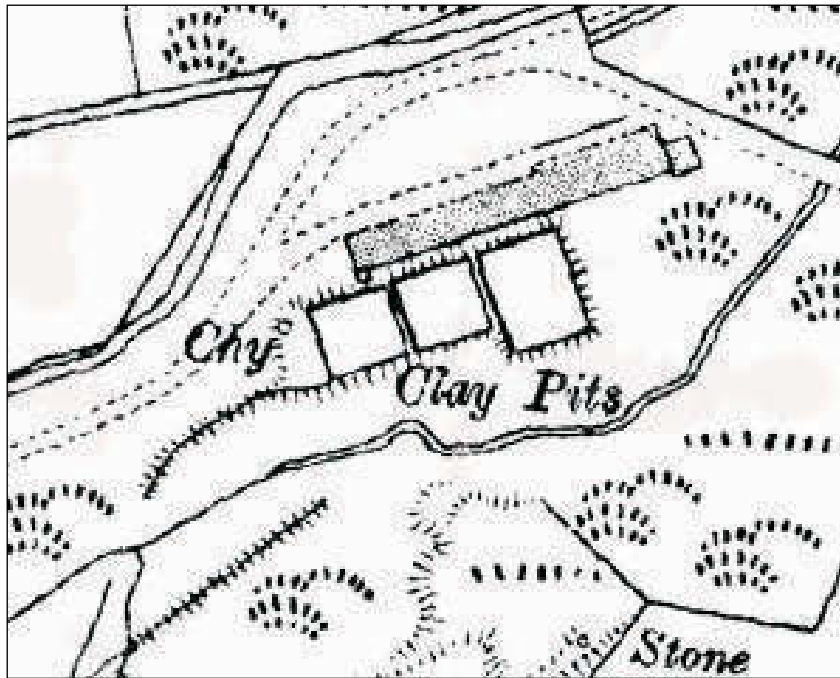
- 2.3 A short distance northeast of the Molinnis Moor works, in an area previously depicted as low lying and marshy, the 1907 map depicts a pan kiln and linhay (store) aligned east-northeast to west-southwest. There is clearly a furnace room at the east end, while the linhay sharing the same roof as the pan kiln is shown along the north side where there is access for road vehicles from the Lower Molinnis lane. There was a detached chimney at the west end and three settling tanks (marked as 'clay pits') on the south side (Fig. 3).

**5.1** The 1907 map (Fig. 3) indicates the main building containing the pan kiln and linhay (store) was 51m long and 6m wide at the west end, with a wider section of 7m at the east end. This is small in comparison with some of the more usual type of pan kilns, recorded as ranging from 72m to 108m long (e.g. Stanier 2010; 2011). The map also shows a furnace room attached at the east end of the kiln, measuring c. 5m by 5m.

Fig. 3: The Molinnis chimney, pan kiln, linhay and settling tanks c.1900. Note the different chimney position compared with Fig. 4. Extract from Ordnance Survey 25-inch map, 1907

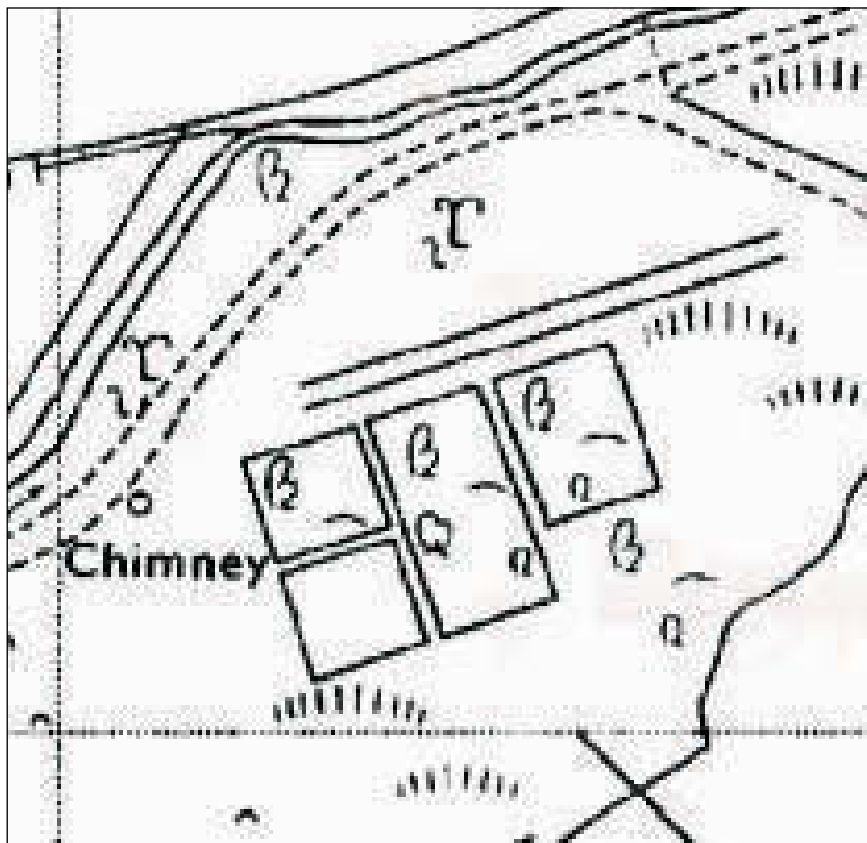
- 2.6 The 1971 map shows that the buildings had been totally demolished, although two parallel lines mark the outline of just the pan kiln (Fig.4). Today, even this cannot be discerned. The kiln and linhay were probably insubstantial and are unusual because the topography of this low-lying site dictated they were built at the same level.

Fig. 4: . Extract from Ordnance Survey 1:2500 map, 1971, showing altered settling tanks and outline of demolished pan kiln c.1970
