BARN AT GLADHAYES FARM, CLAYHIDON, DEVON

Results of an historic building evaluation

Mid Devon District Council planning reference 14/00011/FUL

Document No: ACD858/2/1

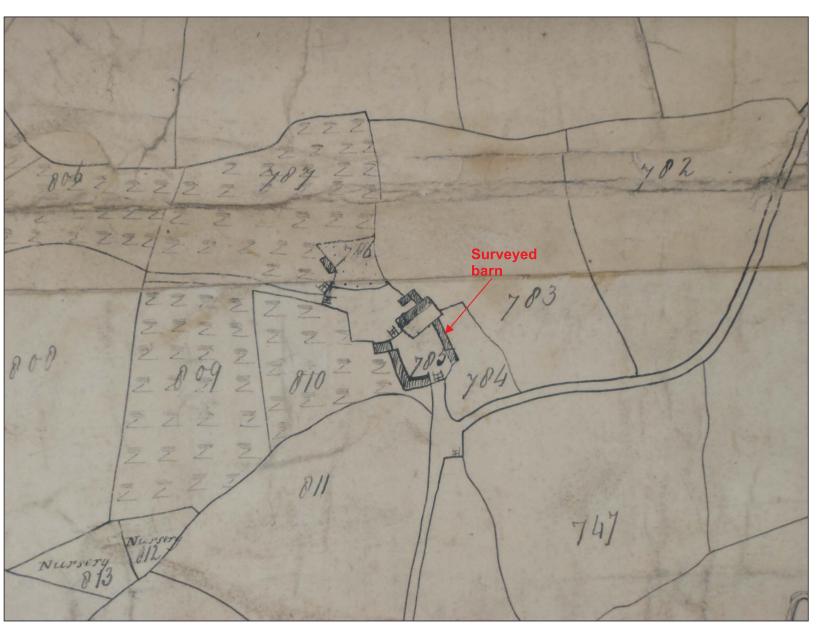
Fig. 2: Extract from the Clayhidon tithe map of 1838

- 4.3 The barn, along with the other buildings is depicted on the 1838 tithe map (Fig. 2), surrounded by arable and pasture fields as well as orchards. The accompanying apportionment describes the farm as being owned and occupied by John Marke, with the farm itself described as "building and courtledge" and the land use as "barton". The barn itself was shown as a long rectangular structure. The barn is similarly depicted on the Ordnance Survey 25-inch map of 1889 (Fig. 3).
