OLDAPORT CAMP, MODBURY, DEVON

Report on Conservation Works and Additional Archaeological Survey

Scheduled Monument: Iron Age promontory fort known as Oldaport Camp (National Heritage List No. 1020234)

Document No: ACD1130/1/0

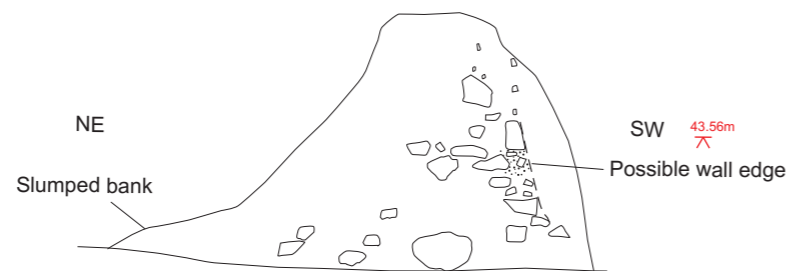
a) North-facing elevation of northwest wall

The northwest angle wall faces on to a neighbouring property.... The external face has not been subject to detailed recording and this, along with a plan for consolidation is a matter of urgency.... Between January and June 2015 – the hedgerow vegetation was heavily cut back. June 2015 – access to the external side allowed the preparation of a condition report and further management recommendations (see section 6 above).
