ST MICHAEL'S CHAPEL, TORRE, TORQUAY

A new survey

On behalf of:
Torbay Council

Document No: ACD1067/2/1

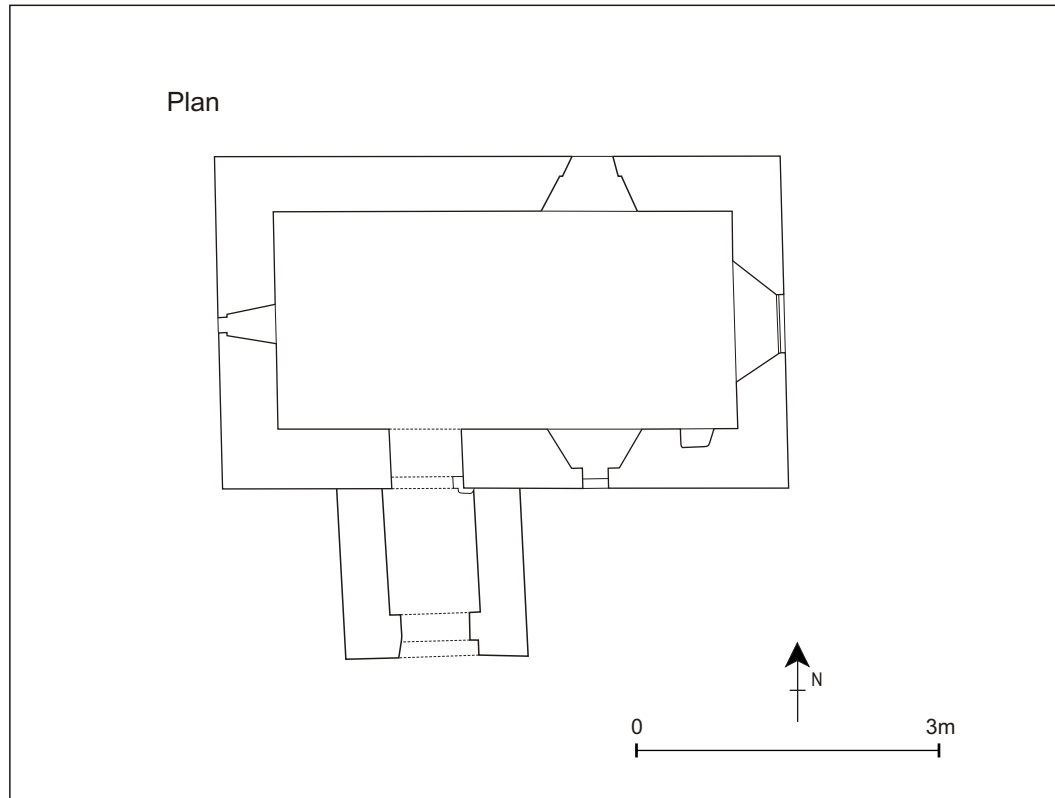
Fig. 5: St Michael's Chapel, Torre. The RCHME plan (after Jones 1997, with amendments)

The chapel is constructed predominantly of limestone rubble with rare red breccia/sandstone and slate/schist fragments set in lime mortar with red sandstone and breccia dressings. It measures 11.2m east-west by 6.6m north-south with walls up to 1.2m thick (Fig. 5). It has a single arched entrance located towards the western end of the south wall and is approached through a ruined porch. The east gable (Fig. 6) accommodates a large arched window and the north and south walls have opposed windows; the north had been blocked historically and was reopened as part of the current project and the south has been partly blocked and its opening reduced in size. The west gable has two small windows at different heights. The roof is completely of stone construction with a barrel vault of local slate blocks. A stone cross was erected above the east gable in the early 19th century by a prominent evangelical; it was removed during the recent works. The plain construction of the chapel and the erosion and removal of dressings which may have been diagnostic has led to problems in dating. Nikolaus Pevsner (1952, 292) concluded that St Michael's was 'hard to date', although elsewhere a 13th or more probably 14th century date has generally been accepted.

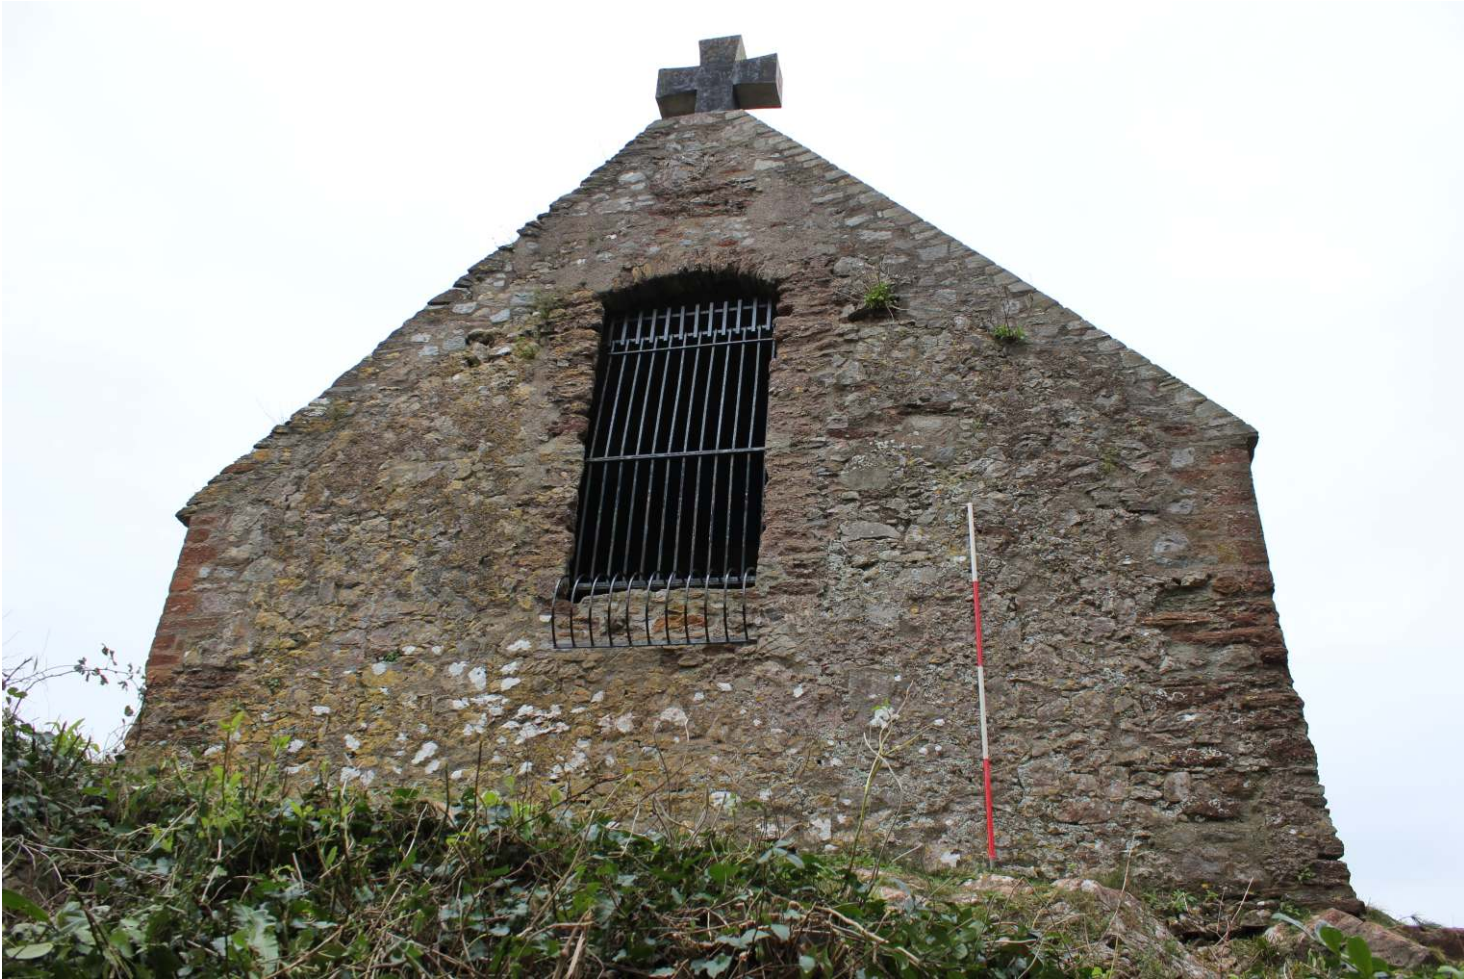
Fig. 6: St Michael's Chapel, Torre east gable end prior to the removal of the 19th century cross (2m scale)

Much cement render survives, particularly higher up. Breccia quoin replacements are situated at both corners, with some lower down eroded ones perhaps being original; these are also in red sandstone, although some individual stones show bedding of both breccia and sandstone. The east window measures 2.5m high by 1.2m wide and has breccia jambs which are angled internally forming part of a splay. It has a shallow arched head which becomes a pointed arch internally. The cill has been repaired with three courses of mixed rubble. The window sits within a clearly defined break in the limestone masonry (also visible in Fig. 6), although this is less clear on the south side due to later cement repairs. Either the opening has been narrowed or the wall was prepared to accept the window once completed. The gable above the window has been subject to several repairs.
