COLEBROOKE MILL, COLEBROOKE, NEAR CREDITON, DEVON

Results of historic building recording and an archaeological
watching brief

Planning ref. Mid Devon District Council 06/01323/FULL,
condition 11

Document No: ACD42/2/0

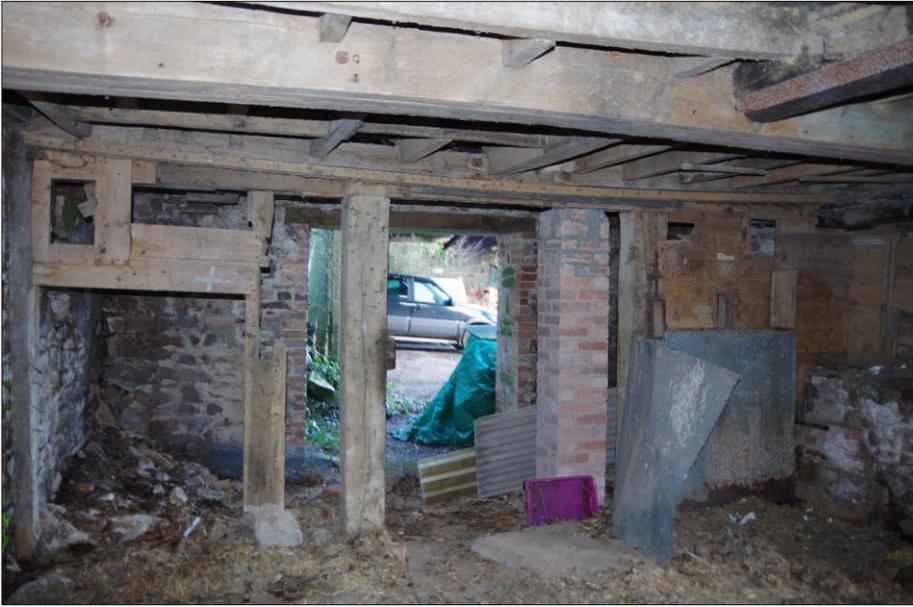
Plate 4: Mill building, ground floor, looking west

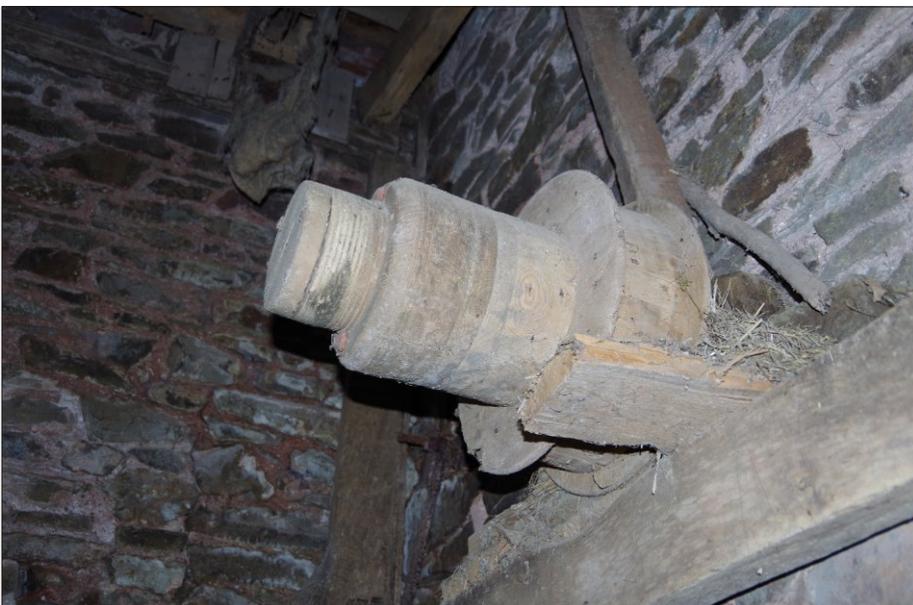
Plate 6: Mill building, north wall, wooden drive shaft

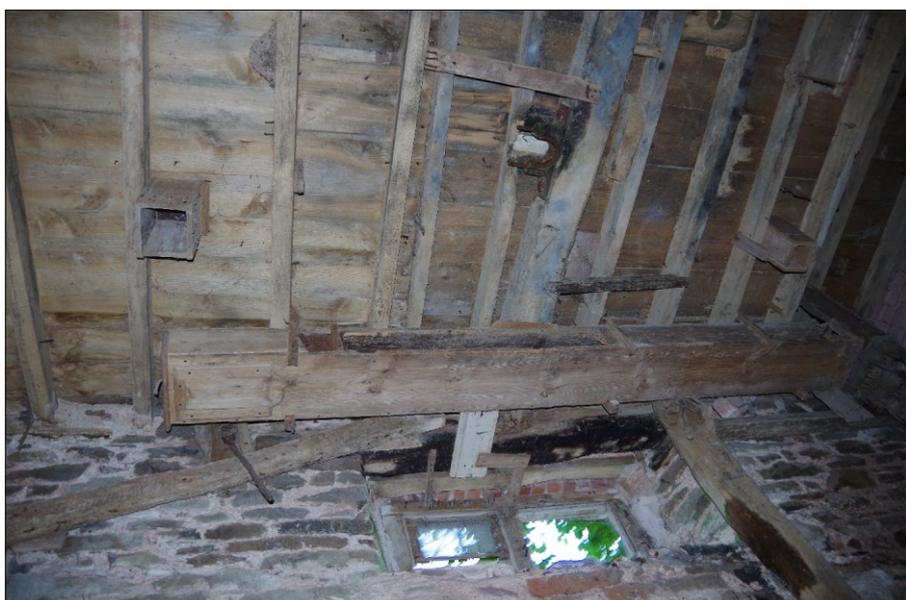
The second floor formed a mezzanine on the west side of the building directly above the location for the former pit wheel, but empty sockets in the north and south wall indicate that the second floor once extended across the whole building. Access was via open wooden stairs. In the floor were five further grain shoots and a wooden box for an Archimedes screw for moving grain (Plate 8). The floor also incorporates some iron fittings and displays oil stains associated with former line shafts to this level. There was a grain storage bin on the north side of the second floor (Plate 9) and in the south wall is an opening that could not be seen externally.

Plate 8: Mill building, base of second floor

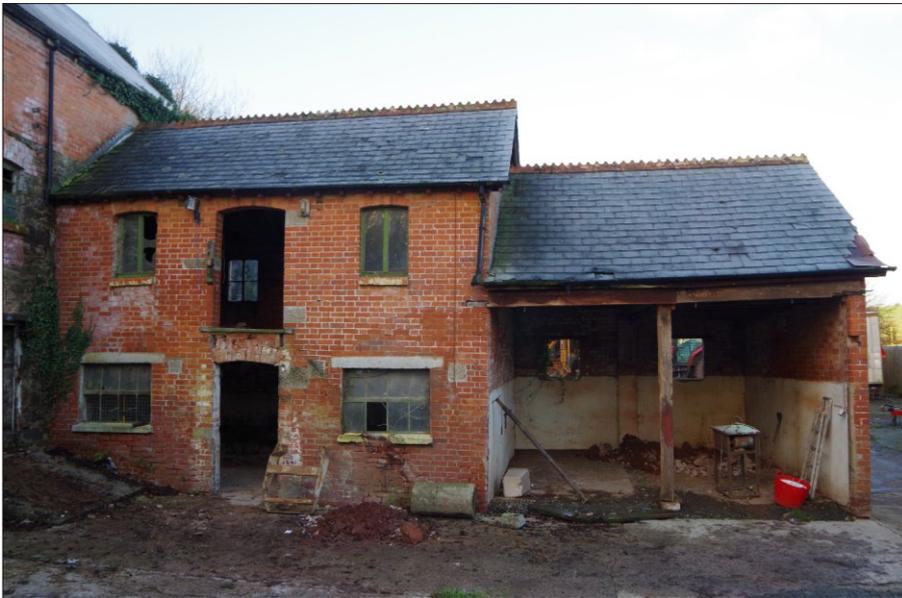
The north range was constructed of brick laid in Flemish bond. The east elevation incorporated two inserted eight-pane windows with concrete lintels and sills on the ground floor situated either side of a central door with a brick arched head (Plate 11). On the first floor was a central loading door, with two small two-pane windows on either side; all had brick arched heads and brick cills. There were occasional blocks of dressed granite of various sizes set within the brickwork that represent the exterior

Plate 11: North range and north range extension, looking west

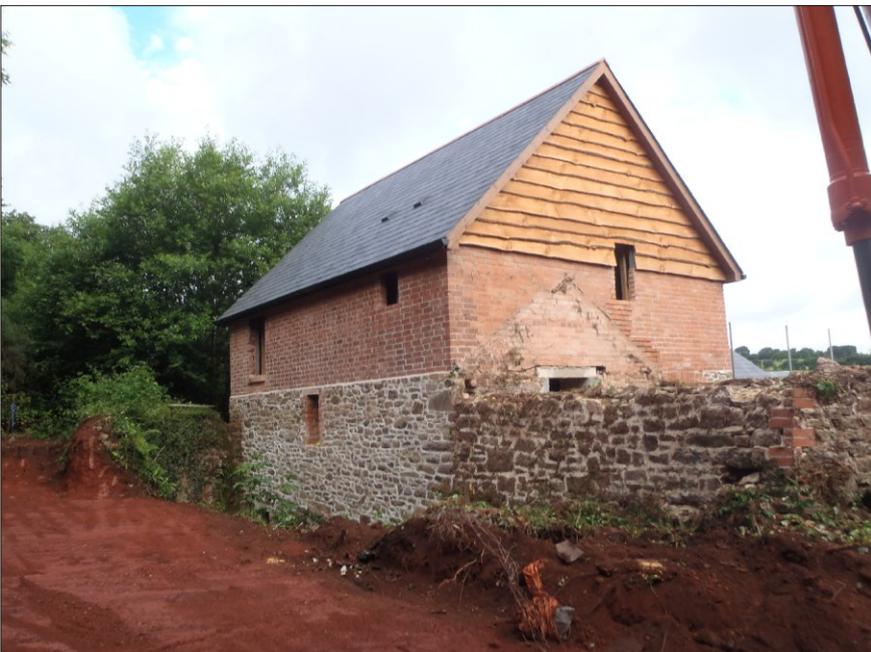
Plate 15: General view of watching brief area showing south elevations of mill building and east range, looking northwest

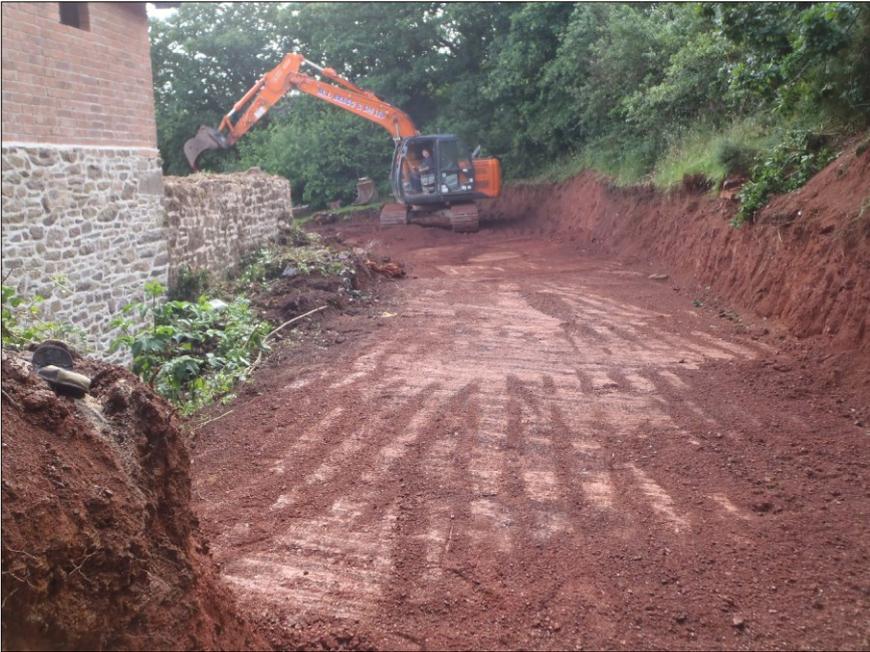
Plate 16: Reduced level of the area to the south of the mill building, looking east

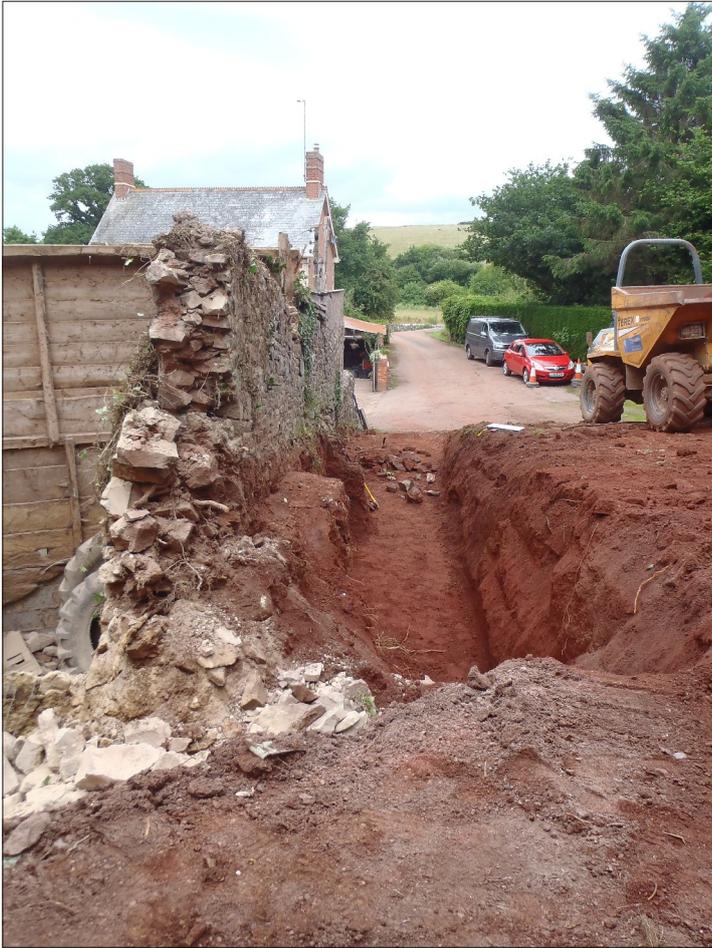
The trench excavated along the south elevation was essentially the removal of modern rubbish debris and the topsoil from the ditch, with slight widening occurring (Plate 17). The return of the trench along the east elevation of the east range was excavated to a depth of approximately 2m at the south end and 0.10m at the north due to the sloping nature of the ground level (Plate 18). The formation level was the natural subsoil and the base of the wall was not reached; there was no foundation cut for the wall indicating that the building was constructed into a terrace formed by the present yard. The excavation revealed no archaeological finds, features or deposits. However, along the east elevation two buttresses were exposed, paced 3m apart and keyed into the wall (Fig. 6 and Plate 19). The northeastern buttress was at least 2.10m high and the southwestern was at least 1.60m; both were 0.60m wide and 0.50m thick. Directly to the northeast of the northeastern buttress was an area of damaged wall with frequent loose building material.

Plate 18: View along trench against east elevation of east range, looking northeast
