TAMAR CANAL, GUNNISLAKE, CORNWALL

Results of archaeological monitoring and recording

Scheduled Monument: Canal lock, island and salmon keeping pond known collectively as the Tamar Canal (National Heritage List no 1007302)

Document No: ACD1420/1/0

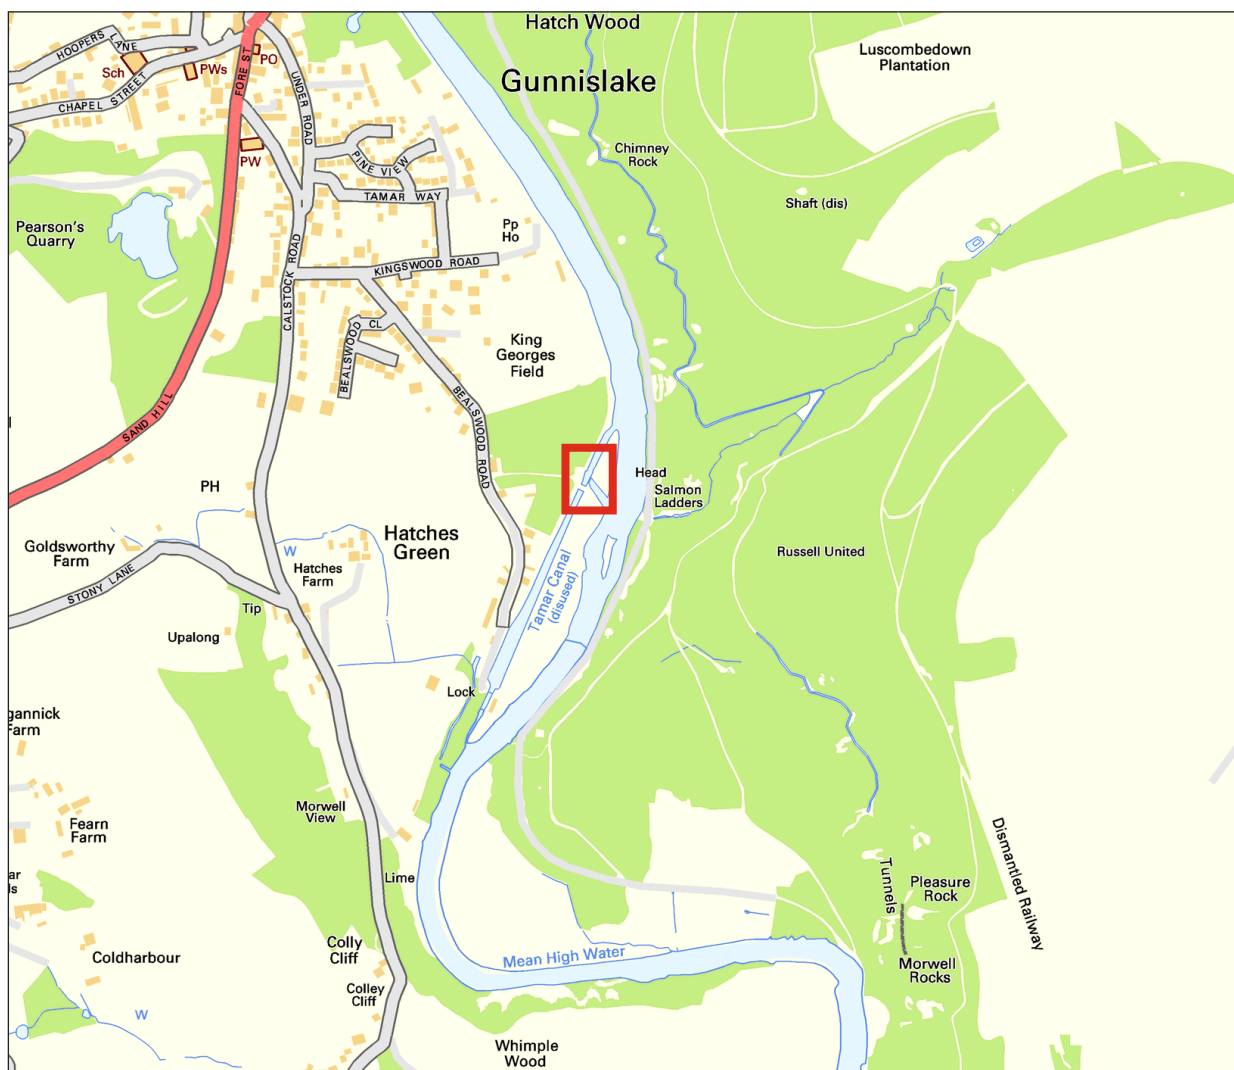
Fig. 2: Plan of lock showing location of repairs

- 1.5 The repairs took place in three nearby locations – the inside of the east face of the lock, the inside of the west face of the lock, and the wall at the head of the overflow channel. This comprised the drilling of injection ports to insert resin to plug water leaks, and involved drilling down through the historic stone walls from within the canal (but above water level), and in the mid 20th-century masonry of the overflow channel to the east. Works also took place to the nearby mid 20th-century penstocks, but did not impact on any historic masonry or architectural features.
