FARLEIGH BARNS, NR CADELEIGH, CHERITON FITZPAINE, DEVON

Results of historic building recording

Mid Devon District Council planning reference 16/01499/FULL, condition 3

Document No: ACD1772/2/0

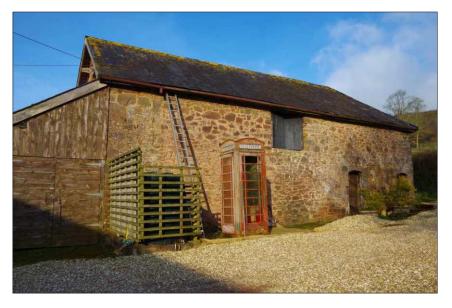
Plate 8: General view of east elevation of the east range, looking northwest

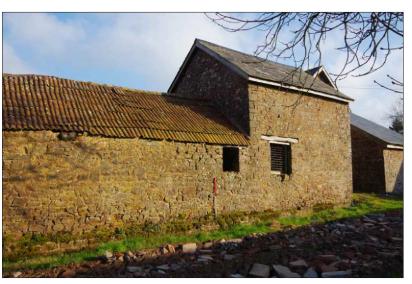
5.11 The north elevation of the barn contains a ground-floor doorway and a window, both with arched openings (Plate 11). The doorway is fitted with a basic wooden plank door. The east elevation has a first-floor loading hatch under a wooden lintel, fitted with a pair of wooden doors. The south elevation features a ground-floor window, fitted with a modern grill, on the ground under a wooden lintel (Plate 12).

Plate 12: General view of south elevation of the south range barn and piggery, looking northeast (1m scale)
