BUDDLE BRIDGE, LYME REGIS, DORSET

Results of historic building recording

West Dorset District Council planning reference
WD/D/17/000504

Document No: ACD1039/2/0

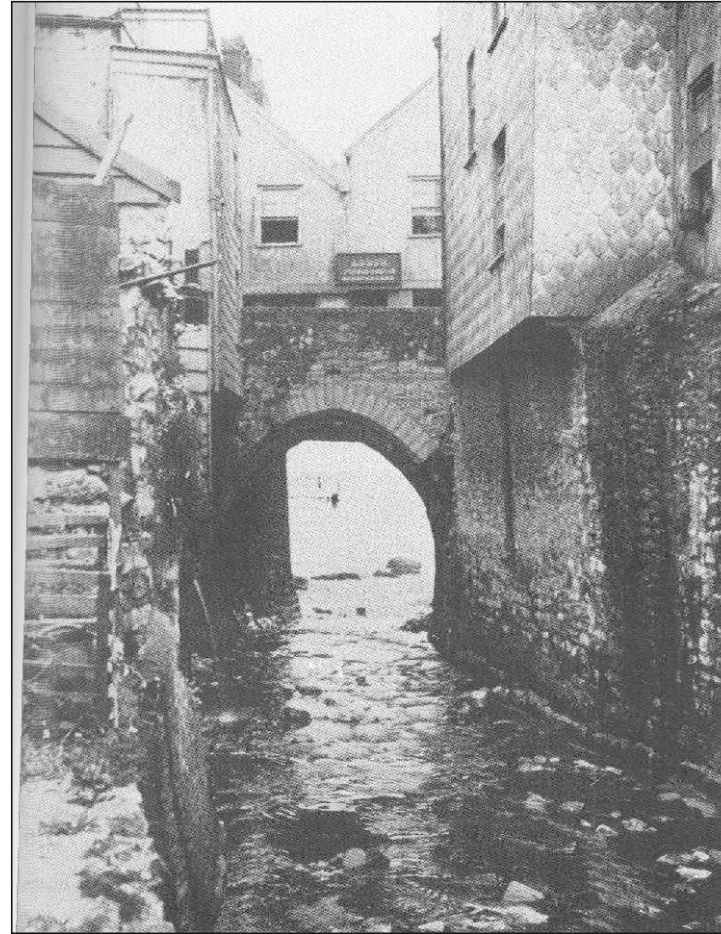
Fig. 4: Historic photographs of Bridge House. (a) view upstream showing the rear of the property, and (b) view downstream partially showing the front elevation, also showing the repair to the ring arch on the north face of the bridge. Photos courtesy Lyme Regis museum.

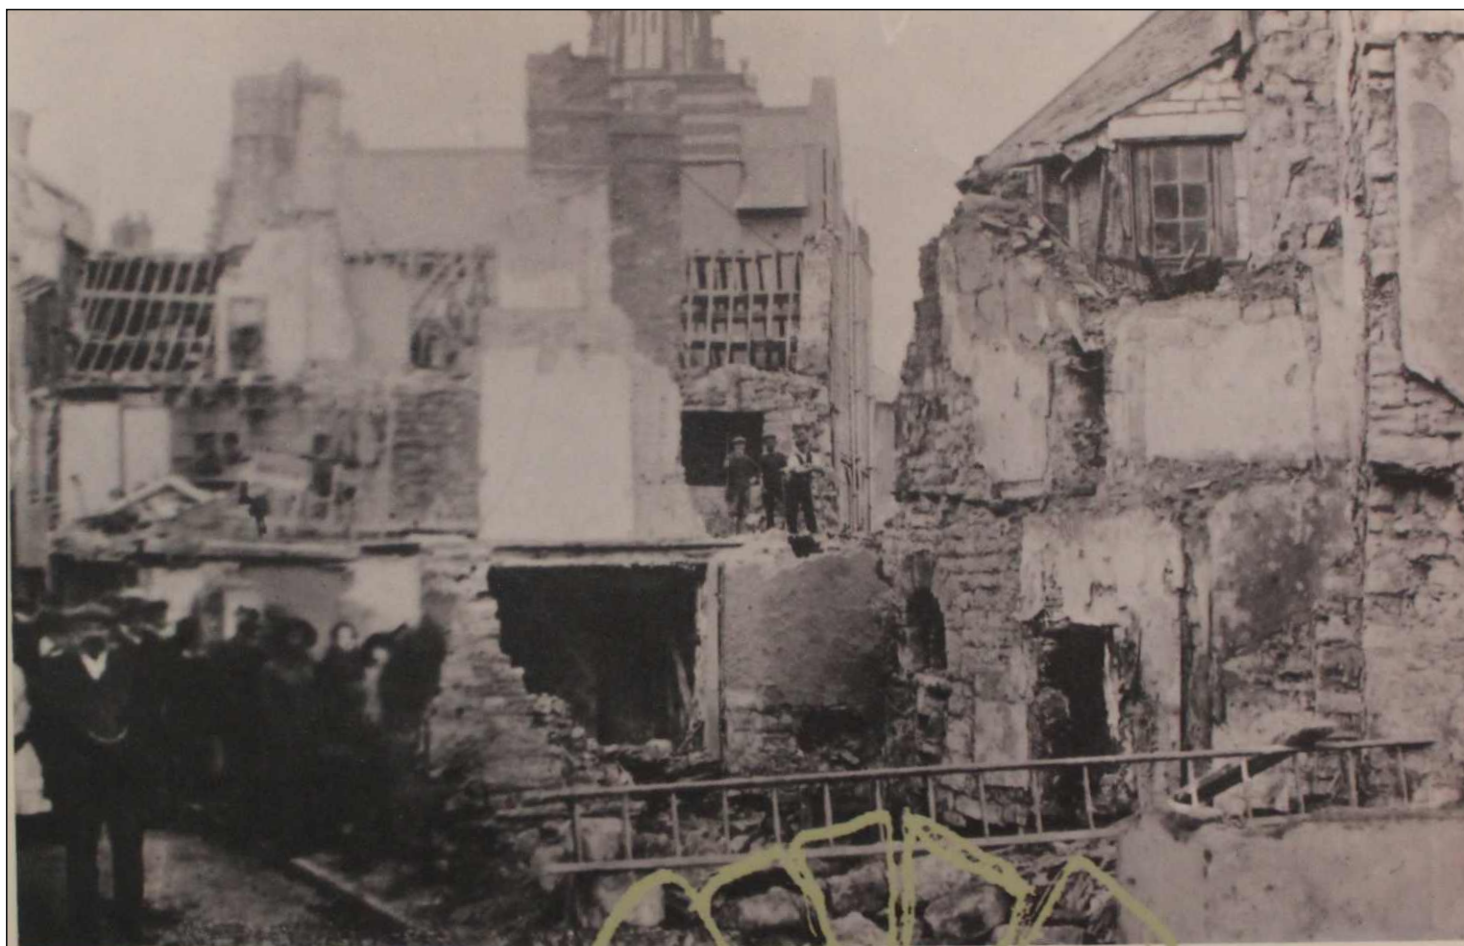
Fig. 5: Photograph taken from
the square in 1913 during the
widening of the bridge showing
the aumbry hole in the stone
wall to the right.

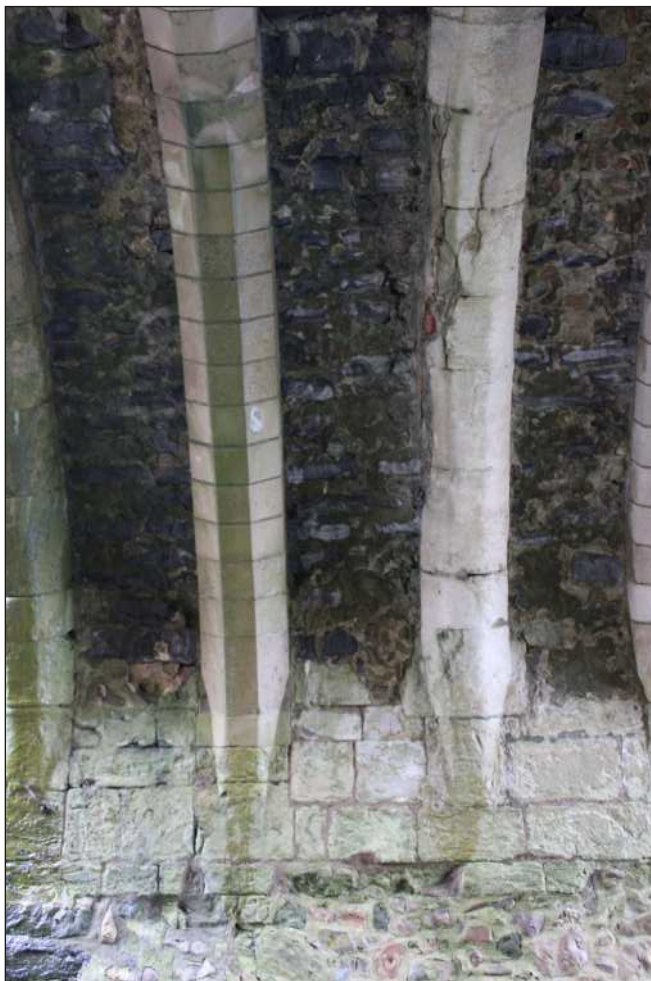
- 5.3** The arch between the base of the ribs is formed from four lower courses of dressed masonry. Above this, the stonework is coursed rows of roughly dressed local blue lias stone (104-106; Plate 8).

Plate 8: Roughly dressed blue lias stone between ribs 2 and 3 on the east side of the bridge

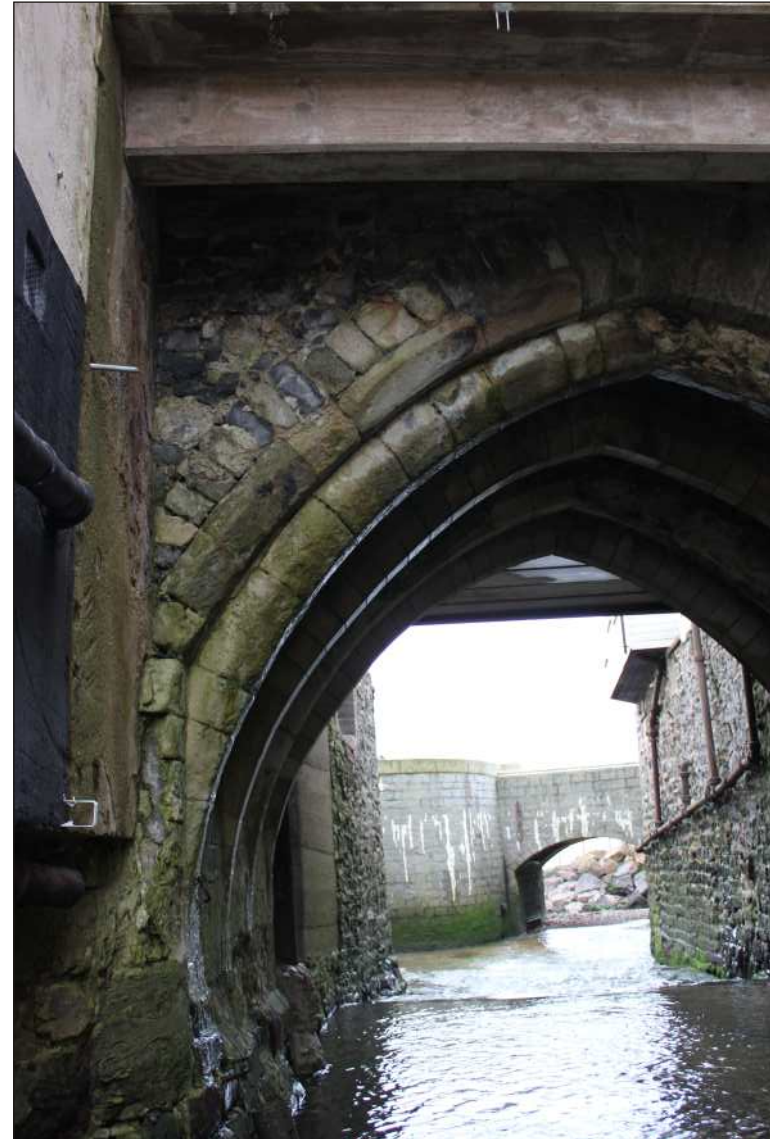
Above the voussoirs is an arch ring formed from vertically-set Salcombe stone and blue lias (Plate 16). Most of the voussoirs and stones forming the arch ring on the west side of the arch, and slightly continuing onto the east side, have been replaced (123). The new masonry comprises long, thin blocks of blue lias, finished with a chamfer matching that on the original voussoirs. The stones are dressed with pocket-hammered and bush-hammered work. The style and condition of the finish appears to indicate this work is of 19th-century date. It appears on an 1890s photograph. The masonry of the bridge above the arch is roughly coursed variously-sized blue lias blocks and some flintwork (124), the latter mostly adjacent to the ring arch. The latter may be a more recent repair. The masonry continues to road level where it is obscured by a concrete beam added when the north parapet was rebuilt in 2006/7.

Plate 16: The northern end of the east side of the bridge, view from the north

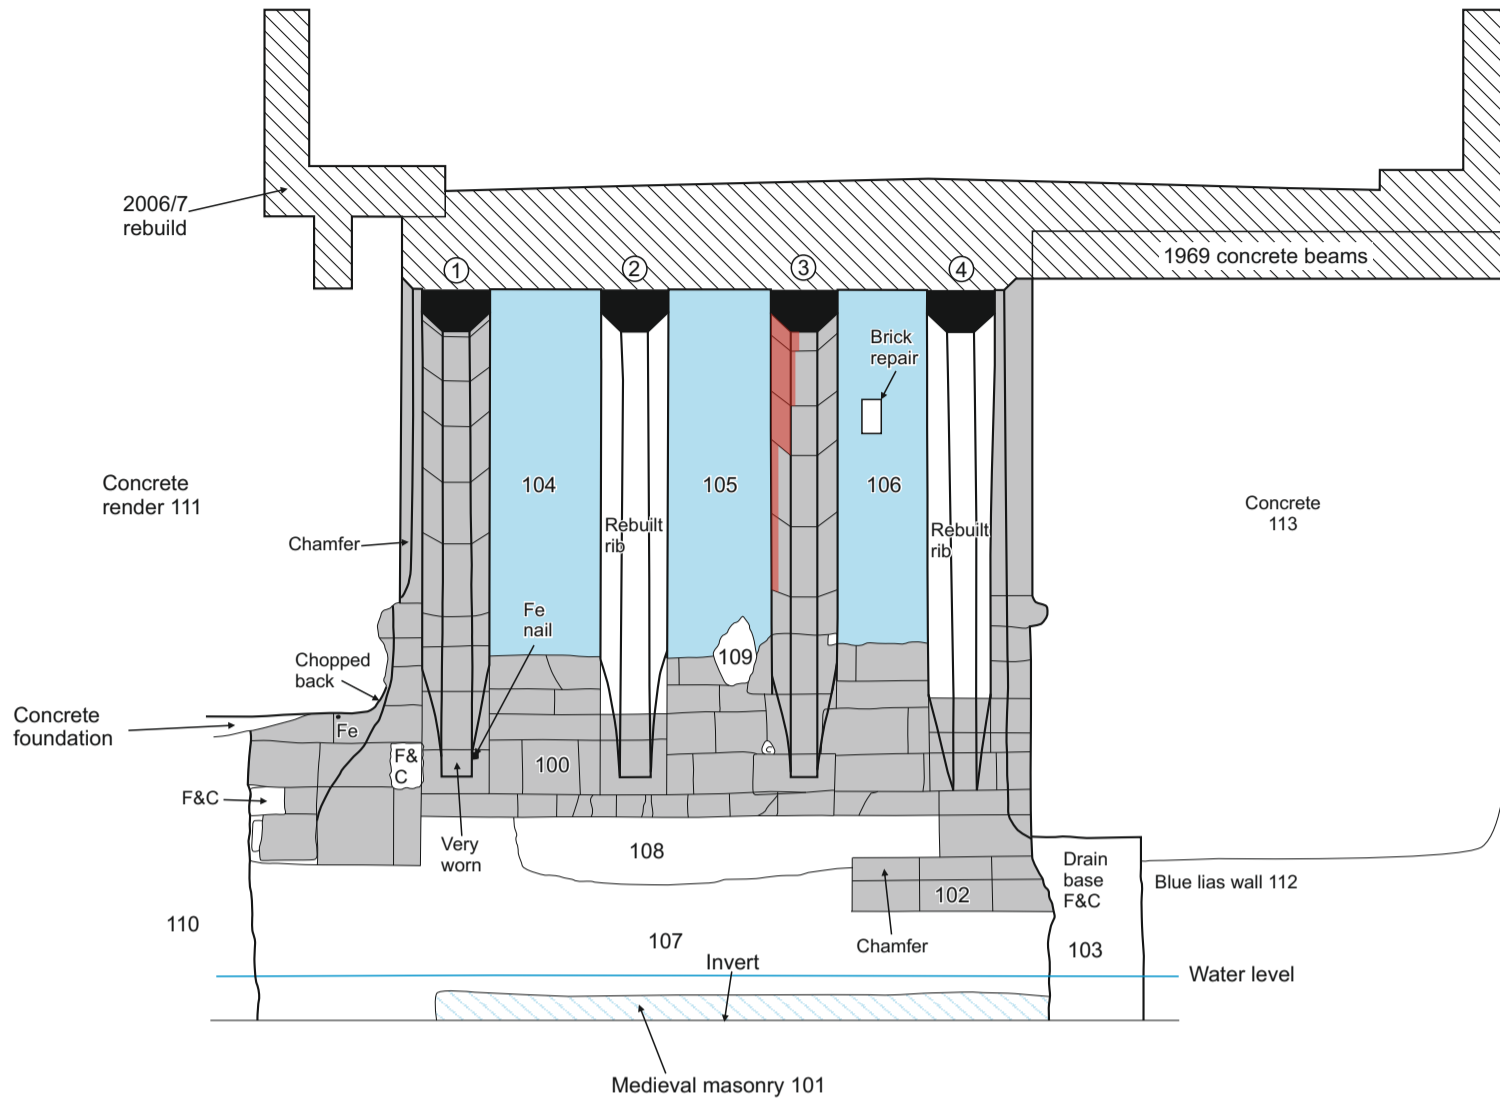
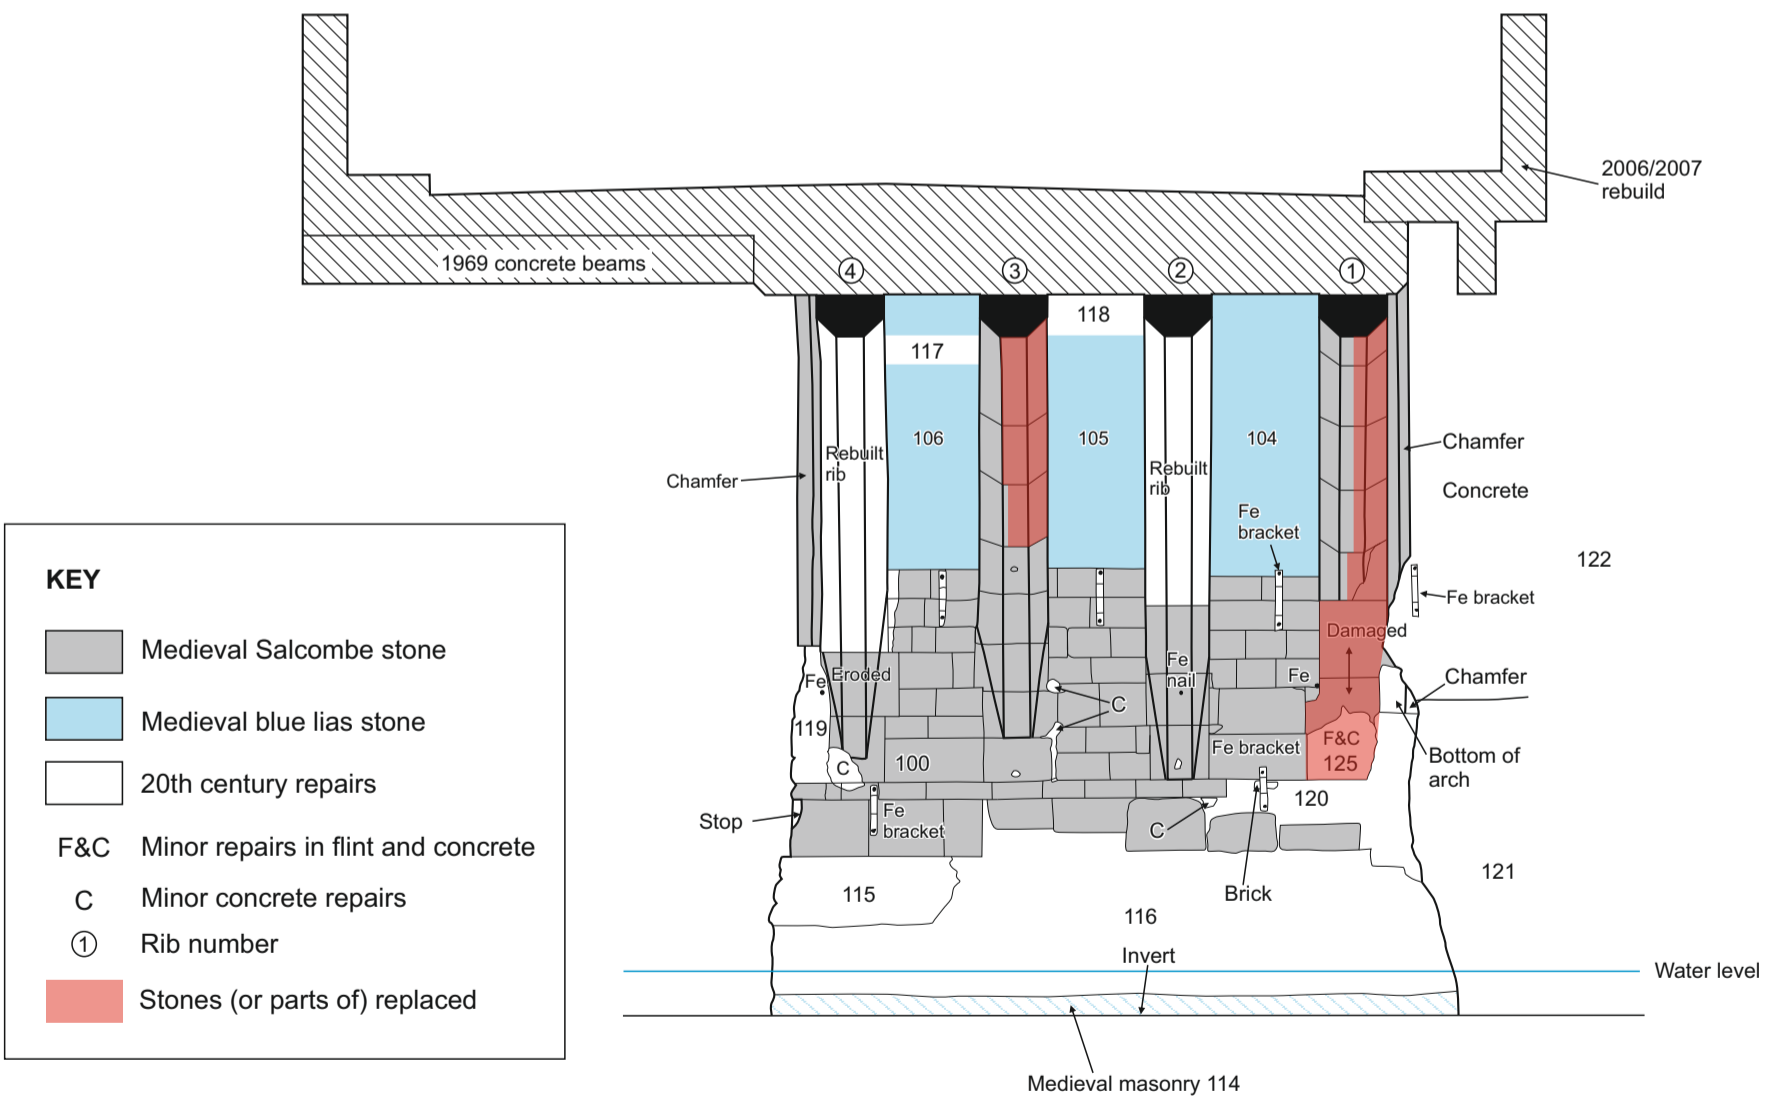
Appendix Fig. 2: The north elevations of ribs 1 and 3 showing locations of replaced stones

1. Damaged elements of the individual voussoirs of ribs 1 and 3 were removed. On both ribs these were on the north faces only. On rib 3 only sections of voussoirs were removed (Appendix Plates 1 and 2), whereas on rib 1 the lower stones were also removed/replaced (Appendix Plate 3).
