Halberton Court Farm, Halberton, Devon

An Historic Building Assessment

COAS reference: C1/SBR/16/HFH

October 2016

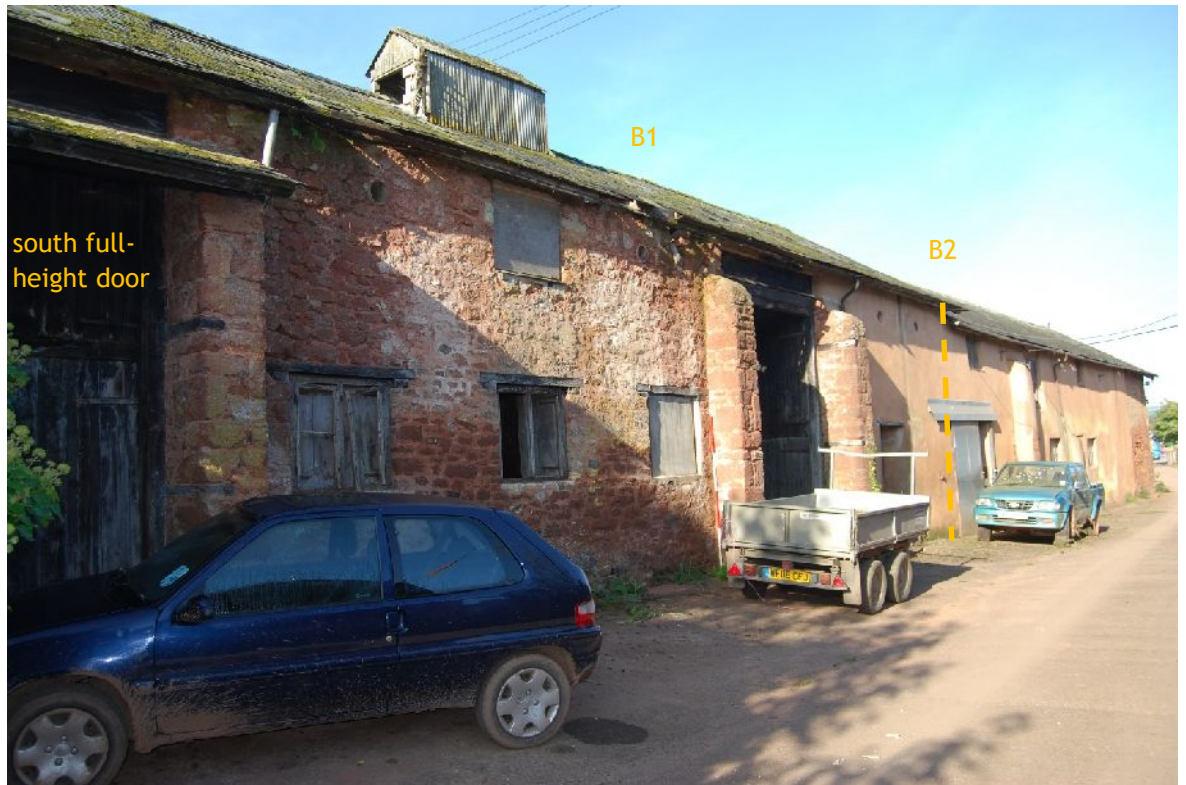
4.4 The roof is supported on scissor beam trusses (**Plates 7 & 8**), which are also a feature of B2 (see below). The central wall of the north-east elevation has four shuttered windows (three at ground floor level and one above) (**Plates 1, 9, 10 & 11**). The south-west elevation also has a blocked rectangular window at first floor height (**Plates 12 & 13**). A change in the surface treatment of the walls and evidence of blocked floor joist sockets suggests the existence of a first floor perhaps for storage or specific activities (**Plate 14**).

Plate 1. North-east elevation of B1 & B2 (from SE; 2m scales)

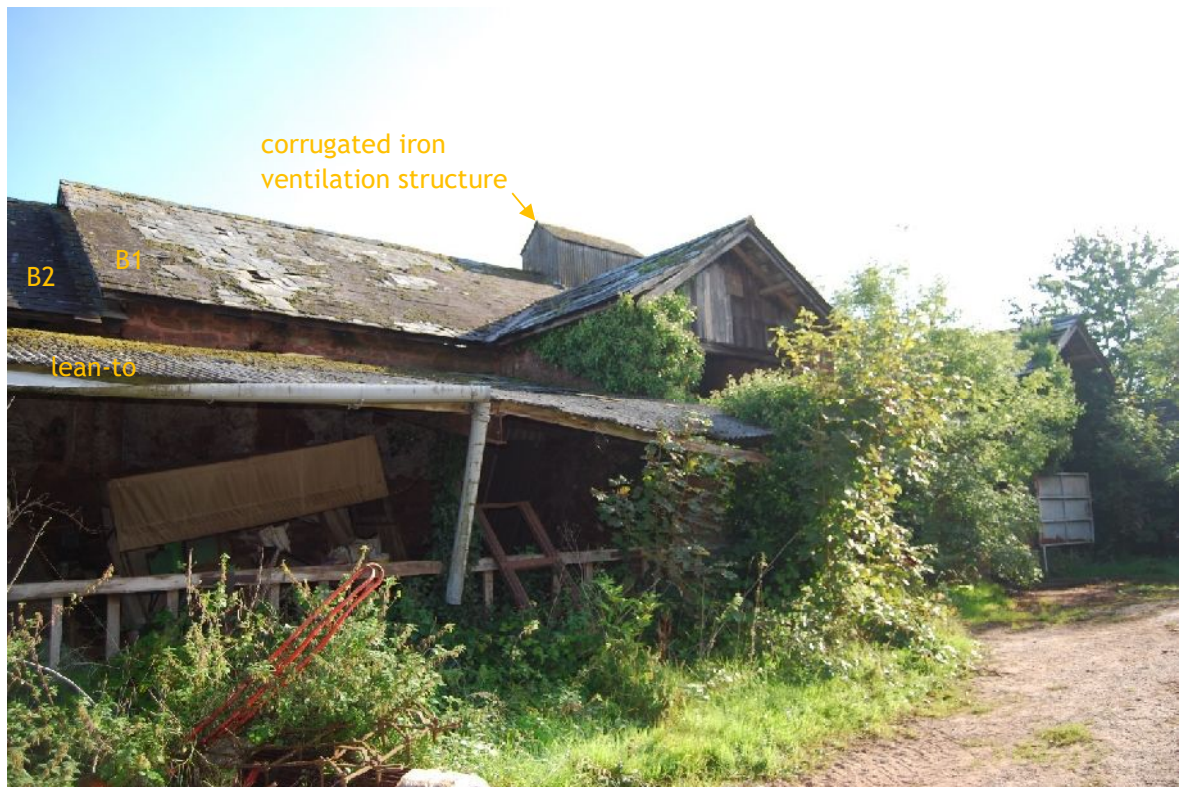
4.2 The main barns pre-date 1814 and consist of two adjoining barns on the western side of the main farm track; B1 is earlier with the south-eastern end of B2 abutting the north-western end of B1. Externally, the roof and eaves level of B1 are slightly higher than those of B2, and the exterior faced with random rubble (**Plate 1**). Both roofs are covered with slate tiles, a corrugated iron ventilation structure on the roof of B1 representing a later addition (**Plates 2 & 3**).

Plate 2. South-west elevation of B1 (from NW; 2m scales)

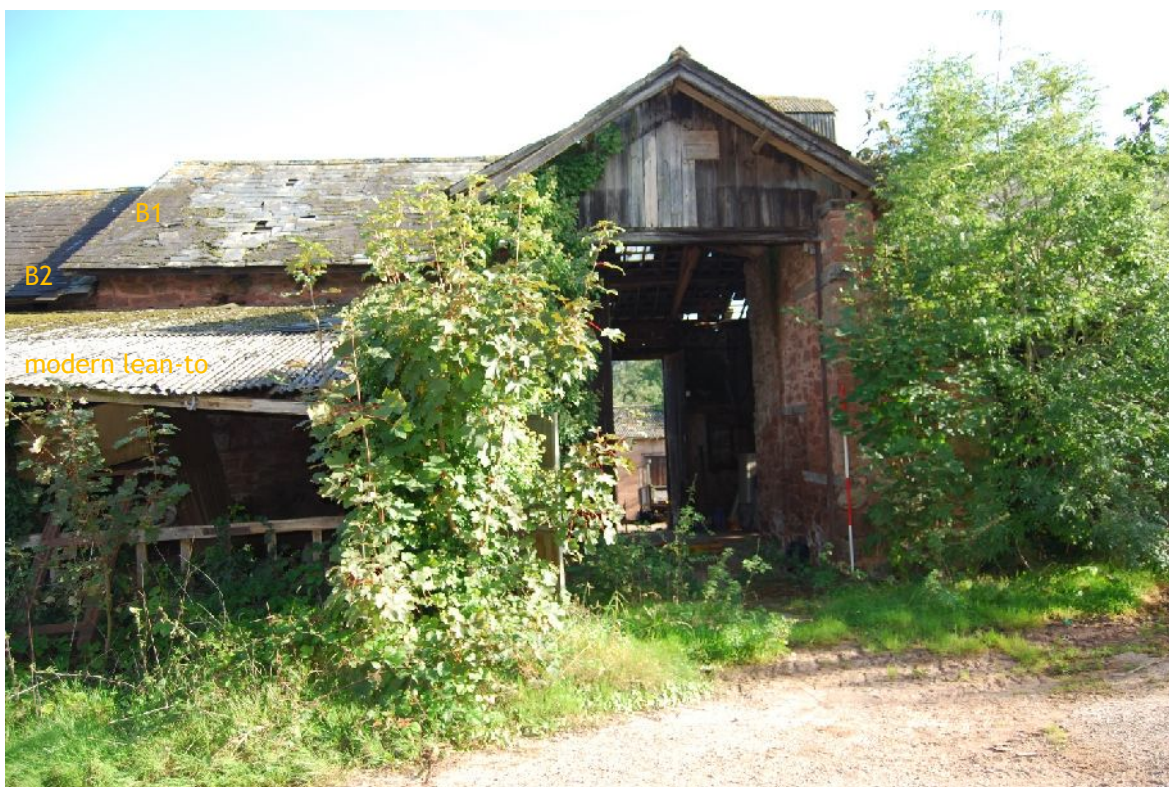
4.3 Opposite the two full-height doors in the north-east elevation, are two opposing porches also with full-height doors (**Plates 4 & 5**). The space between the two porches is occupied by a lean-to - map regression shows a structure in this location by 1889, although the brick outer wall suggests this is a later re-build. Map regression analysis suggests the porches were a later addition, added by 1889, and the architectural evidence supports this (**Plate 6**). The south-west elevation is constructed of random rubble with cob walling above, which differs from the random rubble facing of the porches and of the north-east elevation which overlooked the farmhouse and farmyard.

Plate 4. South-west elevation of B1 showing north porch (from WSW; 2m scales)

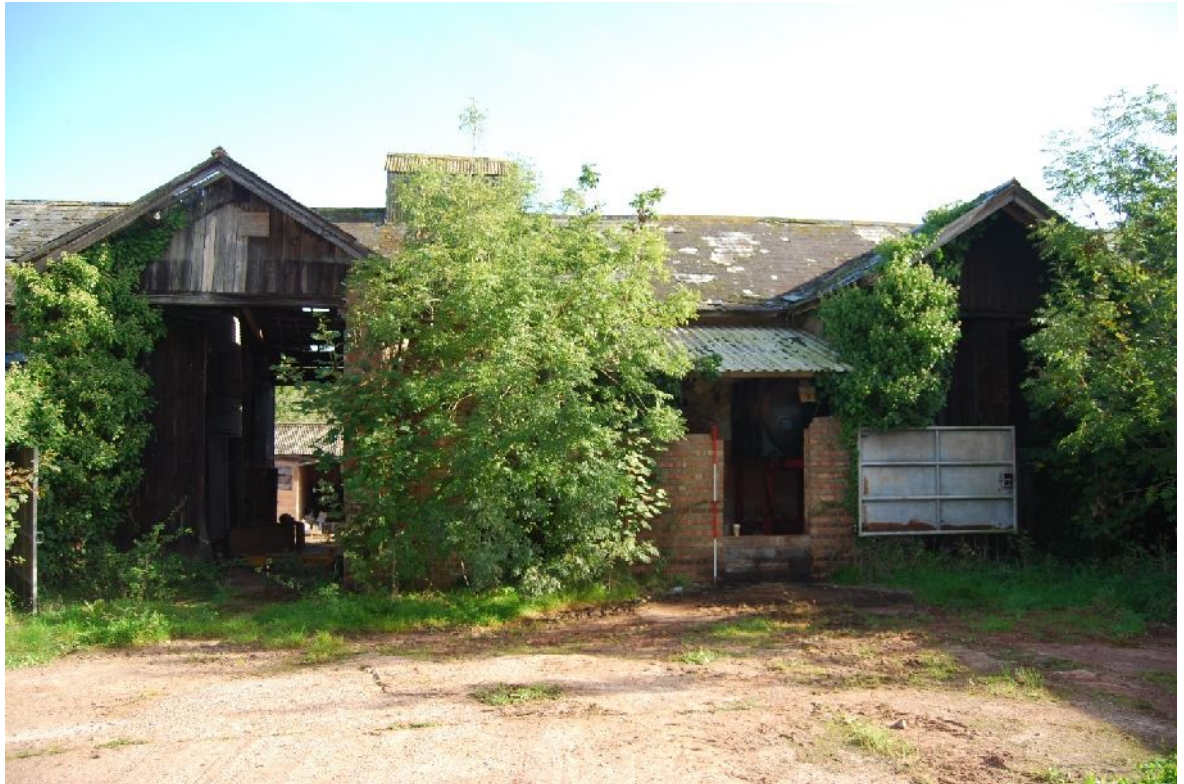
Plate 5. South-west elevation of B1 showing both the north & south porches (from WSW; 2m scales)

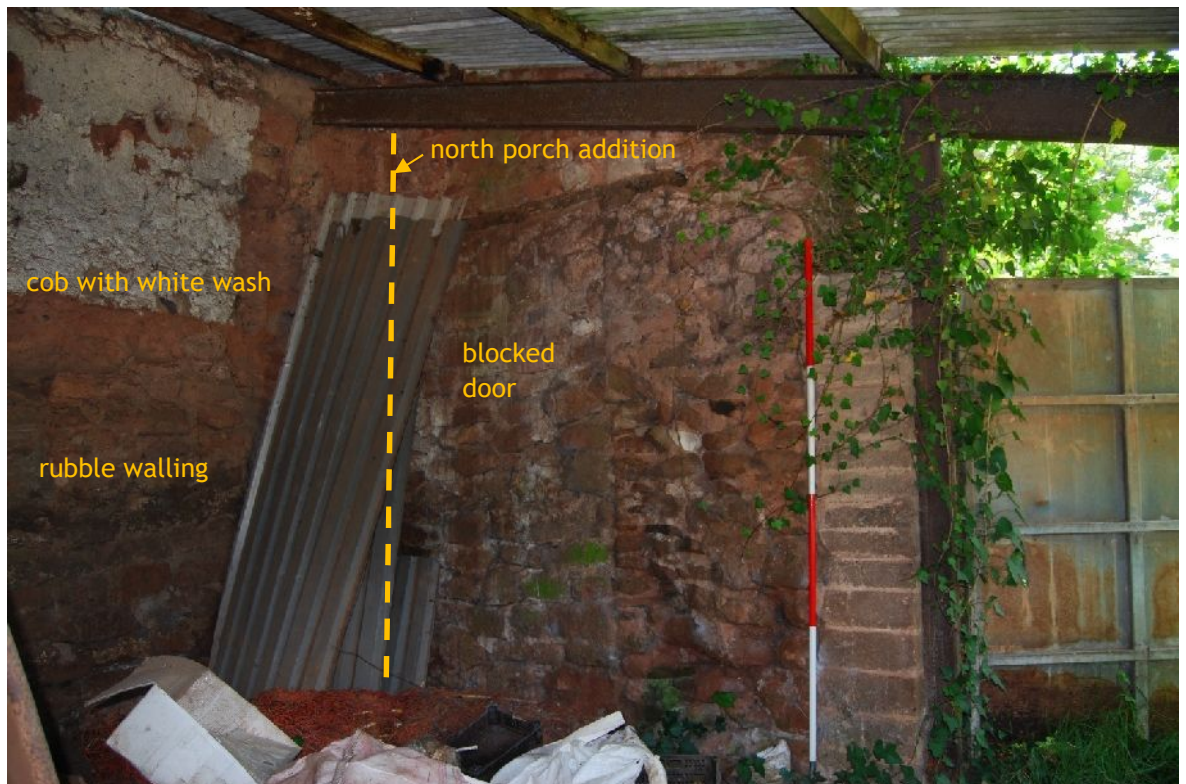
Plate 6. North-west side of added north porch of B1 against SW elevation (from NW; 2m scales)

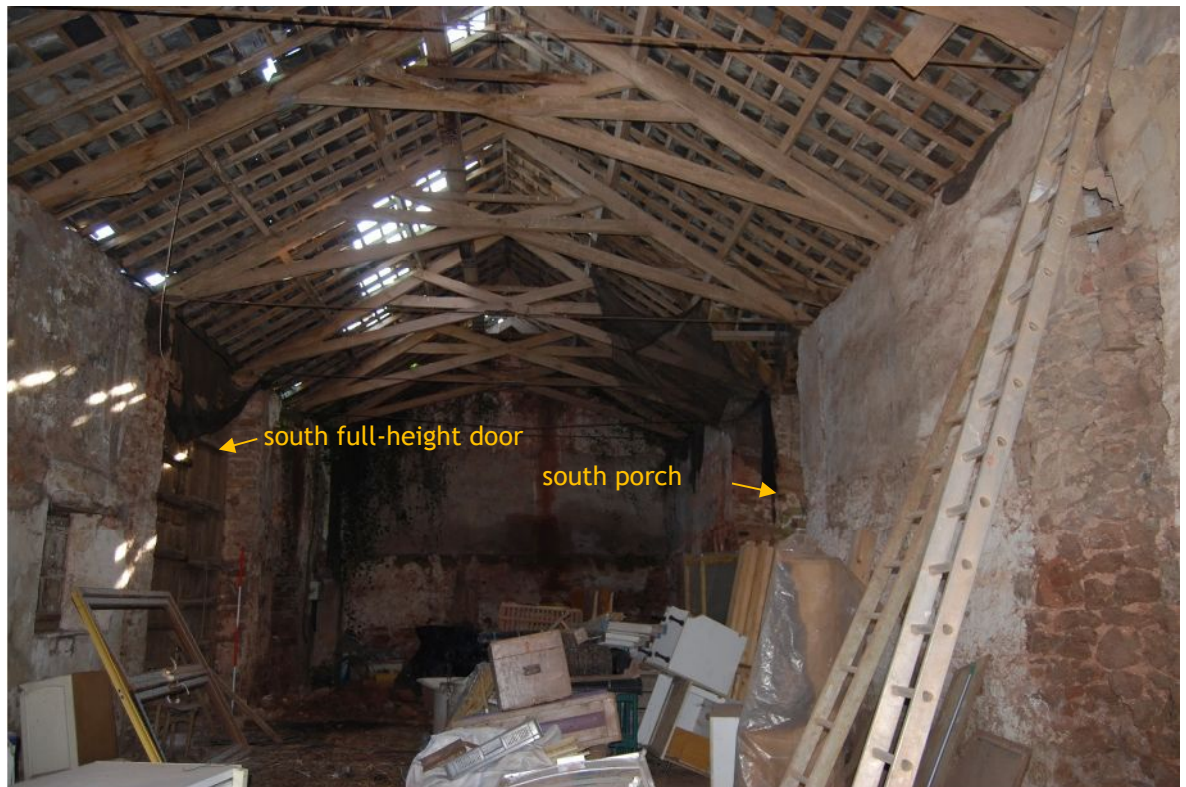
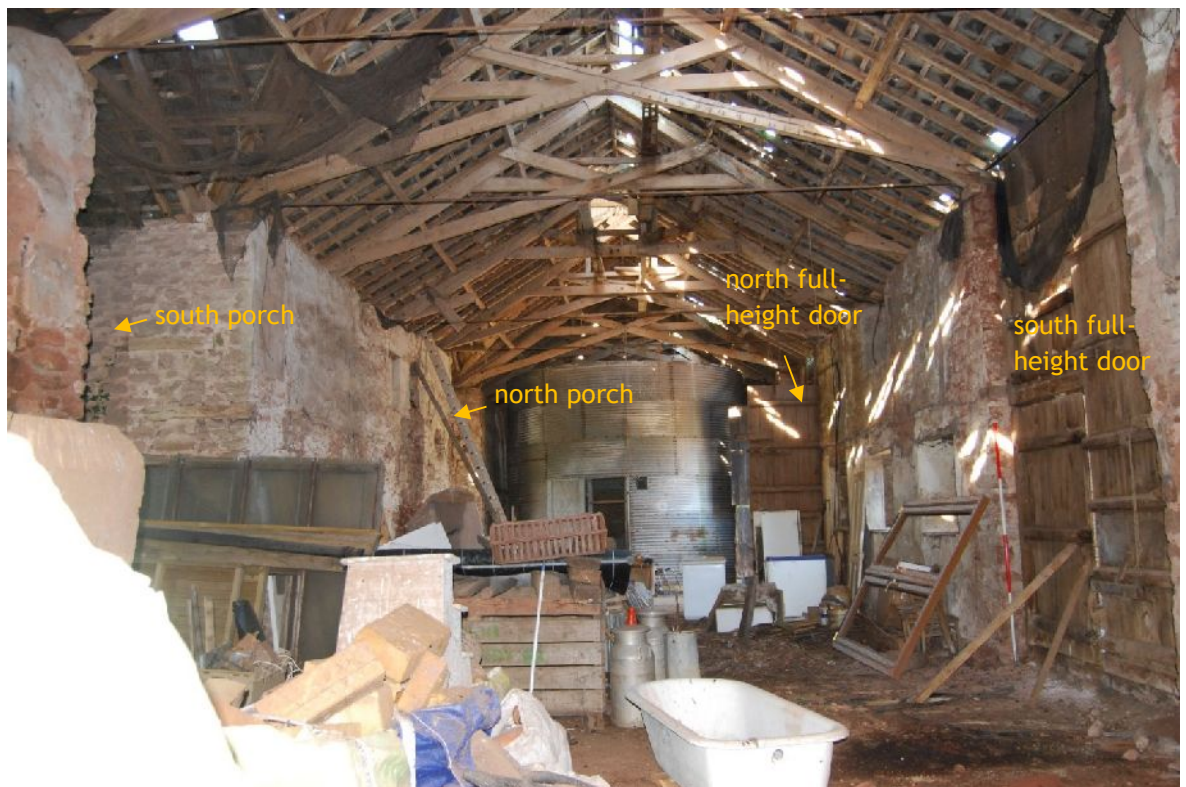
Plate 7. Interior of B1 showing scissor beam trusses (from NNW; 2m scales)

Plate 8. Interior of B1 showing scissor beam trusses (from SSE; 2m scales)

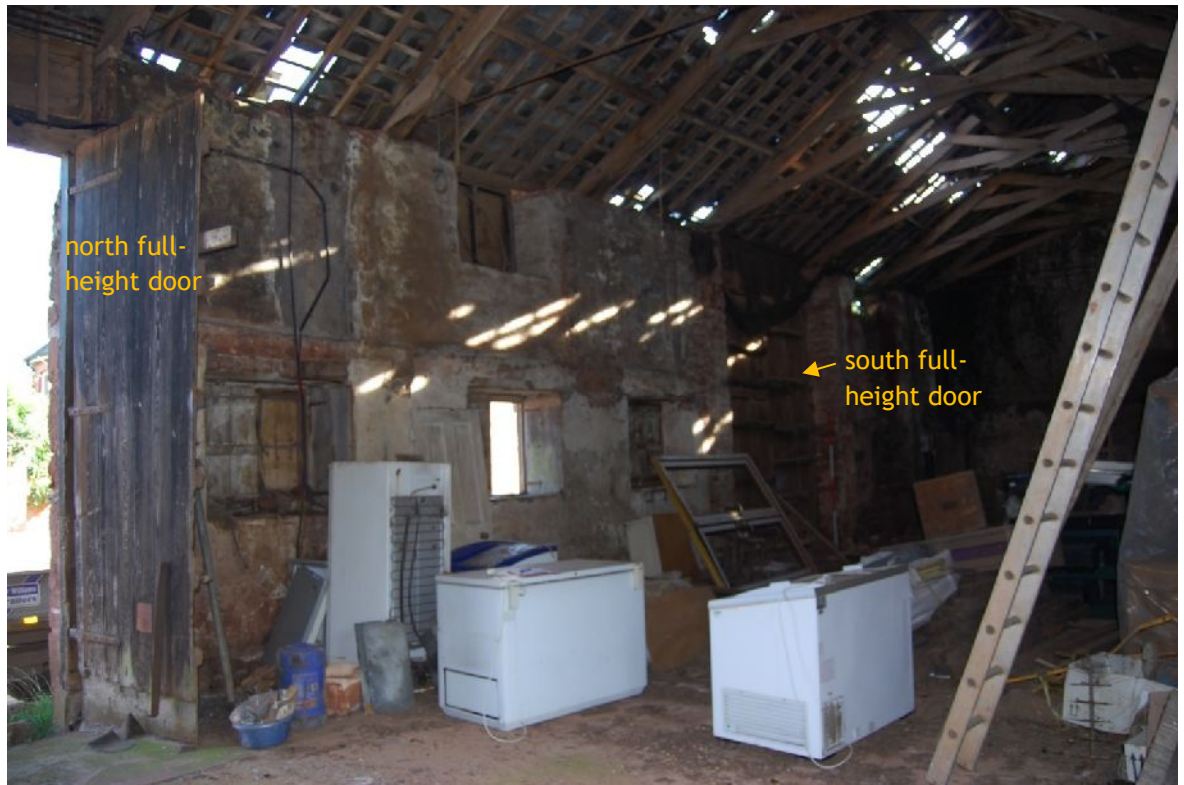
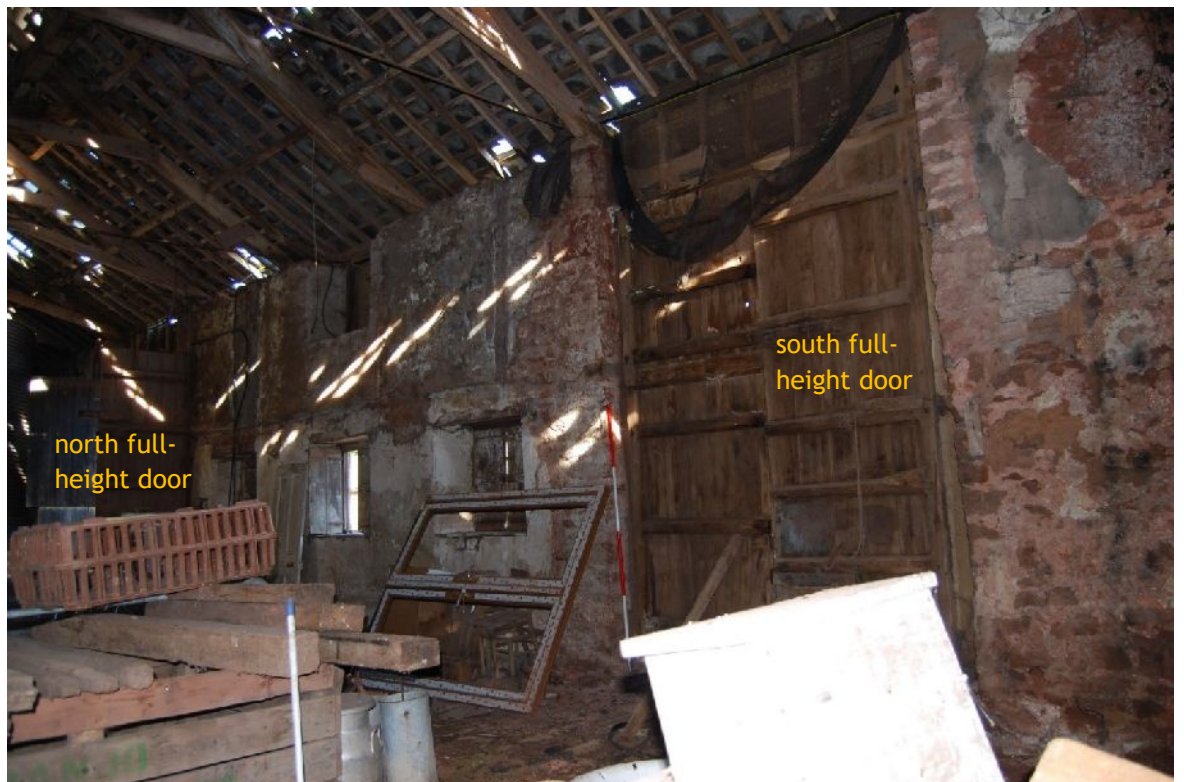
Plate 9. North-east interior elevation of B1 showing 4 shuttered windows (from NW; 2m scales)

Plate 10. North-east interior elevation of B1 showing 4 shuttered windows (from S; 2m scales)

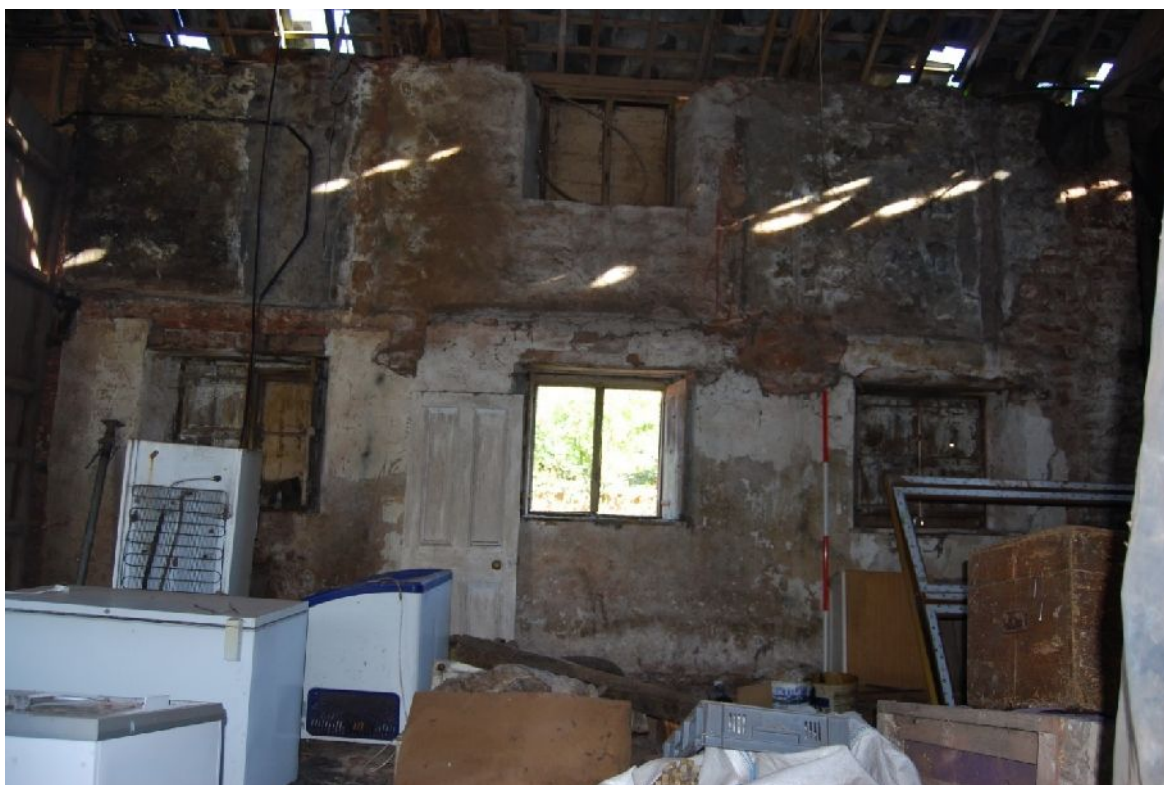
Plate 14. Central part of north-east interior elevation of B1 showing shuttered windows (from SW; 2m scales)

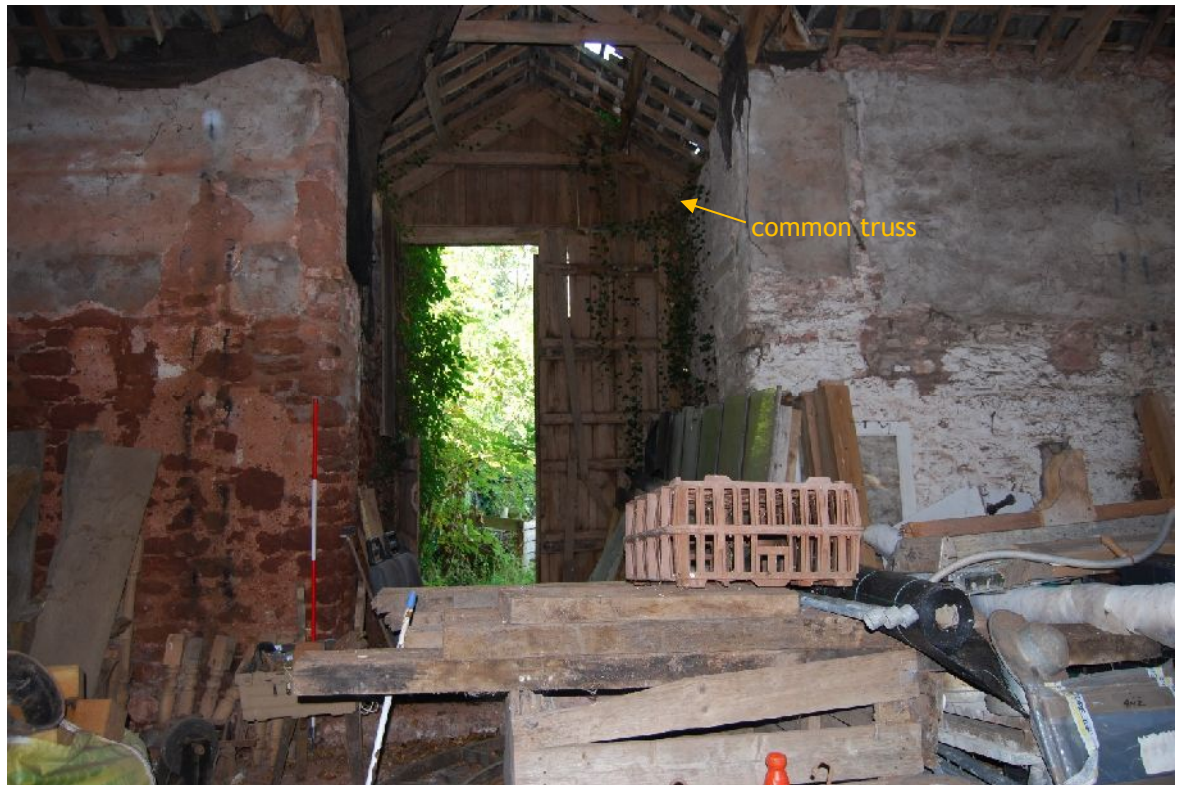
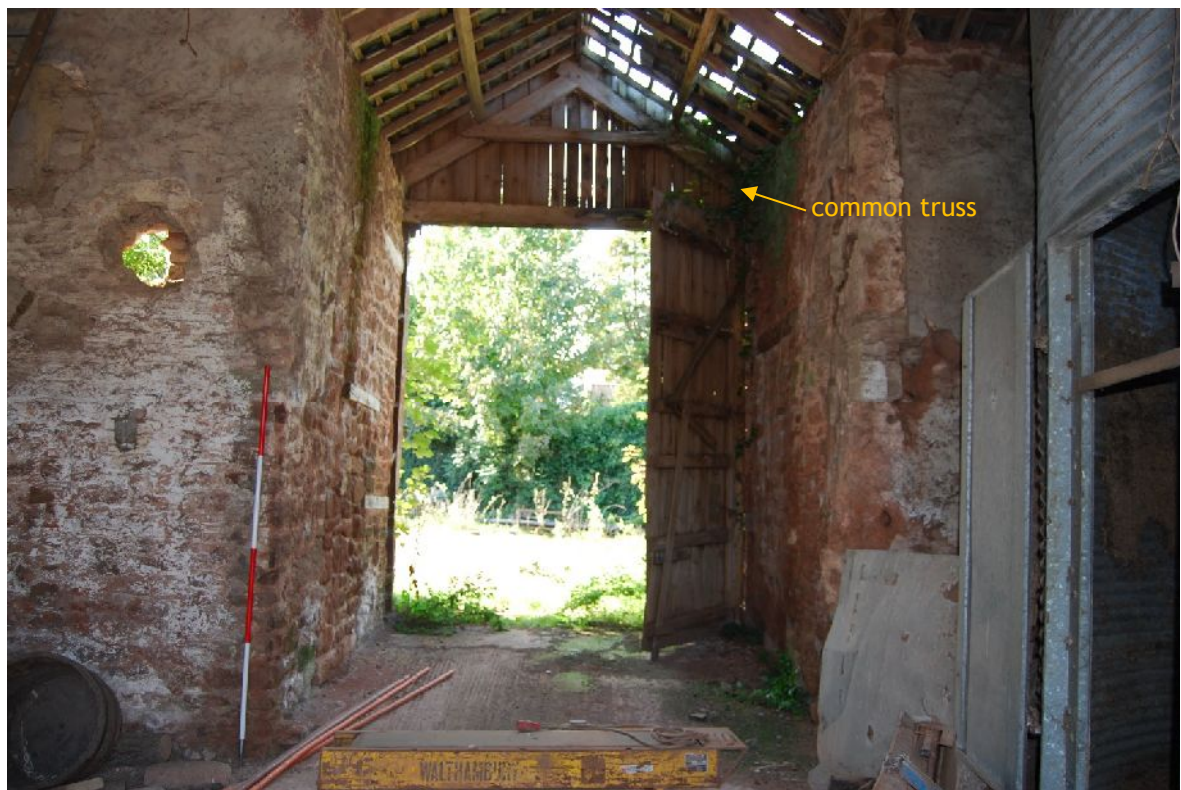
4.5 The roof trusses of the porches are simple A-frames, with rafters halved and pegged together with the blades crossing at the ridge (**Plates 15 & 16**), which differ from the scissor trusses used within the main barn structure. The full-height wooden doors in the porches are identical to the southern full-height door in the north-east elevation (**Plate 17**), suggesting that the three doors are contemporary and that the porch doors were re-used from their original positions. The northern full-height door in the north-east elevation is simpler, with split opening on one side, and is probably later (**Plate 18**). The barn is also accessed by an original door at the southern end of the north-east elevation, an adjacent window sharing the same form as the four shuttered windows in the centre (**Plate 17**). Above the window, the top of the wall is eroded exposing the cob core of the rubble faced wall.

Plate 15. South-west interior elevation of B1 showing south porch with common trusses (from NE; 2m scales)

Plate 16. South-west interior elevation of B1 showing north porch with common trusses (from NE; 2m scales)

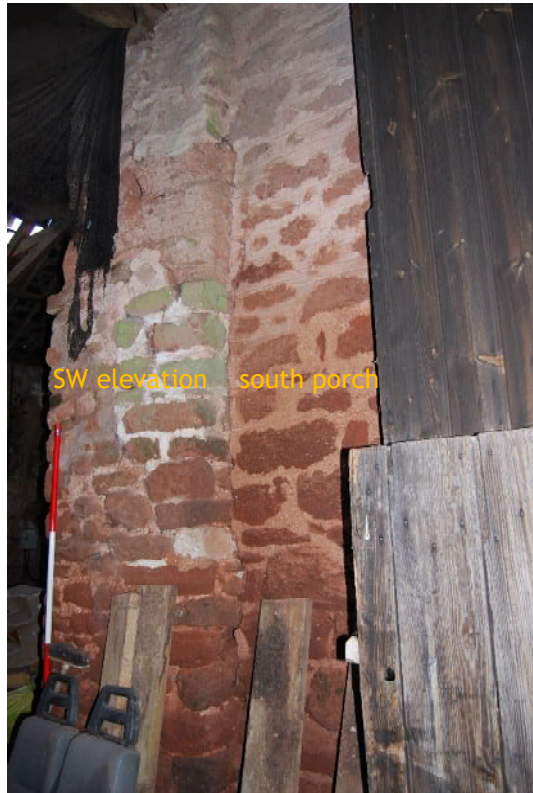
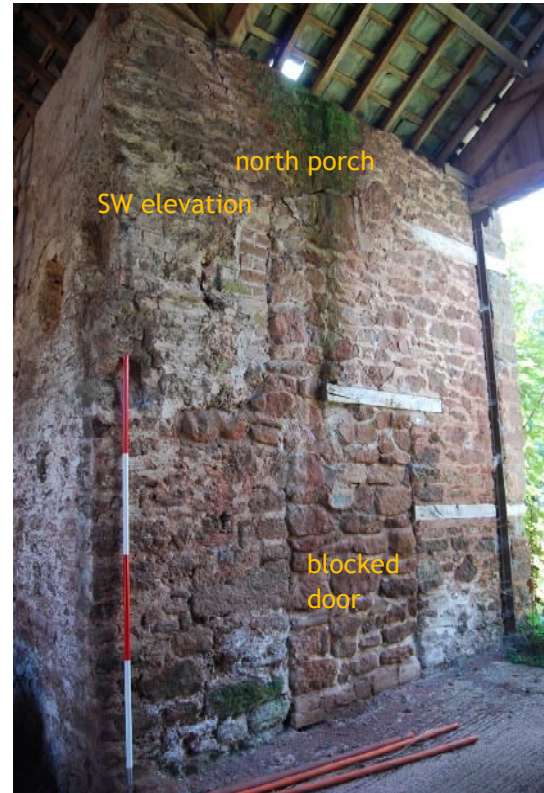
4.6 As for the exterior, the interior masonry of the porches abuts the south-west elevation (**Plates 19 & 20**), with blocked openings evident in the south-east and north-west sides of the northern bay. The other obvious addition is the ventilation structure, which rests on large beams inserted through the scissor beam trusses (**Plate 21**).

Plate 19. South-east side of south porch of B1, added to SW elevation (from WNW; 2m scales)

Plate 20. South-east side of north porch of B1, added to SW elevation (from WSE)

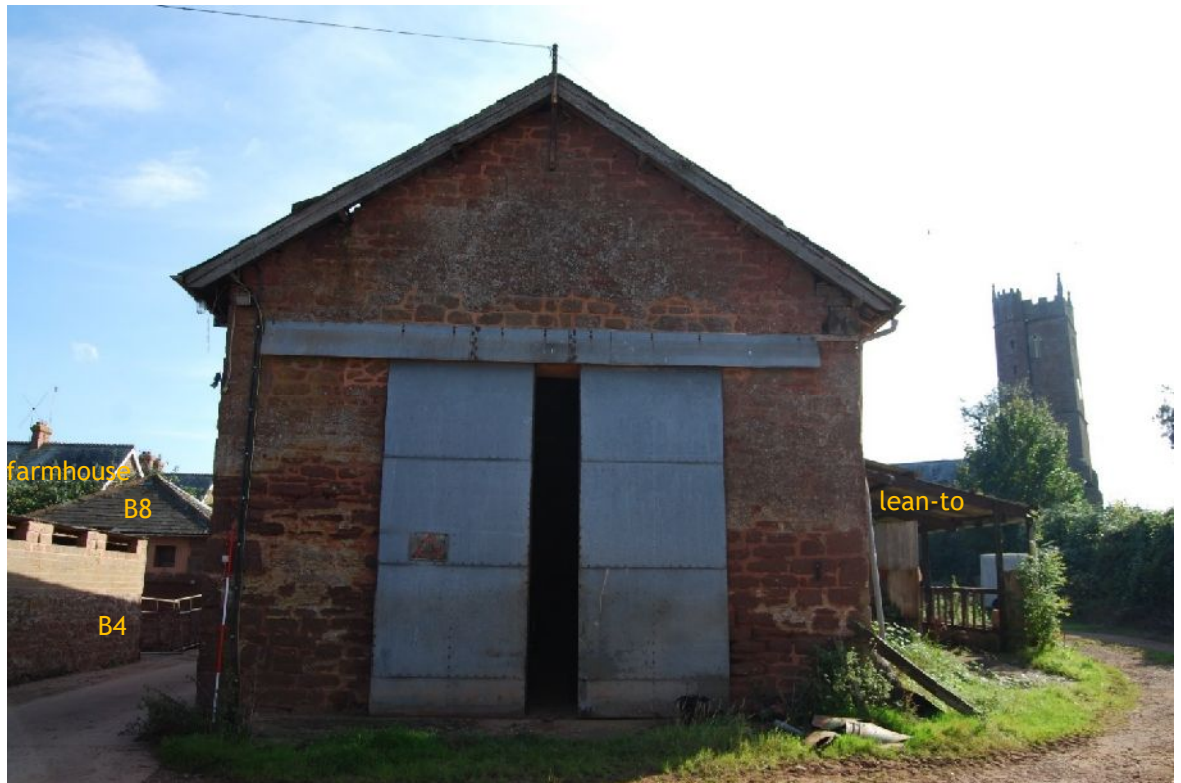
- 4.7 The northern end of B2 has been altered quite extensively. Firstly, the random rubble of the north-east elevation may not be original, as this part of the building once had a return (demolished by 1889). Unfortunately, it is not possible to compare the fabric with the remainder of the elevation as it is covered in render (**Plate 22**), although the north-west gable is of a similar construction, albeit now accommodating large sliding metal doors (**Plate 23**). The opposing south-west elevation has been re-built in brick (**Plate 24**).

Plate 23. North-west gable of B2 (from NW; 2m scales)

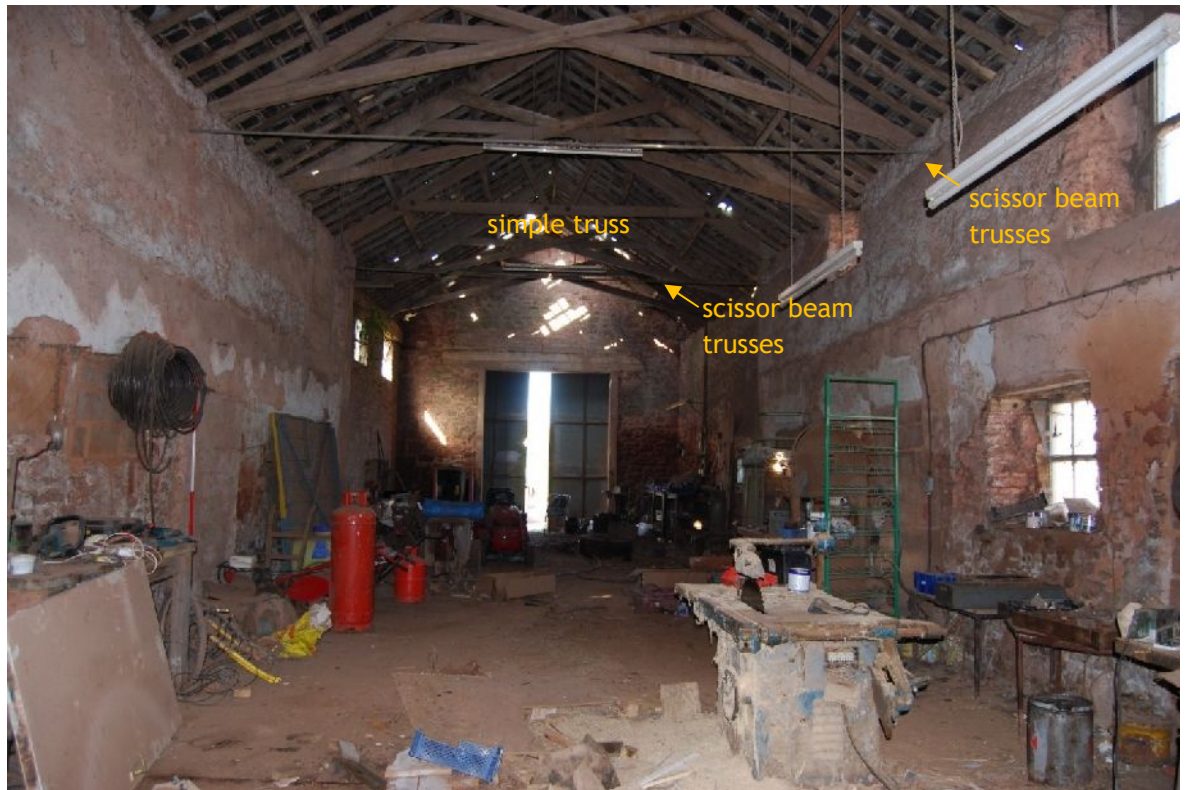
- 4.9 Internally, the change in build at the north end is not only marked by the use of different materials (see above) but the walls are also set back slightly (**Plate 28**). The original walling comprises random rubble with cob above and scissor beam trusses supporting the roof, with the single exception of a simple raised truss at the junction between the original fabric and the largely re-built north end (**Plate 29**).

Plate 29. Interior of B2 (from SE; 2m scales)

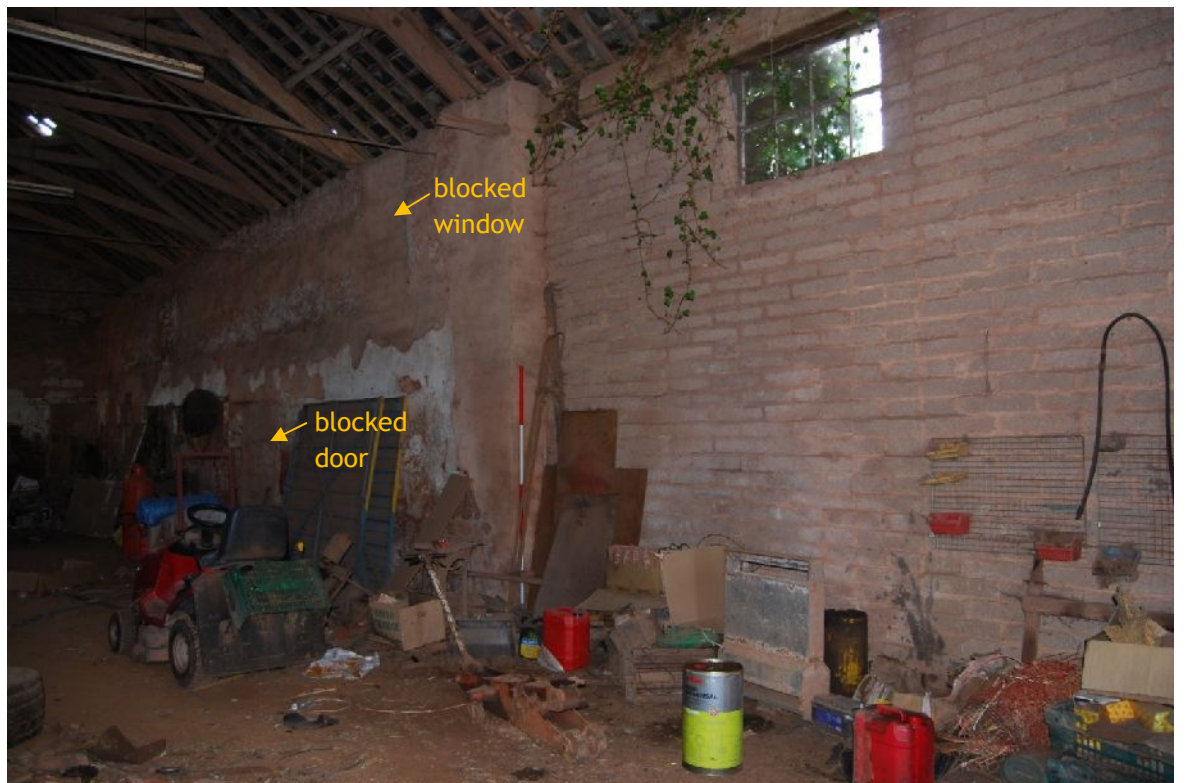
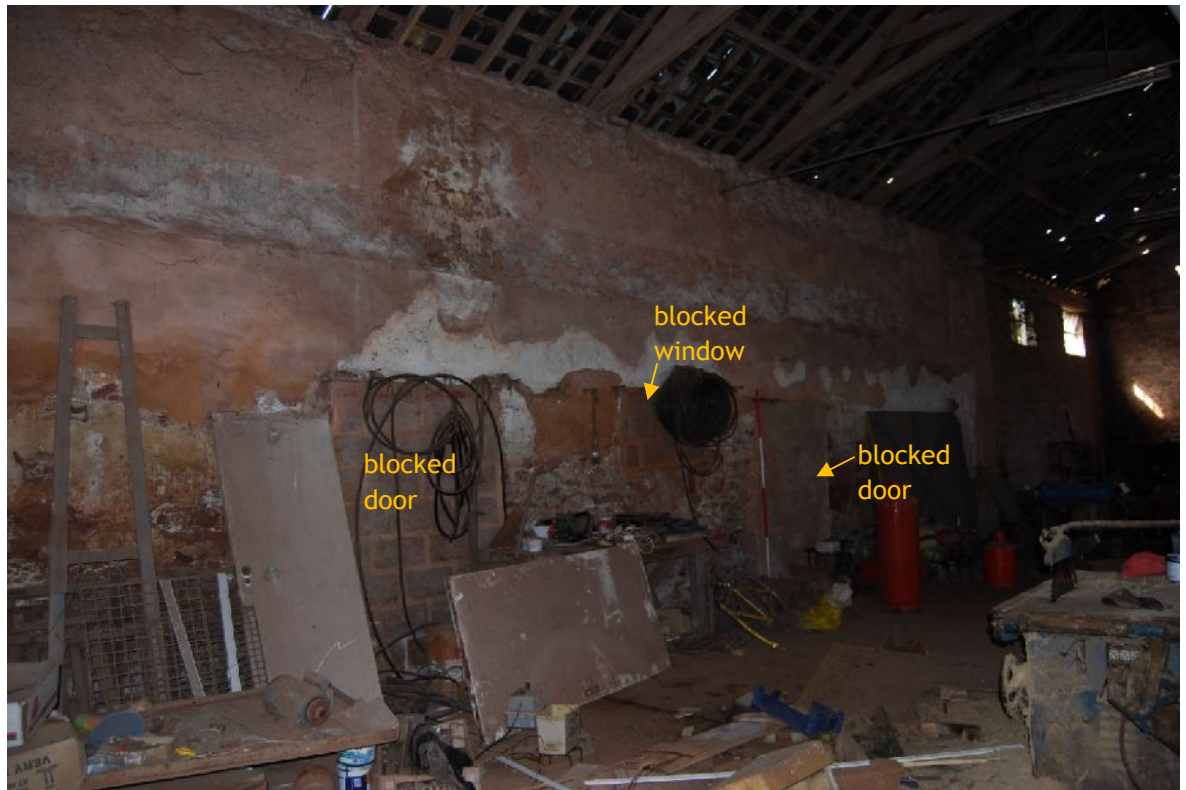
- 4.10 In the south-west elevation there is evidence of three blocked doors, a blocked window and a first floor blocked window (**Plates 27, 30 & 31**), while in the north-east elevation there are three blocked doors interspersed with two extant windows and two further extant windows above at first floor level (**Plate 32 & 33**).

Plate 30. South-west interior elevation of B2 (from N; 2m scales)

Plate 31. South-west interior elevation of B2 (from SE; 2m scales)

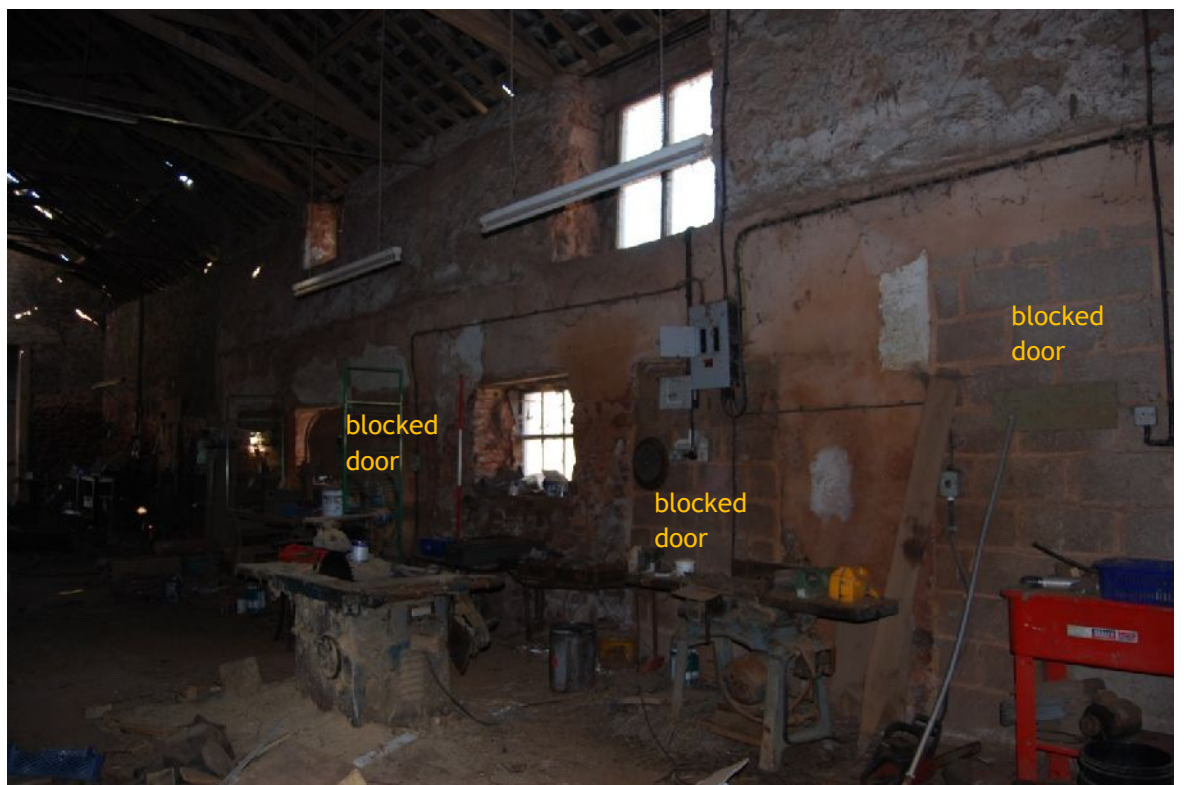
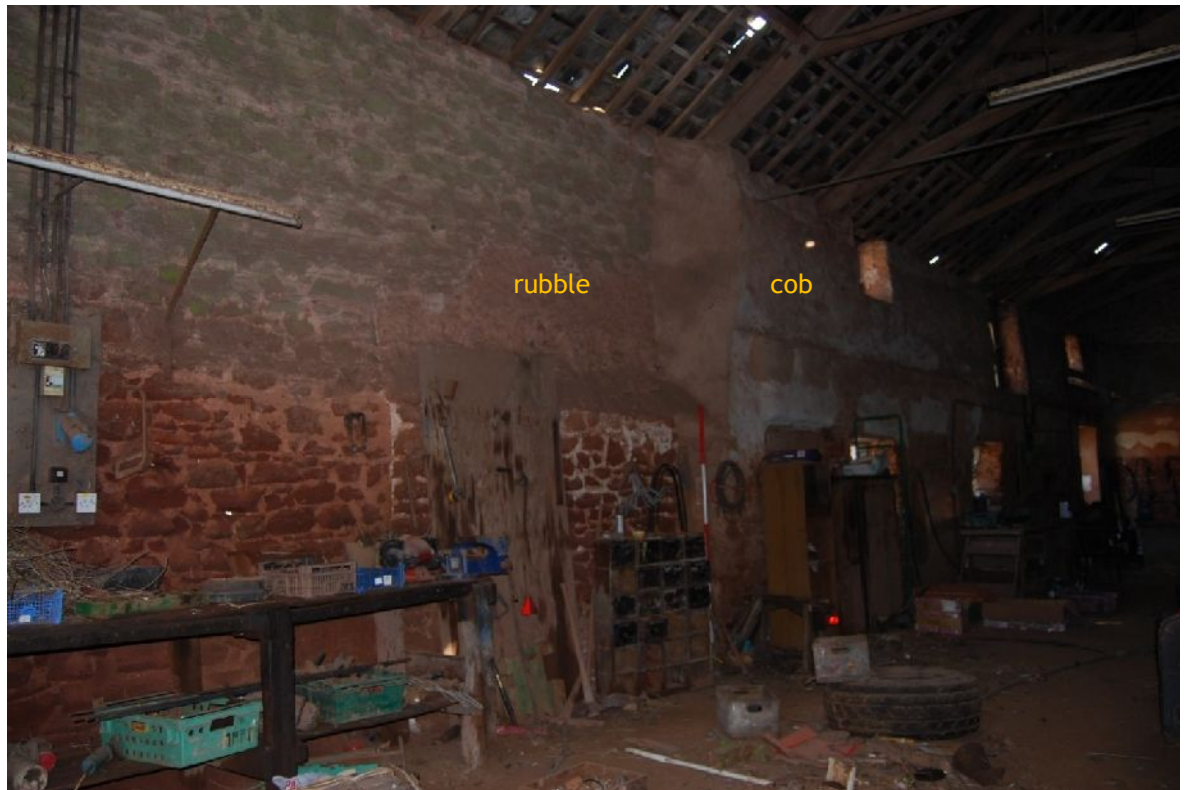
Plate 32. North-east interior elevation of B2 (from S; 2m scales)

Plate 33. North-east interior elevation of B2 showing change in build at N end (from NW; 2m scales)

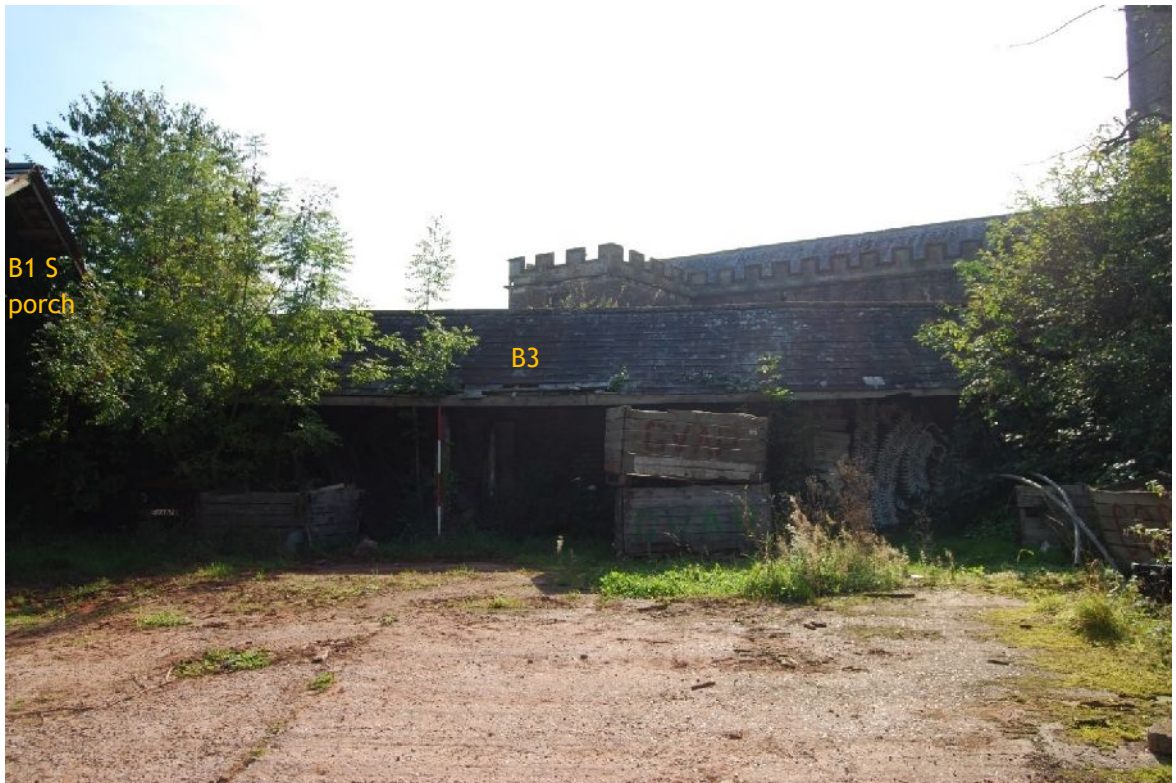
- 4.11 The open-sided building adjoining the churchyard abuts the southern end of the south-west elevation of B1 and overlooks a small yard on the south-western side of B1 and B2 (**Plate 34**). The slate roof is supported on king post trusses resting on a rear (south) wall of random rubble with posts supporting the front of the structure (**Plate 35**). However, much of the rear wall has been re-built with concrete blocks with concrete block piers providing extra support for the roof trusses. The eastern end is subdivided by a random rubble wall with modern brickwork above within the roof space (**Plate 36**). There are blocked rectangular openings at the top of the rear wall of this eastern subdivided area.

Plate 34. North-north-west side (open-fronted) of B3 (from NNW; 2m scales)

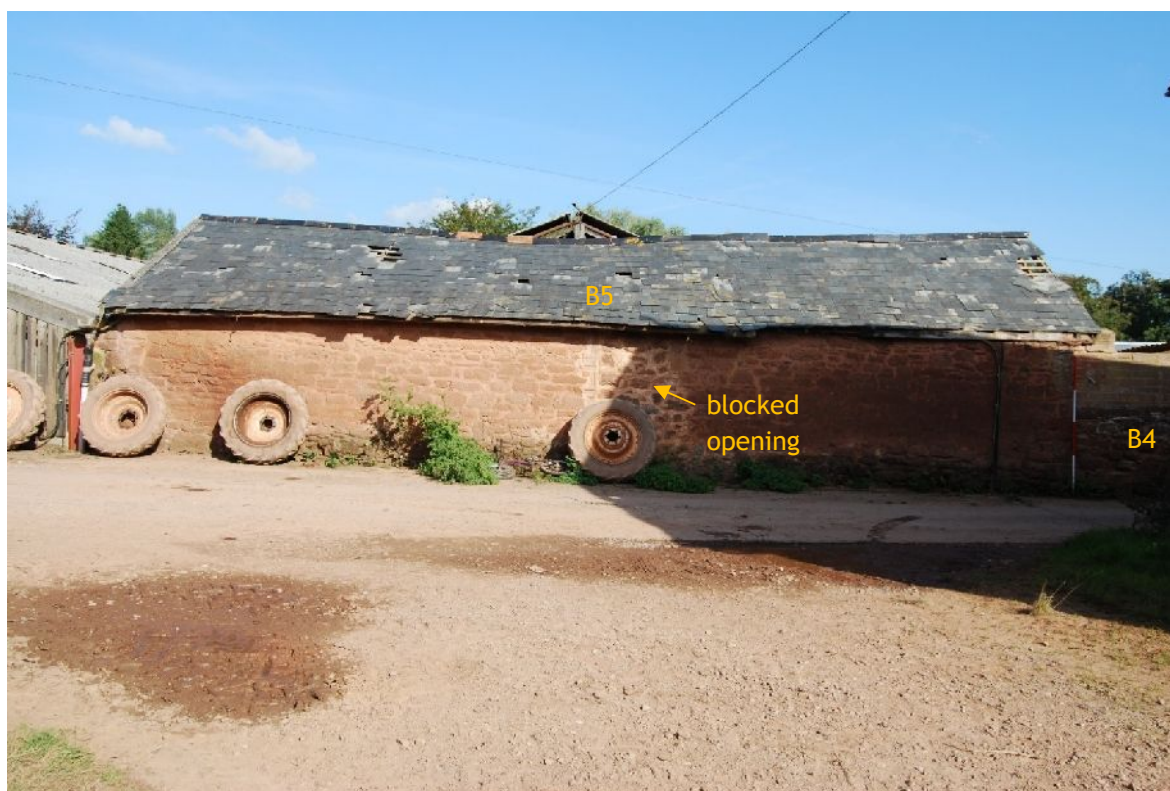
- 4.12 On the eastern side of the main farm track are a series of small farm buildings, including B4 and B5 (Plate 37). B4 was not present on OS mapping until 1969, however the random rubble wall forming its rear (south-western) wall may be earlier (although not before 1838 as the eastern return of B2 once occupied this location). This rubble wall is topped with concrete blocks (Plate 38) with the remains of a corrugated iron roof supported on steel uprights at the front (north-east side) (Plate 39). The south-east gable wall is of modern brick while the north-west end is formed by the south-east gable wall of B5 constructed of random rubble. This is abutted by the south-west rear wall of B5, also constructed of random rubble. A blocked opening in the rear wall (Plate 37) may possibly have provided access from the farm track directly to the first floor, the existence of which is indicated by two stone corbels (Plate 40). The south-east gable wall is of some antiquity and has been repaired quite considerably, suggesting it might possibly be a remnant from the north wall of the B2 north-east return (Plate 41). The north-west end wall (together with the north range depicted on the 1889 OS map) has been replaced by a modern barn wall.

Plate 37. South-west exterior elevation of B5, continuing into B4 (from SW; 2m scales)

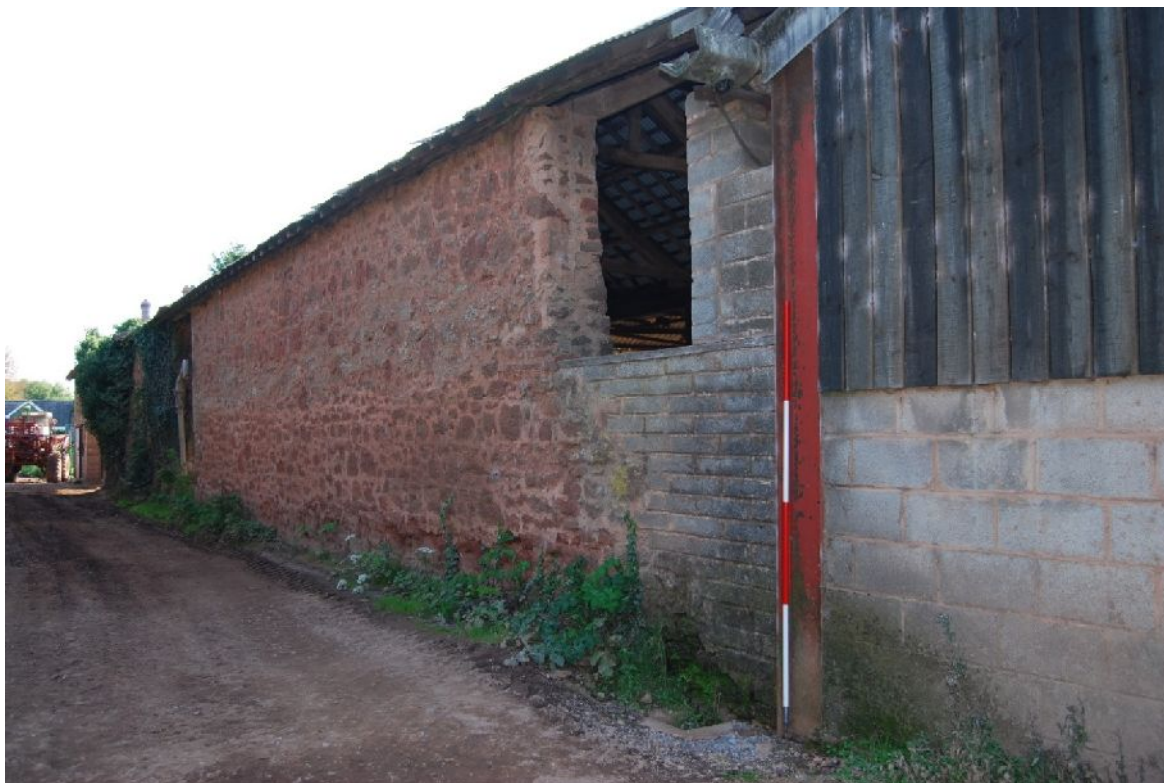
Plate 42. North-east exterior elevation of B6 (from NNW; 2m scales)
